Traffic Paint Performance in Accelerated-Wear Tests

JAMES E. BRYDEN AND RONALD A. LORINI

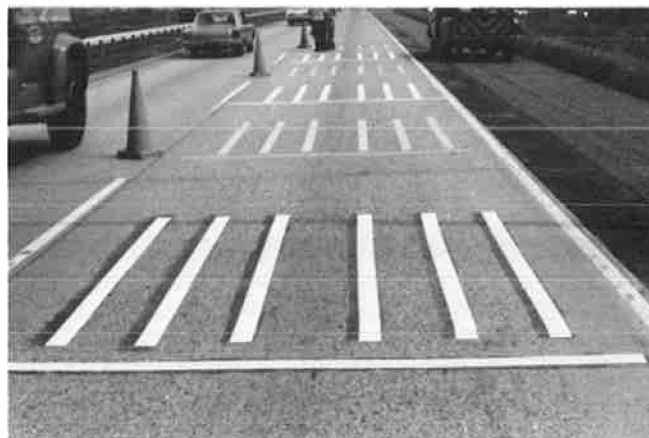
FIGURE 1 Typical completed stripe sets.

Seven lines were installed for each set of test stripes—six 10-ft long longitudinal and one transverse stripe across the lane at the upstream end of the longitudinal lines (Figure 1). Two lines of each set were located in the apparent wheelpath; the other four were spaced across the lane. This layout was thought to offer several advantages over a test layout consisting of transverse stripes:

*WP = wheelpath (Stripes 2 and 3 in Fig. 1),
INT = intermediate (Stripes 3 and 6), NWP =
non-wheelpath (Stripes 1 and 4).

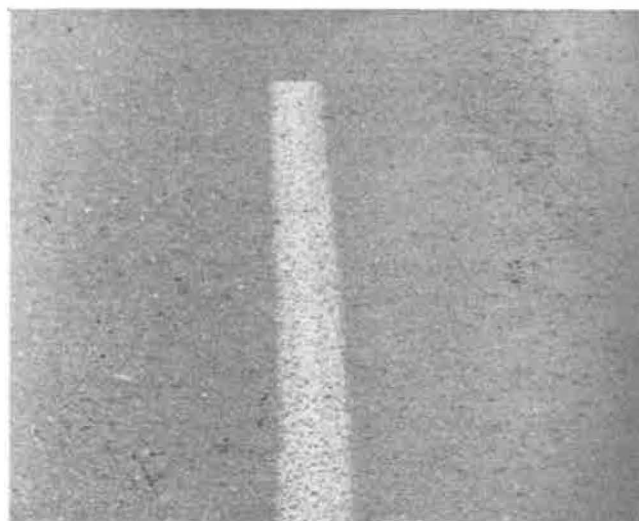
FIGURE 4 Paint stripe rated 4.

1. Durability was evaluated with ASTM D 821-47 (Evaluating Degree of Abrasion, Erosion, or a Combination of Both, in Road Service Tests of Traffic Paints) and D 913-51 (Evaluating Degree of Chipping of Traffic Paint). A single rating on a scale of 0 to 10 (10 is perfect and 0 is complete line loss) was assigned to each of the six longitudinal stripes. The lower of the abrasion or chipping ratings was used to indicate condition, and the controlling wear mode was noted. Typical ratings are shown in Figures 2-5.
