W-Beam Guiderail Transition from Light to Heavy Posts

DONALD G. HERRING AND JAMES E. BRYDEN

Two full-scale crash tests evaluated a transition between light- and heavy-post W-beam guiderail. The transition consisted of lowering the rail height from 30 to 27 inches and reducing the spacing of the light posts as the heavy-post section is approached. The crash-test impacts were just upstream of the heavy-post section using 1,800- and 4,500-pound sedans. Test results were generally acceptable in terms of National Cooperative Highway Research Program (NCHRP) criteria. Although the exit trajectory of the 4,500-pound sedan exceeded the recommended threshold limits, the vehicle was not judged to present a significant threat to other vehicles.

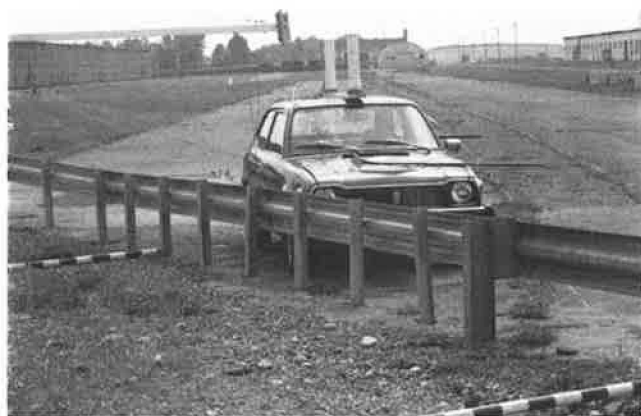
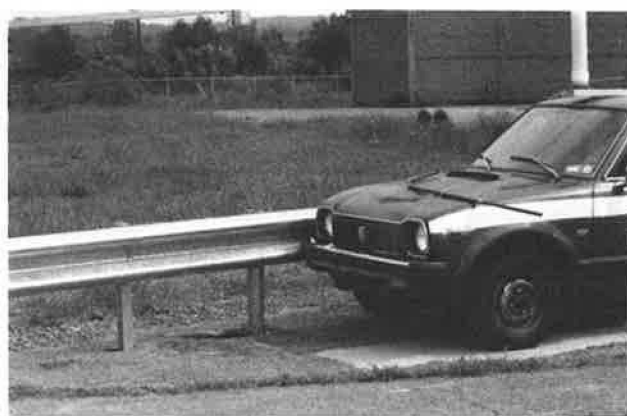
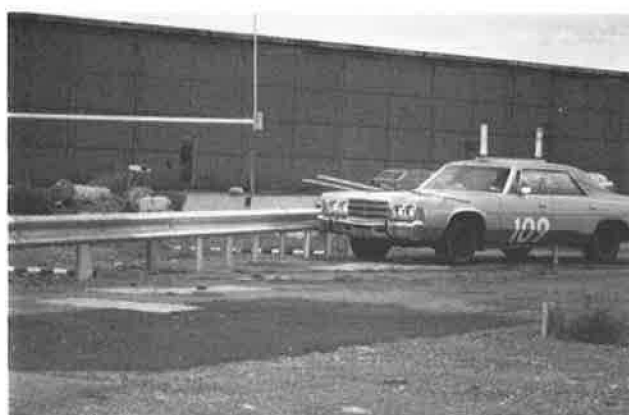
FIGURE 3 Vehicles and barriers before impacts in Test 108 (top) and Test 109 (bottom).

The barrier, constructed of standard 12-gauge W-beam guiderail, transitions from light post (S3 x 5.7) to heavy post (W6 x 9) with blockouts. The barrier consisted of eighteen W-beam sections totaling 225 feet in length and was terminated at both ends with standard turndowns and precast concrete anchors. A plan view of the barrier as tested is shown in Figure 2, with additional details in Figure 3.

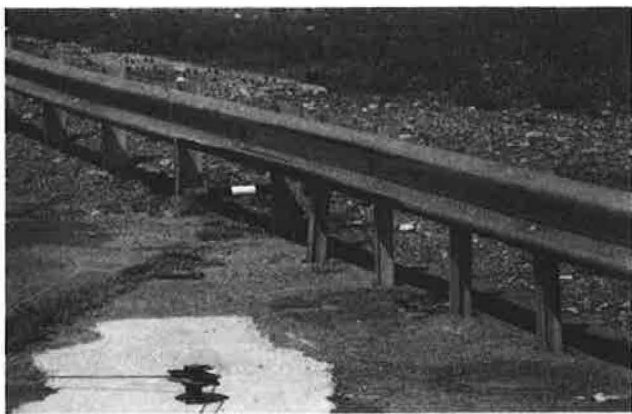
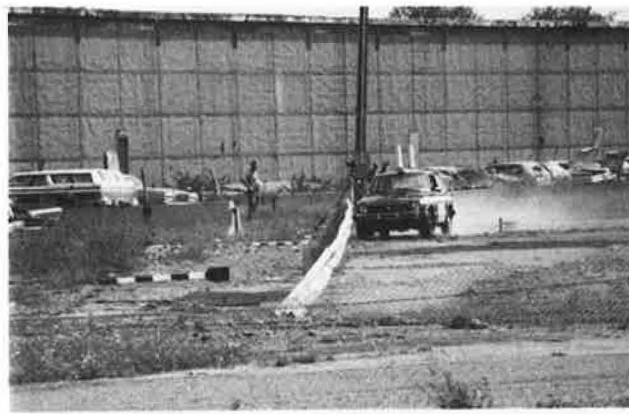
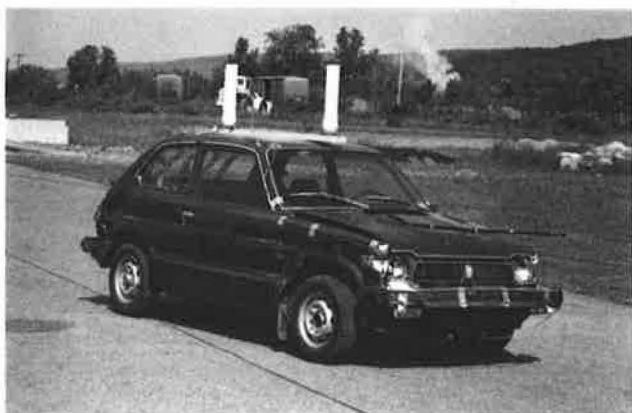
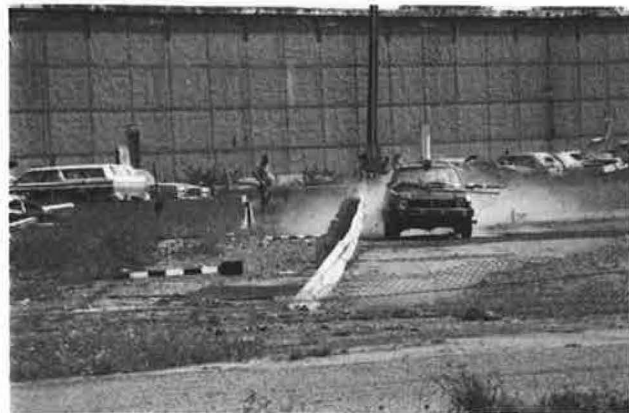
FIGURE 4 Vehicles and barriers after Test 108 (top) and Test 109 (bottom).

Results of the two full-scale crash tests are summarized in Table 1. The vehicles and barrier after the tests are shown in Figure 4, and Figures 5 and 6 provide sequential impact photographs. Vehicle trajectories are diagrammed in Figure 7.

degrees, with impact 4 feet upstream from the first heavy post. The vehicle was in contact with the barrier for only 4 feet, then exited smoothly at 8 degrees and 51.6 mph. There was no measurable barrier deflection, and the W-beam was only scuffed. Vehicle damage was light, consisting of sheet metal damage along the right side, and minor damage to the grill and bumper. Maximum vehicle roll was 3 degrees clockwise, with no measurable pitch or yaw. Peak 50-ms average decelerations were 1.2 g longitudinal and 12.2 g lateral. Thus, longitudinal critical distance was not reached, and occupant impact velocity and occupant ridedown deceleration were not computed. Lateral occupant impact velocity was 17.9 feet per second (fps), based on a measured flail distance of 0.5 feet with a ridedown deceleration of 13.5 g. Vehicle redirection was very smooth and the vehicle was operable after impact.

21 degrees and 33.4 mph. Maximum vehicle roll was 2 degrees clockwise, pitch was 7 degrees nose down, and no yaw was observed. Barrier and vehicle damage (Figure 4) were moderate. Three rail sections, three heavy posts, and eight light posts were bent. The vehicle sustained sheet metal damage to the right front fender, right front door, and right rear fender; there was also grill and bumper damage. Both right tires were deflated, and the right front wheel was damaged. Although not required evaluation criteria for this test, the occupant impact velocities and ridedown decelerations are reported in Table 1. The lateral values are below recommended threshold values, and the longitudinal values nearly meet those for 15 degree impacts. Redirection of the vehicle was smooth, with no excessive roll, pitch, or yaw.

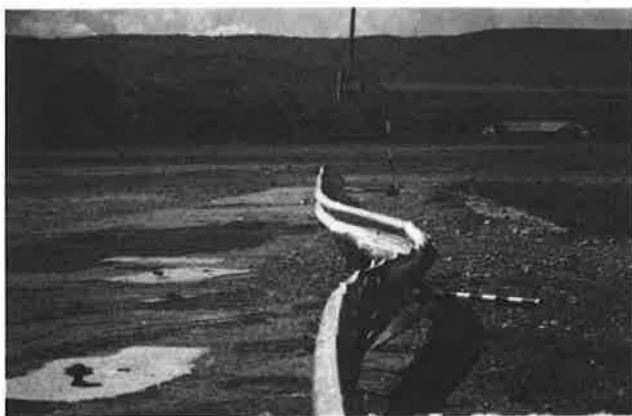
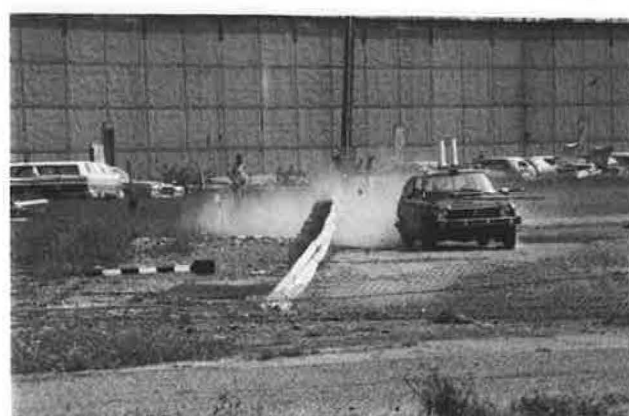
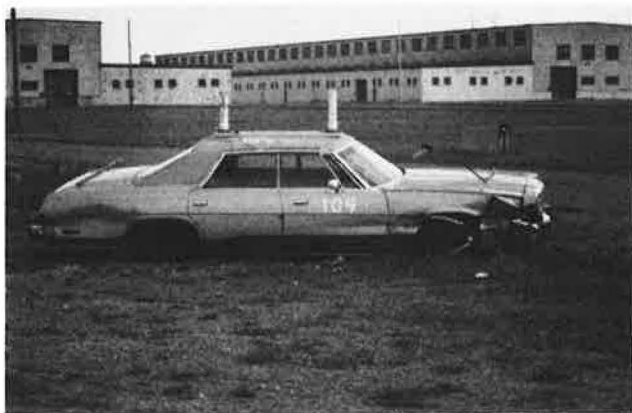
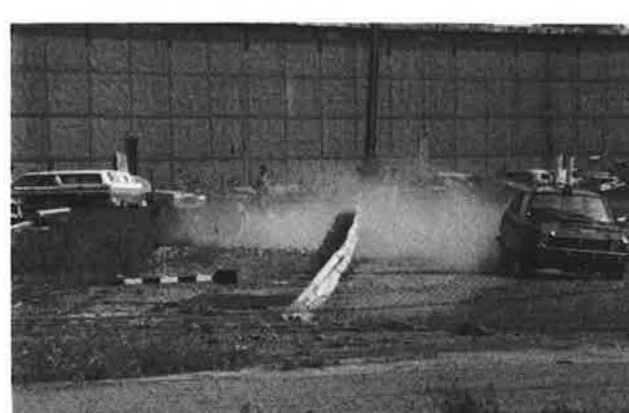
FIGURE 5 Sequential photographs of Test 108.

Test 108 evaluated the transition for snagging or rollover tendencies of small cars. Excessive vehicle decelerations that might cause occupant injuries were also noted. An 1,800-pound Honda Civic impacted the barrier at 61.2 mph and 13

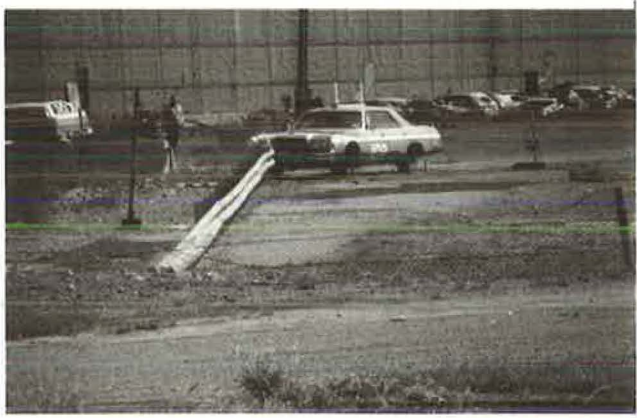
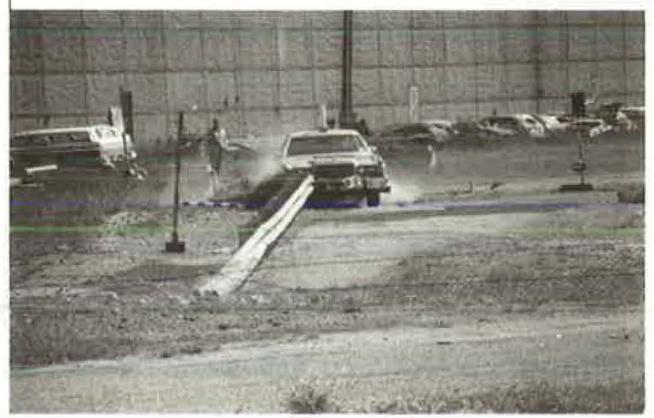
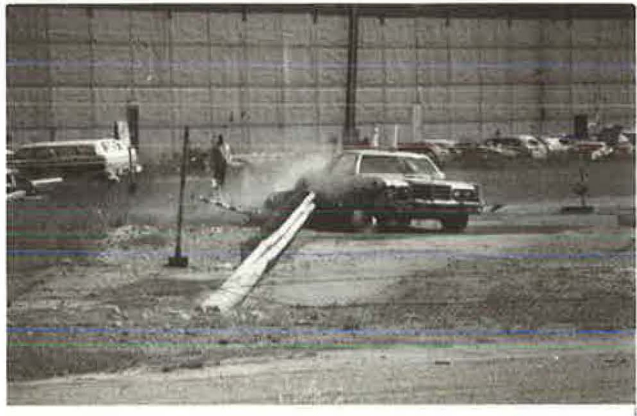
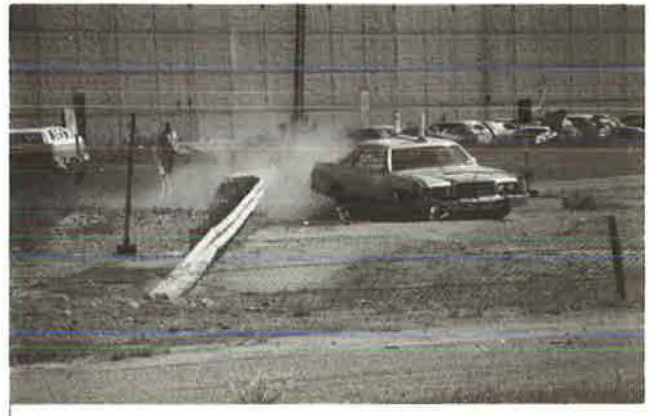
FIGURE 6 Sequential photographs of Test 109.

NCHRP Report 230 Test Designation 30 was used in Test 109 to evaluate the barrier for structural adequacy and redirection capability. A 4,600-pound Chrysler sedan impacted the barrier 17 feet upstream from the first heavy post at 58.1 mph and 27 degrees. Dynamic barrier deflection was 4 feet during the 29-foot contact distance, and the vehicle exited at
