# Measuring Rate of Corrosion of Steel in Field Concrete Structures

KENNETH C. CLEAR

**Three-electrode linear polarization testing has become a valuable tool for measuring the corrosion rate of reinforcing steel in concrete. Discussion covers the test technique, procedures, and specially constructed portable equipment used to collect valid and useful data to help project future distress and its rate, and in defining the effectiveness of rehabilitations. Guidelines are presented for use in data interpretation.**

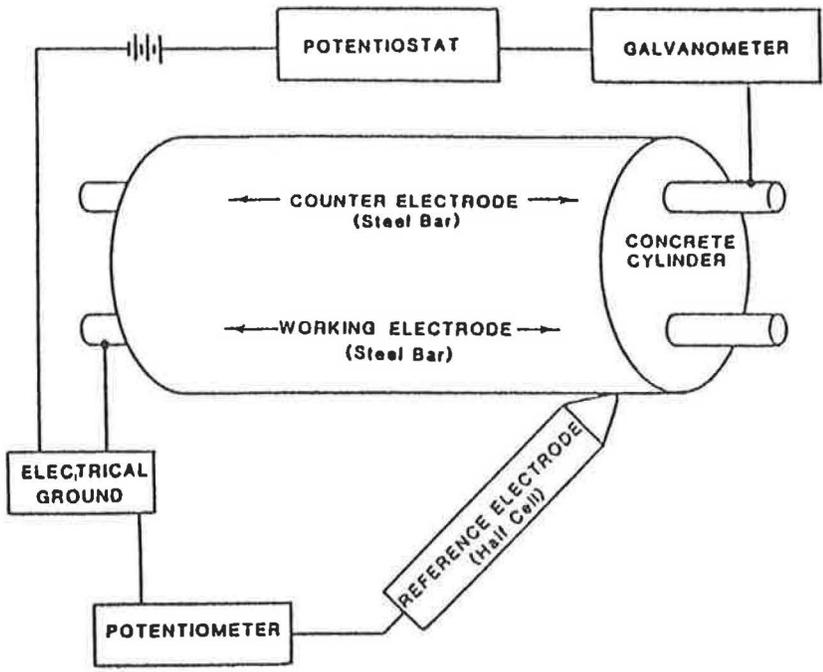
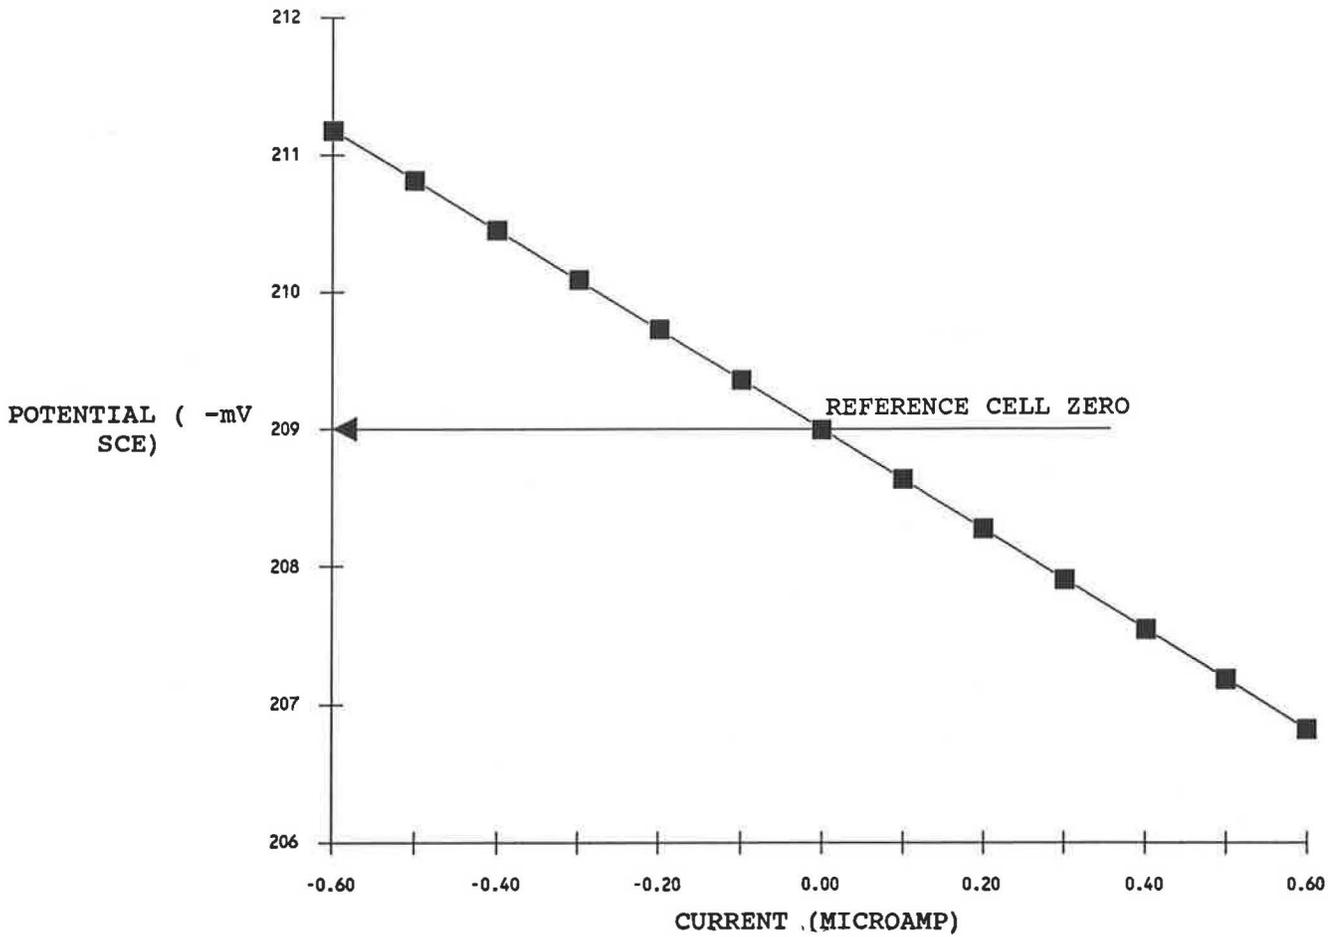
Both tests are usually performed utilizing three "electrodes" in, or on, the test sample. The steel bar being tested for its corrosion condition is often called the "working electrode," as shown in the schematic in Figure 1. The "reference electrode," which is often a copper-copper sulfate half-cell, is used to sense potential changes induced in the steel bar "working electrode" by a current, which is introduced into the ionically conductive system through a "counter electrode." Current output to the counter electrode is variable and is often controlled automatically by the "potentiostat" to maintain a preset potential at the reference electrode.

Figure 1, *bottom*, presents typical laboratory polarization resistance data. It shows a current versus voltage scan in which the scan rates were 0.1 mV/sec. The data plot as a straight line. The polarization resistance data can be expressed as the slope of this straight line (the potential divided by current) per unit area of steel surface affected by the induced currents.

FIGURE 1 Top, schematic of a linear polarization test setup for a laboratory specimen. Bottom, typical plot of laboratory data showing the linearity of potential-current data.

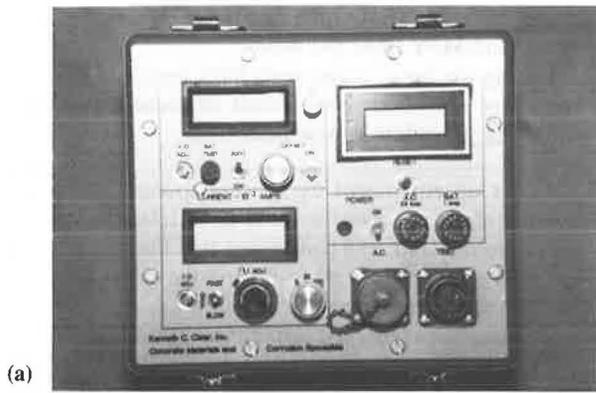
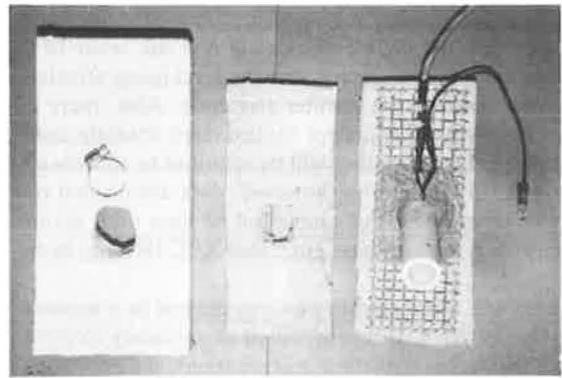
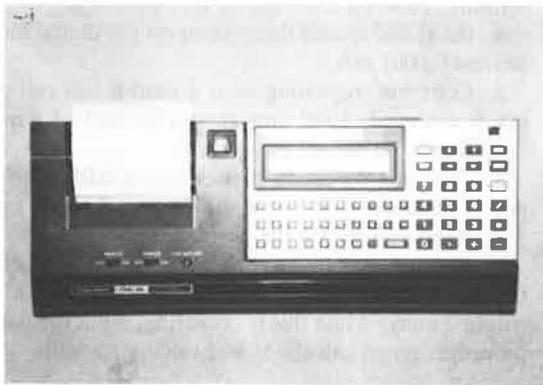
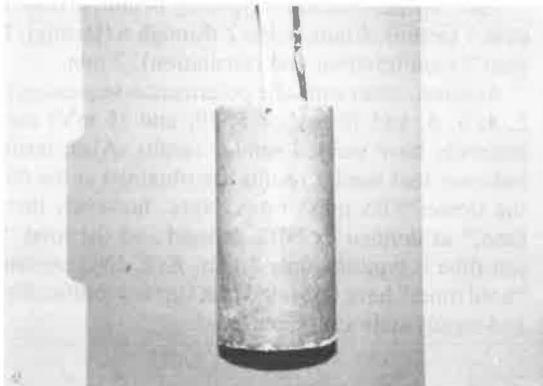
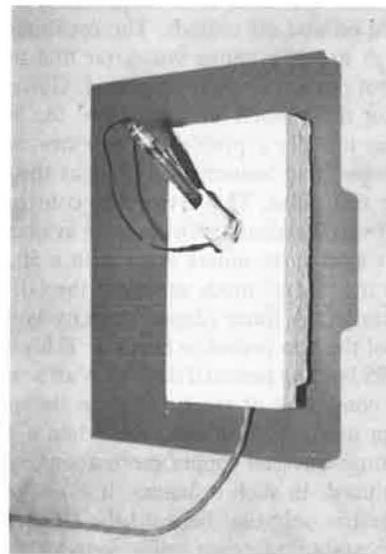
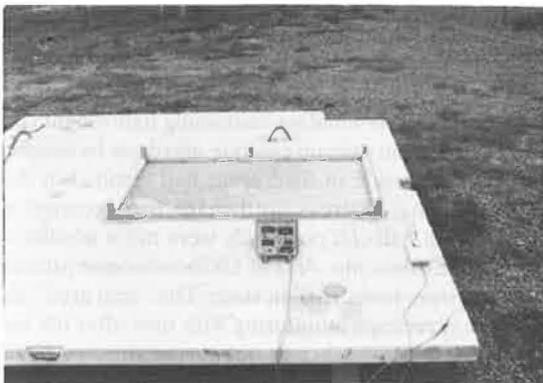
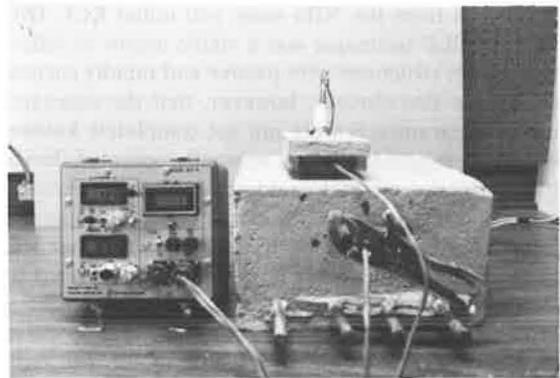
**FIGURE 2** KCC INC rate of corrosion equipment and testing: (a) KCC INC 3LP device, (b) unassembled portable probe, (c) PC-8 pocket computer and printer, (d) assembled portable probe, (e) embeddable probe, (f) test setup: large-scale specimen, and (g) test setup: laboratory specimen.

Equipment was fabricated to perform the test in a manner similar to that of NBS. It was modified as necessary to meet the needs of the various structures, test situations, and improving knowledge. Initially, AC-powered equipment that produced a half-wave DC pulse was utilized, and a battery-operated oscilloscope was used in a nulling mode to measure the half-cell potential during the off periods. This was replaced by battery-operated equipment with pulsing DC output because of the portability and electrical noise requirements and the desire for variable on and off periods. The oscilloscope was eliminated through use of a gating voltmeter that measures only during a select portion of each off period. Galvanic current flow between the counter electrode and the structure reinforcement was initially a problem. Therefore, a special circuit was developed that automatically blocks this current while passing the test pulse. The device was constructed so that two pulses of variable characteristics were available. The "fast" mode uses a 60-hertz square wave with a 50 percent duty cycle, while the "slow" mode simulates the NBS waveform described earlier. A timer (digital clock) was included to allow control of the test period to facilitate  $E \log I$  testing and use of the NBS holding period if desired. Various counter electrodes (CE) composed of steel, platinum, copper, and carbon have been used. In most instances when a portable CE is used, a sponge-encased copper mesh about 3 in. wide and 7 in. long is used. In such instances, it is assumed that the steel under test is only that beneath the CE. The most commonly used portable reference cell is copper-copper sulfate, placed in a "hole" in the center of the copper mesh CE. When embedded probes are used, the CE is usually steel and the reference cell is graphite, and both are embedded in a concrete or mortar cylinder. Figure 2 presents photographs of the various components of the 3LP device.

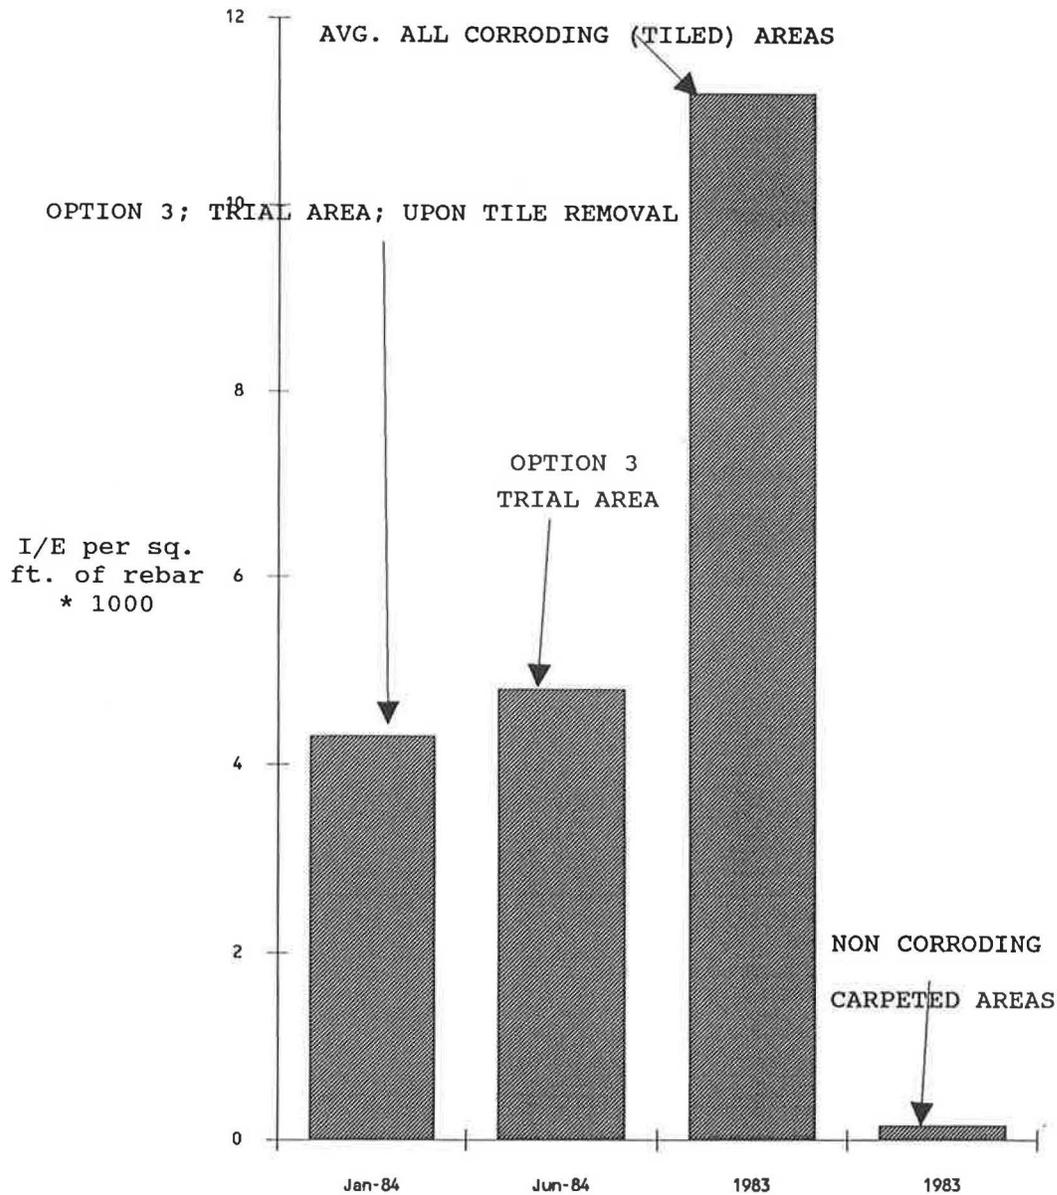
PORTABLE ELECTRODE TESTS - LIGHTWEIGHT  
AGGREGATE CONCRETE BUILDING CONTAINING CaCL<sub>2</sub>

OPTION 3 - 3LP RATE OF CORROSION SUMMARY

FIGURE 3 Linear polarization values for corroding and noncorroding areas of an office building.

Typical results obtained by KCC INC on field structures during the past 4 years are discussed next. Figure 3 presents data obtained in 1983 and 1984 on the interior portions of a multistory concrete building containing lightweight concrete with up to 2 percent calcium chloride dihydrate by weight of cement. Active corrosion in tiled areas had resulted in delamination and spalling, whereas no damage had occurred in carpeted areas. All half-cell potentials were more positive than  $-200$  mV CSE; thus, the ASTM C876 technique provided no help in assessing the corrosion state. The "trial area" shown in the figure represents monitoring with time after tile was removed to determine whether or not corrosion rates would decrease quickly as a result of drying. These data should not be translated directly to ICORR because the equipment at that time was not as accurate as that used today (actual corrosion rate was underestimated). The data can be compared among them-

selves, however, and it is worthwhile to note that the corrosion rates in the deteriorating tiled areas averaged 75 times those in the nondeteriorated carpeted areas, and that no decrease in corrosion rates occurred during 5 months of drying after the tile in one area was removed.

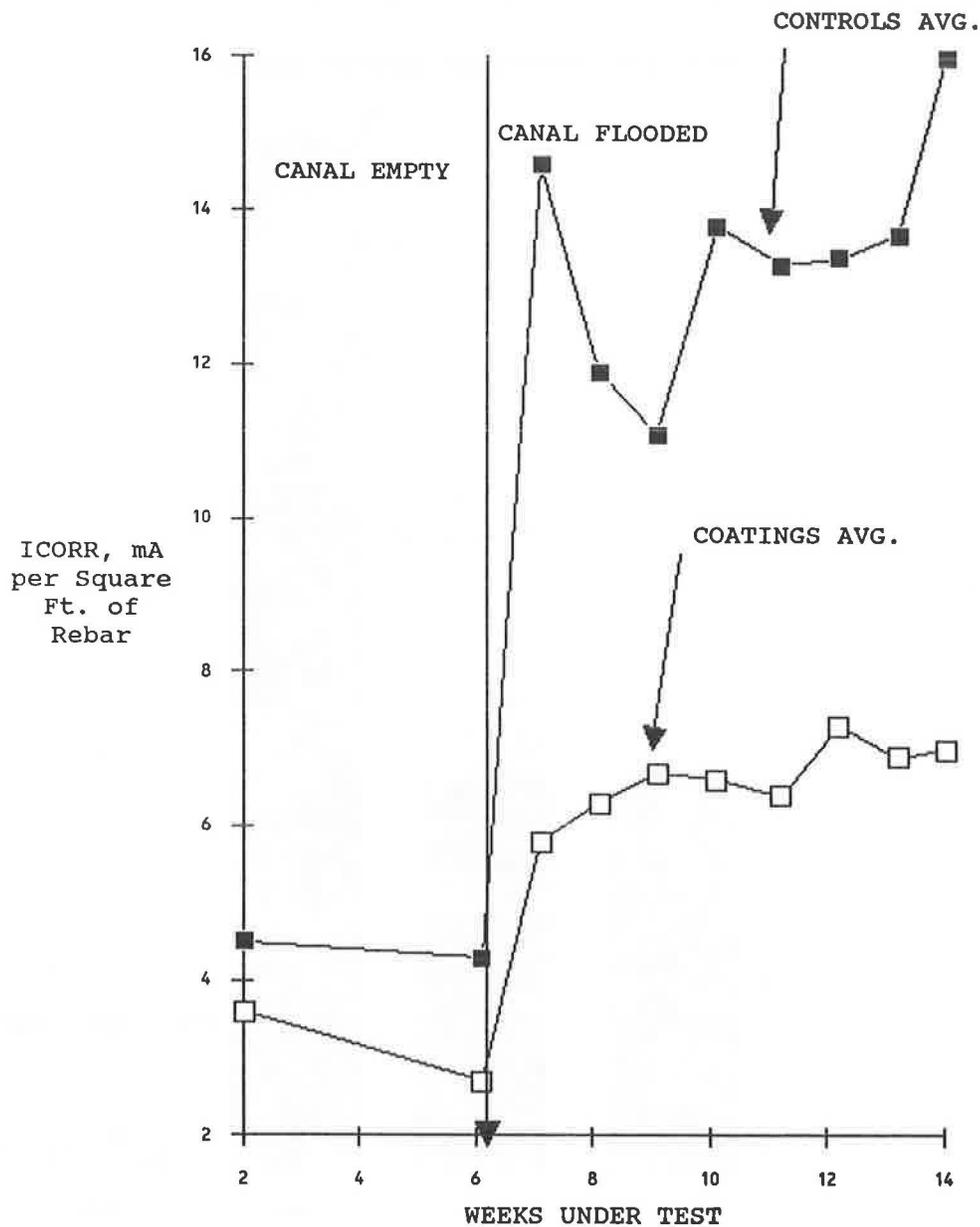
COATINGS AND CONTROL PANELS, 3.4M SUP/RET  
(SLIGHTLY ABOVE WATER LINE)

3 LP CORROSION RATE vs TIME

FIGURE 4 Changes in corrosion currents measured with an embedded linear polarization probe.

Figure 4 presents data obtained later in 1984 and in 1985, using embedded probes in seawalls. The probes were positioned slightly above the water line, and the figure shows the corrosion rate with time, including the effect of canal flooding, for panels that were coated with epoxy and urethane coatings and for uncoated control walls. Each data point represents the average of four or more individual measurements. Note the large increase in corrosion rate when the canal was flooded with seawater and the fact that the increase was much greater for the controls than for the coated panels. For both controls

and coated panels, however, the corrosion rates remained unacceptably high after flooding. Widespread corrosion-induced delamination occurred in the canal system (uncoated) at the test wall level within about 1 year of test completion.

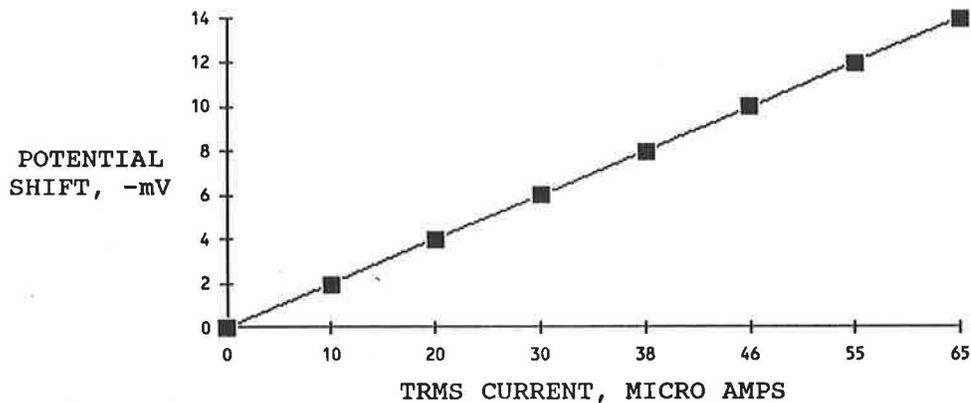
## 3 ELECTRODE LINEAR POLARIZATION

FIGURE 5 Potential shift vs. TRMS current.

Figure 5 shows typical findings from an embedded probe in a sound area of a 45-year-old concrete chimney undergoing carbonation-induced reinforcing steel corrosion. Chloride levels were less than 0.15 percent by weight of cement. The linearity of the data (cathodic polarization vs. current) is excellent. ICORR findings from the four probes on two occa-
