Performance and Structural Evaluation of Cracked and Seated Concrete

R. C. AHLRICH

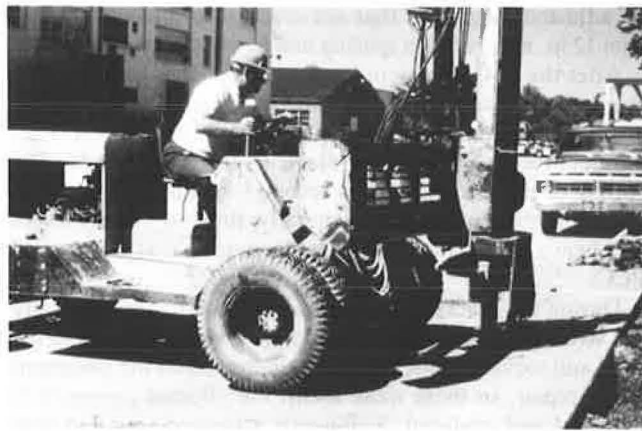
FIGURE 1 Impact hammer used at Rock Island Arsenal.

The cracking of the PCC parking lot was accomplished using an impact hammer shown in Figure 1. A cracking pattern was

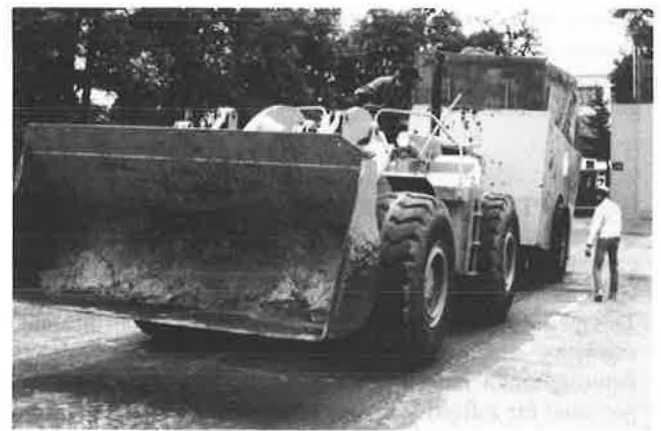
FIGURE 2 Fifty-ton pneumatic-tired roller used to seat cracked PCC pavement.

selected to break the existing PCC slabs into pieces with a minimum size of 18 in. and a maximum size of 24 in. After cracking, the PCC pavement was seated using a 50-ton roller shown in Figure 2. A minimum of two passes was required to seat the cracked PCC. After the cracking and seating procedures were completed, a minimum of 4 in. of asphalt concrete was placed.

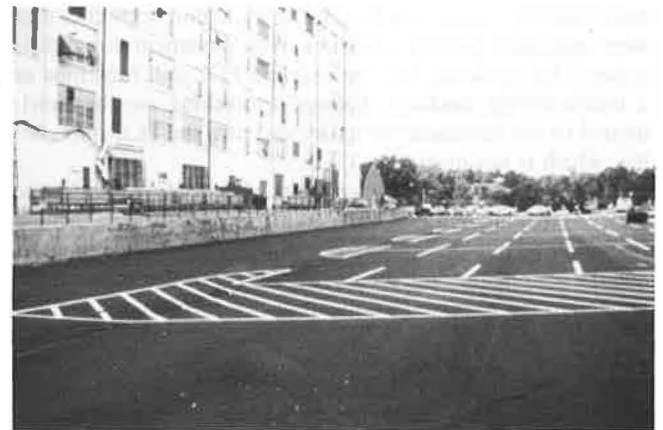
FIGURE 3 Completed asphalt concrete pavement.

The rehabilitation project was completed in 1984. Figure 3 shows the finished AC pavement surface. The pavement was inspected in August 1988, and no reflective cracks were observed. The performance to date has been very satisfactory. The cracking and seating method has been successful in preventing reflective cracking for 4 years. The cracking and seating method has been an effective and economical method to reduce reflective cracking of PCC pavement through an AC overlay (4).

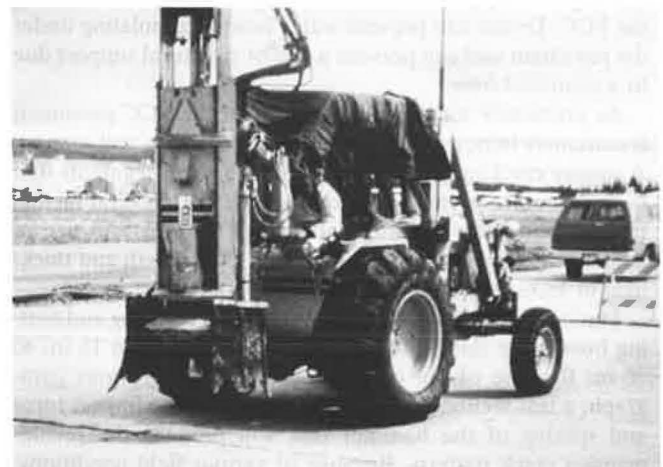
FIGURE 4 Hydraulic impact hammer for cracking PCC slabs.

The specified cracking pattern required the breaking of the PCC pavement into 2-ft squares. An impact hammer was used to produce hairline cracks that penetrated the full thickness of the pavement. A section of PCC was removed to evaluate the total cracking of the pavement. Typical scenes of the construction are shown in Figures 4 through 6.

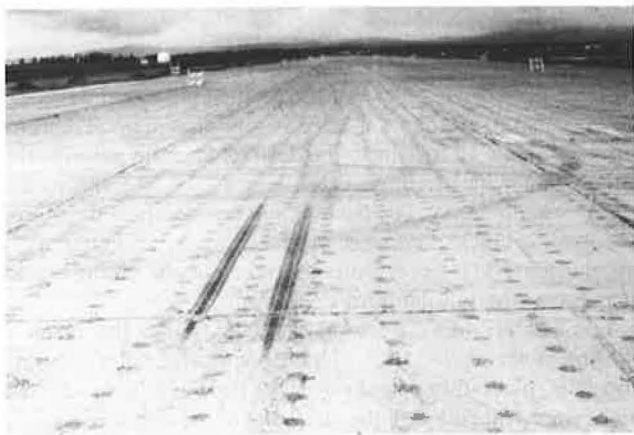
FIGURE 5 Overall view of cracking pattern.

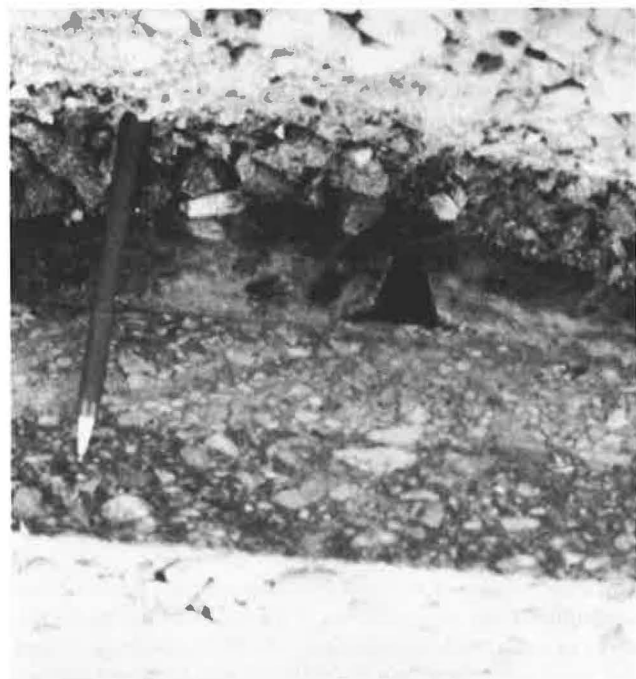
FIGURE 8 Cut-away section of asphalt overlay over a PCC pavement joint (ballpoint pen shows scale).

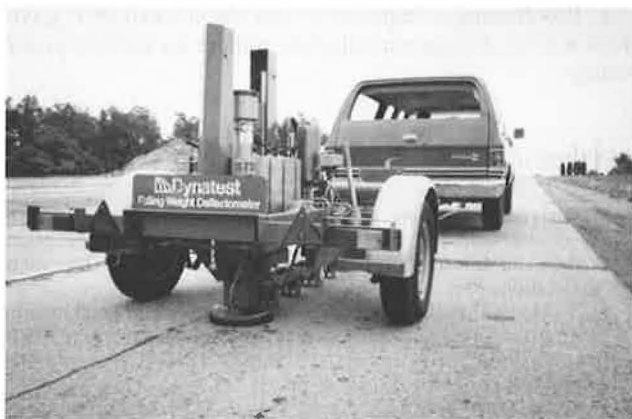
FIGURE 12 Dynatest Falling Weight Deflectometer.

The effective modulus values for the cracked PCC pavement were determined using measured deflection basins obtained by the Falling Weight Deflectometer (FWD) shown in Figure 12. This FWD uses a weight dropped on a steel plate to produce an impulse load to the pavement that causes the pavement to deflect. Four drop heights were available to vary the impact load, which ranges between 8,000 and 26,000 lb. For these deflection readings, the maximum load was used for each slab. The actual load applied to the slab was measured by a load cell. Velocity transducers that are spaced at 0, 12, 24, 36, 48, 60, and 72 in. from the center of the plate were used to measure surface deflections (Figure 13).

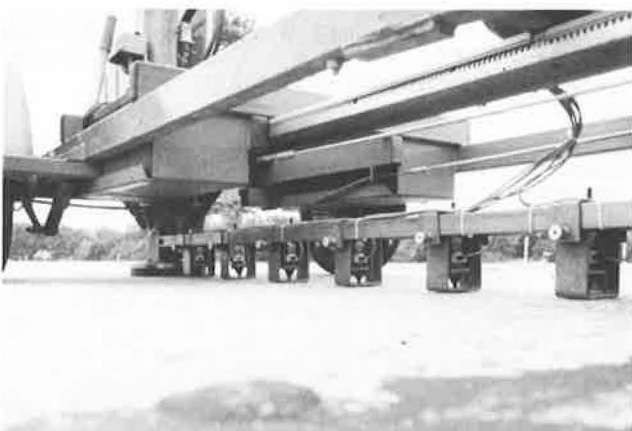
FIGURE 13 Close-up view of velocity transducers.
