Seismic Retrofit of Bridge Columns by Steel Jacketing

Y. H. CHAI, M. J. NIGEL PRIESTLEY, AND FRIEDER SEIBLE

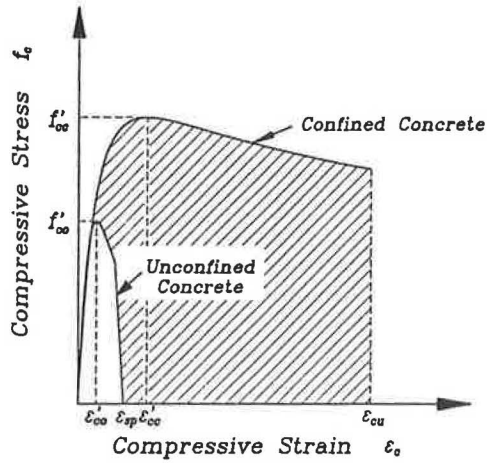
Fig. 1 Stress-Strain Model for Confined Concrete

Recent research [3] has established that closely spaced lateral confinement reinforcement in the potential plastic hinge regions increases both the compressive strength and the effective ultimate compressive strain in the core concrete. The ultimate compressive strain increases from a value of about 0.005 in unconfined concrete to a value of 0.03 or higher in confined concrete. The increase in ultimate compressive strain significantly enhances the ductility capacity of the concrete section. Provided that the transverse reinforcement is spaced no wider than 6 times the longitudinal bar diameter and is properly anchored by either lap welding or bending back into the core, the ultimate compressive strain in the concrete corresponds to longitudinal strain at fracture of the transverse reinforcement. A method for estimating the ultimate compressive strain of confined concrete by equating the strain energy capacity at fracture of the transverse reinforcement to the additional energy stored by the confined concrete above its

unconfined state has been proposed [4]. The enhancement in compressive strength and strain due to confinement is illustrated in Fig.1.

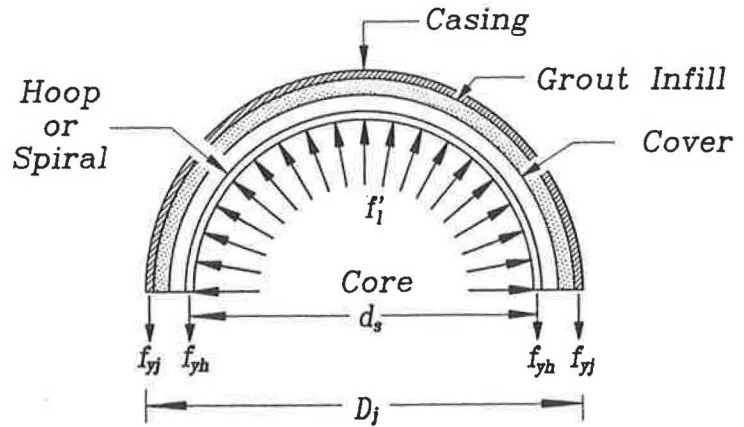
Fig. 2 Confining Action of Steel Casing

The confining action of the steel jacket is illustrated in Fig.2. Under the combined effect of axial compression and column flexure, the compression zone attempts to dilate as the flexural strength of the member is approached. The dilation is restrained by the radial stiffness of the jacket; placing the jacket in circumferential tension and the concrete in radial compression. Ignoring any contribution from existing hoops to the confinement of concrete core, the radial confining stress at yield of the steel casing is given by:

$$f'_i = \frac{2f_{yj}t_j}{D_j - 2t_j} \quad (1)$$

$$= \frac{1}{2}f_{yj} \rho_{sj} \quad (2)$$

where

$$\rho_{sj} = \frac{4t_j}{(D_j - 2t_j)} \quad (3)$$

represents the volumetric confinement ratio of steel jacket. The variables f_{yj} , t_j and D_j are the yield strength, thickness and outside diameter of the steel jacket respectively. Hence for a column 60 inches (1524 mm) in diameter and retrofitted with a 0.5 inch (12.7 mm) thick A36 steel jacket ($f_{yj} = 36$ ksi or 248 MPa), the equivalent volumetric confinement ratio ρ_{sj} would be 0.0328 when 0.5 inch gap is used for grout. Thus the maximum confining stress f'_i due to steel casing would be 590 psi (4.07 MPa). The level of confinement provided by the steel jacket would correspond to the upper

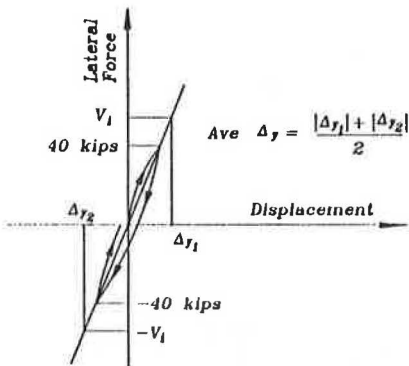
(a) Standard Loading History for All Test Columns

(b) Experimental Definition of Yield Displacement

FIGURE 5: Standard Load Pattern for Test Column

All test columns were subjected to the same lateral displacement pattern of increasing magnitude, as shown in Fig.5 (a). The experimental yield displacement Δ_y was determined by extrapolating a straight line from the origin through ± 40 kips which approximately corresponds to the theoretical first yield of extreme tension steel to the ideal

capacity V_1 which is calculated using the Mander's model for confined concrete [4]. As shown in Fig.5 (b), the average of the two displacements was adopted as the experimental yield displacement.

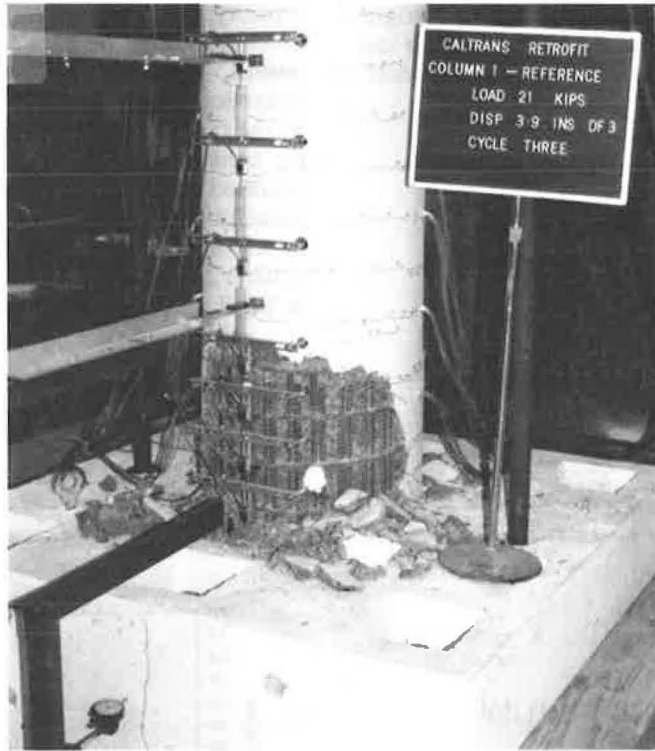
Figure 6: Bond Failure in Column 1

Column 1 was observed to suffer early bond failure at the lap of longitudinal reinforcement. Rapid strength degradation occurred after displacement to ductility factor $\mu=1.5$. Maximum lateral load of 49 kips (218 kN) was noted during the push cycle to $\mu = 1.5$ and was 97% of the theoretical ultimate capacity V_u . Significant drop in lateral load to 83% of theoretical capacity occurred in the pull direction of the same cycle. Bond failure in the lap was initiated and caused serious strength degradation under additional cycling (see Fig.6). The strength envelope is seen to degrade asymptotically after $\mu = 1.5$ to the moment resisted purely by

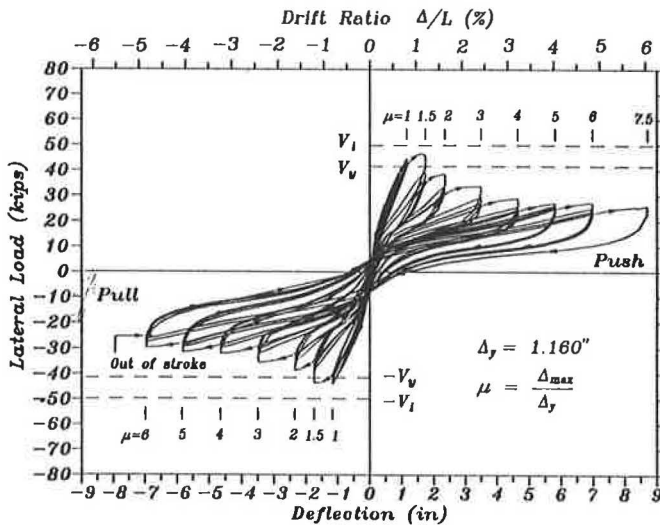
FIGURE 9: Hysteretic Response of Weak Retrofit Column

The weak retrofit approach adopted in column 5 uses a soft Styrofoam wrap as cushion to allow dilation of cover concrete and relative slip between main reinforcement and starter bars to occur. Without complete loss of cover concrete, strength degradation is not expected to be as rapid as the uncased column and vertical load carrying capacity can be maintained even after excursion to large lateral displacement. The response of column 5 and column 1 were very similar during the initial stages of loading (see Fig.9). Bond failure was again initiated at $\mu = 1.5$ but subsequent degradation of strength is comparatively more gradual. Theoretical capacity of column 5, as predicted without steel jacket, again could not be achieved.

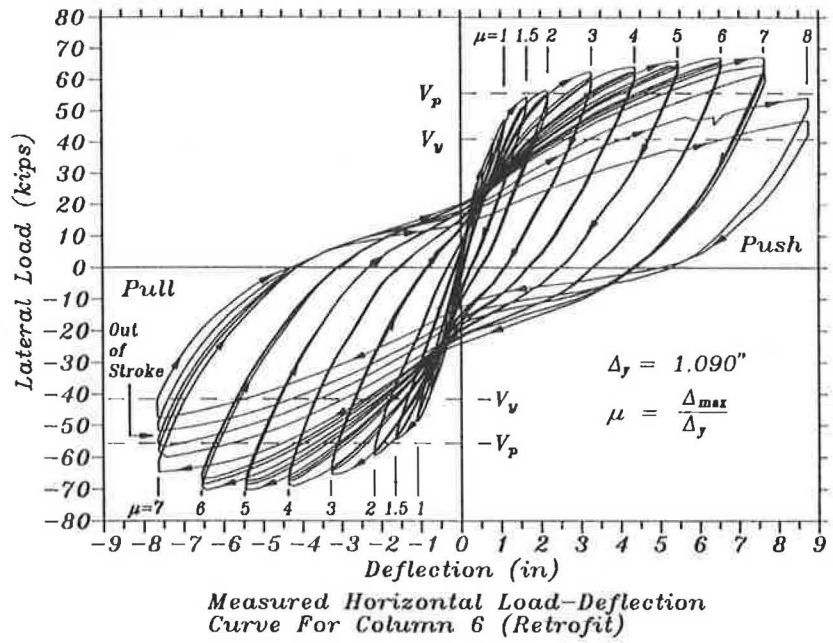
Figure 10: Hysteretic Response of Column with Starter Bars and Strong Footing

Column 6 was constructed and retrofitted with a steel jacket identical to column 2 except with a strong footing so that response at large displacement would be studied. Because columns 1 and 2 have been supported on 1 inch (25.4 mm) high pile-blocks, the compliance of the footing is reflected in the larger experimental yield displacement when compared with that of column 6 whose footing was placed in uniform bearing. The response of column 6 shown in Fig.10 is very similar to that of column 4 which was constructed with continuous reinforcement. Hysteretic loops for column 6 were stable up to $\mu = 7$ after which extreme tension reinforcement fractured due to low-cycle fatigue (see Fig.11). Bond failure which would otherwise prevail without retrofit was completely inhibited.

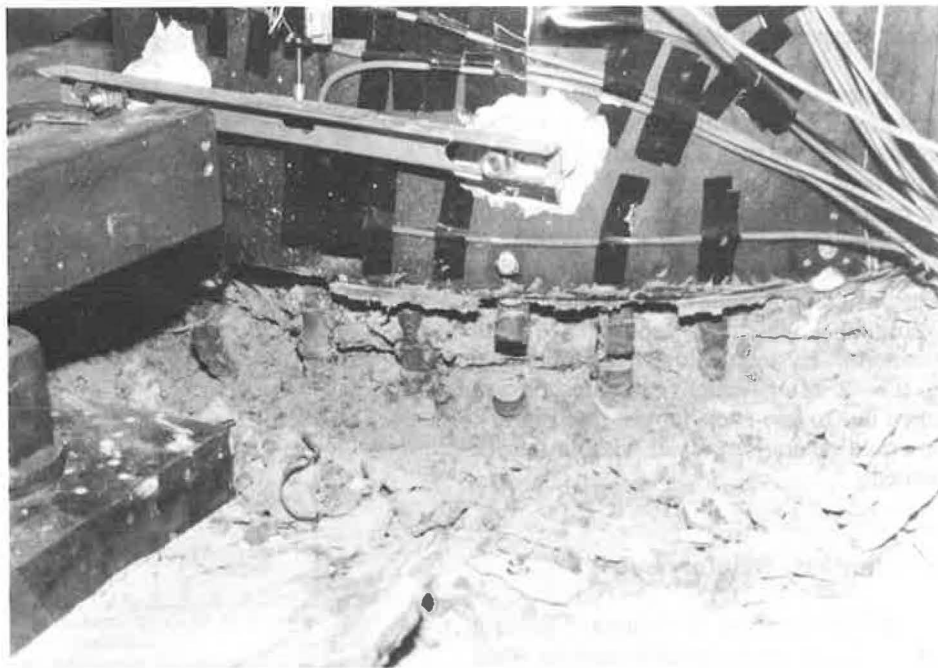
Figure 11: Low-cycle Fatigue Fracture of Main Steel in Column 6

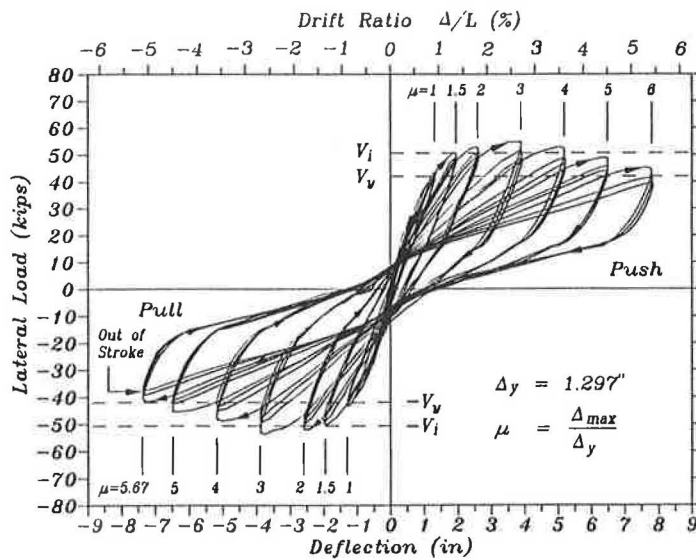
FIGURE.13: Hysteretic Response of Repaired Column

Hysteretic response after repair of column 1 is shown in Fig.13. Compared to first testing without a steel jacket, significant improvement in the cyclic behaviors of repaired column was observed. Theoretical flexural capacity of the original column (50.6 kips or 225 kN) was exceeded by 6% at $\mu = 3$ after which gradual degradation of strength occurred due to development of bond slip in the lap of main reinforcement. There is no observed enhancement of flexural capacity due to strain-hardening of longitudinal steel as evident in the full retrofit case.
