Flood Disaster Rehabilitation, Charnawati, Nepal: A Case Study

After a brief mention of the principles of design applied to the construction of the Lamosangu-Jiri Road in the central region of Nepal, the authors describe the effort undertaken to rehabilitate a road section heavily affected by a flood in the early monsoon season of 1987. Innovative techniques for the construction and maintenance of roads in the Himalayan region, such as anchoring, drilled subsurface drains, and flexible river protection, were introduced. In view of design options for low-volume roads in hilly terrain, practical suggestions such as low initial investment and event-related rehabilitation are discussed.

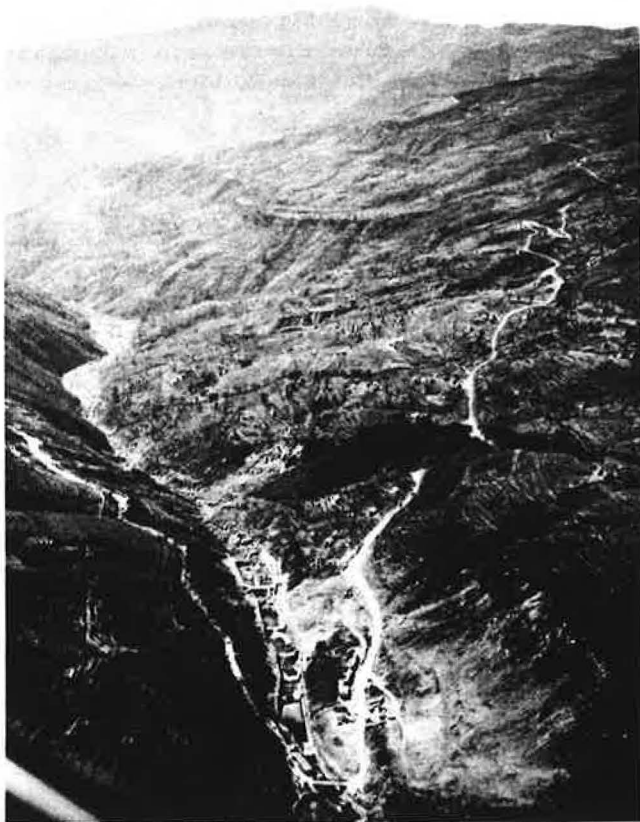
FIGURE 2 Aerial photograph of project area, looking south; Charnawati crossing in the foreground.

Figure 2 shows an overview of the project area with the Charnawati crossing in the foreground.

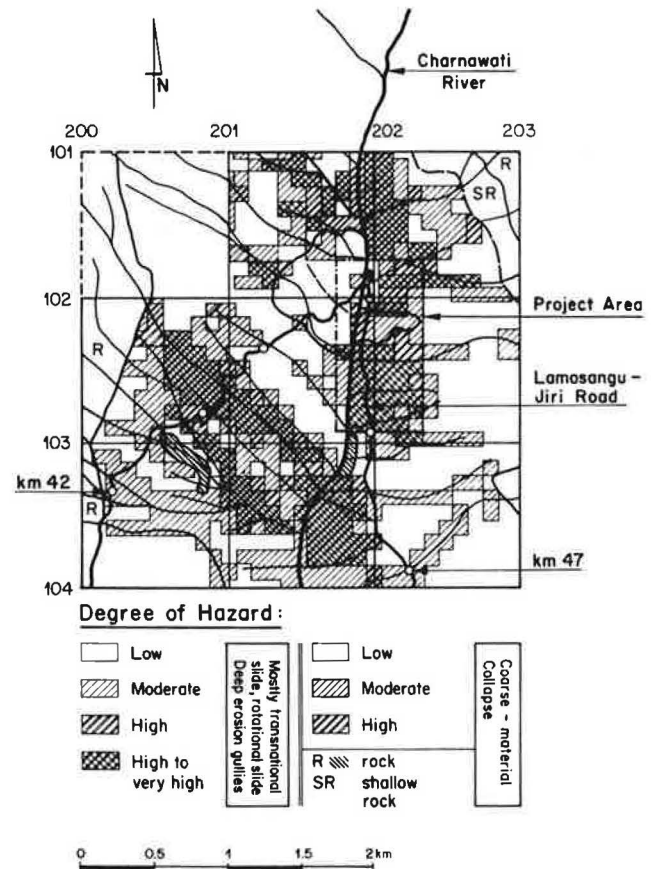
The combination of all parameters results in a soil hazard map (Figure 3) showing areas of low, moderate, and high instability. This map is used to design possible realignment alternatives and to define the locations where further detailed investigations are necessary. The map clearly shows the high-hazard area on the left bank of the Charnawati River (Km 45 to 46 and Km 47).

FIGURE 3 Charnawati Valley soil hazard map.

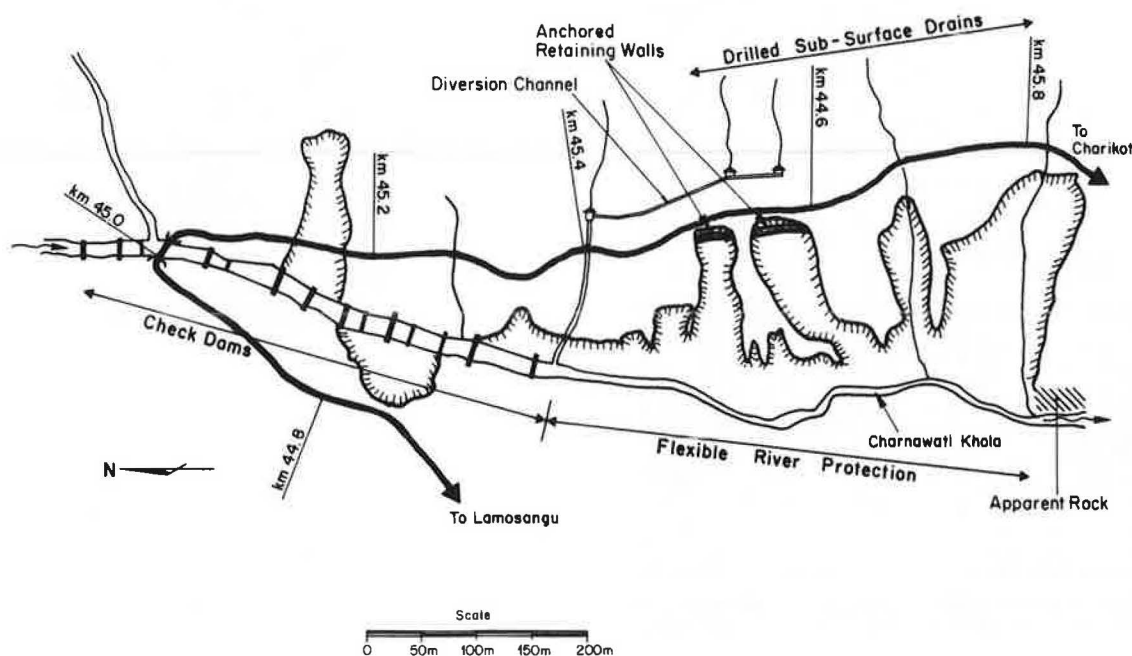
Figure 4 shows a plan of the project area indicating the extent of the slides and the main structures.

FIGURE 4 Charnawati Project: overall plan view. Only the main substantial structures are presented; drainage and biotechnical measures in the slides are not shown.

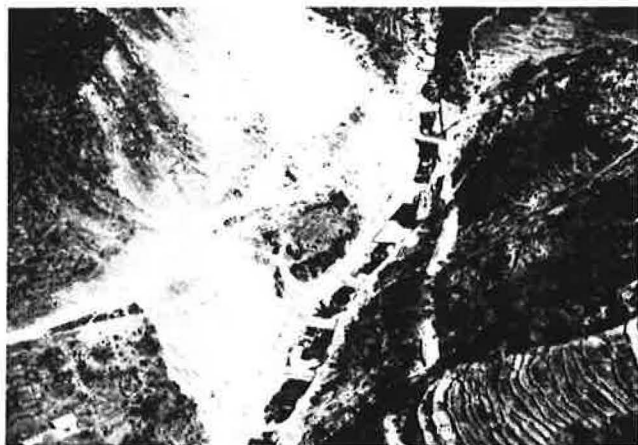
banks between the dams were protected by gabion guide walls, thus buttressing the toe of the endangered slopes. Figure 5 shows the layout of the check dams in the vicinity of the river crossing.

FIGURE 5 Aerial photograph of check dams and road crossing. Note the slide on the right-hand bank where the alignment had to be shifted to the mountainside. The cleared area to the left of the bridge was used for quarrying.

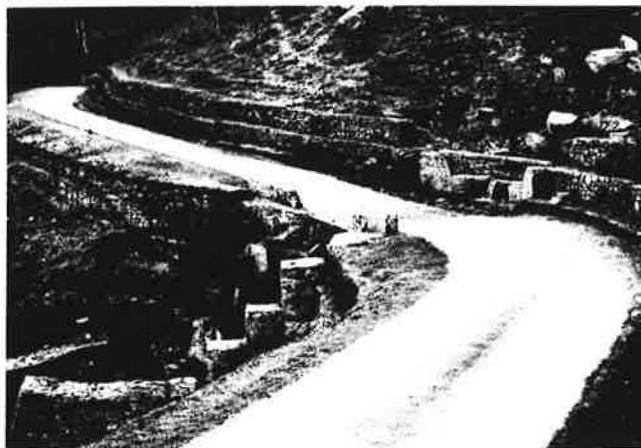
FIGURE 6 Typical causeway for smaller rivulets.

In principle, an attempt was made to control all surface water in the sliding area. A typical causeway with gabion protection, as used for cross drainage before the slides at Km 45.4 to 45.6, is shown in Figure 6. Surface water of two rivulets was contained above the road and diverted to a rivulet in a more stable area. All slide areas were drained to a depth of 2 m by gabion drains located in topographical depressions and aligned in the direction of the slope gradient, thus evacuating water by the most direct route. Tributary drains at intervals of 15 m were designed to collect water and guide it to the gabion drains. A successful application of this system can be seen in Figure 7, showing a stabilized slide with two main gabion drains crossing the road.

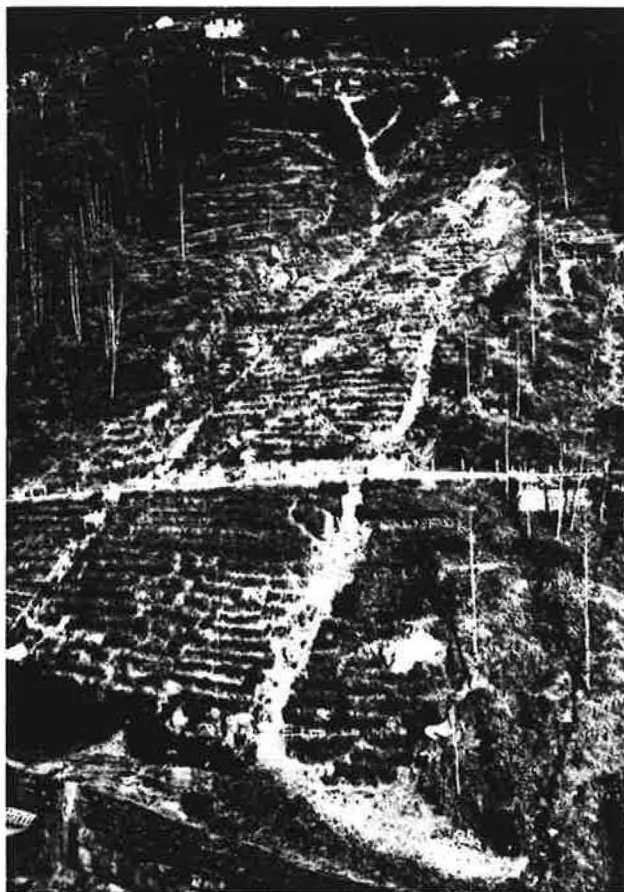
FIGURE 7 Stabilized slide at Charnawati left bank, Km 45.1. Two main drains crossing the road are supported by the gabion guidewall at the river.

For these measures a nursery was maintained throughout the construction period. Successful applications of these techniques which are also aesthetically satisfying, are shown in Figure 7 and 8 (upper parts of these views).

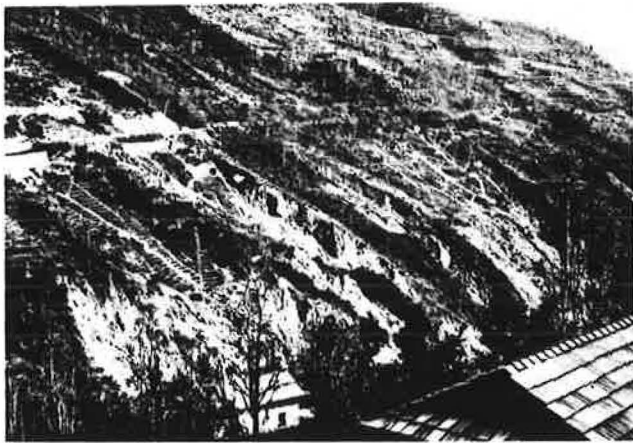
FIGURE 8 General view of slides, Km 45.4 to 46.0. Drainage and biotechnical measures can be seen in the upper parts of the slides.

Figure 8 is a general view showing the status of the upper parts of the four slides from Km 45.4 to 46.0 in February 1990. It shows that parts of the slides could be stabilized but that further work is necessary. At the upper edge of the two main slides in the foreground, anchored retaining walls were constructed just below the road to prevent further upward development of the slides and to retain the road. The layout of the walls and drainage efforts are shown in Figure 9.

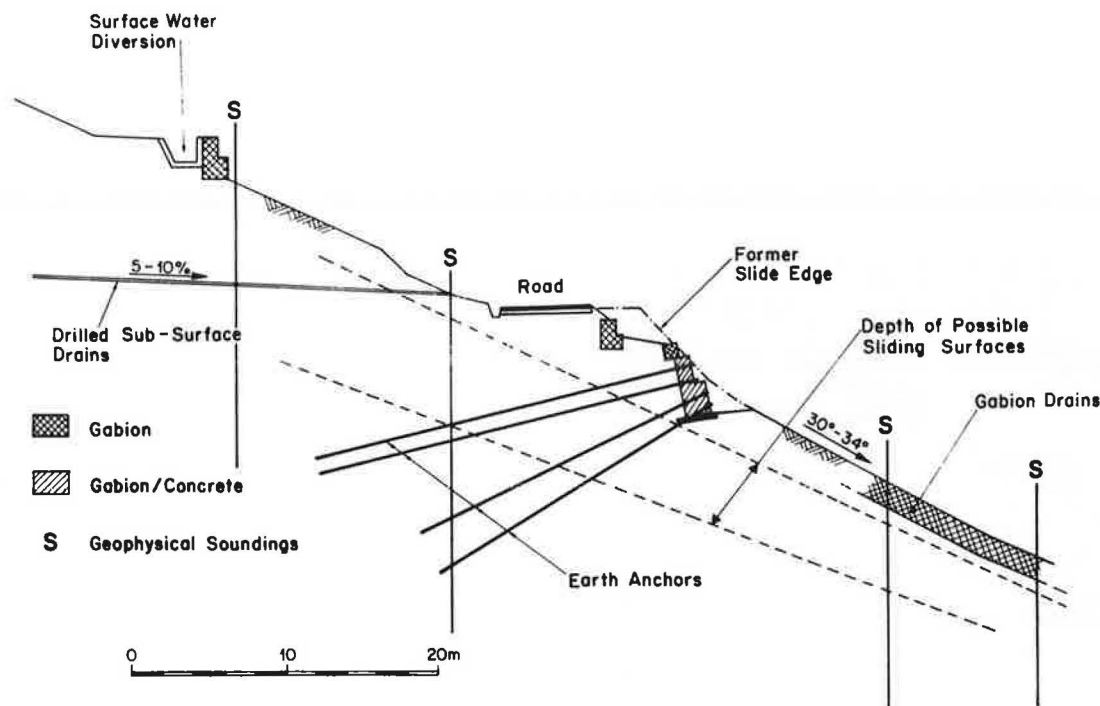
Vertical series of four earth anchors were arranged at intervals of 4.3 m. The anchors consist of steel rods St 500/600 with a diameter of 32 mm and a length of 25 m (upper two anchors) and 20 m (lower two anchors). Anchor forces are built up by friction and dilatation effects between the grouted anchor hole and the soil. In the stability computations the permissible anchor forces were 250 kN per anchor. Pullout tests showed that values of 400 kN could be reached if boulders were hit during drilling, thus expanding the anchor root.

FIGURE 9 Cross section of slide stabilization measures at Km 45.4.

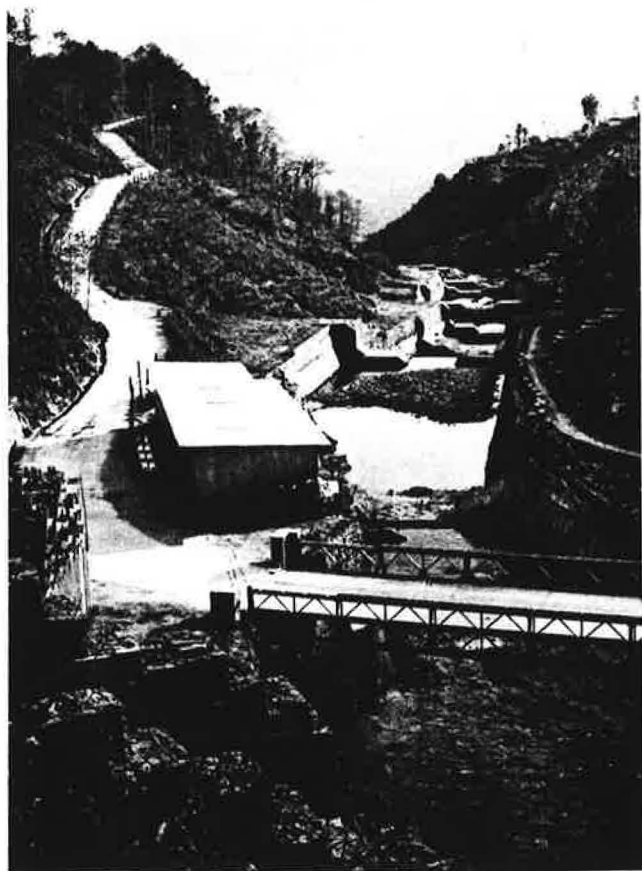
FIGURE 10 New Charnawati bridge crossing. The store in the foreground is used for current construction work.

Soon after the disaster the 10-m-span concrete bridge that was washed away was replaced by a Bailey bridge of 21.3-m span, which can be erected in short time (Figure 10). This bridge was initially meant as a semipermanent solution, but is likely to become permanent.
