Use of High Molecular Weight Methacrylate Monomers To Seal Cracks in Bridge Decks, Retard Alkali-Silica-Aggregate Reactions, and Prime Bridge Surfaces for Overlays

MICHAEL M. SPRINKEL

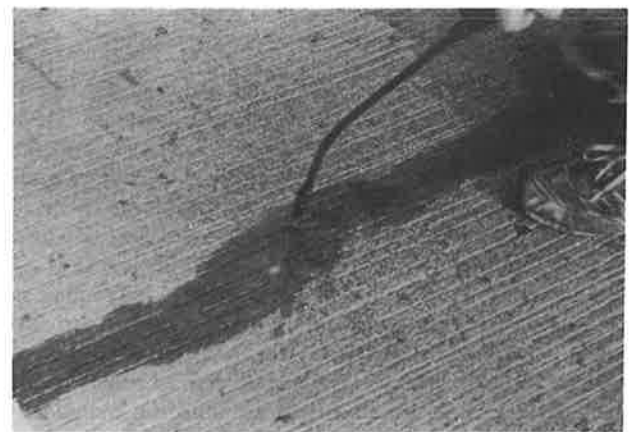
FIGURE 1 HMWM monomer applied to cracks in tined bridge. To maintain good skid number, excess resin in valleys must be broomed over deck surface before it gels.

Each monomer was mixed in 1- or 2-gal batches and poured into 2-gal spray cans that were used to apply it to the cracks. HMWM monomer gels rapidly when contained in large quantities, and therefore 1 gal or less of mixed monomer was placed in a spray can. The monomer was applied to the cracks at the rate of 200 ft/gal. According to the inspector, many spray cans became inoperable because the monomer gelled in the nozzle or in the line between the nozzle and the container. The special provision required three applications to each crack. However, because of the narrow width of many of the cracks and because the first application tended to seal the top of the cracks, only the wider cracks received more than one application. As can be seen in Figure 1, the deck surface within 3

in. of a crack was usually treated with the resin. When too much resin was applied to a crack, the excess resin was brushed over the deck surface before it gelled so that the grooves were not filled.

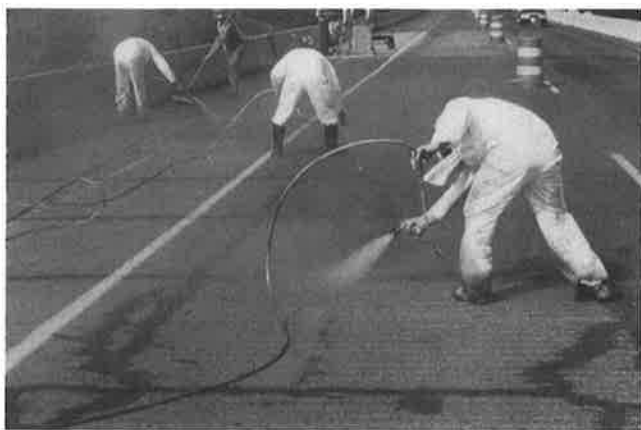
FIGURE 2 Airless spray guns were used to apply HMWM resin to surface of tined bridge deck. Note that work crew is wearing rubber boots and gloves, impermeable coveralls, and canister breathing masks.

Once the cracks were filled, the monomer was applied to the deck surface to seal the concrete and bring the color of the deck surface between the cracks close to the color of the surface in the vicinity of the cracks. The monomer used to seal the deck surface was mixed in 5-gal batches and applied with an airless sprayer (see Figure 2).
