# Lessons Learned from Diagnostic Load Testing of 100-Year-Old Elevated Mass Transit Structures

R. W. KRITZLER, S. G. PINJARKAR, R. A. ROLSING, AND P. O. MCCARTHY

A comprehensive study has been undertaken by the Chicago Transit Authority and its consultants for condition assessment of the rapid-transit system's elevated steel structures. This study included a series of full-scale diagnostic load tests performed to evaluate actual behavior of these structures under train loading. Static and dynamic load tests, using an empty four-car test train, were performed on four different line segments, representing different structural systems. Dynamic monitoring of tensile bending stresses was also conducted for normal rush-hour traffic, providing actual variable stress and average response data to be used for fatigue life assessment. Strain gauge response data for the test structures showed that stringer midspan bending stresses were 36 to 93 percent of nominal calculated stresses, assuming simply supported spans. The measured negative moments at the supports, caused by partial end continuity, were 25 to 86 percent of the fully continuous end moments for three of the test structures. The

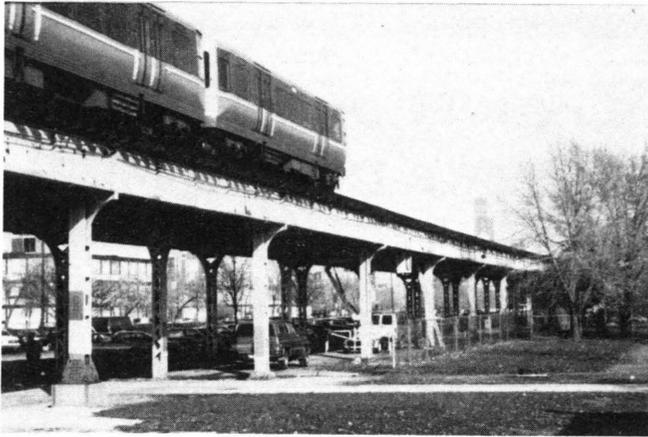
FIGURE 1 South Mainline elevated structure.

The South Mainline structure was built in two phases. The present southbound structure was built in 1891 using wrought iron. The present northbound structure was added in 1905 and constructed of steel (Figure 1). The stringers are riveted built-up plate-and-angle I-sections connected to the support bents with full-depth web angles (Figure 5). A stringer expansion seat bearing connection ("pocket") is typically lo-

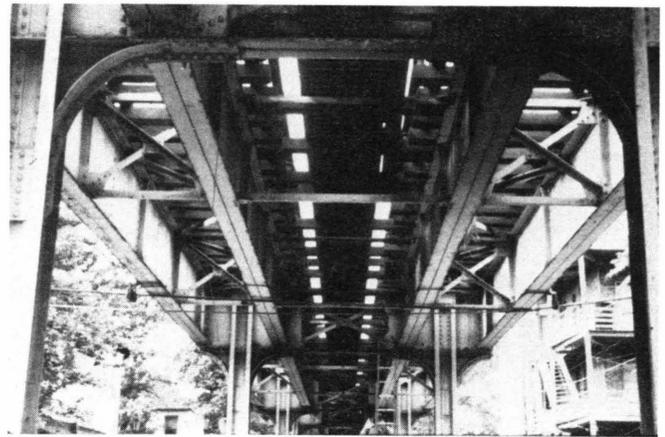
FIGURE 3 View from below Englewood test structure.

The elevated structures at the four test locations are generally constructed of steel or wrought-iron longitudinal stringers spanning 40 to 60 ft to transverse support bents. Two stringers support each open-deck standard-gauge track on timber ties. The ties also support the electric "third" rail to power the train cars. The support bents carry two active tracks and sometimes a third inactive track (Figures 1 through 4). The two stringers supporting each track are laterally braced between their top flanges and contain either vertical cross bracing at span third points (Figure 3) or lateral bracing between the bottom flanges. The stringer pairs supporting each track are generally connected with a top and bottom flange horizontal strut at the span third points (Figure 3).

cated on one side of every third bent. The support bent columns are located below the centerline of each track (similar to Figure 3). Longitudinal forces on the elevated structure are resisted by bending of the columns.

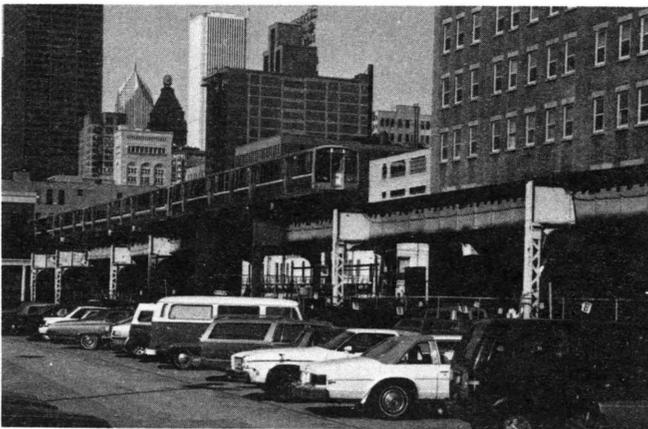
FIGURE 2 South Loop elevated structure.

The South Loop Line structure in the test area was built in 1891 using wrought iron (Figure 2). The stringers and end connections are similar to those of the South Mainline structure. The support bent columns are located outboard of the two supported tracks, forming a rigid frame for supporting the track stringer gravity loads. The transverse ("cross") girders are single-web riveted built-up I-sections. Longitudinal

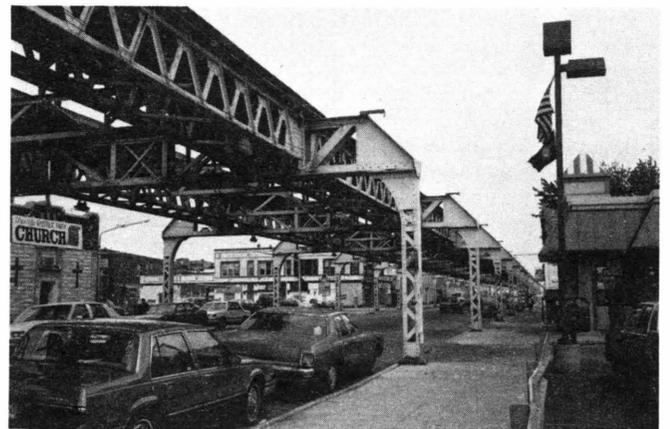
FIGURE 4 Jackson Park elevated structure.

The Jackson Park Line was constructed in 1892 using "soft steel" (Figure 4). The stringers were replaced in 1940, and the stringer end connections were modified in 1964. The stringers are riveted open-web trusses with chords and web members composed of wide-flange tee sections. The stringers are connected to the support bents with a combination of a top chord bearing connection and full-depth web angles (Figure 5). There are no stringer-end longitudinal expansion joints in the structure. The support bent columns are located outboard of the tracks and support the cross girders that span across 63rd Street from curb to curb. The support bent cross girders are double trusses tied with top horizontal batten plates and vertical diaphragms. Again, longitudinal forces applied to the track by train braking and accelerating are resisted by cross-girder horizontal bending and longitudinal column bending.

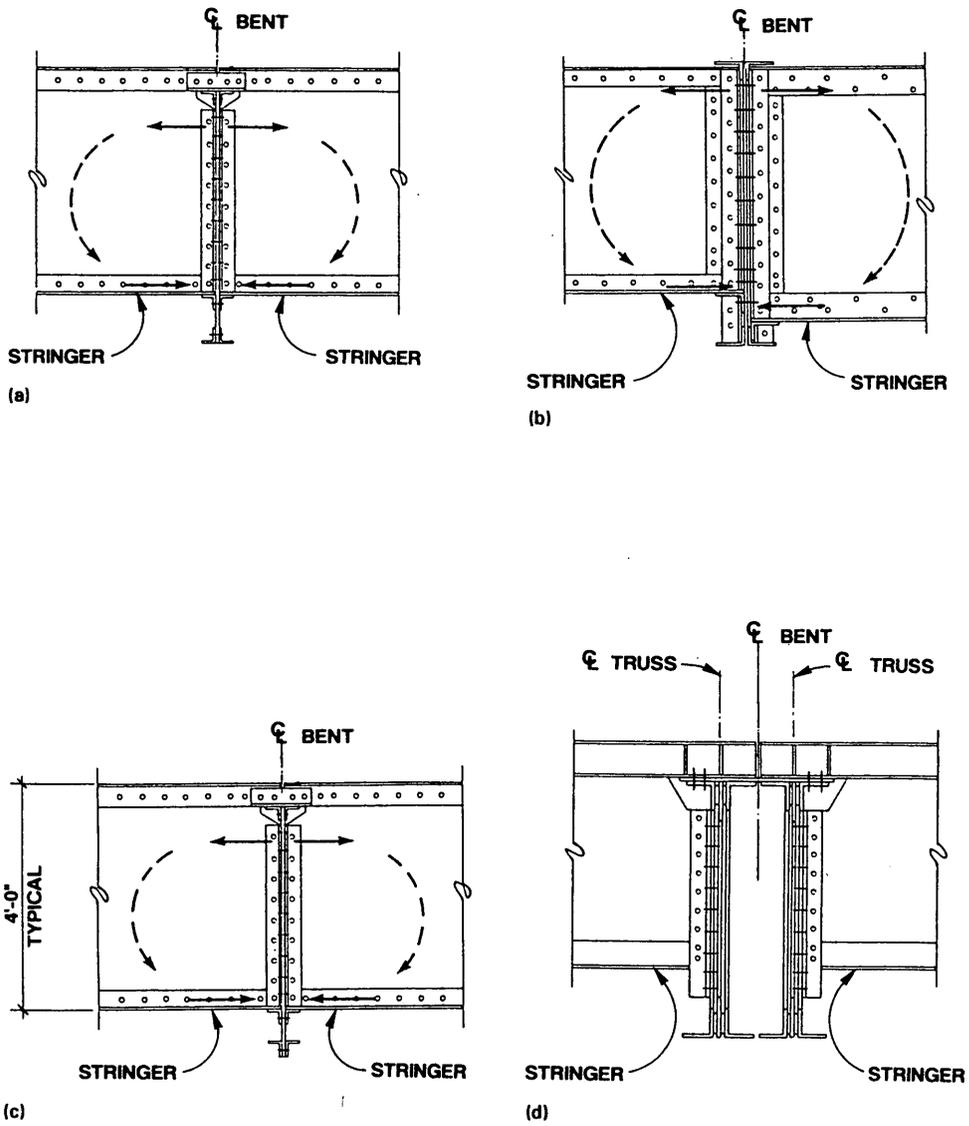
FIGURE 5 Typical details at fixed connections between stringers and support bent: *a*, South Mainline; *b*, South Loop Line; *c*, Englewood Line; *d*, Jackson Park Line.

The stringer-end support connections consist of full-depth web connection angles (Figure 5) except at the expansion seat bearing connections, typically located at every third or fourth bent support. The partial continuity, provided by the full-depth web connections on both sides of a support bent, transfers stringer negative bending moment across the support bent and into the adjacent stringer span. This continuity, or stringer end rotation restraint, causes tension through the connection angle top rivets and compression or thrusting through the bottom portion of the connection angles or bottom flange ends. The rotational stiffness of these particular connections is enhanced by the near full-depth length of the connection angles, the short outstanding legs and rivet gauges of the connection angles, and the opposing stringer end rotations caused by the train axle loads acting simultaneously on both spans.

The maximum continuity (72 to 86 percent) was found in the South Loop Line, which has the longest vertical end connection angles relative to the depth of the stringer (Figure 5). The Englewood and South Mainline structures indicated less continuity (25 to 84 percent) because of the web coped below the top flange angles (Figure 5). The top flange tie angles are deteriorated and too small to increase the degree of stringer continuity at these structures. The static tests on the Jackson Park structure indicated very little or no measured end continuity. The double truss cross-bent support at this structure (Figure 5) allowed nearly free end rotations of the stringers through twisting of each cross truss between vertical diaphragm spacers.

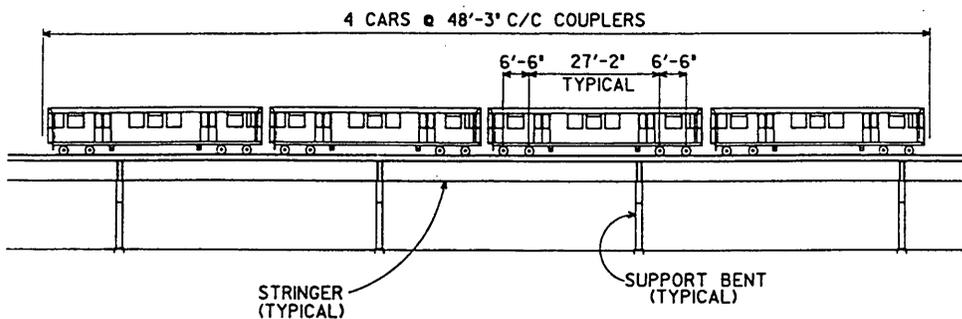
FIGURE 6 Elevation of four-car test train.

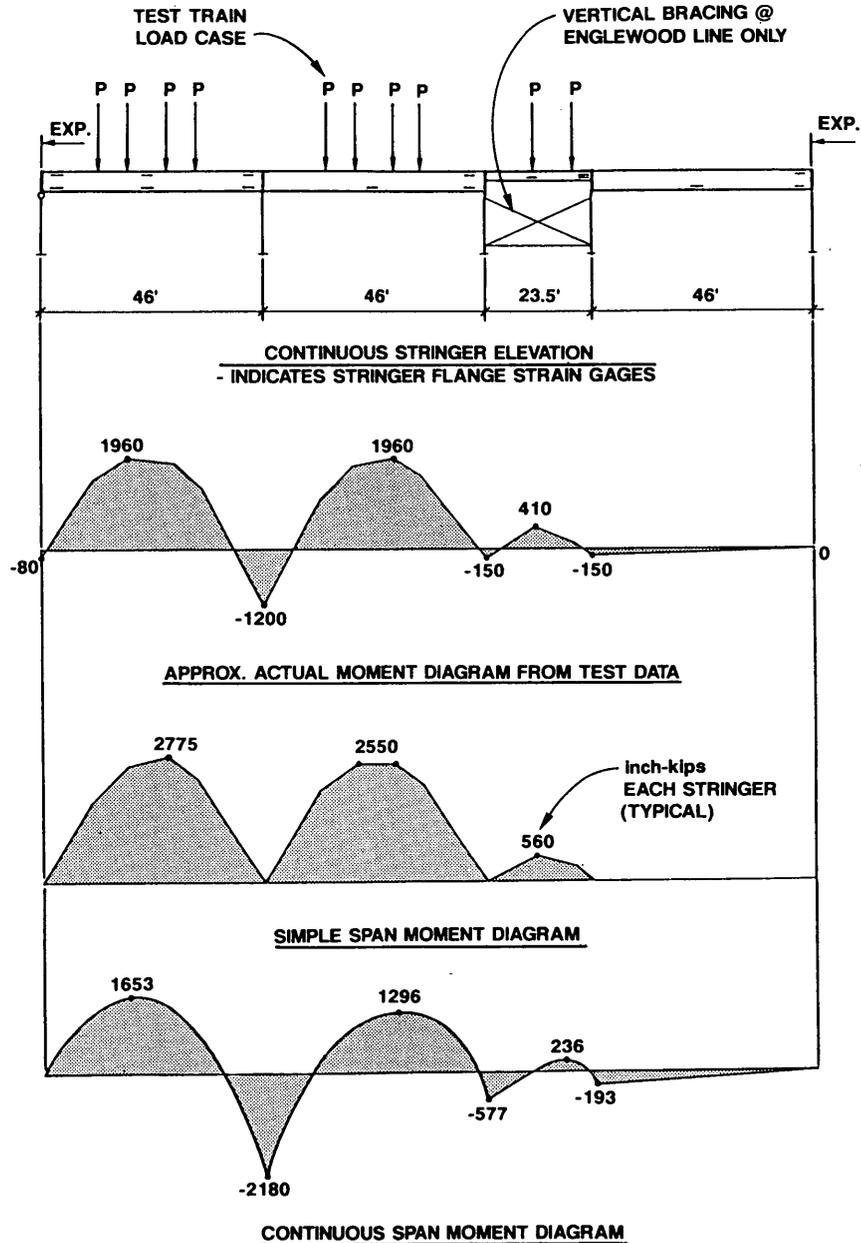
**FIGURE 7** Example of comparison of measured and calculated stringer bending moments.

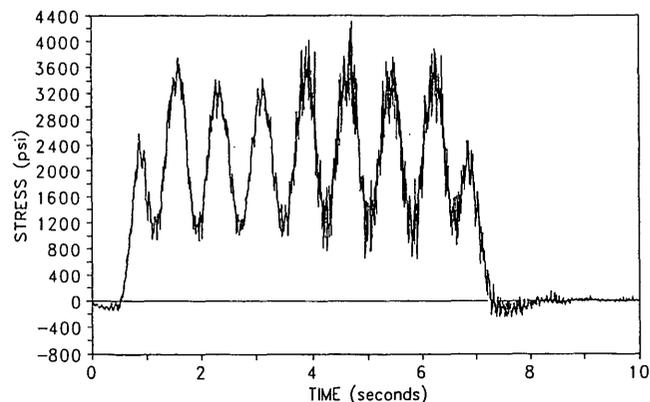
**FIGURE 8 South mainline stringer dynamic response at midspan of bottom flange for eight-car rush-hour train (speed, 44 mph).**

The passage of a moving train across a stringer span produces a stress-time history record of a variable amplitude complex stress cycle. An example of a measured dynamic stress record is shown in Figure 8. The stringer midspan bottom flange stress cycle indicates the passage of an eight-car rush-hour train (Figure 8). Each group of car axles crossing the span produces a variation (subcycle) in stress as shown by the nine peaks. The dynamic effects of the moving train load are shown by the higher-frequency oscillations in the stresses, or vibrations, with frequencies typically in the range of 70 to 100 Hz for these elevated structures.

The rush-hour average response data (Table 4) and the actual variable stress cycle plots (Figure 8) can be used for fatigue life assessment of the stringer bottom flanges at midspan. These data verify that the train loads of 19.5 kips per axle (plus impact), used by the CTA for fatigue evaluation, are conservative for these test structures. The average weight of passengers during the rush-hour tests was approximately 1.5 to 2 kips per axle at the South Loop and South Mainline test locations and was negligible at the Jackson Park and Englewood test locations.

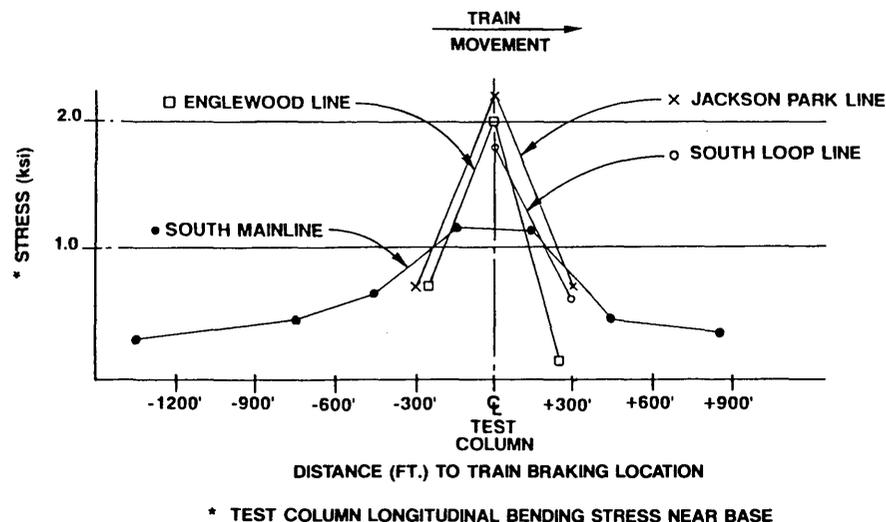
**FIGURE 9** Measured effects of longitudinal force (braking) tests using four-car test train.

The results of the train braking tests on the four structures are summarized in Figure 9. Longitudinal forces were computed on the basis of measured bending stresses near the test column bases or axial stresses in vertical bracing. The Figure 9 graph, showing the maximum test column bending stress relative to the distance of the braking train from the test column, indicates that the longitudinal braking forces are non-uniformly distributed along the track structure, and the rails are effective in distributing those braking forces across lon-

The Jackson Park and South Loop test locations recorded a reduction of column bending stress 300 ft away from the train braking location to about one-third of the maximum value directly below the braking train. The measured maximum longitudinal forces in the column directly below the test train were approximately 2.4 and 1.6 kips, respectively, for the Jackson Park and South Loop braking tests. The AREA manual longitudinal design load for both structures is approximately 3.8 kips in each column, distributed uniformly along a 200-ft length of elevated structure directly below the 200-ft-long test train. The AREA load is calculated as 15 percent of the test train load (weight) multiplied by a standard factor of 0.80 to account for continuous rail along the elevated structure exceeding 1,200 ft in length.

For the test train stopping 250 ft away from the x-bracing, the reduction in x-bracing forces and column bending stresses was approximately one-half, or less, of the maximum recorded braking force. The maximum horizontal force resisted by the vertical bracing was 22.6 kips, and by column bending 0.9 kips, when the train was stopped directly over the test spans. The AREA longitudinal design load for the entire test train is 25.9 kips distributed to 200 ft of elevated structure, consisting of one bay of vertical x-bracing and five columns in bending.
