TRANSPORTATION RESEARCH
RECORD

No. 1419

**Roadside Safety
Features and
Landscape and
Environmental Design**

Development and Proving Tests of a Four-Rope Safety Fence

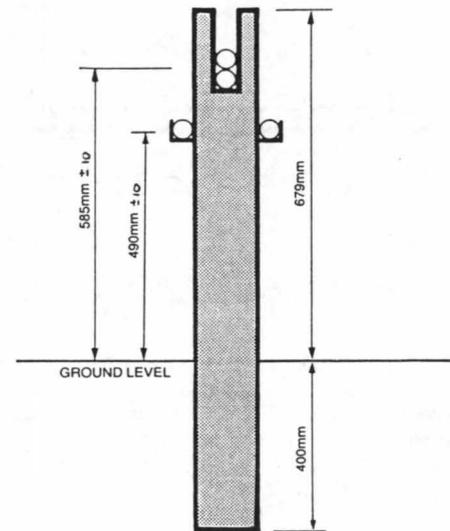
FIGURE 1 Z-section slotted post.

First, a second pair of ropes was added (Figures 1 and 2). The distance between the upper and lower ropes and their heights above the ground were selected to permit vehicles to traverse an undulating surface and hit the fence without risk of a rope slipping over the hood. The posts may be held in socketed footings for easy replacement or repair, or soil-mounted posts can be used.

In the final design, posts of z-shaped cross section were manufactured from 6-mm gauge steel having a yield strength of 335 N/mm². A short slot supported the two upper ropes at a height of 585 mm; the lower ropes were supported by small brackets each side of the z-posts at a height of 490 mm (Figures 1 and 2). The posts were held in concrete sockets with sufficient clearance for easy removal and replacement of damaged posts.

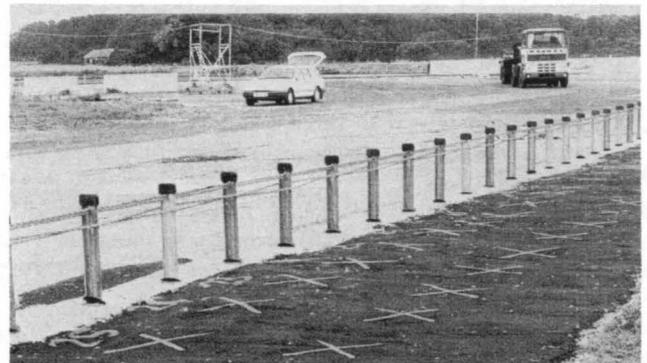
FIGURE 2 Four-rope safety fence.

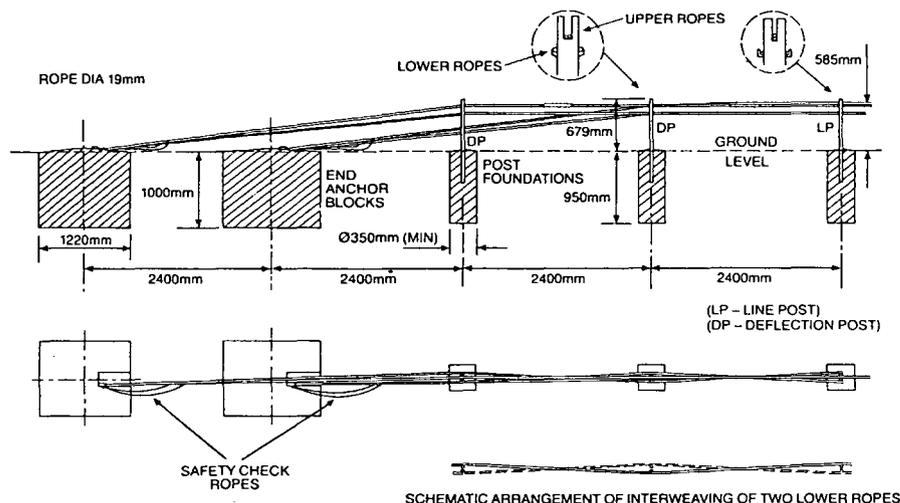
FIGURE 3 General arrangement of four-rope safety fence showing rope interwoven between every post.

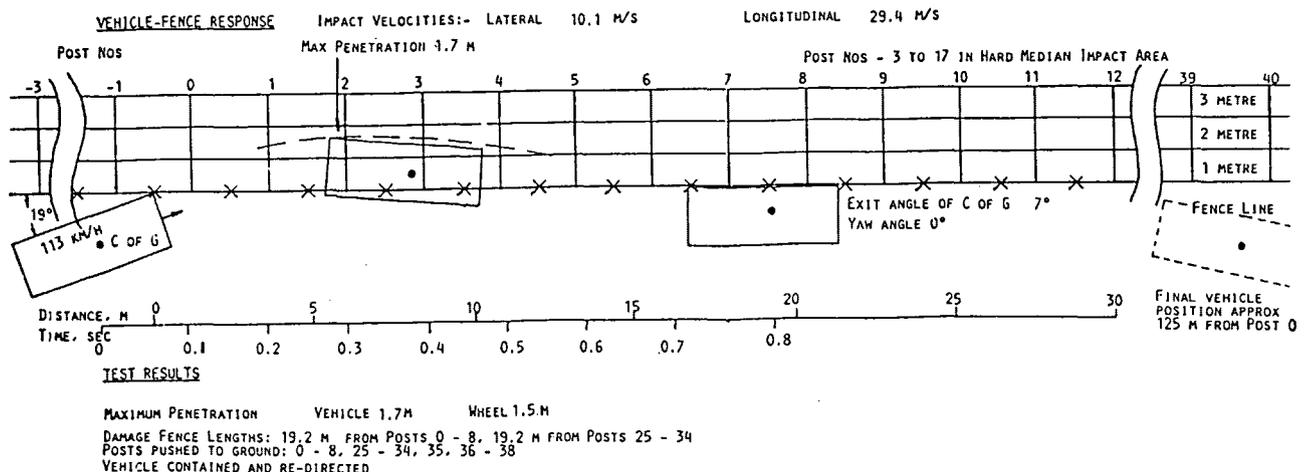
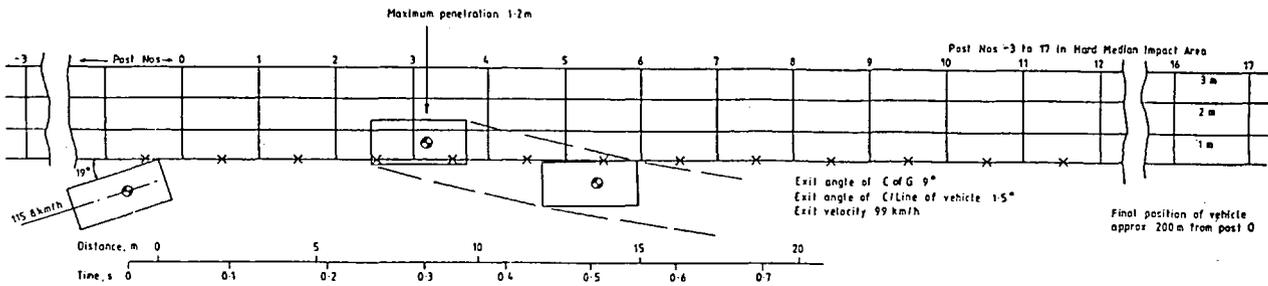
FIGURE 4 Summary of 1500-kg car test (2.4-m post spacings).

VEHICLE FENCE RESPONSE Impact Velocity: Lateral 10.5 m/s Longitudinal 30.4 m/s

Maximum Penetration: Vehicle 1.2 m Wheel 1.2 m
 Damage: Posts 0 to 4 pushed to ground.
 Posts 5 & 6 bent 65° to vertical.
 Remarks: Vehicle contained and redirected.

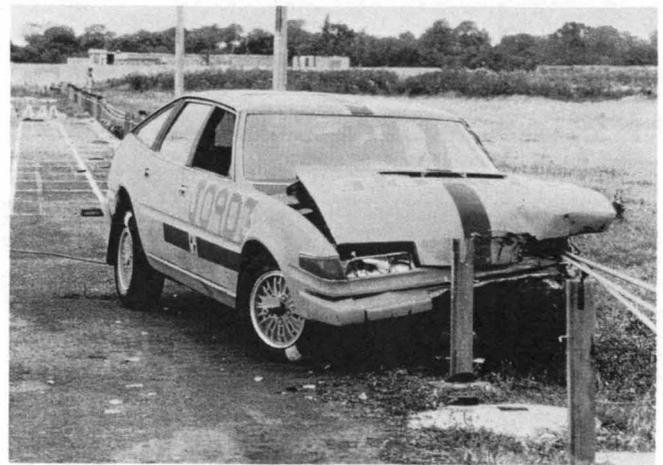
FIGURE 7 Final position of 1500-kg car (1.0-m post spacings).

The effect of reducing the post spacings from 2.4 to 1.0 m reduced the deflection of the wire rope fence from 1.7 to 1.12 m.

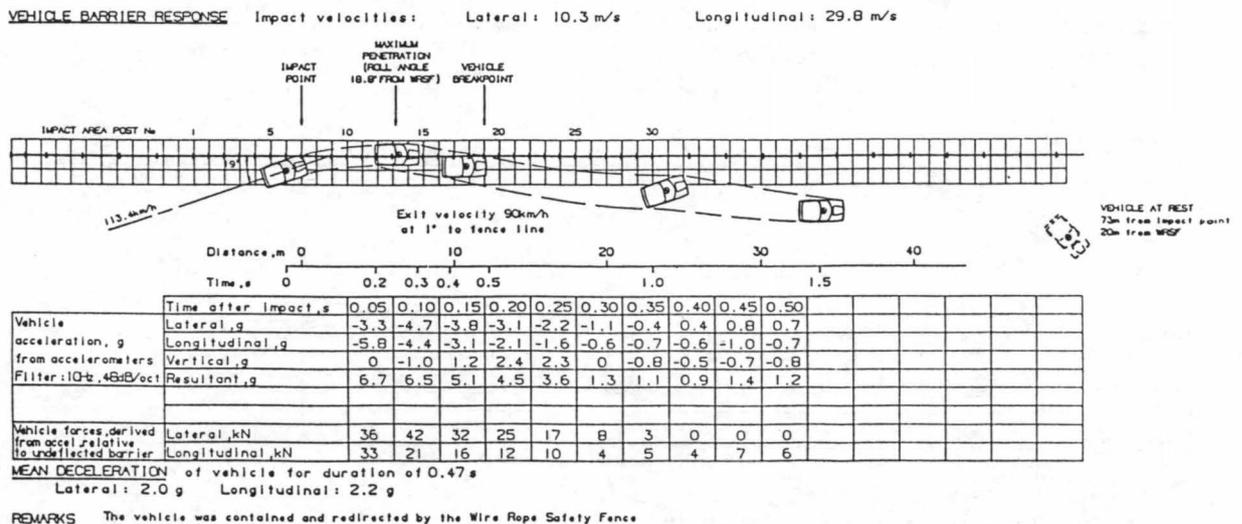
FIGURE 8 Summary of 750-kg car test (1.0-m post spacings).

A 750-kg car test (Figure 8), as mentioned earlier, is not a requirement of the DTp regulations; however, there was a possibility that the closer post spacing of 1.0 m could cause wheel snagging and induce a small car to spin out. Also there was the possibility that the lower profile of the smaller car, compared with the 1500-kg car, could permit the ropes to slip over the hood. In addition, the smaller car could represent a larger vehicle running on soft ground, whose height, relative to the fence, was lowered by the wheels penetrating the running surface. In addition, the test with a light vehicle would give an indication of the severity of impact.

About seven posts were run down and another six posts were bent and needed replacement.

The test successfully passed the DTp requirements, and the exit angle complied with BS6779. Also, all ropes remained in contact with the side of the car; none slipped over the hood.

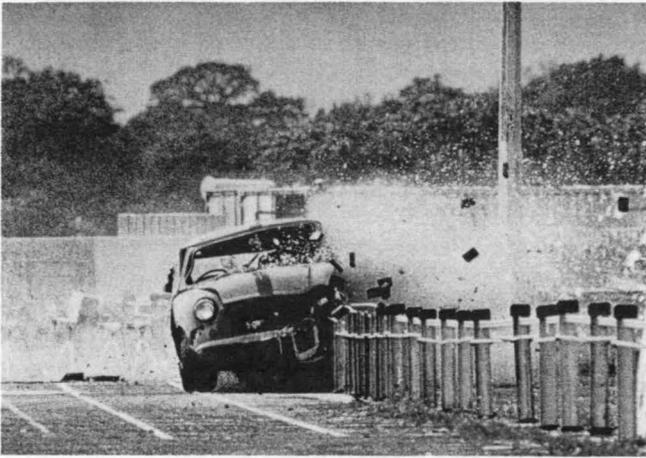
FIGURE 9 750-kg car during impact (1.0-m post spacings).

The test demonstrated that the four-rope fence met the running height conditions for soft ground.

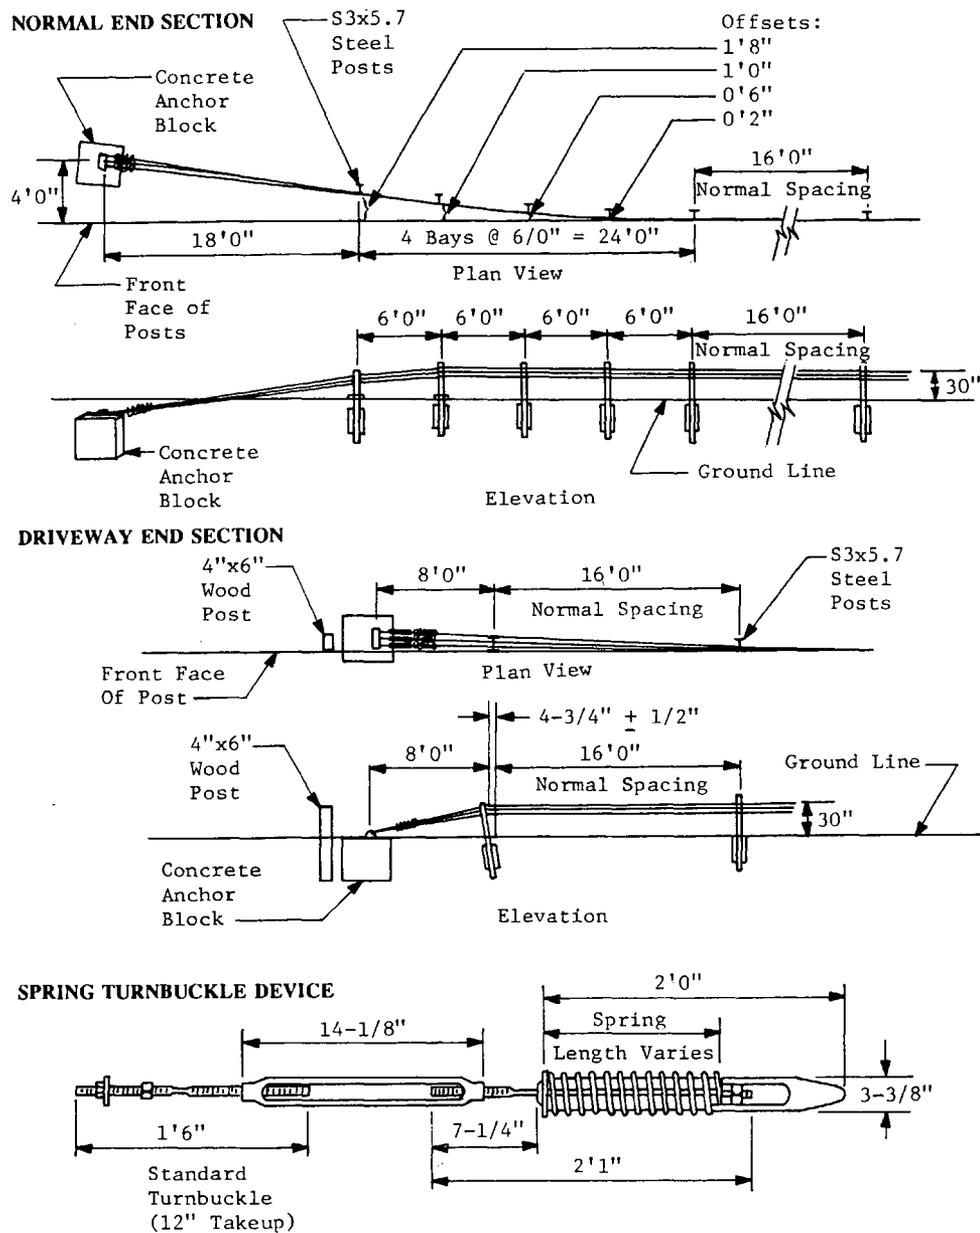
FIGURE 1 Cable-guiderail detail (1 mm = 0.04 in.).

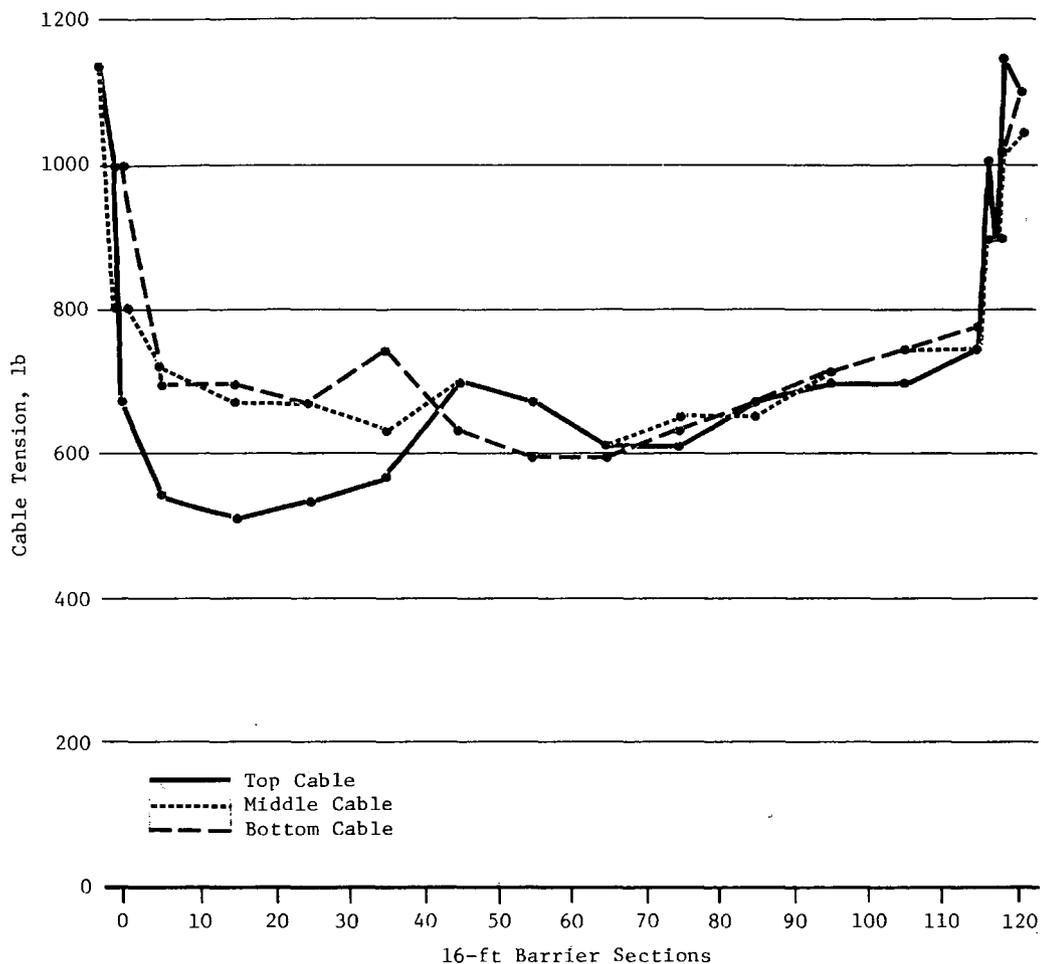
FIGURE 2 Distribution of tension through barrier after tensioning by former normal procedure (1 N = 0.225 lbf, 1 m = 3.28 ft).

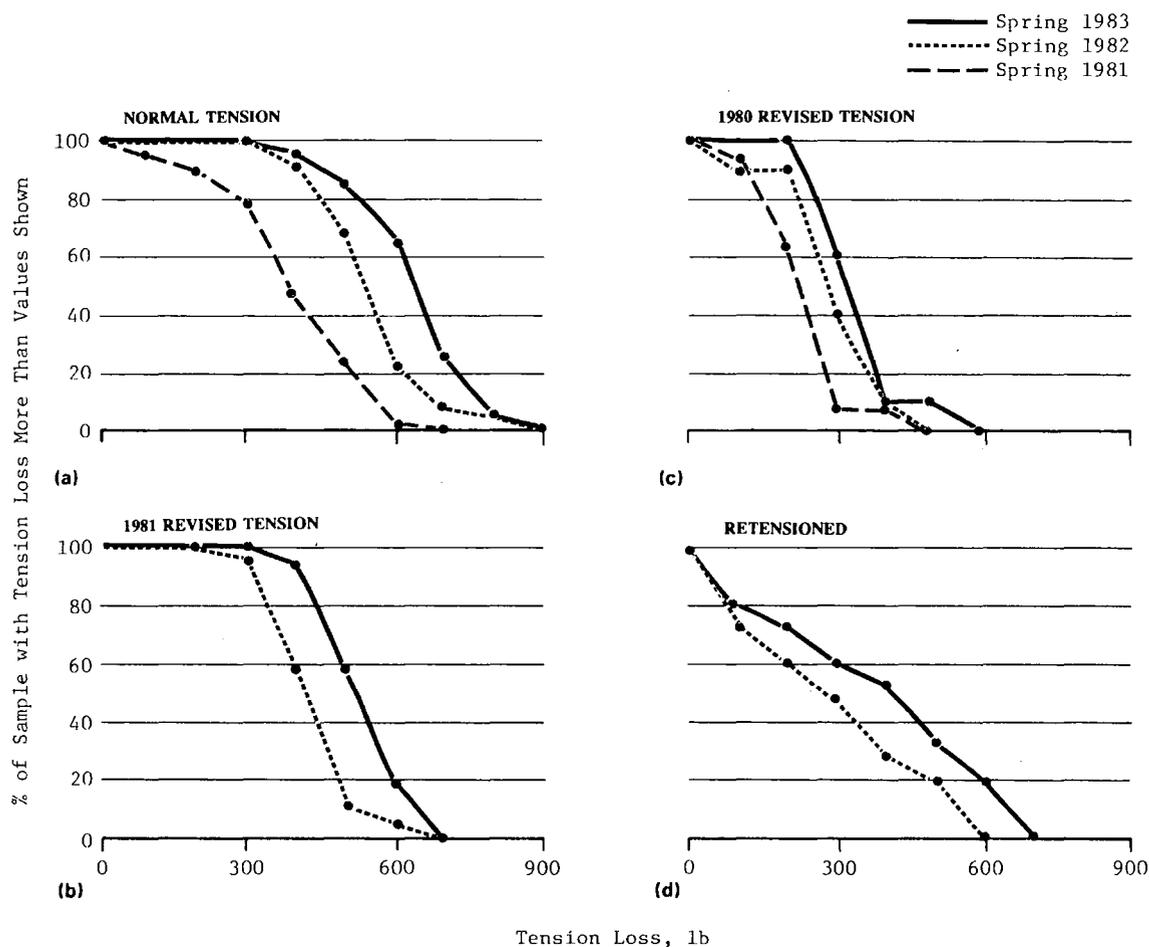
FIGURE 3 Distribution of tension loss after final adjustments 1980 revised tension (1 N = 0.225 lbf).

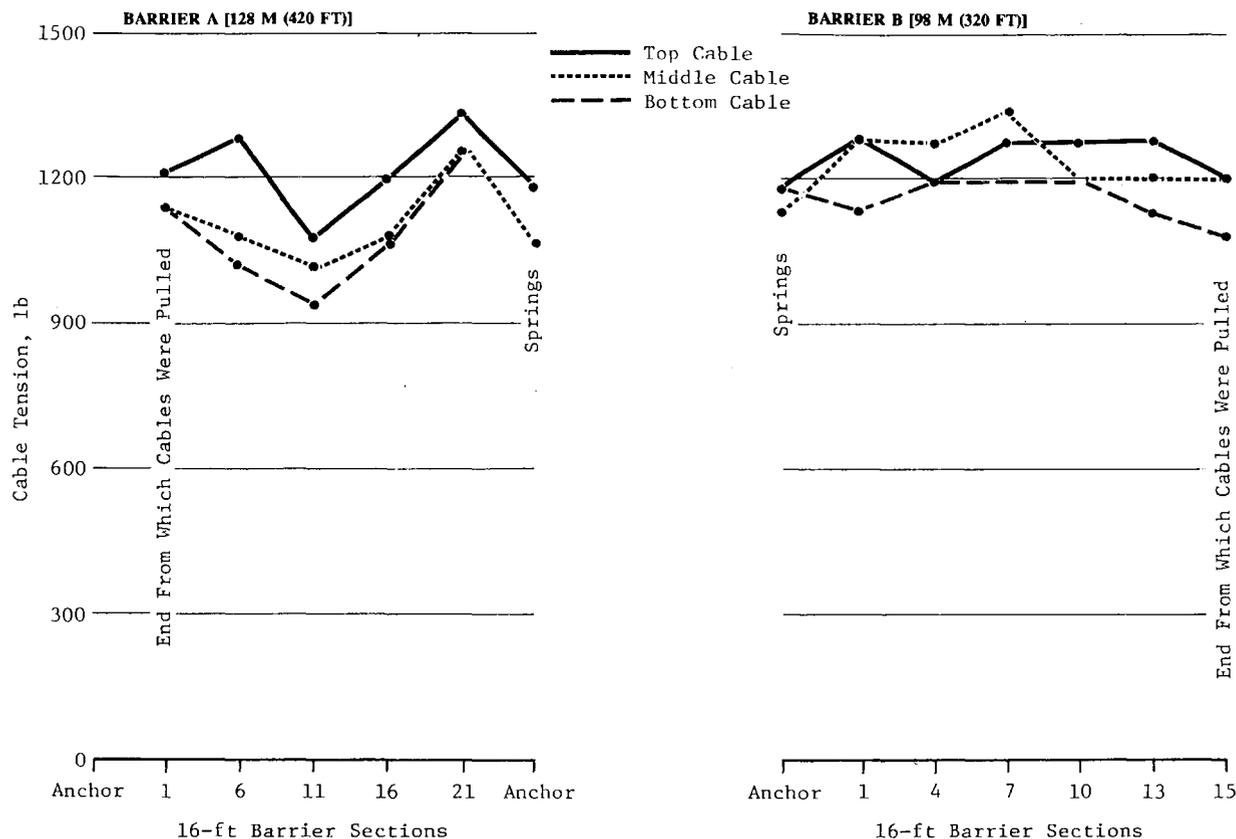
FIGURE 4 Distribution of tension in two barriers after final adjustments for four sample groups (1 N = 0.225 lbf).

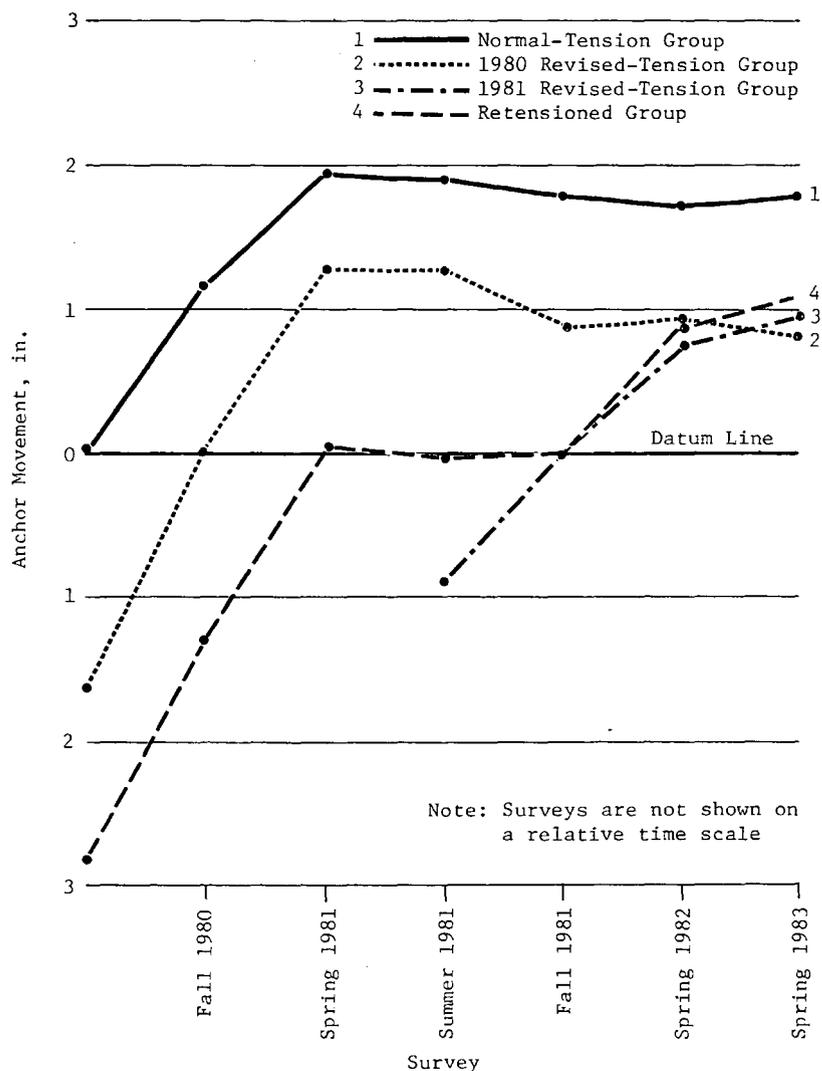
FIGURE 5 Summary of anchor movement for four sample groups (1 mm = 0.04 in.).

Anchor movement for each sample group is summarized in Figure 5. The curves represent average measured anchor movements for the samples in each survey. Most movement occurred immediately after tensioning and between the first fall and spring surveys. After the first spring, a slight decrease in average anchor movement was often noted, probably caused as the anchors settled back. During and after tensioning, the anchors tipped forward, pressing against the fresh fill and compacting the soil beneath the front portions of the anchors. Most guiderail is installed during late summer and fall, and falling temperatures maintain a load on the anchors. Movement probably ceases during winter because soil around the anchor freezes, but high moisture levels and thawing in spring result in low soil support. This poor support is normally coupled with relatively high cable tension from the cool temperatures, compared with installation, and this situation probably produces the significant movement measured in the first spring

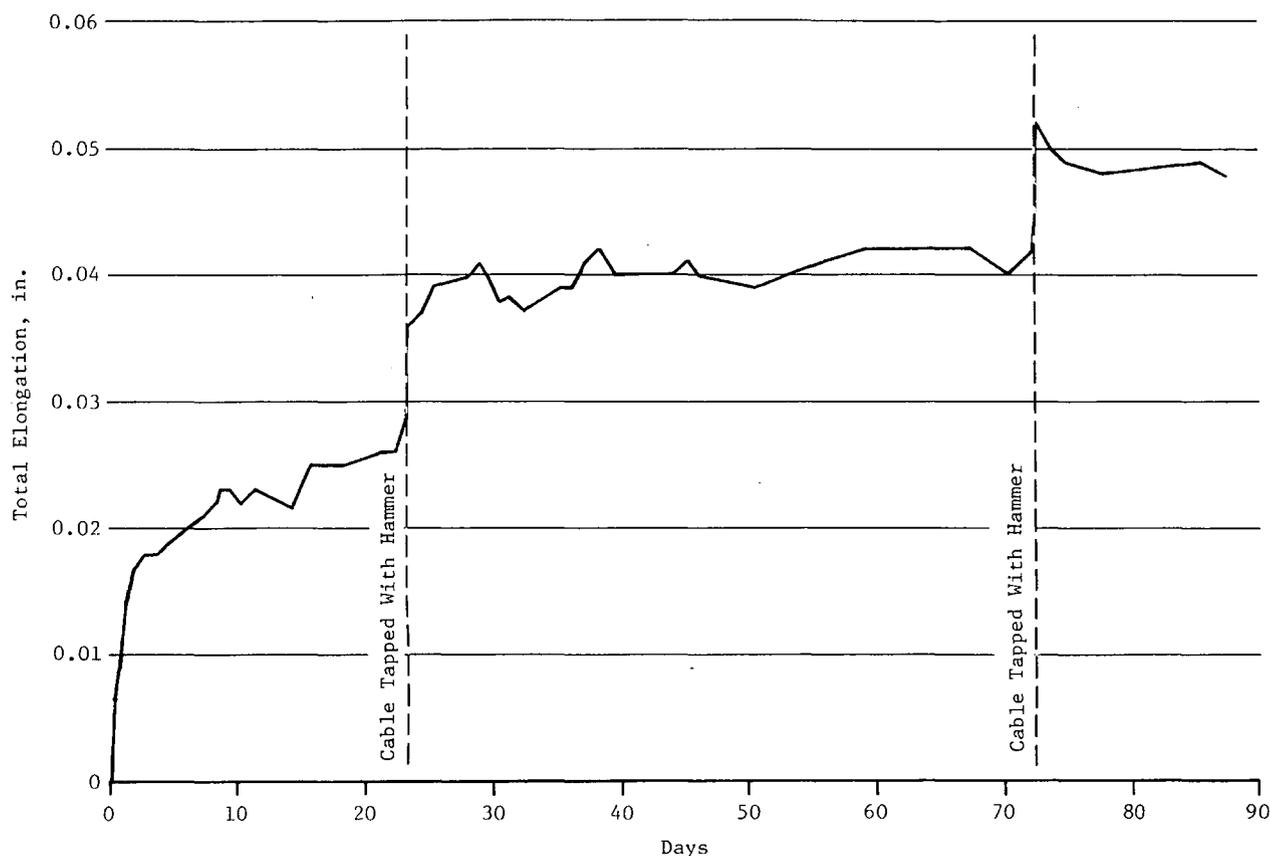
FIGURE 6 Permanent cable stretch over 12-week period (1 mm = 0.04 in.).

Manufacturers of a wire rope contacted in this study claimed that guiderail cable may experience a permanent stretch of 0.25 to 0.50 percent of its unloaded length (personal correspondence, S. E. Chehi, Bethlehem Steel Corporation, March 1981). This much stretch would produce large tension loss in cable guiderail. According to industry representatives, guiderail working loads of up to 2,000 lb would never remove all the potential stretch, which would continue as long as the cable was loaded (personal correspondence, S. E. Chehi, Bethlehem Steel Corporation, March 1981). They further indicated that even setting initial tension in the upper range of the working load will not remove all potential stretch, but probably would help reduce tension loss from subsequent cable stretch. Prestretching the cable at loads of 1,200 to 15,000 lb would be the only way to remove all the stretch, but this was not considered feasible by one major manufacturer because of lack of facilities to perform the work. The manufacturer did prestretch one reel containing 1,078 ft of cable. This material was then made available for field instal-

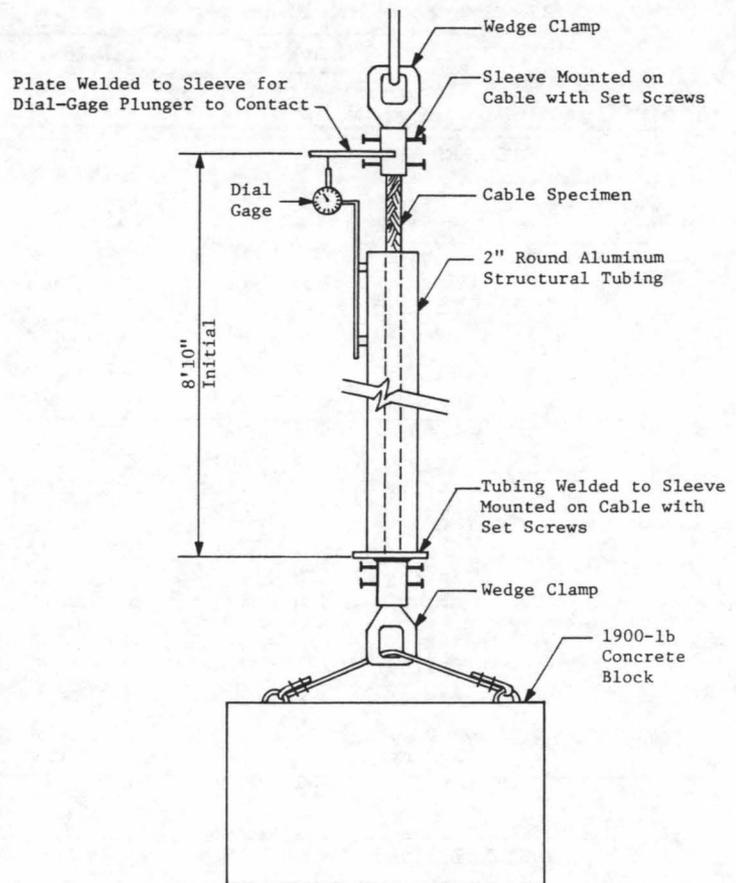
FIGURE 7 Cable stretch tests: as cable specimen elongates under load, structural tubing fixed to cable bottom moves down with it, and gauge mounted on top of tubing registers this movement with respect to plate fixed above cable (1 m = 3.28 ft, 1 mm = 0.04 in., 1 kg = 2.21 lb).

Laboratory stretch tests were conducted using normal and prestretched cable to find any significant differences in cable strain due to long-term loading. Bethlehem Steel Corp. pro-

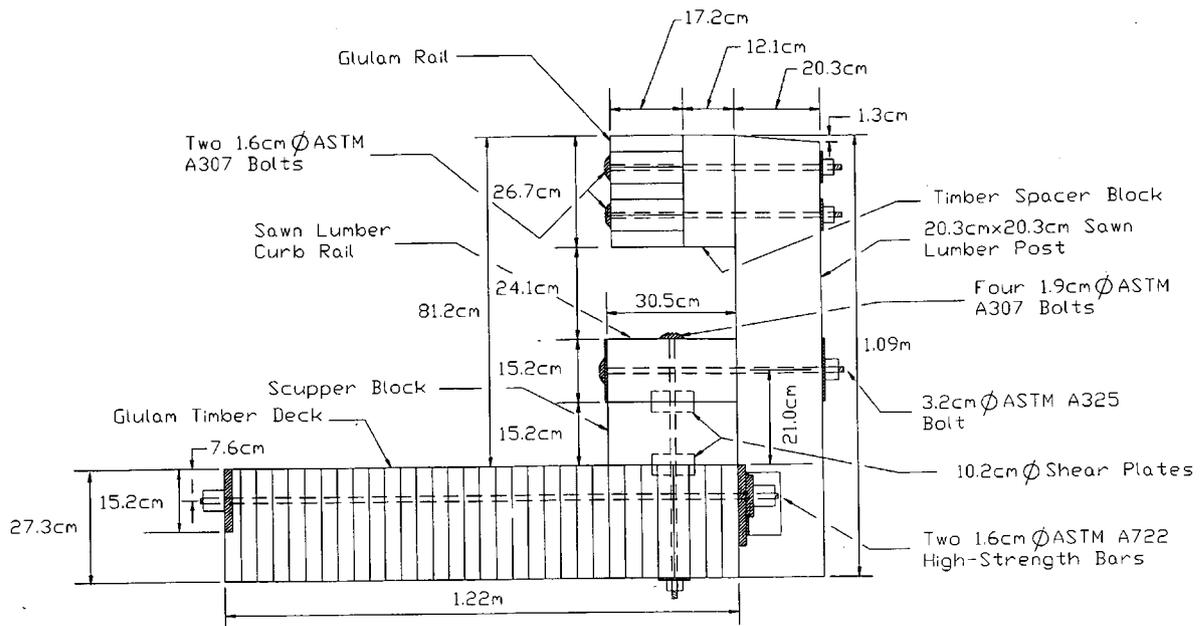
- Notes: (1) Post Spacing 1.90m
 (2) Many details have been omitted, refer to reference (10)
 (3) 1in=2.54cm

FIGURE 1 Longitudinal glulam and sawn lumber curb bridge railing, or curb system.

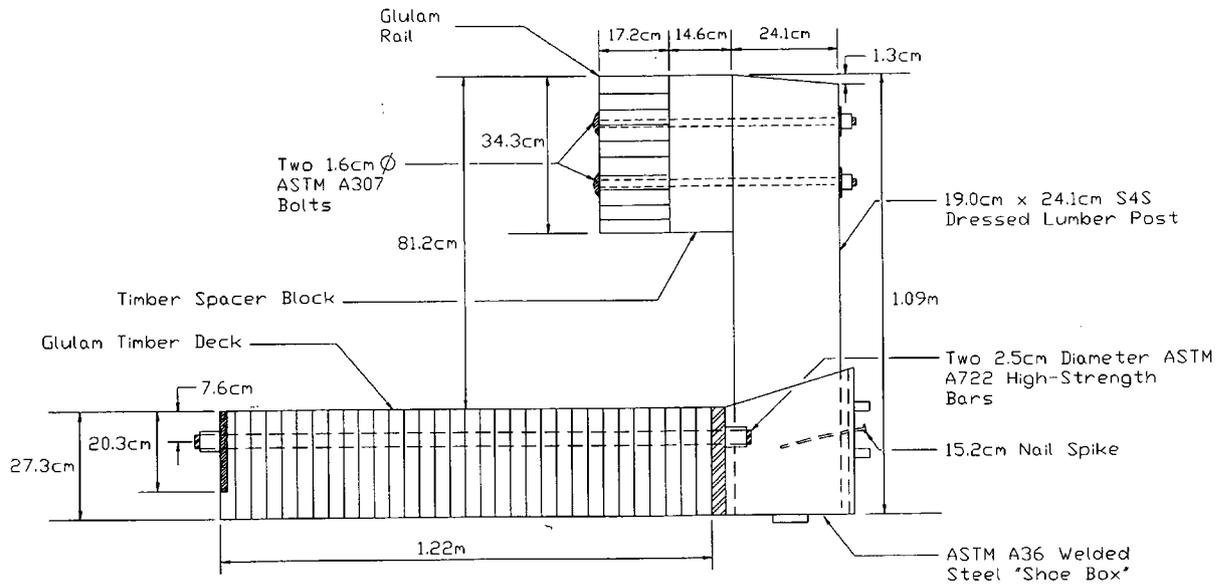
- Notes: (1) Post Spacing 1.90m
 (2) Many details have been omitted, refer to reference (10)
 (3) 1in = 2.54cm

FIGURE 2 Single longitudinal glulam bridge railing, or shoe-box system.

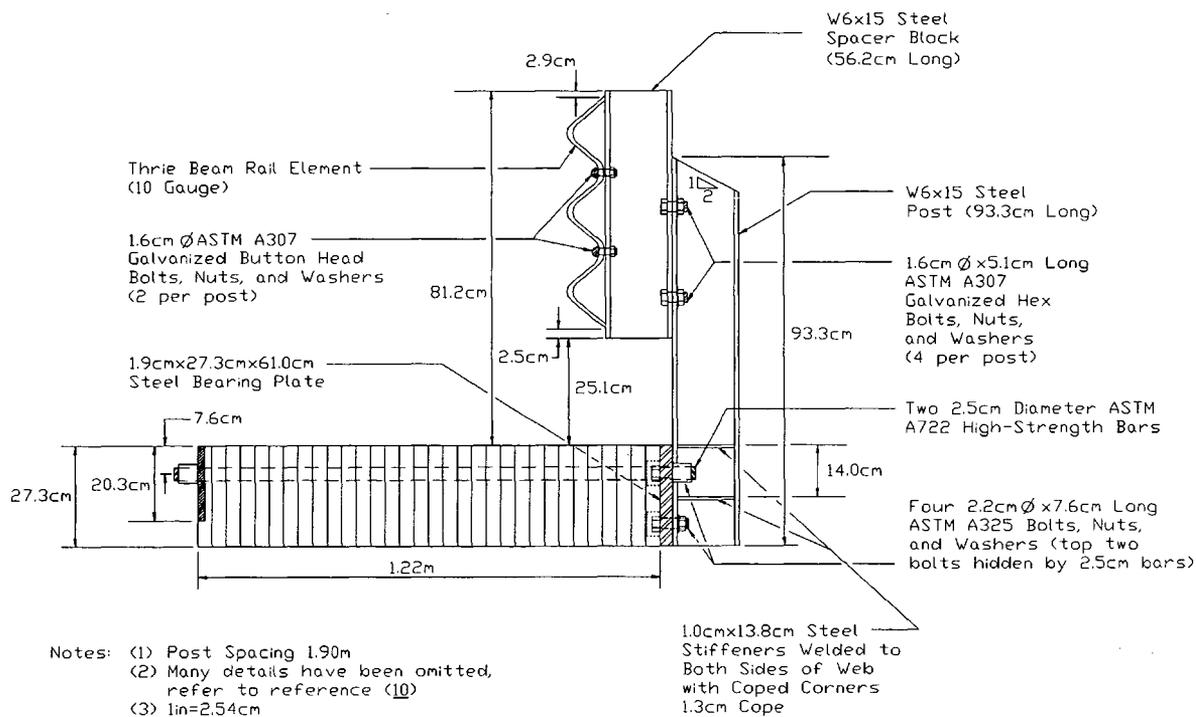
FIGURE 3 Single steel thrie-beam bridge railing, or steel system.

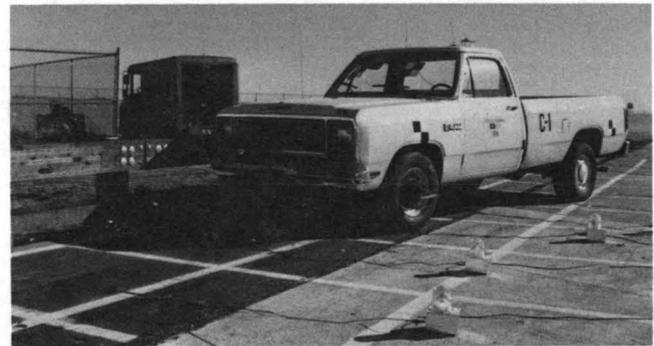
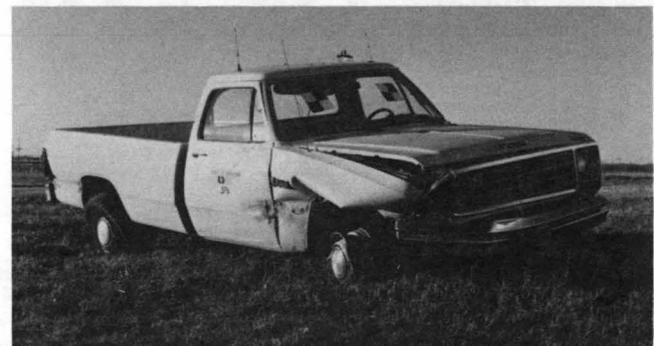
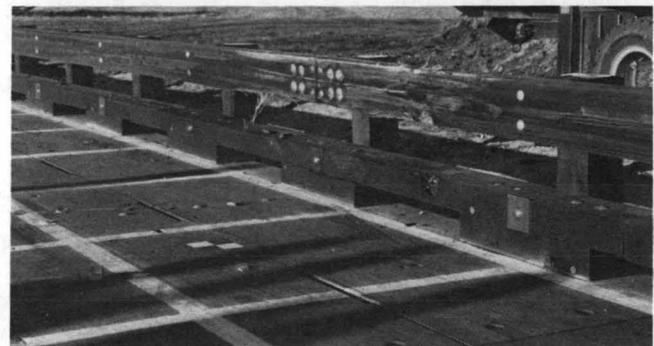
FIGURE 4 Impact location (top), vehicle damage (middle), and bridge-rail damage (bottom), Test C-1.

The moderate test vehicle damage is shown in Figure 4. The superficial damage to the bridge-railing system is shown in Figure 4. Minor scrapes occurred along both the upper glulam and lower curb rails. The length of vehicle contact on the upper glulam rail was approximately 2.74 m (9 ft). The lower curb rail received a gouge 15.2 cm (6 in.) long near impact. During the test, the 15.2-cm (6-in.) square steel plate washer located on the back side of Post 8 was deformed.

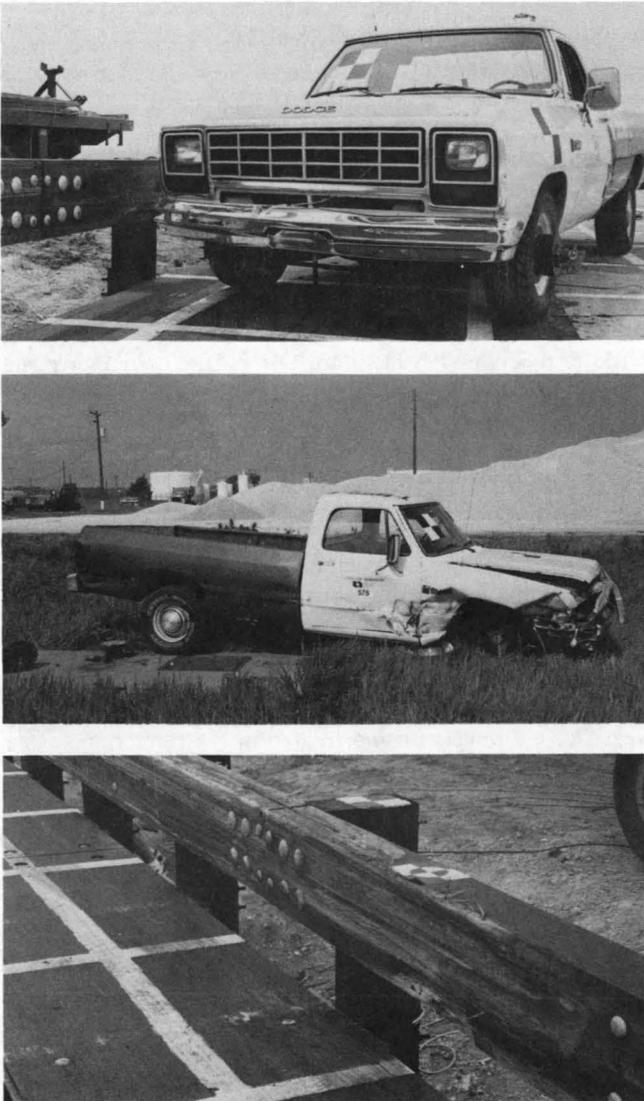
FIGURE 6 Impact location (top), vehicle damage (middle), and bridge-rail damage (bottom), Test FSSB-1.

The moderate test vehicle damage is shown in Figure 6. The superficial damage to the bridge rail is shown in Figure 6. Both minor scrapes and gouging were evident along the traffic-side face of the bridge rail. Post 8 received some indentations and black marks on the upstream exposed corner; evidence of tire marks on the timber deck near Post 8 are shown in Figure 6. The gouging on the lower portion of the rail oc-

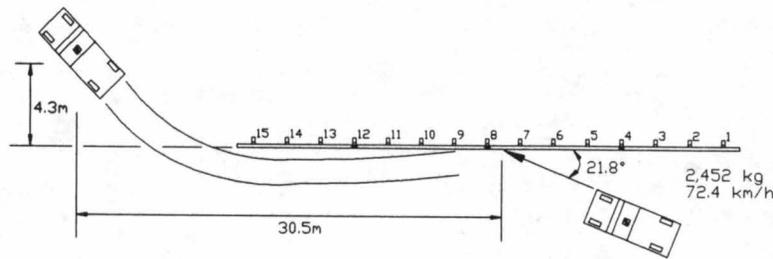
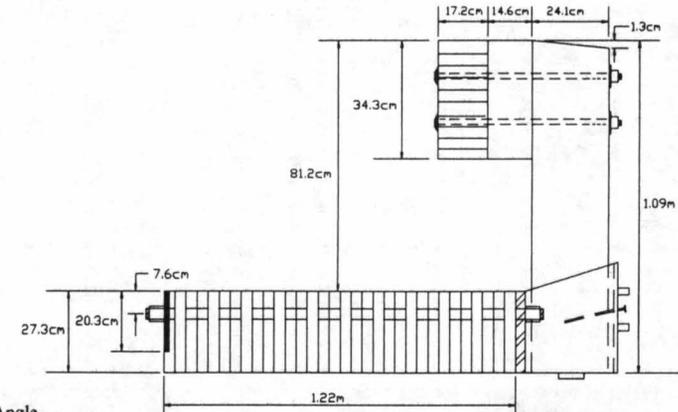
Test Number	FSSB-1
Date	5/14/91
Bridge Rail Installation	Glulam Timber Bridge Rail With Steel Shoe Box
Length	28.59 m
Glulam Timber Rail	
Width	17.2 cm
Depth	34.3 cm
Top Mounting Height	81.2 cm
Material	Glulam Rail-Comb. No. 2
Posts (No. 1 through 15)	
Size	19.0 cm x 24.1 cm x 108.6 cm
Material	S4S Dressed Lumber
Bridge Deck Installation	Longitudinal Glulam Timber Bridge Deck Panels
Panel Size	27.3 cm x 1.22 m x 5.72 m
Material	Glulam Timber Deck Comb. No. 2
Vehicle Model	1984 Dodge Ram
Test Inertial Weight	2,452 kg
Gross Static Weight	2,452 kg
Vehicle Speed	
Impact	72.4 km/h
Exit	57.0 km/h

FIGURE 7 Summary of test results and sequential photographs, Test FSSB-1.

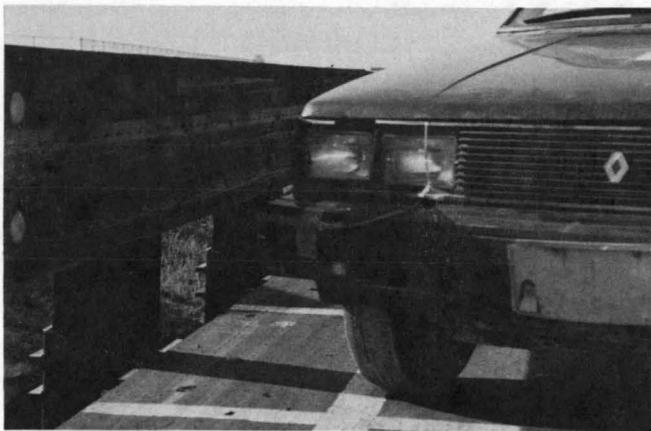
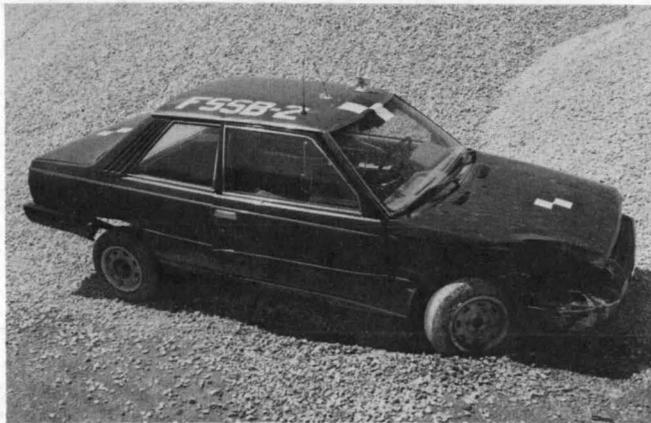
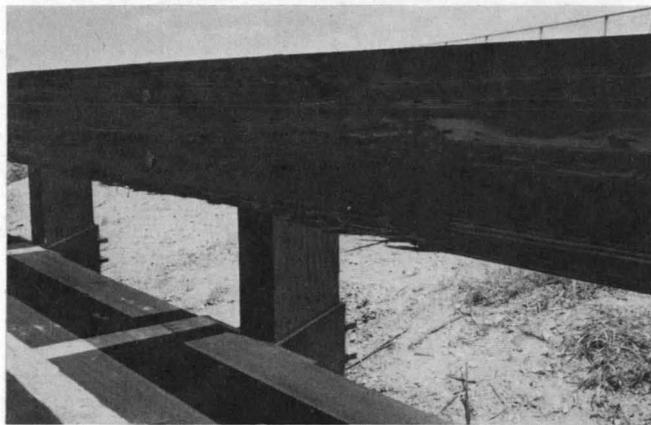
FIGURE 8 Impact location (*top*), vehicle damage (*middle*), and bridge-rail damage (*bottom*), Test FSSB-2.

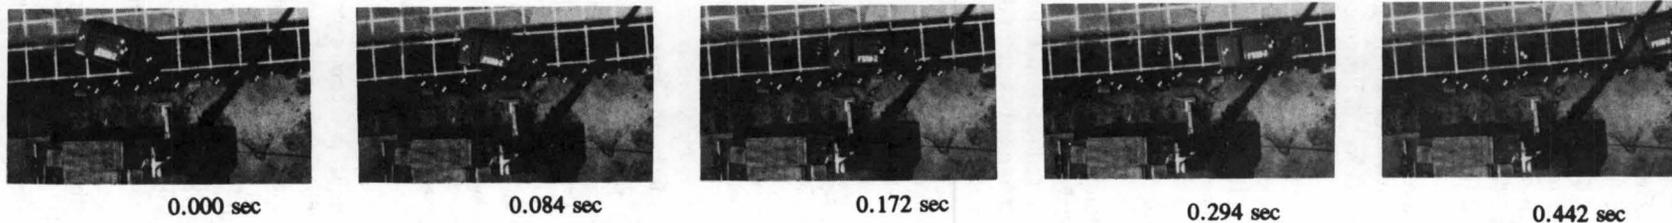
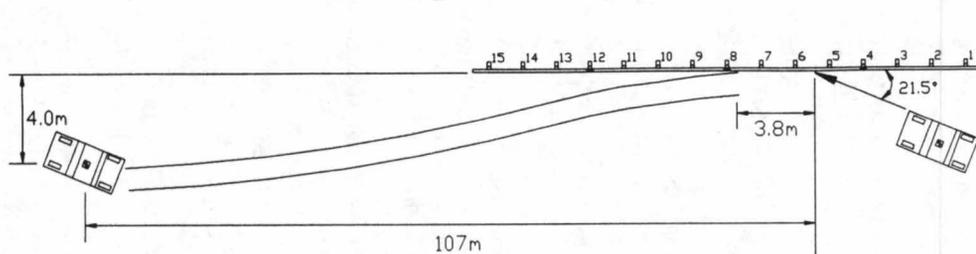
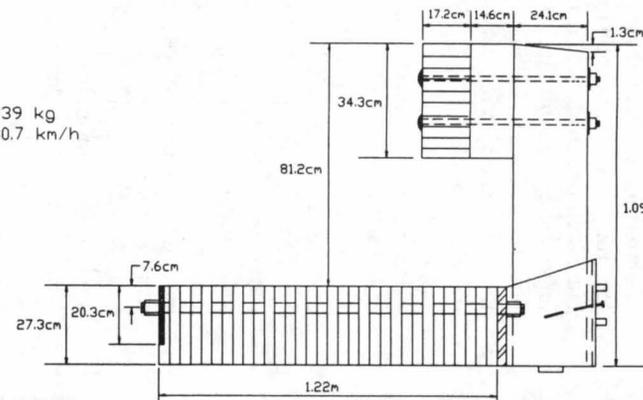
Test Number	FSSB-2
Date	6/12/91
Bridge Rail Installation	Glulam Timber Bridge Rail With Steel Shoe Box
Length	28.59 m
Glulam Timber Rail	
Width	17.2 cm
Depth	34.3 cm
Top Mounting Height	81.2 cm
Material	Glulam Rail-Comb. No. 2
Post (No. 1 through 15)	
Size	19.0 cm x 24.1 cm x 108.6 cm
Material	S4S Dressed Lumber
Bridge Deck Installation	
Longitudinal Glulam Timber Bridge Deck Panels	
Panel Size	27.3 cm x 1.22 m x 5.72 m
Material	Glulam Timber Deck Comb. No. 2
Vehicle Model	
1984 Renault Alliance	
Test Inertial Weight	839 kg
Gross Static Weight	839 kg
Vehicle Speed	
Impact	80.7 km/h
Exit	60.9 km/h

FIGURE 9 Summary of test results and sequential photographs, Test FSSB-2.

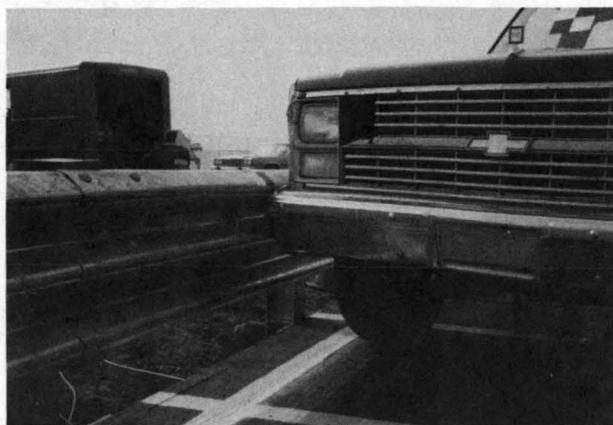
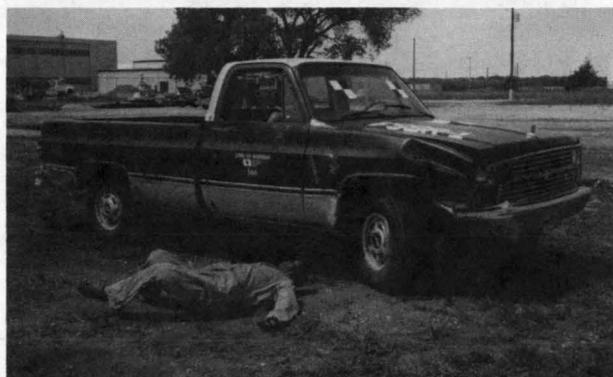
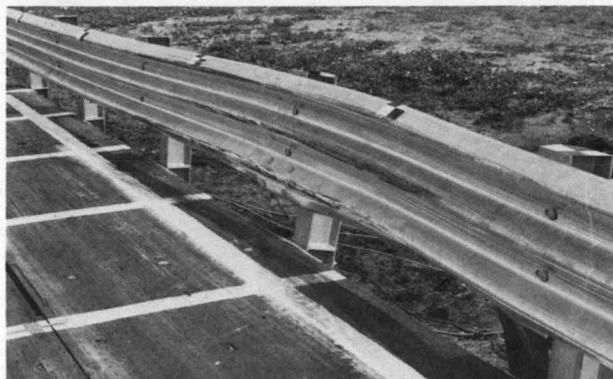
FIGURE 10 Impact location (*top*), vehicle damage (*middle*), and bridge-rail damage (*bottom*), Test FSSR-1.

The minor test vehicle damage is shown in Figure 10. The moderate bridge-rail and post damage is shown in Figure 10. The physical damage to the thrie beam, consisting of scrapes, tire marks, and deformation, was measured to be 3.94 m (12 ft 11 in.) long.

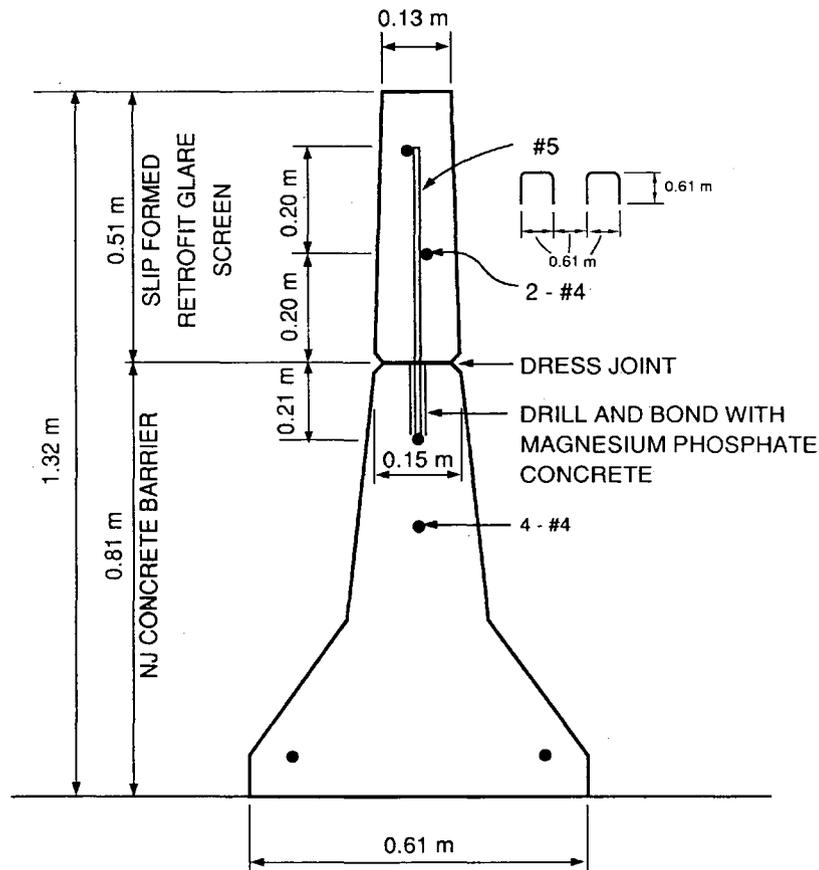
FIGURE 1 Type 50R typical cross section.

The height selected for the Type 50R barrier was 1.32 m (52 in.): a 0.81-m (32-in.) CMB plus a 0.51-m (20-in.) CGS. This is 51 mm (2 in.) higher than the minimum height recommended in the NCHRP Synthesis on glare screens (3). It is also higher than the vertical center of gravity height for

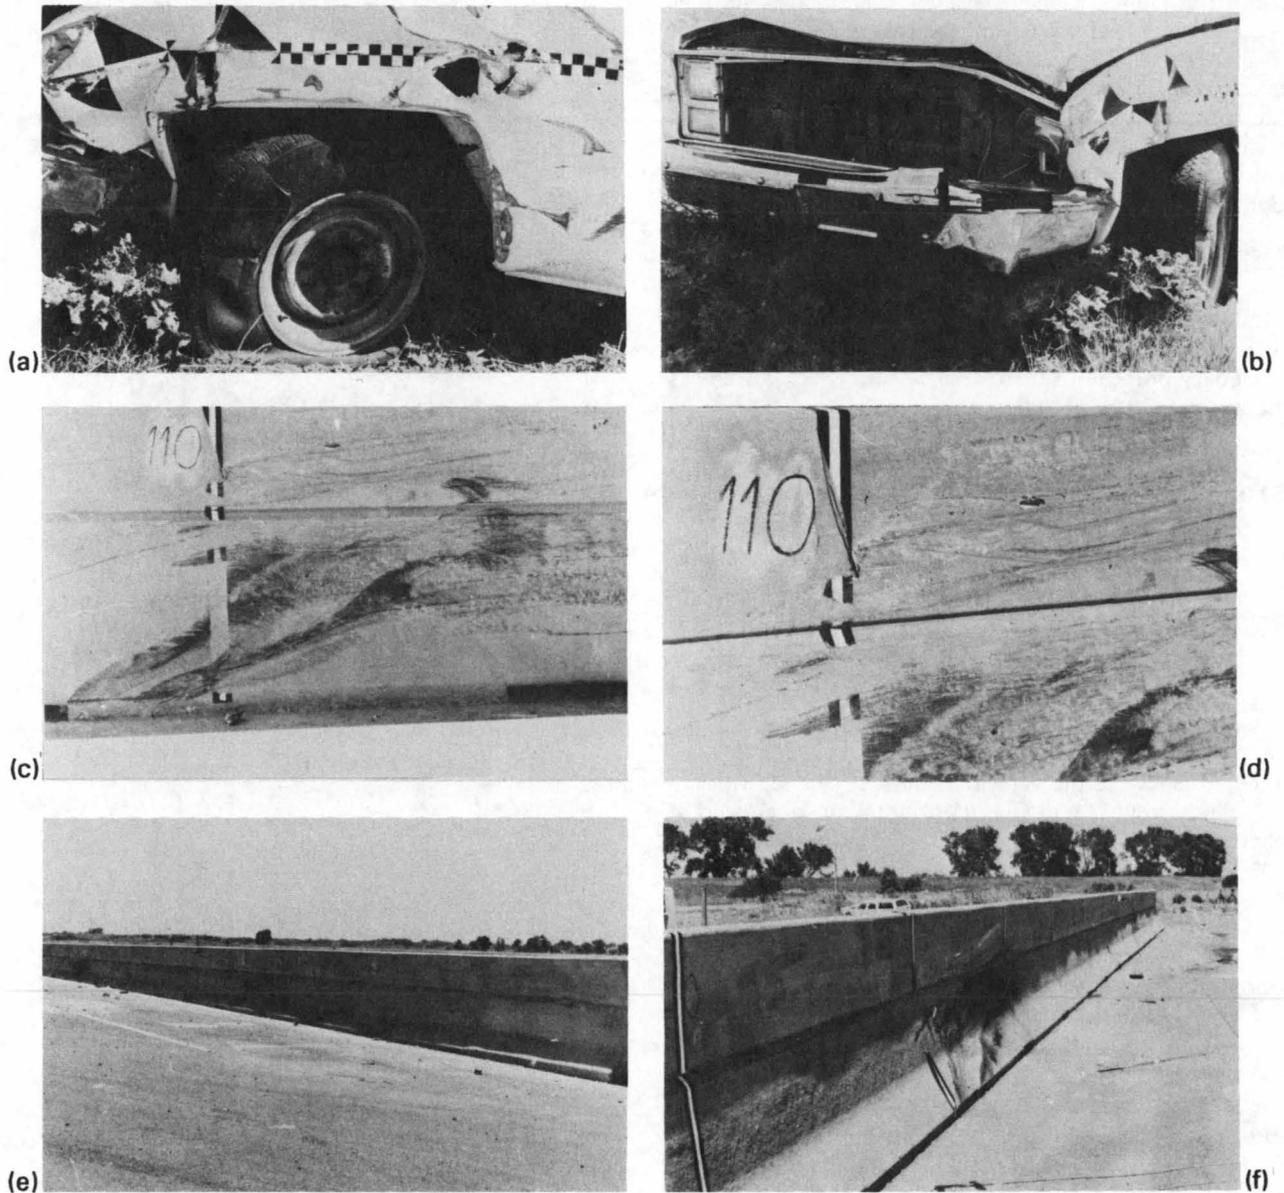
FIGURE 4 Test 481, postimpact photographs: (a) left front tire of vehicle, (b) left front corner of vehicle, (c–f) barrier.

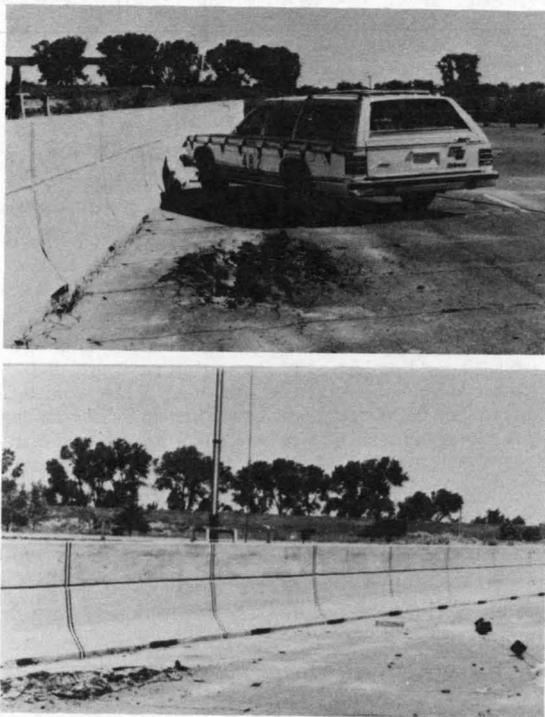
FIGURE 5 Test 482, preimpact photographs: *top*, vehicle; *bottom*, barrier.

The planned test conditions for Test 482 were 2043 kg (4,500 lb) at 97 km/hr (60 mph) and 25 degrees (Figure 5).

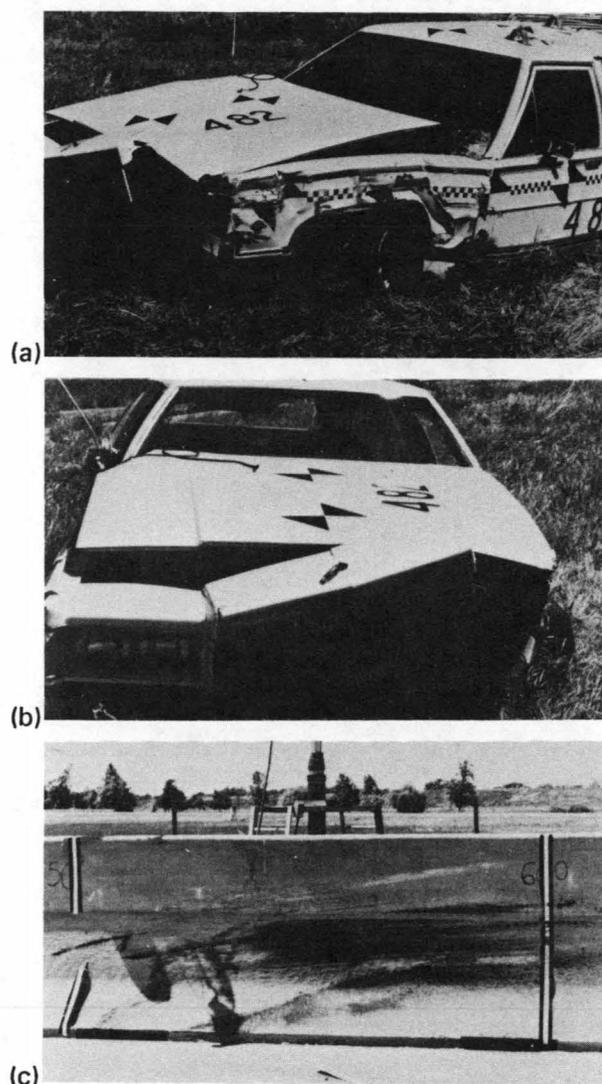
FIGURE 7 Test 482, postimpact photographs: (a,b) vehicle, (c) barrier.
