TRANSPORTATION RESEARCH
RECORD

No. 1419

**Roadside Safety
Features and
Landscape and
Environmental Design**

Development and Proving Tests of a Four-Rope Safety Fence

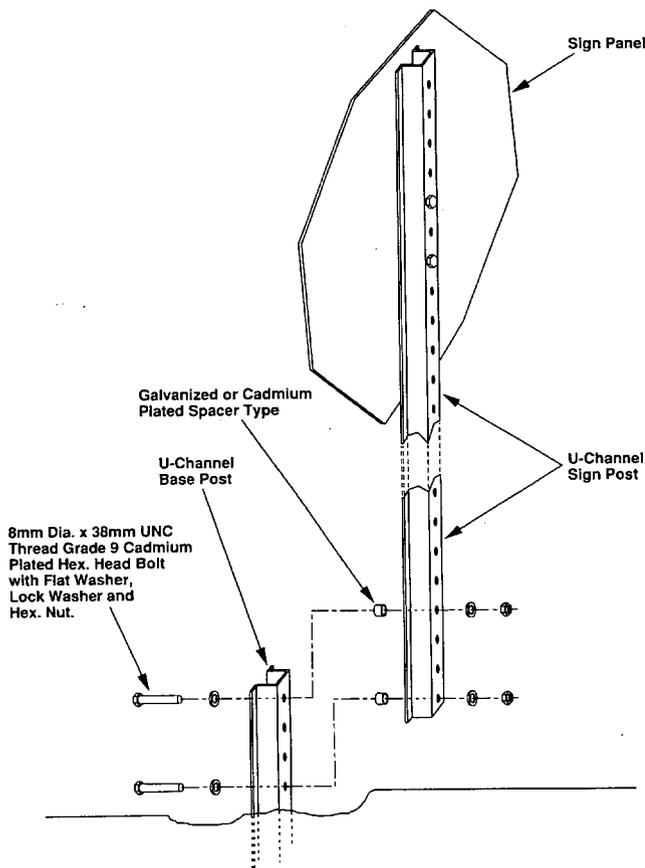
FIGURE 1 U-channel installation pictorial.

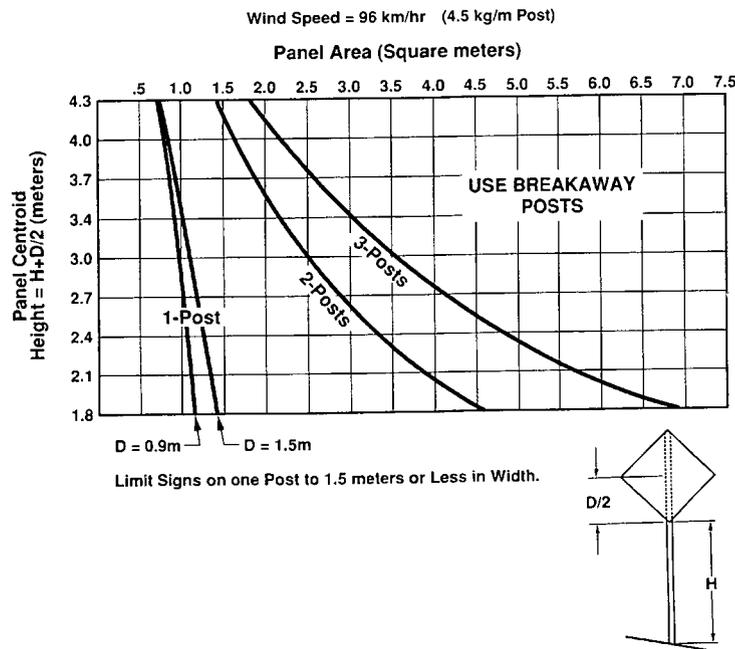
FIGURE 2 U-channel selection chart.

The U-channel selection chart, which is part of the ADOT U-channel small sign support standard drawing, is shown in Figure 2. The selection chart is used to determine support configurations for a given sign panel. The selection chart is based on a 96.5-km/hr (60-mph) wind speed. AASHTO specifications state that for roadside supports a 10-year mean recurrence interval should be used (2). A U.S. map indicating that for a 10-year mean recurrence interval the wind speed is 112.6 km/hr (70 mph) for most of Arizona is also given by

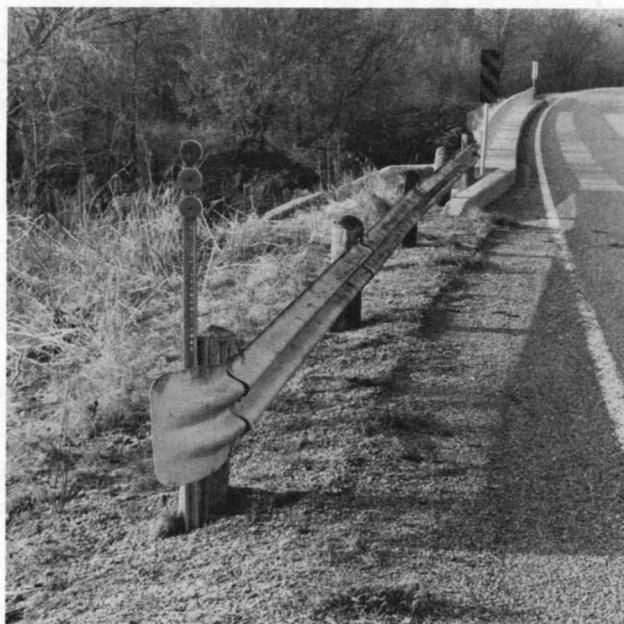
FIGURE 1 Example of typical exposed guardrail end.

Most of the guardrail-end accidents on Oklahoma highways were at either exposed ends or turned-down ends. There were a few accidents involving breakaway cable terminals, parabolic end sections, and double-faced turned-down ends. Oklahoma turned-down ends typically have an initial wooden post, and all posts have block-outs. The turned-down end design specifies 7.62 m (25 ft) between the embedded end and the first post, and 3.81 m (12.5 ft) between the first two posts. Figures 1 and 2 show examples of the two end types at which almost all of the guardrail-end accidents occurred.

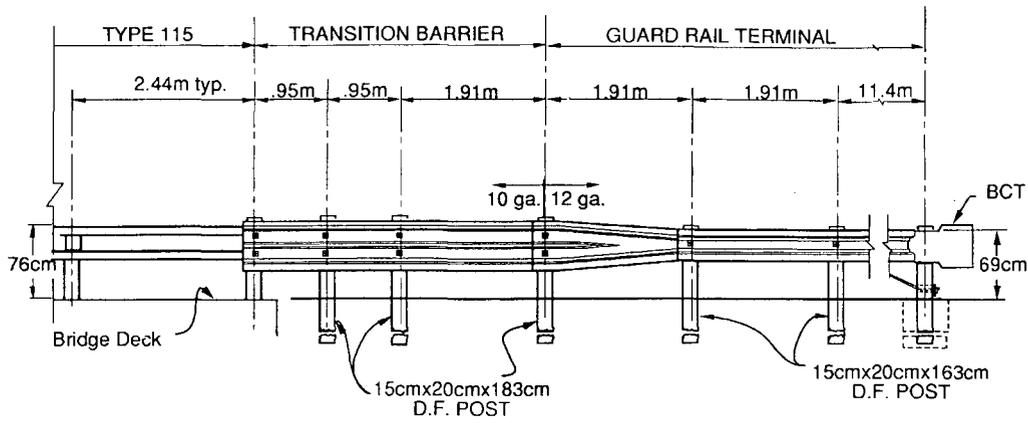
FIGURE 3 Type 115 transition.

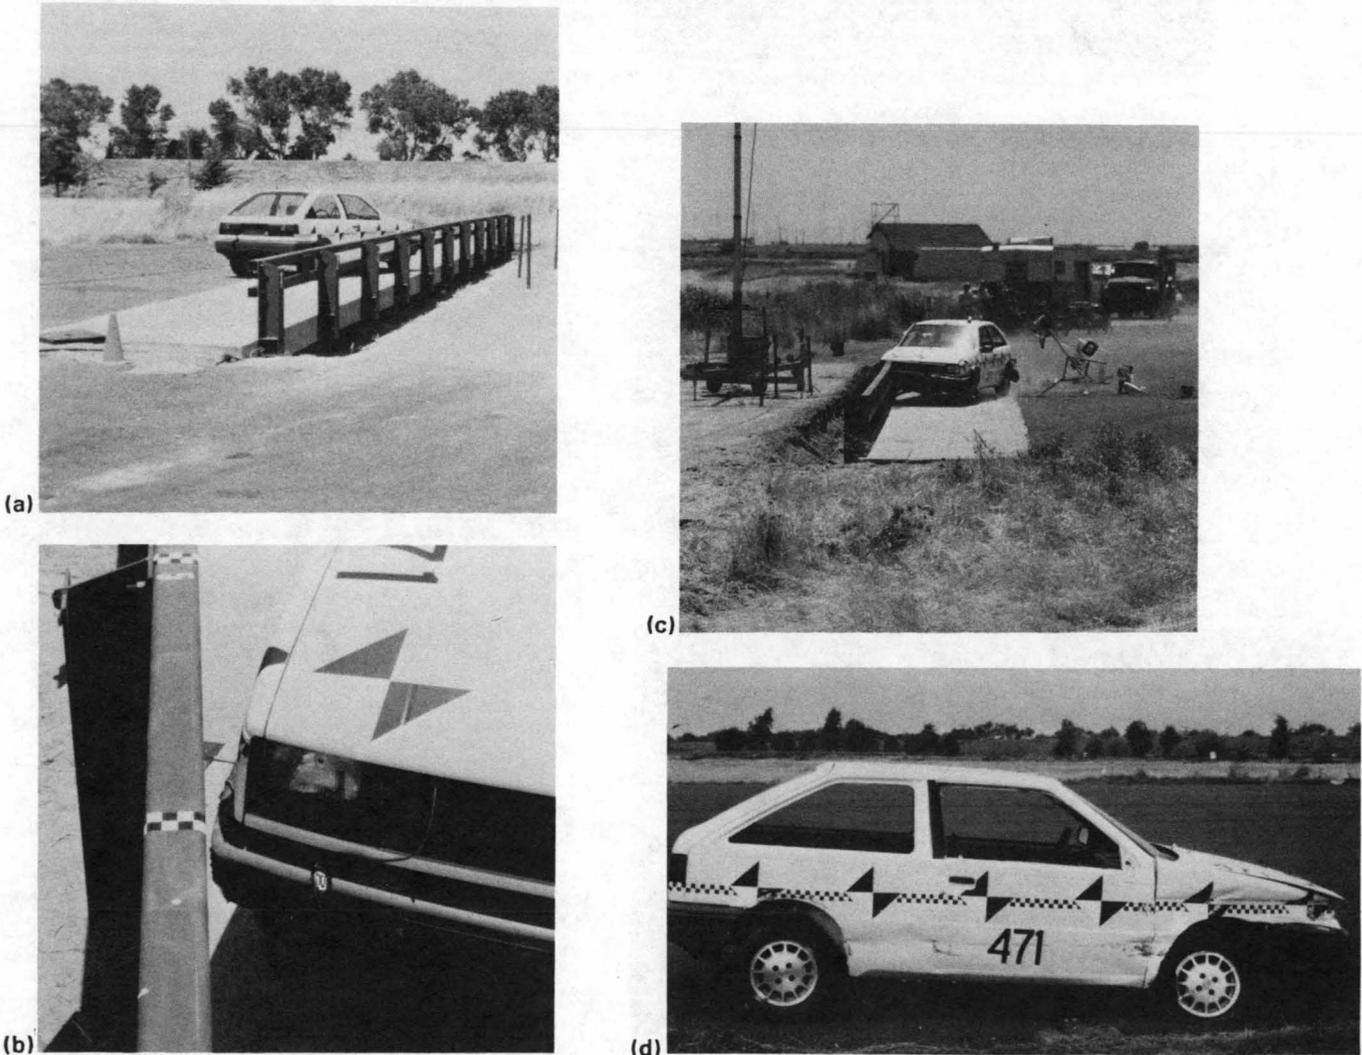
FIGURE 6 Crash sequence, Test 471.

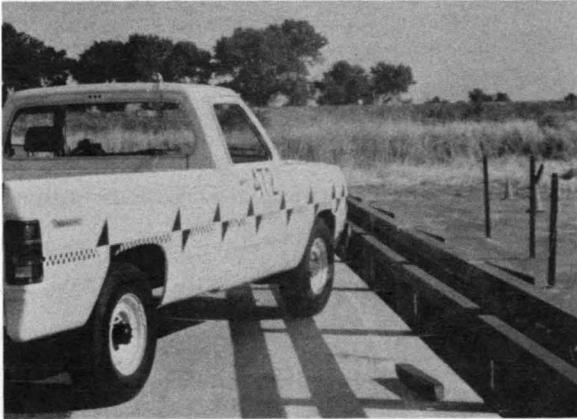
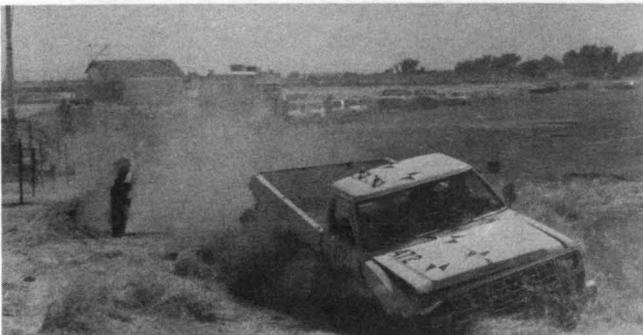
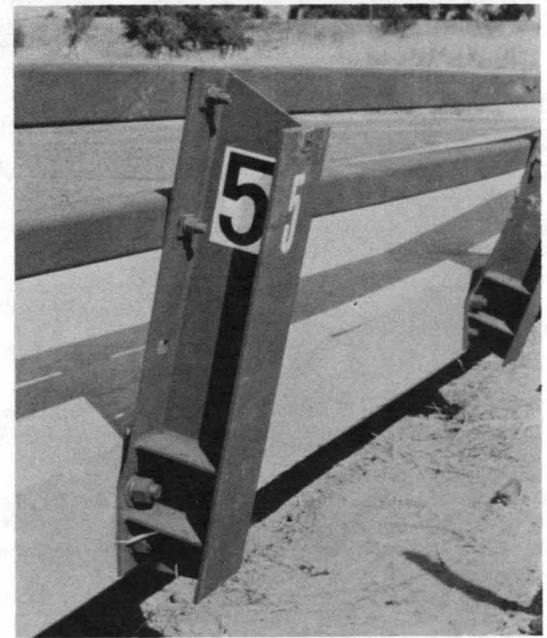
FIGURE 8 Crash sequence, Test 472.

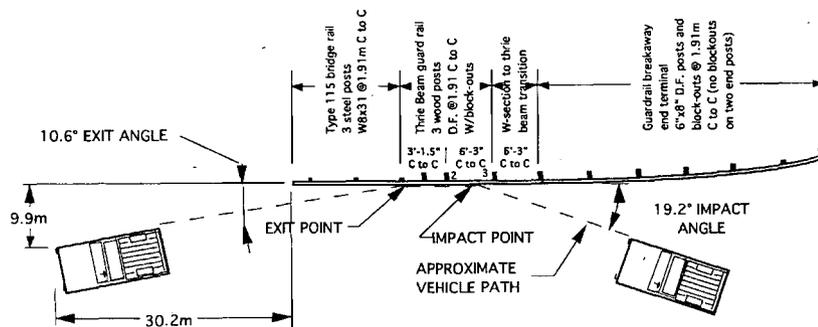
FIGURE 9 Vehicle trajectory, Test 477.

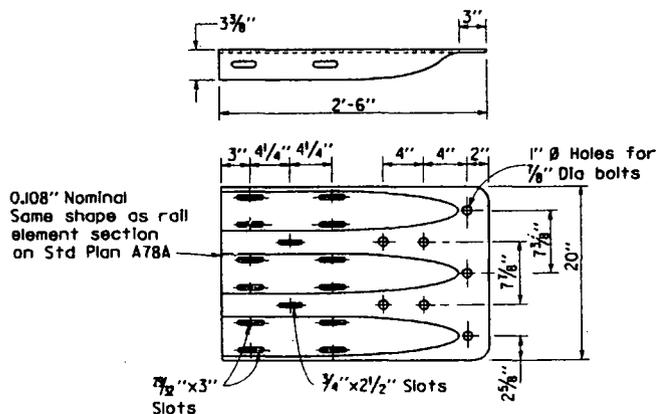
FIGURE 11 California standard plan A78B terminal connector.

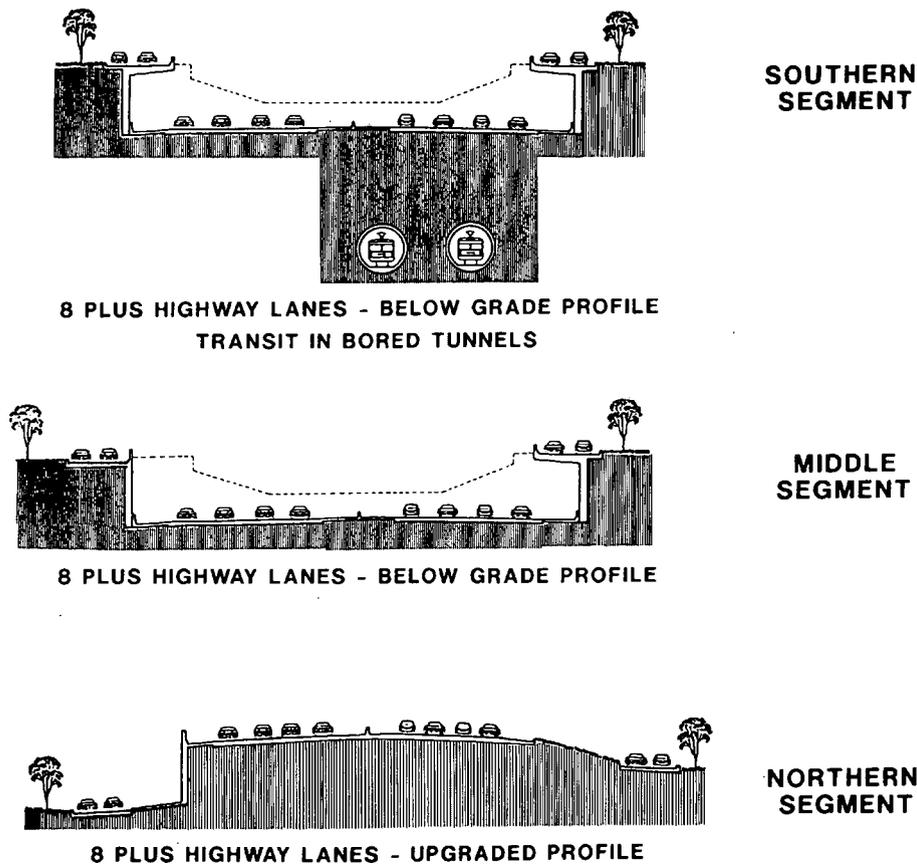
FIGURE 1 Typical sections.

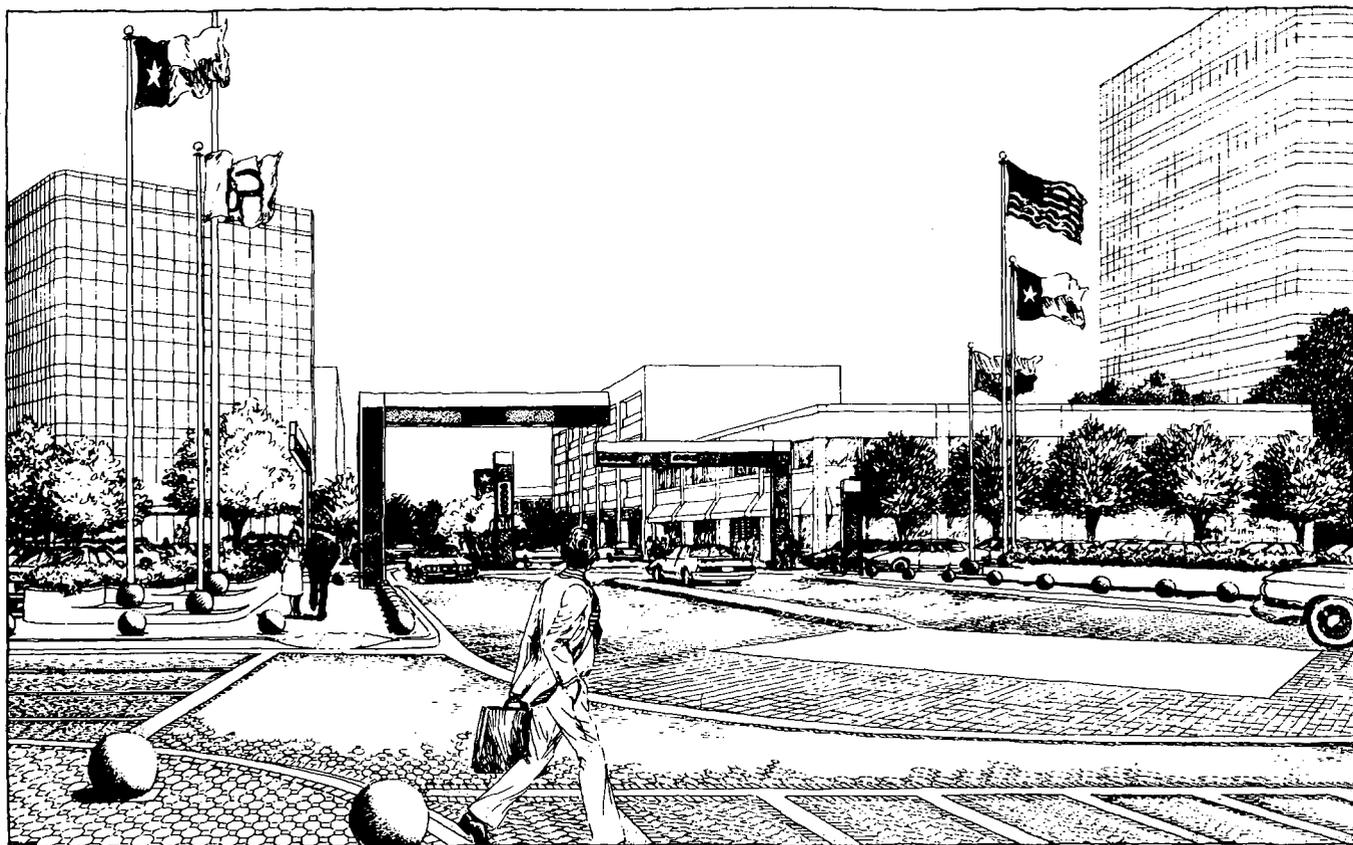
FIGURE 9 Cross Street bridge.

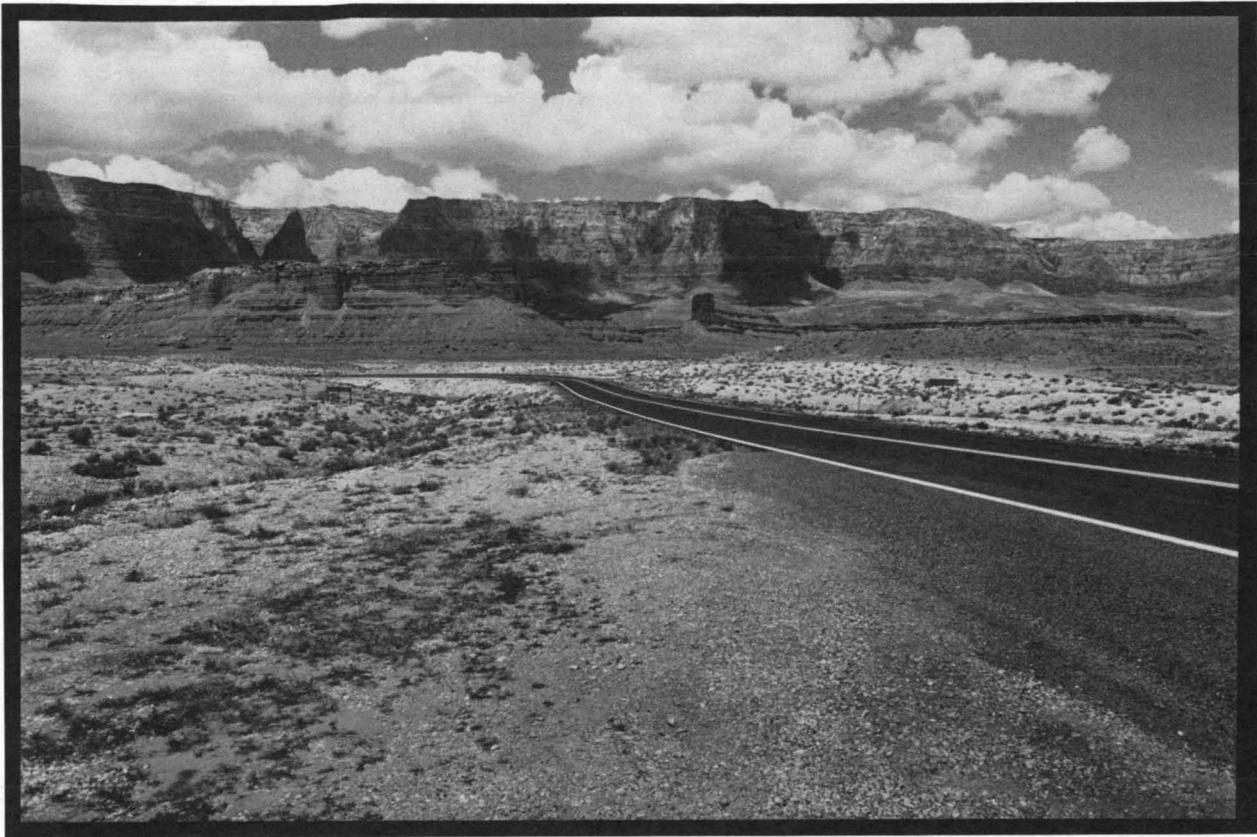
FIGURE 3 Najavo bridge project.

VPP has been used on six different projects (see Figure 3). Landscape architects and civil engineers agree that VPP gives direction to a reasonable and effective mitigation approach. VPP gives guidance on distributing mitigation fairly by showing areas that need more mitigation and those that need only the minimum level. Other guides only help to determine the visual objective, resulting in a homogeneous mitigation. This often results in excessive mitigation in some areas and under mitigation in other areas. At the design level, VPP results in varying mitigation levels that are balanced between the visual objective and the funding available. At the planning level, VPP is used to guide the project's alternative selection and preliminary design, which also leads to less required mitigation. VPP successfully links land management planning to project design and implementation and construction. Because VPP uses numerical scores, it is much easier to communicate where the mitigation is needed and why.

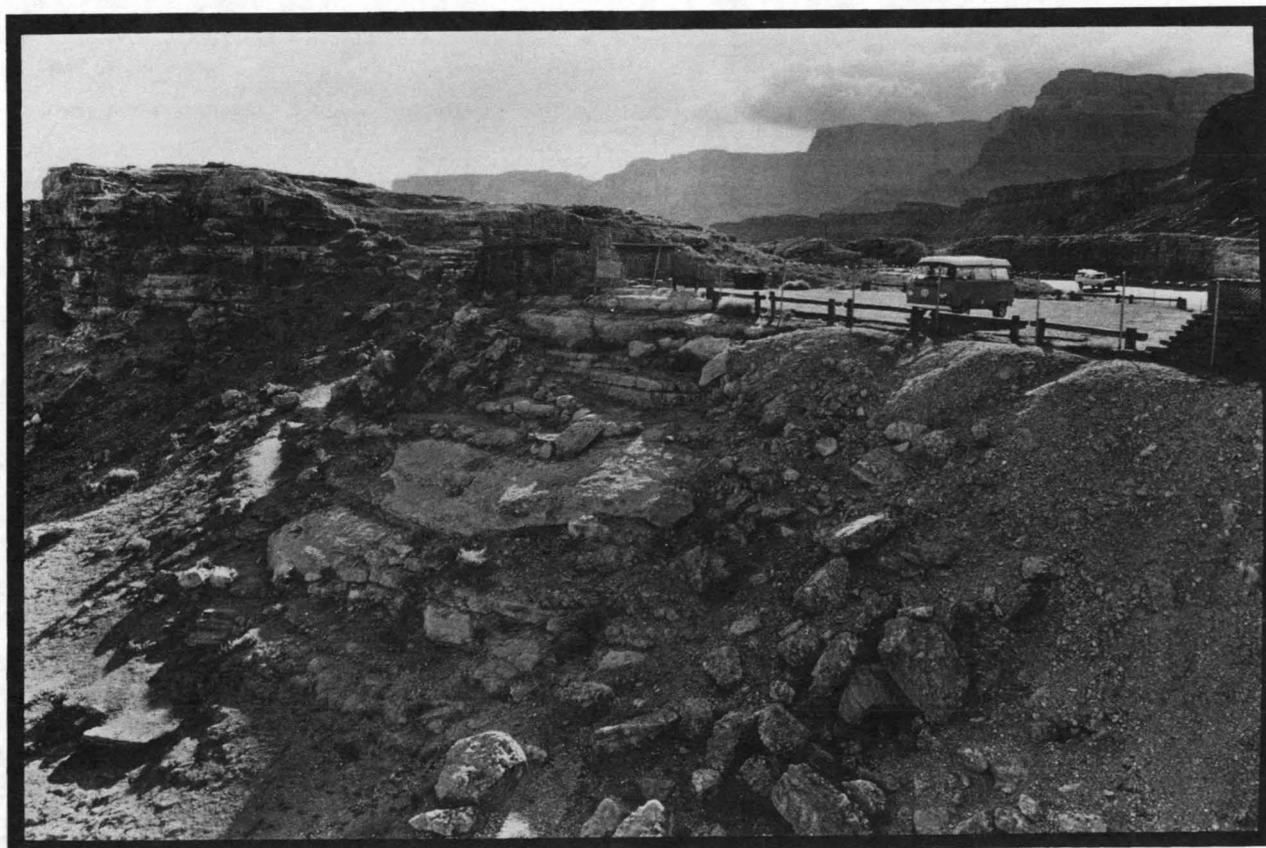
FIGURE 4 Various existing visual resources.

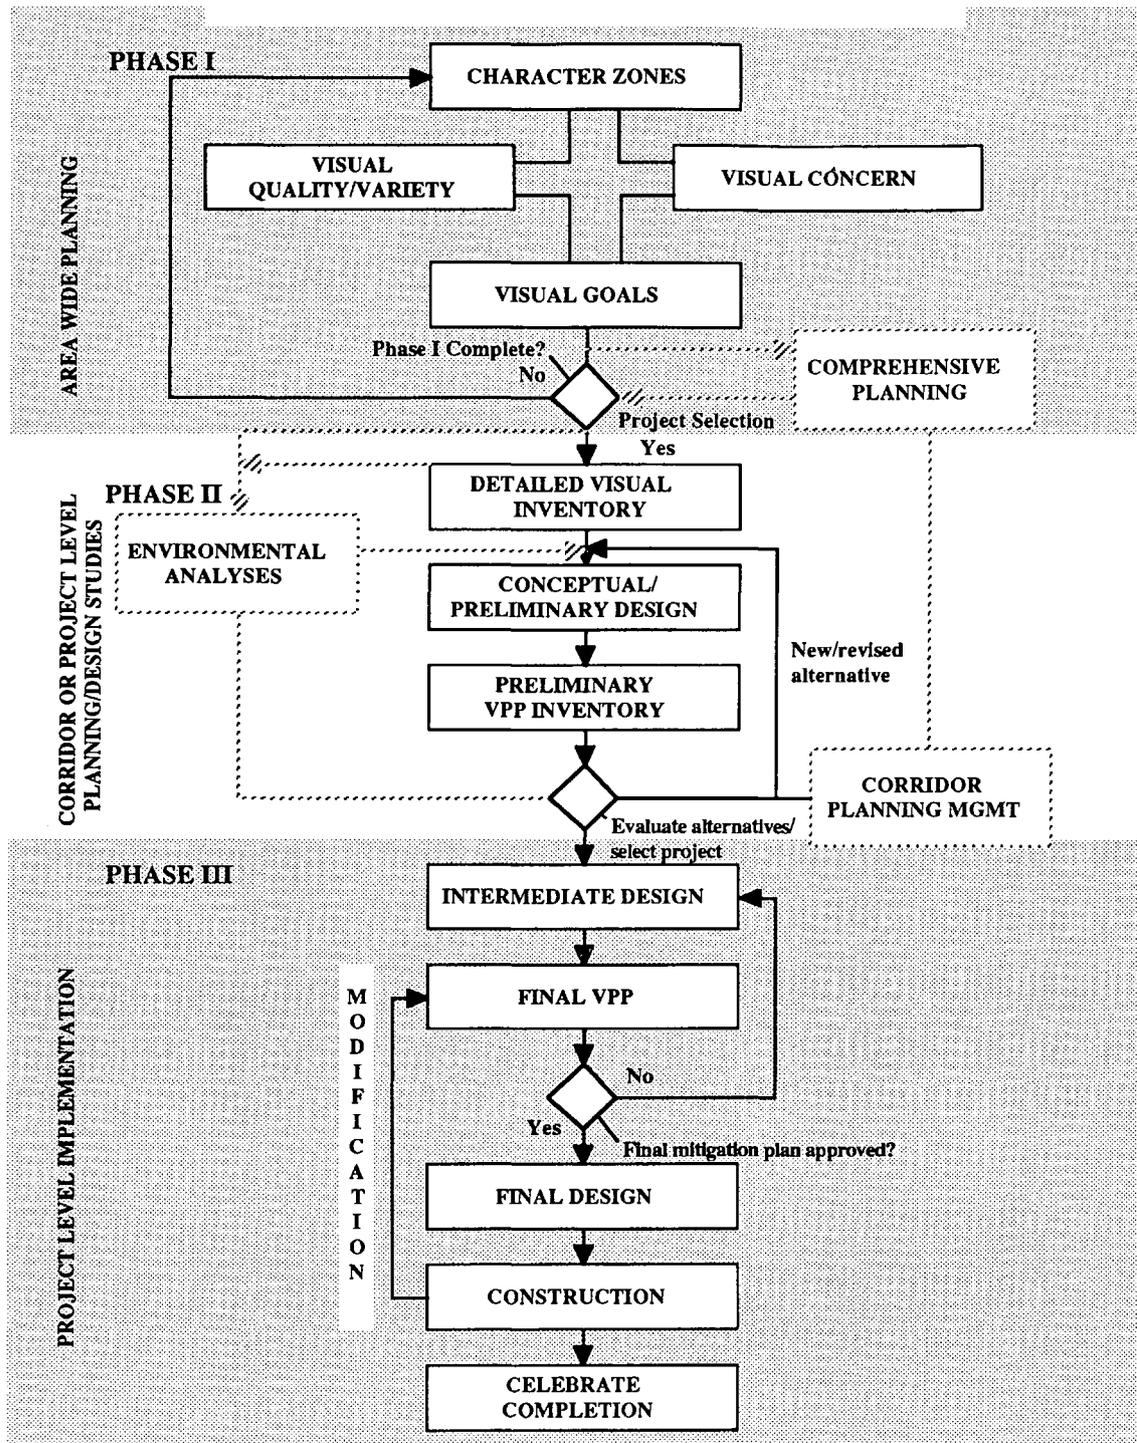
FIGURE 6 VPP flowchart.

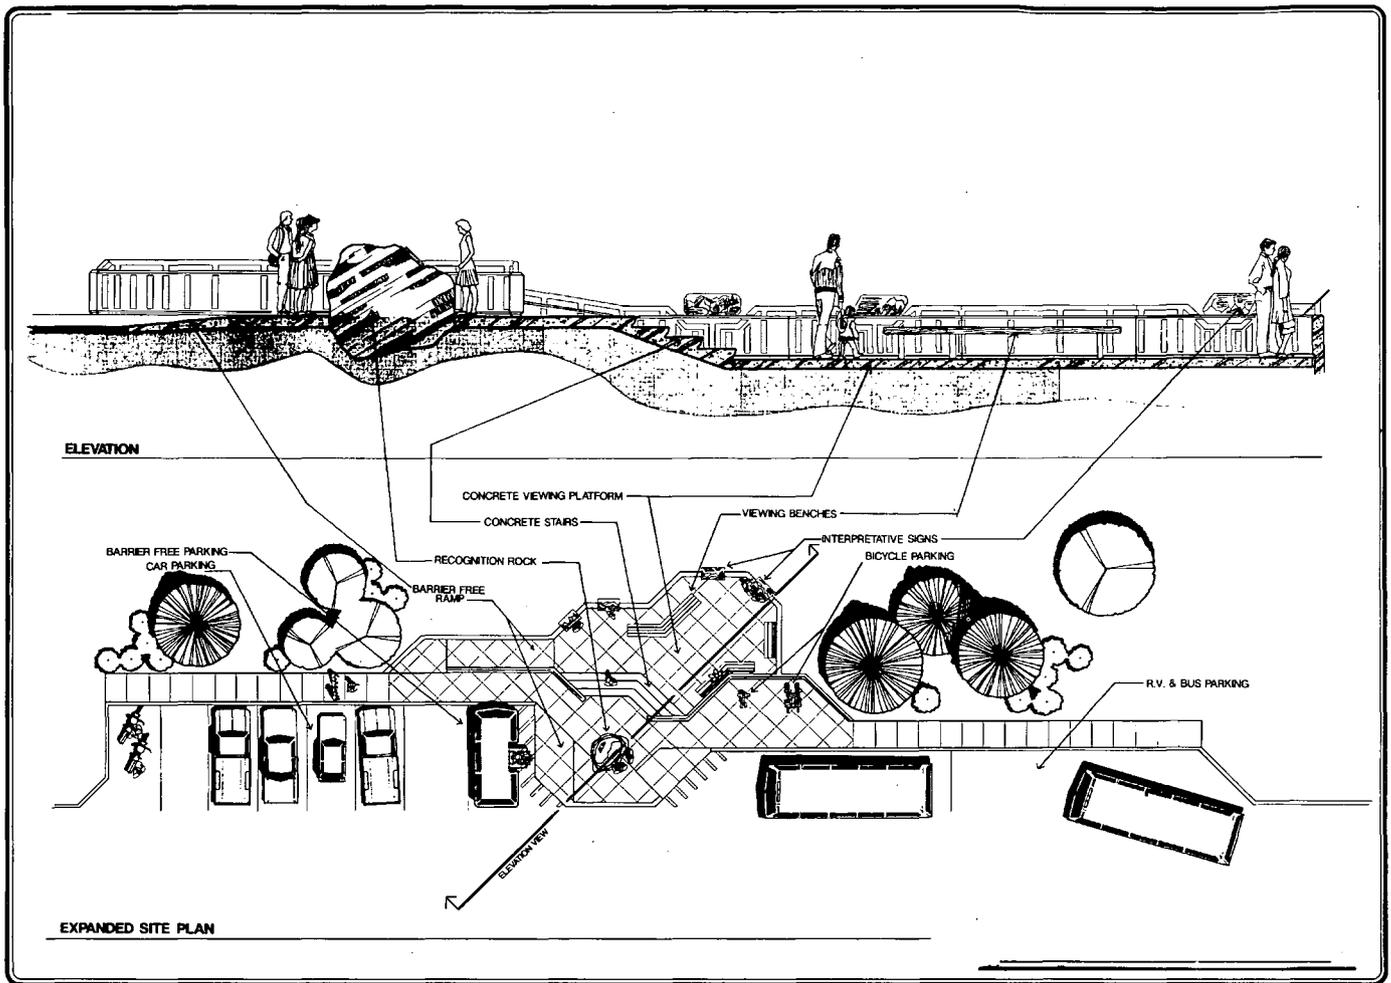
FIGURE 1 Section detail (top) and plan (bottom) of standard plan for proposed interpretive facilities.

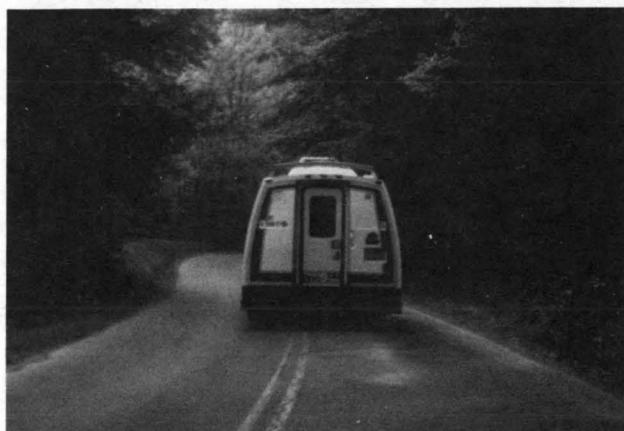
FIGURE 1 Vehicle cheating centerline.

Examples of the difficulty of keeping an RV within its lane are illustrative. Figure 1 shows an RV "cheating the lane" on a park road at Elkmont, in the Great Smokies. Figure 2 shows the same vehicle off the pavement edge on the tangent section and the associated edge deterioration problem.

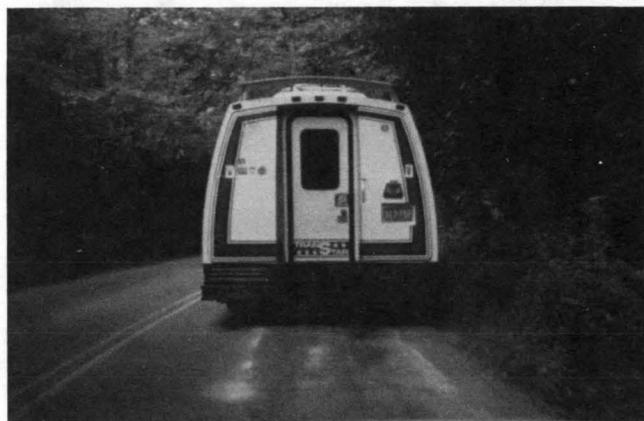
FIGURE 2 Edge deterioration problem.

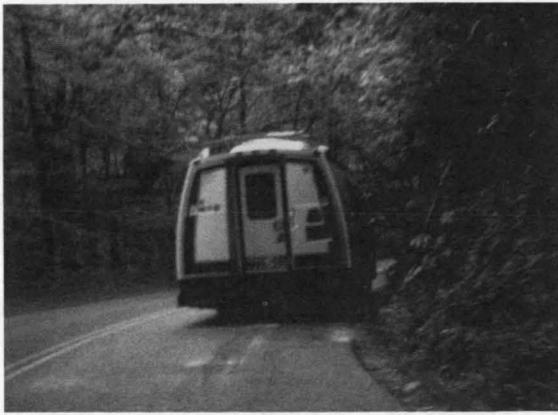
FIGURE 3 Example of “vee” at tangent-to-spiral of curve.

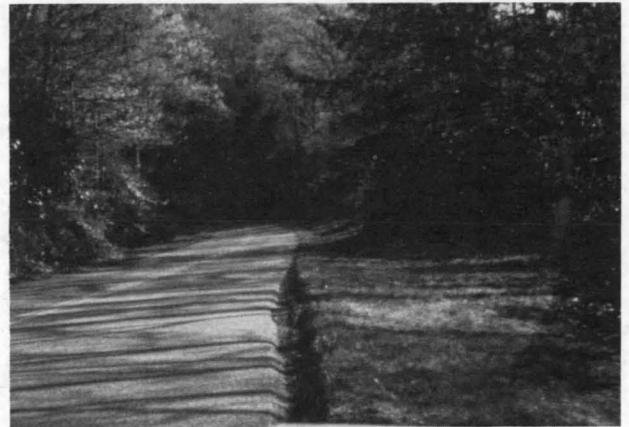
FIGURE 4 Example of extreme deviation outside pavement.

Other concerns arise. One is the high frequency of informal pulloffs on scenic and park roads, even when the practice is officially restricted. Edge dropoff, edge failure, and shoulder deterioration can result. Figure 3 shows the effect of roadside "tunnel/vista effect" and the presence of a "vee" at the tangent-to-spiral of a curve on driver behavior and vehicle positioning. Figure 4 shows what can happen if a vehicle outside tire does leave the road for a length of time.
