Destructive Testing of Two 80-Year-Old Truss Bridges

A. E. AKTAN, K. L. LEE, R. NAGHAVI, AND K. HEBBAR

Two decommissioned 80-year-old steel truss bridges were subjected to a series of nondestructive and destructive tests. The trusses had built-up members that were rigidly connected by rivets at the gusset plates. The floor system, many truss members, and the connections exhibited considerable deterioration. The bridges were retrofitted at critical connections by welding A36 plates on the pre-A7 steel. Both bridges exhibited acceptable performance during the tests at all the limit states. One bridge yielded initially at 371 tons and failed at 415 tons. The other bridge yielded initially at 458 tons, and failure could not be induced under as much as 622 tons because of displacement limits in the loading equipment. The test results revealed that serviceability, damageability, and failure behavior of steel truss bridges possessing built-up members rigidly connected by rivets at the gusset plates are not adversely affected by local deterioration. The built-up members and the connections possessed adequate deformability permitting extensive redistribution. Connection retrofit by weldin

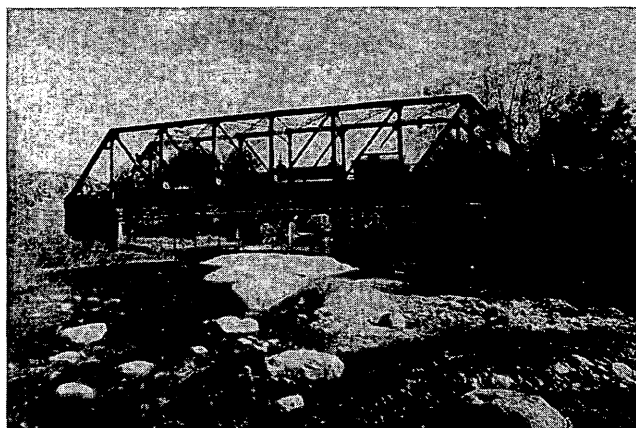
FIGURE 1 Test bridges.

The first bridge (Figure 1a) was an eight-panel Pratt through truss bridge (the Pratt), with a span of 46.4 m and a roadway width of 6.1 m. Truss members were fabricated with built-up riveted members. Bottom chords consisted of four angles. Top chords consisted of two channels and a plate. Verticals were made of two laced chan-

(a) Pratt Truss Bridge

nels, and diagonal members were fabricated from four angles and a plate. The truss connections were constructed by gusset plates 8 mm thick and rivets 19 mm in diameter. The floor system consisted of main transverse girders, longitudinal stringers, and a wood deck. Interior stringers were I-sections 46 cm deep spaced 122 cm center to center. Exterior stringers were built up of angles and plates. Transverse floor girders were I-beams 76 cm deep. The truss was supported by rollers and hinges bearing on reinforced concrete abutments faced with sandstone.

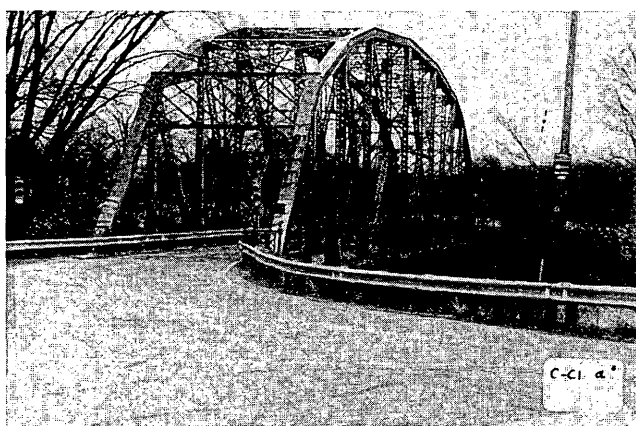
(b) Camelback Truss Bridge

The second bridge (Figure 1b) was a 12-panel Camelback through truss bridge (the Camelback) 12 m high at the midspan, with a span of 76.2 m and a roadway width of 6.1 m. The construction of the Camelback was similar to that of the Pratt, with the exception that gusset plates were 11 mm thick and rivets were 22 mm in diameter.

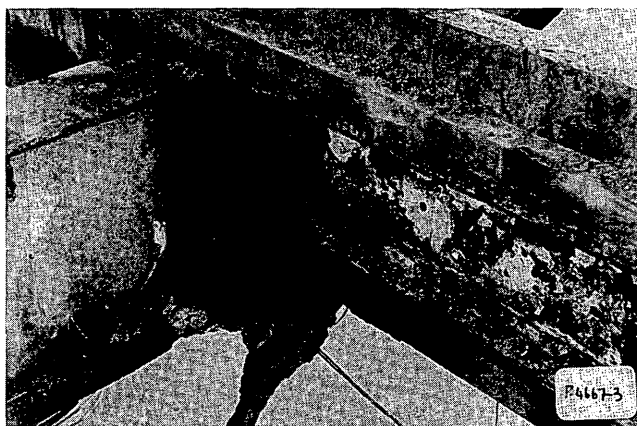
FIGURE 2 Examples of deterioration effects.

(b) Connections of Floor Beam and Exterior Stringer

Bottom chords on both trusses had lost some lacings at end panels. Rust was noticeable on the tips of built-up angles of bottom chords. The maximum area reduction caused by rust was approximately 15 percent of the total cross section. Interior stringers were in good condition, with less than 5 percent cross-section reduction caused by rust. Stringers were in satisfactory shape at the connections to the floor girders. Exterior stringers, however, were so deteriorated that they had lost more than 80 percent of their cross sections at the connections. Both ends of the floor girders exhibited considerable rust at connections to the trusses so that the loss of effective web and rivet cross-sectional areas was about 40 and 30 percent, respectively.

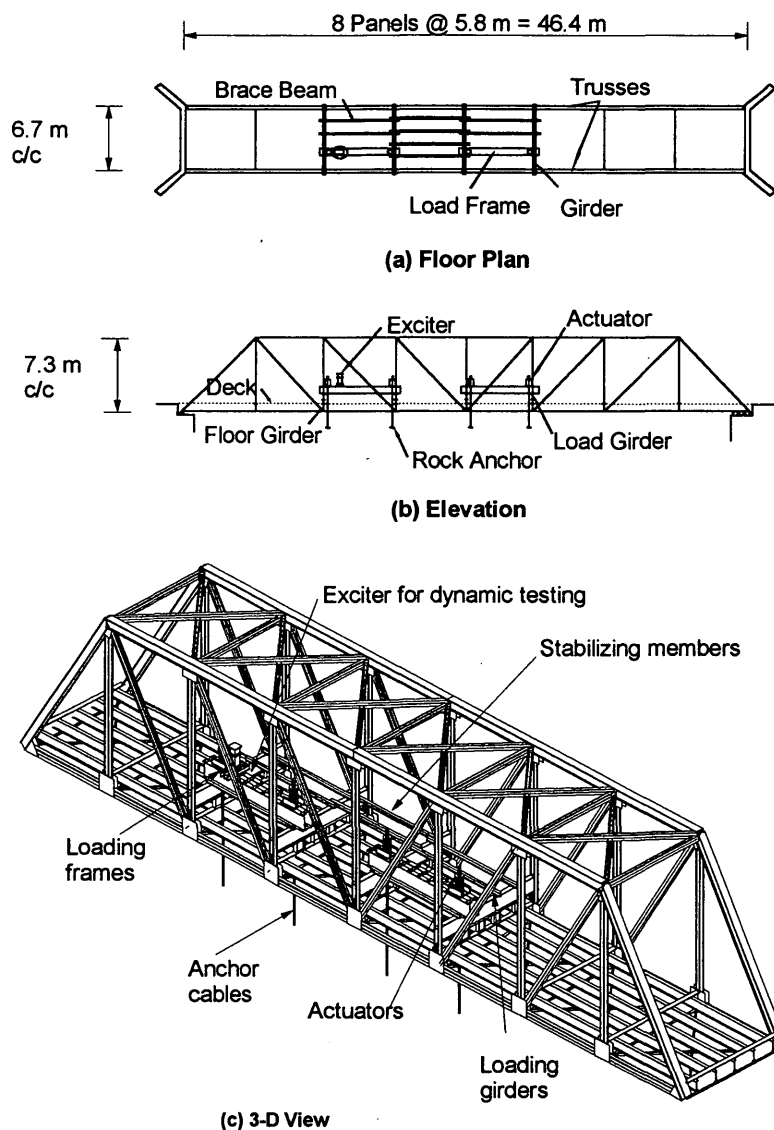
FIGURE 3 Set-up of loading system for Pratt bridge.

To simulate one-lane truck loading (9), a loading system that was capable of applying loads of any proportion to four consecutive girders was used (Figure 3). The servo-controlled electro-hydraulic system consisted of a pump, four actuators, four servo-valves, and a four-channel digital controller (Figure 4). Each double-action actuator had a capacity of 182 tons and 30.5 cm of total stroke. Rock anchors embedded 24.4 m into the bedrock under the riverbed provided reactive force. Actuators could be individually or simultaneously controlled in force or displacement modes. The tests were conducted by prescribing master-slave relationships to actuator forces while commanding a master actuator in terms of either force or displacement. Actuator forces and strokes were respectively monitored by calibrated pressure transducers and wire potentiometers.

The load transfer system shown in Figure 3 was designed to ensure safe transmission of loads to trusses at all the limit states while maintaining similitude with single or multiple one-lane truck loading (10). Four girders were fabricated from $W27 \times 84$ beams running on top of and parallel to the floor girders. Each girder had four vertical legs that were bolted to floor girders. In addition to transmitting load to the floor girders, the ends of the loading girders also transmitted approximately 20 percent of the load directly to the verticals of the trusses using roller bearings. In this manner, the truss adjacent to the loaded lane was transferred about 70 percent of the total load (in the linear limit states) while avoiding a premature failure in the participating floor girder-to-truss connections.

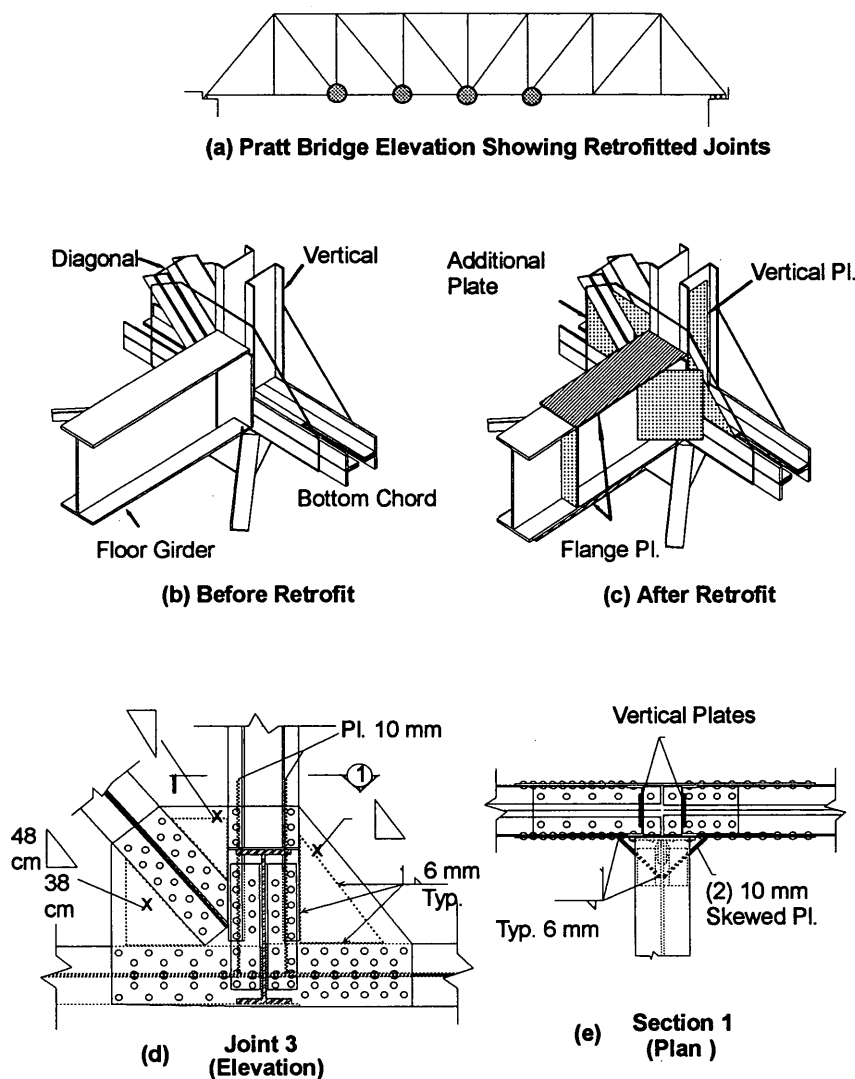
FIGURE 5 Typical joint retrofit.

nections as a result of high-magnitude concentrated loads. The bridge retrofit was designed considering possible maximum forces that the loading system could transmit to the affected connections (Figure 5), also accounting for the existing conditions of the members, gusset plates, and rivets at the connections. Although necessitated by the loading scheme, the retrofit also created an opportunity to explore effective and feasible manners of treating extensive deterioration or upgrading similar steel truss bridges, or both, with minimal change on the aesthetics. A simple solution to all these problems was to add A36 plates to the affected connections by some simple fillet welds, as shown in Figure 5. This design did not require removal of any rivets, it was unobtrusive, and finally it did not alter the original appearance of the exposed joints. The low cost of the retrofit with welding (approximately a few thousand dollars per connection) and its successful performance during destructive tests indicated that a possibly superior alternative to retrofit with bolting/riveting may be found in welding.

The Pratt and Camelback resisted total loads equivalent to 12.8 and 19 HS20-44 trucks, respectively. After completion of each destructive test, no evidence of distortion or failure was found at the connections that were retrofit. The effectiveness of the retrofit was demonstrated under the heavy concentrated loads that the connections experienced during destructive testing. Therefore, it is concluded that it should be possible to retrofit similar bridges up to acceptable levels of safety with minimal effort and cost. Truss connections may be upgraded easily by inserting properly designed triangular plates that are welded to truss members behind the existing gussets. This method maintains the aesthetics and the original appearance of the joints while providing the extra strength needed to assist deteriorated rivets and gusset plates. In the case of rivet deterioration alone, lines of simple fillet welds between a healthy gusset and the truss member may be sufficient to compensate for rivet (fastener) losses.

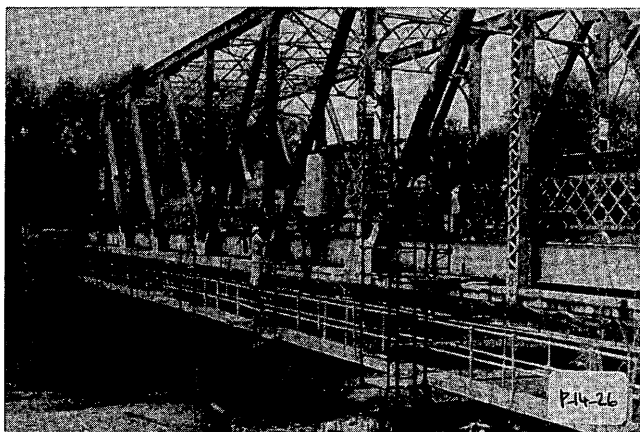
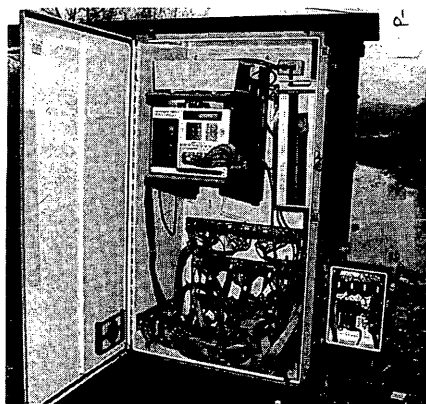
FIGURE 6 Scaffolding and instrumentation box.

selected for monitoring during the destructive tests. An instrumentation box was installed on the bridge to house data acquisition, connection slots, power, and current stabilizer (Figure 6). A high-speed communication cable transmitted the data to a control center in a field trailer next to the test bridge.

(a) Pratt Showing Scaffolding and Instrument Box

(b) Instrumentation Box

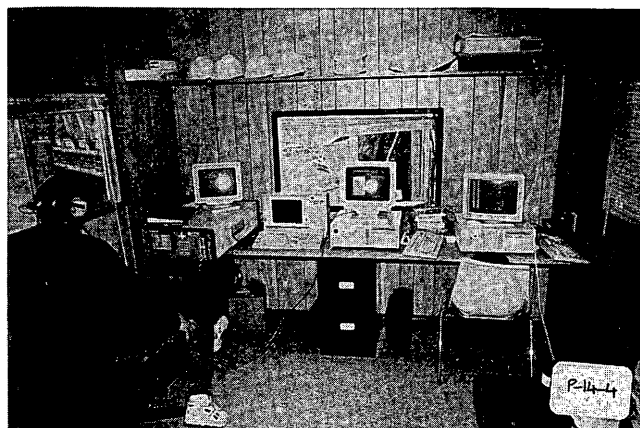
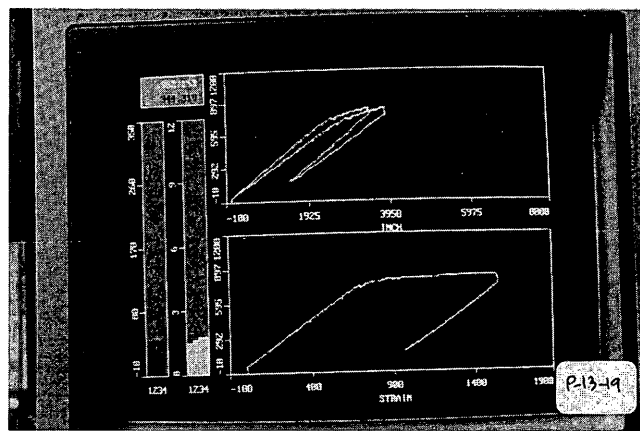
FIGURE 7 Test control and data acquisition.

During tests a portable PC was used to communicate with the OPTIM system and control data acquisition from the control room (Figure 7a). Real-time digital plotting software was used for instantaneous feedback of actuator loads, strokes, and critical global and local-member responses (Figure 7b). This system revealed the loading condition and critical responses and was essential for decision making while maintaining a reasonable pace of the test. In addition, a PC software was developed to postprocess all of the measured responses within only a 15-min intermission during a test. This permitted visually verifying the reliability of the data from applied load versus measured response plots to perform preliminary correlations with analytical predictions to check for any anomalies. A large number of loading-unloading excursions (10 to 20) to load levels of up to 20 trucks could be confidently executed within several hours once the test control and data reduction systems were debugged.

(a) Control Room

(b) Real-Time Display
