# July 1993 Flood Damage to US-71 Bridge Over Brushy Creek, Carroll County, Iowa: Case Study

The flood of 1993 inundated much of the upper Mississippi River Basin, resulting in significant damage at numerous sites in Iowa. A record flood on Brushy Creek resulted in failure of the US-71 bridge 14.5 km south of Carroll, Iowa. Development of a computer flow model at the site and analysis of scour for the failed bridge and its replacement are included. On the basis of data from plans, topographic maps, and a United States Geological Survey (USGS) crest stage gage at the site, the computer model was developed using WSPRO (a USGS/FHWA computer program for Water Surface Profile Computations). To construct the computer model, cross sections were developed, and Manning's roughness coefficients  $n$  were assigned, such that known stage elevations were produced for a given flow. The model was then used to estimate flood flows during the event. Scour was estimated using the WSPRO data, soil boring data, and procedures from HEC-18, *Evaluating Scour at Bridges*. Long-term aggradation or degradation, contraction scour, and local pier scour were all evaluated. The case study allowed verificatio

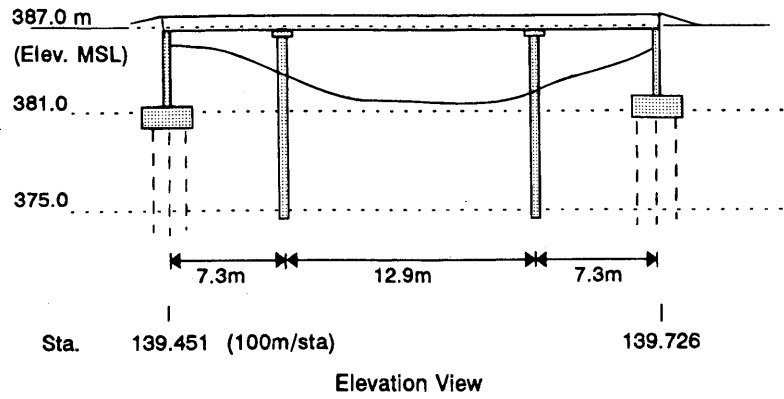
FIGURE 2 Situation plan for existing bridge.

The existing structure was a 27.4 m  $\times$  8.5 m three-span, prestressed, concrete beam bridge. It was constructed in 1957 to replace a 27.4 m  $\times$  6.1 m pony truss built in 1925. The abutments from the pony truss were widened and used in the replacement bridge. The abutments were high abutments supported on timber piles. The piers were pile bent type consisting of 5 to 406 mm<sup>2</sup> prestressed concrete piles with a concrete cap to support the superstructure. Plans called for 12.2-m piles driven to full penetration, if practicable, but to at least 285 kN bearing. Full penetration would have placed the pile tip at 374.7 m above mean sea level as calculated from the original contract plans. That would have provided about 7 m penetration below streambed, with about 2.5 m penetration into a gravel layer. Individual pile tip data are not available; however, because of the pile type and the dense gravel layer near the design tip, it is reasonable to expect that the piling achieved refusal at or near the design tip elevation. A situation plan for the site is shown in Figure 2.

The bridge was built so that the stream channel was parallel to the piers and abutments. However, over the years channel migration resulted in channel flow striking the piers and the south abutment at approximately 5 degrees (Figure 2).

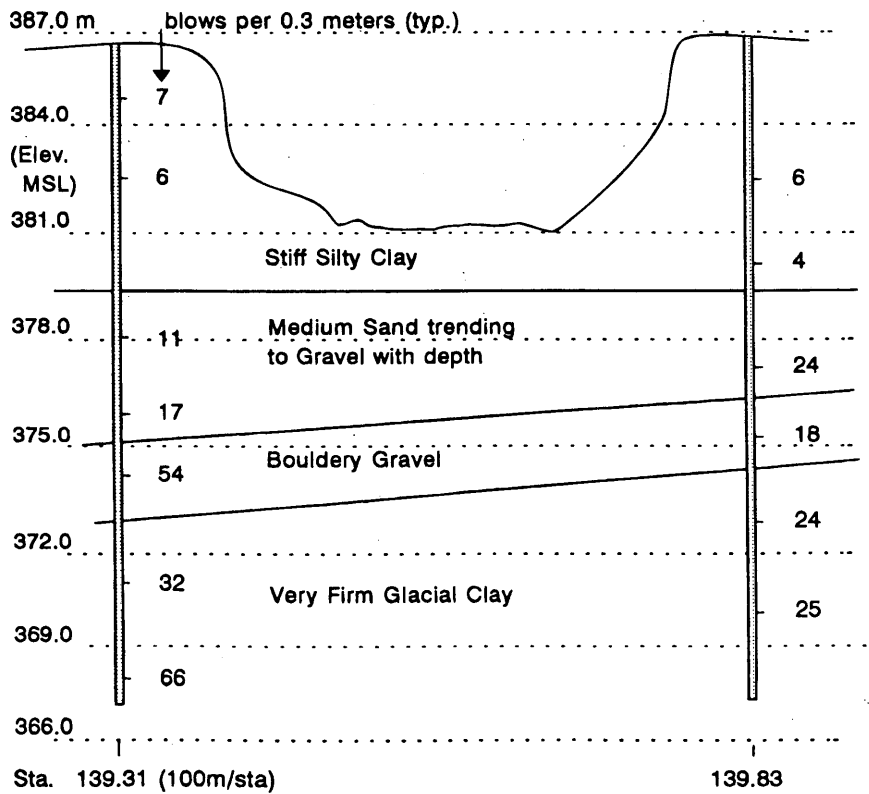
FIGURE 3 Soil borings for US-71 Bridge (Iowa DOT, 8/1993).

This study site is located just west of the west edge of the Wisconsin glaciation into Iowa (3). The stratigraphy of the site is shown by soil borings taken near the roadway centerline and adjacent to the stream. The borings are shown in Figure 3. The borings indicate a layer of stiff silty clay, which is most likely colluvial loess washed in from the uplands. The sand layer that trends to gravel at 377 m elevation is interpreted as glacial outwash from the Des Moines lobe of the Wisconsin glacier. The glacial clay shown is probably pre-Illinois (3).

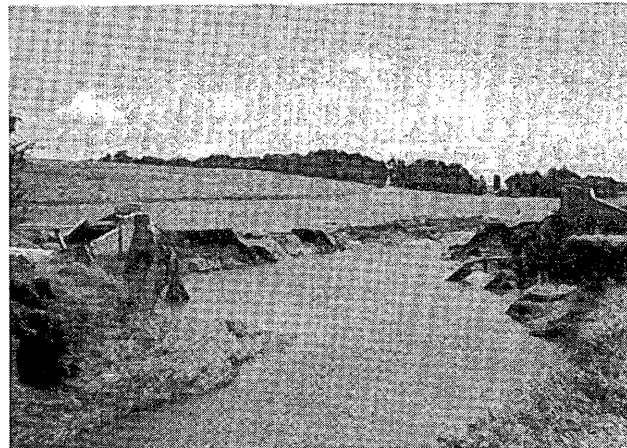
c

Contraction scour occurred because a floodplain that was 274 m wide was constricted to a 26.5-m bridge opening. As previously indicated, 75 percent of the 1993 flood was being carried in the overbank area and was forced through the restriction at the bridge site. The consequence of such a restriction is apparent: as the flow was forced through the constriction, velocities increased from 0.7 m/sec upstream to 3.5 m/sec through the bridge opening. This resulted in 6.4 m of scour (Table 2). Calculations using HEC-18 procedures indicate that scour would have been greater except for natural armoring (increase in particle size) in the form of a gravel strata left by an ancient glacier (4,8).

**FIGURE 6** Site after flooding: (a) looking north along centerline of highway, (b) looking north (note scour hole upper right), (c) looking downstream (note blowout of channel), (d) south abutment (note piers failed and beams fell from abutment seat), and (e) looking upstream (note broad flat floodplain oversized for modern stream).
