Control of Vehicle Speeds in Temporary Traffic Control Zones (Work Zones) Using Changeable Message Signs with Radar

NICHOLAS J. GARBER AND SURBHI T. PATEL

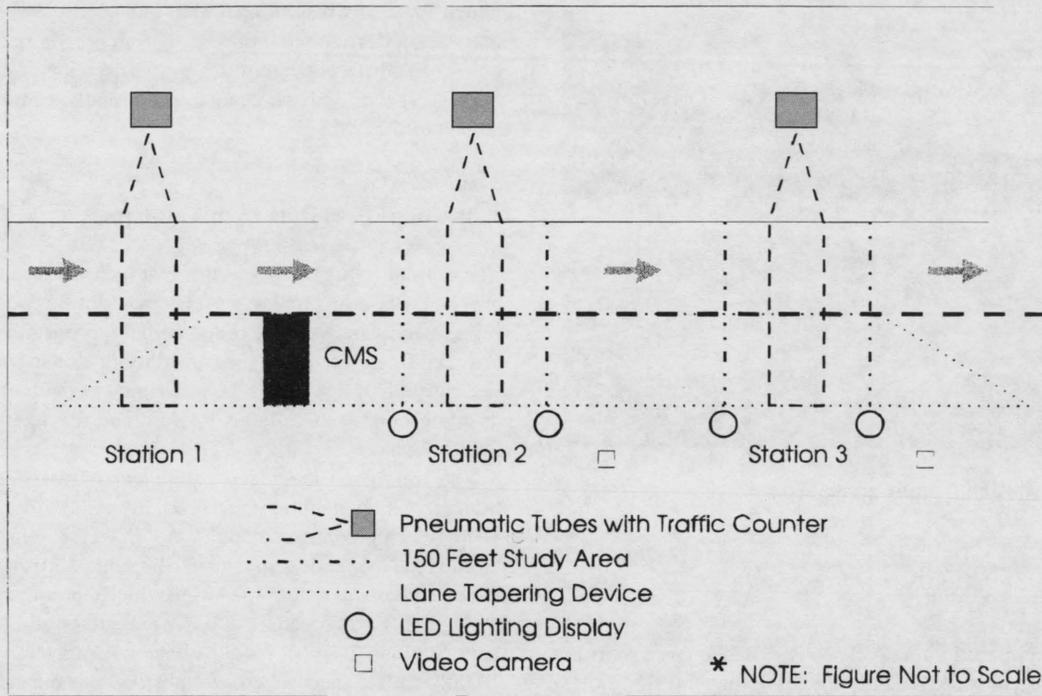
FIGURE 1 Example of typical work zone study area—two-lane highway tapered to one lane.

Seven sites were selected for data collection throughout the course of the project (Table 1). The normal speed limits shown in Table 1 are the posted speed limits on these roads under normal conditions (i.e., when no work is being performed on the roads). Only regulatory signs were used for the posted speed limits at all study sites. Figure 1 shows an example of a typical work zone study area.

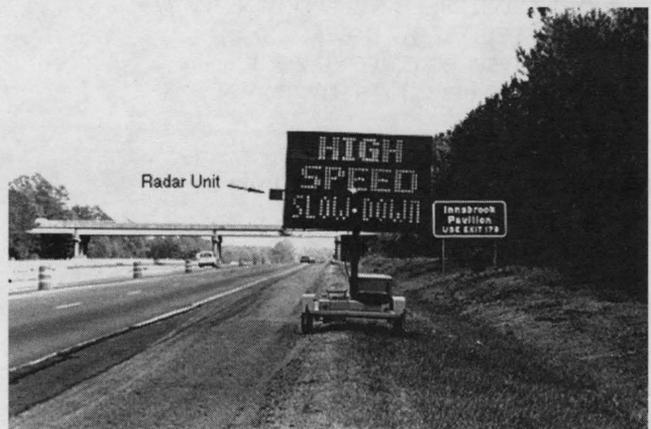
FIGURE 2 Changeable message sign with radar unit.

CMS that was used in this project was specially designed for the study. It used the standard message display board (CMS-T300, American Signal Company). The radar unit attached to the side was a special feature (Figure 2). This radar (TRACKER TDW-10 Wide Beam Vehicle Detector) was connected to the central processing unit that controls the functions of the message display. If the radar was activated and it detected a speed higher than a preset threshold speed, the message display could be programmed to flash a particular message instantaneously.

The radar, attached directly to the side of the message display (Figure 2), was positioned to align with vehicles as they entered the work zone at a range of 91.4 m to 182.9 m (300 to 600 ft). Generally, the main objective was to direct the radar to a point where only *one* vehicle's speed would be detected by the radar. The purpose of this particular arrangement was twofold. First, when the radar detected a speeding vehicle, an observer was able to identify that particular vehicle, take note of its key characteristics (color of vehicle, vehicle type) and relay this descriptive information over the walkie talkie to the crew activating the video cameras. At the same time, the driver of the vehicle would be in the range to see the message as it came up on the display and then be able to act accordingly, if he or she so desired.

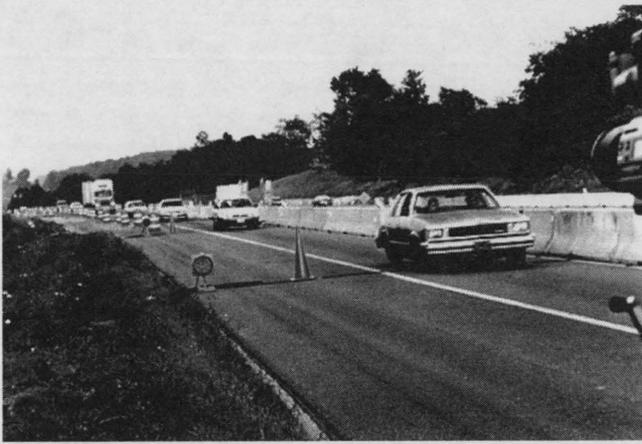
FIGURE 3 Typical 150-ft study area.

At the second and third locations (near Stations 2 and 3, where the counters were placed), additional tubes were set down marking a distance of 45.7 m (150 ft). These tubes designated a section of known distance to calculate the speeds of those vehicles for which the message was activated. The cameras provided the means to determine the vehicles' travel times across the sections as their movements were recorded on film. The speeds of the vehicles at

To enhance the visibility of the tubes, during the extraction of the data from the video tapes, an air-pressure-activated lighting device, which consisted of a light-emitting diode (LED) display, was constructed. The lighting device was attached to each of the two tubes marking the entrance and exit of the 45.7-m (150-ft) sections (Figure 2). The light was activated when the tire exerted pressure on the tubes, giving a clear indication of when each vehicle's front wheels entered and exited the study area. The light did not in any way distract or endanger drivers as it was placed off the traveled way and faced the opposite direction of travel. A typical study area is shown in Figure 3.

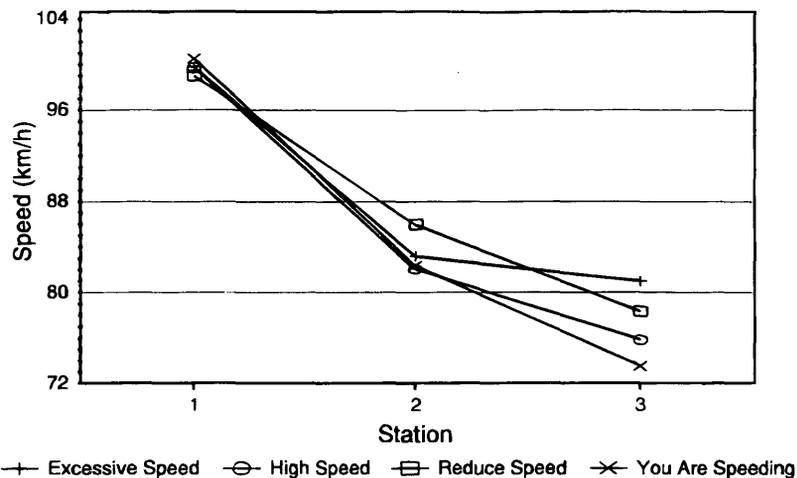
FIGURE 4 Average speeds calculated from camera data for I-81, South Buffalo Gap (threshold speed limit = 93.3 km/hr; posted speed limit = 88.5 km/hr; 1 km = 0.6 mi).

Figures 4 and 5 show the average and 85th percentile speeds calculated for the high-speeding vehicles (using the camera data) at the work zone on I-81 South at Buffalo Gap. This site was chosen to illustrate some of the trends that were observed at nearly all of the sites. The graphs in Figure 4 show that vehicle speeds reduced at Stations 2 and 3 for all of the messages that were used on the CMS. In addition, the messages HIGH SPEED SLOW DOWN and YOU ARE SPEEDING SLOW DOWN appear to have had a greater impact on vehicle speeds than the other two messages. Figure 5, which illustrates the 85th percentile speeds at this site, confirms this finding.

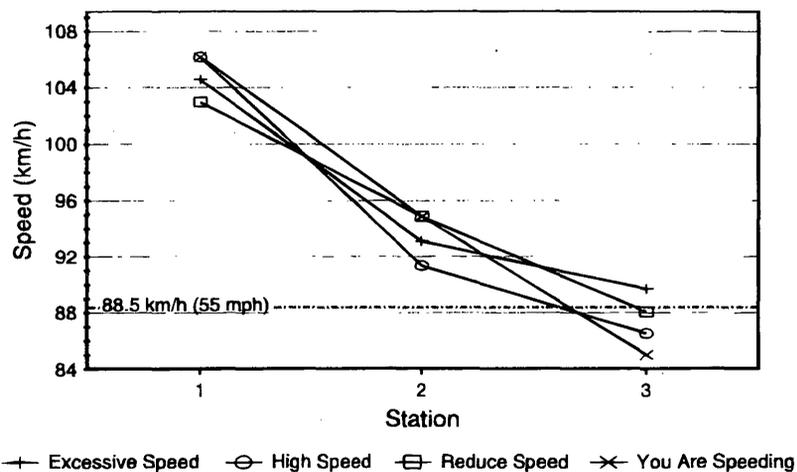
FIGURE 5 85th percentile speeds calculated from camera data for I-81, South Buffalo Gap (threshold speed limit = 93.3 km/hr; posted speed limit = 88.5 km/hr; 1 km = 0.6 mi).
