## **Vertical Electrical Impedance Scanner for Concrete Bridge Deck Assessment without Direct Rebar Attachment**

Final Report for  
NCHRP IDEA Project 202

Prepared by:  
Brian A. Mazzeo  
W. Spencer Guthrie  
Brigham Young University

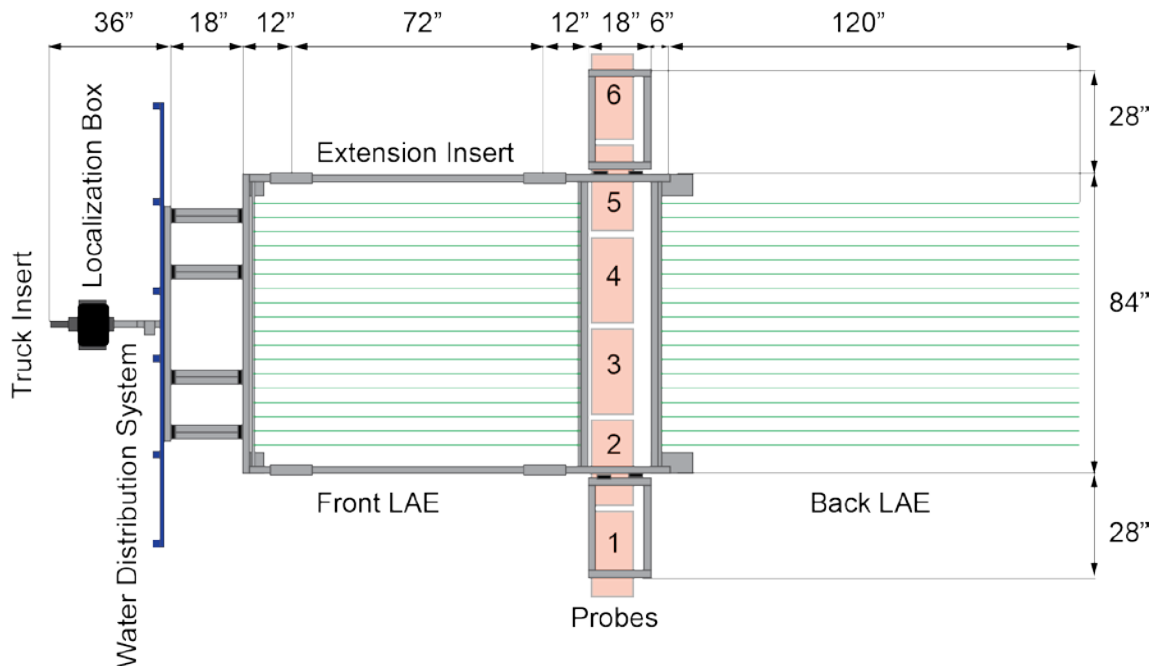
**FIGURE 4 Schematic of VEI scanner including the localization unit, water distribution system, sensing probes, and LAEs as deployed in the field on bridge decks.**

The VEI scanner shown in Figure 2 was constructed for quick deployment in the field and accurate and efficient data collection. A schematic of the VEI scanner is shown in Figure 4. The trailer supporting the scanner was modeled after similar scanner designs that had been deployed for impact-echo surveys [2, 3]. The main trailer components were fabricated with 2 x 2 x 1/8 in. square tube, and the extension insert connectors were fabricated with 2.5 x 2.5 x 1/4 in. square tube. The two-hinge system at the front of the scanner trailer was designed to accommodate differences in hitch heights on towing vehicles as well as irregularities in bridge deck surfaces. The scanner frame was designed so the scanner could be quickly unfolded on a job site, deployed, and then folded up after scanning was completed. The frame supporting the probe electrodes and LAEs was constructed of aluminum because aluminum is light, corrosion-resistant, and rigid enough to support the loads under which it was placed.

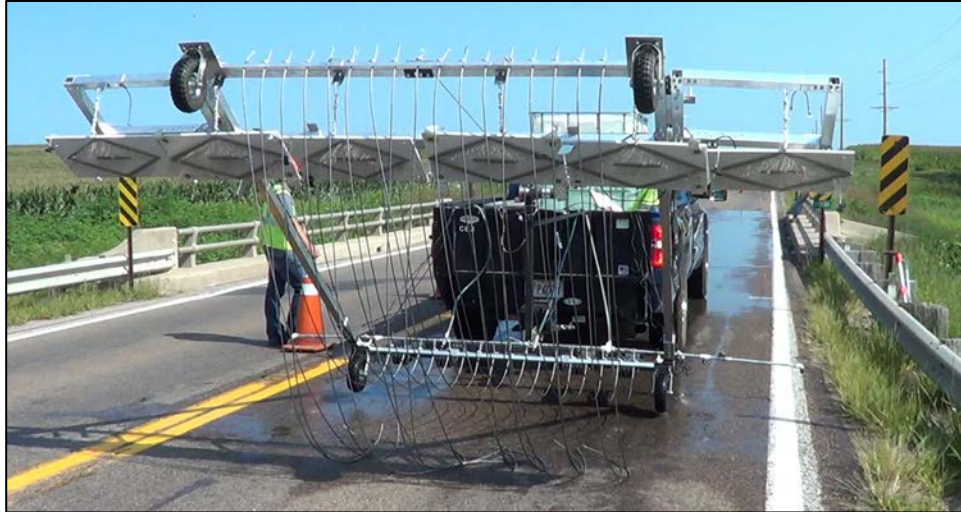
**FIGURE 5 Photograph of VEI scanner raised for transport over short distances.**

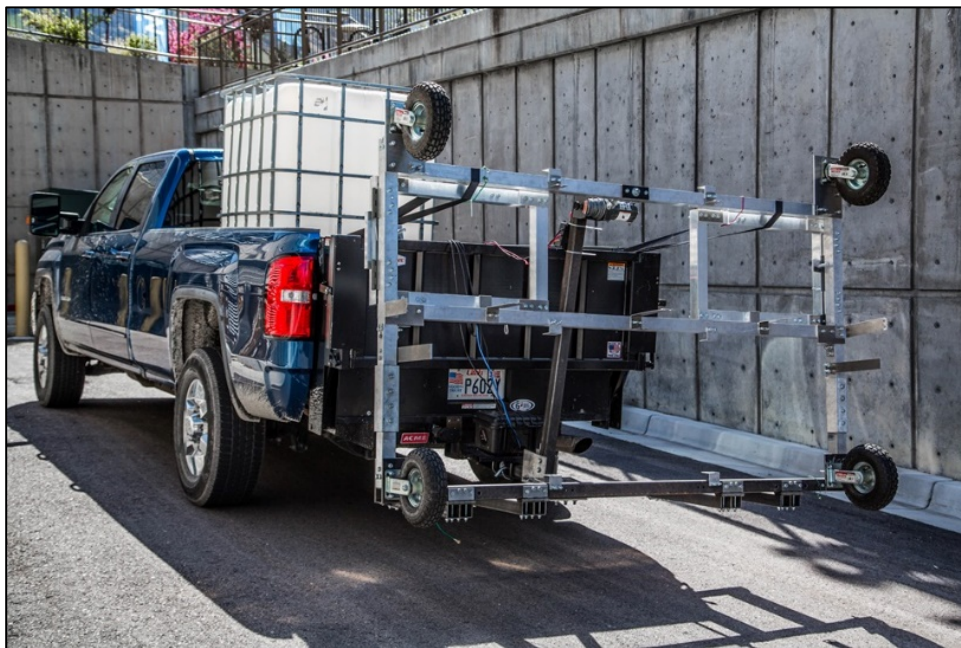
**FIGURE 6 Photograph of VEI scanner reduced in overall size and folded up for transport over long distances.**

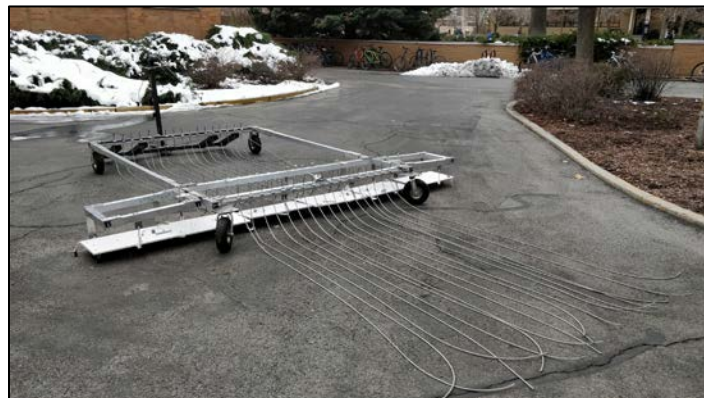
**FIGURE 8** Photograph of front and back LAEs with the guarded probes between them.

The scanner is shown in Figure 8 in an unfolded position with the front and back LAEs in place. Because slight perturbations of the effective area of the LAEs do not yield strong impedance changes [4], the rear LAE was designed to be dragged unconstrained. This open-ended design of the rear electrode also reduced the weight and the complexity of the folding mechanism when the trailer was stowed for travel between testing locations (earlier versions had a rigid frame that required significant complexity to fold). The parallel arrangement of the corrosion-resistant aircraft cables used as electrodes also reduced the probability of debris catching on the cables as the device moved over the bridge deck surface. The construction of the LAEs produced good electrical contact with the deck surface under a variety of surface conditions.

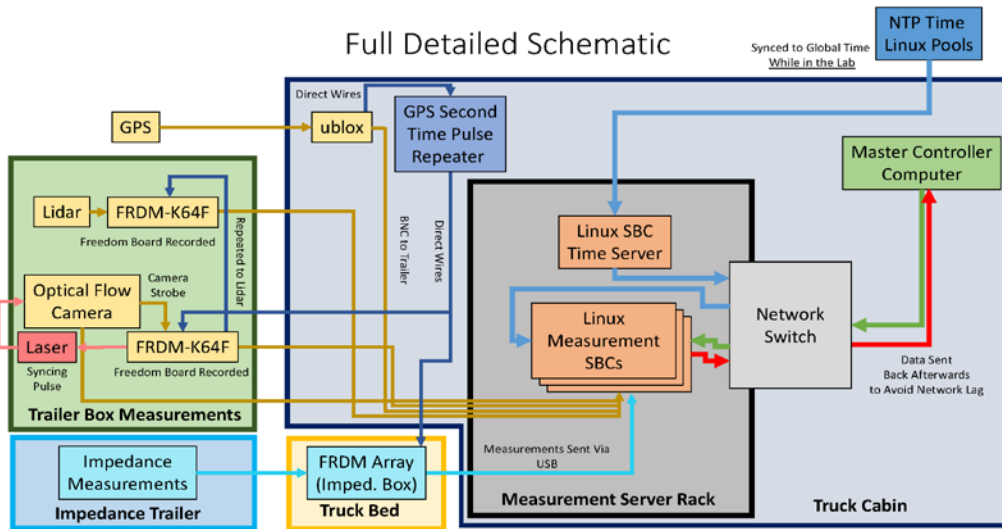
**FIGURE 12** Schematic of the data collection framework for the VEI scanner, with VEI, GPS, LiDAR, and camera measurements being recorded on different SBCs during scanning.

The data collection framework for the VEI scanner was custom-built to allow localization to be performed quickly after obtaining VEI data in the field. An overall schematic of this data collection framework is displayed in Figure 12. The data collection framework consisted of multiple single-board computers (SBC) that were linked together to acquire data from many different channels. A photograph of the rack that held all of these units is shown in Figure 13. The VEI measurement units were individual channels configured specifically to log their data in this framework synchronized with positioning data acquired from a global positioning system (GPS), a light detection and ranging (LiDAR) system, and a high-definition camera. After a scan was completed, the data could all be downloaded to a master controller computer by requesting the data from the different SBCs through the network switch.

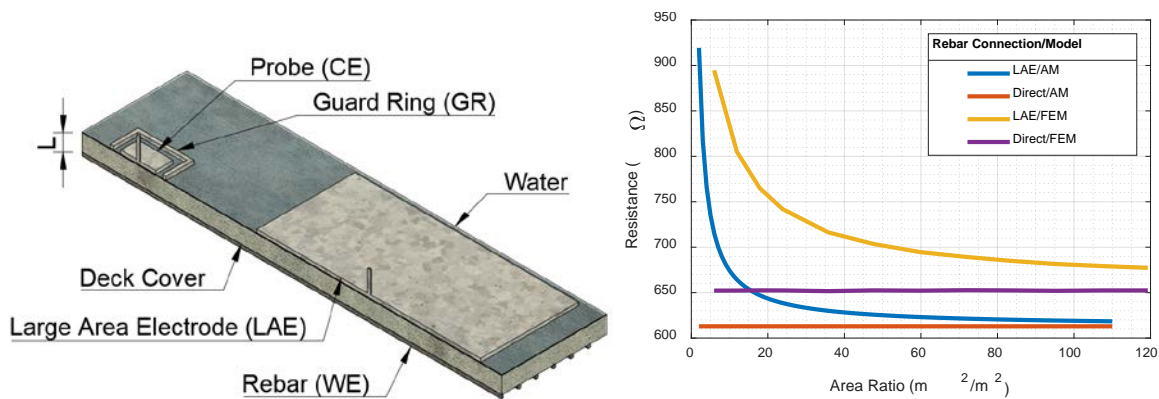
**FIGURE 20 (Left) 3D model of a vertical impedance configuration where an LAE replaces a tapped connection to the steel reinforcement used for development of both an AM and FEM of VEI for multiple electrode configurations and (right) results of analysis and numerical FEM experiments for direct and LAE connections using the two models showing that, as the area ratio increases, the resistance of the LAE connections asymptotically approach the direct connections and that, above a ratio of about 30, the influence of changes in the area ratio is significantly decreased.**

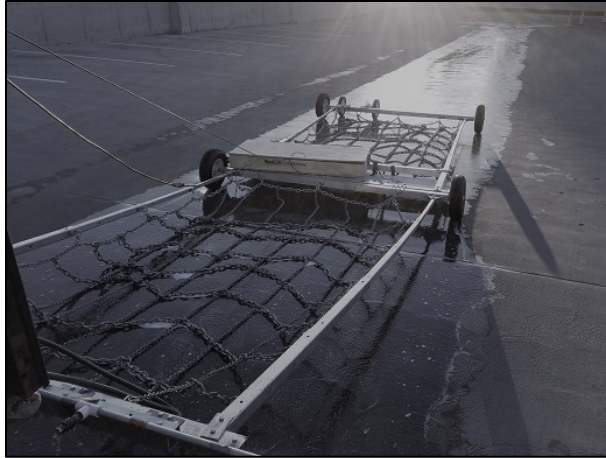
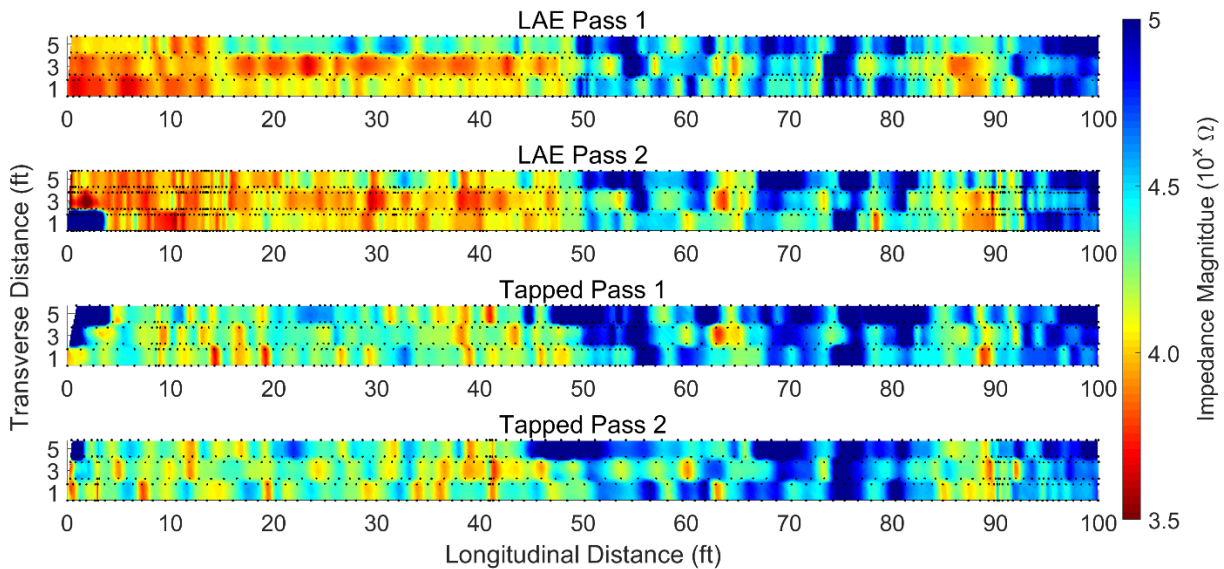
**FIGURE 22 (Top) early prototype version of VEI scanner deployed on an upper deck of a concrete parking garage and (bottom) results of four-channel experiments showing good reliability and comparability between the LAE and tapped experiments.**

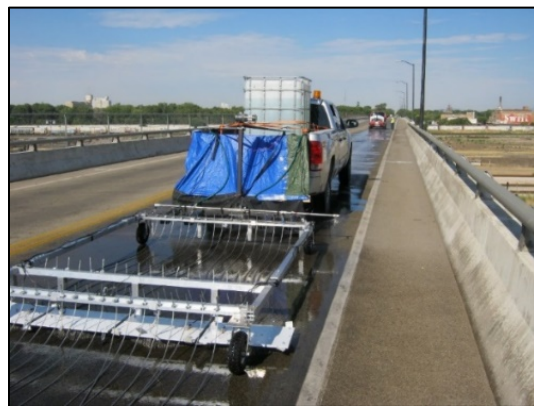
**FIGURE 23** Photograph of VEI scanner deployed on the longest bridge deck in Utah.

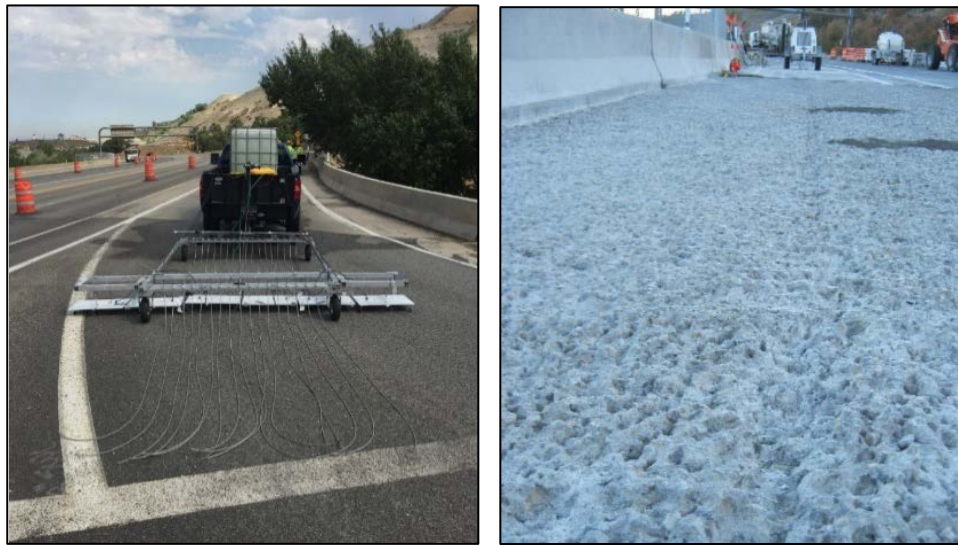
**FIGURE 25 (Left) impedance testing of an outer lane on a bridge deck with a PPC overlay in northern Utah and (right) scarified surface of the same bridge deck prior to application of the PPC overlay.**

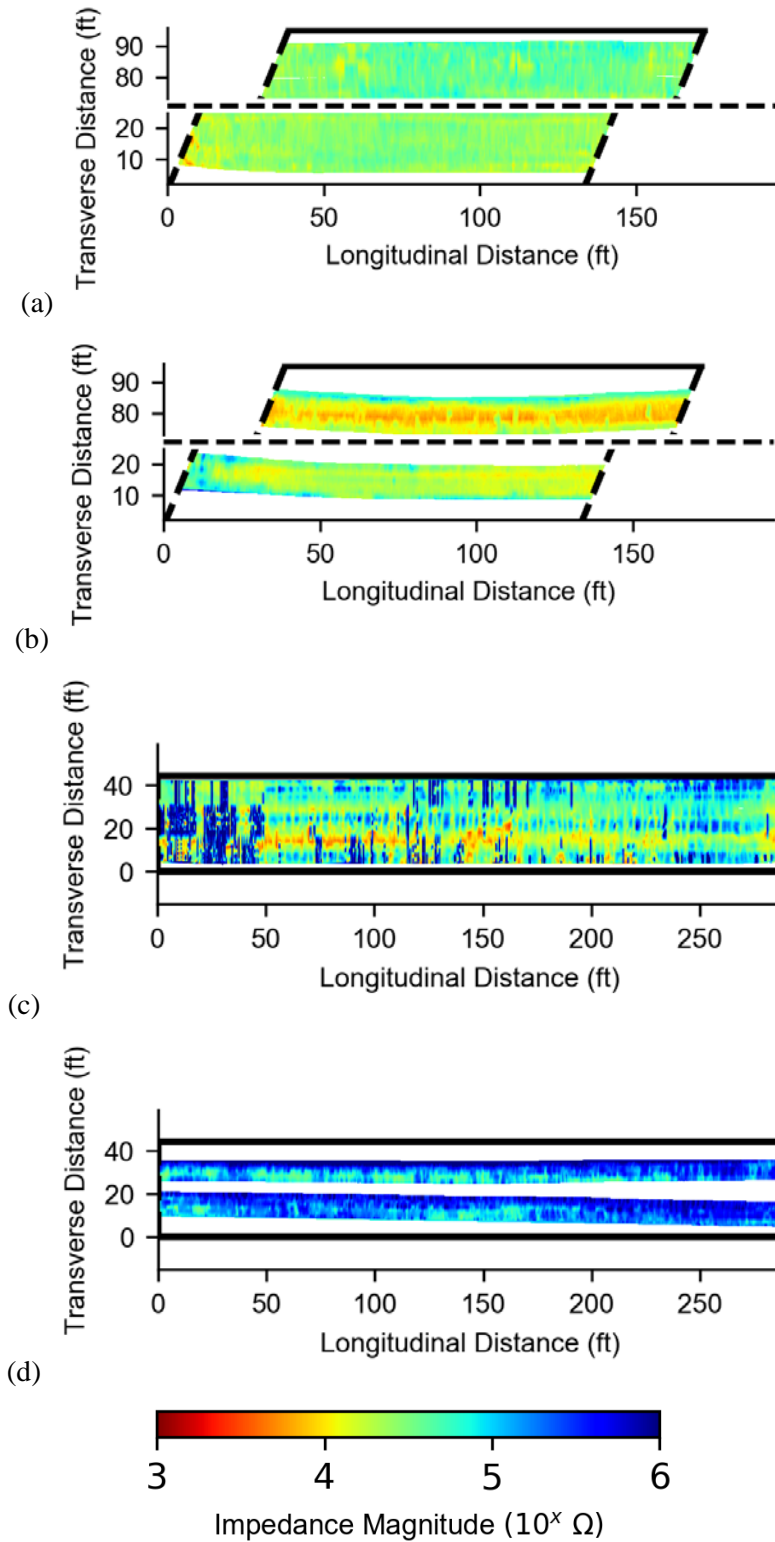
**FIGURE 26 (a) VEI map of bridge deck 1 before overlay placement. (b) VEI map of bridge deck 1 approximately two years after overlay placement. (c) VEI map of bridge deck 2 before overlay placement. (d) VEI map of bridge deck 2 approximately two years after overlay placement.**

On bridge deck 2, the PPC overlay was placed at a uniform thickness of approximately 0.75 in. across the entire deck, and the impedance testing demonstrated that this approach was very effective; the impedance of bridge deck 2 measured after overlay placement was about an order of magnitude higher than that measured before overlay placement.

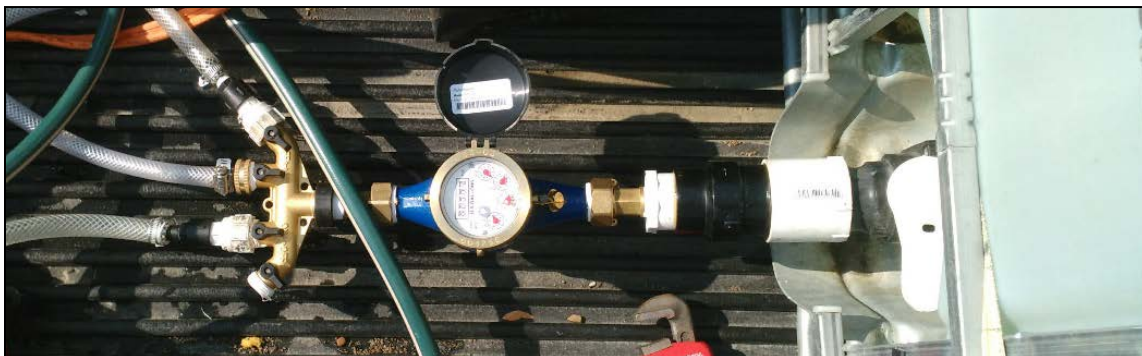
**FIGURE 28** Photograph of the new inline water meter used to log water flow during VEI scanning.

The next improvement made to the apparatus was the addition of a third 5-gpm pump in parallel with the existing two pumps as part of the water sprinkler system. The addition of this pump increased the flow rate of the overall system by approximately 50%. The new flow rate is approximately 15 gpm, which equates to approximately 0.007 gallons per square foot when traveling at 2 mph. This water flow rate now can exceed the recommended minimum flow rate of 0.005 gallons per square foot specified. A water flow meter with 1.5% accuracy from 0.22 to 22 gpm was also added to the outlet pipe of the main water tank, as shown in Figure 28. This meter permitted more accurate calculations of the volume of water being sprayed onto the bridge deck in a given test and increased understanding of the effects of water on the overall impedance measurements. This meter has a mechanical readout but can be instrumented in the future for digital tracking of water usage dynamically during scanning.

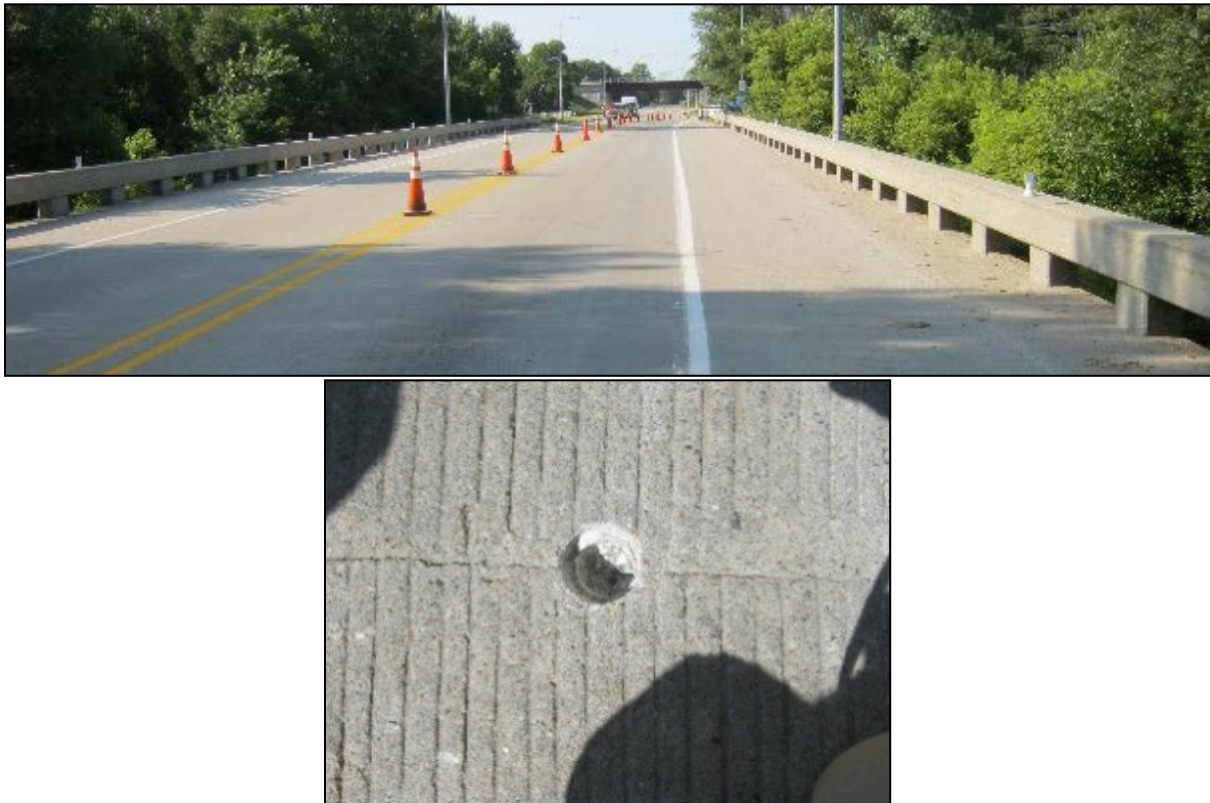
**FIGURE 29 (Top) photograph of Nebraska Bridge Deck 1 on which scanning took place in the southbound lane and shoulder and (bottom) photograph of a chloride concentration sampling location that corresponded to a construction joint characterized by lower impedance values.**

In collaboration with researchers at the University of Nebraska-Lincoln, a bridge scanning tour was arranged in Nebraska in August 2018 under the auspices of the Nebraska Department of Transportation. Three bridge decks, one bare, one with a low-slump concrete overlay, and one with an asphalt overlay, were selected for scanning in eastern Nebraska. Nebraska Bridge Deck 1 (Figure 29 (top)) was built in 1995. It is a three-span cast-in-place concrete deck with a monolithic concrete surface and epoxy-coated reinforcing steel and was supported by continuous steel girders. The bridge deck is 293 ft long and 46.3 ft wide (out to out) and is located on a rural minor arterial road with an estimated average daily traffic (ADT) of 3730. At the time of testing, the deck carried a northbound and a southbound lane with approximately 8-ft-wide shoulders on each side. To evaluate Nebraska Bridge Deck 1 with the VEI scanner, both the southbound lane and shoulder were scanned twice. During these four passes, 12.5, 12.3, 18.9, and 15.6 gallons of water were applied to the deck surface. These amounts corresponded to approximately 0.003 to 0.005 gallons per square foot, which was consistent with the water usage specifications developed earlier in this research. (During the second pass along the southbound shoulder, one of the probe cables was accidentally cut when the apparatus was winched up, which resulted in a loss of data for that probe only; interpolation between adjacent probes was used to estimate values for the missing data.) Immediately after impedance scanning was performed, preliminary impedance maps were generated to enable identification of a low-impedance location and a high-impedance location on the deck for chloride concentration testing. At each location, two samples were obtained using a rotary hammer. The first sample represented the depth interval from 0 to 1 in., while the second sample represented the depth interval from 1 to 2 in. After removal, the samples were returned to Brigham Young University for laboratory analysis.

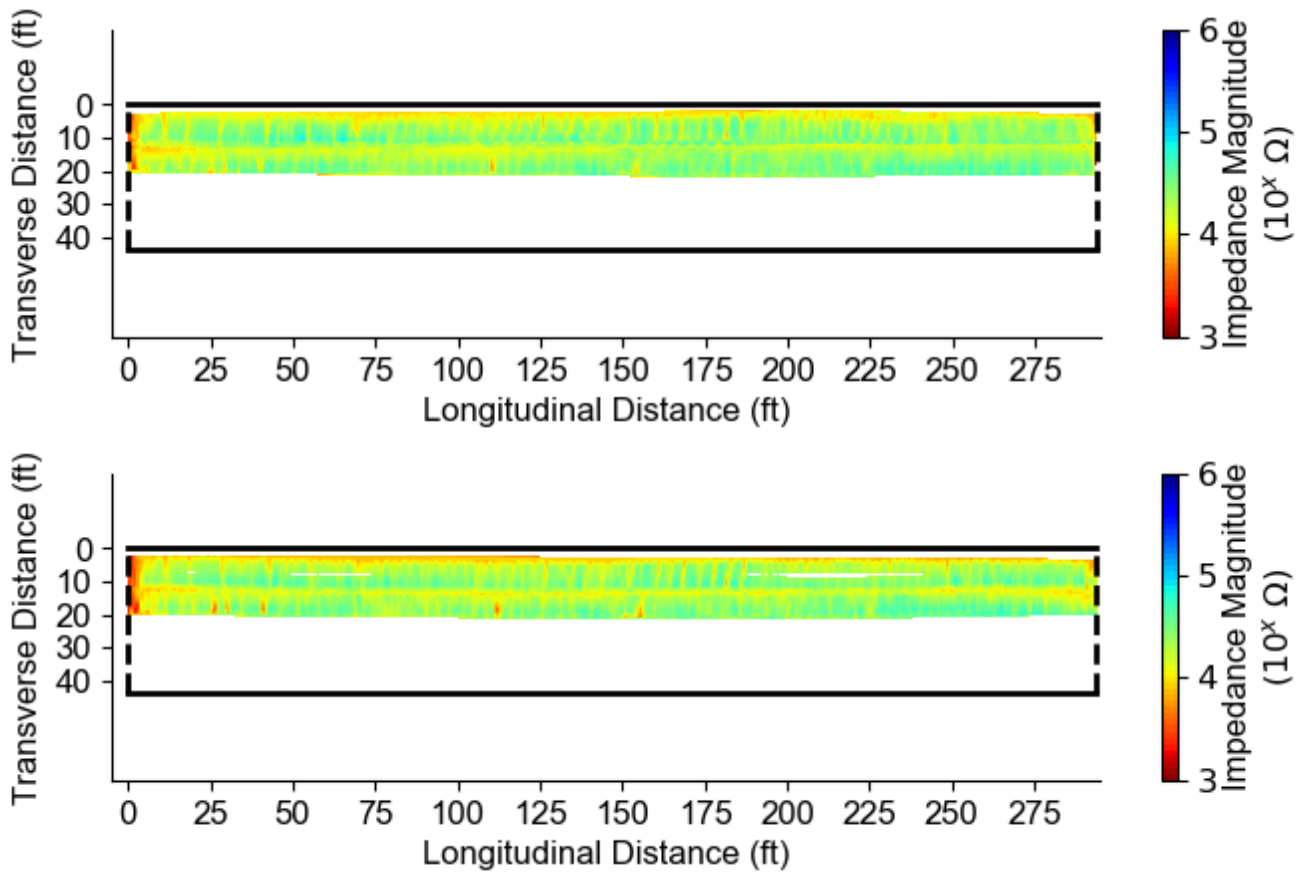
**FIGURE 30 (Top) VEI map generated from the first passes and (bottom) VEI map generated from the second passes.**

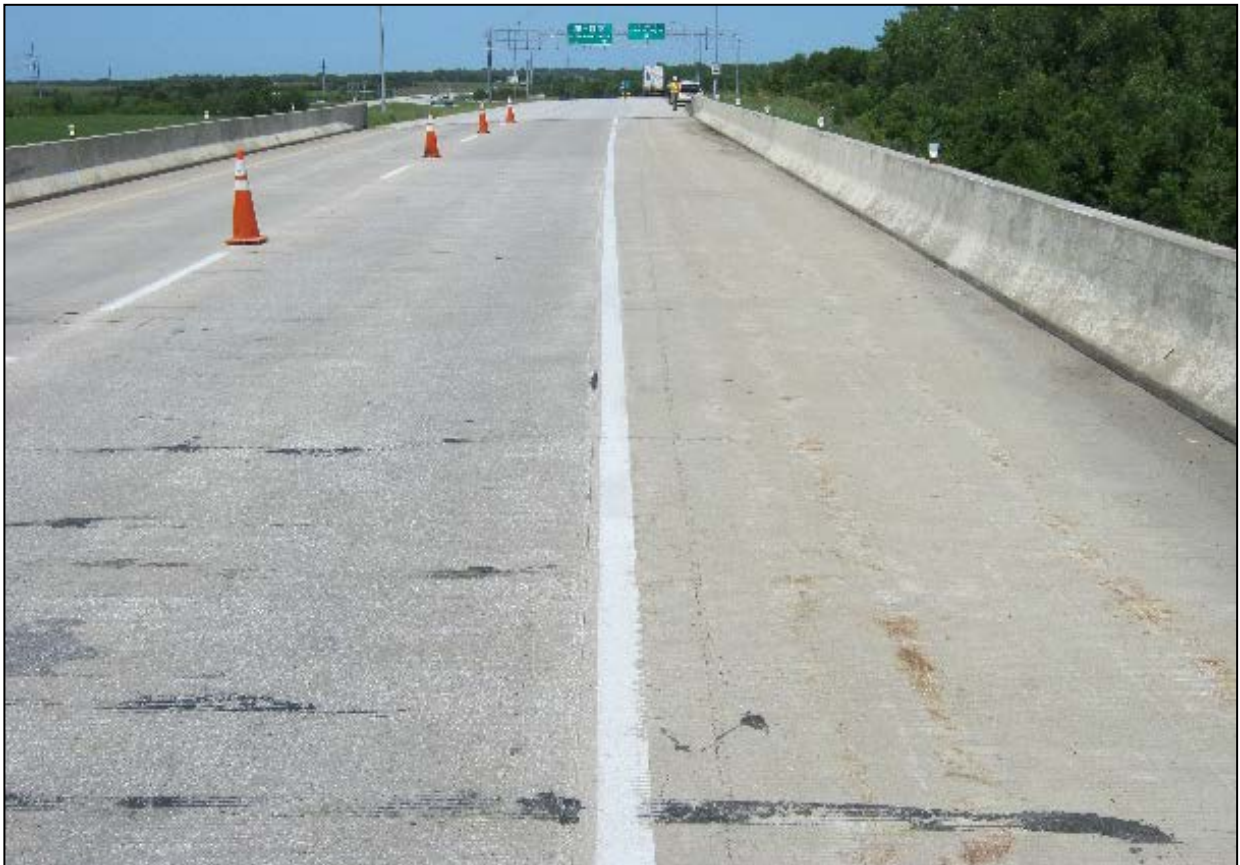
**FIGURE 31 Photograph of Nebraska Bridge Deck 2 prior to scanning.**

Nebraska Bridge Deck 2 was built in 1965 and was reconstructed in 1978. Shown in Figure 31, it is a three-span cast-in-place concrete deck with a low-slump concrete overlay and is supported by continuous steel girders. The bridge deck is 180 ft long and 39.6 ft wide (out to out). The bridge is located on a principal road with an estimated ADT of 12,415. At the time of testing, the deck carried two lanes of northbound traffic with an approximately 10-ft-wide shoulder on the right and a 5-ft-wide shoulder on the left. To evaluate Nebraska Bridge Deck 2 with the VEI scanner, both the right lane and right shoulder were scanned three times. The third pass of the shoulder was deliberately performed at about 10 mph, which is approximately triple the speed of all other passes shown. During the six passes across the bridge deck, 12.0, 10.8, 11.6, 10.2, 8.8, and 3.8 gallons of water were applied to the deck surface. These amounts corresponded

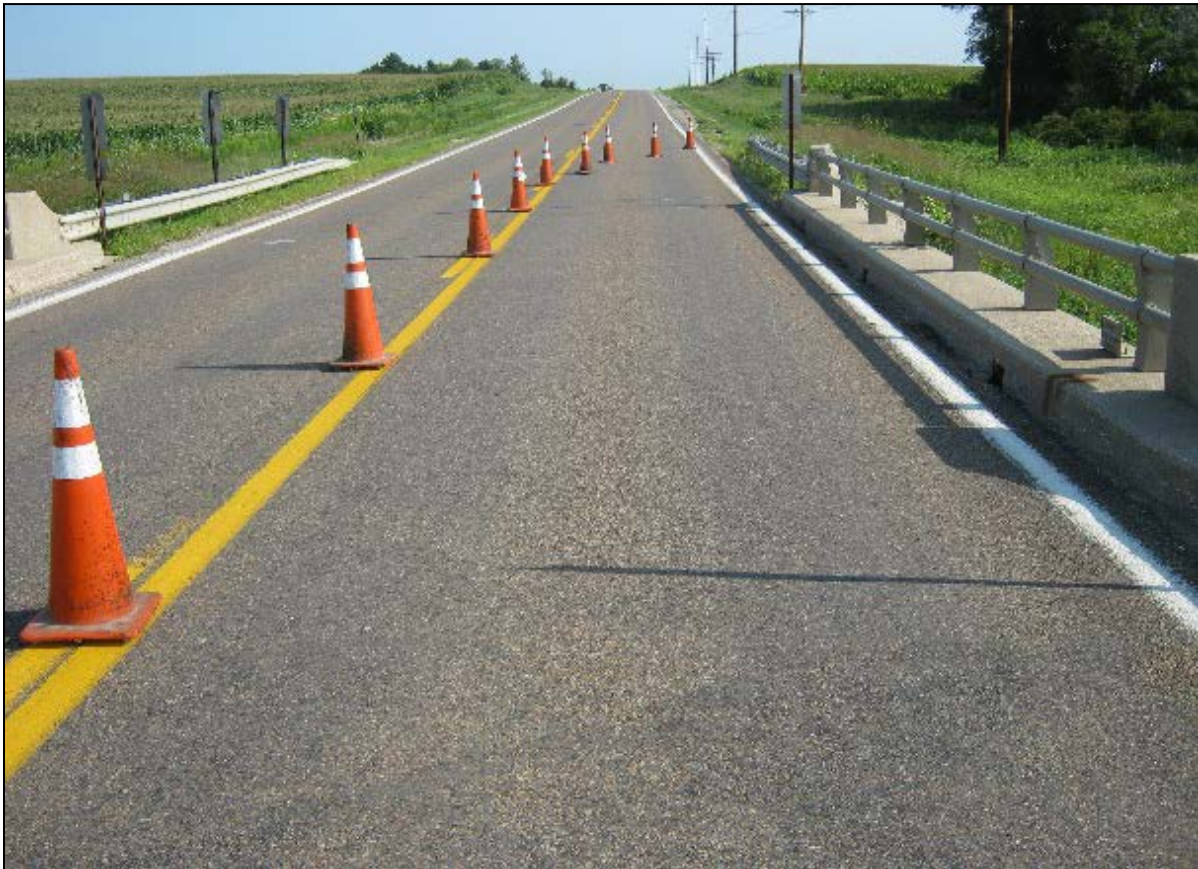
**FIGURE 33 Photograph of Nebraska Bridge Deck 3.**

Nebraska Bridge Deck 3, shown in Figure 33, was built in 1958. It is a three-span cast-in-place concrete deck with an asphalt overlay and is supported by continuous concrete girders. The bridge deck is 54 ft long and 33 ft wide (out to out) and is located on a rural minor arterial road with an estimated ADT of 1950. At the time of testing, the deck carried one lane of northbound traffic and one lane of southbound traffic with minimal shoulders. To evaluate Nebraska Bridge Deck 3 with the VEI scanner, both the northbound and southbound lanes were scanned three times. During the six passes across the bridge deck, 14.2, 8.1, 6.7, 14.1, 9.8, and 11.5 gallons of water were applied to the deck surface. These amounts corresponded to approximately 0.008 to 0.017 gallons per square foot for the six passes, which was above the recommended water usage specification. The extra water was deliberately applied, however, to ensure that the asphalt overlay was sufficiently soaked for testing. Immediately after impedance scanning was performed, preliminary impedance maps were generated to enable identification of a low-impedance location and a high-impedance location on the deck for chloride concentration testing, which was performed using the same procedures applied to Nebraska Bridge Decks 1 and 2.

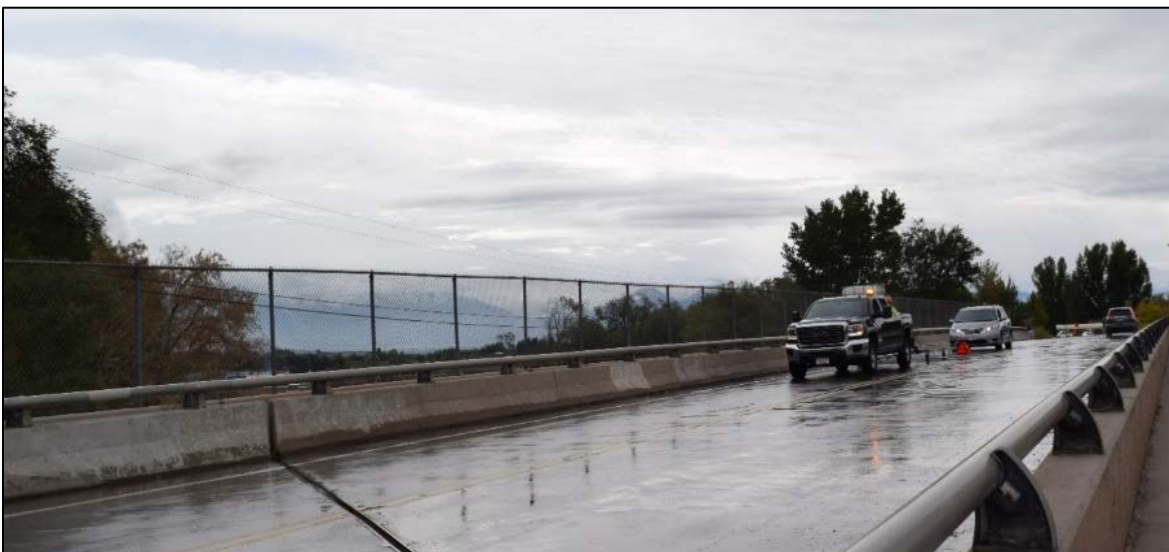
**FIGURE 35** Photograph of VEI scanning on Utah Bridge Deck 1.

The final task performed in Stage II was scanning a bridge deck in northern Utah. Shown in Figure 35, Utah Bridge Deck 1 was built in 1970. It is a two-span cast-in-place concrete deck with a monolithic concrete surface and is supported by continuous concrete girders. The bridge deck is 256 ft long and 45 ft wide (out to out). The bridge is on an urban local road with an estimated ADT of 5,000. The bridge has a 12-ft-wide northbound lane and a 14-ft-wide southbound lane with an approximately 3.3-ft-wide northbound shoulder and a 2.8-ft-wide southbound shoulder. This bridge also has 6-ft-wide pedestrian walkways on both sides of the bridge. Testing occurred after a week of heavy rain, so the bridge deck had been exposed to high levels of moisture that enabled excellent electrical coupling of the impedance probes to the deck surface. During VEI scanning, both lanes were alternately scanned six times, with each pass having a slightly different transverse offset. Each pass was performed at the recommended speed of approximately 1 to 3 mph, with the exception of the sixth pass that was performed at a higher speed of approximately 8 mph in both lanes. One of the probes on each pass measured lower-than-expected impedance values, which were subsequently determined to be invalid and discarded; interpolated values based on valid measurements obtained using adjacent probes were used instead. During the six passes in the northbound direction, approximately 16.6, 13.0, 20.6, 13.5, 13.4, and 5.6 gallons of water were applied to the deck surface. During the six passes in the southbound direction, approximately 11.9, 14.1, 15.0, 12.7, 12.2, and 4.7 gallons of water were applied to the deck surface. These amounts corresponded to approximately 0.004 to 0.005 gallons per square foot for the five passes, which was consistent with the water usage specification developed earlier in this research. For the last, fast pass, the amount corresponded to about 0.002 gallons per square foot. Noticeably, the soaking time for the fast pass was also reduced. One year prior to testing, this bridge deck had been extensively inspected using chain dragging to develop a delamination map. In addition, a detailed crack map was also prepared from a careful visual inspection. The crack and delamination map is shown in Figure 36(a).

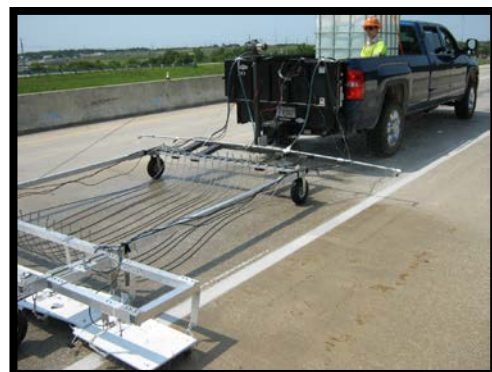
The research objective was to develop a multi-channel vertical electrical impedance scanner with a large-area electrode to quantify the cover protection offered to reinforcing steel in bridge decks without a direct rebar connection.

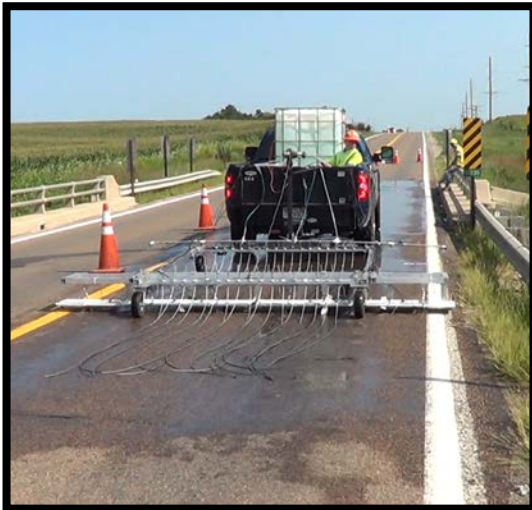
Field deployment demonstrated that multi-channel measurements could be performed in parallel and that implementation of the large-area electrode successfully eliminated the need for a direct electrical connection to the steel reinforcement. Vertical electrical impedance scanning at rates exceeding 1500 ft<sup>2</sup>/minute was achieved in this project.

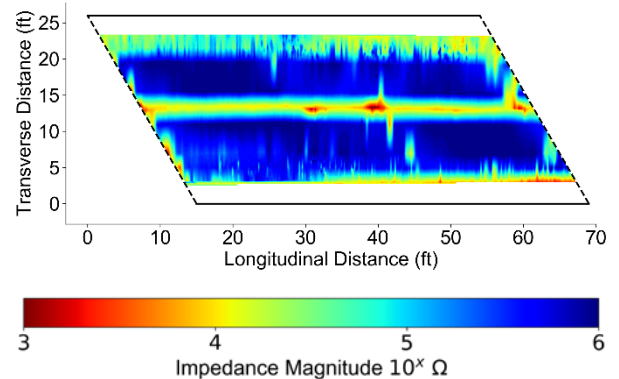
Map of vertical electrical impedance data on an asphalt-overlaid concrete bridge deck, with areas of compromised cover protection indicated.
