Material Characteristics of Cu-Based Superelastic Alloys for Applications in Bridge Columns to Improve Seismic Performance

Final Report for
NCHRP IDEA Project 210

Prepared by:
Bora Gencturk
University of Southern California
M. Saiid Saiidi
Infrastructure Innovation, LLC

May 2022

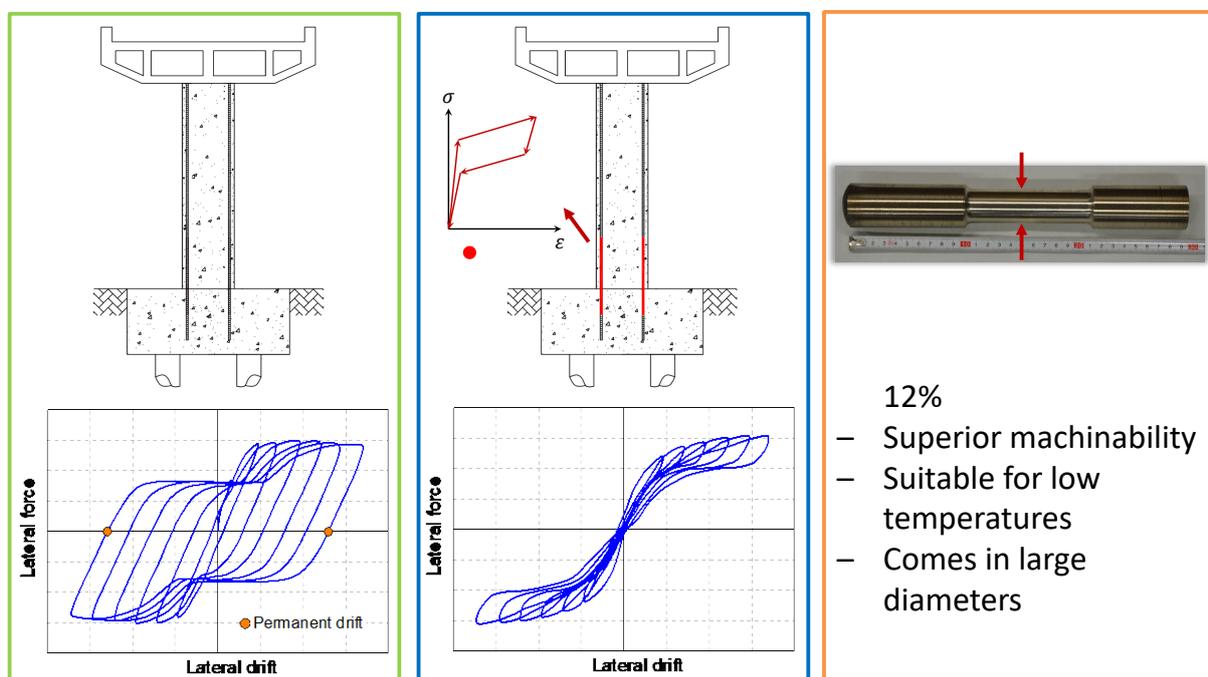
Figure 1-1 Concept of using SEAs as plastic hinge reinforcement in columns to improve seismic performance.

The concept of using superelastic alloys (SEA), a type of shape memory of alloy (SMA) to improve seismic performance of bridge columns is illustrated in Figure 1-1. This project investigated the feasibility of using a new composition of shape memory alloy (SMA), specifically, Cu-Al-Mn (CAM), in bridge columns as plastic hinge reinforcement to improve seismic performance. Reinforcement in concrete structures subject to earthquakes have certain requirements. These include sufficient low-cycle fatigue life, corrosion resistance, and the ability to splice with conventional reinforcement. The latter requirement implies sufficient machineability for certain mechanical splices. Additionally, cost is always a primary consideration in implementation of new technologies. This project specifically investigated these characteristics of CAM SEAs.

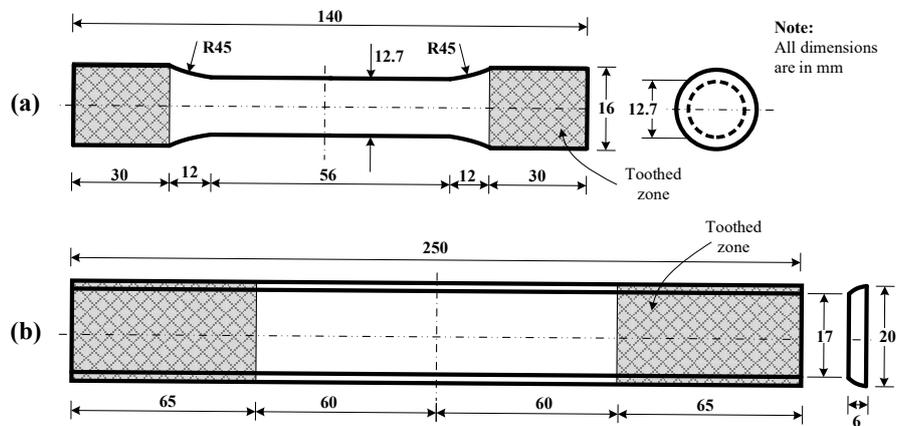
Figure 3-1 Dimensions of (a) SCB, NTB, and (b) PCP specimens.

CAM SEA bars), and polycrystal NiTi SEA bars (NTB). The as received CAM and NiTi SEA bars all had a 20 mm diameter. The SCB and NTB were machined from as received rods to 140 mm long and 16 mm diameter coupons with a diameter of 12.7 mm in the gauge length. To obtain PCP, the as received polycrystal CAM rods were sliced along the length into four pieces, the middle two larger pieces were used for testing. The dimensions of SCB, NTB and PCP used in this study are shown in Figure 3-1.

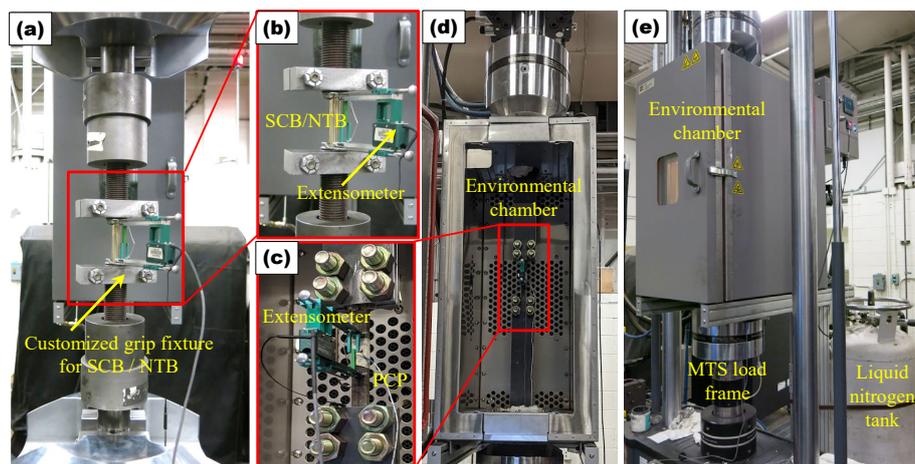
Figure 3-2 Setup for low cycle fatigue test. (a) Setup for SCB and NTB at room temperature, (b) zoom-in view of customized grip fixture for SCB and NTB, (c) zoom-in view of grip fixture for PCP, (d) inside view of environmental chamber and setup for PCP, and (e) outside view of environmental chamber connected with liquid nitrogen tank.

Figure 3-2 shows the setup of the low-cycle fatigue tests. An MTS 370.5 dynamic servo-hydraulic frame with 500 kN force capacity, 15.24 cm displacement and 30 gpm flow capacity was used to apply the cyclic loading. For high, 50°C, and low, -40°C, temperature tests, an MTS 651.06E-04 environmental chamber was equipped to the MTS frame. The environmental chamber has internal dimensions of 35.56×43.18×81.28 cm (W×D×H) and a temperature range from -128.9°C to 215.6°C. An Epsilon Model No. 3542-0200-050-ST with 50.8 mm gauge length extensometer, ASTM E83 B-1 [8], was used to measure the strain in the specimens. A Mars Labs BMS16HR-53 Data Acquisition System (DAQ) was used to collect the data.

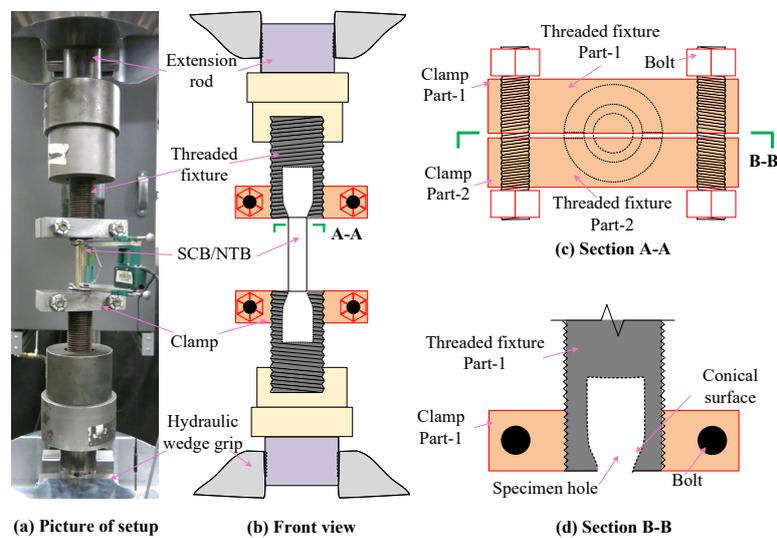
Figure 3-3 Schematic diagram of the grip fixture used for SCB, NTB: (a) picture of setup, (b) front view, (c) section A-A, and (d) section B-B.

specimens, as shown in Figure 3-3. This mechanical contact-based grip effectively reduced the stress concentrations and eliminated premature failures. The PCP was gripped by two steel plates at the ends, where two steel plates were tightened by four high strength steel bolts, as shown in Figure 3-4.

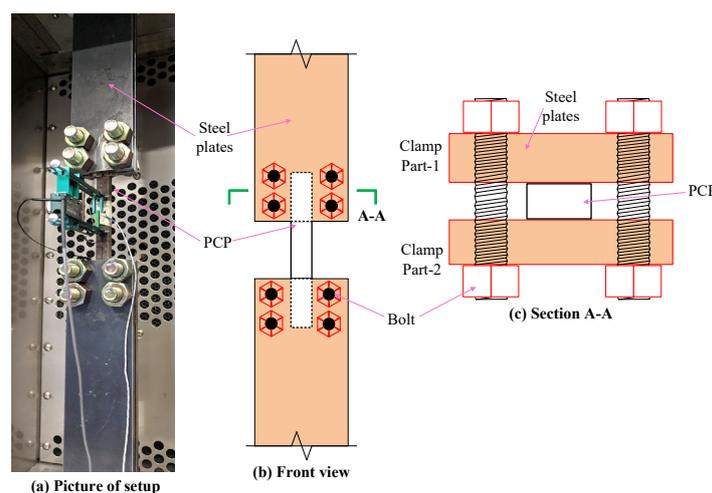
Figure 3-4 Schematic diagram of the grip fixture used for PCP: (a) picture of setup, (b) front view, and (c) section A-A.

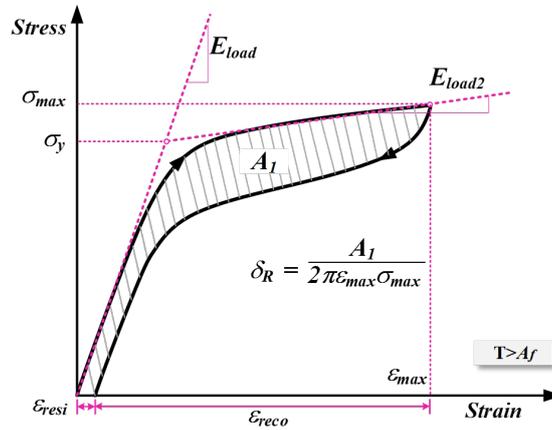
Figure 3-5 Definition of critical mechanical properties considered in low-cycle fatigue test.

To quantify the effect of fatigue and temperature on the superelasticity of CAM and NiTi SEAs, seven critical properties were extracted from the stress-strain curves; namely, the elastic modulus, E_{load} , the elastic modulus after yielding, E_{load2} , the maximum stress, σ_{max} , the yield stress, σ_y , the damping ratio, δ_R , the maximum strain, ϵ_{max} , and the residual strain, ϵ_{resi} . The definition of these properties is shown in Figure 3-5. The damping ratio is calculated using the equation shown in Figure 3-5 by dividing the area enclosed by the hysteresis loop by the product of the maximum strain and maximum stress applied in that cycle.

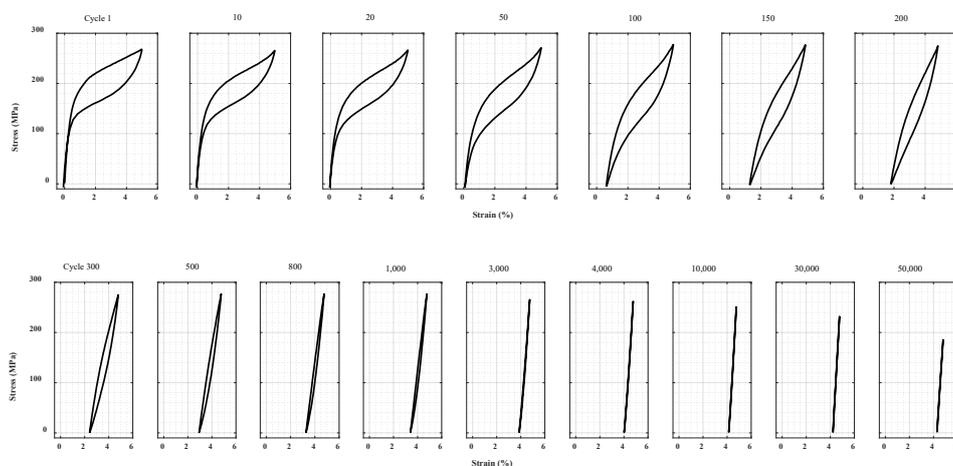
Figure 3-6 Stress-strain curves of SCB-25C-1 at room temperature, 25°C.

Figure 3-6 shows the room temperature, 25°C, stress-strain curves of SCB-25C-1. It is seen that both single crystal CAM SEA bars show excellent superelasticity until about 200 cycles. In the first 100 cycles, the stress strain curves remain ideal flag-shaped and almost no degradation of strain recovery is observed. From 100 to 1,000 cycles, the stress-strain curves shrink, and the residual strain increases. Moreover, the damping ratio shows an obvious increase from 100 to 1,000 cycles. The reason for this increase is the reduction of the transformation stress and increase in the area of the stress-strain curves. A similar behavior was observed for the other specimens.

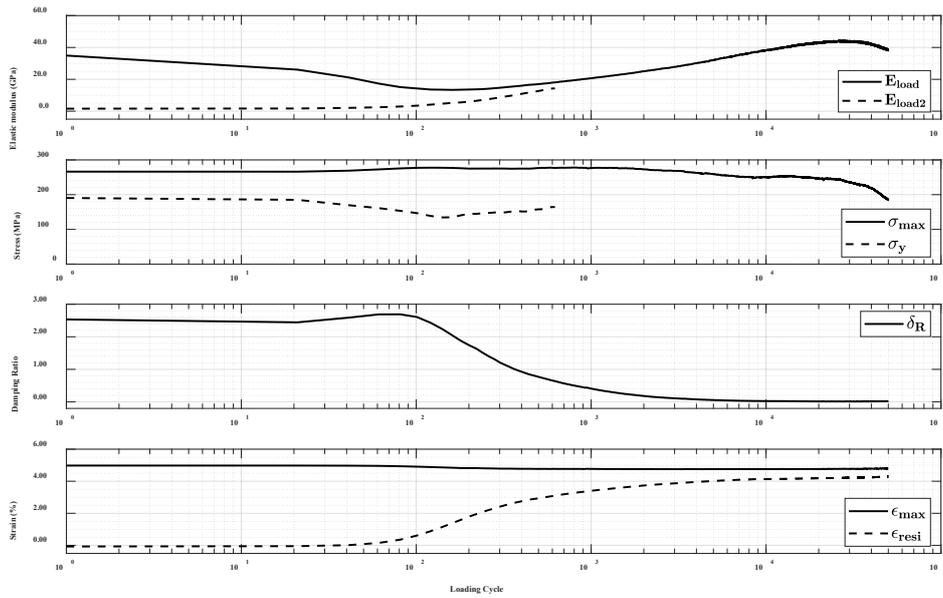
Figure 3-7 Variation in mechanical properties of SCB-25C-1 at room temperature, 25°C.

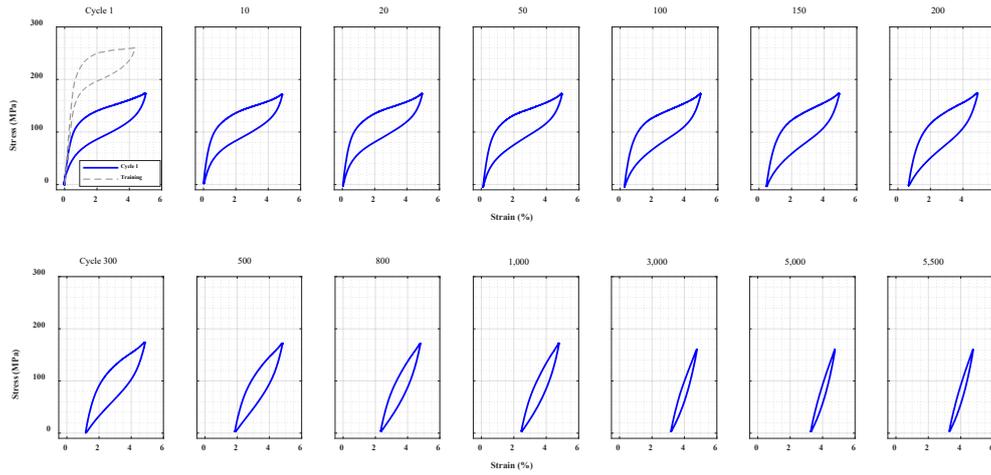
Figure 3-8 Stress-strain curves of SCB-m40C-1 at -40°C .

Figure 3-8 shows the stress-strain curves of SCB-m40C-1 at -40°C. It is seen that at -40°C, the SCB shows an ideal flag-shaped stress strain curve and excellent damping capacity until 200 cycles. Furthermore, the specimen SCB-m40C-1 showed no rupture after 5,500 cycles of fatigue loading. The test was stopped because the liquid nitrogen tank ran out and the environmental chamber could not sustain a stable low temperature condition. The envelope curve from training at room temperature is presented with a grey dashed line at Cycle 1. As seen in Figure 3-8, the transformation stress at -40°C is lower than that at room temperature. However, area inside the stress strain cycles at -40°C is larger than that at room temperature (refer to Figure 3-6), which indicates higher energy dissipation capacity of CAM SEAs at low temperature. The variation in the mechanical properties at -40°C is similar to that at room temperature. But what is worth noting is that the energy dissipation capacity and strain recovery at -40°C are superior to those at room temperature, demonstrating the promise of CAM SEAs for use at cold temperatures.

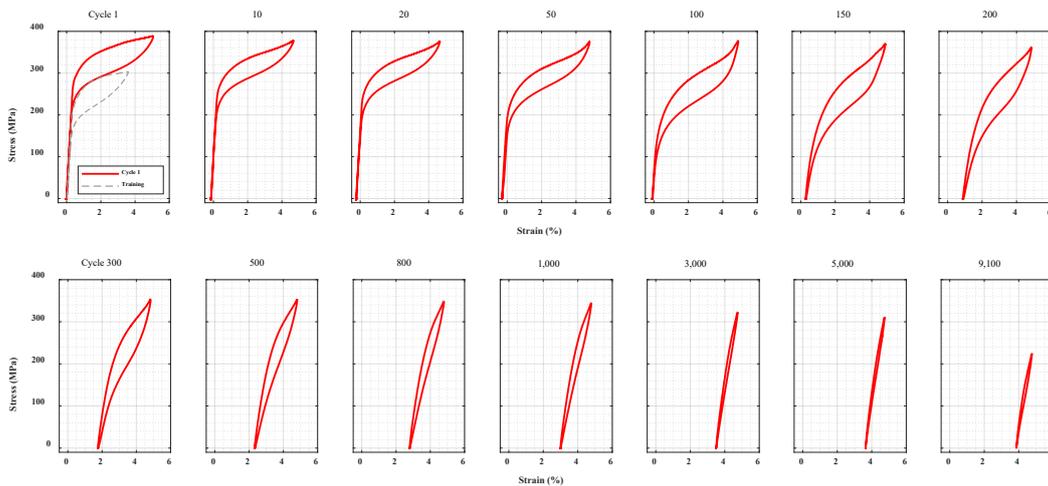
Figure 3-9 Stress-strain curves of SCB at 50°C , (a) SCB-5-C-1 and (b) SCB-50C-2.

The stress-strain curves of SCB-50C-1 at 50°C are shown in Figure 3-9. The envelope curve from training at room temperature is presented with a grey dashed line. SCB-50C-1 showed no fracture after 9,100 cycles of loading. Compared with the stress strain curves at room temperature (shown in Figure 3-6), and -40°C (shown in Figure 3-8), the transformation stress of CAM SEAs at 50°C is higher and the stress-strain curves become narrower. The general variation in the mechanical properties at 50°C is similar to those at room temperature and -40°C . An important observation is that the damping ratio at 50°C shows an increase after 100 cycles. The reason is that in the first several cycles, the stress-strain curves are very narrow, and the damping only is a result of the flag-shaped zone while as the residual strain increases and the transformation stress decreases, the stress-strain curve becomes larger and leads to an increase in the damping ratio. After around 1,000 cycles, the response of the CAM SEAs becomes almost linear.

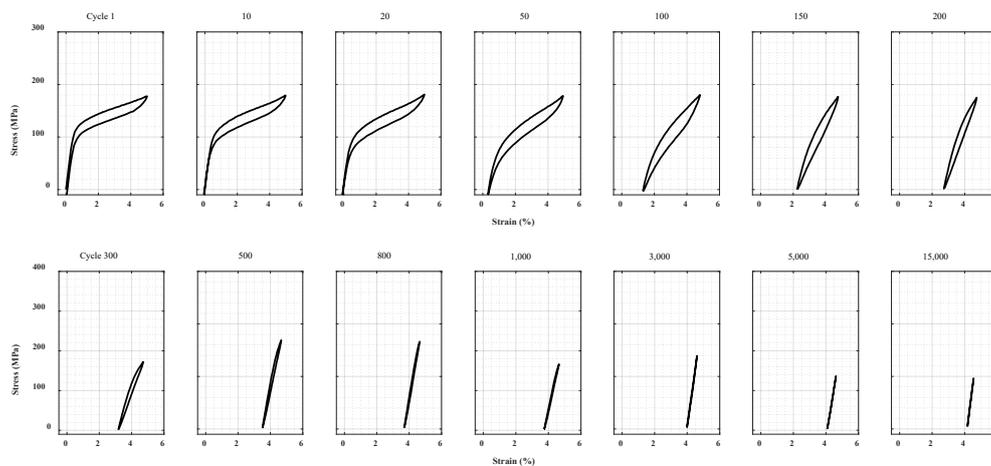
Figure 3-10 Stress-strain curves of PCP-25C-1 at room temperature, 25°C.

Figure 3-10 shows the stress-strain curves of PCP-25C-1 at selected cycles at 25°C . The specimen ruptured after 15,000 cycles of fatigue loading. It is seen that the fatigue resistance of PCP-25C-1 is similar to that of single crystal CAM SEA bar. In the initial 100 cycles, the superelasticity shows almost no degradation, and flag-shaped stress-strain curves and energy dissipation are observed. From 100 to

1,000 cycles, the stress-strain curves become narrower, and the residual strain accumulates rapidly. After 1,000 cycles, the specimen behaves almost linearly until fracture.

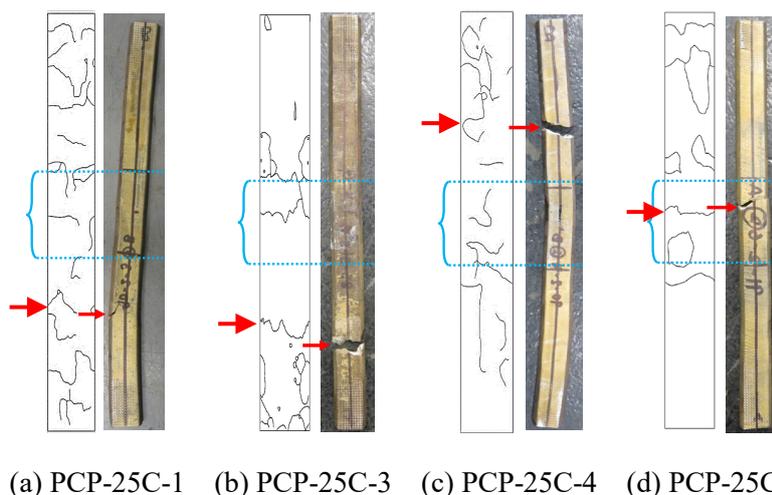
Figure 3-11 Grain distribution and fracture locations of (a) PCP-25C-1, (b) PCP-25C-3, (c) PCP-25C-4 and (d) PCP-25C-5. The blue bracket shows the location of the extensometer. The red arrow shows the fracture location.

Even though a long fatigue life (i.e., 15,000 cycles) exhibited by PCP-25C-1, the fatigue life of the rest of PCP showed a large scatter. The rest of four PCP, respectively, fractured at 1,280, 357, 110 and 104 cycles. Figure 3-11 shows the grain distribution and fracture location of the PCP specimens. The black solid lines indicate the grain boundaries on the specimen surface, obtained by visual observation; the blue dash line and the bracket indicate the gauge length where the extensometer was placed during the test. Compared with the SCB, the reason why the PCP show a large scatter in fatigue life is that each polycrystal plate is composed of several small and randomly distributed grains with different sizes and orientations, as shown in Figure 3-11. In fatigue loading, the boundaries of neighboring grains, particularly when the neighboring grains have different orientations, may cause stress concentrations and result in crack formation and propagation [2,9,10]. The fracture location of each of the PCP is marked with a red arrow in Figure 3-11, which supports this explanation. Because of the large dependence of the fatigue behavior on the grain size, distribution and orientation, no further tests on PCP were conducted at low or high temperatures.

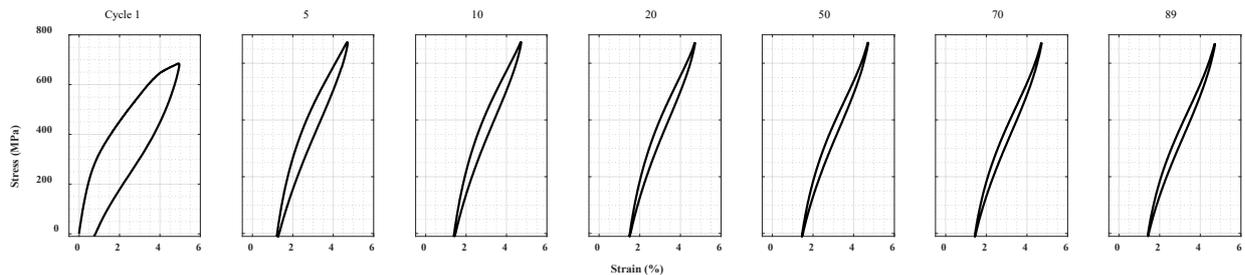
Figure 3-12 Stress-strain curves of NTB-25C-1 at room temperature, 25°C.

Figure 3-12 shows the stress-strain curves of NTB-25C-1 at 25°C. The three tested NiTi SEA bars at 25°C all fractured rapidly with fatigue lives of 89, 31 and 54 cycles. It is seen that the stress-strain curve of NTB in the 1st cycle is not an ideal flag-shape. The transformation stress and residual strain of NTB reach 400 MPa and 1%, both of which are higher than those of CAM SEAs in the 1st cycle. More importantly, the stress-strain curve of the NTB narrows even in the first few cycles, leading to a sharp decrease in the energy dissipation. The residual strain also increases slightly in the first few cycles and then stabilizes until fracture. This ratcheting phenomenon of NiTi SEAs is consistent with the results presented by Maletta et al. [11].

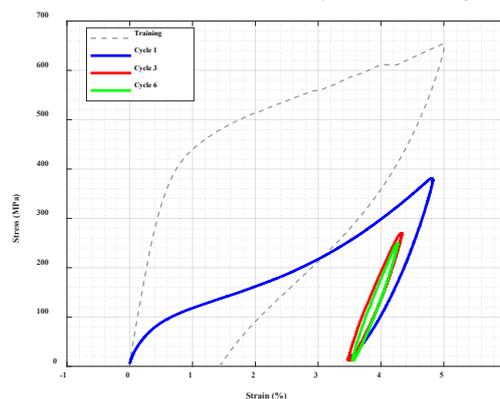
Figure 3-13 Stress-strain curves at typical cycles of NTB-m40.

The low temperature fatigue tests on NiTi bars were conducted at -40°C and -10°C. Stress-strain curves at select cycles of NTB-m40 are shown in Figure 3-13 in addition to the envelope curve of training at room temperature in grey. From Figure 3-13, it is seen that the NiTi SEA is in pure martensitic phase at -40°C. No superelasticity is seen because no austenite-martensite phase transformation is involved. The specimen NTB-m40C fractured after 6 cycles of fatigue loading.

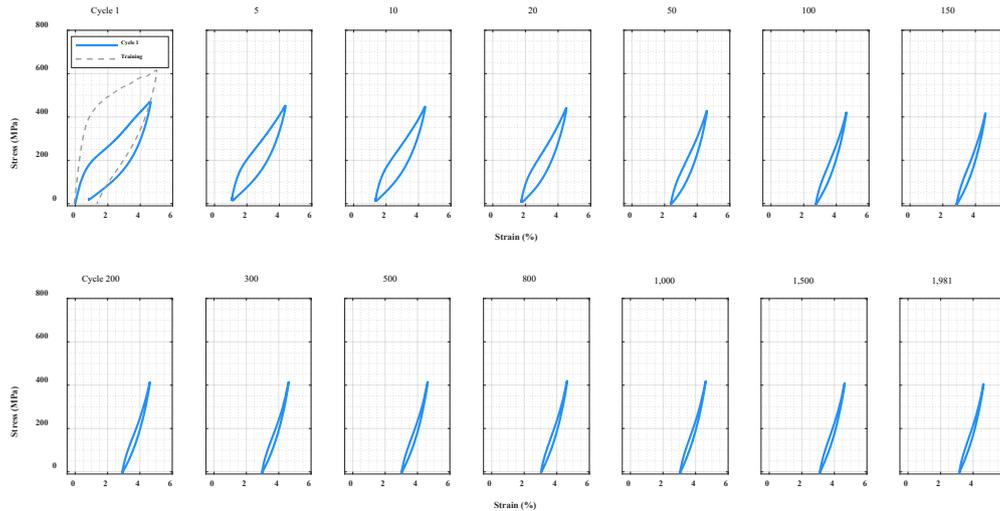
Figure 3-14 Stress-strain curves at typical cycles of NTB-m10-1 at -10°C.

Because no superelasticity was observed at -40°C, additional testing was performed at -10°C to investigate the fatigue resistance of NiTi SEAs. Figure 3-14 shows the stress-strain curves of NTB-m10C-1 at -10°C. Compared with NiTi SEAs at 25°C, the specimen at -10°C shows a higher fatigue life, this trend is consistent with Iasnii et al. [12] and Mahtabi et al. [13]. The energy dissipation and strain recovery at -10°C starts to degrade rapidly at around 10 cycles and stabilize at around 100 cycles.

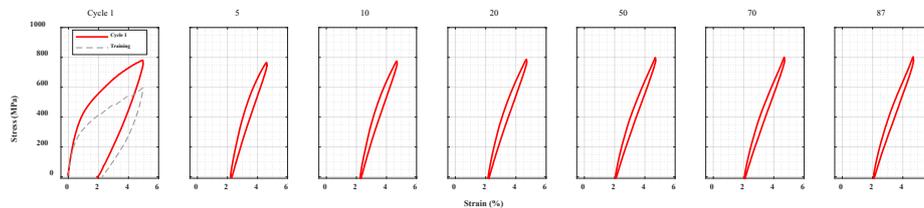
Figure 3-15 Stress-strain curves of NTB-50C-1 at 50°C.

The stress-strain curves of NTB-50C-1 at 50°C are shown in Figure 3-15. The transformation stress of NTB at 50°C reaches 500 MPa, which is higher than the training results. All NiTi bars at 50°C fractured after a few cycles of loading. The first one ruptured after 87 cycles of fatigue loading while the second and the third ones fractured after 15 and 29 cycles, respectively. Furthermore, the stress-strain curves became narrow very rapidly and then kept constant until fracture. It is observed that the elastic modulus and transformation stress shows negligible degradation. The damping ratio and the residual stress degrade rapidly and then stabilize. Even in the first cycle, significant residual strain is observed, indicating the poor superelasticity of NTB at 50°C.

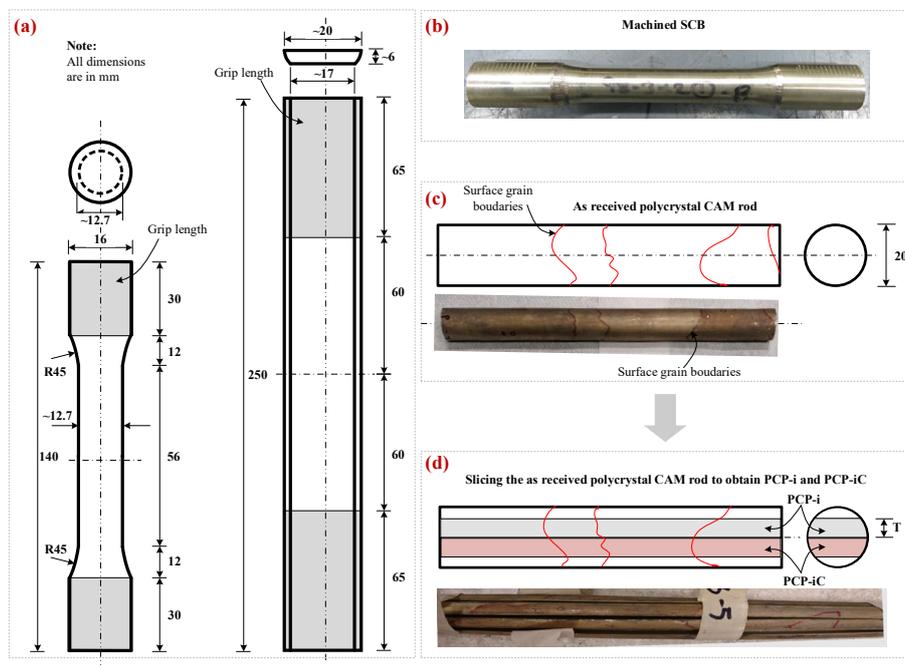
Figure 3-16 Preparation of test specimens for long-term corrosion testing: (a) dimensions of SCB and PCP, (b) machined SCB, (c) surface grain boundaries of as received polycrystal CAM SEA, and (d) preparation of PCP.

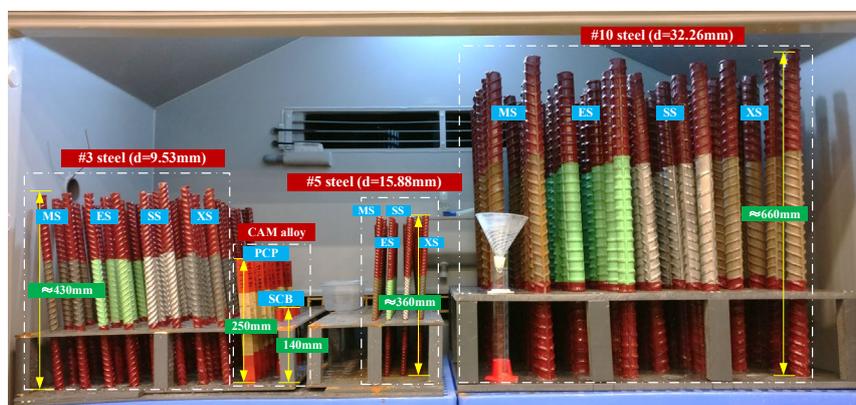
Figure 3-17 Arrangement of test specimens in the corrosion chamber for accelerated corrosion.

Figure 3-17 shows all the test samples in the corrosion chamber prior to testing. As shown in Figure 3-17, all specimens were placed vertically in the chamber to allow for air circulation around the specimens and prevent ponding on the surfaces. The specimens were taken out regularly for subsequent tests at predetermined corrosion times. A red corrosion resistant coating was used to prevent corrosion of the gripped ends.

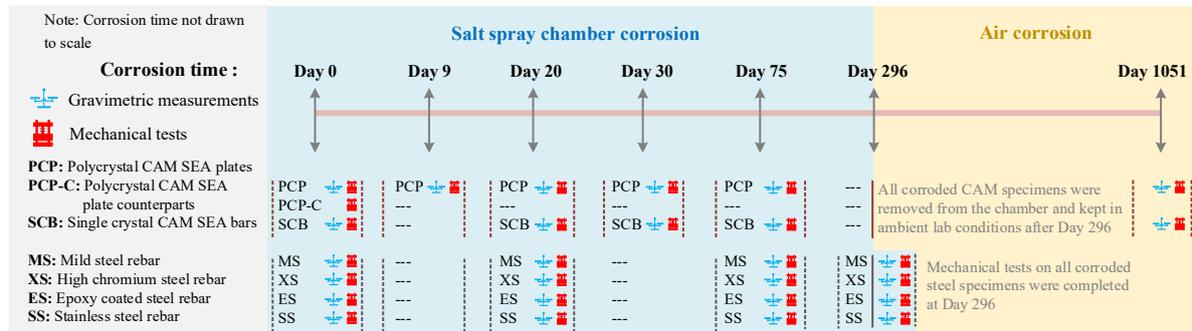
Figure 3-18 Timeline of long-term corrosion and mechanical tests.

The timeline of the long-term corrosion tests and mechanical tests is shown in Figure 3-18. It is noted that the PCP and SCB specimens were taken out of the corrosion chamber at predetermined days, cleaned, mechanically tested without failure, and then put back into the chamber for subsequent corrosion and mechanical testing. On the other hand, the steel rebar specimens that had reached the predetermined days were taken out, cleaned, and monotonically tested until failure. Relevant measurements were collected from those specimens before disposal. The mechanical test results are omitted in this report for brevity and they will be presented in future publications.

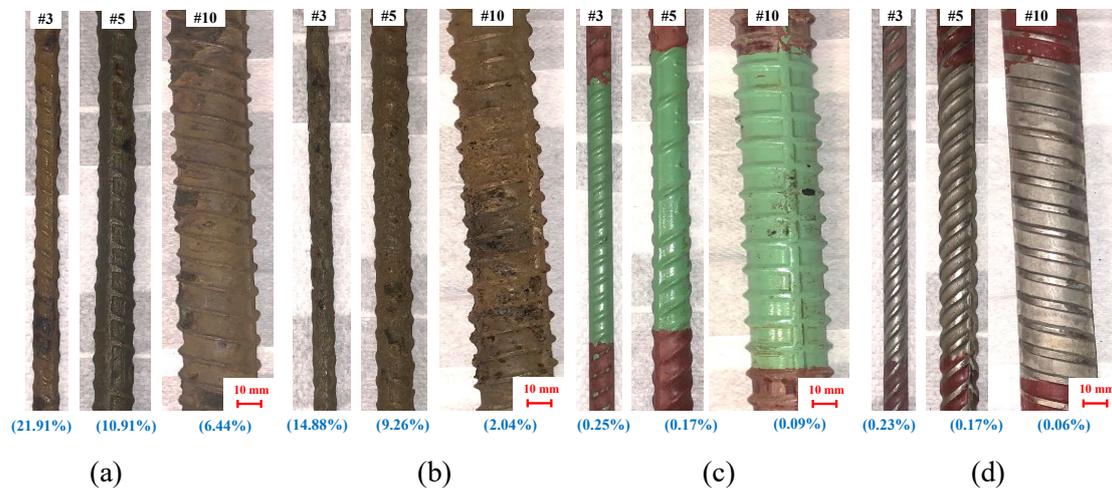
Figure 3-19 Surface conditions of four types of steel rebar after 296 days of corrosion and cleaning (numbers inside parenthesis indicate the mass loss): (a) MS, (b) XS, (c) ES, and (d) SS.

Figure 3-19 shows the typical corrosion surface of four types of steel rebar after 296 days of exposure and cleaning. In the figure under each rebar image, the percentage in the bracket indicates the corresponding mass loss percentage. For brevity, only one typical specimen is selected from each diameter of rebar to show the surface conditions. It is seen in Figure 3-19 that after 296 days of exposure, the MS and XS corroded more severely than ES and SS, furthermore, rebar with smaller diameter showed a higher amount of corrosion than rebar with larger diameter. The corrosion on MS was found to be relatively uniform; however, the corrosion on XS was highly inhomogeneous. Apart from the significant cross-sectional area reduction along the whole specimen, some very deep pits were observed. The interconnected deep pits led to a porous-like corrosion surface on XS. The similar porous surface was also observed for XS by Nachiappan et al. [20]. The ES and SS were both in good surface condition after corrosion, almost no damage could be observed on their surface after cleaning. The epoxy coat on ES was intact and the surface condition of SS had no visible change.

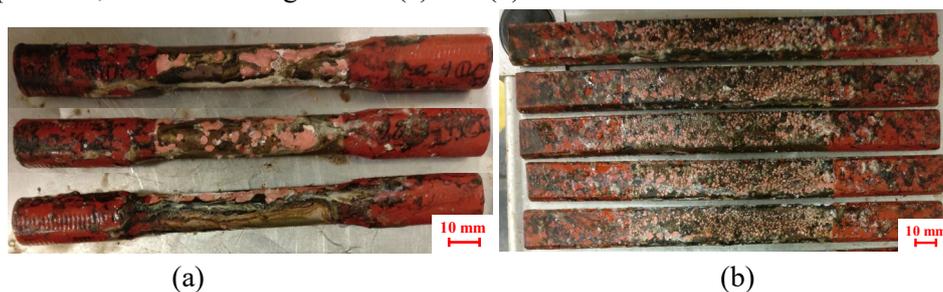
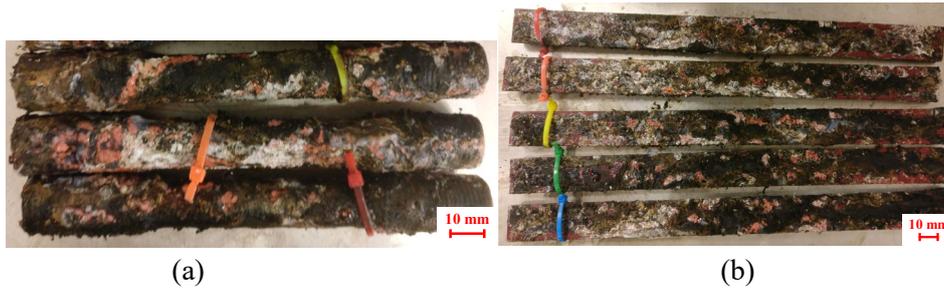
Figure 3-20 Surface conditions of CAM SEA specimens prior to cleaning: (a) SCB after 20 days of exposure, (b) PCP after 20 days of exposure, (c) SCB after 75 days of exposure, and (d) PCP after 75 days of exposure.

Figure 3-20 shows the surface conditions of corroded SCB and PCP before cleaning. The corrosion of both SCB and PCP started with some tiny speckles, some visible dull red speckles were observed after nine days of exposure when the mass loss was approximately 0.15%. Then, the speckled corrosion areas gradually merged into some bigger spots. As shown in Figure 3-20(a) and (b), after 20 days of exposure, at a mass loss of approximately 0.2%, some obvious local corrosion spots were observed, but the spots on PCP were smaller and more uniform than those on SCB. As corrosion progressed, the local spots turned into some deep-black and soft corrosion products. After 75 days of exposure, with at a mass loss of approximately 1%, the surface of both PCP and SCB were covered with cotton-like corrosion products, as shown in Figure 3-20(c) and (d).

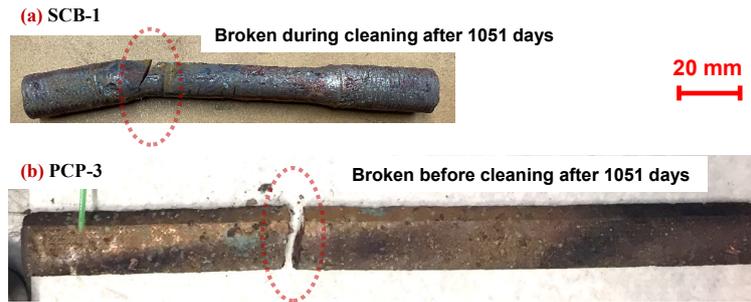
Figure 3-22 Two CAM specimens that broke naturally at 1051 days, (a) SCB-1 and (b) PCP-3.

It is worth noting that two of the specimens broke without an application of external force before (PCP-3) or during (SCB-1) the cleaning at Day 1051 as shown in Figure 3-22. These two specimens were different in that they became very brittle with corrosion and broke without any external force while the rest of the specimens were able to withstand the subsequent cyclic mechanical tests. This problem may be attributed to the local corrosion concentrated on the surface defects or grain boundaries, which grew into intergranular corrosion cracks penetrating through the specimen.

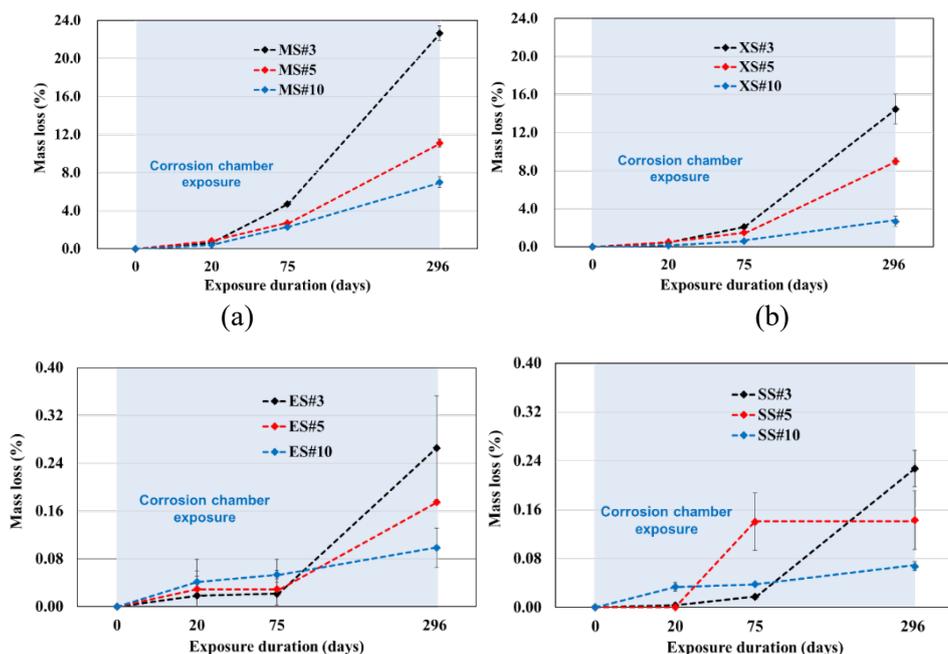
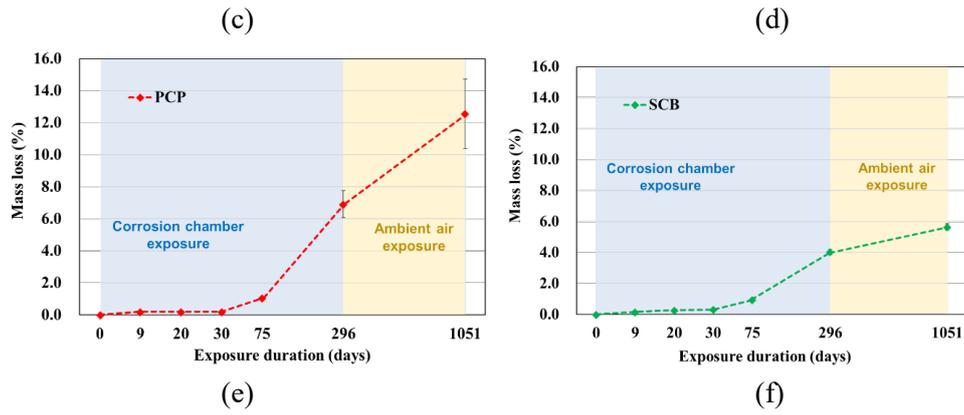
Figure 3-23 Mass loss in long-term corrosion tests: (a) MS, (b) XS, (c) ES, (d) SS, (e) PCP, and (f) SCB.

Figure 3-23 shows the mass loss of CAM SEAs and steel rebar over the testing duration. The exposure duration is not drawn to scale. It should be noted that some specimens (PCP in early corrosion, ES and SS) had negligible mass loss. For these cases, the mass loss is taken zero. It is seen that during the salt spray exposure up to 296 days, the MS shows the highest mass loss, but its mass loss shows large dependence on the rebar diameter. The mass loss of #3 MS is around three times that of #10 MS. The mass loss of XS is smaller than MS but it shows similar diameter dependency. The mass loss of #3 XS is around 60% of #3 MS. The ES and SS showed negligible mass loss (around 1/100 of MS and XS) throughout the testing program, which agrees with the visual observation in Figure 3-20. The large scatter in the test data is due to measurement error associated with small changes in the mass of the rebar. An apparent increase in the mass loss of #3 ES after 75 days should be interpreted with caution due to large error associated with the measurements and very low mass loss in ES and SS specimens over the entire period of testing. The mass loss of PCP is close to the #3 XS and is around twice that of the SCB. During corrosion in the ambient laboratory conditions from 296 days to 1051 days, the mass loss of PCP is almost doubled (increased by 82%) while the SCB increased by 40%. The average mass loss of six types of specimens at 296 days of exposure is normalized by the mean value of #3 MS and compared in Figure 3-24. It is seen that the mass loss of PCP is about the same as that of #10 MS and it is around 1/3 of the #3 MS. The mass loss percent of SCB has been observed to be around 1/5 of #3 MS.

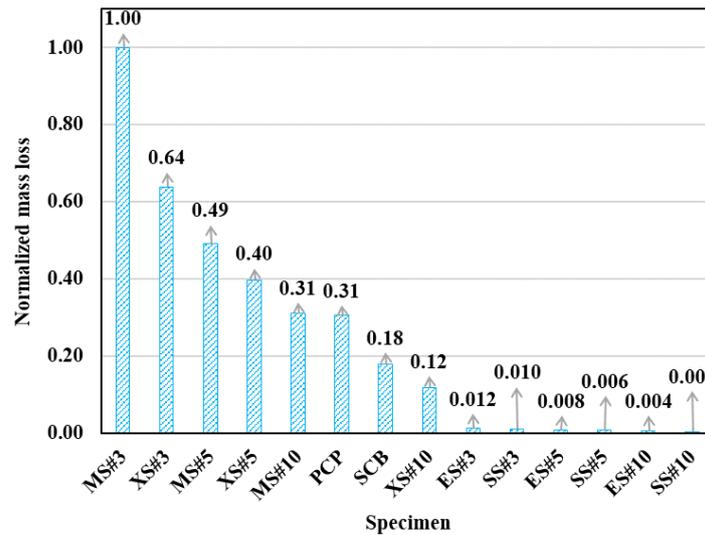
Figure 3-24 Ranked normalized mass loss of PCP, SCB, MS, XS, ES and SS after 296 days of exposure.

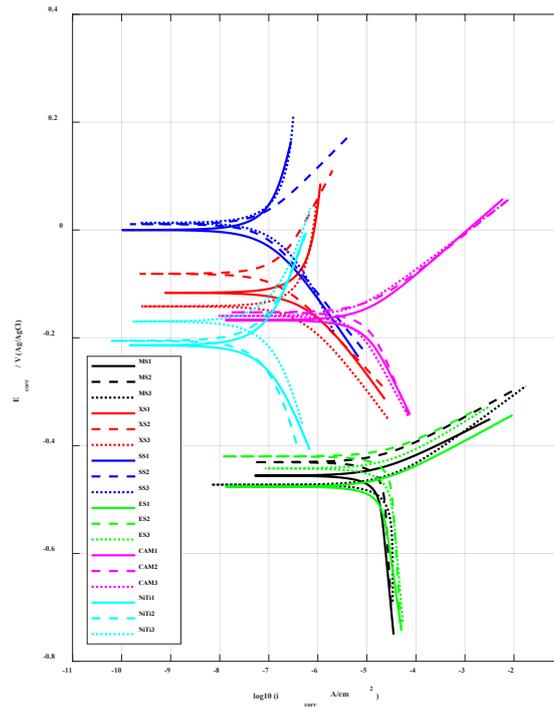
Figure 3-25 Potentiodynamic polarization curves of MS, XS, ES, SS, CAM and NiTi, where E_{corr} denotes the open corrosion potential, and i_{corr} denotes the corrosion current density.

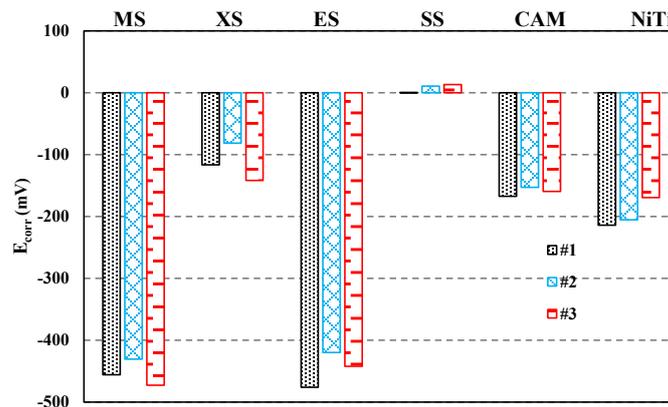
Figure 3-26 Open corrosion potential of MS, XS, ES, SS, CAM and NiTi.

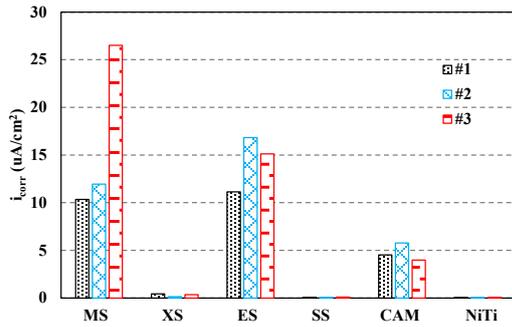
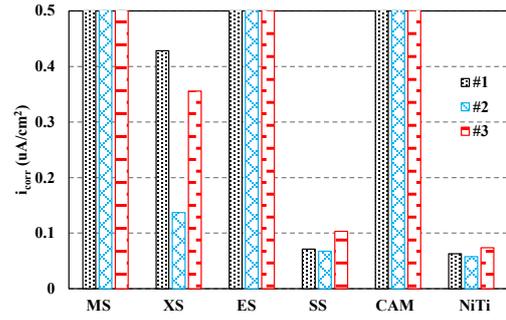
(a) Corrosion current density, i_{corr}

(b) Corrosion current density, i_{corr} within the range from 0-0.5 $\mu\text{A}/\text{cm}^2$

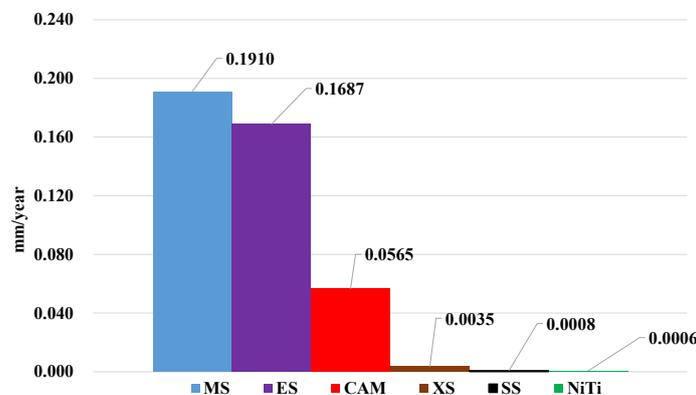
Figure 3-28 Corrosion rate of MS, XS, ES, SS, CAM and NiTi.

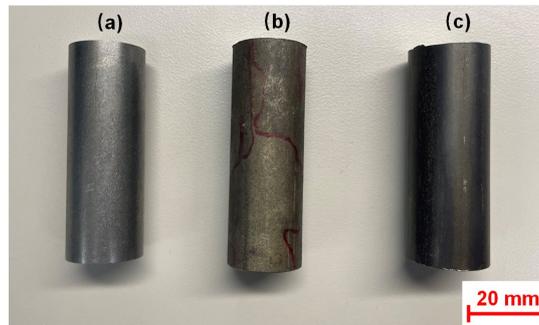
Figure 3-29 Samples used for machinability tests: (a) mild steel, (b) CAM and (c) NiTi.

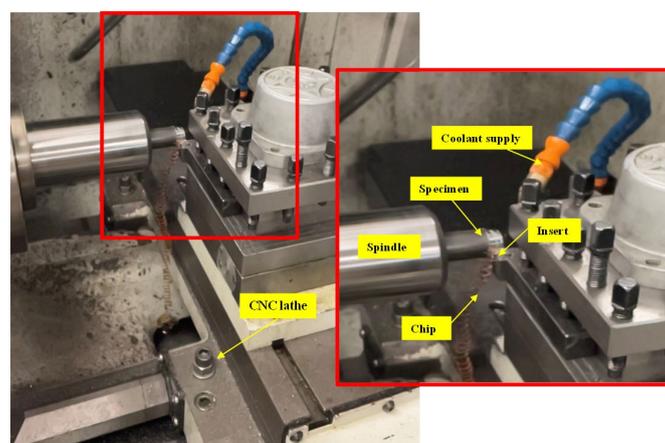
Figure 3-30 Setup for machinability tests.

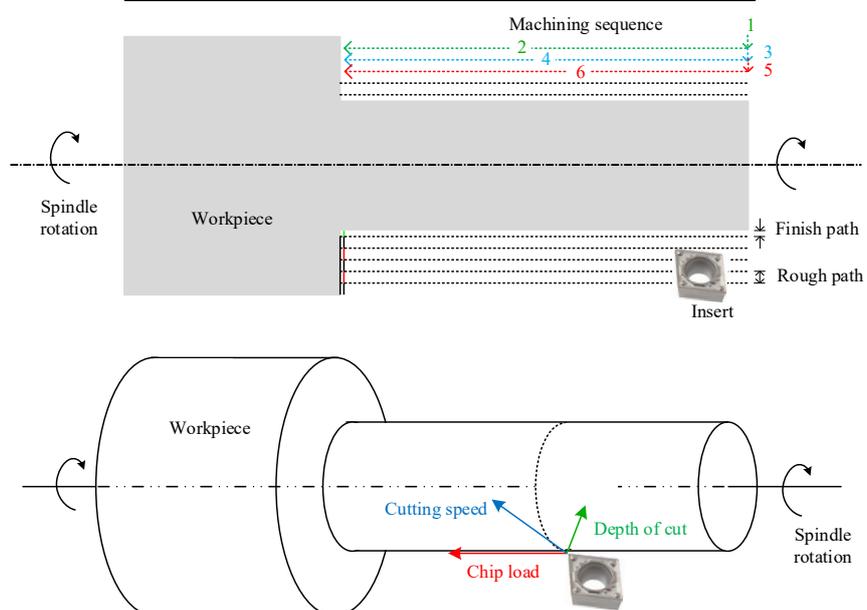
Figure 3-31 Protocol used in machinability tests.

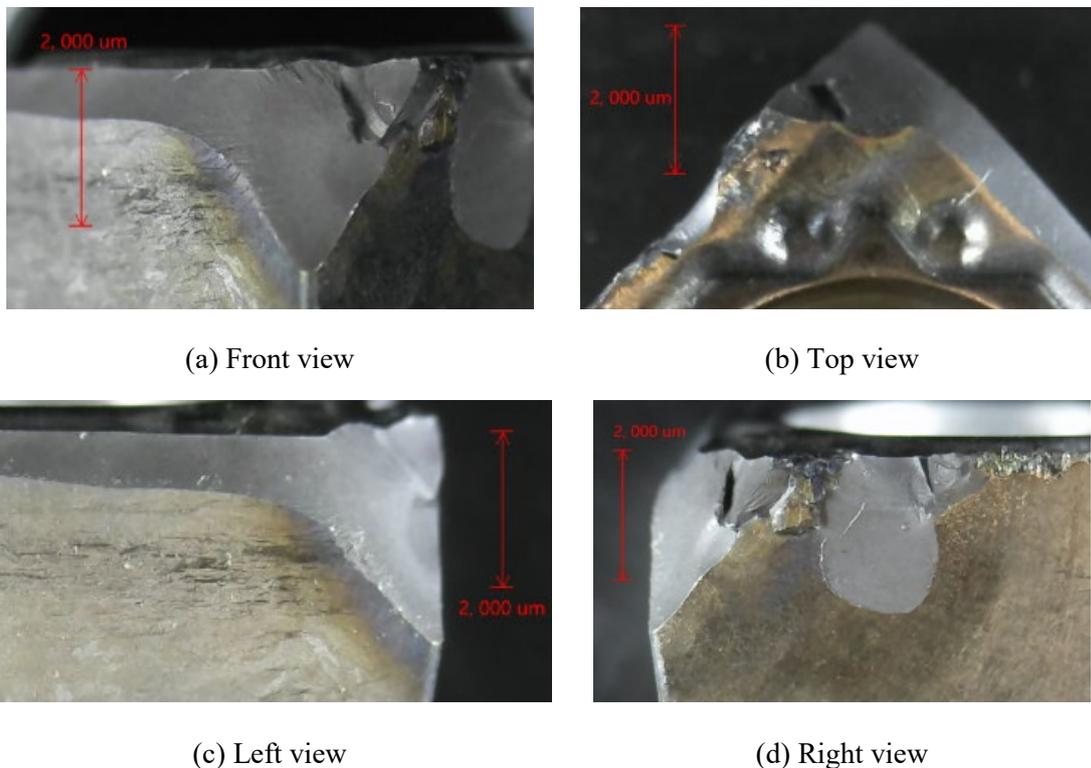
Figure 3-33 Condition of I-NT-1 after machining NT-1 at $V_c=60.96$ m/min, (a) front view, (b) top view, (c) left view and (d) right view.

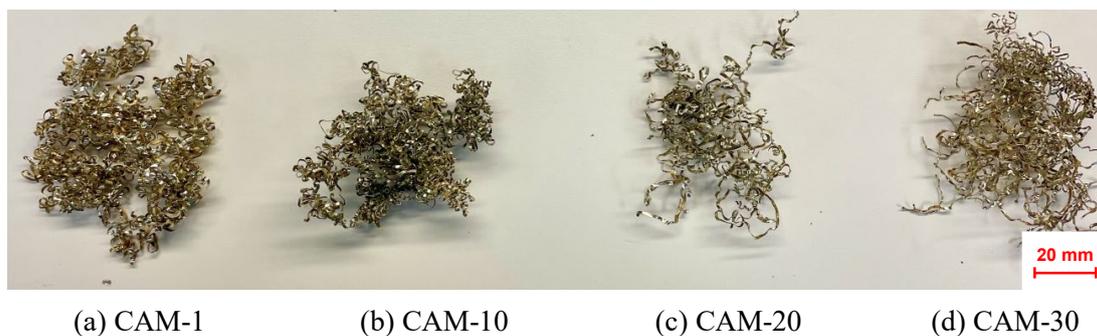
Figure 3-34 Chips produced during machining CAM SEA, (a) CAM-1, (b) CAM-10, (c) CAM-20 and (d) CAM-30.

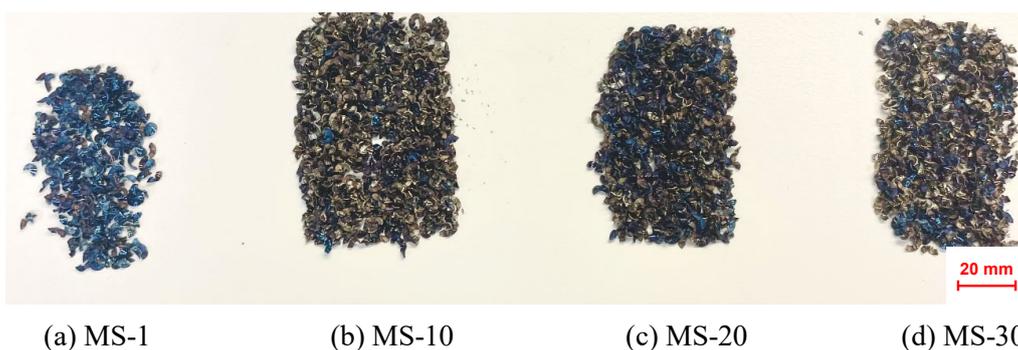
Figure 3-35 Chips produced during machining mild steel, (a) MS-1, (b) MS-10, (d) MS-20, and (d) MS-30.

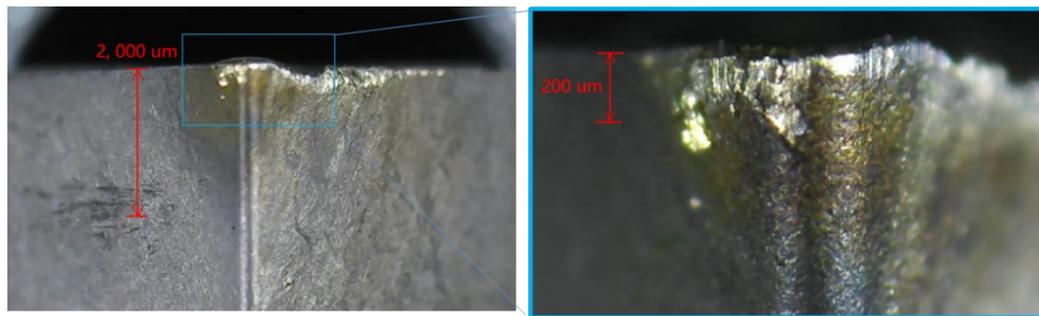
Figure 3-36 Condition of I-CM-30 at $V_c = 60.96$ m/min after machining 30 continuous workpieces.

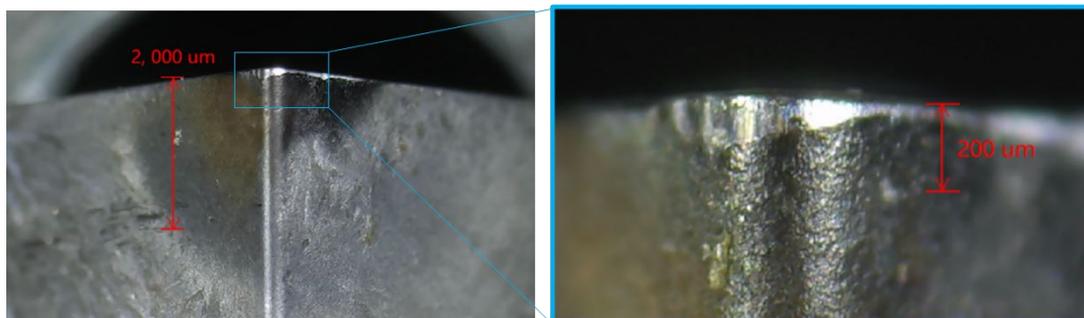
Figure 3-37 Condition of I-MS-30 at $V_c = 60.96$ m/min, after machining 30 continuous workpieces.

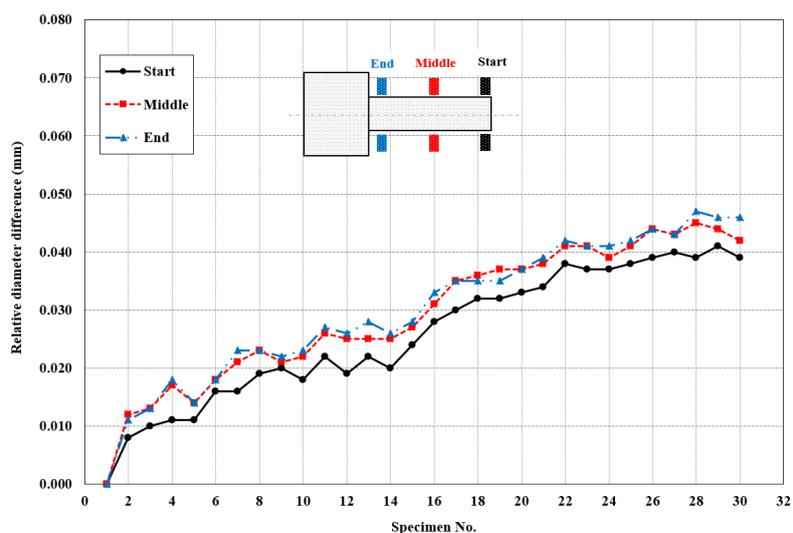
Figure 3-38 Change in diameter of 30 mild steel specimens after machining.

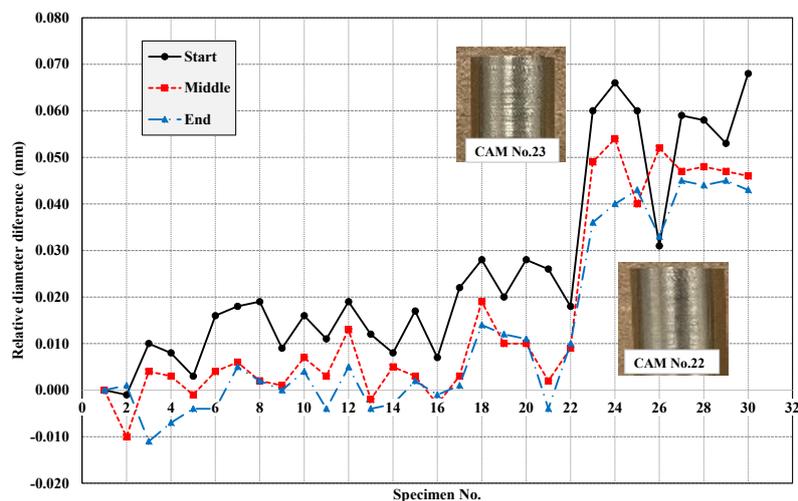
Figure 3-39 Change in diameter of 30 Cu-Al-Mn specimens after machining.

machining of Cu-Al-Mn showed a larger scatter in diameter; however, the final increase of diameter was only around 10 μm bigger than that of mild steel.

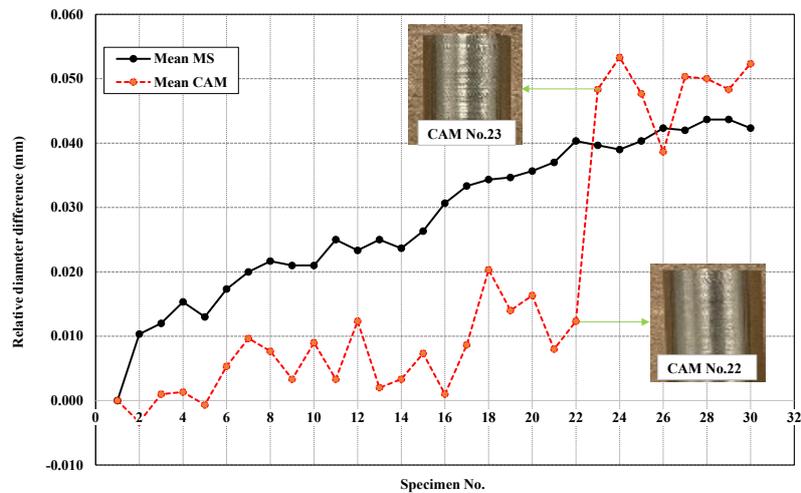
Figure 3-40 Mean value of diameter difference of Cu-Al-Mn and mild steel.

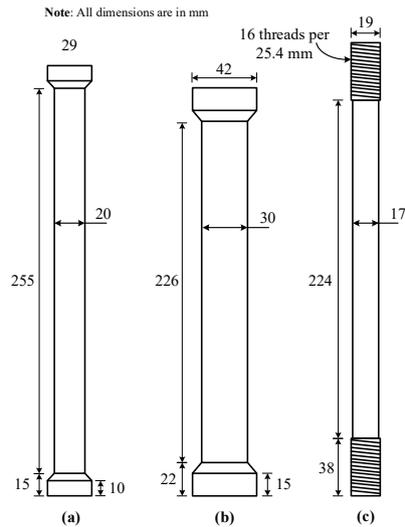
Figure 3-41 Dimensions of headed end CAM SEA bars for coupling tests: (a) 20 mm diameter headed bar, (b) 30 mm diameter headed bar, and (c) 20 mm diameter threaded bar.
