Material Characteristics of Cu-Based Superelastic Alloys for Applications in Bridge Columns to Improve Seismic Performance

Final Report for
NCHRP IDEA Project 210

Prepared by:
Bora Gencturk
University of Southern California
M. Saiid Saiidi
Infrastructure Innovation, LLC

May 2022

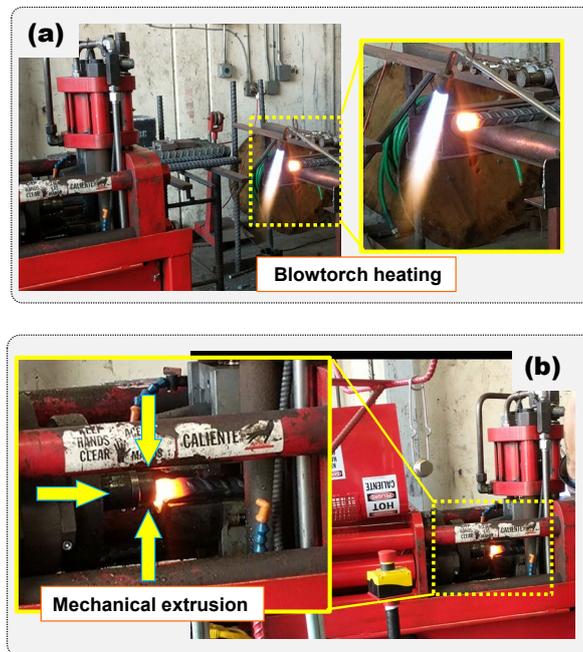
Figure 3-42 Pictures from heading process: (a) heating specimens by blowtorch, (b) heading specimens using a mechanical extruder.

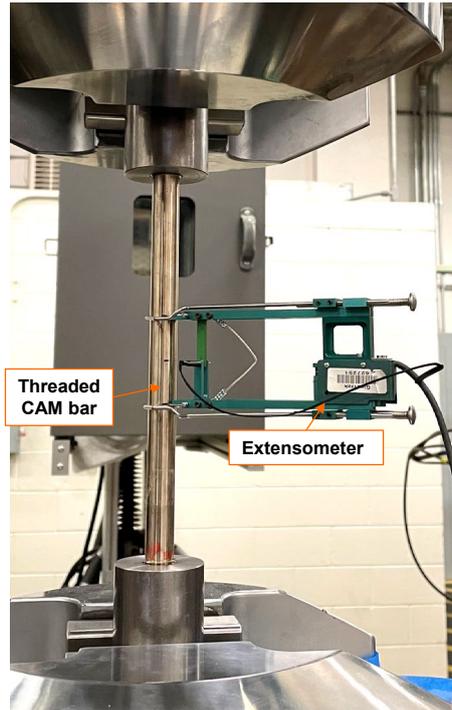
Figure 3-43 Setup for single coupling tests on threaded CAM SEA bar.

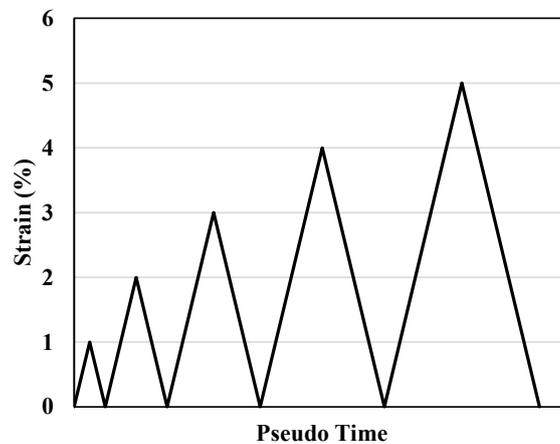
Figure 3-44 Loading protocols used for training CAM SEA bars in coupling tests.

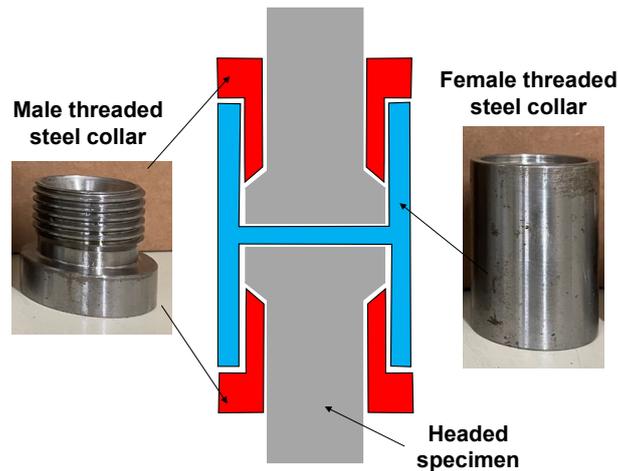
Figure 3-45 Mechanical coupler used to connect headed specimens.

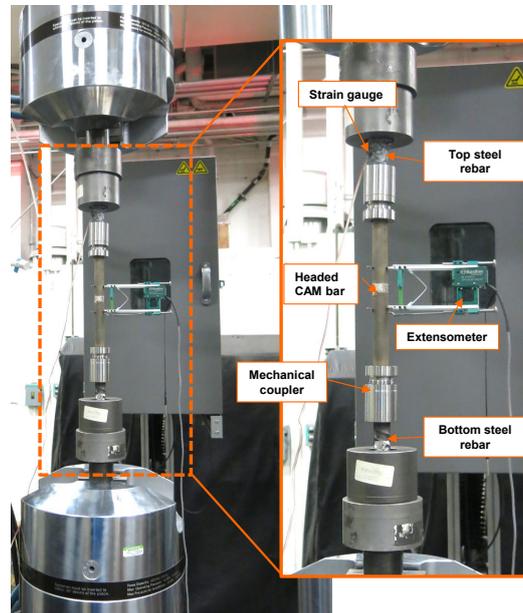
Figure 3-46 Setup for single coupling tests on headed CAM SEA bars.

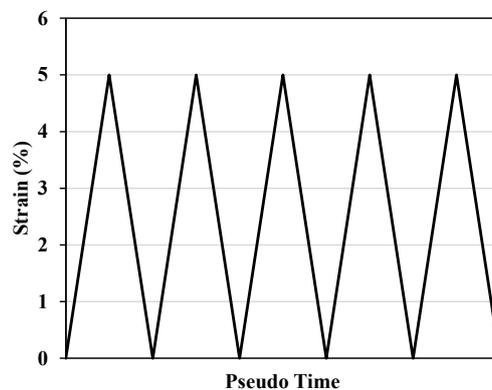
Figure 3-47 Constant amplitude cyclic tensile loading protocol for coupling tests.

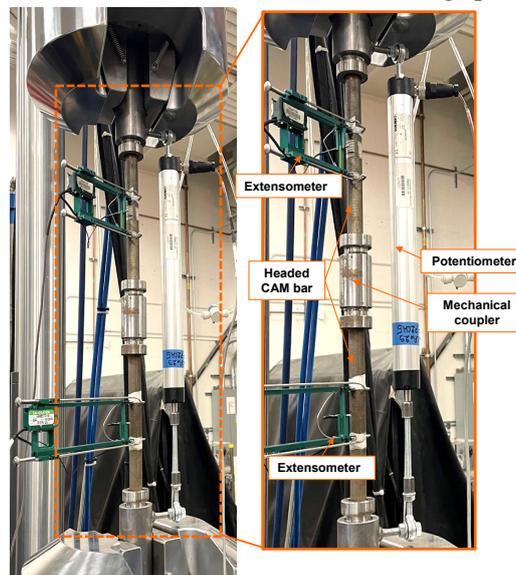
Figure 3-48 Test setup for double coupling tests on headed CAM SEA bars.

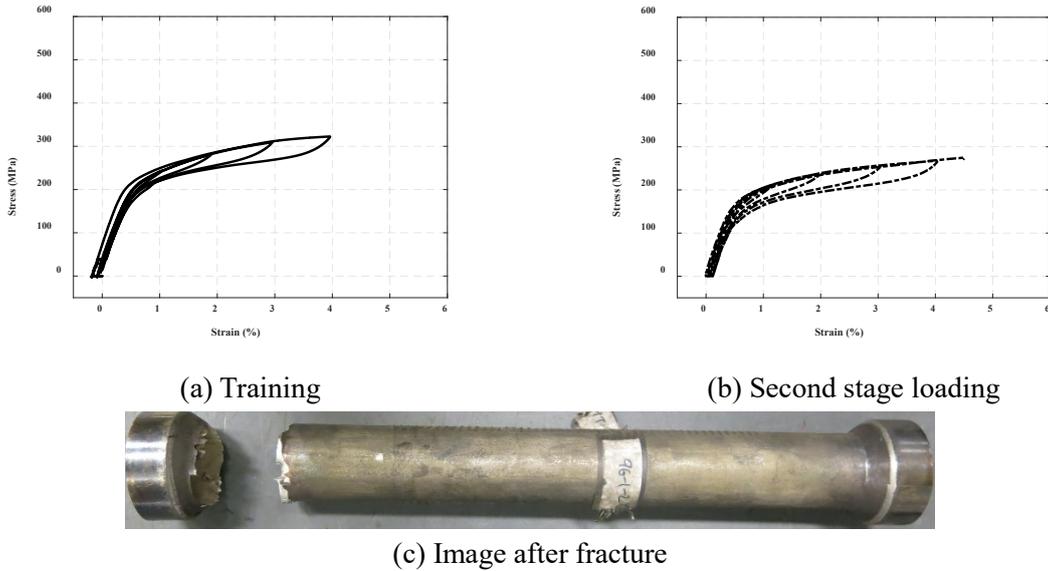
Figure 3-51 Results of HC30-1: (a) first training, (b) second stage loading, and (c) specimen after fracture.

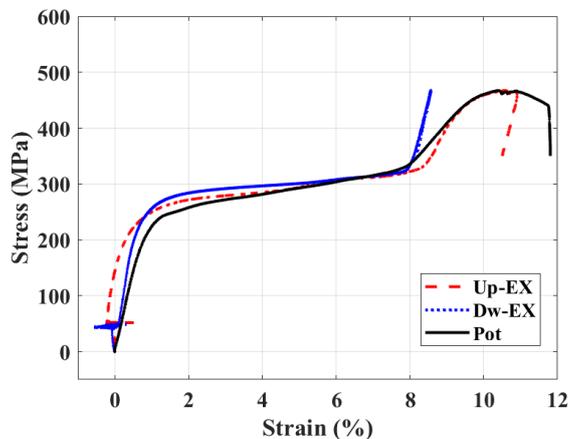
Figure 3-52 Double coupling test results of HC20-3 and HC20-4. Up Ex and Dw Ex denote the results respectively collected from the upper extensometer installed on HC20-3 and lower extensometer installed on HC20-4. Pot denotes the results collected by the linear potentiometer.

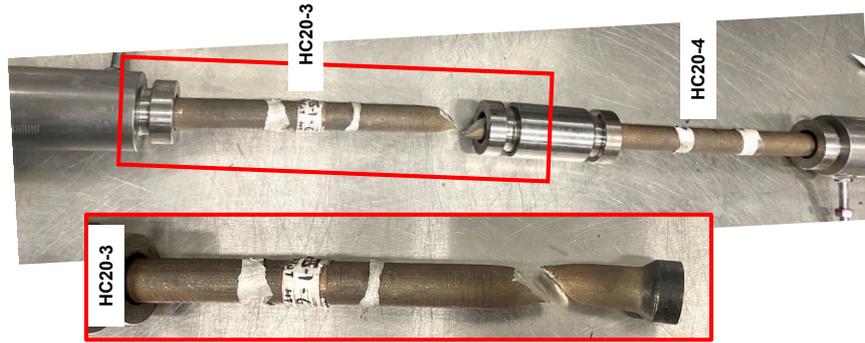
Figure 3-53 After fracture image of double coupling test specimens HC20-3 and HC20-4.

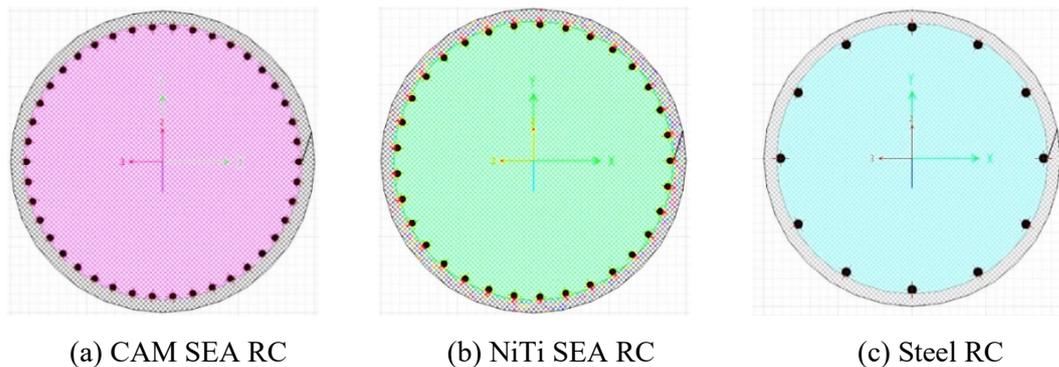
Figure 3-54 Sectional configuration of designed columns: (a) CAM SEA RC, (b) NiTi SEA RC, and (c) steel RC.

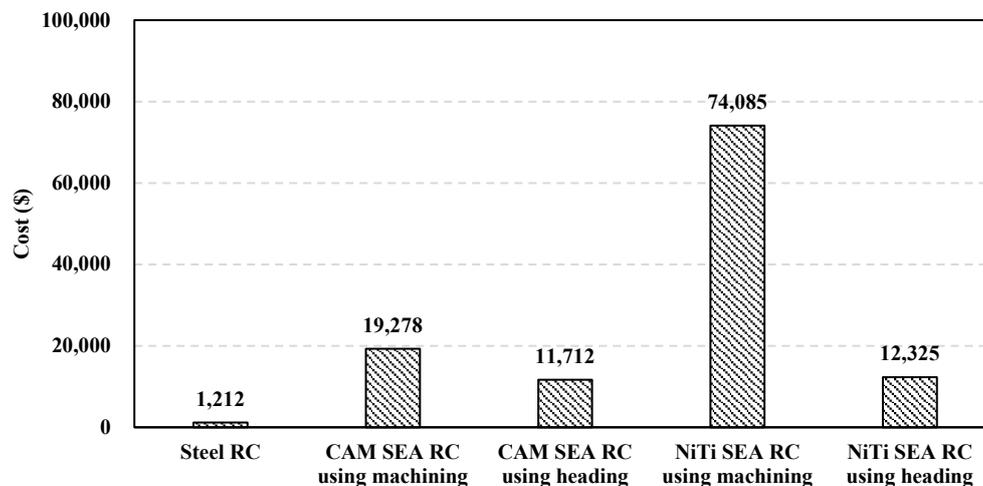
Figure 3-59 Cost comparison of steel RC, CAM SEA RC, and NiTi SEA RC.
