Rail Vehicle Bearing Defects Detection

Final Report for
Safety IDEA Project 16

Prepared by:
Dr. Yu-Jiang Zhang
ENSCO, Inc.
Springfield, VA

October 2011

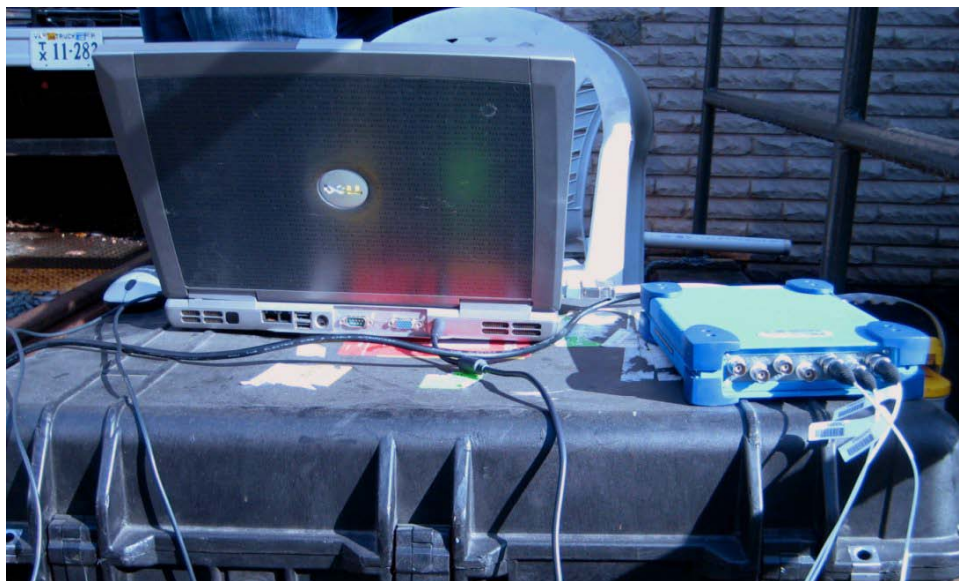
FIGURE 2 Data acquisition equipment.

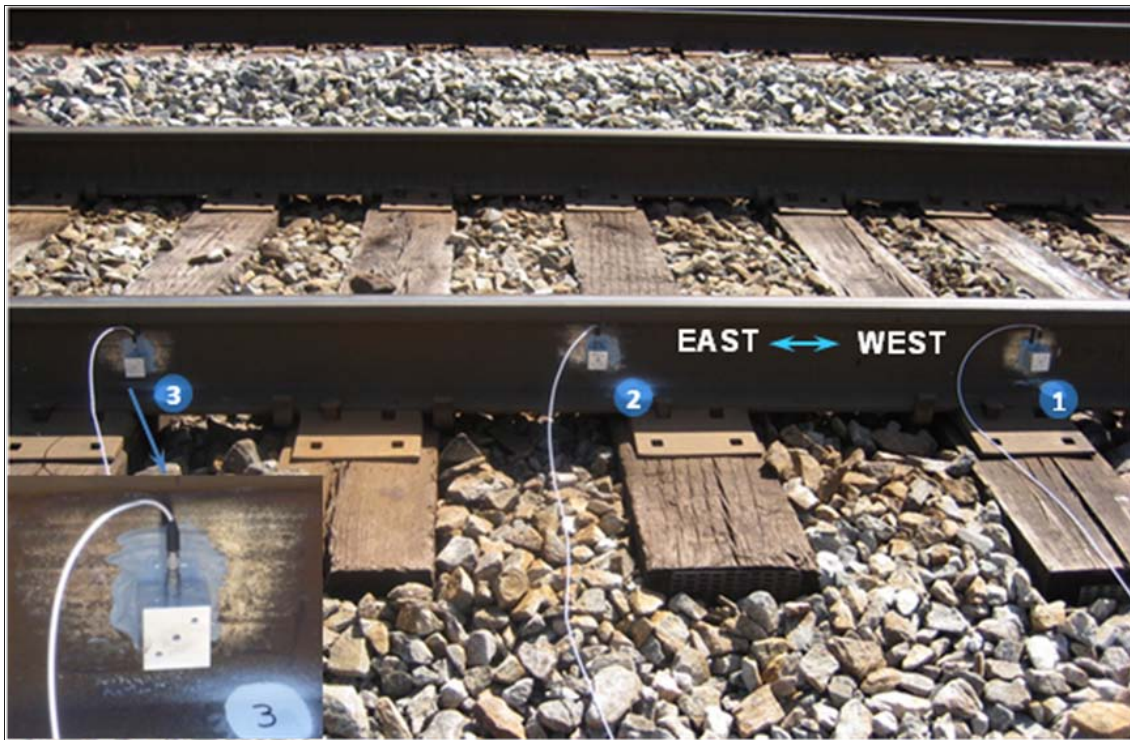
FIGURE 9 Installation of accelerometers on rail.

Three high-frequency PCB 353B18 accelerometers were fixed on the north rail, designated as channels 1, 2 and 3, from west to east (FIGURE 9). Each accelerometer was stud-mounted on an aluminum block which was affixed to the rail web using a two-part epoxy glue. Uniaxial accelerometers were used since only vertical signals are of interest to this project.

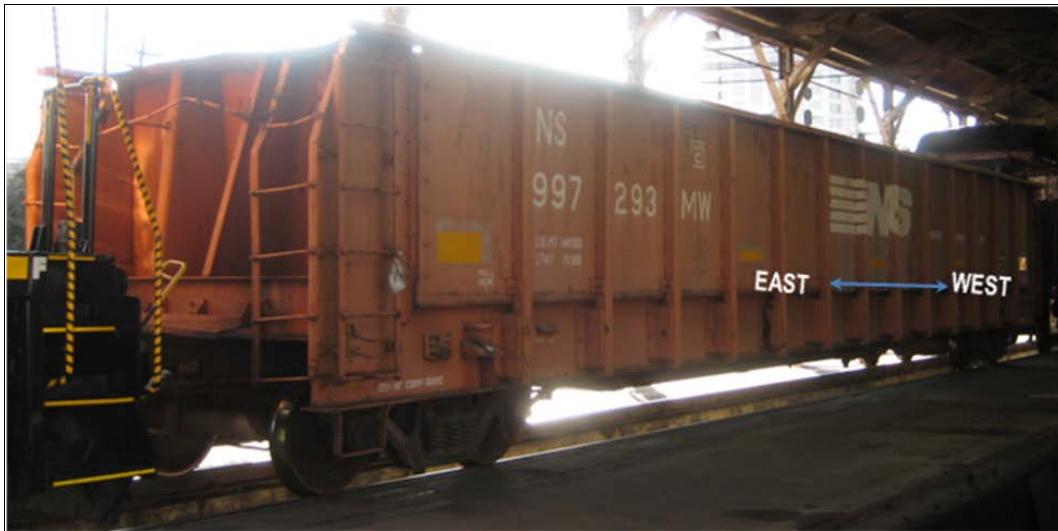
FIGURE 10 Test car.

The gondola car was fully loaded with new wood ties, which helps generate stronger defective bearing acceleration signals. The test wheel set with the known defective bearing was off an in-service, 70-ton hopper car. Before the wheel set was removed, the loaded hopper car passed the TADS site several times. The latest pass was on September 16, 2007. The bearing was identified to have cup defects three times, non-defects once and growler (multiple, large cup defects) once. The average speed of the car passing the TADS site was approximately 40 mph.

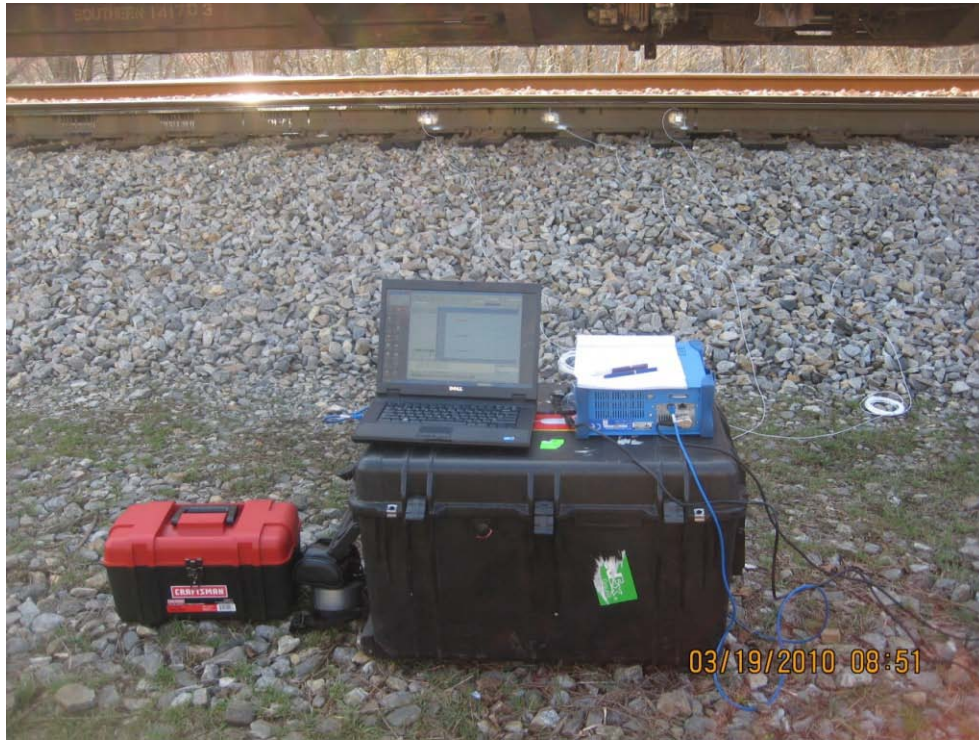
FIGURE 13 Wayside data collection system.

The other OROS unit was set up on the wayside as shown in FIGURE 13. The data collection equipment was set up on the north side of test rack. The position provided sufficient sight distance in both east and west directions. A portable generator was used to supply power to the wayside data collection system. An engineer from NS served as the watch person during the accelerometer installation and field test. Another NS engineer riding the test train coordinated the test preparation and field test.

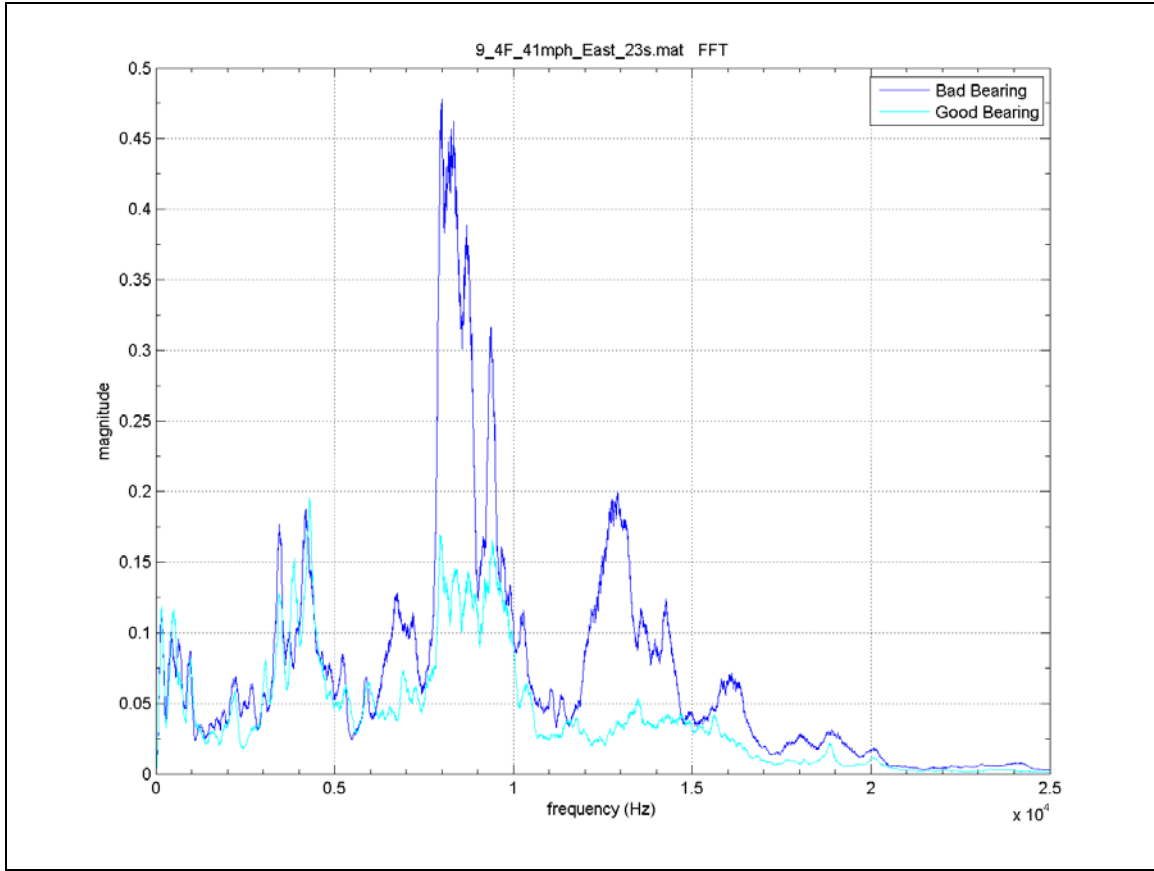
The power spectral density for the same piece of data is plotted in FIGURE 18. The dark blue line is the PSD for the defective bearing. It indicates that the bearing defect vibrations generated the highest power in the

frequency range between 7 and 10 kHz. Some power concentration can also be seen around 13 kHz. These frequencies provide useful references for data analysis in the next stage.

FIGURE 18 PSD for defective bearing from onboard data for test run 4F.

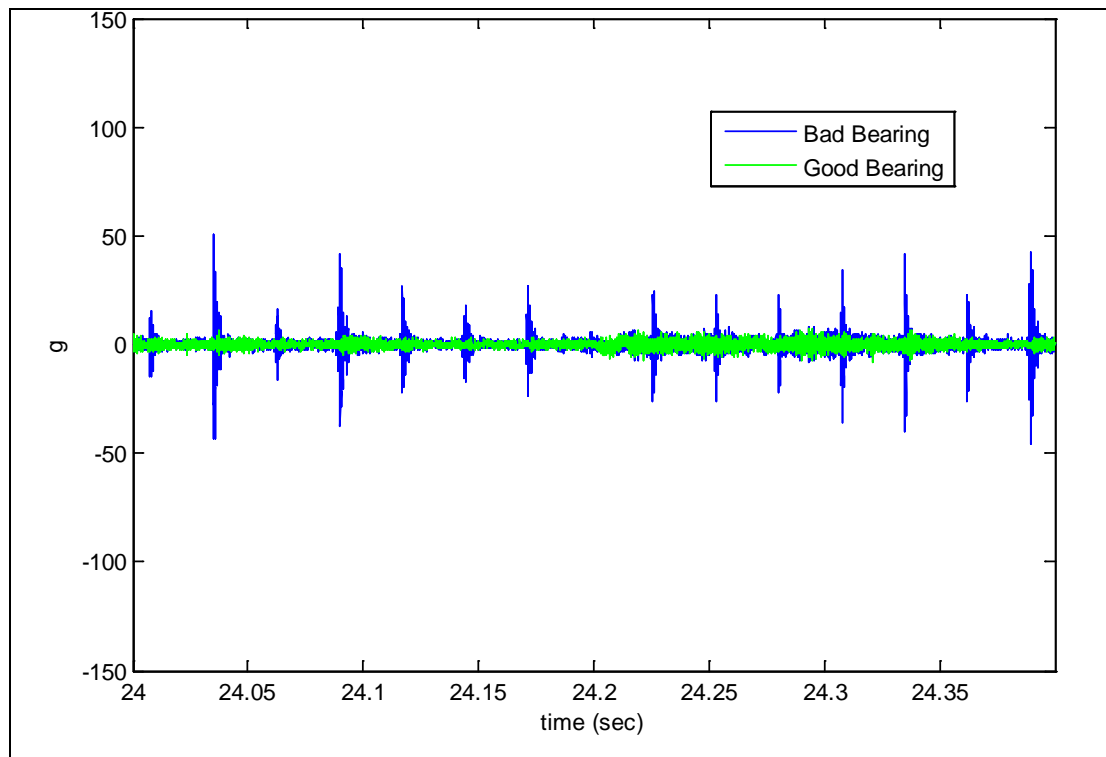
(a) Test Run 2F at Speed 49 mph

(b) Test Run 9F at Speed 22 mph

FIGURE 22 Comparison of time history of different speeds.

The effects of car speeds are obvious as expected. FIGURE 22 shows the comparison of the time history from on two onboard accelerometers for test runs 2F and 9F. The nominal speeds for the two test runs are 49 mph and 22 mph, respectively. From the acceleration time history, it is readily seen that the signals are stronger at higher speed. It is also noted that the strength of the background noise, i.e., the acceleration signals of the good bearing in this case, increased proportionally.
