**Field Validation of Inspection Gauges for Wheel Climb Safety
at Switch Points**

Final Report for Rail
Safety IDEA Project 28

Prepared by:
Dr. Allan M. Zarembski
University of Delaware

November 2016

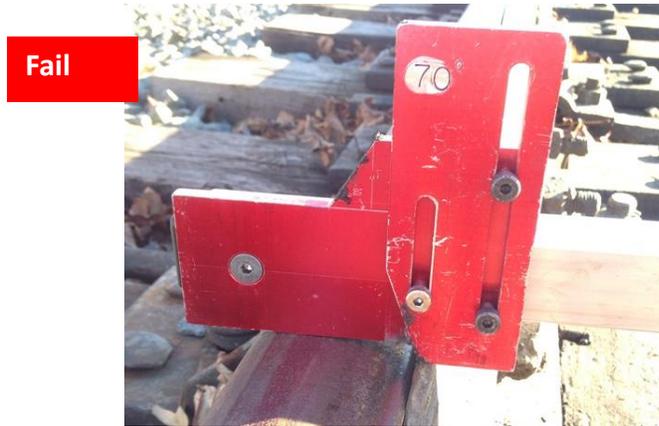
Figure 5: Severely worn wheel profile gauge (severe profile gauge) (courtesy of LIRR).

This gauge gives an indication of the potential for wheel climb derailment for severely worn (but non-condemnable) wheel profiles. It can be used to identify gapping or broken points or top-worn stock rails that can, when combined with a severely worn wheel flange, result in a wheel climb derailment. The gauge has a slider mechanism (see instructions in Appendix A), which is used to determine if the gauge will catch on the top of the switch point, indicating a potential wheel climb condition (“fail” condition as shown in Figure 5) or whether the slider on the gauge slides down the gage face of the switch point, indicating a “pass” condition (Figure 6). The gauge is designed with a 70° gage face angle that appears to correspond to unsafe severely worn wheel conditions.

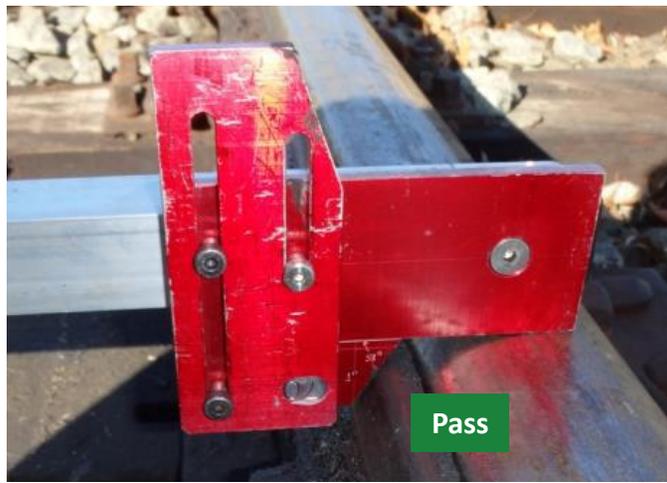
Figure 7: Gage face wear angle gauge (courtesy of LIRR).

This gauge checks the gage face wear angle of the switch point and the potential for wheel climb, particularly for high L/V conditions. The gage is designed with a 32° gage face angle (58° if the complementary angle is used); so that if the switch point’s gage-face angle is greater than 32° and the switch condition is safe otherwise, the switch is unsafe. Figure 7 shows a safe condition using this gauge.

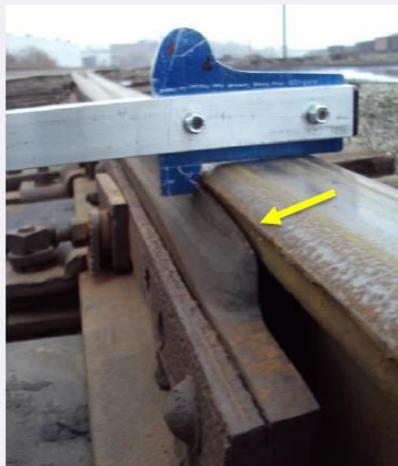
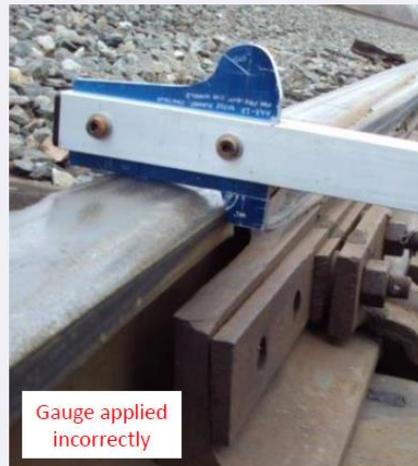
When evaluating a switch point that has been ground back

Apply gauges starting at the ground-back tip (yellow arrow)

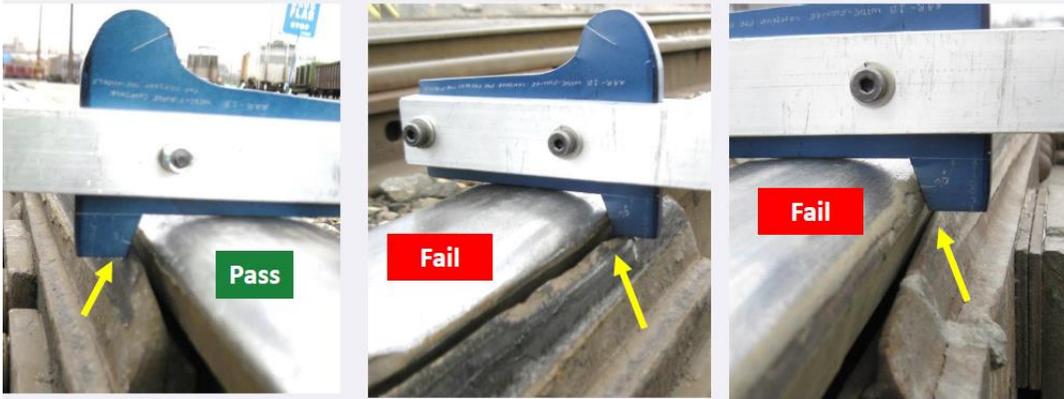
G1 - Chipped point

Apply this gauge where the point is worn or broken. This is typically within 24 inches of the tip, but could be anywhere along the point.

- If the bottom edge slides over the top of a broken or worn point, **Fail**
- Otherwise, **Pass**

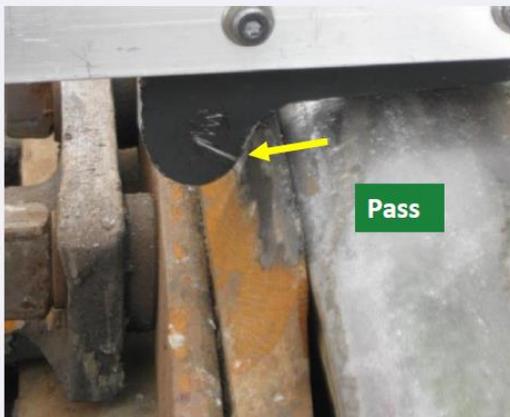
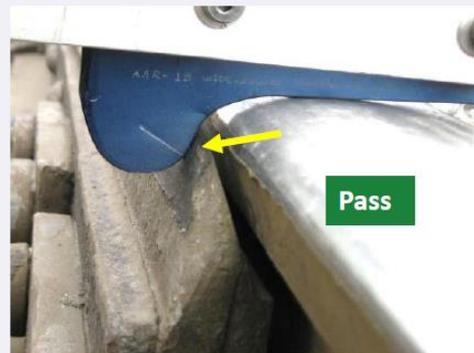
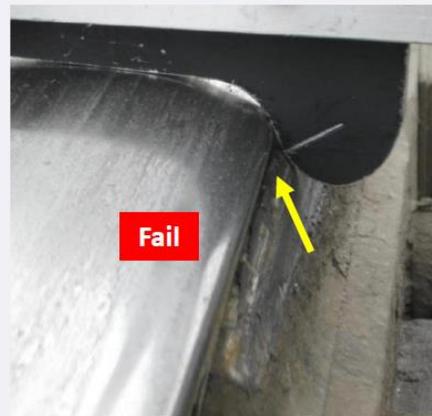
G2 - AAR 1B wheel contact

Apply this gauge where the point is worn or broken. This is typically within 24 inches of the tip, but could be anywhere along the point.

If contact with the switch point is...

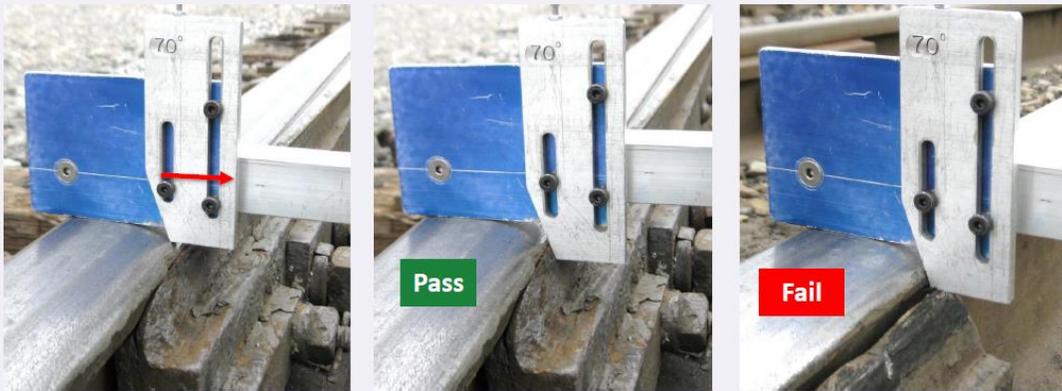
G3 - Severely worn wheel profile

Apply this gauge within the first inch of the tip of the point, or where wheel flange contact is first evident. Start with the 70° slider on top of the stock rail, then slowly shift the gauge until the slider slides off the stock rail.

- If the slider slides down the gage face of the switch point, **Pass**
- If the corner of the slider lands on top of the switch point, **Fail**

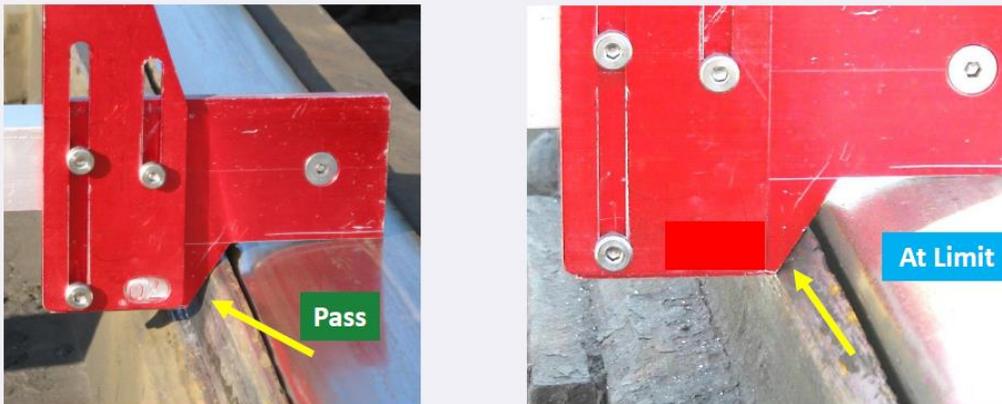
G4 - Gage-face wear angle

Apply this gauge anywhere along the length of the point where it is worn.

If the switch point gage-face angle is...
