# **AUTONOMOUS DETECTION OF COMPRESSED AIR LEAKS ON TRAINS**

Final Report for  
Rail Safety IDEA Project 48

Prepared by:  
Christopher Stoos  
Southwest Research Institute

***September 2022***

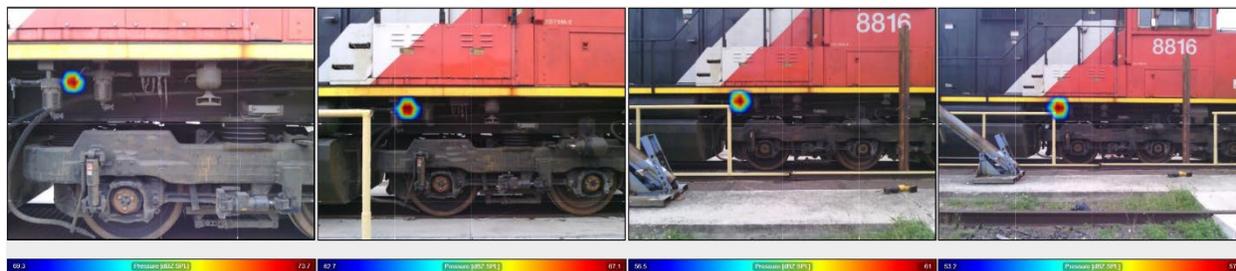
**Figure ES-1. Air Leak at 3.0, 4.5, 6.0, and 7.5 Meter Distances**

During initial testing, the optimal settings to detect air leaks while mitigating other sounds were determined. A versatile stand to support the SV600 sensors and cameras was built and various positions of the sensors in relation to the track were investigated (Figure ES-1). It was determined that air leaks were best captured with a minimum decibel threshold of 45dB and a frequency range of 30kHz-45kHz.

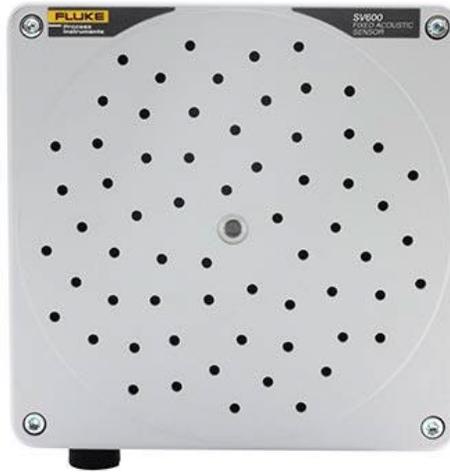
**FIGURE 1. Fluke SV600 Fixed Acoustic Imager**

The Fluke SV600 (Figure 1) is a commercially available fixed acoustic imager that is designed to enable users to detect, locate, and visualize sounds at specified frequency and decibel ranges. It is powered through power over ethernet (PoE) and allows for communication through a standard ethernet cable, providing a html based user interface. This allows significant customization options to narrow the detection range, eliminating non-air leak related sounds as much as possible which was needed for this project.

Through discussions between SwRI, Fluke, and Sorama it was determined that the Fluke SV600 Fixed Acoustic Imager (Figure 1) would be the ideal sensor option for this prototype development project. Table 1 shows the technical specifications of the SV600, which is a small form factor microphone array with an integrated camera that functions at the frequencies needed for compressed air leak detection (30-45kHz).

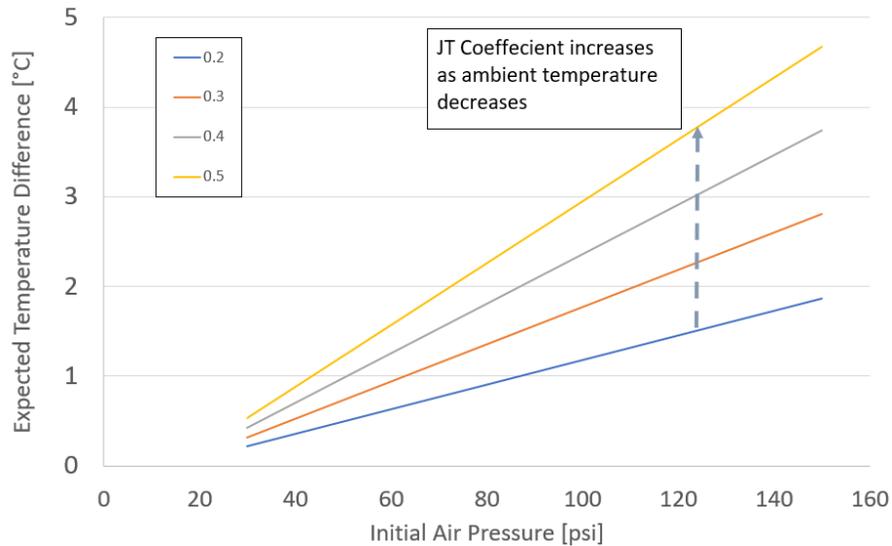
**FIGURE 2. Joule-Thompson Effect Cooling at Various JT Coefficients**

The visual spectrum camera was used to allow for better part identification and leak location clarity, it also allowed for viewing behind the sound overlay map provided by the Fluke SV600 Sensor output. As mentioned above, the thermal imaging camera was being used to provide additional information in possible leak detection. Due to the Joule-Thomson effect, compressed air leaks create a cooling effect. This cooling effect varies based on initial pressure and ambient temperature, as shown in Figure 2. As the initial pressure of the air increases, the change in temperature becomes more severe [3]. Additionally, that temperature difference also becomes greater as the ambient temperature drops because it increases the Joule-Thompson coefficient.

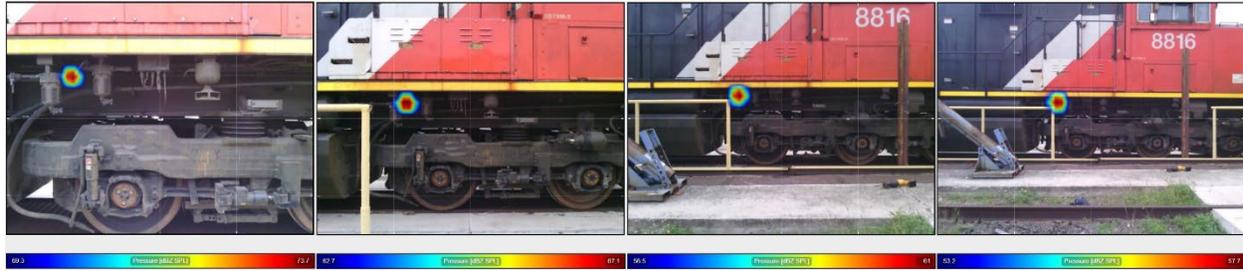
**FIGURE 3. Air Leak at 3.0, 4.5, 6.0, and 7.5 Meter Distances**

Once the Fluke SV600 sensors arrived at SwRI, one sensor was sent to the machine learning team to get familiar with sensor and its capabilities and the other was devoted to initial testing at the Locomotive Technology Center. During initial testing, air leaks were induced on a locomotive at multiple locations. As seen in Figure 3, the sensor was

capable of detecting a compressed air leak with the locomotive engine running in self load at Notch 3 at various distances. The sensor height was set at 1.2 meters above the rail and the sensor distance was varied.

In Figure 3, one thing that isn't noted is that there is an additional air leak that is not being detected using the auto-range for the decibel settings on the sensor. The decibel minimum was tested at various levels to determine where the bottom cutoff was to detect smaller compressed air leaks. In Figure 4 the unit was auto-ranged with a minimum of 51 decibels. The second air leak was not detected at all with this minimum setting.

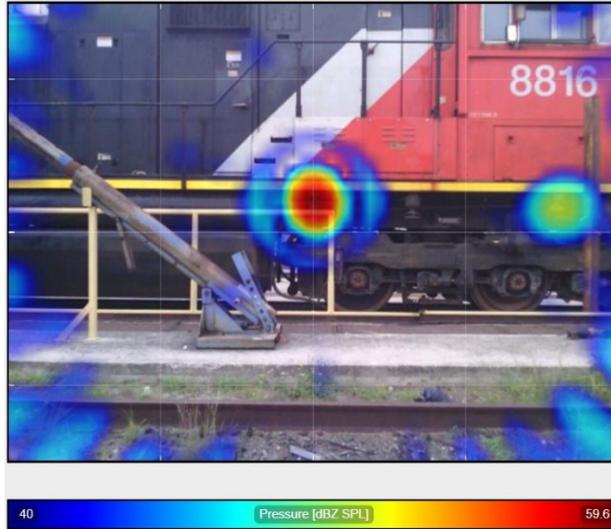
**FIGURE 5. Compressed Air Leaks at 40dB Minimum Detection Threshold**

In Figure 5, the minimum range was set to 40 decibels, which is slightly louder than a whisper. The second leak becomes obvious in this range but note that there were significant other detections displayed on the sound map with this minimum which can be seen at the edge of the field of view below.

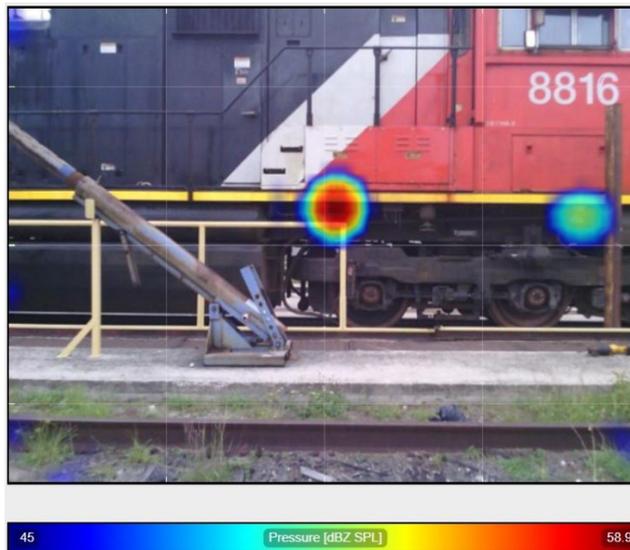
**FIGURE 6. Compressed Air Leaks at 45dB Minimum Detection Threshold**

The minimum detection threshold was then set to 45 decibels (Figure 6). This minimized the additional detections and gave a good, clean detection signal for both air leaks in the image. While various other settings were tested throughout the course of the development, a 45dB minimum detection limit was consistently shown to be the optimal setting.

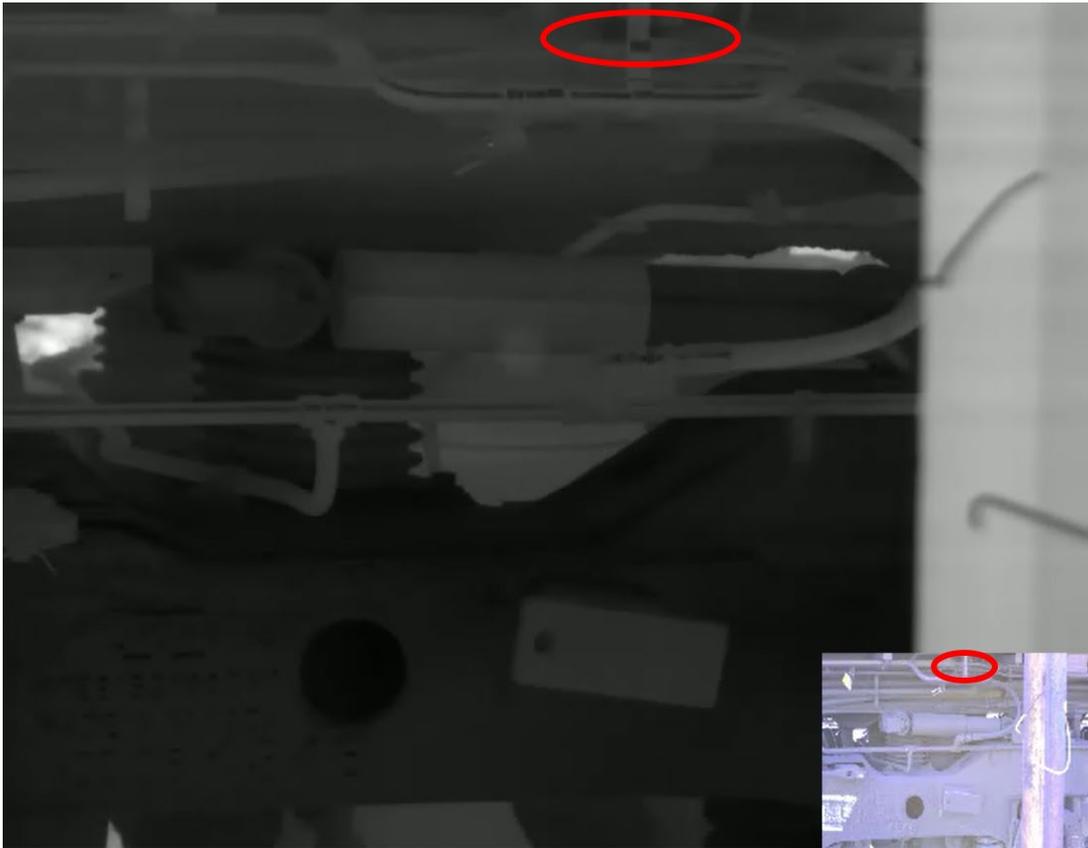
**FIGURE 7. Compressed Air Leak on Piping Using Thermal and Visual Spectrum Cameras**

Images produced by both the thermal and visual spectrum cameras, showing air leaks in piping and a drain valve, are shown in Figures 7 and 8. The larger photo in each figure is the thermal image; the inset photo is the visual spectrum image. In each photo the leak location, indicated by a circle, shows to be slightly cooler than the surrounding area. Figure 7 shows a significant cooling of the clamp on which the leak was blowing; behind the clamp, note a dark area which is the leaking pipe fitting.

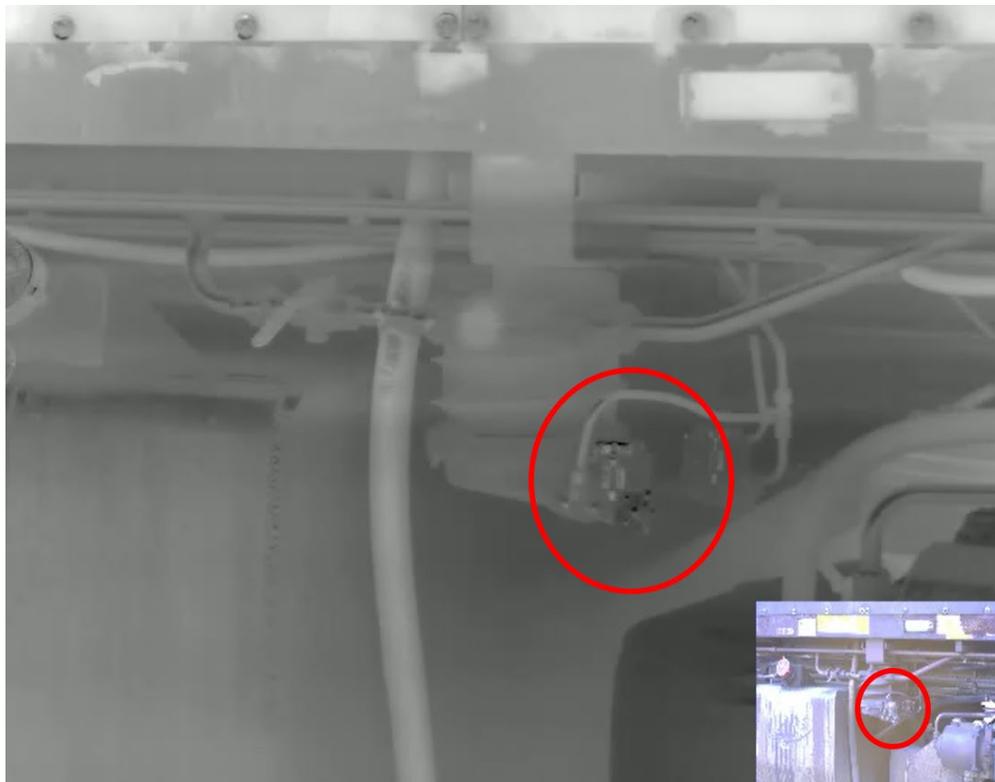
**FIGURE 8. Compressed Air Leak at Drain Valve Using Thermal and Visual Spectrum Cameras**

Figure 8 shows similar dark areas where the leak was, but in this case the leak itself was not blowing on to any surrounding part as the drain valve was simply blowing down to atmosphere. You can see some cooling occurring on the top of the valve body as well as at the handle. Obviously, these images themselves are not enough to detect the leaks, as there are temperature variations throughout the images. It is notable though that the cooling is detectable via the thermal imaging, which means it may assist in positive identification of compressed air leaks.

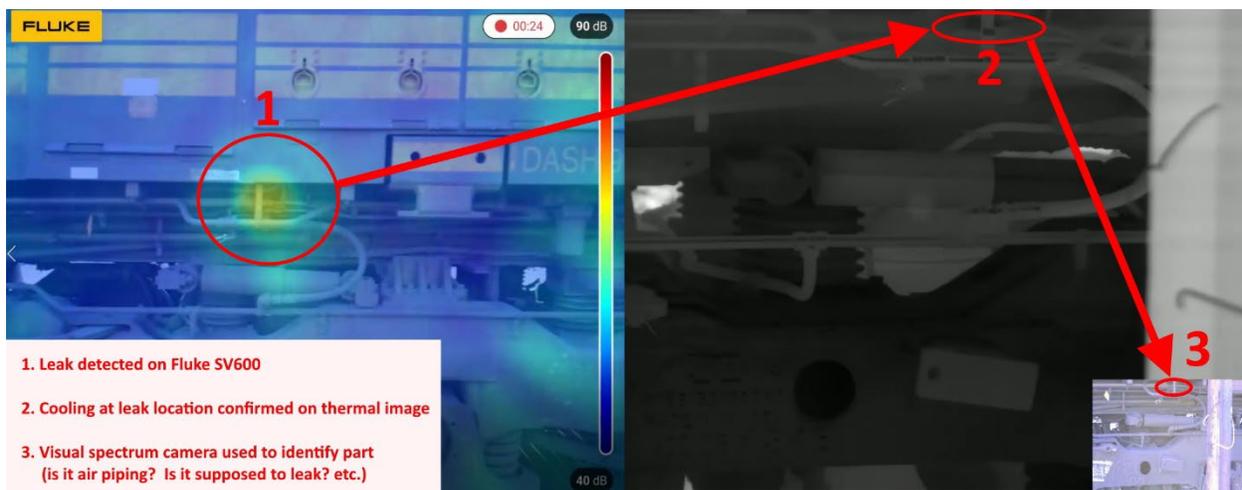
**FIGURE 9. Train Air Leak Detection Using 3 Cameras**

Using the three imagers in combination gives a good understanding of how the sensors can work together. In Figure 9, you can see that the leak was detected on the Fluke SV600. Cooling was also detected on the thermal imaging camera at the same time and location while the visual camera helped identify the suspect component. At this point, the system was ready to proceed with the machine vision development and integration.

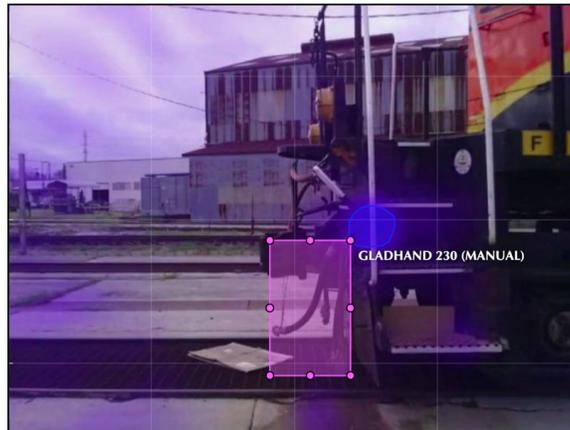
FIGURE 10. Annotated frame in CVAT

Prior to training and evaluating a machine learning model, images collected from the SV600 were manually annotated using CVAT, an open-source annotation tool. Regions including and around known leaks were labeled with closed polygons and the gladhands were labeled with bounding boxes (Figure 10) in order for the system to understand where pieces of equipment meet. To separate unique runs of data collection, the start and end times of each data collection run was recorded for future use in the training pipeline. A held-out validation set was created by randomly selecting 20% of these runs, leaving the rest of the annotations as example for training the model. Images collected from the Basler and Boson sensors were then registered to the SV600 image for each run to spatially align all images to the labels.

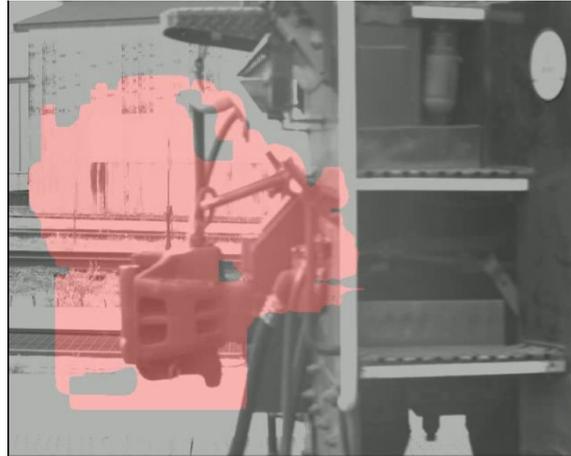
**FIGURE 11. Pixelwise Semantic Segmentation Mask of Air Leak**

Development of the leak detection algorithm began with training the segmentation model on the images from the first data collection. While this model was able to detect larger leaks with confidence, it frequently reported smaller leaks as background. These false positives were determined to be inherent to the segmentation approach as larger leaks were given significantly more importance than smaller ones. This issue was further compounded by the ambiguity of what constitutes a leak on a pixel level. The visible and longwave images were also introduced as inputs to the model during this iteration of model development. While telling features of a leak were present in this data, poor overlap in the field of view of the cameras did not provide sufficient information for model to increase performance.

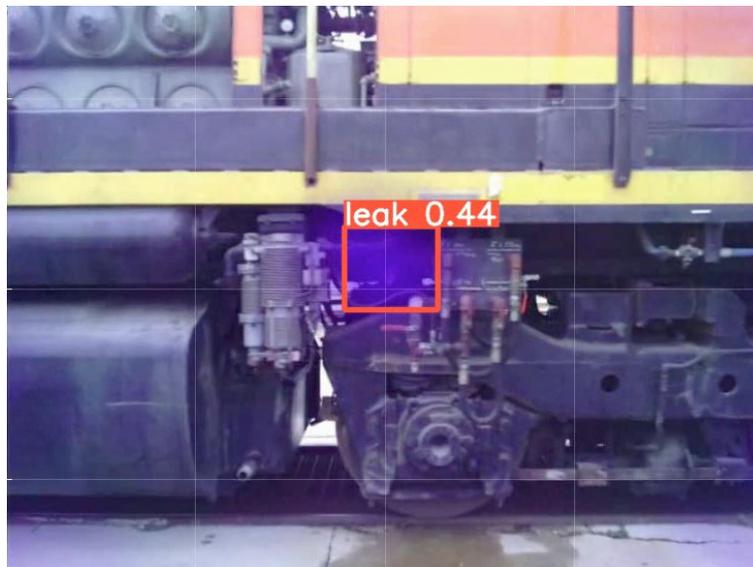
**FIGURE 12. YOLOv5 Detection of an Air Leak**

Following the second round of data collection, the YOLOv5 model was implemented and trained. A python script was written to convert the air leak labels into the bounding box format required by the model (Figure 12). To reduce the errors from ambiguous labels seen previously, the identification of leaks was weighed relatively higher than bounding task in the training process. Results from this model showed a large improvement in the detection of smaller leaks and a higher confidence when detecting larger leaks. More false positives were found than with the previous model, though they lacked consistency between frames and could be filtered out with post-processing methods. The YOLOv5 architecture also allowed new features to be detected, such as gladhands, with only a marginal increase to the model size. Additional annotations were created for the past data collections to include the presence of gladhands and the model was retrained using both classes of labels.

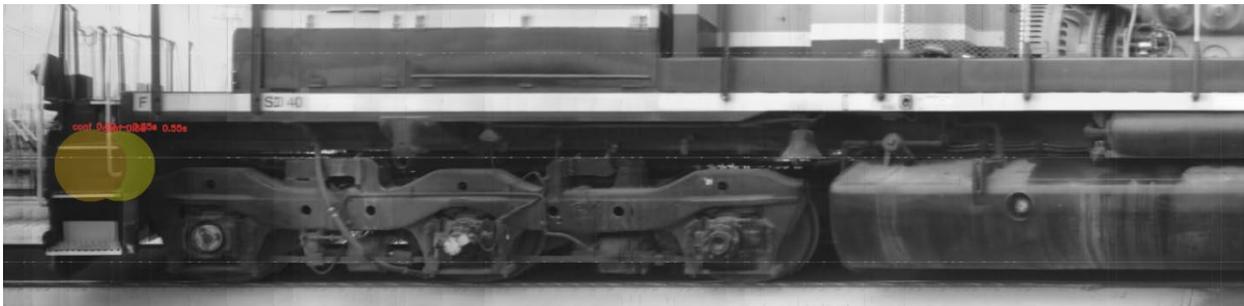
**FIGURE 13. Example Composite Image of Passing Locomotive with Detected Air Leaks**

An alerting system was developed to notify users of a detected leak and provide visualizations of their locations. A composite image is generated for each piece of rolling equipment, with the post-processed leaks being overlaid on the image. This image is then reported to the appropriate mechanical personnel for further investigation and repair as time permits. Figure 14 shows an example of the automated notification system. Note that this notification system is just an example and can be adapted as necessary to meet the needs of each railroad.

Once detection (and false detection) had been accomplished at an acceptable level, a basic notification system was developed. When a leak is detected, a composite image of the piece of equipment is created with the location of the detected leaks marked. Figure ES-2 shows an example of this composite image. In addition to the images, a

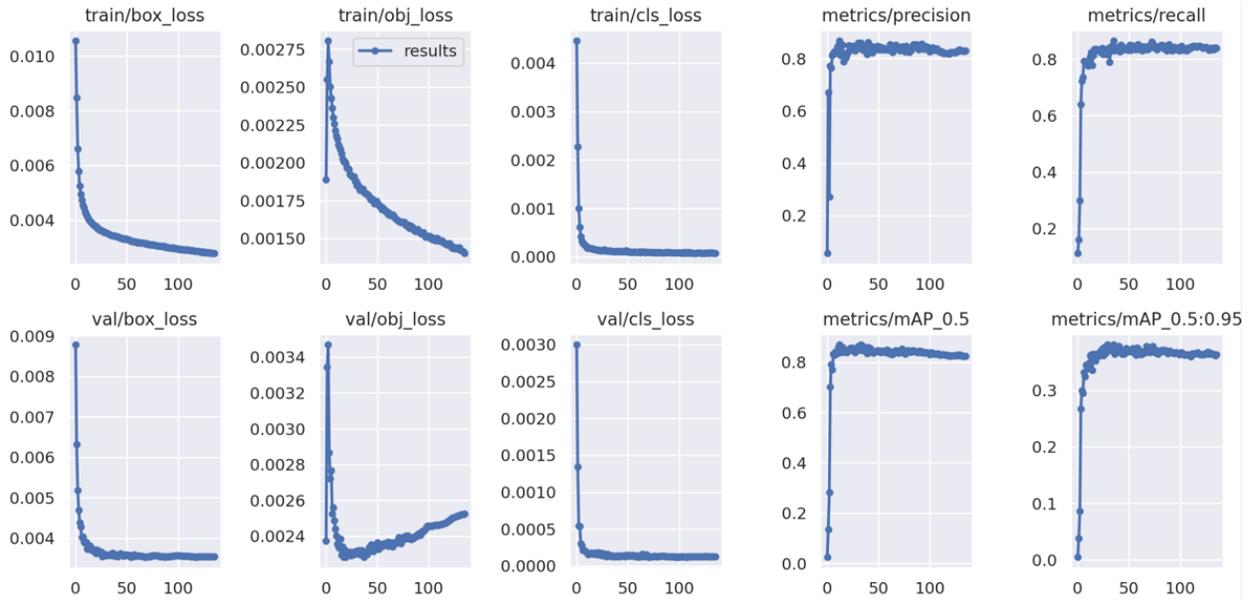
**FIGURE 15. SSD Training and Validation Metrics**

The selected model has a precision of 0.57 and recall of 0.63 with a mAP of 0.54. mAP\_0.5 refers to the model's ability to detect and classify objects with at least a 50% overlap in the object detection region vs. the ground truth label. mAP\_0.5:0.95 is the average of the mAP scores between 50% and 95% overlap with steps of 5%. Table 3 shows results from the validation process.

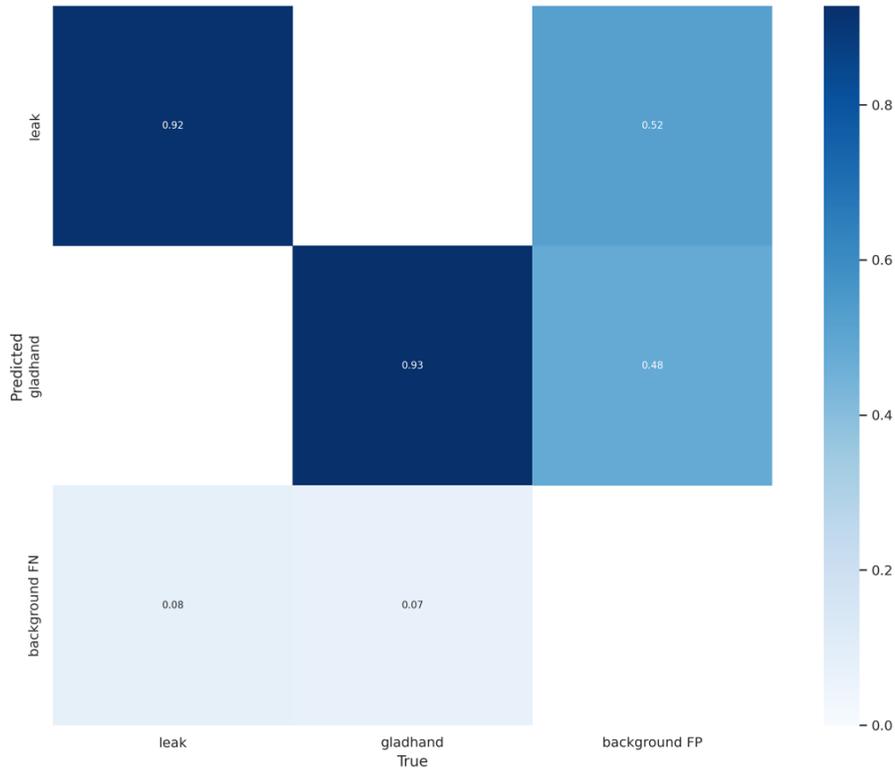
**FIGURE 16. SSD Confusion Matrix**

Figure 16 shows the confusion matrix over the selected classifier. This matrix is a heatmap of how the classifier is predicting based on the labels. The Y-axis is what the classifier determined was in the image. The X-axis is the ground truth. A perfect classifier would have a diagonal line from top left to bottom right. In the case of this classifier, we can see that it does very well at identifying gladhands with little false negatives. With Air leaks it predicts correctly 65% of the time, there is some confusion when the air leaks are on top of gladhands and there are cases where some air leaks were missed entirely. This matrix also shows that all the false positives that the model reported were for air leaks. The performance and metrics of the model could be improved over time with more training, testing and validation data.

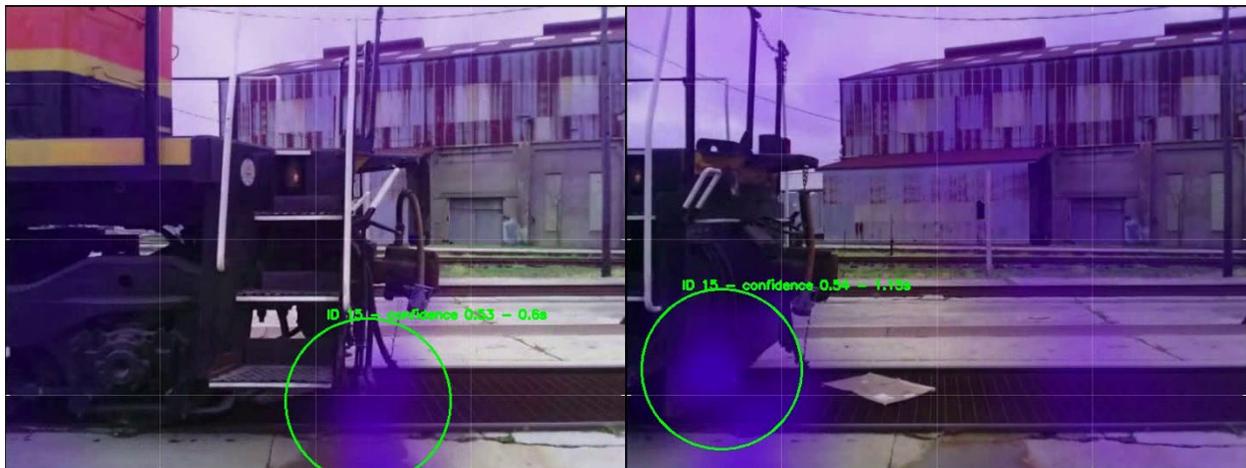
**FIGURE 18. Spatial and Temporal Tracking of an Air Leak**

The metrics discussed above are pointwise metrics, meaning they are calculated and aggregated over every image in the validation dataset and do not consider the temporal and spatial relationships of an air leak as it progresses through the field of view of the camera (Figure 17). Using the object tracking techniques described above, we were able to reduce the false positives caused by track noise, bells, and main reservoir blowdown events. Additionally, the number of false negatives was reduced by allowing for infrequent missed detections while tracking a leak. Figure 18 depicts the tracking of an air leak as the locomotive passes the ID value of the leak is tracked.

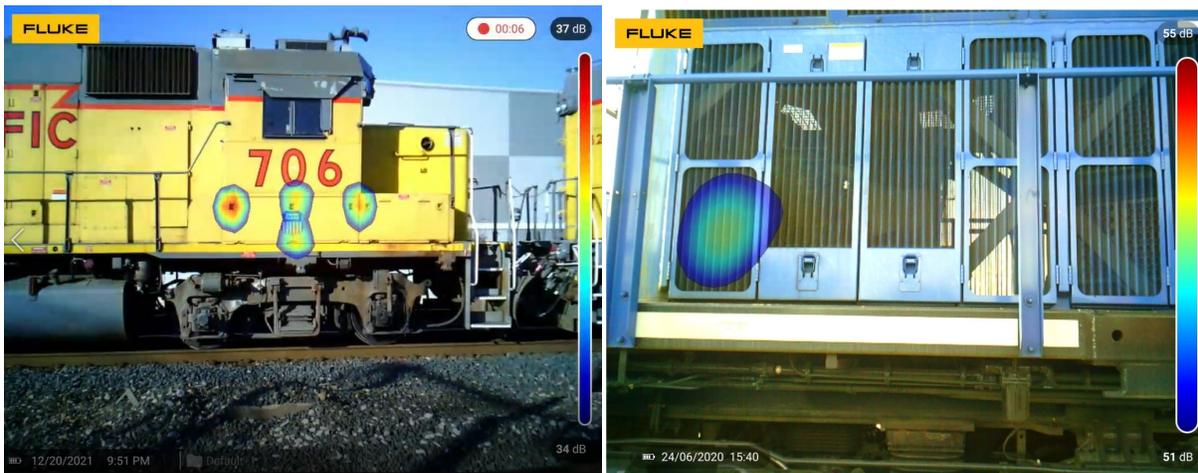
**FIGURE 19. Air Leaks in Air Brake Compartment Below Cab (left) and Rear Sander Mag Valve (right)**

There are additional complications with detecting leaks without direct line of sight and how to address those leaks. As you will note in Figure 19 below, the Fluke sensors are capable of detecting air leaks behind closed carbody doors. Leaks in areas like compressor compartments, air brake compartments, etc. are all very common on locomotives. In these situations, neither the SV600 nor the visual spectrum camera will be able to identify the exact location of these leaks, which means component identification is impossible. It is therefore difficult to determine if the leak is a purposeful leak such as the J1 Relay releasing brake cylinder air or an actual leak at a mag valve or something similar. These leaks may be detected on a single pass, but may require multiple passes of the same piece of equipment to determine if the leak is an undesirable leak or a necessary air release.

Similar situations will arise on rail cars with brake pipe piping that is not exposed. On rail cars we can assume that any leak is unintended (outside of brake release situations), so there is less concern with false positive in these situations. Work will need to go into determining how to approach this issue on locomotives though, as there are more complications in the compressed air system. While both leaks shown in Figure 19 were indeed unintended leaks, without further inspection this may be difficult to determine on a single pass by the sensors.
