Recoating Electrified Third Rail Cover Boards - Phase 2

Final Report for
Transit IDEA Project 59

Prepared by:
Arun Vohra, P.E.
MINI LLC
Bethesda, MD

June 2010

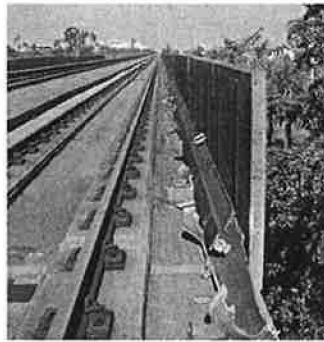
Cover board blown off along with third rail
during Hurricane Wilma, Miami, October 2005

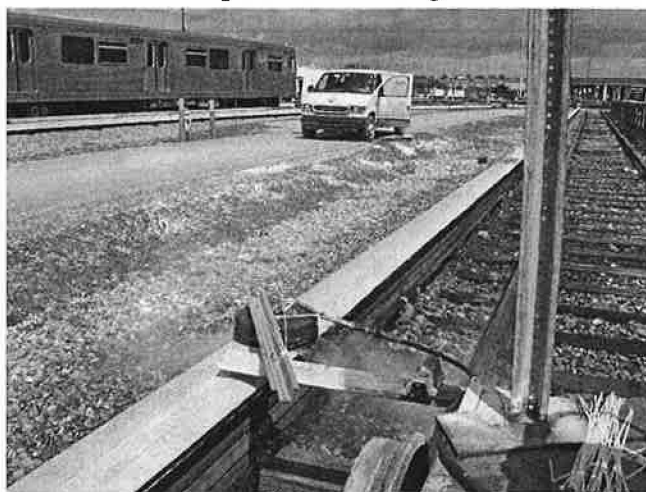
Fig 3. Spinning bar with 2 nozzles for improved cleaning

An improved cleaning system was tested. A pressure washer was attached to a surface cleaner consisting of a swivel that had two hollow arms with an offset round jet nozzle at the ends. The reaction force of the water jets at the nozzles caused the arms to spin. The pressure washer was carried on a service vehicle and the surface cleaner was attached to an arm positioned on the cover board. The service vehicle was moved along the track to test clean a section of cover board. The dwell time and the standoff distance of the spinning water jets were found to clean the cover board satisfactorily in one pass.

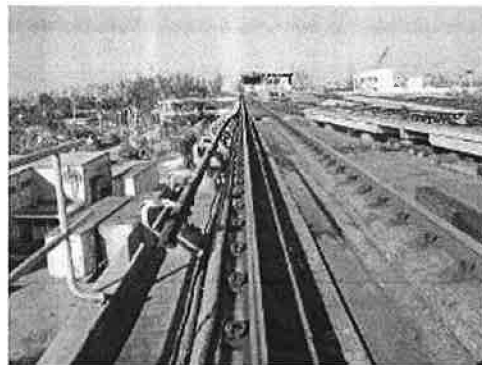
Fig 5. Weakened cover board blown off by Hurricane Wilma, Miami, October 2005

MDT, Miami has 57 miles of elevated and on grade track. The cover boards are severely deteriorated because MDT had no means to periodically recoat the cover boards in the past. MDT estimates that a crew of 8 workers at \$41 per hour per worker can replace 1000 feet of cover board in an 8 hour shift. The labor cost is \$2.60/foot of cover board. The estimated cost of a standard 10 foot piece of 14 inch wide cover board, contiguous 10 foot piece of 7 inch wide back drop, 2 brackets and retaining pins is \$250. The labor and material cost is \$ 27.60/foot of cover and side board. Fringe and night differential labor cost has to be added to the total cost of replacement. As a result of Hurricane Andrew in 1992 and Wilma in 2005, several miles of deteriorated cover
