IDEA PROJECT FINAL REPORT
Contract NCHRP-94-ID023

May 1996

**PAINT REMOVAL FROM STEEL
STRUCTURES**

Prepared by:
Rudolf Keller
EMEC Consultants

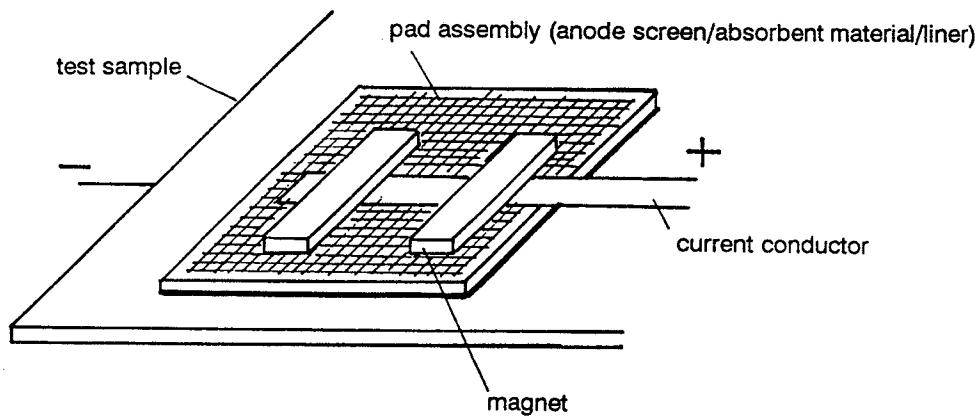
FIGURE 1 ElectroPad™ attached to metal surface.

to a substrate, electrochemically assisted debonding of the paint is achieved. The environmentally benign electrolyte is contained in a liquid-absorbent material to which a counter electrode is attached. This combination, called ElectroPad™ and shown in Figure 1, often includes a liner, and is applied to the metal surface in the case of steel with magnets. After electrochemical treatment for $\frac{1}{2}$ to 2 hours, the ElectroPad™ is removed and paint fragments recovered. No particles become airborne, a decisively advantageous feature for the removal of lead-based paint.

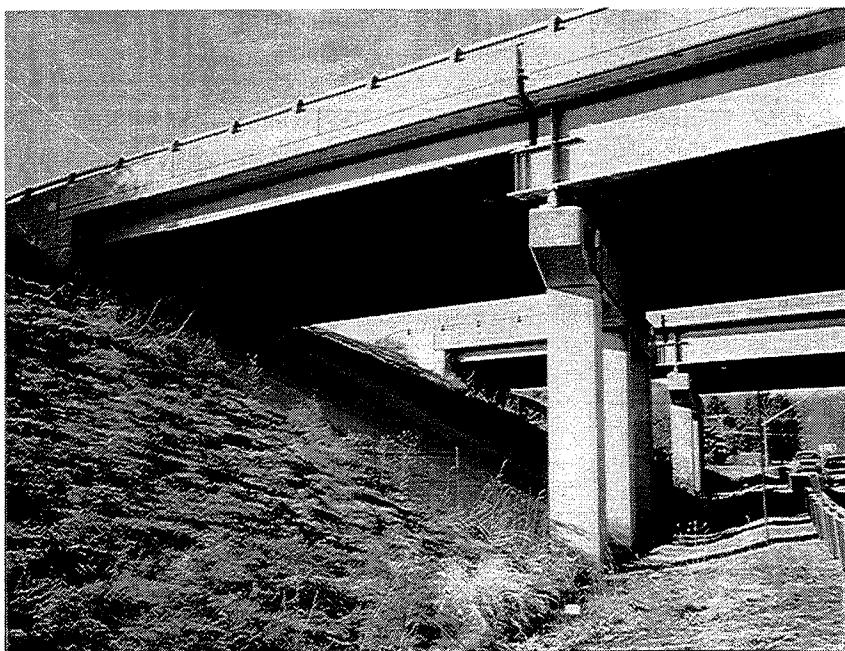
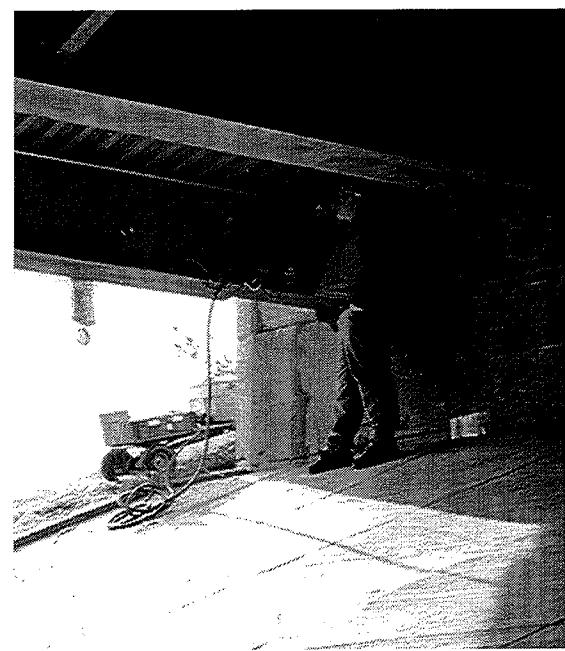
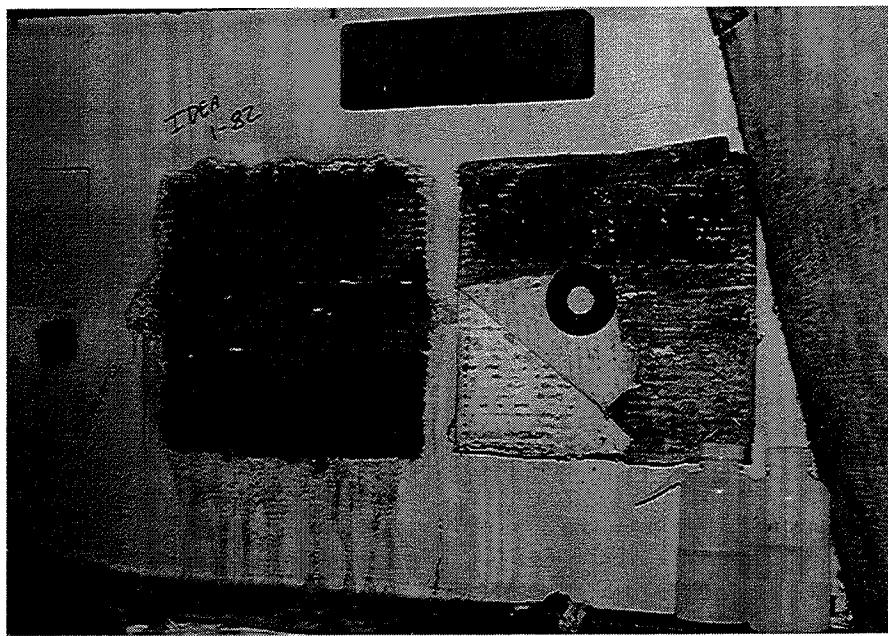
FIGURE 1 Field experiment on Pennsylvania Route 28, Exit 16

An example of a field test is illustrated by Figure 2. The overpass is shown, then the test in progress, with a one-square-foot pad mounted to a girder, and with the equipment cart carrying the dc power source in the

background. The result is shown on the bottom. Horizontal score lines, 1 cm apart, can be seen in the treated area. Debonding was essentially complete. The removed ElectroPad™ is mounted to the right, showing the side that contacted the painted surface during the treatment. The paint coating was removed with the pad; the red color indicates the lead-based primer. In one corner, the paper liner is peeled back and the yellow-colored absorbent material is visible. To the left of the treated area, there are some marks from the characterization of the coating, as performed by KTA/SET Engineering.

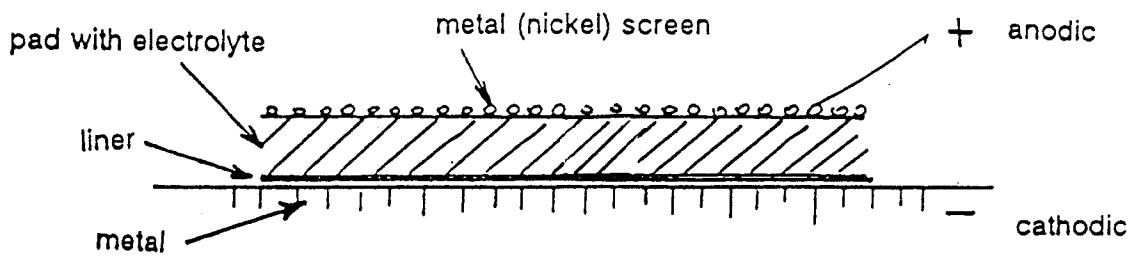
FIGURE 3 The "ElectroPad™" for electrochemically assisted paint removal.

To remove paint coatings, steel surfaces are brought in contact with an aqueous electrolyte, e.g., with a neutral sodium sulfate solution. Direct current is then passed from a counter electrode to the work piece; for coherent coatings, this has to be facilitated by scoring the surface. The cathodic current results in debonding of the paint. Containment of electrolyte, placement of electrodes, and retention of paint fragments can best be achieved through the use of an "electric blanket", or ElectroPad™, a pad soaked with electrolyte, possibly equipped with a liner contacting the metal surface, and combined with a counter electrode mesh. Such an arrangement is shown schematically in Figure 1, its structure in Figure 3. To remove paint from steel, pads can be held in place by magnets that may also serve as current connectors. After use, the pads will be collected and processed by specialized personnel who separate the paint debris and prepare it for use in secondary lead smelting.

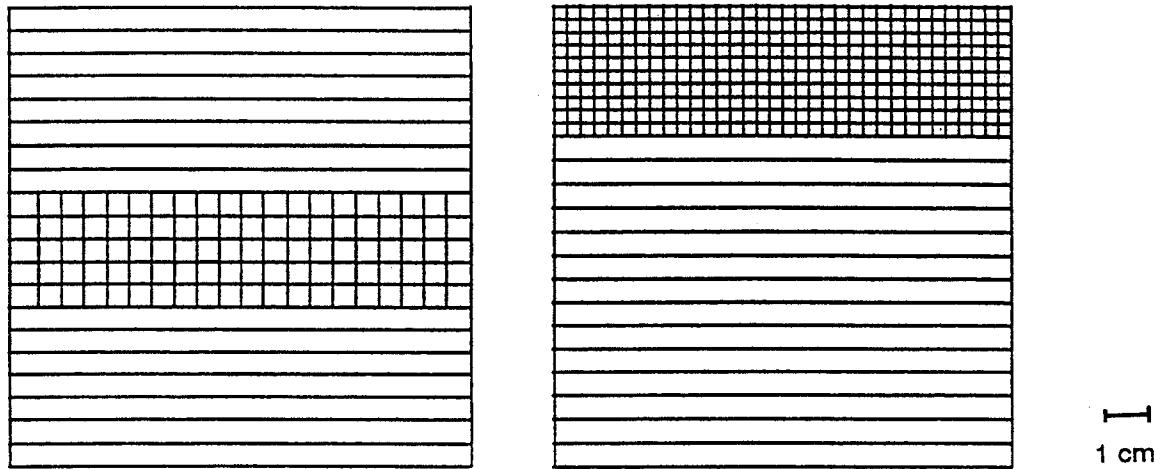
FIGURE 4 Scoring patterns used on test samples.

Testing was based on a standard test procedure, occasionally with slight variations. Samples were scored to facilitate initiation of the cathodic action. The two patterns used are shown in Figure 4. In fields of 10 cm x

10 cm, 0.5-cm wide stripes were separated by scratches applied with a knife blade. Cross-hatched patterns for pressure-tape testing were applied, consisting of 2 mm x 2 mm squares in early tests or 5 mm x 5 mm in later tests. The pattern was then covered by a 10 cm x 10 cm Sorb-X₂ pad (a material sold for the control of liquid spills) which was saturated with an aqueous 0.4 M Na₂SO₄ solution. A nickel Exmet screen was pressed against the pad and served as counter electrode. Magnets were used to hold the arrangement in place.

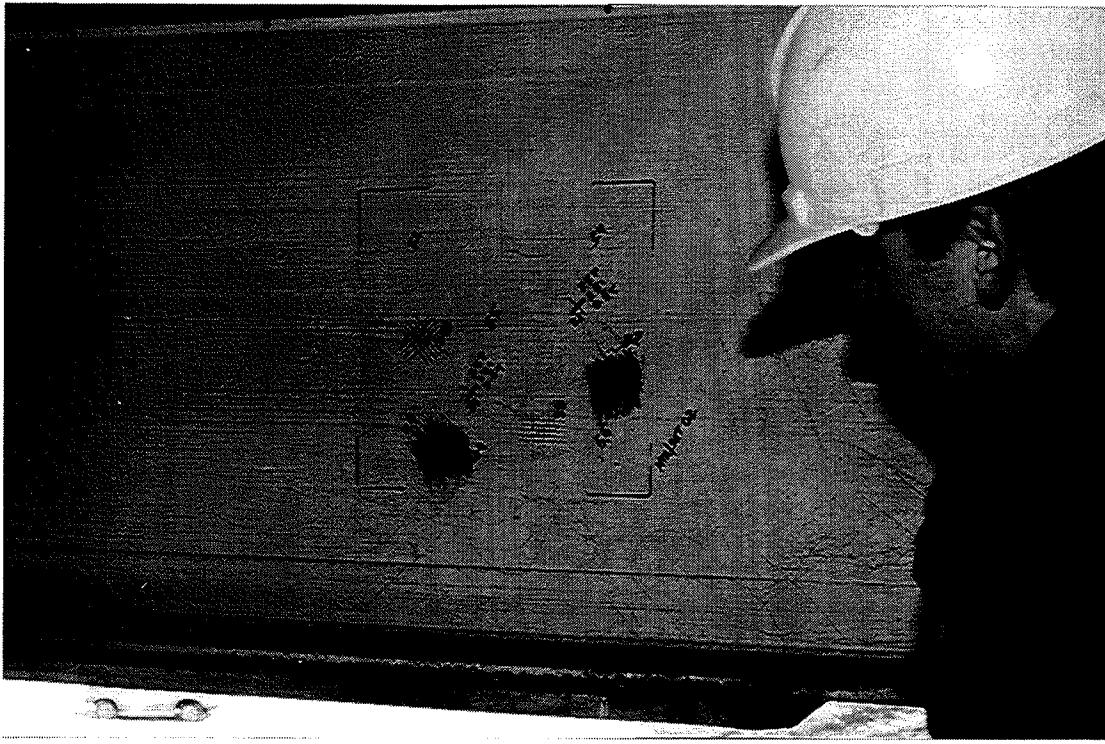
FIGURE 5 Coating characterization tests.

These structures were characterized in the same manner as the laboratory samples by KTA/SET Environmental. Bill Corbett is shown in Figure 5 with a coating test pattern completed on a bridge girder. The data is presented in Table 2.

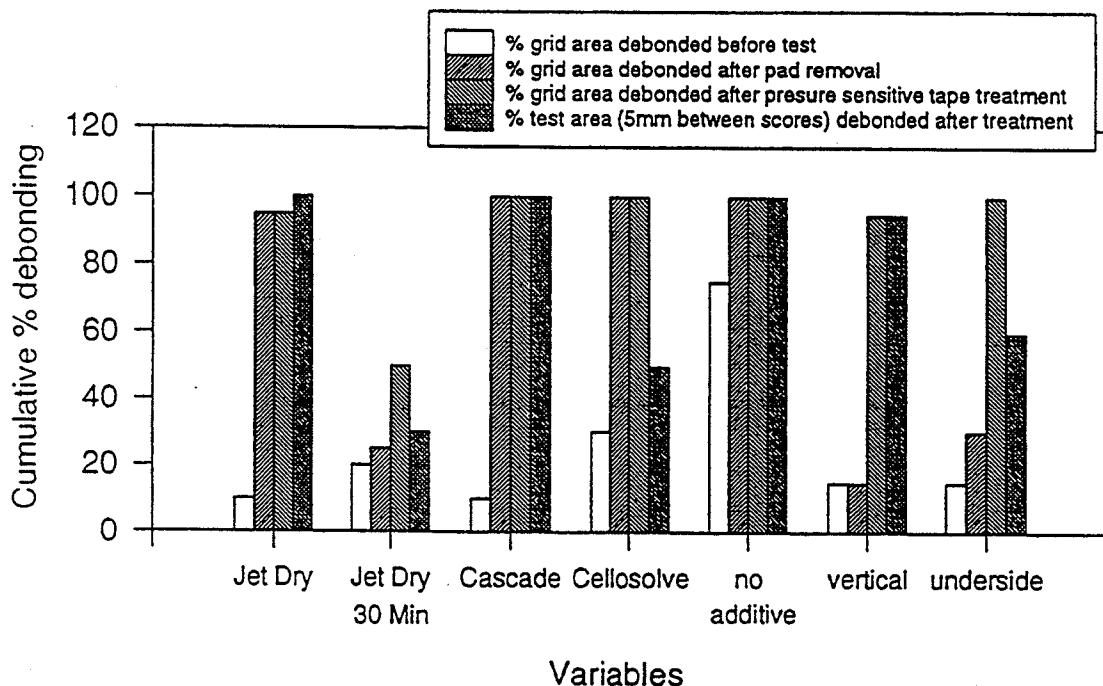
Tests were run for 1 hour at 8-12 V in a 0.4 M Na₂SO₄ solution. The grid pattern consisted of 5 x 5 mm squares.

**FIGURE 6 Effects of additives and test configuration on debonding rates.
(Coraopolis Bridge samples)**

Various results obtained with Coraopolis bridge samples are compared on Figure 6. A Sorb-X₂ pad with 0.4 M Na₂SO₄ solution was used. A constant voltage between 8 and 12 V was applied to maintain a current of approximately 7.5 A for one hour. The first data set represents the fraction that fell off in the cross-hatched section during the scoring process; slight variations in procedure and local paint consistency could have a significant effect. The second data column represents the cumulative total of the first and the amount removed along with the pad; the next column shows the preceding total plus the amount removed with pressure tape. The last column indicates the degree of debonding in the test area, an area of 5-mm parallel scoring lines; this is not comparable to column 3 because of different debonding lengths and cleaning methods.

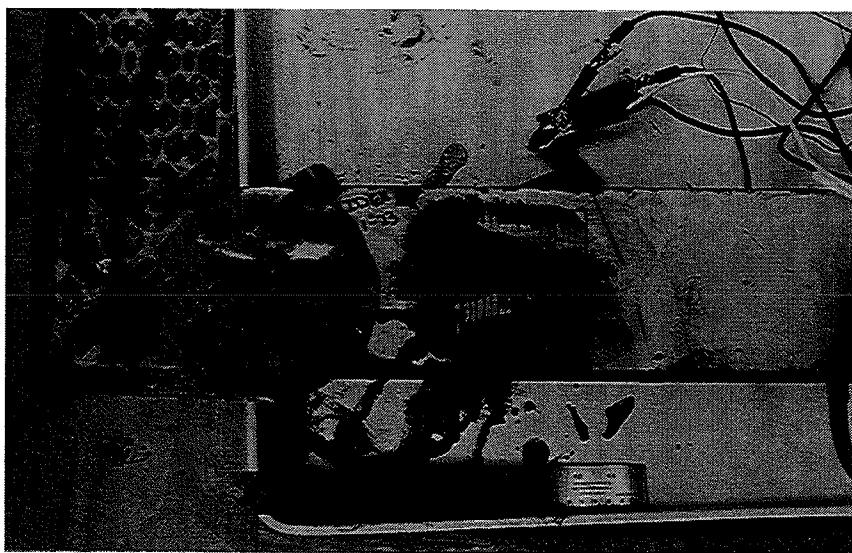
Test ran for 1 hour at a current density of 75 mA/cm².

FIGURE 7 Experiment # IDEA-1-23: Condition of West End bridge sample after pad removal.

In the case of the West End Bridge samples, the coating system was microcracked to the point that scoring was not needed to obtain a conductive path. Application of the electrochemical process reduced the coating to a sludge that could be wiped away or collected easily. This behavior is shown in Figure 7 (Experiment # IDEA-1-23). This one-hour test was run at 77 mA/cm^2 . In the areas in which the paint was not removed, plastic thermocouple

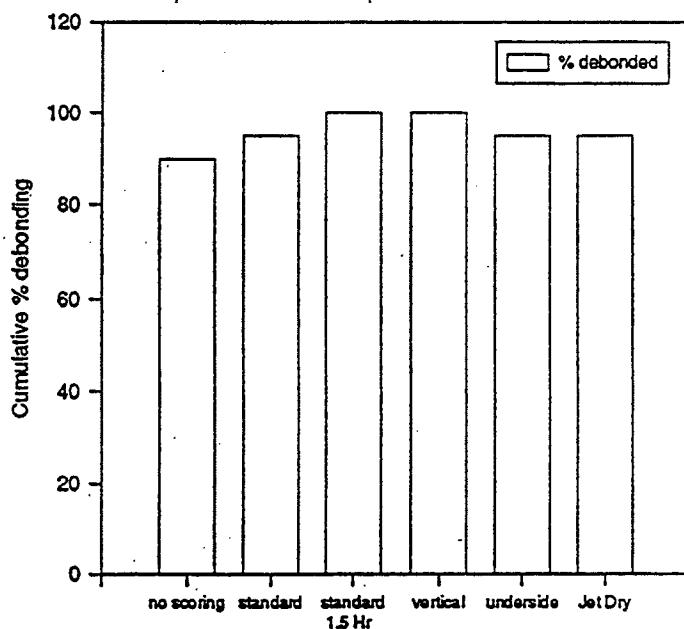
FIGURE 8 Results of debonding tests on Westend Bridge samples.

Figure 8 shows that wetting agents did not help the debonding, and different orientations such as vertical and upside-down positioning did not hinder the process.

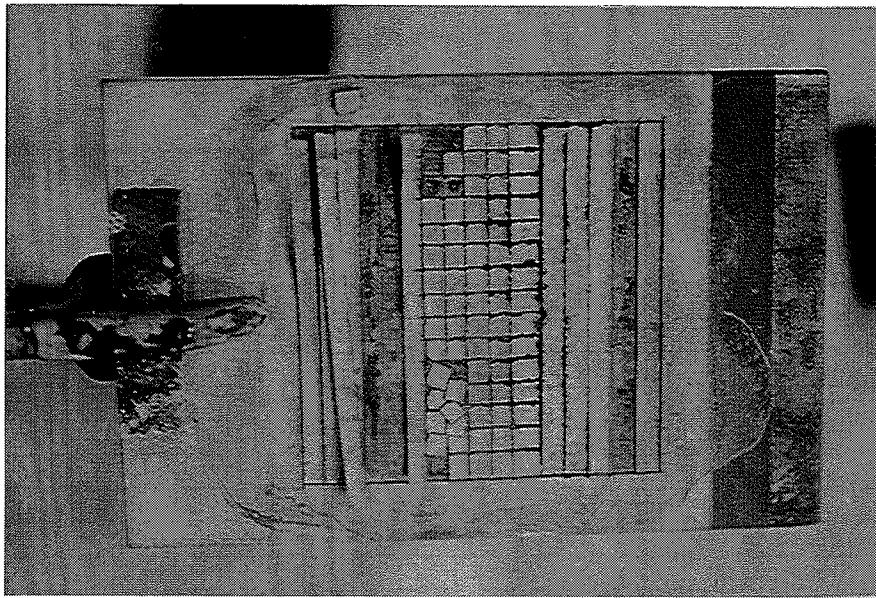
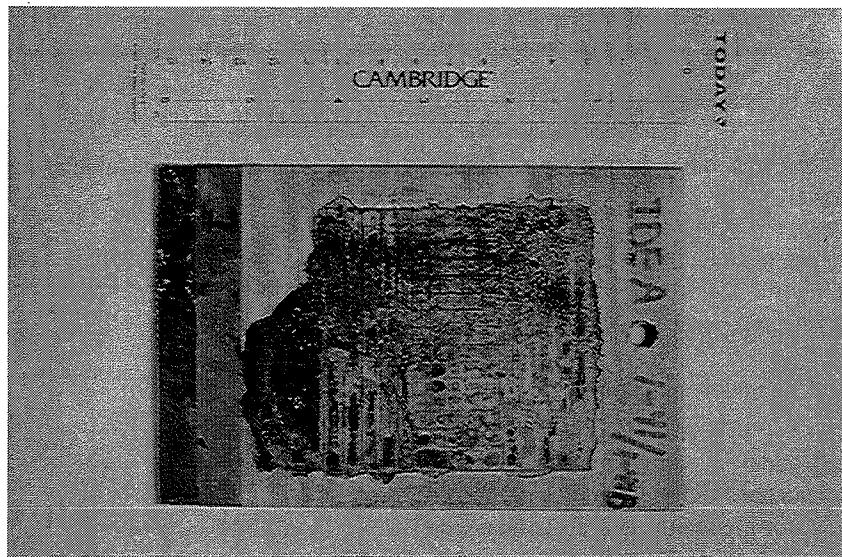
After pad removal (Experiment # IDEA-1-42)

After light scraping and wiping with a dampened paper towel (Experiment # IDEA-1-41b)

FIGURE 9 Testing with samples prepared by KTA/SET Environmental.

The test panels prepared by KTA/SET exhibited a different debonding behavior. In this case, the top coat stayed intact but the primer was dissolved away from under it. Figure 9 shows two tests, one after pad removal in which a non-adherent coating can be seen, and the other after a light putty knife scraping and wiping with a damp paper towel. These samples needed two to three hours for coating removal, which is much longer than the times needed on the field samples.

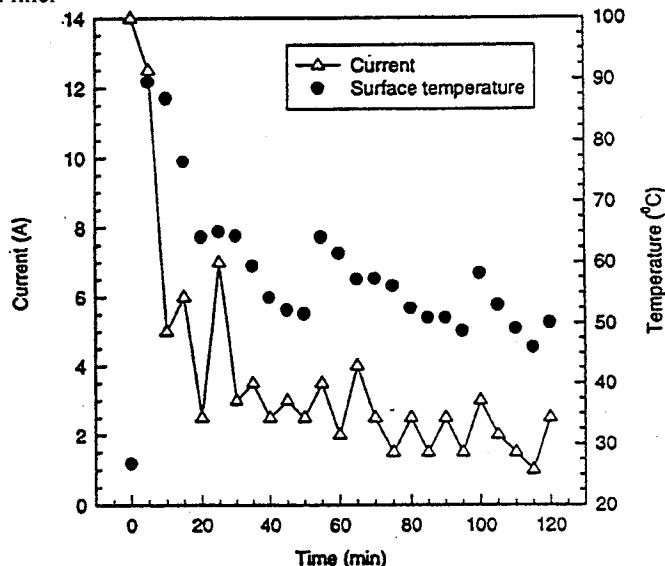
FIGURE 10 Current and temperature with time, for Experiment # IDEA-1-41, run at 12 V. Current spikes are due to periodic water or electrolyte additions.

Once again, adding wetting agents or applying the test in different orientations did not significantly affect the rates. As expected, for a coating with no holidays or pinholes, the rate of removal decreased as the scoring distance increased. One other significant comparison in this table is the current range to average current relationship. The current range was large but the average current was toward the low end. As the tests got longer, the average got closer to the low range point. This effect was produced by a current decay (Figure 10) that was observed in all the tests.

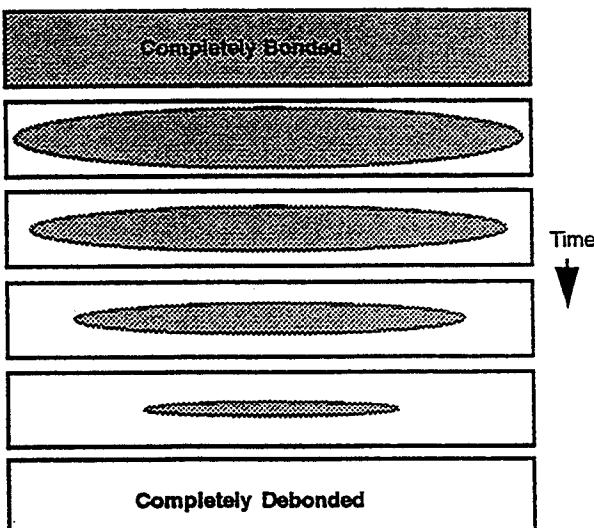
FIGURE 11 Debonding pattern of individual paint strips developing with progressing time, for samples with undamaged topcoats.

Our explanation for this current decay is illustrated schematically in Figure 11. Initially in the tests, the conductive area was at the scoring marks or the microcracks. As the test proceeded and the coating was debonded, a nonconductive layer, possibly iron hydroxide, is thought to have formed on the newly exposed metal surface. This would mean that the remaining conductive surface and electrochemically active area was limited to the zone between the unbonded and bonded coating, which was continually progressing but decreasing in size, resulting in an increasing overall resistance and, consequently, lower current.

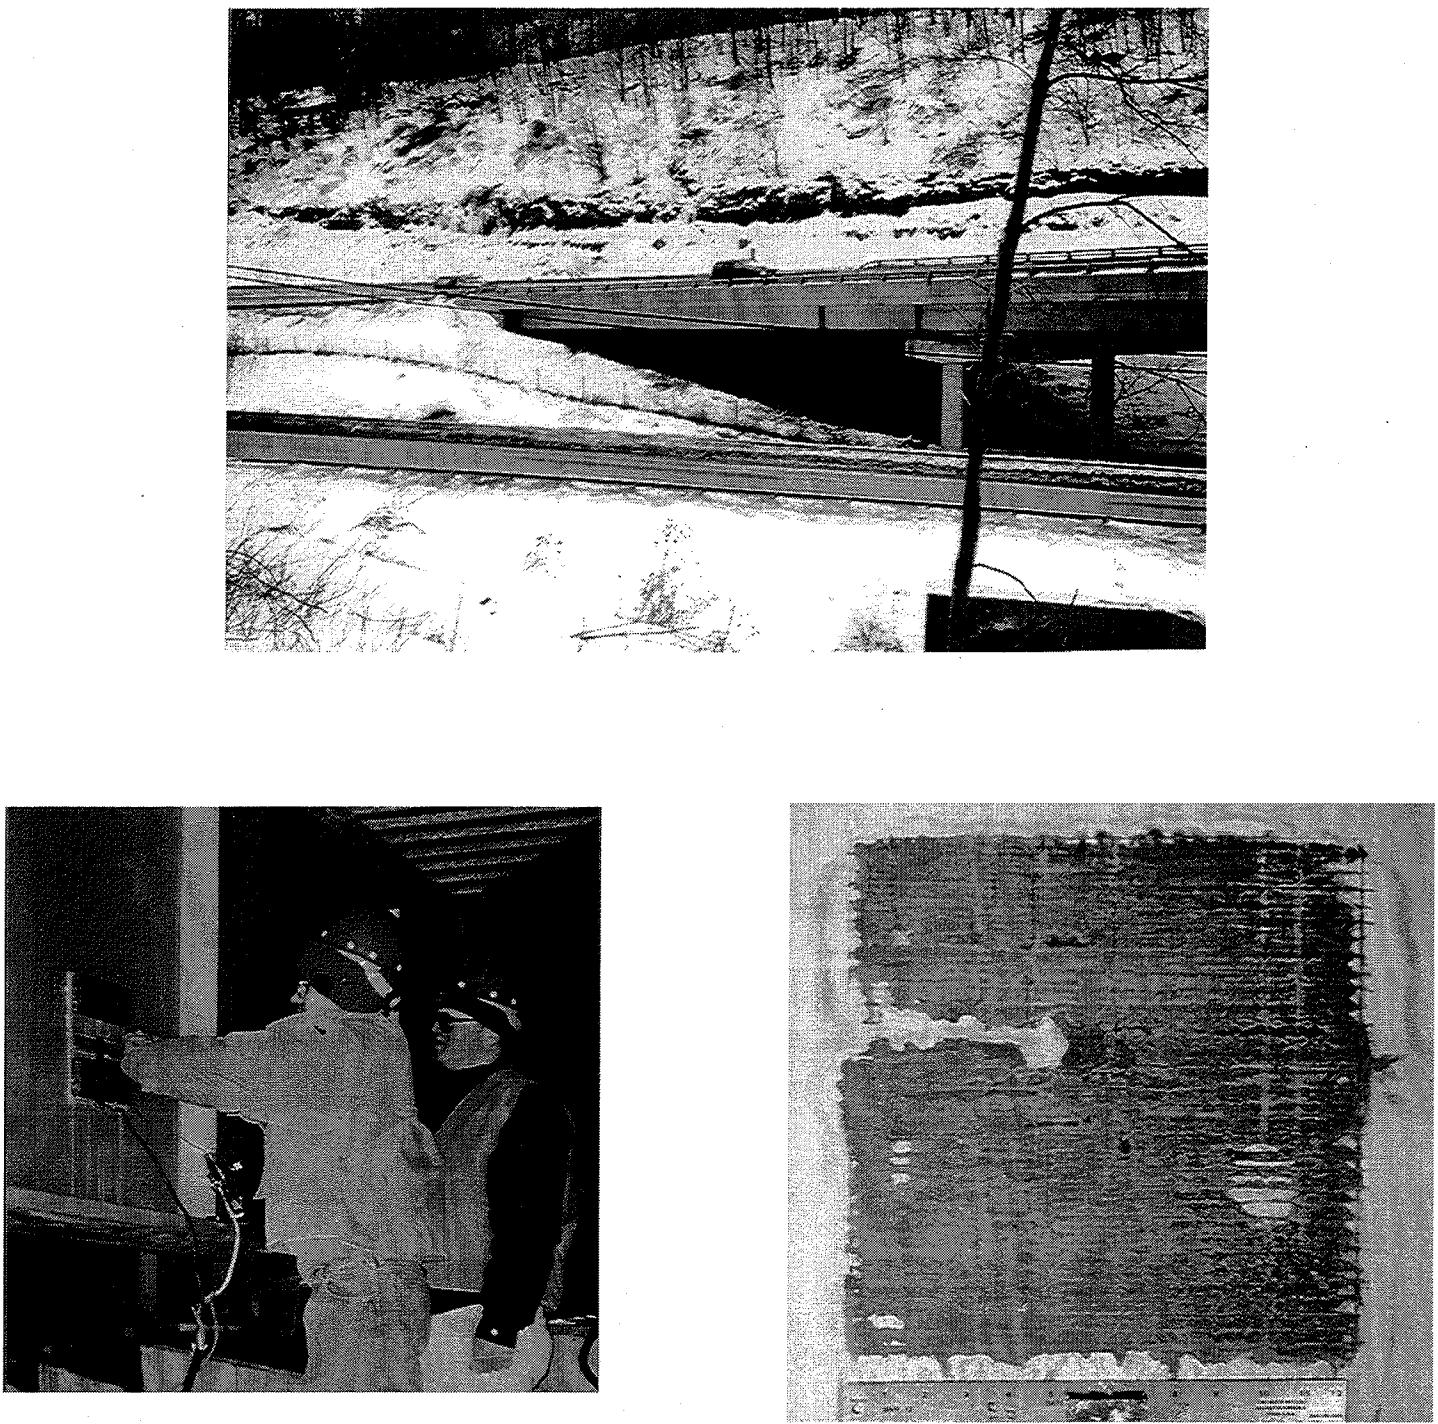
FIGURE 12 Test at Route 28 overpass over Saxonburg Road.

The conditions at the start of the test were as follows: air temperature 10.0 °C, surface temperature 9.6 °C, relative humidity 31%. The voltage used was normally between 10 and 12 V. Current was applied for 1.5 hours. This coating system debonded like the coating of the Rt 28 over SR 1037 overpass. Nearly all of the test area was stripped to a bare metal/millscale surface, as shown

in Figure 12. As a result of the low humidity, the pad needed to be replenished with water more often.

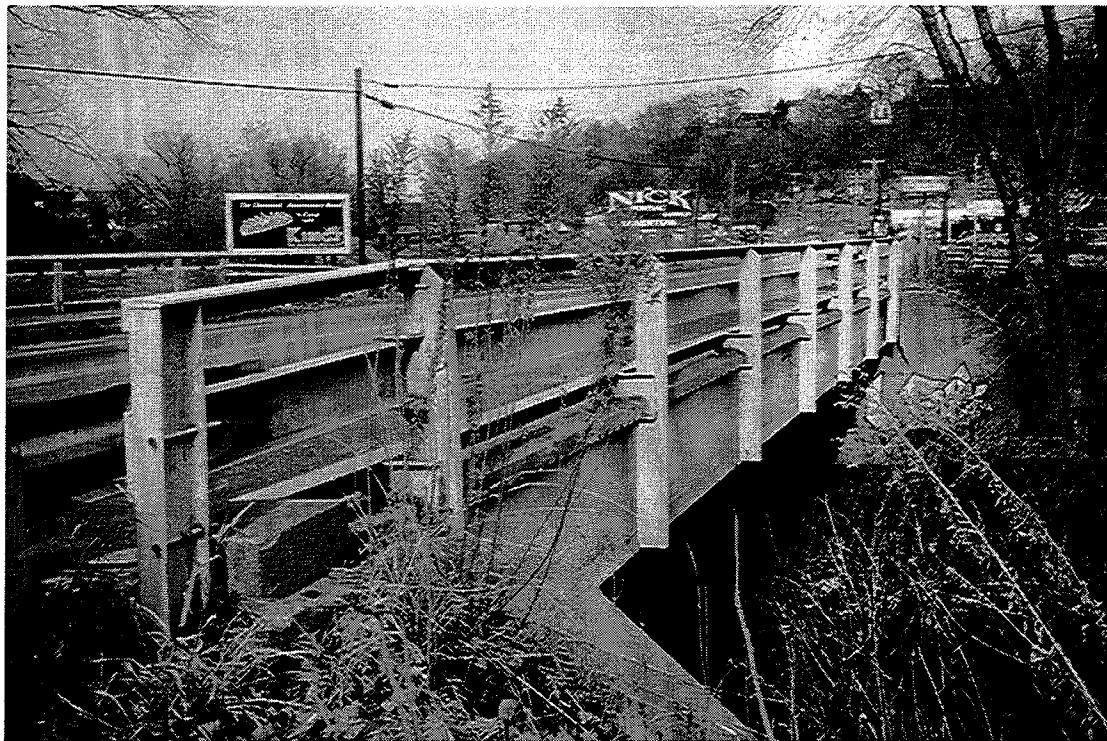
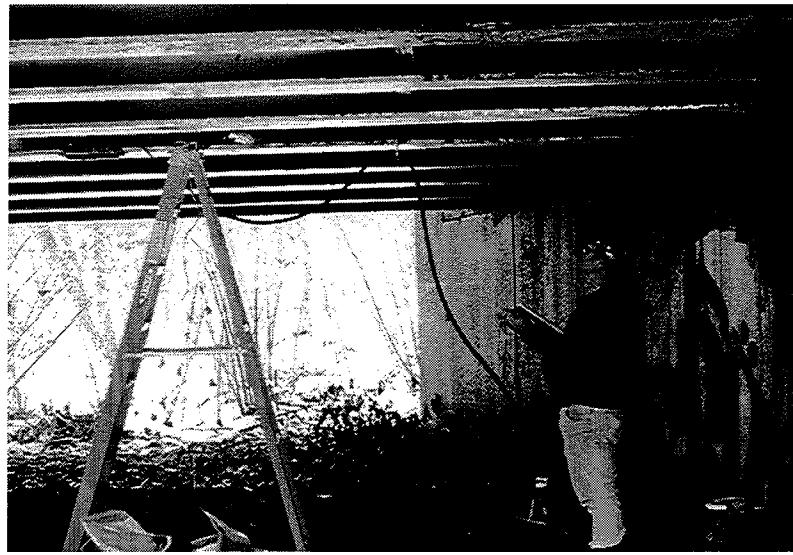
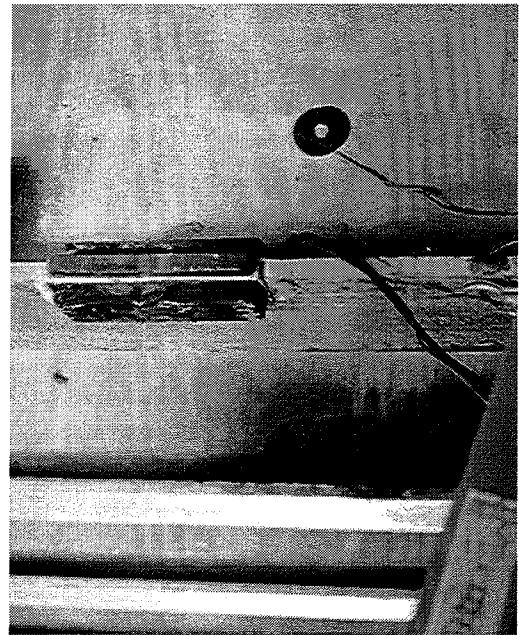
FIGURE 13 Field experiment on Pucketa Creek Bridge in New Kensington.

In the 1-ft^2 test, the voltage was normally between 10 and 13 V and the test was run for 2 hours. The main difference, when compared to other tests, was the use of a thicker copper current collector. This evidently caused uneven pressure on the pad (the magnet holding the copper did not push down the pad as well in areas immediately adjacent to the copper) and resulted in incomplete debonding in less pressured areas. A total of 85% of the coating was removed.

In the 4-ft^2 test, the voltage was normally between 7 and 10.5 V and the test was run for 3 hours. As in the

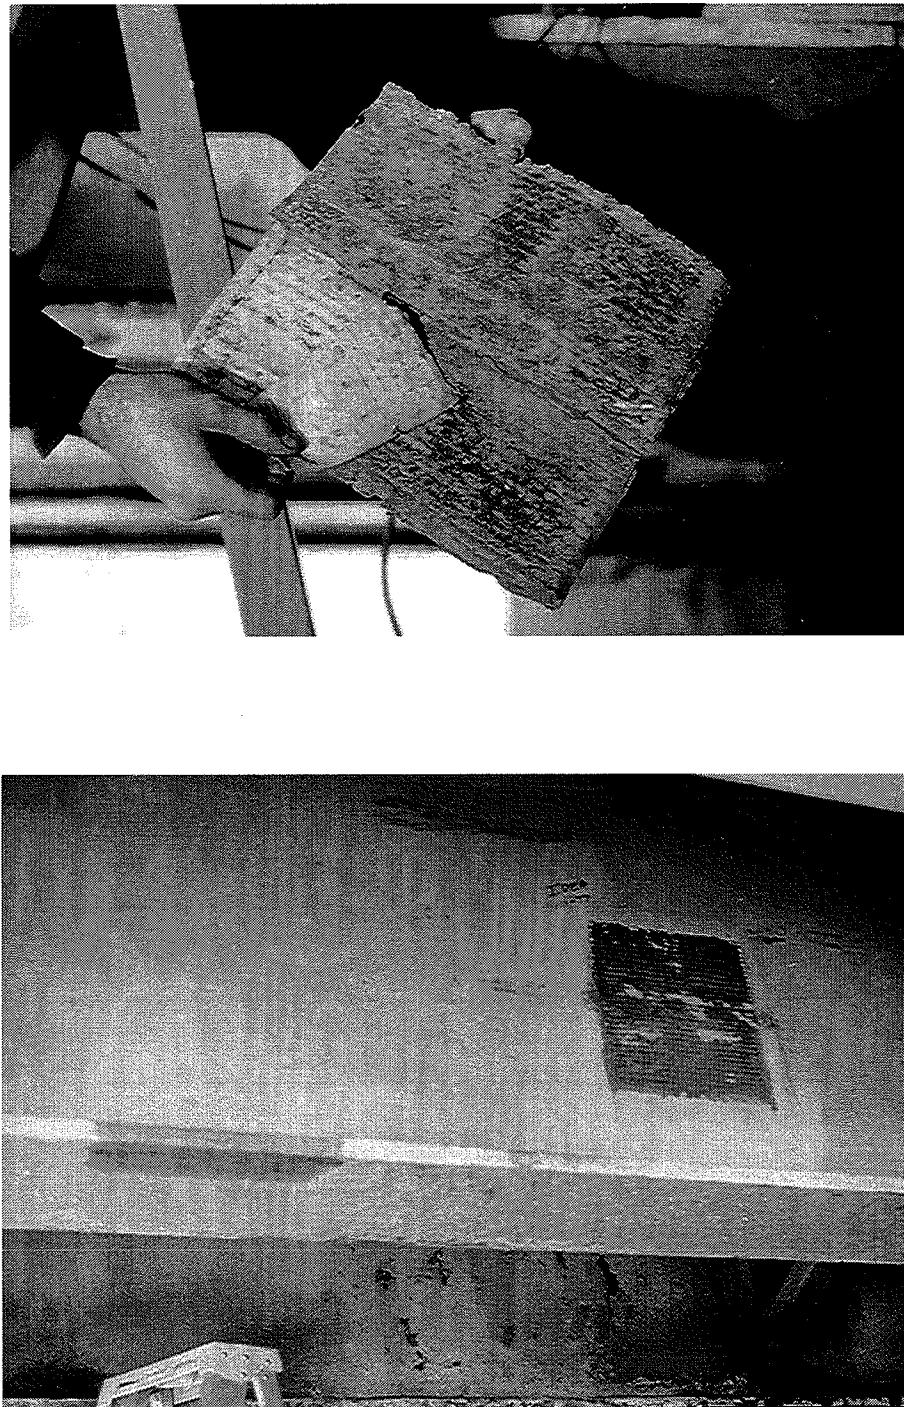
FIGURE 14 Results of tests at Pucketa Creek bridge.
Removed ElectroPad™.
One-square-foot test and wrap-around test.

last large test, we could not obtain the desired cathodic current density due to equipment problems. Despite the low current density of $37.5 \text{ A}/\text{ft}^2$, 80% of the coating was removed, and the remaining coating was situated between magnets, as in the previous test.

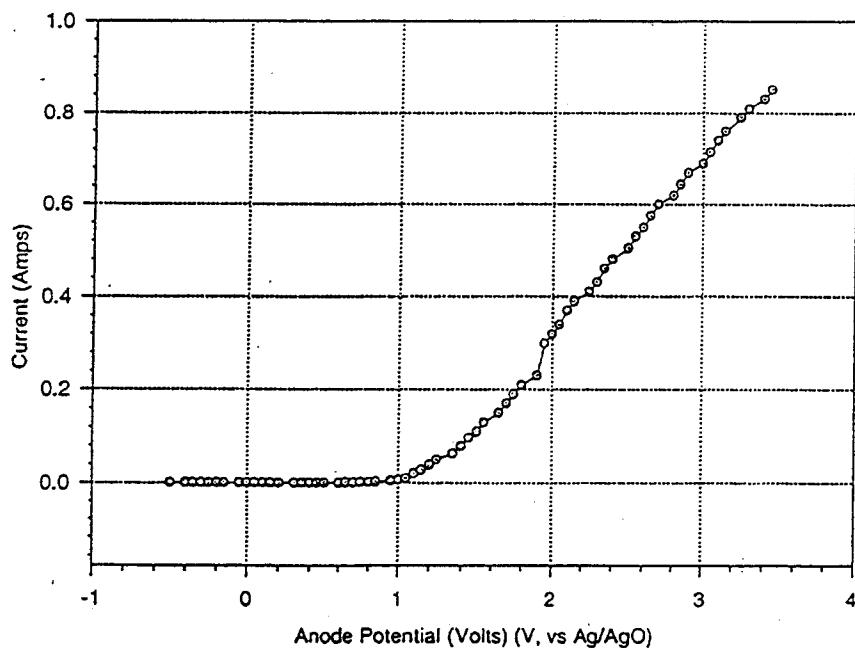
FIGURE 15 Anodic polarization curve for Exmet nickel electrode.

Nickel Exmet screen electrodes were used to evolve oxygen at the counter electrode. These electrodes were not fully stable. To gain background information on the stability of the material, potentiostatic polarization curves were taken with a $0.4 \text{ M Na}_2\text{SO}_4$ solution, the electrolyte primarily used in our studies. An example is shown in Figure 15. It clearly displays a passive region, presumably with oxygen evolution setting in at 1 V versus the reference electrode used. Different electrolytes, presumably with lower nickel solubility, were tried. K_2SO_4 and a mixture of Na_2SO_4 and Na_2SiO_3 electrolytes showed no benefits. A $0.4 \text{ M Na}_2\text{SiO}_3$ solution helped passivate the anode but at the cost of a much higher voltage needed to evolve oxygen.
