*Non-Destructive Evaluation Method for Determination of
Internal Grout Conditions inside Bridge Post-Tensioning
Ducts using Rolling Stress Waves for Continuous Scanning*

Final Report for Highway IDEA Project 102

Yajai Tinkey and Larry D. Olson, Olson Engineering, Inc., Wheat Ridge, CO

December 2006

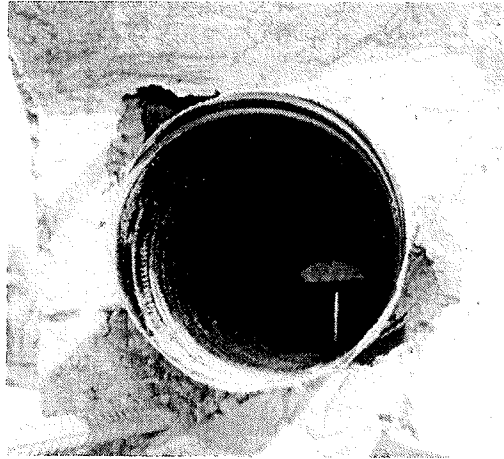
Figure 10 - View of Styrofoam defect inside a duct

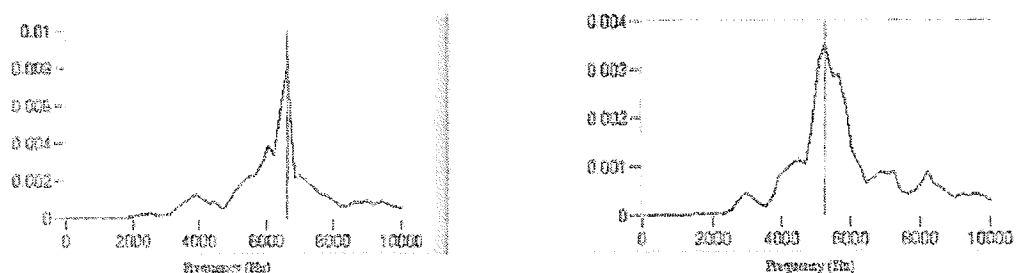
Localization of grouting discontinuities through Impact Echo Scanning in the mock-up slab and girder was based on an analysis of variations in the impact-echo frequency. A direct echo from the void or duct wall, measured as an impact-echo frequency corresponding to the depth of the discontinuity (given by the formula $D = \beta V_p / 2f$ where βV_p = factored compressional wave velocity and f = frequency), has not yet been observed with the scanner. The only IE-based indication of the presence of well-grouted, filled tendon ducts is the apparent minor increase in apparent wall thickness over such a duct (typically on the order of 12.7 mm or 0.5 in or less). Grouting defects cause a much more significant increase of the apparent wall thickness in IE results as shown herein. This is in accordance with the interpretation of the impact-echo signal as a resonance effect, rather than a reflection of a localized acoustical wave. The shift in the IE thickness indicating grout voids can be seen most clearly in a three-dimensional surface plot. Figures 16a and 16b present frequency spectrums of the two extreme cases: a fully grouted duct and a completely voided duct. The frequency peak was observed at 6,445 Hz for the completely grouted duct. This results in an IE thickness of 11.17 inches. However, the frequency peak shifted to 5,274 Hz and resulted in an increase in the IE thickness to 13.65 inches for a test of a completely voided duct. This is a 20% decrease in the frequency peak with a corresponding increase in the IE thickness.

Figures 16a and 16b – Spectrum from U-Shaped Girder 4 inch ducts with good grout condition (left) and no grout condition (right)
