Assessment of Rear Facing Wheelchair Accommodation on Bus Rapid Transit

Final Report for Transit IDEA Project 38

Prepared by:
Dr. Katharine Hunter-Zaworski and Dr. Joseph R. Zaworski,
Oregon State University, Corvallis, OR

January 2005

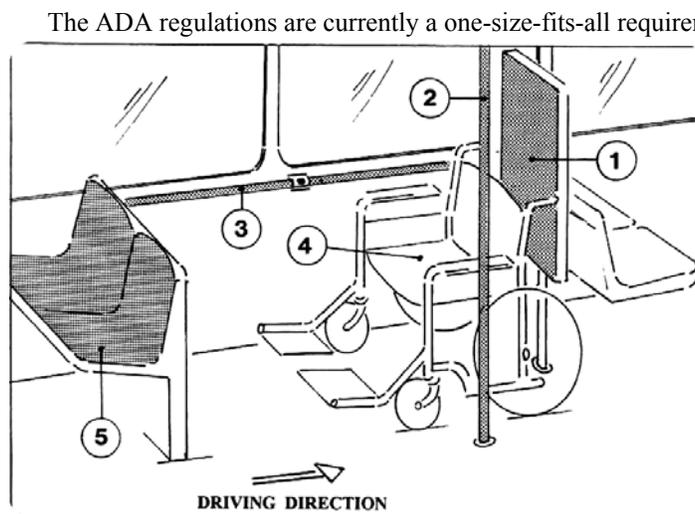
FIGURE 2 - Sketch of rear facing securement (courtesy Uwe Rutenberg) Numbered features are (1) rear-facing load bearing back rest, (2) aisle side vertical stanchion, (3) horizontal handrail, (4) rear facing wheelchair (5) rear facing general seats.

The principle benefit of the research has been a determination on the adequacy of rear facing compartment securement systems (Figure 2). Specifically, the project determined whether this type of passive securement provides acceptable levels of comfort and safety for users of wheelchairs. In addition, the project has resulted in an increase in knowledge of bus transit vehicle operating dynamics, the effect of those dynamics on passengers using wheelchairs, and detailed information that would justify less restrictive requirements for mobility aid securement.

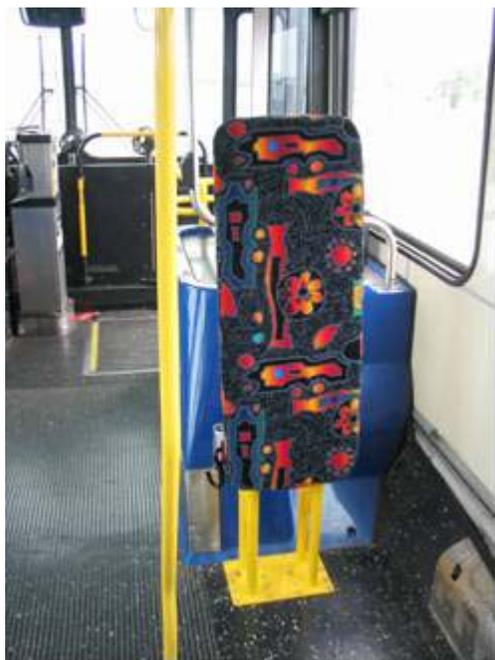
FIGURE 3 - A rear-facing securement station on a BC Transit vehicles showing the padded backrest and aisle side stanchion.

In Europe and Canada, a different concept in wheelchair securement has emerged. This consists of a padded compartment for a wheelchair in a rear facing orientation (Figure 3). The wheelchair is stationed in this compartment but there are no belts or other attachments to the chair. It should be noted, that some rear facing systems have belts available as an extra option. Currently, this concept is not considered in the U.S., due to public perceptions on rear facing and interpretation of the transportation regulations of the ADA. However, this approach appears very attractive for the innovative BRT systems which will use new transit vehicles, new modes of operation and new operating conditions.

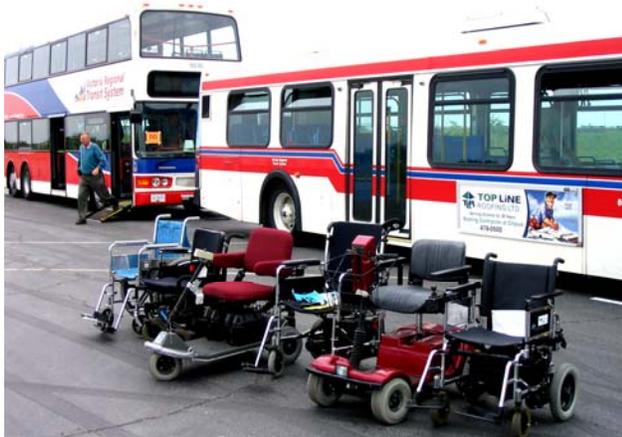
FIGURE 4 - Some of the BC Transit buses and wheelchairs used in the course of determining vehicle dynamics and the corresponding response of wheelchairs when secured in a rear facing compartment.

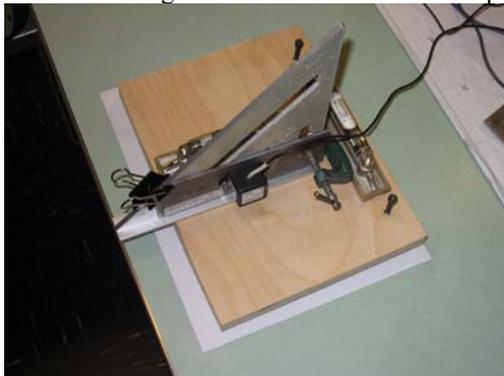
FIGURE 5 – The calibration apparatus for checking the offset voltage and calibration constant for each axis of the accelerometers.

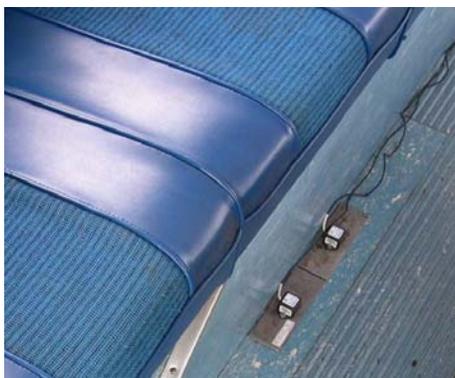
FIGURE 6 – A pair of tri-axial accelerometers mounted on the floor of a LTD bus.

The basic instrumentation consisted of accelerometers for the measurement of bus accelerations and video recording of the mobility aid response to bus accelerations. The accelerometers were Crossbow 4-g tri-axial accelerometers model CXL02LF3-R) which have a sensitivity of 2V/g and include internal supply voltage regulation. The analog output signal of the accelerometers was connected to an IOTech model 300 Logbook standalone data acquisition system. This system is capable of analog to digital (A/D) conversions at a rate of 100 kHz and it uses a 16 bit A/D converter. Both before and after testing, the accelerometer and data acquisition unit were calibrated as a package using a static calibration procedure based on accelerometer orientation. A digital format video camera was used to record mobility aid response during bus maneuvers. Figure 5 shows the calibration equipment, and Figure 6 shows the mounting of the tri-axial accelerometers.

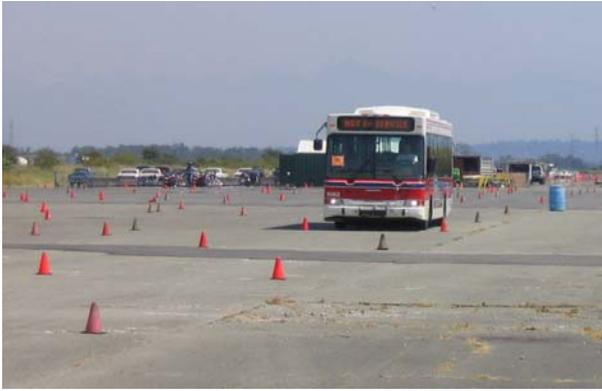
FIGURE 7 – A 35 ft low floor BC Transit bus being driven through the extreme maneuvering test track.

Extreme Maneuvering Tests- Extreme maneuvering tests were conducted in buses with no passengers. The test areas were a large open area at the Lane Transit District yard in Eugene, Oregon and a test track in Delta, British Columbia, Canada. The tests involved driving the bus on a prescribed path that included maximum accelerations, maximum turns, and maximum stops. Figure 7 shows a 35 ft low floor bus being driven through the extreme maneuvering test track.

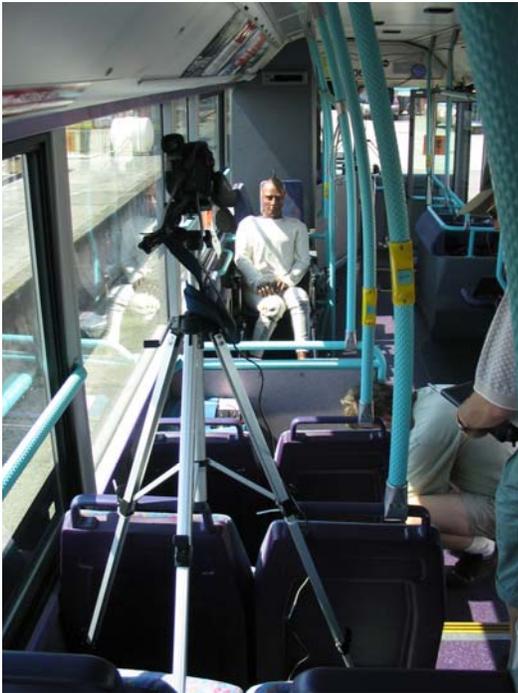
FIGURE 8 – Looking forward in a BC Transit test bus with a video camera in the foreground to record motion of the dummy seated in a rear facing manual wheelchair.

In addition, for most of the extreme maneuvering tests, wheelchairs occupied by a 50th percentile anthropometric male test dummy were positioned in either a rear or side facing securement test station. In the course of the extreme maneuvering tests, accelerations corresponding both to normal driving conditions and to extreme maneuvering were experienced. The motion of the mobility aid and test dummy to all accelerations was recorded on video for review in parallel with the measured acceleration data. Figure 8 shows the equipment set up on a test vehicle.

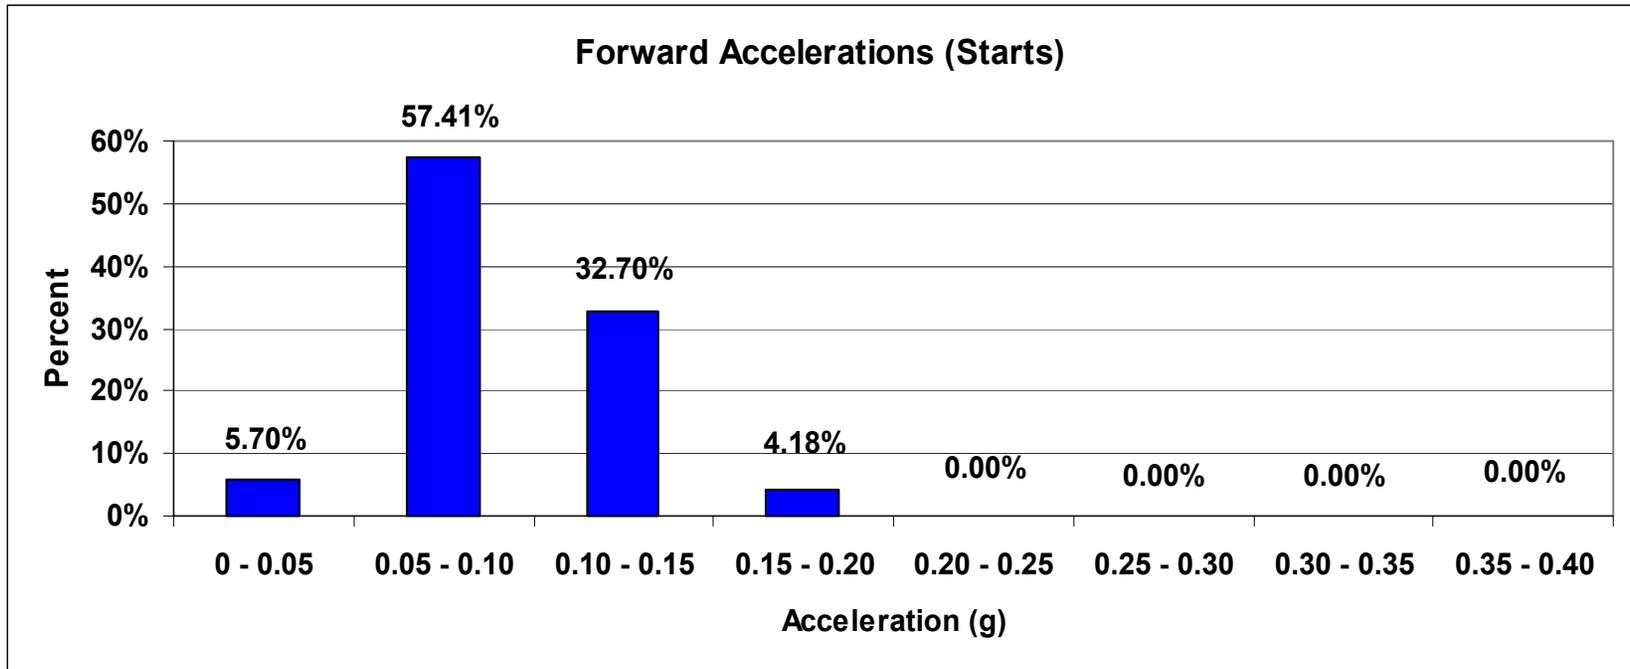
Acceleration(g)	Percent of starts
0.00 - 0.05	5.7%
0.05 - 0.10	57.4%
0.10 - 0.15	32.7%
0.15 - 0.20	4.2%
0.20 - 0.25	0.0%
0.25 - 0.30	0.0%
0.30 - 0.35	0.0%
0.35 - 0.40	0.0%

FIGURE 9 –Distribution of normal driving forward accelerations shown graphically and in a table. The accelerations are shown in units of “g” and the percentages represent the number of starts at a given acceleration out of the total of 270 accelerations that were identified in the data.

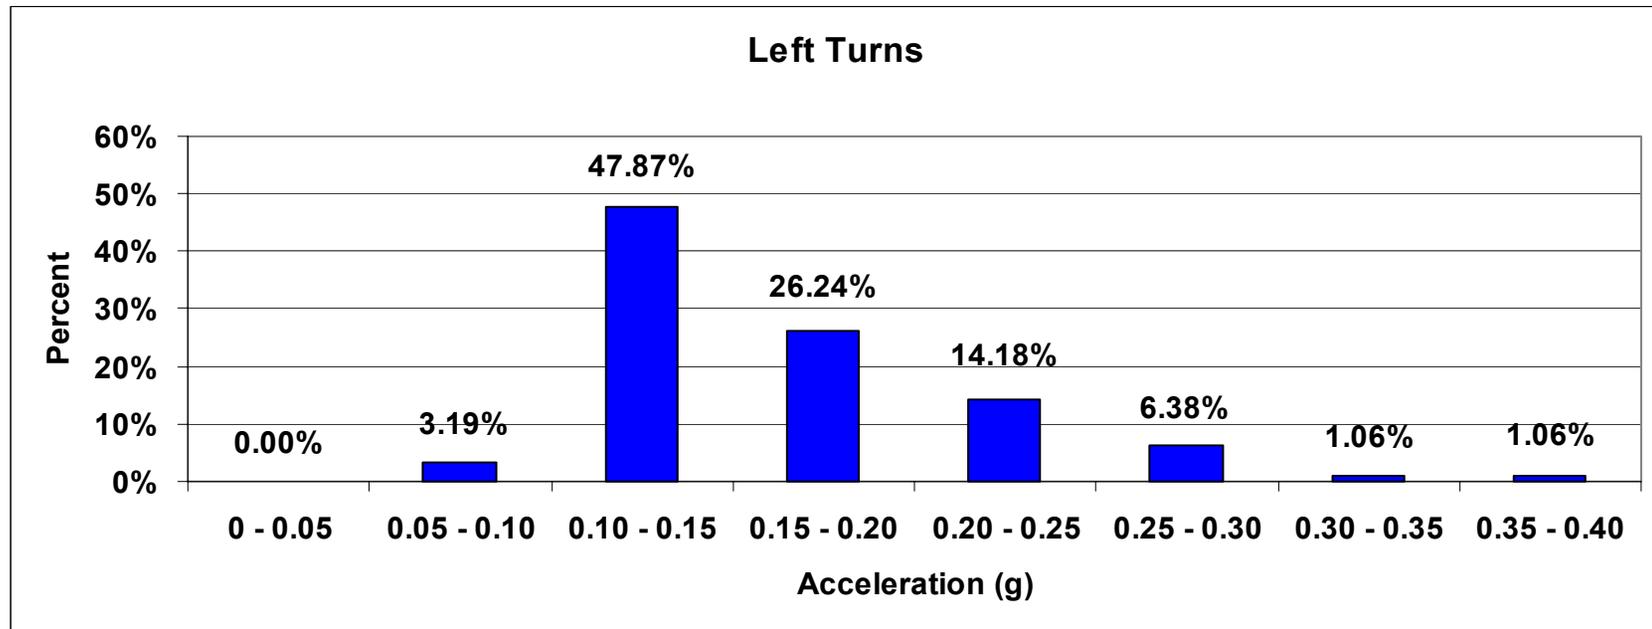
Acceleration (g)	Percent of Left Turns
0.00 - 0.05	0.0%
0.05 - 0.10	3.2%
0.10 - 0.15	47.9%
0.15 - 0.20	26.2%
0.20 - 0.25	14.2%
0.25 - 0.30	6.4%
0.30 - 0.35	1.1%
0.35 - 0.40	1.1%

FIGURE 10 – Distribution of normal driving left turn accelerations shown graphically and in a table. The percentages shown are out of the total of 282 left turns identified in the data.

In general, turns can be expected to generate accelerations somewhere between 0.1 and 0.3g. It is interesting to note that the distribution is nearly identical for left turns and right turns. There was speculation by drivers that right turns would be shifted towards the lower end. The rationale was that right turns would be slower than left turns because a typical city block has a curb and a pole at the corner around which the bus must go when turning right. In transportation engineering terms, the radius of curvature for right turn is much smaller, or tighter than the radius of curvature for a left turn.

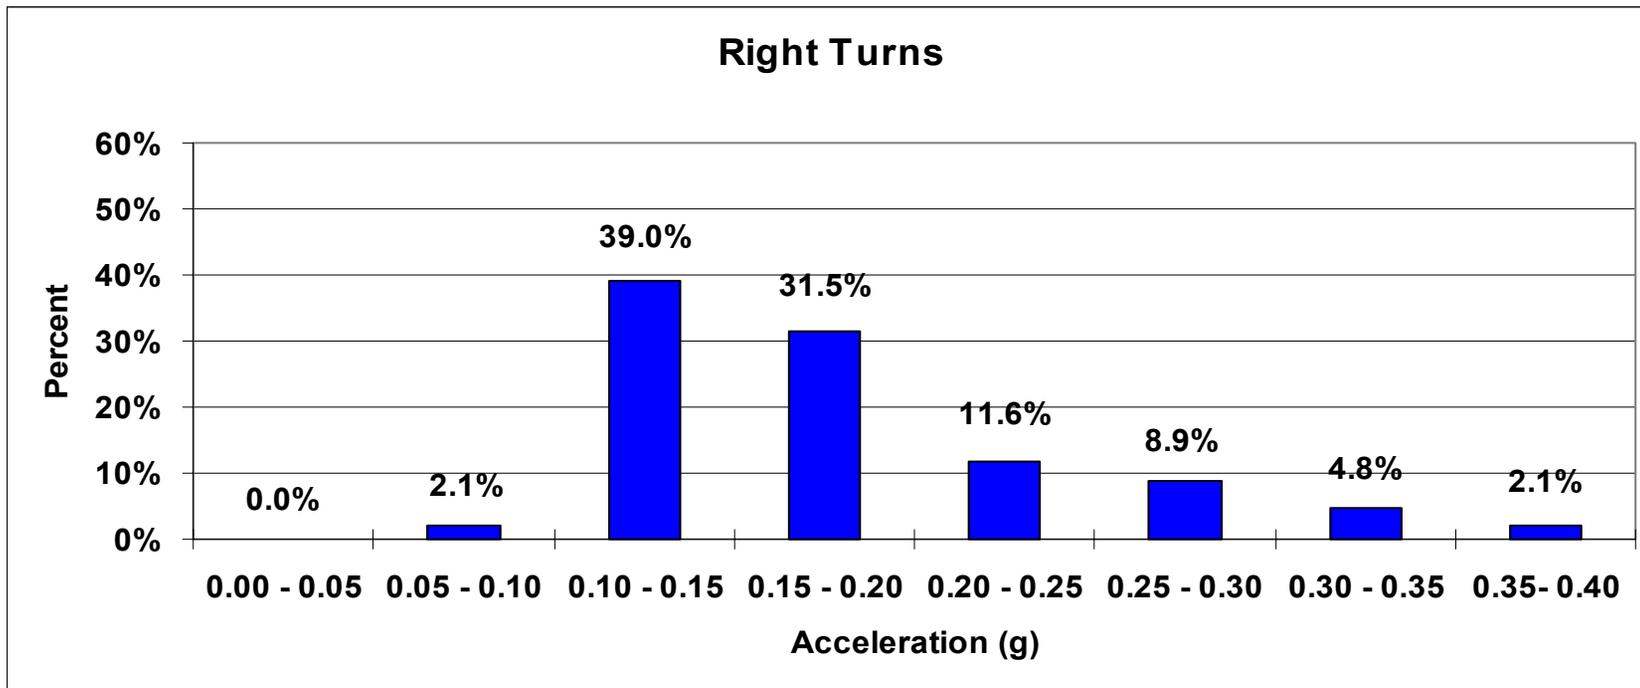
Acceleration (g)	Percent of Right Turns
0.00 – 0.05	0.0%
0.05 – 0.10	2.1%
0.10 – 0.15	39.0%
0.15 – 0.20	31.5%
0.20 – 0.25	11.6%
0.25 – 0.30	8.9%
0.30 – 0.35	4.8%
0.35- 0.40	2.1%

FIGURE 11 - Distribution of normal driving right turn accelerations shown graphically and in a table. The percentages shown are out of the total of 146 right turns identified in the data

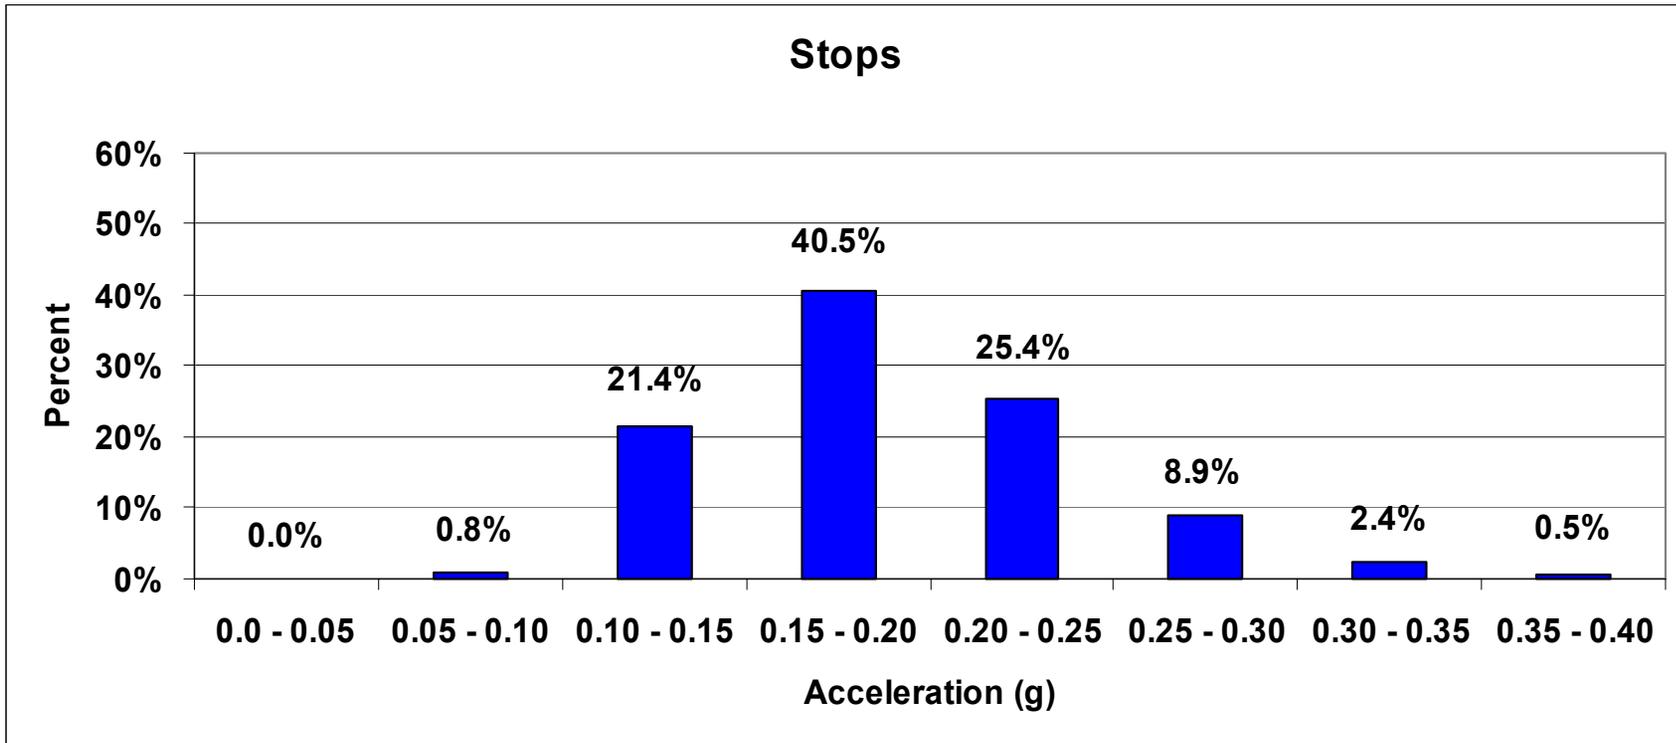
FIGURE 12 - Distribution of normal driving decelerations (stopping or slowing down) shown graphically and in a table. The percentages shown are out of the total of 370 decelerations identified in the data.

Accel.(g)	Percent of Stops
0.0 - 0.05	0.0%
0.05 - 0.10	0.8%
0.10 - 0.15	21.4%
0.15 - 0.20	40.5%
0.20 - 0.25	25.4%
0.25 - 0.30	8.9%
0.30 - 0.35	2.4%
0.35 - 0.40	0.5%

Stops were expected to result in the strongest accelerations but, as can be seen by comparing Figure 12 with the previous two figures, stopping acceleration is in the same range as accelerations for turns. In fact, except for starting accelerations which are limited by the bus power train, all accelerations which are controlled by the driver are remarkably similar. Based on the data collected for these normal driving accelerations, a summary of maximum and average accelerations for each direction were developed and are shown in Table 2.

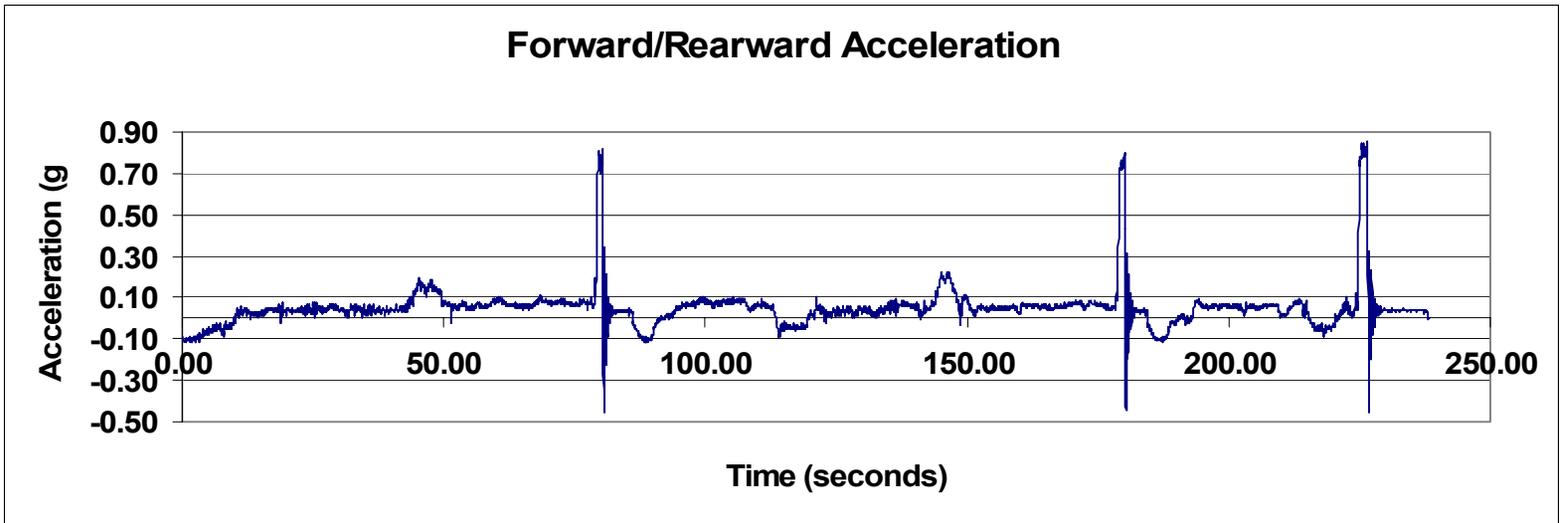
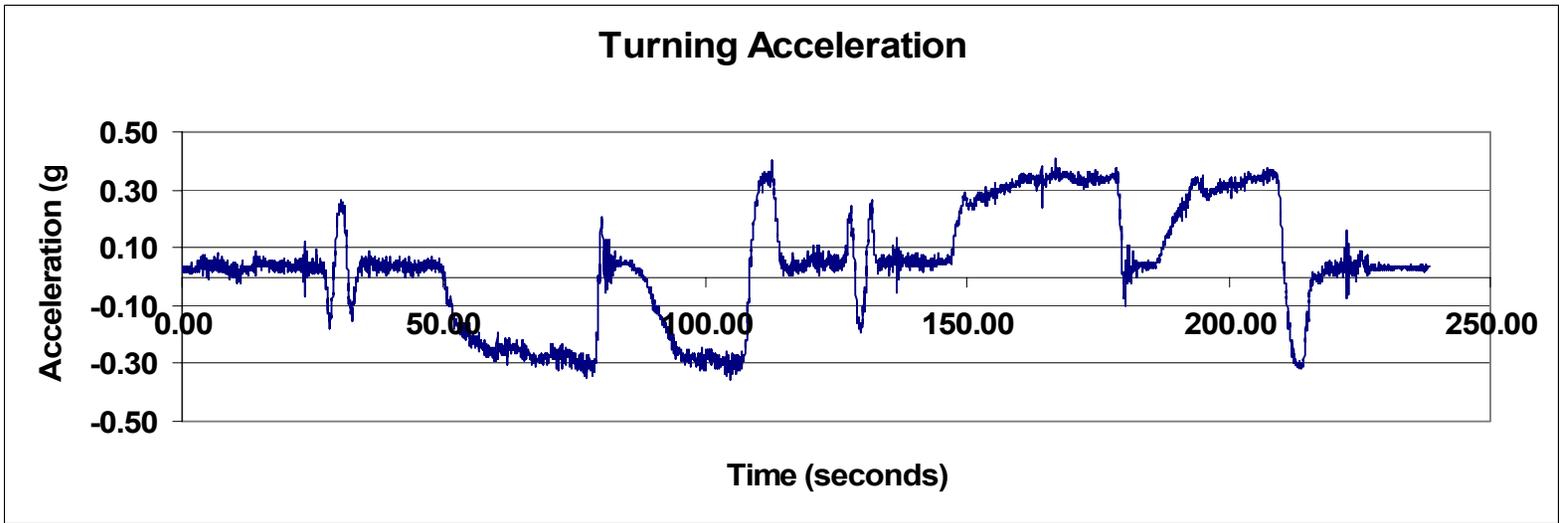
FIGURE 13 – An example record of accelerations from an extreme maneuvering test. In the top plot positive values of “g” correspond to bus decelerations and vice versa. In the bottom plot positive values of “g” correspond to left turns and negative values of “g” correspond to right turns.

In contrast to the normal driving tests, the events of interest were very clearly identified in these extreme maneuvering tests. No manual logging of events was necessary as each event was easily identified from the accelerometer recordings. A sample of the reduced data from one run on the B.C. track is shown in Figure 13. The top plot is of acceleration along the primary axis of the bus. That is to say, it is a track of forward/rearward accelerations. On this plot negative values correspond to the bus accelerating forward and positive values correspond to decelerations (slowing or stopping). The lower plot is of side accelerations. In this plot negative values correspond to right turns and positive values correspond to left turns. These plots are for the same run so there is a direct correspondence between the top and bottom curves.

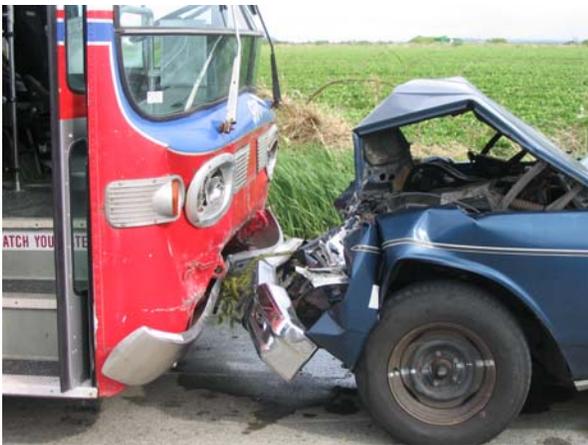
FIGURE 14 – The car and bus (rolled back into pre-crash position) showing the damage resulting from a 30mph full frontal crash. (BC Transit)

As can be seen in Figure 14, the bus was damaged as a result of the collision, but the majority of the crash energy was dissipated in crushing the front end of the car. In fact, the bus was drivable after the crash test although the steering system had been damaged. Following the impact, the unbraked bus rolled backwards at a speed of several feet per second until its progress was stopped by an attached safety cable. The car did not move following the impact.

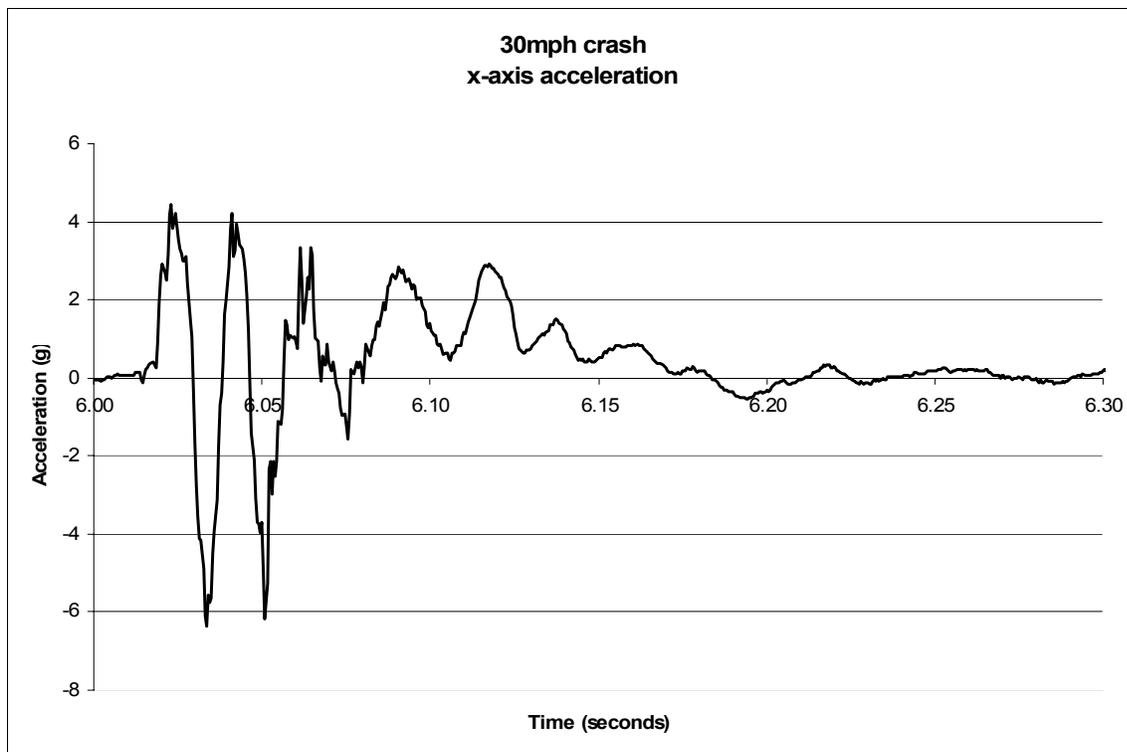
FIGURE 15 - A time history of the floor acceleration of a large urban transit bus. The plot starts immediately prior to impact in a 30mph full frontal crash with an automobile. This curve differs greatly from a typical sled test simulation. (Courtesy Innovative Vehicle Testing, Ltd., Delta, B.C., Canada)

The acceleration of the bus floor was recorded at a rate of 2kHz (one reading every 0.0005sec). After reducing the raw data a plot of acceleration as a function of time was prepared. This plot is shown in Figure 15. The features of this plot that should command the attention of anyone involved in securement are that (a) the accelerations are substantially lower than the standard of 20g currently in use, (b) the actual acceleration resulting from a crash is not a simple rectangle as is usually used in sled test simulations of crashes, and (c) on impact the bus frame appears to ring at a frequency of about 45 Hz

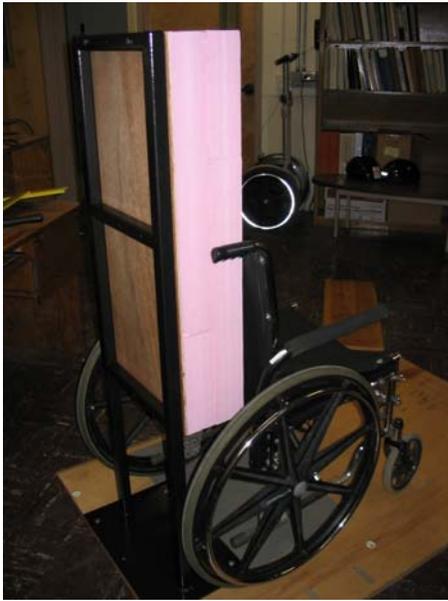
FIGURE 16 – Construction of the backrest used in rear facing Securement tests. A steel frame was built and welded to a base plate. The wheelchair contact plane is moved away from the frame using foam to allow lower portions of the wheelchair to fit.

For testing purposes, the backrest was mounted on a plywood base which had been marked with a grid to aid in monitoring wheelchair movement both during the tests and when reviewing video of the tests. This base also had an area of very high friction boat decking material located in the area of the the rear wheels of the wheelchair. The entire assembly was then mounted in in an open area near the front of the bus (Figure 17). This allowed testing of the backrest

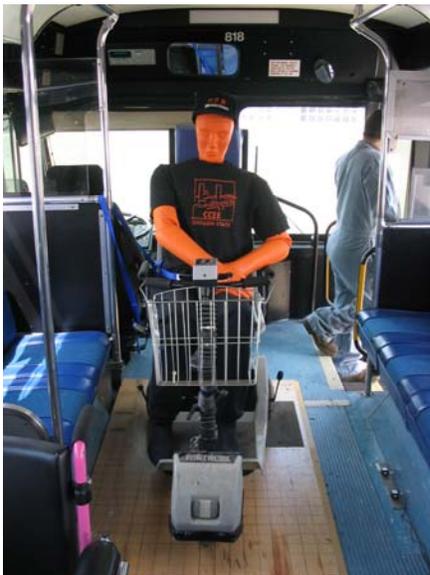
FIGURE 17 – Test dummy in Three-Wheel Scooter backed against rear-facing securement backstop mounted in center aisle of LTD bus.

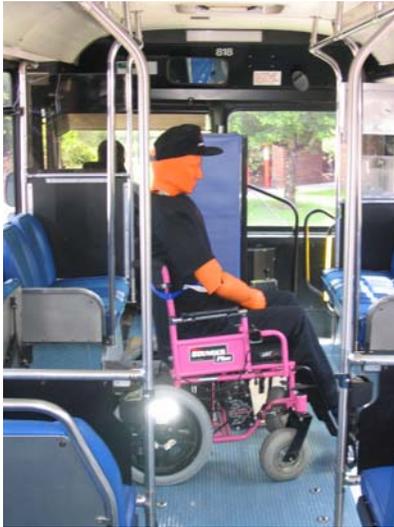
FIGURE 18 – The power wheelchair in position for side facing tests. No rear, forward, or right side constraints were used for this test of a simplest possible side facing securement station. (LTD Vehicle)

On completion of the initial rear facing tests, a set of side facing tests was conducted. The backrest used for rear facing was moved to a position where it would simulate a wall at the front of a side facing securement station. The wheelchairs were then placed facing the right side of the bus with the torso of the tests dummy lined up with the simulated wall as shown in Figure 18.

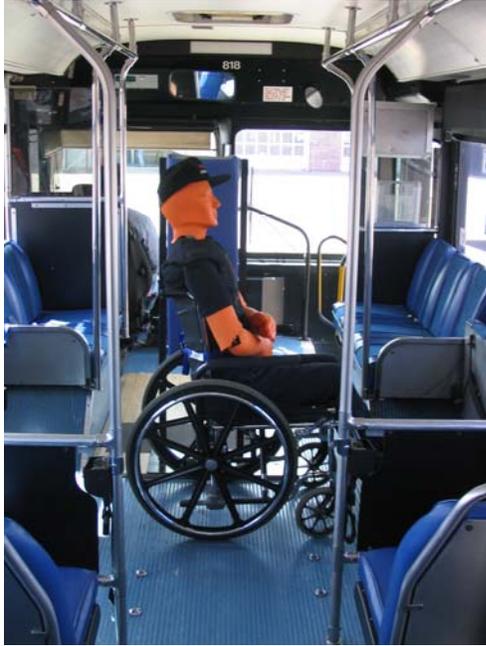
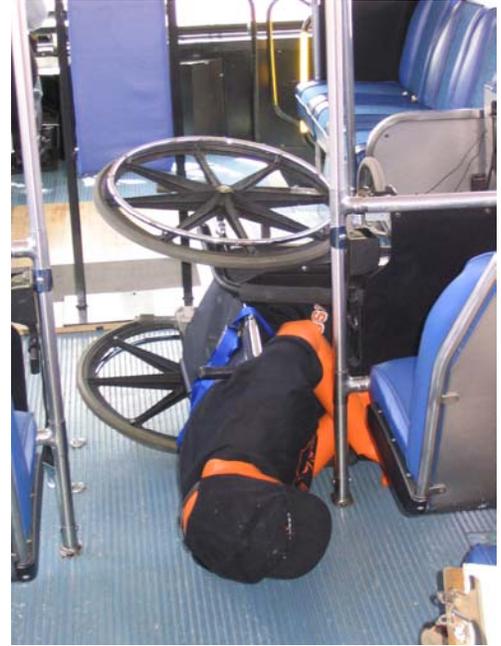
FIGURE 19 – The results of a panic stop when a manual wheelchair occupied by a test dummy is side facing and has only a forward wall for “Securement.” The manual chair did not move appreciably during the actual stop (left) but it tipped over on its side during the forward acceleration due to the bus suspension system rebound (right).(LTD vehicle)

- During a maximum bus acceleration there was no observed movement of the wheelchair.
- During left turns the wheelchair slid forward across the floor (wheels were not turning). Right turns were not tested because a simple pull test showed that this wheelchair would tip over backwards even sooner than the scooter.
- Stops, as with the scooter, occurred in two parts. During the stopping phase, the wheelchair would tip forward against the wall but enough for the wheels towards the rear of the bus to lift up. It also tended to rotate towards a forward facing position during the stop phase. The second part of the stop was forward acceleration due to the rebound of the bus suspension system. As a result of the rebound, the manual wheelchair tipped over on its side (Figure 19).

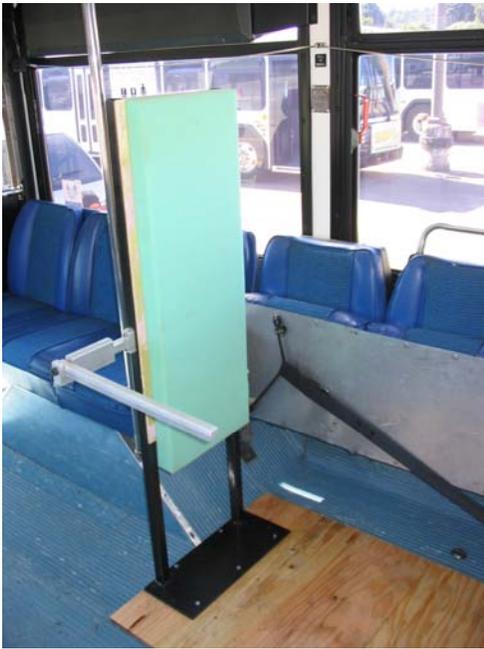
Figure 20 -A rear facing wheelchair securement station with a movable armrest. It is mounted immediately behind a wheel well in the LTD test bus.

Following the side facing tests, the rear facing system was modified to include an 18 inch long aisle-side movable armrest at a height of 30 inches above the floor. The armrest could be moved from its normal horizontal position to a vertical position to maximize the wheelchair maneuvering room available for entering the securement station. In a second modification, the depth of the foam backing was decreased from 8 inches to 3 inches to maximize the available space (length) in the securement station. This modified system was mounted on a temporary plywood base in an existing securement station on the test bus (Figure 20).
