Low Cost Steel Bridge Pile Inspection Technology

Final Report for High-Speed Rail IDEA Project 57

Prepared by:
Thomas R. Hay
WavesinSolids LLC
State College, PA

October 2009

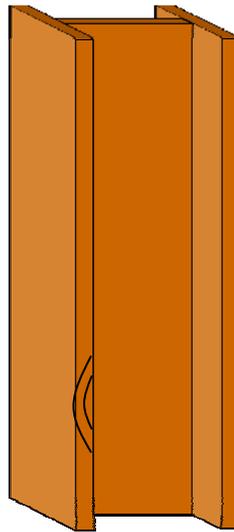
Inspection of bridge piles on a regular basis for the presence of defects is essential for the long term safety of bridge infrastructure over water. Currently these inspections are done visually and in the case of submerged piles, divers perform these inspections. Current pile inspection approaches are highly subjective and will vary depending on inspector training, skill and experience. In many cases, significant sections of pile can not be visually inspected since they are submerged in environments that prevent visual inspection. H-pile wall loss is of primary concern in aerobic water zones. Aerobic zones are those that exist only in the presence of air or free oxygen. Therefore, these zones are found near the water surface. The most severe wall loss is typically observed on the section of H-pile that experiences the most aerobic cycles. A description of common wall loss is shown in Figures 1. Wall loss commonly initiates towards the edge of the H-pile flange and is semi-circular in shape. The most severe wall loss is commonly towards the edge. Wall loss decreases towards middle of the beam. Wall loss is observed on the top and bottom surfaces of the flange.

FIGURE 1 Common Wall loss in H-pile

The following sources/mechanisms are common causes of and accelerators of wall loss:

- Submersion and oxidation cycles in aerobic zones
- Impact damage
- Tannic acid in water due to local vegetation run-off
- Acid rain
- Coastal zone fusion
- The sand blast effect on submerged h-pile in rivers accelerates wall loss. Flanges are particularly susceptible to this effect since 99% of flanges are perpendicular to the track and are therefore parallel to the river current

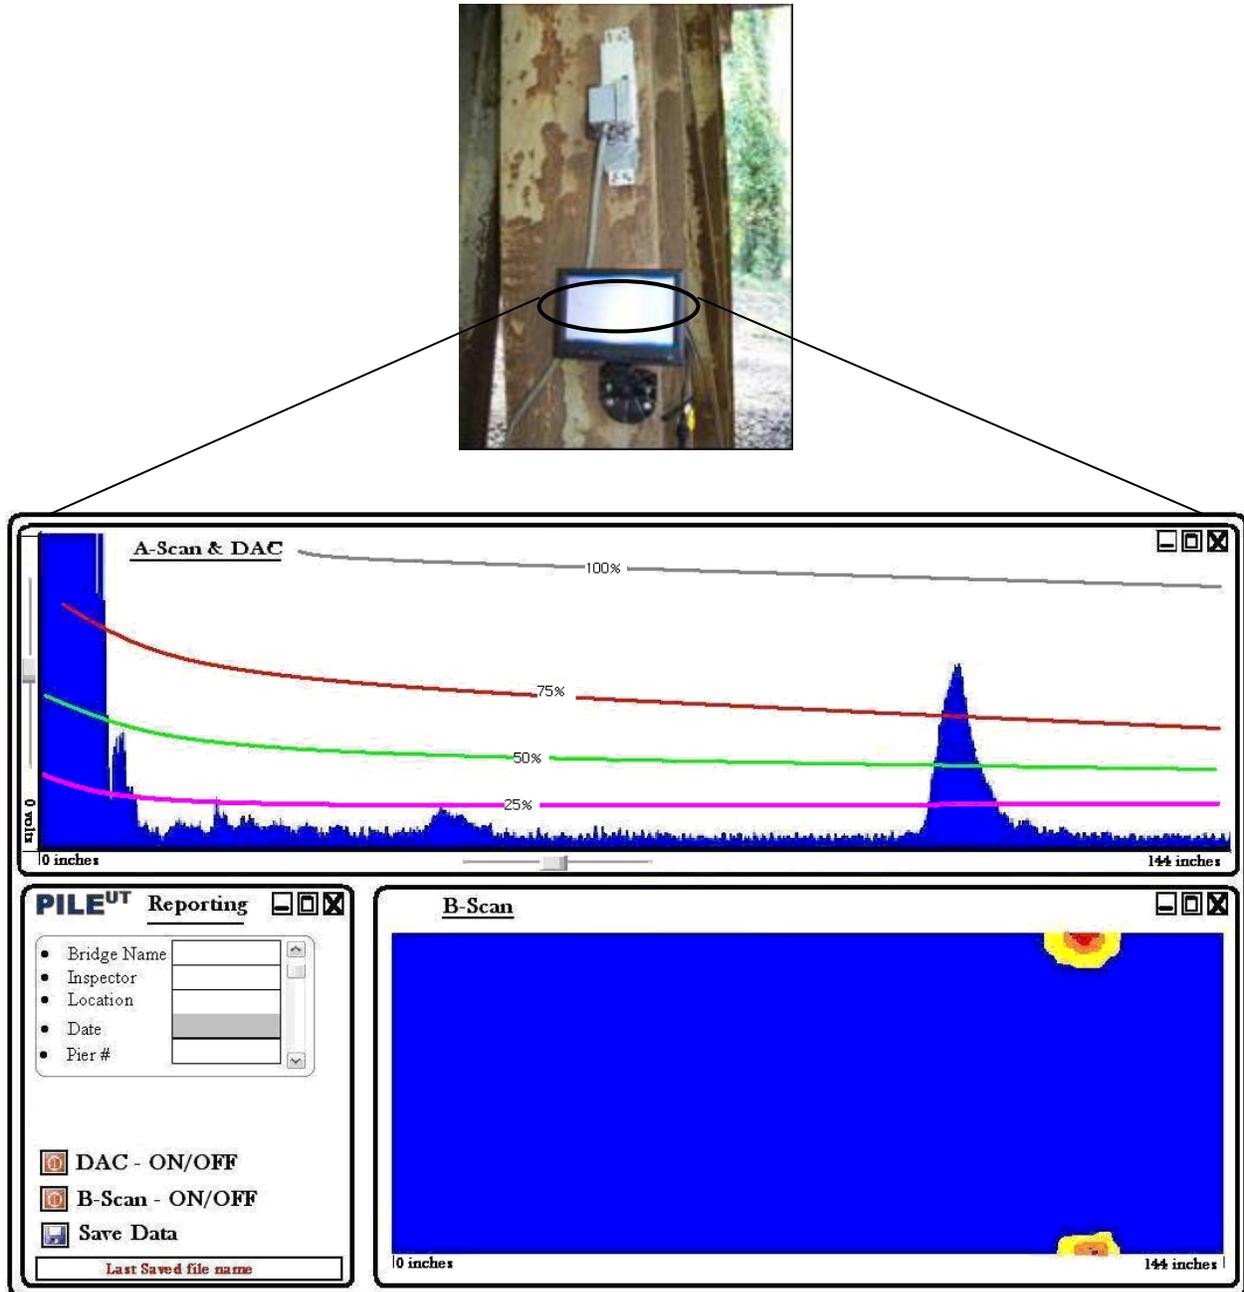
The ultimate goal of this project was to develop a technology based on long range ultrasound using EMATs for not just the detection of wall loss in H-piles but also its characterization. WavesinSolids, as a result of this project, has developed a commercial prototype of an EMAT scanner capable of inspecting the H-pile for wall loss and characterize the wall losses as 75%, 50 % and 25%. 100% wall loss indicates an H-pile end or complete break. The Distance-Amplitude Correction (DAC) curves generated from observed field data for different amounts of wall loss are overlaid on the signal reflected from wall loss. This provides a quick and easy way for the bridge inspector to interpret the data and identify the amount of wall loss. The scan along the width of the H-pile provides a 2-D display of the H-pile flange scanned with color coded depiction of wall loss.

FIGURE 2 Description of IDEA product

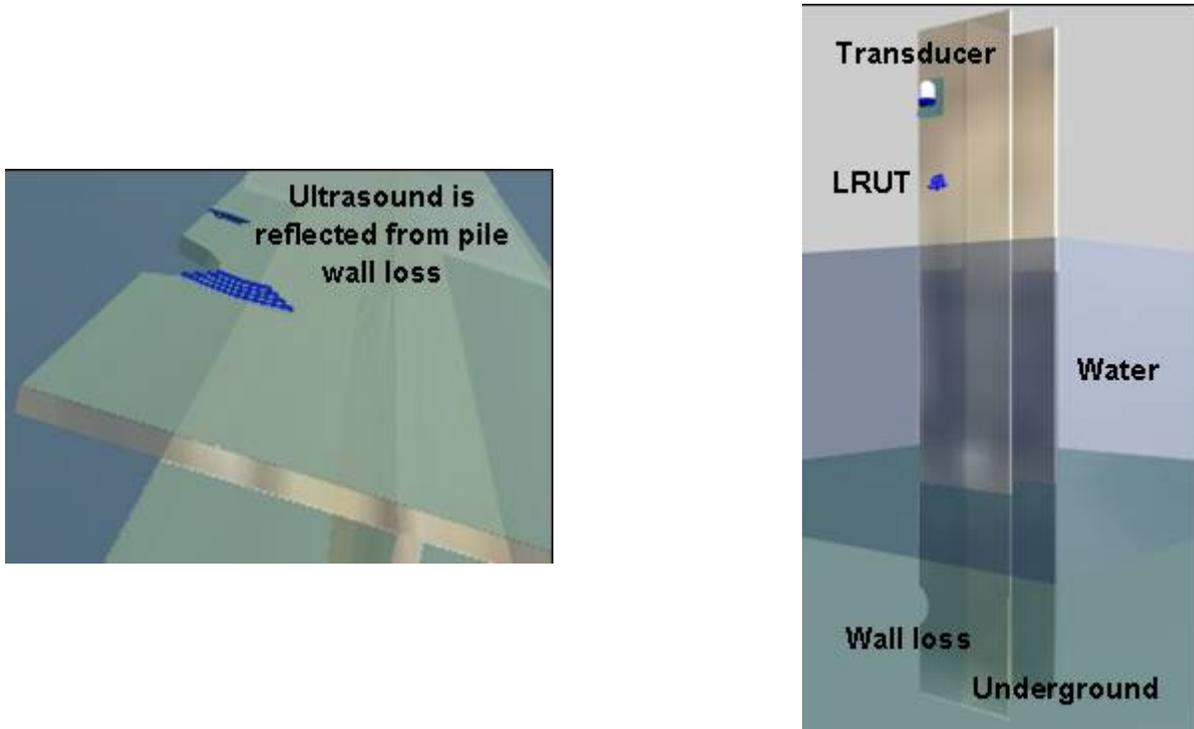
Using WavesInSolids' LRUT inspection technology, it is possible to inspect submerged pile from above the water line. Current methods for underwater inspection of submerged bridge structures require that divers visually inspect 100% of the underwater structures. The developed technology will be cost-effective because it minimizes the requirement to send divers underwater to inspect all piles for wall loss or failure. The inspection principle using LRUT is illustrated in Figure 3. Guided wave transducers (EMATs) are mounted above the waterline. LRUT is generated above the waterline and then travels underwater then underground. Where wall loss is present, ultrasound is partially reflected backwards and transmitted forward. The reflected ultrasound locates and sizes the wall loss. This TRB project is the first effort to apply guided wave ultrasound to H-pile inspection.

FIGURE 3 H-pile inspection principle using long range ultrasound generated by EMATs

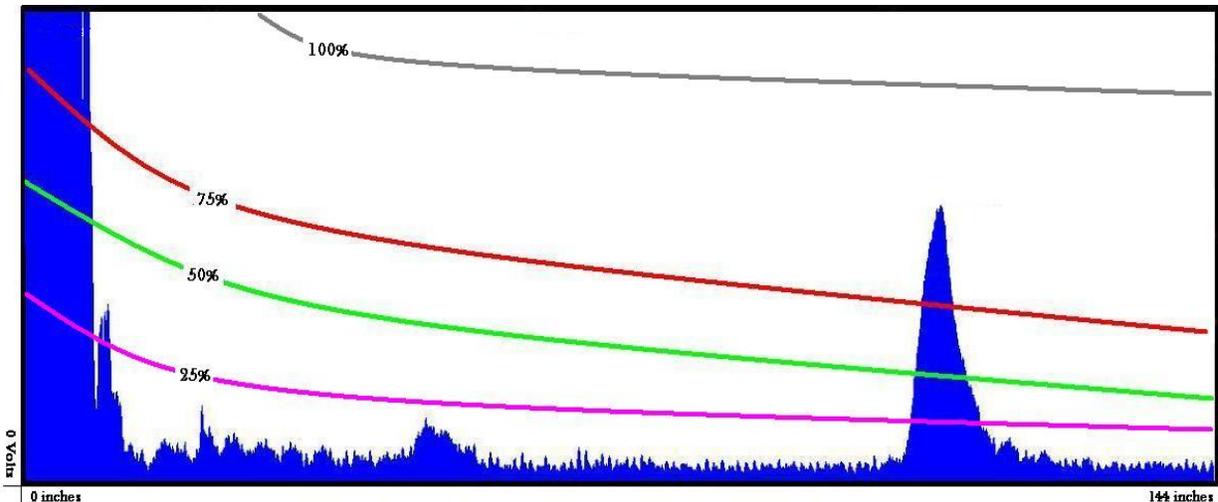
The objective of the inspection is not only to detect wall loss in H-piles but also to characterize it in terms of 25%, 50%, 75% and 100% wall loss. The ability to characterize wall loss is accomplished using Distance Amplitude Correction (DAC) curves for each wall loss category. DAC curves are calculated using experimental data from known wall loss. For instance, to generate the 50% DAC curve data were acquired from more than 10 pile flanges with approximately 50% wall loss at sensor-to-wall loss distances ranging from 18 to 100 inches. The amplitudes of the reflections were used to generate the 50% wall loss DAC. The same procedure was used for the 25%, 75% and 100% wall loss scenarios. Once the DACs are superimposed on to the amplitude scan (A-scan), interpretation becomes quick and easy. In Figure 4, a reflection exceeds the 75% wall loss DAC at approximately 100 inches. This means there is 75% wall loss at 100 inches from the sensor location.

FIGURE 4 H-pile data interpretation procedure to characterize wall loss

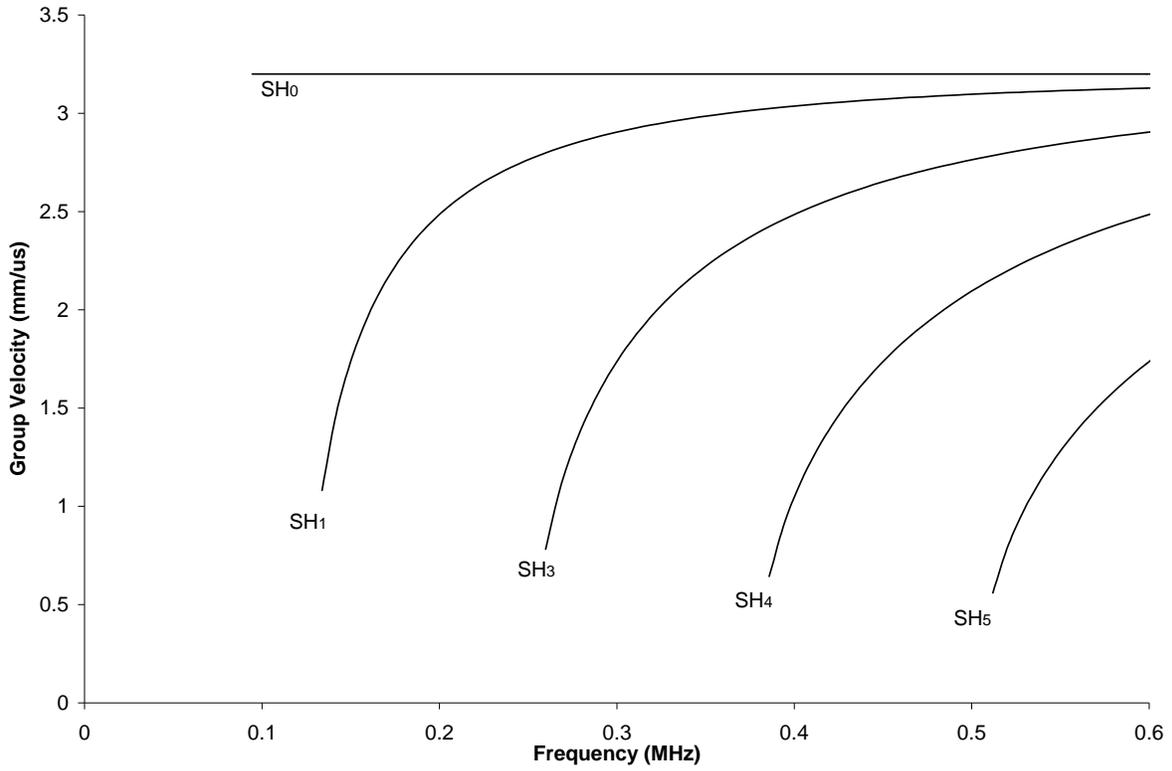
H-pile inspection with long-range ultrasound starts with modeling sound propagation. The wave mechanics model outputs the group and phase velocity dispersion curves. The dispersion curves provide information on the velocity at which modes travel, their dispersive nature, and the generation of different modes at different frequencies. The dispersion curves for steel H-pile are shown in Figures 5 and 6. The dispersion curves show that inspection will occur in the 0.1 to 0.6 MHz range. The SH-waves are non-dispersive where they approach a flat horizontal line. The expected wave velocities, which will be used for defect location, range from 2 mm/us to 5 mm/us. The curves shown are the basis for sensor design and inspection data interpretation.

FIGURE 5 SH-wave group velocity dispersion curves for 12.5-mm thick H-pile

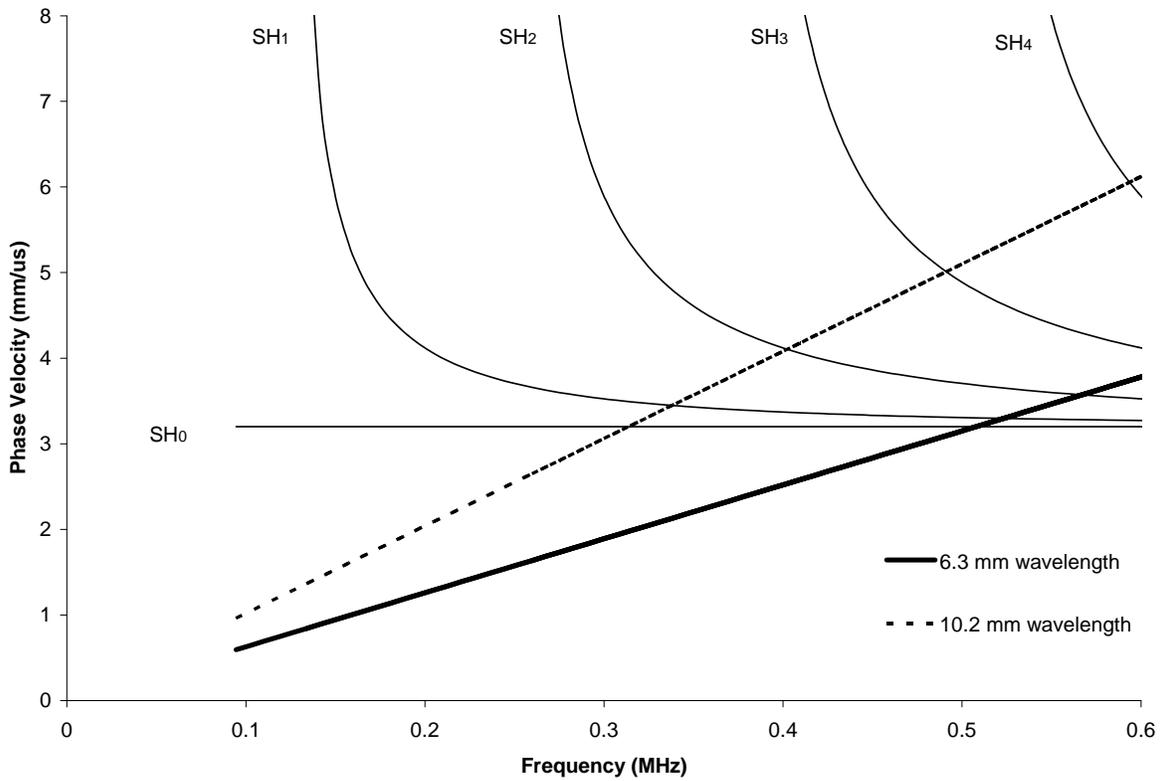
FIGURE 6 SH-wave phase velocity dispersion curves for 12.5-mm thick H-pile showing the 10.2 and 6.3 mm wavelength activation lines.

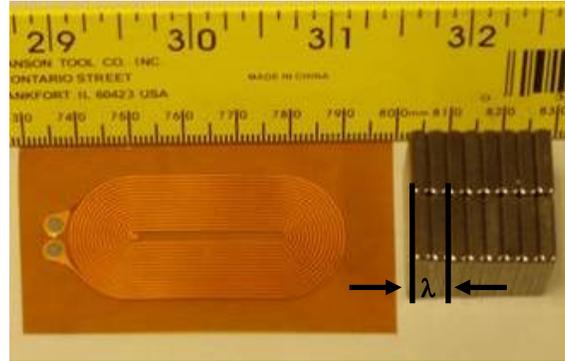
A custom SH EMAT coil and magnet set, for testing steel H-pile, is shown in Figure 7. The coil pattern is etched on to both sides of flexible Kapton, a polyimide insulating material. Note that the same coil may be used with different sets of magnets. The thicker magnets sets are used to generate lower frequency (larger wavelength) guided waves. For example, the 6 mm wavelength (λ) of the generated wave is determined by the 3mm magnet width.

FIGURE 7 SH EMAT coil and magnets placed on top of coil to generate guided waves in H-pile

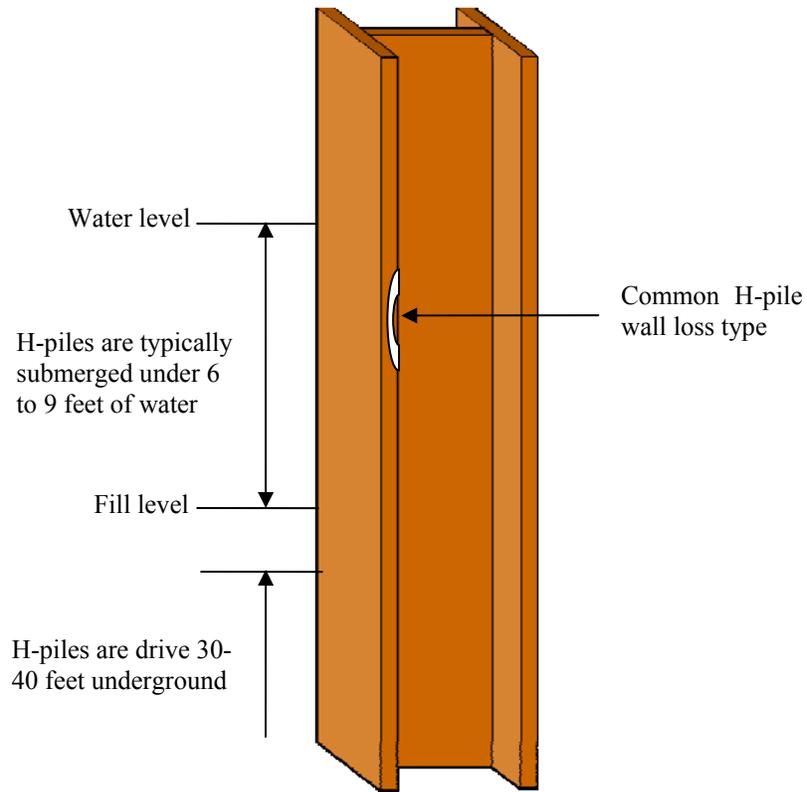
The inspection requirements are defined in terms of the submerged H-pile length to be inspected and the, wall loss size, and shape to be detected. The inspection requirements are listed in Table 1 and depicted in Figure 8. Inspection obstacles, including welded repairs and diagonal H-pile reinforcements, were to be identified as well. The inspection requirements were determined and documented after visits to bridge pile locations in Alabama, and also from helpful discussions with Mr. Willie Benton, and Assistant Bridge Engineer for NSCORP.

FIGURE 8 Description of inspection requirements specifications

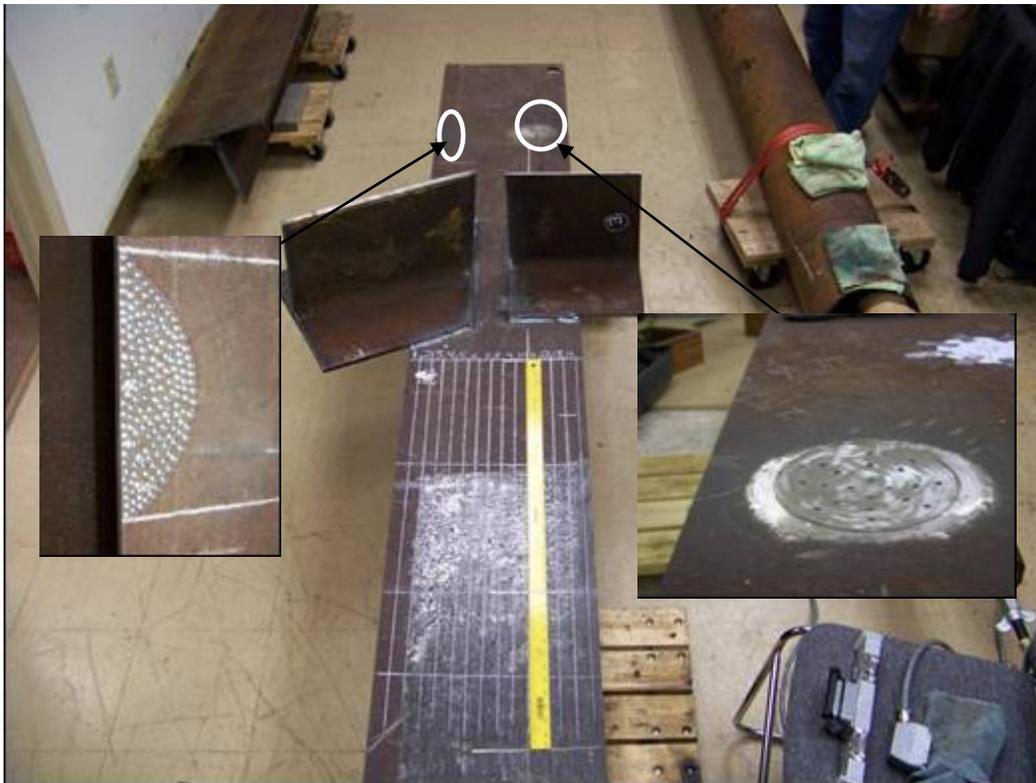
Two H-pile sections were obtained from NSCORP. The first was a 10-foot section with a weld at approximately 4 feet from one end. Simulated defects were inserted in this specimen to determine if the LRUT technology can detect wall loss beyond a weld. On the second H-pile section, horizontal and diagonal H-Pile braces were welded to it on opposite sides (Figure 9). This specimen was used to determine if the LRUT technology can detect defects beyond braces and reinforcements. The diagonal brace was oriented at 45° to the longitudinal axis of the pile and was welded 5 inches into the flange. The horizontal brace was welded on to the pile at the same location with its edge located roughly 6 inches from the pile edge. In this specimen, simulated wall loss was inserted at the locations circled in Figure 9. The edge wall loss behind the diagonal brace measured 9 in. (L) x 3 in. (W). The circular wall loss behind the horizontal brace is of 4 inch diameter. The spliced pile and wall loss beyond the splice is shown in Figure 10. The circular wall loss behind the splice was 4 inches in diameter. Experiments were conducted for submerged piles as well (Figure 11). Drums of 9 feet height and 60 gallon capacity were used. There were two wall loss sections inserted at the middle and edge of the flange. The middle (circular) wall loss in the submerged pile was of 4-inch diameter. The wall loss at the edge of the flange measured 6 in. (L) by 3 in. (W). All wall loss was roughly 50% of the pile wall thickness or 0.25-inch deep.

FIGURE 9 H-pile specimen with welded diagonal and horizontal braces (The locations of simulated wall loss beyond the braces are circled)

The objectives of these tests were to confirm that the long-rang ultrasound generated from above the pile bracing could penetrate through the bracing to detect a 50% wall loss beyond the bracing. Sample data from the braced pile are shown in Figure 12 for (a) edge and (b) interior wall loss, respectively. The wall loss was successfully identified (boxed) by the software as shown in these figures. The data shown was acquired at 66 inches from the wall loss. The bracings shown in Figure 9 were located approximately midway to the wall loss.

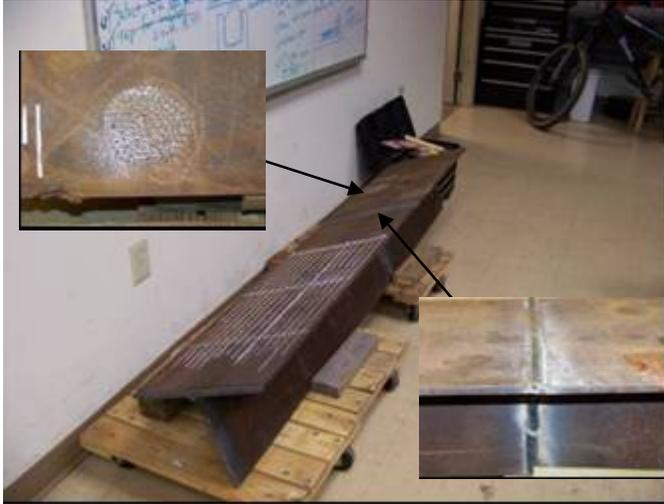
FIGURE 10 Spliced pile with wall loss located beyond the defect

Testing was conducted to determine if long range ultrasound could penetrate through splices to detect wall loss beyond the splice. The full splice used for testing is shown in Figure 10. Sample data from the spliced pile is shown in Figure 13. The reflection from the simulated wall loss is observed at 48” from the scanner. The splice was located midway between the scanner and wall loss. The reflection from the wall loss is shown boxed in Figure 13 and is clearly observable above the baseline noise.

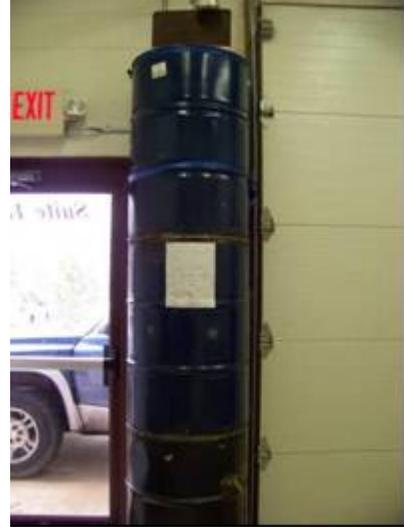
FIGURE 11 Submerged pile

Testing was undertaken on the submerged pile in a 9-foot drum which was filled with local creek water. Wall loss was machined into the H-pile. Data was acquired from the pile at different water levels to study the attenuation effect of the water. Data are presented here at minimum and maximum water depths for both wall losses. Data are presented for the edge wall loss in Figure 14. The distance to the defect from the scanner was 85 inches. The wall loss was 17 inches below the water level. The data shows that the ultrasonic wave attenuation in water is negligible, ~ 0.31 dB. Similar results are observed in Figure 15 for the circular wall loss. The data in Figure 15 was acquired at submerged depths of 40 inches. Again, negligible attenuation of the ultrasound reflected from the wall loss was observed, ~ 0.29 dB.

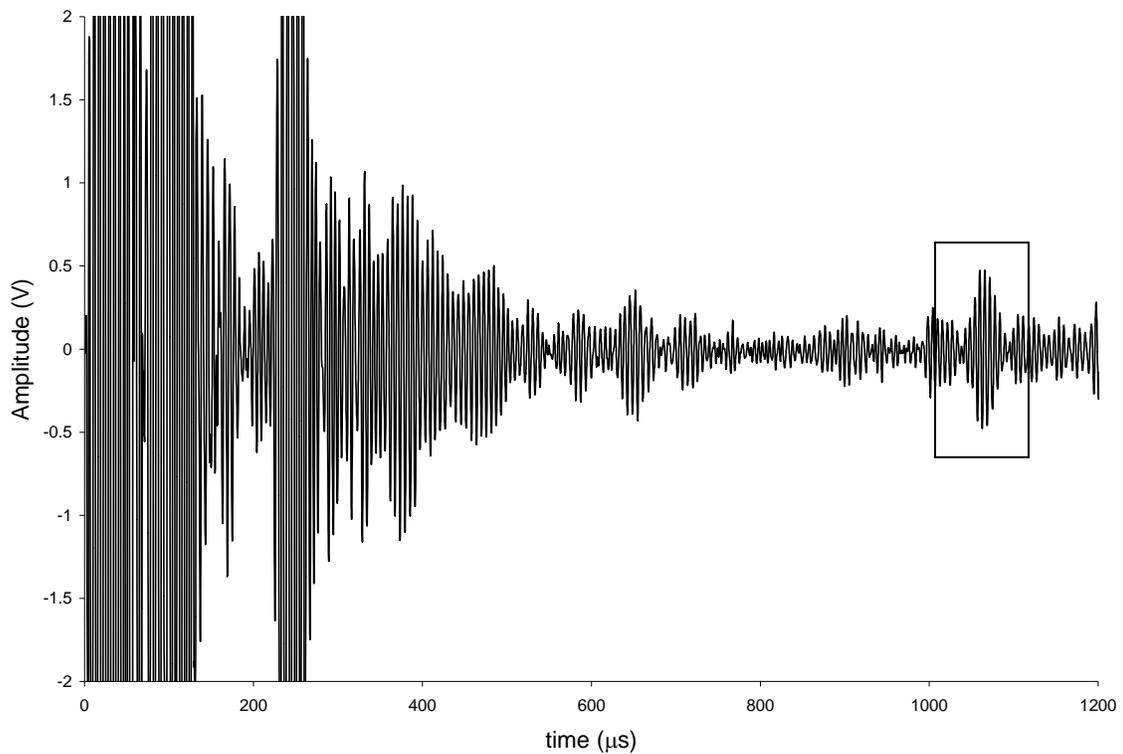
FIGURE 12(a) Edge wall loss detection through the diagonal braces from 66 inches away

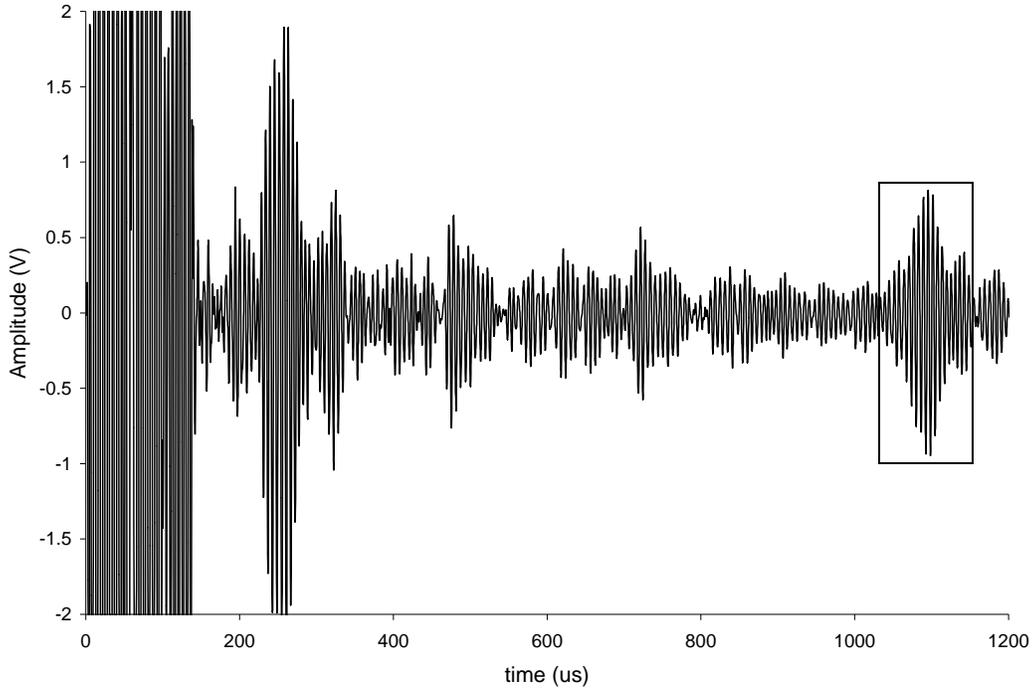
FIGURE 12(b) Circular wall loss detection through the diagonal braces from 66 inches

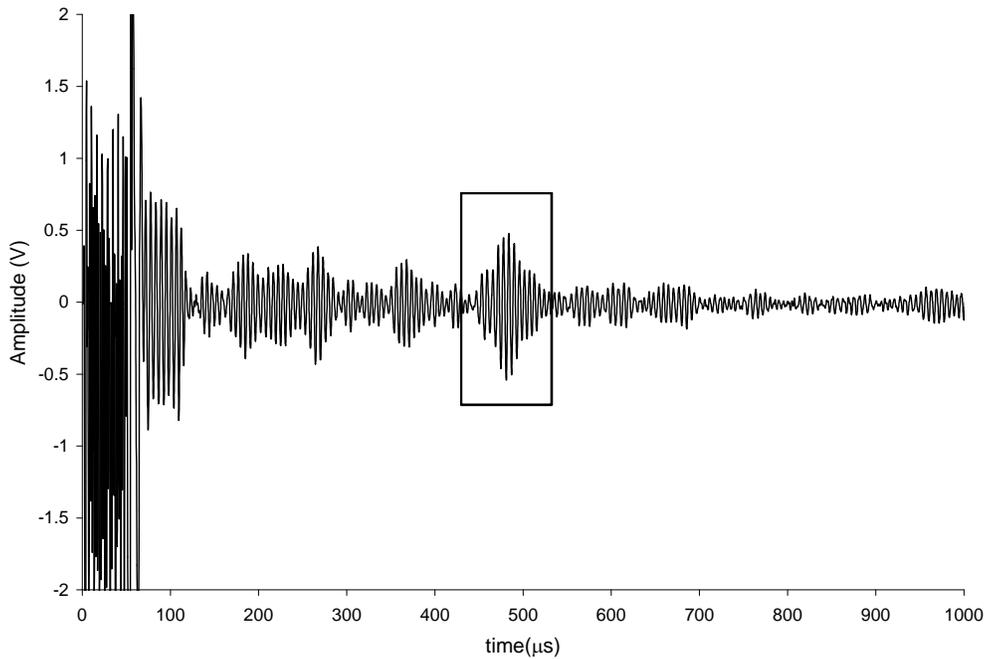
FIGURE 13 Circular wall loss detection through splice from 48 inches

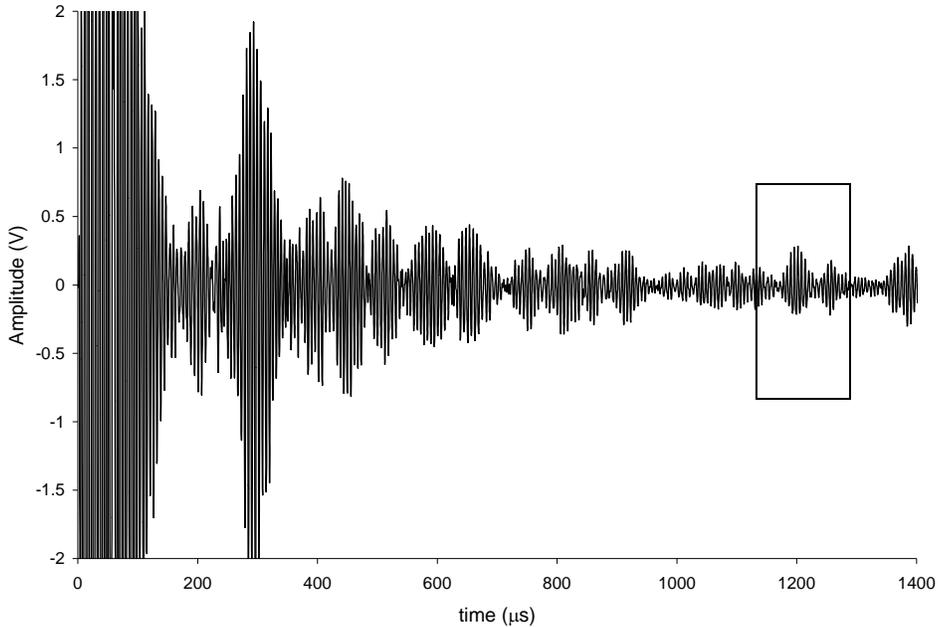
FIGURE 14 Detection of edge wall loss 85 inches away from scanner through 17 inches of water

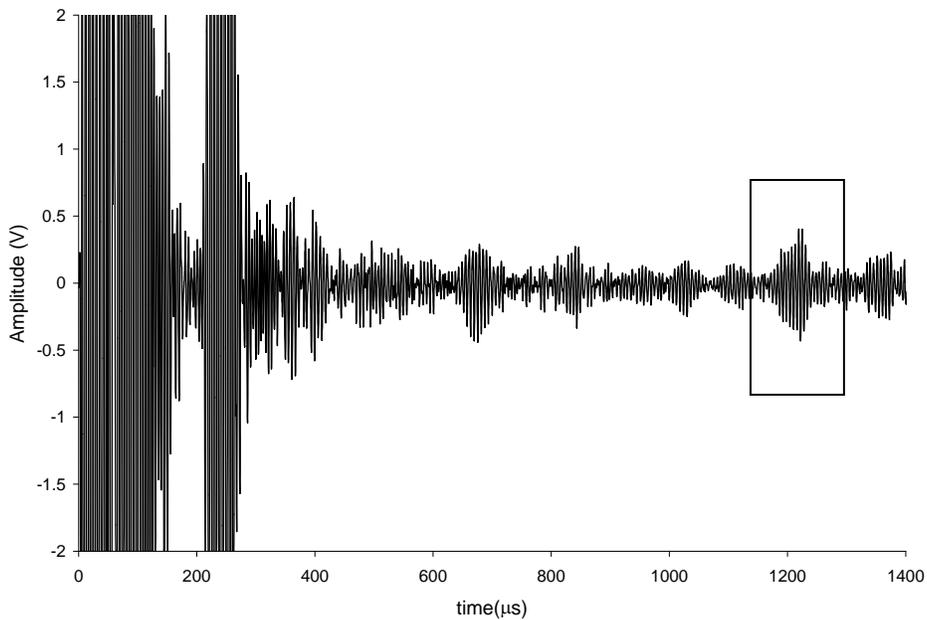
FIGURE 15 Detection of Circular wall loss 72 inches from the scanner through 40 inches of water

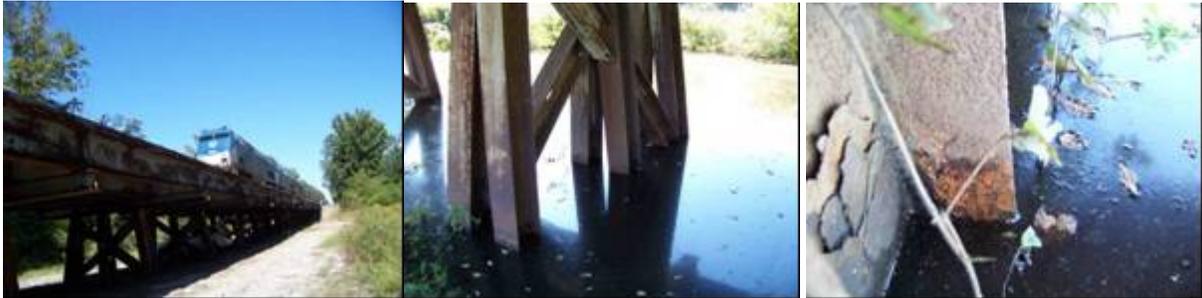
Field testing of the prototype-pile inspection system was carried out on bridges in Mississippi and North Carolina. The primary focus of the inspection trip to Mississippi was to test the H-pile inspection system in the field and get a sense of its sensitivity in real situations as well as to develop a procedure for data interpretation to aid the inspector in the field. The first bridge inspected in Mississippi was in a completely dry swamp bed as seen in Figure 16a. Edge wall loss was observed on most piles, some of it as severe as 75% loss. The second bridge inspected was in a swampy area with a maximum water depth of 2 feet (2 feet or 20 feet – see below) around the piles, as seen in Figure 16b. The water level appeared to be lower than normal because there were areas of wall loss observed above the water line as seen in Figure 16c. The third bridge inspected was in a dry swamp bed as well with edge wall loss observed on some of the piles as much as 75%. Piles were selected with interest in obtaining valuable data corresponding to wall loss reflection amplitude and distance. When a pile was found with an area of wall loss, 6-8 readings were taken from this zone at distances ranging from 24 to 96 inches.

FIGURE 16 Field Testing in Mississippi

(a) Dry swamp bed at bridge 1, (b) Partially submerged pile at bridge 2 and (c) Wall loss observed above the water line at bridge 2

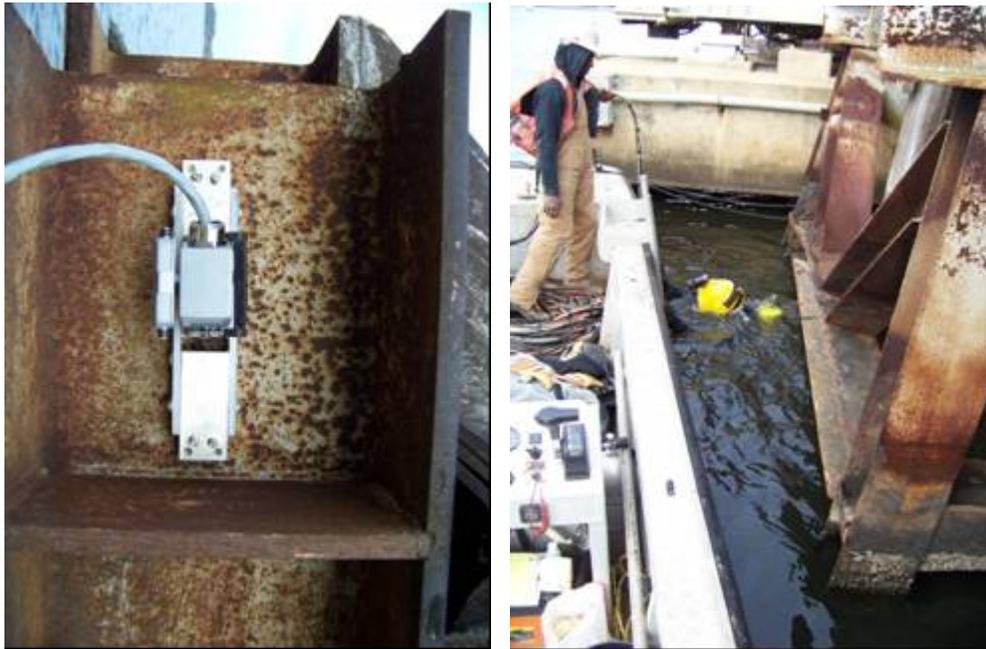
The objective of the field testing conducted in North Carolina was to evaluate the data interpretation procedure using the developed Distance Amplitude Correction Curves (DACs). The defects identified and characterized using the H-pile system were then cross-checked with visual inspection by divers.

FIGURE 17 Field Testing in New Bern, NC

(a) H-pile inspection using the EMAT scanner (b) Visual inspection of H-pile wall by diver

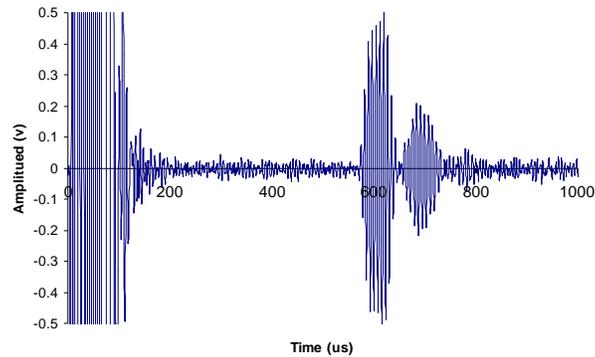
Before any inspection took place it was necessary to calibrate the system. Calibration of the system consisted of finding an H-pile with an unobstructed end. Bracing members were typically used. The scanner was placed 3 feet from this end and the data acquisition system settings were adjusted in such a way that the end reflection was maximized on the screen as seen Figure 18. Once calibrated, the system could not be shut down or adjusted in any way without at least confirming that the calibration was still accurate by taking another 3-foot end reading. This voltage level is then called “Full Screen Height Voltage at 3 feet (FSH @ 3 feet)”. This value is then used for standardizing future field data.

FIGURE 18 Calibration Waveform

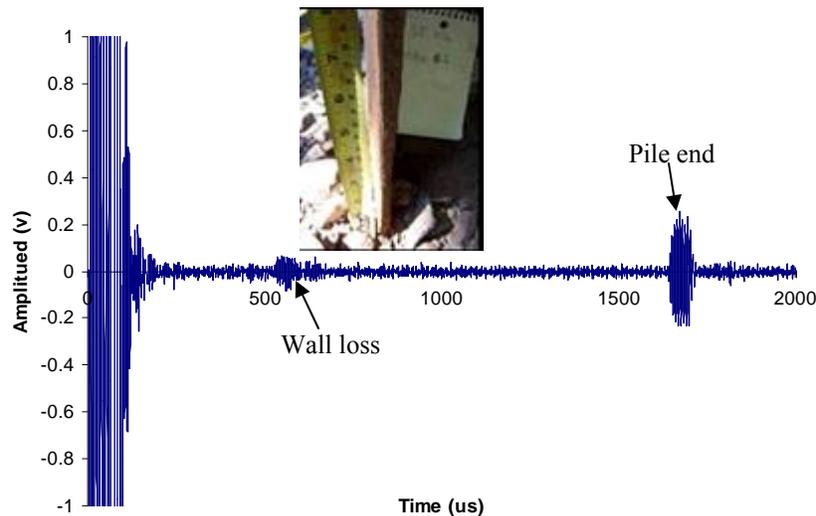
Wall loss found in the pile ranged from very minor edge loss to more severe edge loss (75%). Comparisons of the physical observations and resulting waveforms from the three categories of wall loss are shown in Figures 19 through 21. The percent wall loss was calculated using the ratio of remaining wall thickness and the measured thickness of the pile where no obvious wall loss was observed.

FIGURE 19 25% wall loss and corresponding waveform from 36 inches

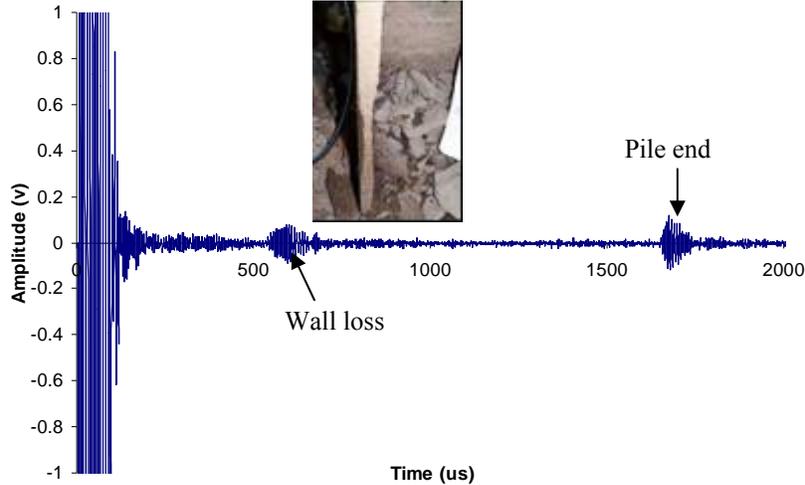
FIGURE 20 50% wall loss and corresponding waveform from 36 inches

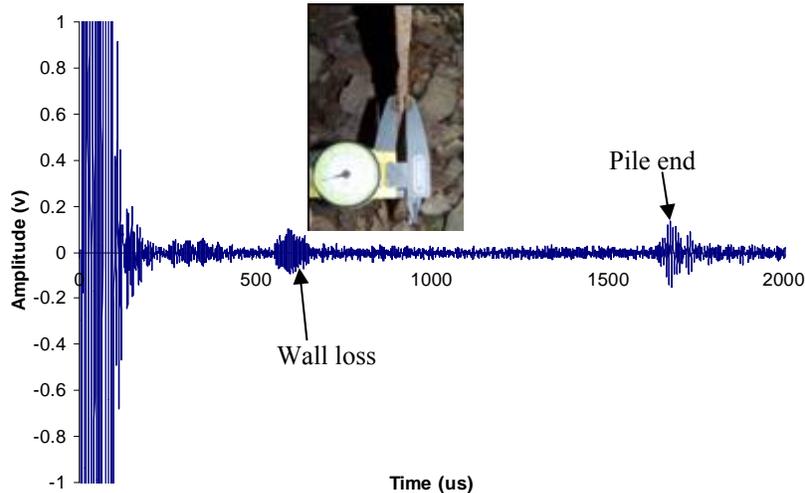
FIGURE 21 75% wall loss and corresponding waveform from 36 inches

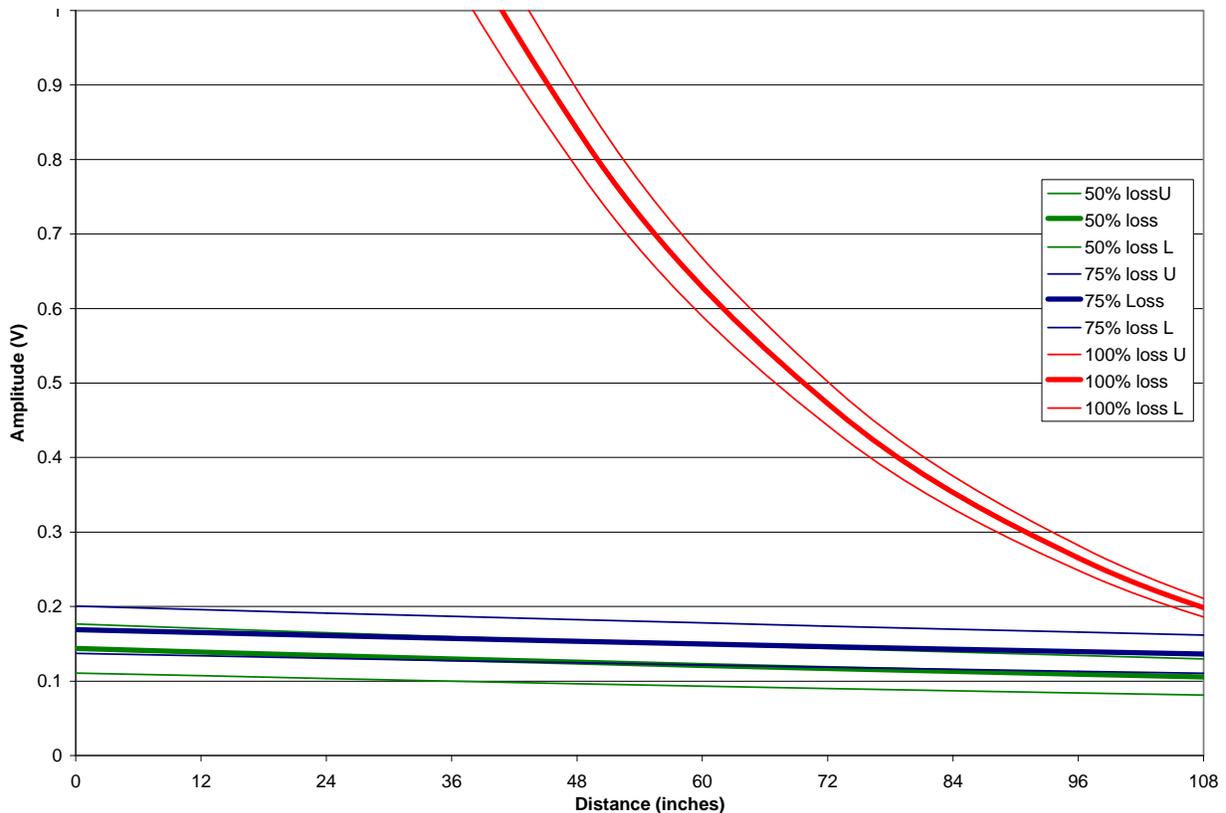
The DAC curves in Table 2 are shown in Figure 22. The upper and lower bounds for each wall loss amount (tolerance) were obtained using the standard deviation and were plotted in the DAC curves as shown in the same figure. Note that the 100% DAC is significantly higher than the other DACs. Note also that the other DACs are distributed over a much smaller voltage range. For this reason voltage scale adjustment will be incorporated into the display. The DAC curves displayed over a smaller voltage range are shown in Figure 23.

FIGURE 22 DAC Curves for H-pile wall losses of 100%, 75% and 50% with upper and lower bounds for each wall loss amount

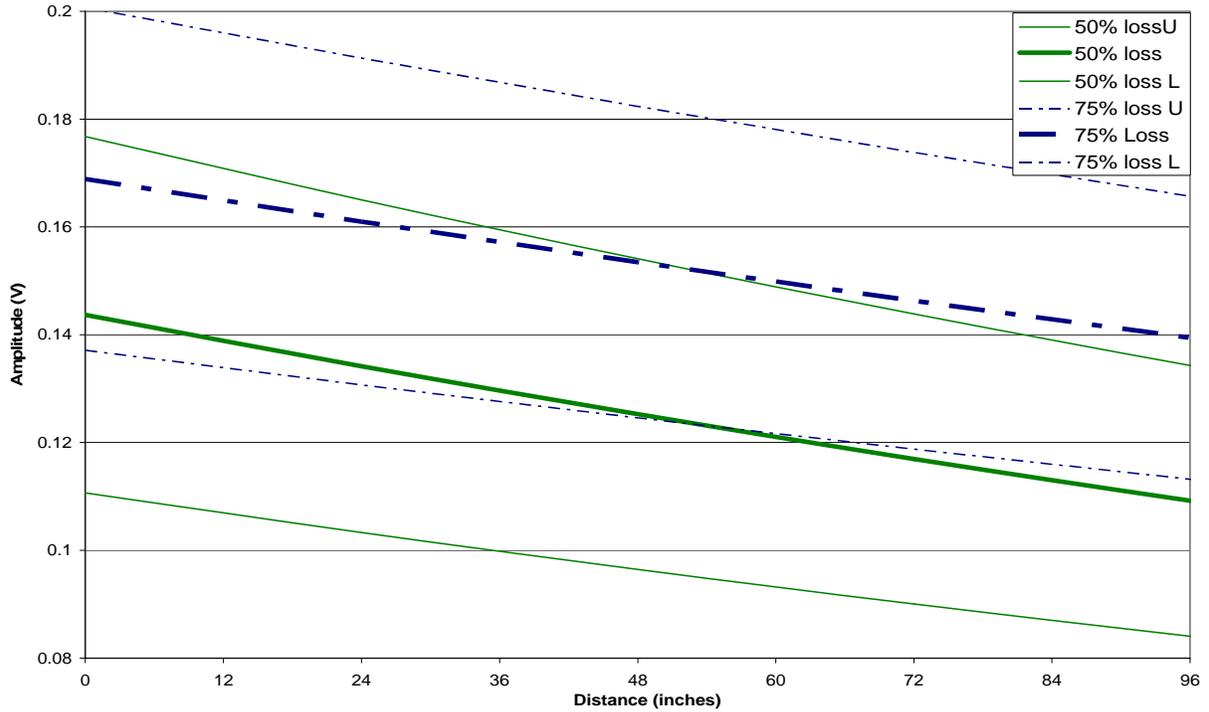
FIGURE 23 DAC Curves (Zoomed in on 50% and 75% wall loss)

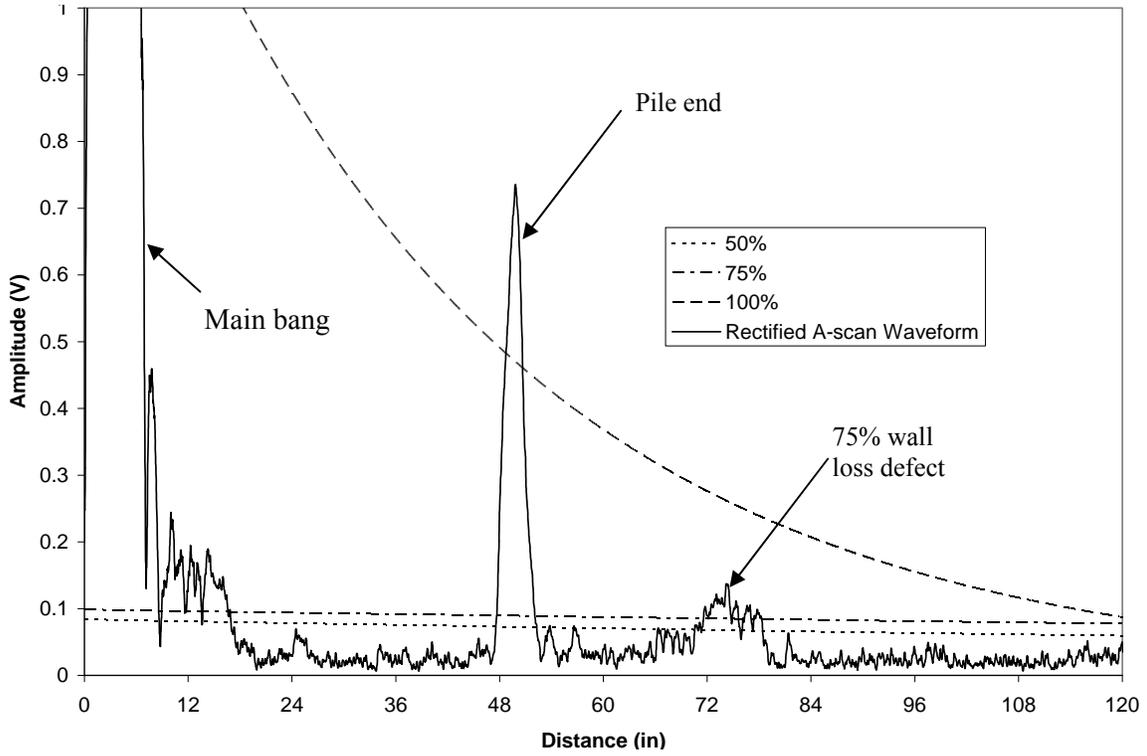
Figure 24 shows the rectified A-scan waveform from a defect (identified as 75% wall loss) that was located approximately 72 inches away from the EMAT scanner. The field data from this defect was not used to develop the DAC curves. The inspected H-pile was 10 feet in length (120 inches). The H-pile end was roughly 48 inches from the EMAT scanner. The DAC curves for 100%, 75% and 50% wall loss amounts were then overlaid on the A-Scan waveform. As can be seen from Figure 24, the A-scan has two significant peaks, one near the 48-inch mark and the other near the 72-inch mark. The first peak (at 48 inches) exceeds the DAC curve for the 100% wall loss, thereby identifying the H-pile end, and the one near the 72-inch mark, exceeds the 75% wall loss DAC curve. Thus, it could be seen that this data interpretation procedure could be used to characterize the wall loss defects in H-piles.

FIGURE 24 Rectified A-scan Waveform and the DACs overlaid showing the 75% wall loss defect “identified”

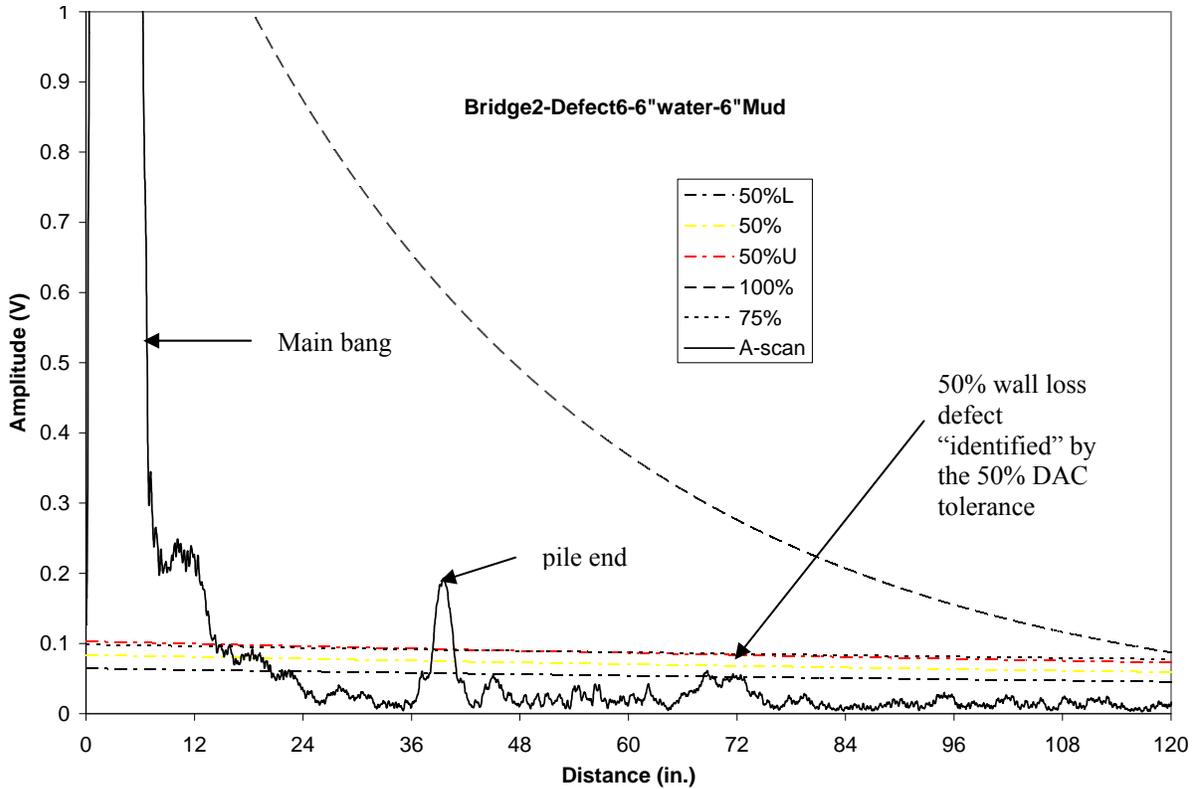
Due to an extended drought, these inspections were carried out when the H-pile was standing in a water depth of only 6 inches and a mud depth of 6 inches. The EMAT scanner detected a 50% defect 6 feet (72 inches) from it (Figure 25). After the data were acquired, the mud around the H-pile was cleared to verify the presence of the wall loss defect. The remaining wall thickness was measured to be 0.3 inches and classified as a 50% wall loss (design thickness was 0.5 inches). The pile end was 48 inches from the scanner and a corresponding signal was seen in the A-scan waveform but not picked up by the “100% DAC”. This could be due to the presence of braces near the pile end which reduces the amplitude of the reflected signal. Accommodations for such situations will be incorporated in the DAC curves in the future.

FIGURE 25 50% Wall loss defect identified by the H-pile inspection system through water and mud

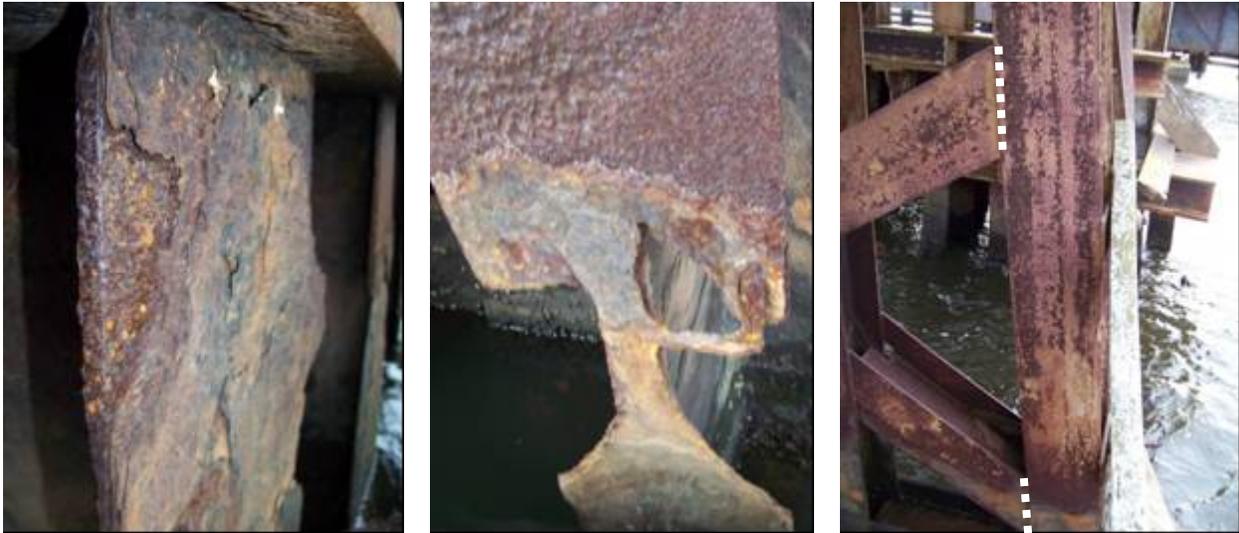
The field tests provided valuable feedback on the capabilities and limitations of the LRUT technology. It was determined that the EMATs did not couple enough ultrasound into piles through heavy corrosion as shown in Figure 26 (left). This heavy corrosion acts like an extremely thick coat of paint and minimizes acoustic coupling into the metal. The second limitation is the inability to scan beyond complete section loss as shown in the middle of Figure 26. It is impossible for the ultrasonic waves to travel beyond this loss. Similarly, it would be difficult to transmit ultrasound beyond heavily corroded areas to detect wall loss beyond these zones. A third limitation relates to bracing of the pile as shown in on the right of Figure 26. The left side of the pile would be difficult to inspect because of the multiple braces but the right side would be fairly straightforward to inspect. When a pile is double braced the welds absorb a significant amount of ultrasound.

Figure 26: Pile scenarios affecting technology performance.
