***Three-Dimensional Digital Imaging for the
Identification, Evaluation and Management of Unstable
Highway Slopes***

Final Report for Highway IDEA Project 119

John Kemeny, Brian Norton, and Jeff Handy, Split Engineering, Tucson, AZ
James Donovan, University of Utah, UT

March 2008

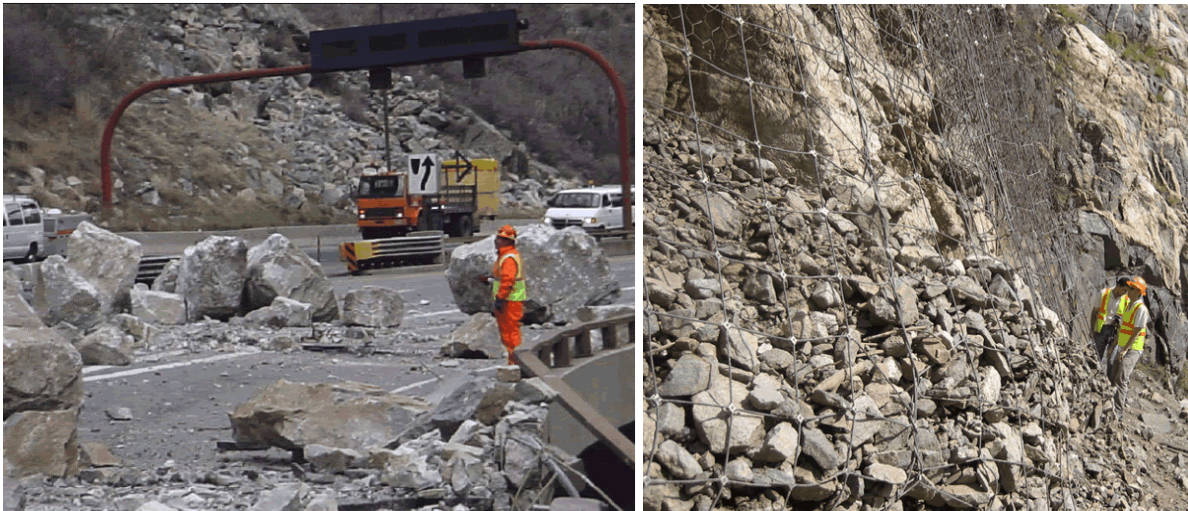
Figure 1. Examples of rockfall. Interstate 70 after 2004 Glenwood Canyon rockfall (left); Rockfall filling a rockfall capture device along Interstate 70 near Georgetown, CO (right).

This site was used to test photo draping, rock mass characterization tools, and the change detection algorithm, and also to develop best practices for field LIDAR scanning. Some pictures of this site are shown in Figure 1. Scans at this site were conducted with three scanners, the Optech Iris3D, the Leica HDS 3000, and the Riegl Z360. In addition to scanning, 110 manual fracture orientation measurements were made to compare with LIDAR results. 30 survey control points were installed on the highway (survey nails, see Figure 2) in order to test scanner registration accuracy.

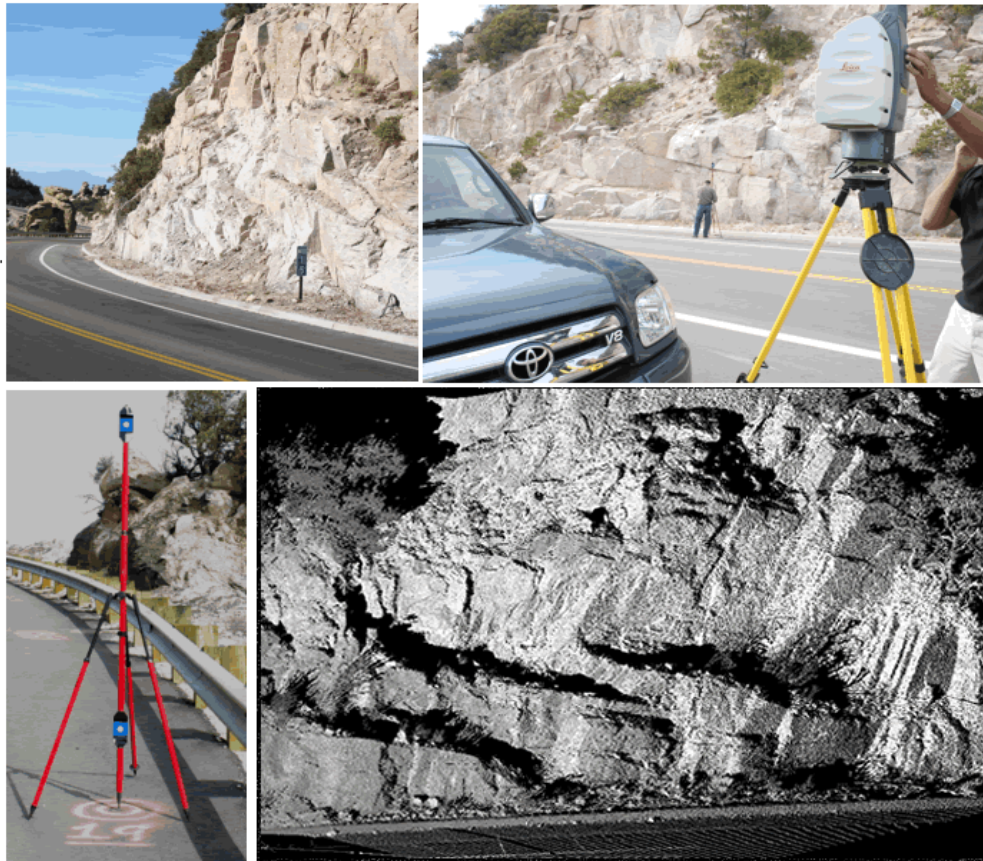
Figure 2. Example of ground-based LIDAR scanning, Milepost 15 on Mt. Lemmon Highway, AZ. Scanning conducted with the Leica ScanStation (Leica, 2008). Point cloud is registered using surveyed nails in the highway. Point cloud consists of about 1.5 million points.

New technologies are becoming increasingly important for the design, construction and maintenance of highways. Ground-based LIDAR (also called 3D laser scanners) along with high-resolution digital imaging is a potential new technology to address the issues described above. Figure 2 shows an example of a LIDAR scan being conducted along a highway slope in Arizona. LIDAR scanning is conducted at a distance from the slope, eliminating potential safety hazards. Also, surveying points used to register the scan can be conducted at points in front of the rock face, eliminating the safety hazard of using surveyed targets on the slope (see Figure 2). The output from a laser scanner survey is a “point cloud” consisting of millions of reflection points that represent the 3D surface that was scanned. Figure 2 shows the point cloud created

from the scan of the rock slope. After some data cleaning, a triangulated surface can be rendered from the point cloud data, and many subsequent calculations and visualizations can be made using the 3D surface. In addition, a technique called texture mapping or photo draping can be used to overlay high-resolution color information from digital images onto the 3D surface. Additional information on the accuracy and features of ground-based LIDAR units can be found at POB (2007).

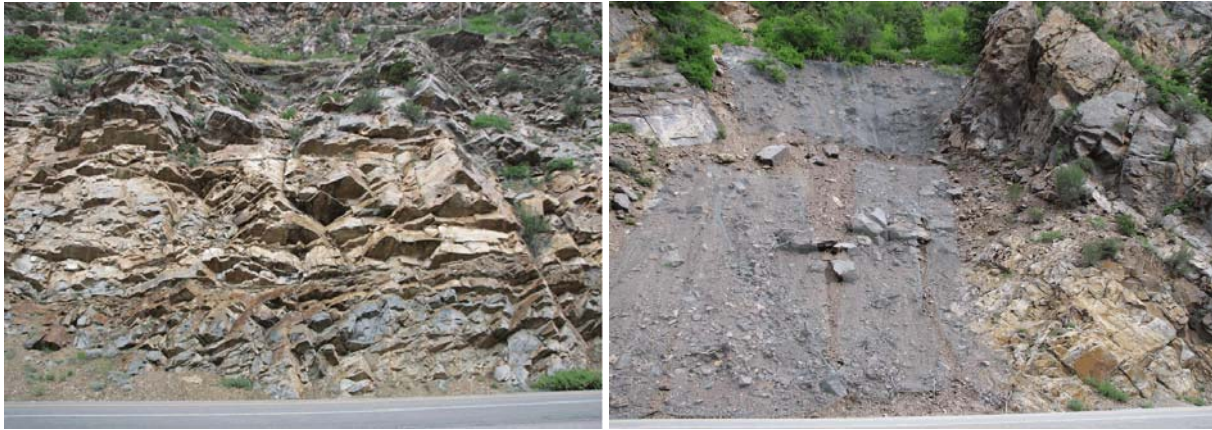
Figure 13: Examples of scanned sites along SR 190.

In 2006 Scans were performed along State Route 190 (SR 190) in Big Cottonwood Canyon, Utah. SR 190 runs eastward from the mouth of Big Cottonwood Canyon at Wasatch Boulevard to the Brighton ski area. The road is approximately 16 miles long and contains along its length 39 inventoried and rated rockfall sites. Of these 39 sites, 8 have been designated with rockfall

hazard ratings of A indicating immediate potential for rockfall danger. Examples of the scanned sites are shown in Figure 13.

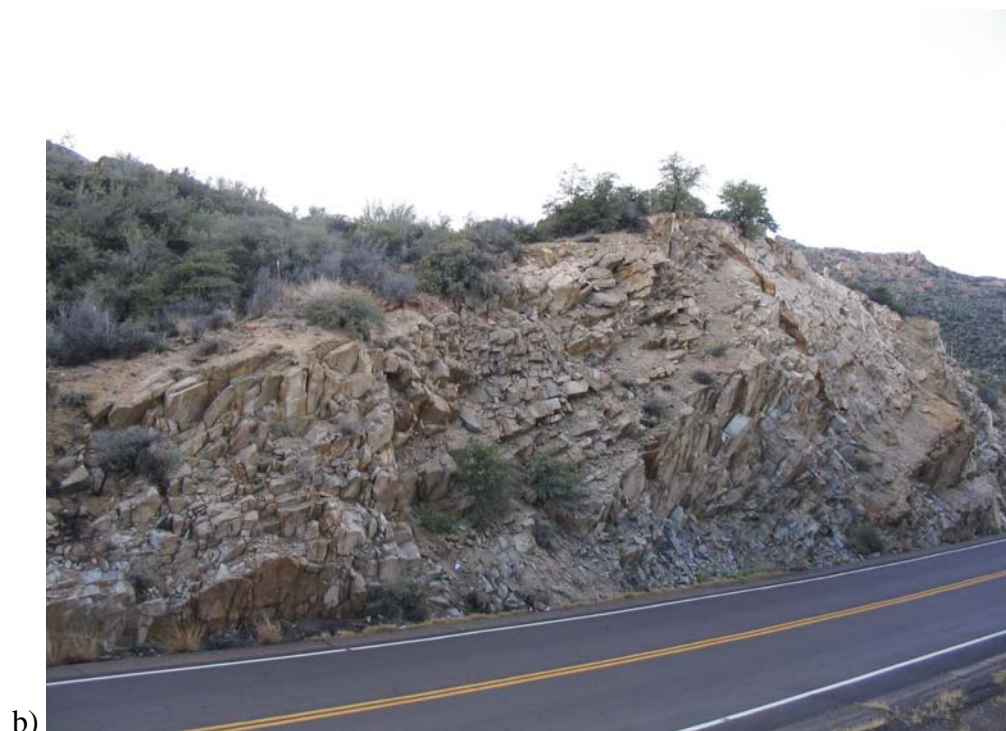
Figure 15. Digital images and point clouds used to determine the UDOT RHRS for a 57 meter cut along Highway 60 in Arizona, a) digital image parallel to highway with road cut on left, b) digital image of cut, c) point cloud h602 to determine discontinuity characteristics, slope height and angle, ditch parameters, d) top down view of point cloud h603 with cut on upper left to determine width of highway and stopping distance (the front view of this point cloud is shown in Figure 5).

The site chosen is a section of Highway 60 near Globe, Arizona. Figure 15a shows the overall site, and Figure 15b shows the specific slope where the rockfall hazard rating was calculated (you can also see this slope in Figure 15a). The geology consists of crystalline geology with overhanging discontinuities that strike parallel to the highway. LIDAR scans were taken of the specific slope as well as a scan showing both sides of the highway, as shown in Figures 15c and 15d.

data sheet and analyses including the stereonet are contained in a single file (shown in Figure 15a) with a size less than 60 MB. LIDAR scanning at the site took less than two hours, and the determination of the rockfall hazard ratings were conducted with just a few hours of office time. As stated before, of the 15 parameters in the Utah system, 12 can be determined from LIDAR scanning and the remaining parameters are easily determined from traffic statistics, posted speed limits and AASHTO charts.

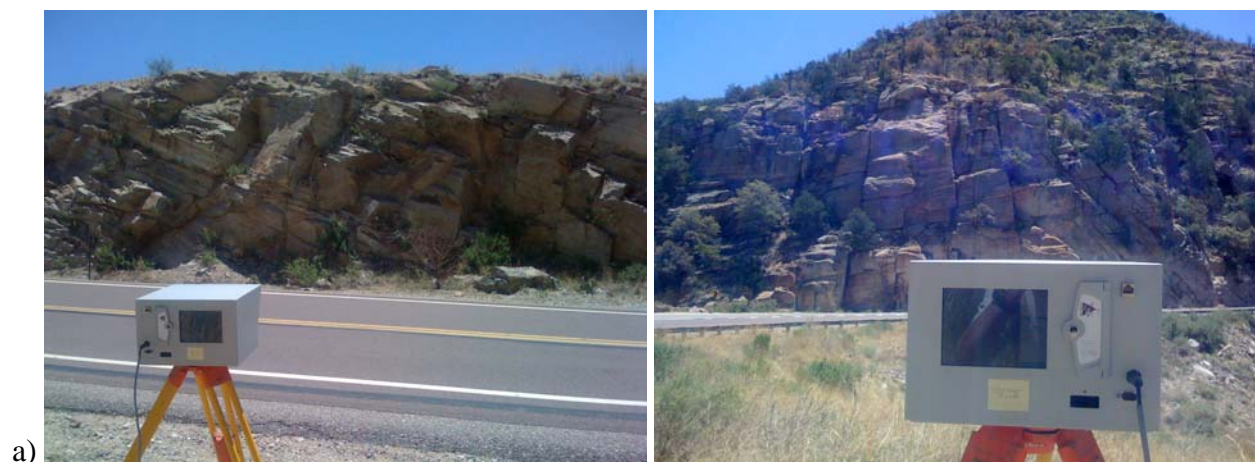
Figure 17. Rescanning of two sites along the Mt. Lemmon Highway near Tucson, Arizona. Original scans taken more than 5 years before and the locations of the original scans are not known precisely a) pictures of the two sites, b) and c) difference point clouds of the two sites.

Several change detection examples are shown here to demonstrate the usefulness of taking repeated scans at a site, even if the original scan locations are not known. The first two examples are scans taken of rock slopes along Mt. Lemmon Highway in southern Arizona. Originally the scans were taken over 5 years ago and the locations of the original scans are not known precisely. The first scan location is at mile marker 6, and the second scan location is at mile marker 8. Pictures of the two sites are shown in Figure 17a (taken April 2009 at the time of the re-scans). In both cases the rescans could be as far as 40 feet from the locations of the original scans.

The difference point clouds for the two sites are shown in Figures 17b and 17c. Red represents missing material and blue represents new material. In the site shown in Figure 17b, some new vegetation is clearly apparent in blue and some missing vegetation is clearly apparent in red. In terms of rock changes, there are some obvious boulders that have dislodged on the right side of the image. The volume of these boulders can be measured in the difference point cloud using the tools described in Section 3.1 and shown in Figure 6, giving a volume for the largest boulder of about 0.04 m^3 . Also there appears to be missing material near the top of the slope even though this could be false change due to the difference in locations between the before and after scans. In the site shown in Figure 17c, there are red and blue outlines of many of the discontinuities, due to the before and after scans being taken from different locations. In spite of this noise, a large dislodged boulder is apparent in the mid-height and right part of the outcrop with a volume of about 2.1 m^3 , and also some dislodged boulders (possibly scaled) are apparent near the bottom right of the image.

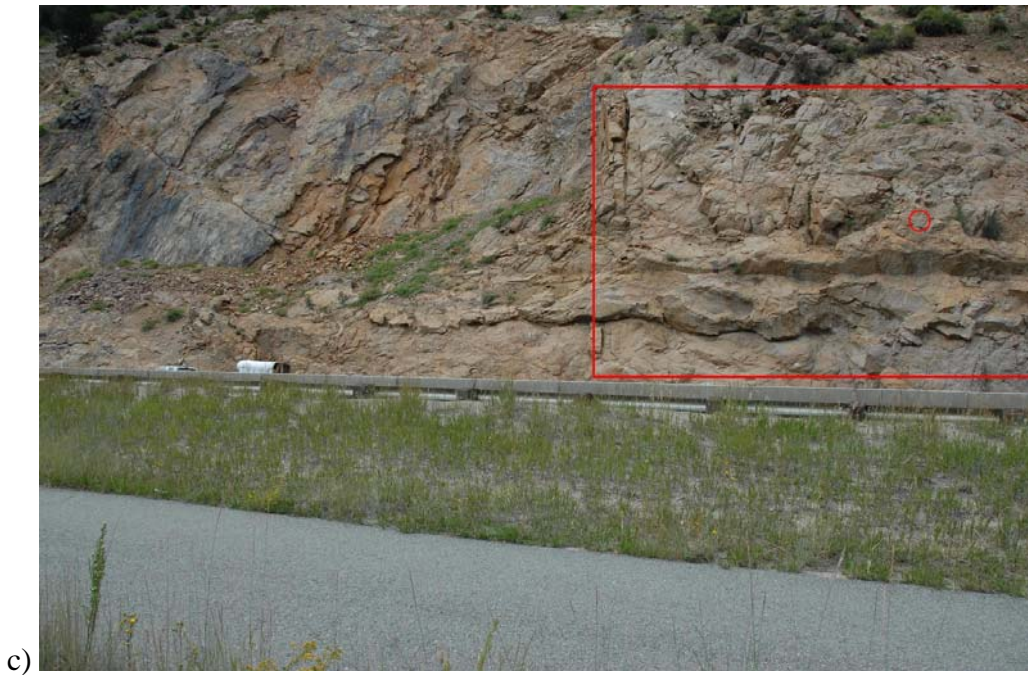
Figure 18. Change detection along Interstate 70 at station W12, two scans taken one year apart. a) “after” point cloud, b) difference point cloud, c) photo showing scan region and location of possible dislodged boulder.

then one year later in 2007. Figure 18a shows the “after” point cloud taken from station W12 in the Interstate 70 test area. Figure 18b shows the difference point cloud with blue indicating new material and red indicating missing material. Two red regions in the difference cloud indicate locations of possible rockfall. Figure 18c is a photograph showing the region scanned at station W12 (red rectangle) and also shows the location of the dislodged rock near the center of the scan (red circle). The volume of this dislodged rock block is calculated to be about 1.6 m^3 .
