***GUIDE TO RECOMMENDED PRACTICE FOR THE REPAIR  
OF IMPACT-DAMAGED PRESTRESSED  
CONCRETE BRIDGE GIRDERS***

Prepared for the  
National Cooperative Highway Research Program  
Transportation Research Board  
of  
The National Academies

May 2012

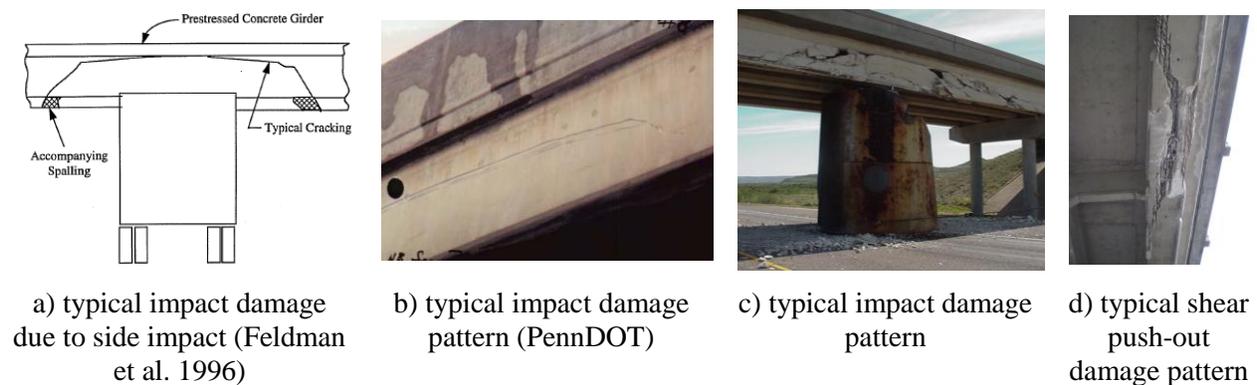
**Figure 1 Examples of typical damage due to vehicle impact.**

Impact damage is usually readily apparent and varies from minor scrapes to structural collapse. The most commonly occurring damage pattern associated with side impact to prestressed concrete girders causes a torsion-induced shear cracking pattern in the exterior (or fascia) girder as shown in Figure 1a. In cases where the impact is more direct, this pattern becomes more of a shear push-out (Figure 1d). Examples of impact damage are provided in Section 1.3.2 through 1.3.4 of the *Report*.

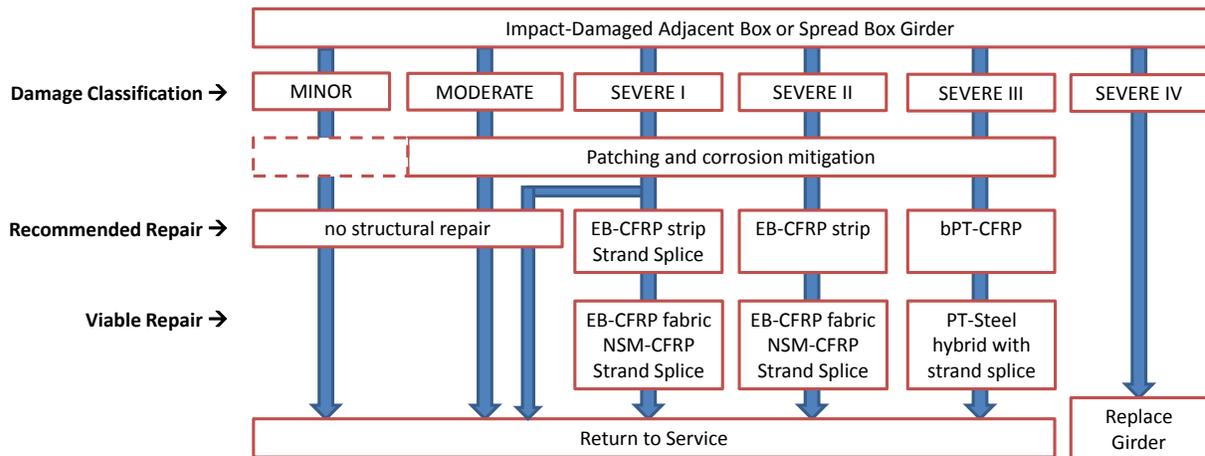
Figure 2 Repair selection flow chart for prestressed concrete box girders.

Selection of recommended repair techniques for prestressed concrete box girders is shown schematically in Figure 2. Repair techniques, their application and limitations are described in Section 6. It is generally not feasible to provide additional confinement (i.e.: CFRP U-wraps) to box girder repairs.

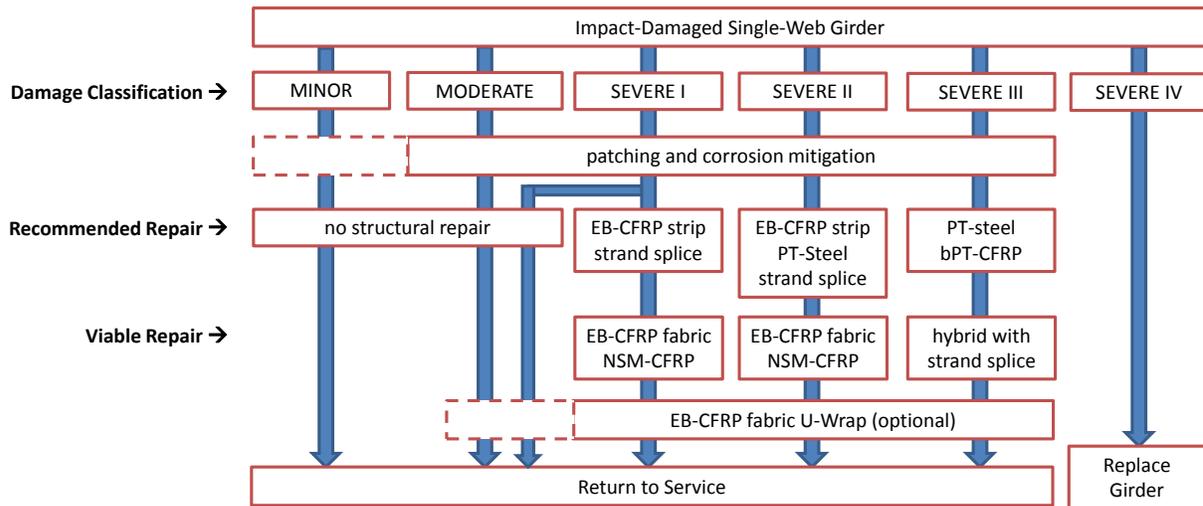
Figure 3 Repair selection flow chart for prestressed concrete single-web girders.

Selection of recommended repair techniques for prestressed concrete single-web girders is shown schematically in Figure 3. Repair techniques, their application and limitations are described in Section 6. It is recommended to provide additional confinement (i.e.: CFRP U-wraps) to single-web girder repairs; this also provides confinement to any necessary concrete patches.

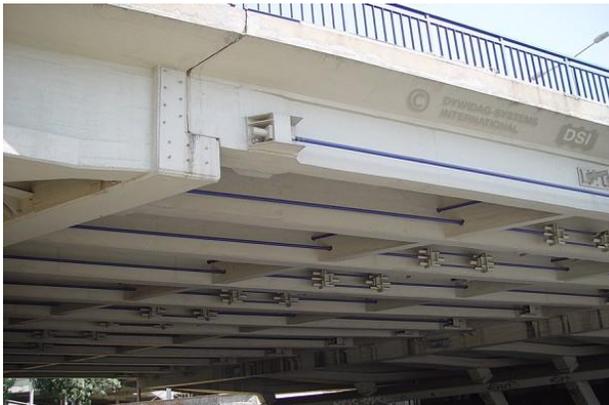
a) PT-steel anchored to girder using steel bolster bolted through girder web (second PT bolster on back of web) [DYWIDAG Systems International]

**Figure 4 Anchorage of post-tensioned repair systems.**

External post-tensioned systems are more easily used in bridge systems where the webs are accessible. PT-steel systems in particular, may be attached to the girder webs using bolsters (Figure 4a) or be located between girders, anchored to new or existing diaphragms (Figure 4b). In these cases, installation of king- or queen-post to harp the PT strand is feasible and may be used to improve the efficiency of the repair (the example shown in Figure 4b shows a small degree of harping between the anchorage and subsequent diaphragm supports).

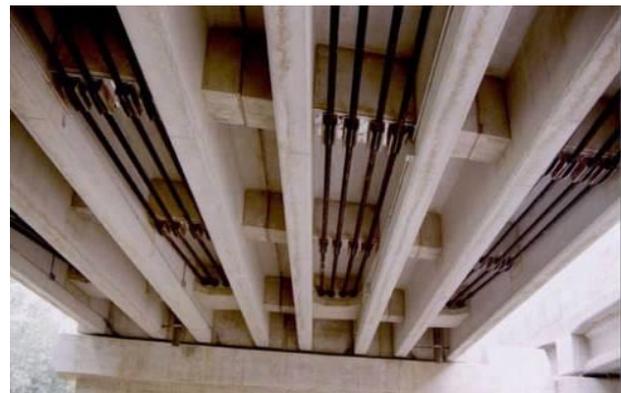
b) PT-CFRP anchored and harped by diaphragms [Mamlouk and Zaniewski *Materials for Civil and Construction Engineers* 2011]

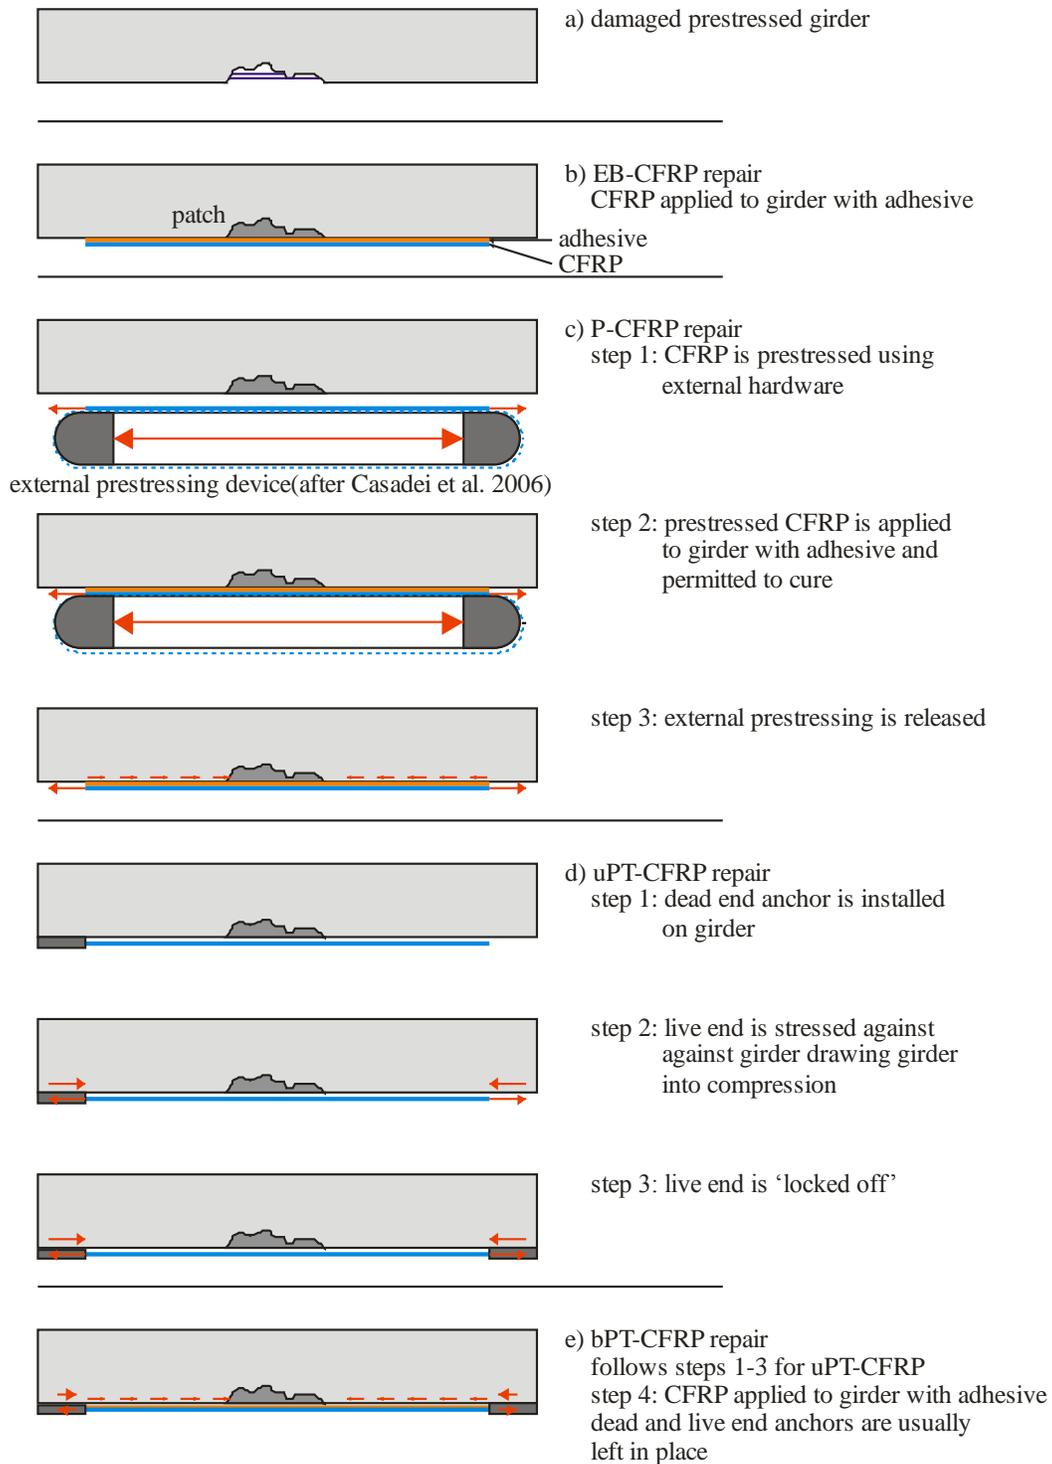
**Figure 5 Schematic representations of CFRP applications.**

There are three approaches to prestressing or post-tensioning (the terms are used inconsistently in the literature) CFRP. The following terminology is adopted to clarify the types of prestressed CFRP systems. Figure 5 provides a schematic representation of each approach.

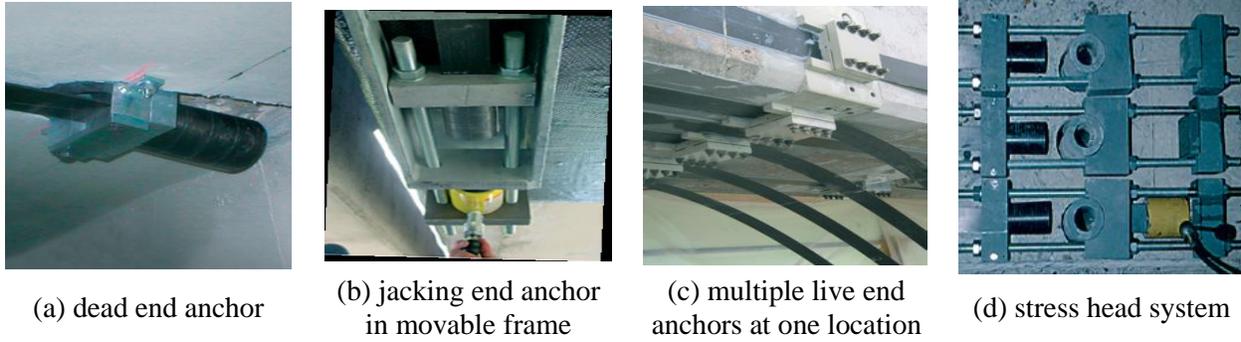
**Figure 6 Components of commercially available PT-CFRP system.**

There are only two known commercially available ‘standardized’ PT-CFRP systems. Both systems work on the same principle, have essentially the same capacities and differ only in the proprietary nature of the jacking hardware used. An example of such a system is shown in Figure 6. The anchorage has a capacity of 67 kips (300 kN) and is intended for a maximum applied prestress force of 45 kips (200 kN). Material properties of the CFRP strips are those given for HS-CFFP in Table 2. This system is comprised of CFRP strips with ‘potted’ CFRP anchorages referred to as ‘stressheads’ manufactured on each end. These stressheads are captured by steel anchorages mounted on the concrete (Figure 6a) or by the jacking hardware (Figures 6b and d). One anchor is the fixed or ‘dead’ end (Figure 6a) while the other is the jacking end (Figure 6b). The jacking end stresshead connects into a movable steel frame which connects to a hydraulic jack, thus allowing the strip to be stressed. Once the desired stress level is reached, the jack can be mechanically locked to retain the stress in the CFRP or the CFRP strip can be anchored by ‘clamps’ (Figure 6c) near the jacking end. Anchor points can also be located at discrete intervals along the beam. The stress in the strips can vary according to structural need and is limited to the tensile strength of the strip. In many cases, the strength of the beam at the anchor location controls the amount of prestress force that can be applied.

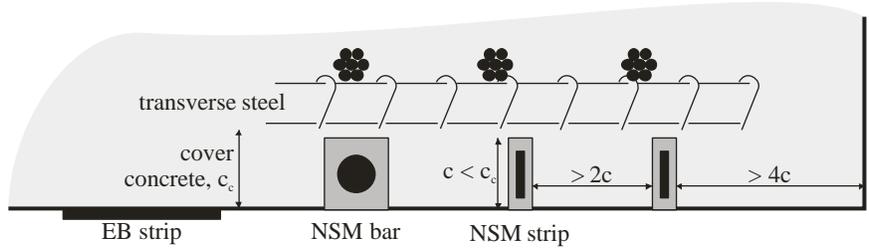
**Figure 7 Schematic of externally bonded and NSM CFRP techniques.**

Near-surface mounted (NSM) CFRP repairs provide an alternative to externally bonded repairs. The NSM technique places the CFRP in the cover concrete of the member (see Figure 7). This protects the material from impact forces and environmental exposure. Although there is no prohibition against prestressing NSM CFRP, there is presently no practical method by which to prestress such systems. An NSM CFRP repair is completely enclosed in epoxy, making it possible to achieve higher bond strength as compared to external strip bonding due to the larger surface area which is bonded. Additionally, an NSM application engages more cover concrete and is able to transfer greater stresses into the concrete substrate. Since bond capacity is typically the limit state associated with EB repairs, NSM repairs will typically require less CFRP material due to the enhanced bond characteristics. NSM repairs are sensitive to the amount of concrete cover and are not a viable option when cover is not sufficient.

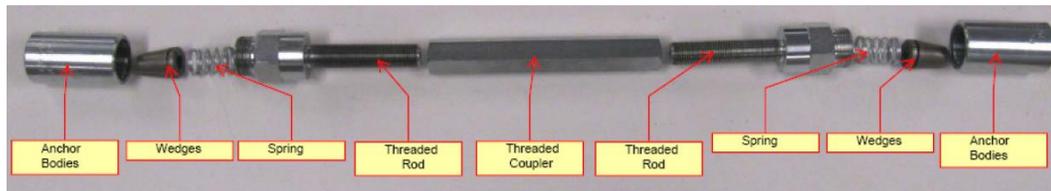
a) components of strand splice [Prestress Supply Inc. 2011]

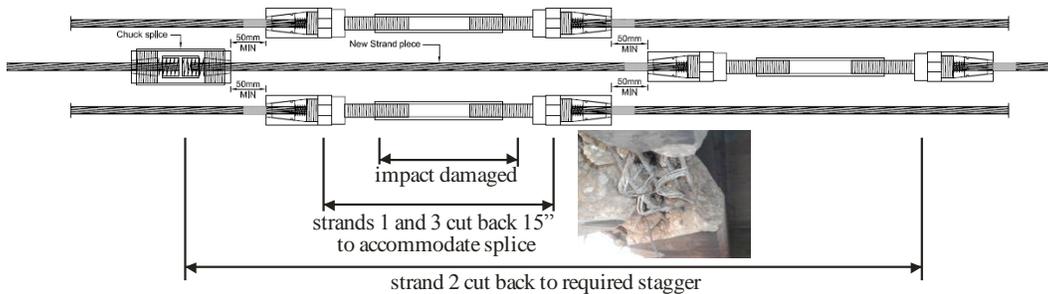
b) required longitudinal stagger of adjacent strand splices [Prestress Supply Inc. 2011]

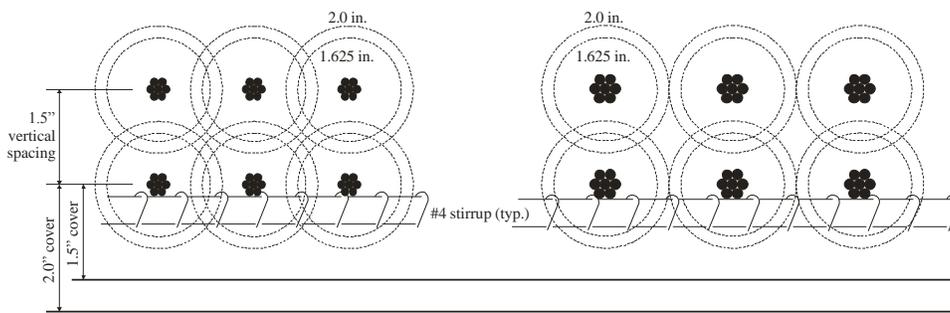
3/8" strand at 1.5 in. spacing

1/2" strand at 2.0 in. spacing

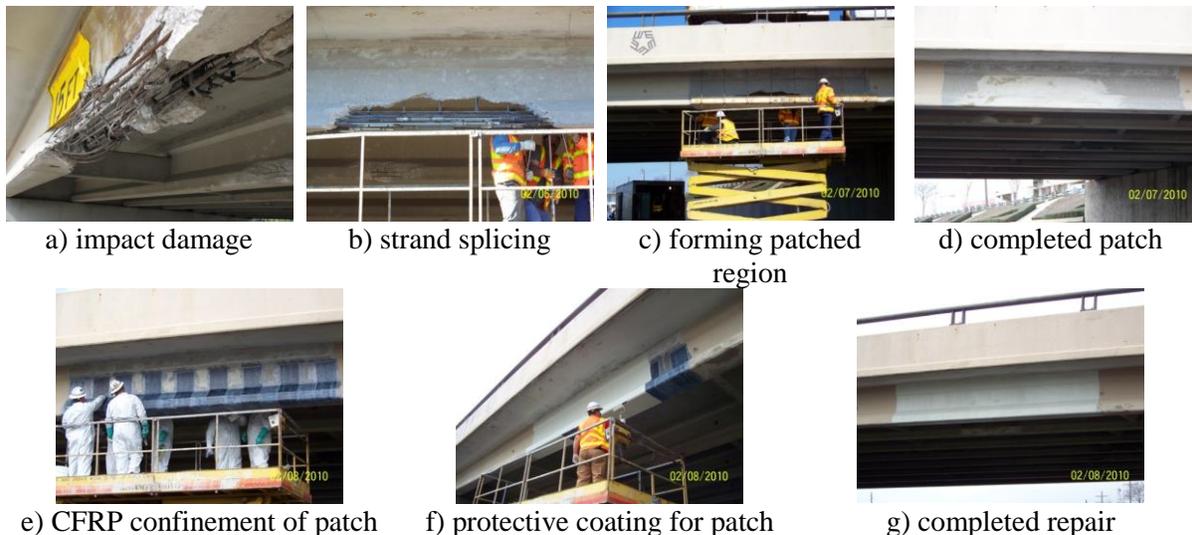
**Figure 9 Strand splicing and patch repair sequence.**
