UPDATED RESEARCH FOR COLLISION DAMAGE AND REPAIR OF PRESTRESSED CONCRETE BEAMS

Final Report

Prepared for the
National Cooperative Highway Research Program
Transportation Research Board
of
The National Academies

May 2012

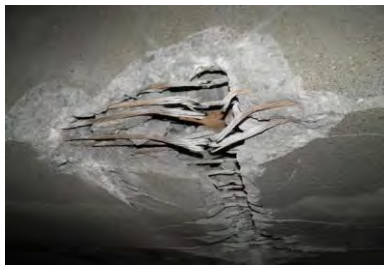
a) Lake View Drive collapse onto I-70. Impact damage led to significant strand loss, subsequent corrosion and eventual collapse under girder self-weight.

[Pittsburgh Post-Gazette]

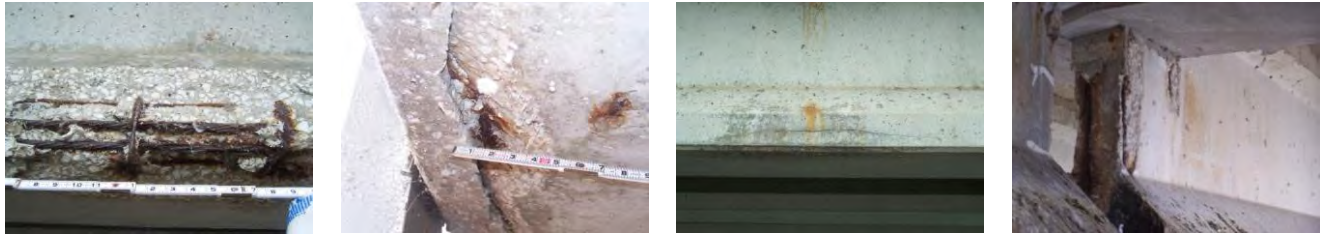
Figure 4 Typical corrosion damage following impact-related damage.

a) AASHTO I-girder [photos: ILDOT]

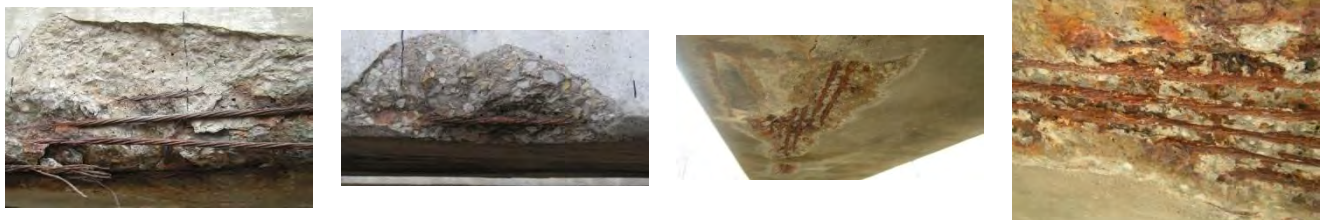
c) Adjacent box girder [photos: Harries]

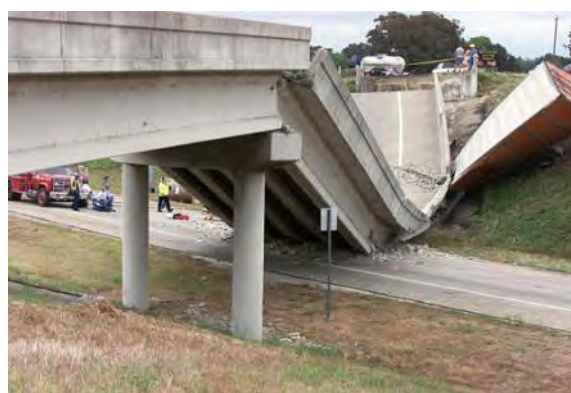
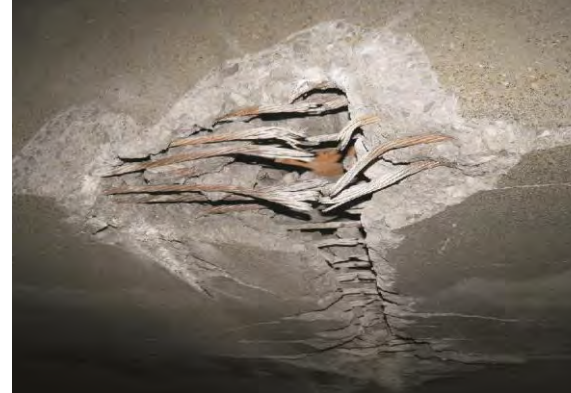
<p>Lake View Drive bridge over I-70, Washington PA. Exterior girder collapsed December 26, 2005 under self-weight load only. Adjacent Box Girder; entire bridge demolished and replaced [Pittsburgh Post Gazette]</p>	<p>An I-45 overpass sits on the cab of a tractor trailer rig after collapsing when it was hit by the vehicle near Richland, Texas, Sunday, Sept. 8, 2002. <i>Impact was to pier column.</i> AASHTO I-girder; clearly, span was replaced [AP Photo/Donna McWilliam]</p>	<p>Soffit and fascia of McIlvaine Road bridge over I-70 damaged by vehicle October 18, 2010. Adjacent Box Girder; entire bridge was demolished and replaced [PennDOT D12-0]</p>

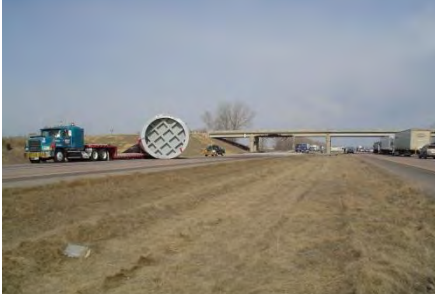
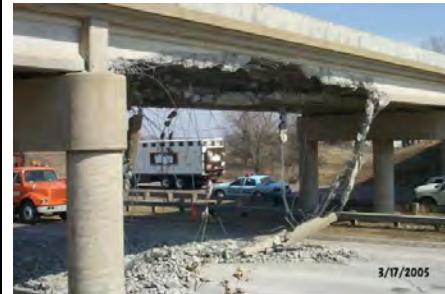
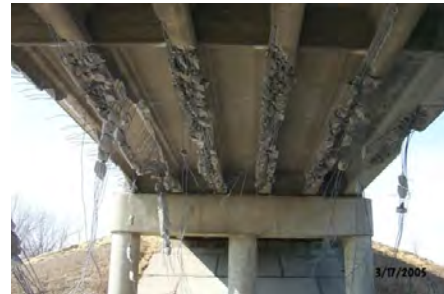
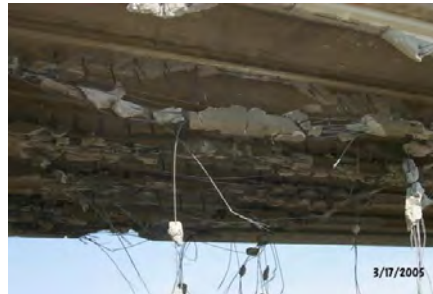
<p>Vehicle impact to Sgt. Bluff bridge in Iowa, March 17, 2005. AASHTO I-girder; assume entire bridge was replaced [ODOT]</p>

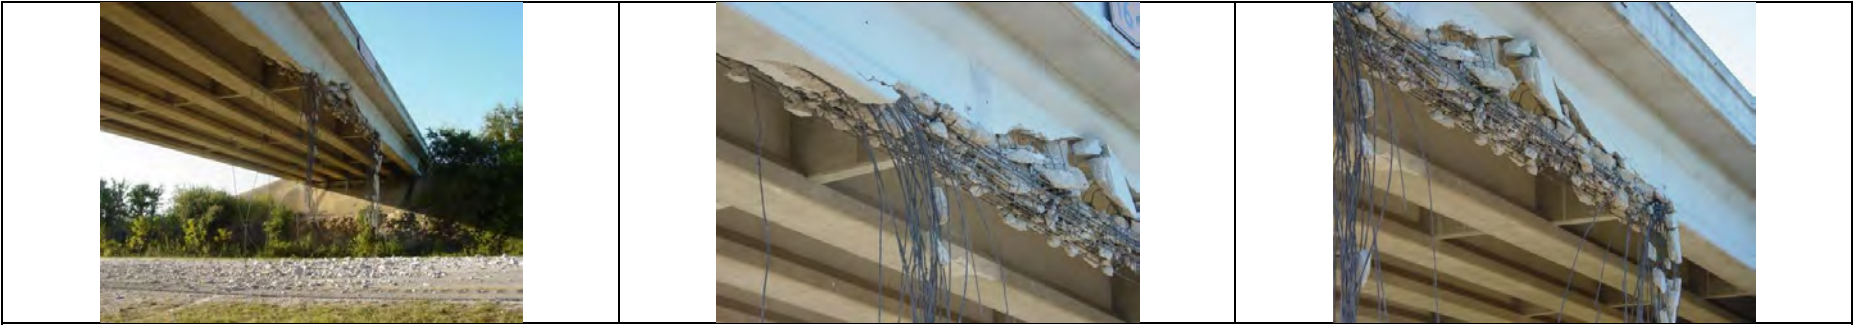
Exterior girder FM479 over Kerr Road, San Antonio TX.
 AASHTO I-girders; reported that entire bridge was demolished and replaced
 [Courtesy of the Texas Department of Transportation, © 2007 All rights reserved.]

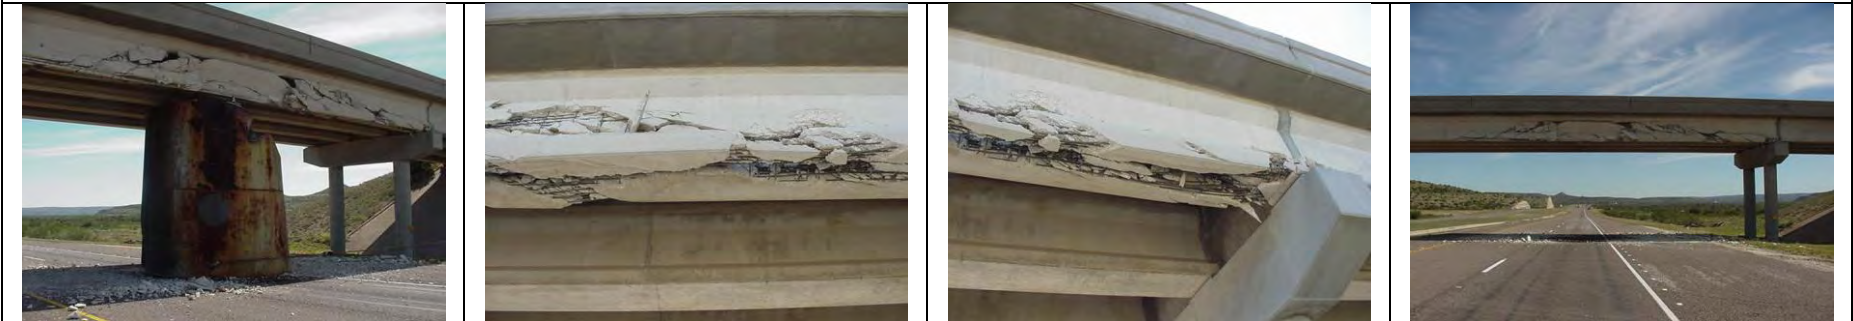
RM215 over IH10, Pecos Co. TX.
 AASHTO I-girders; reported that only exterior girder was replaced
 [Courtesy of the Texas Department of Transportation, © 2007 All rights reserved.]

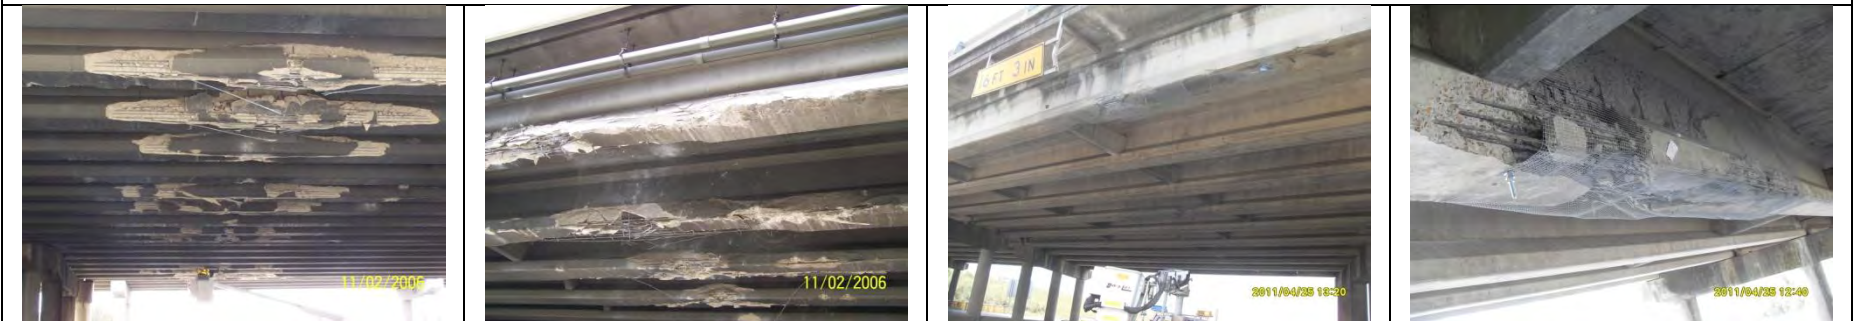
SH 183 at LP12, Dallas TX
 AASHTO I-girder; reportedly repaired
 [Courtesy of the Texas Department of Transportation, © 2007 All rights reserved.]

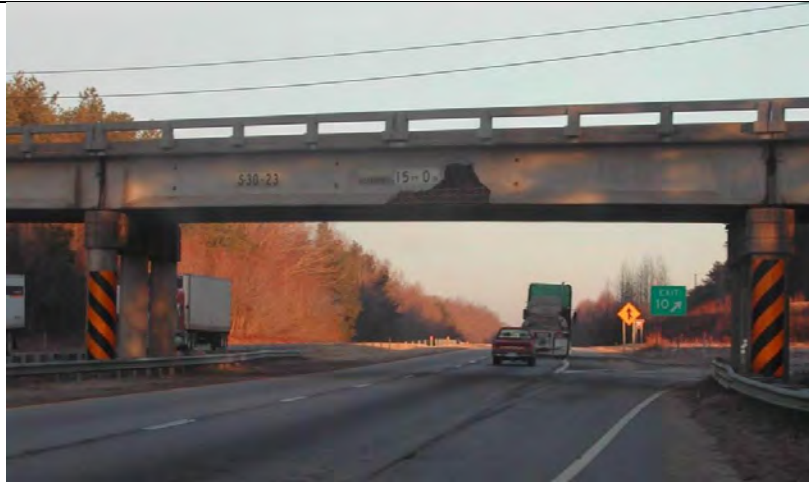
Impact damage to SC bridge structure
AASHTO I-girder; bridge shown in service
[Harries]

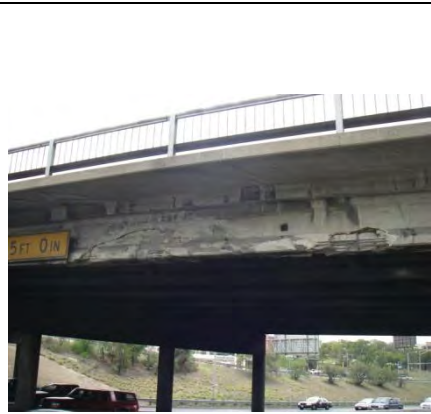
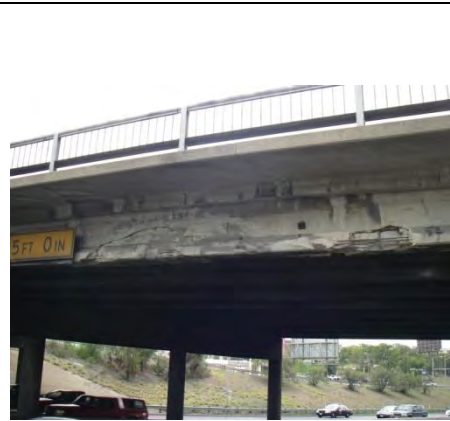
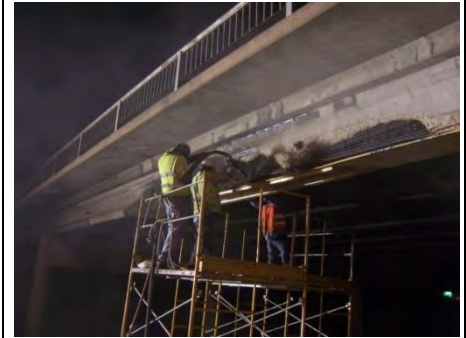
12th Street over IH35, Austin TX
AASHTO I-girder; strands appear intact (fig b), repair shown in fig d
[Courtesy of the Texas Department of Transportation, © 2007 All rights reserved.]

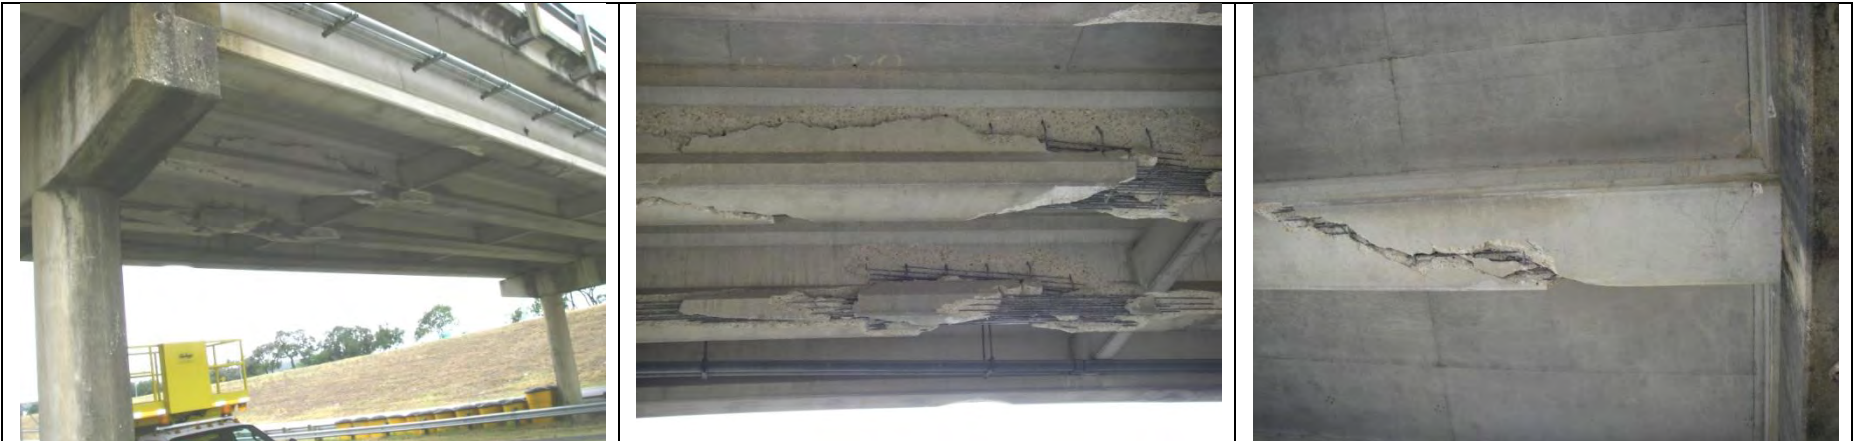
FM3351 over IH10
AASHTO I-girder; reportedly repaired
[Courtesy of the Texas Department of Transportation, © 2007 All rights reserved.]

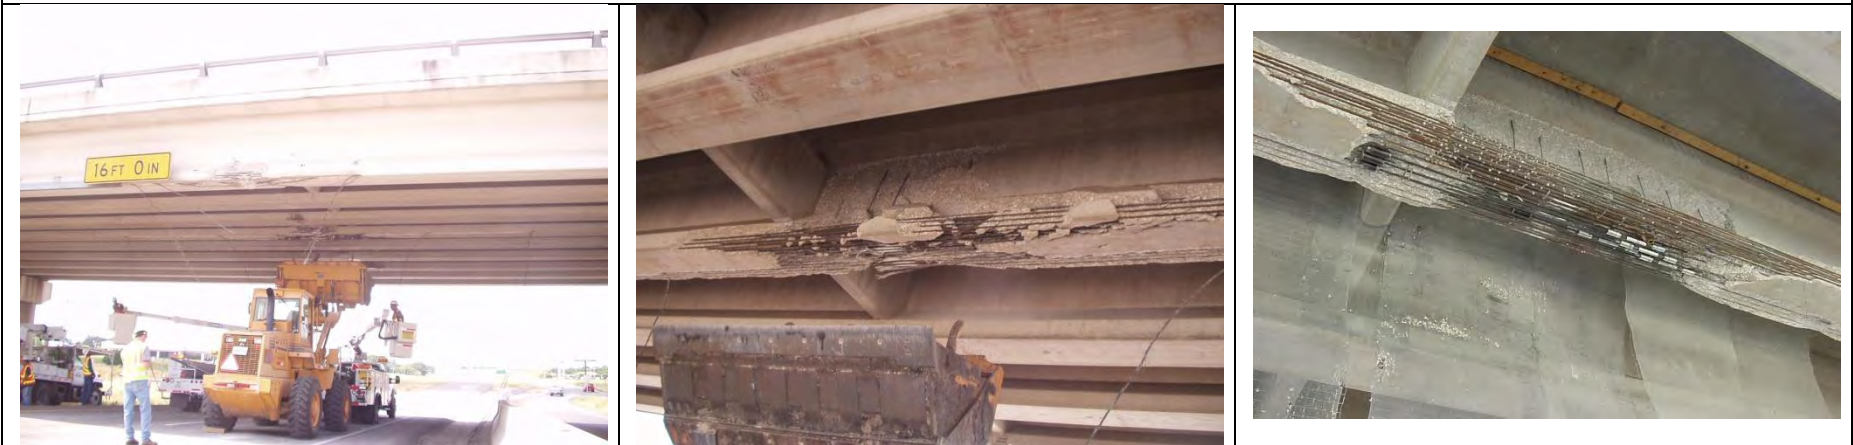
LP363, Temple TX
AASHTO I-girder; reportedly repaired
[Courtesy of the Texas Department of Transportation, © 2007 All rights reserved.]

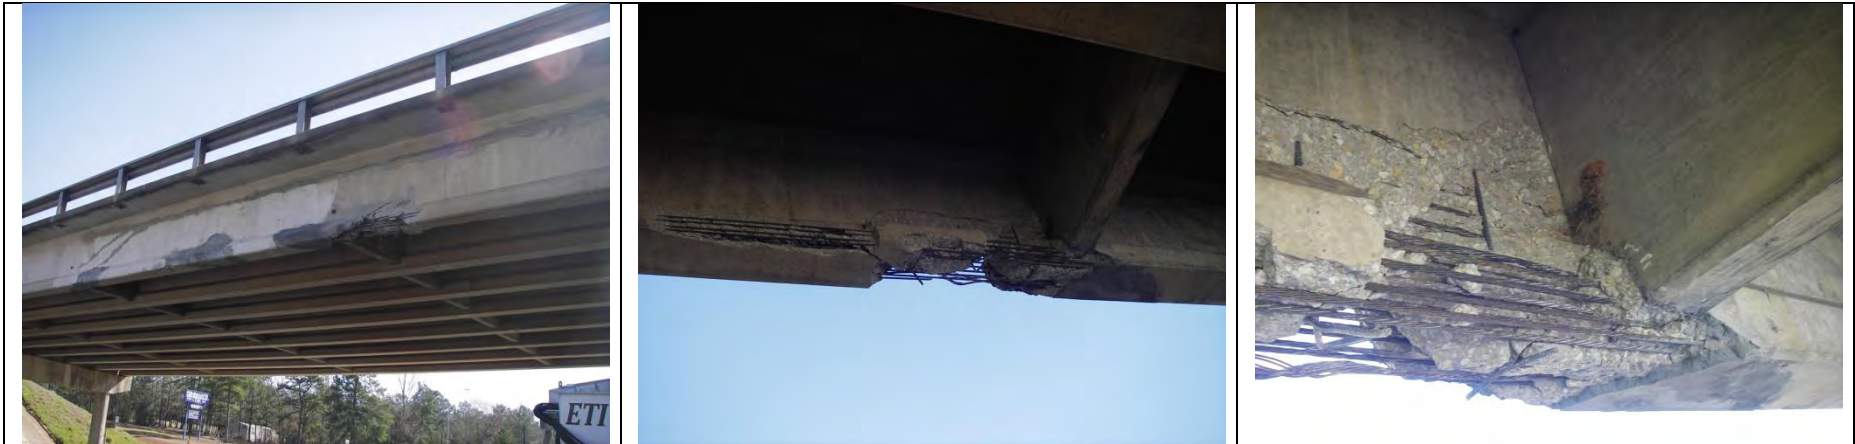
Lufkin TX
AASHTO I-girder; reportedly repaired
[Courtesy of the Texas Department of Transportation, © 2007 All rights reserved.]

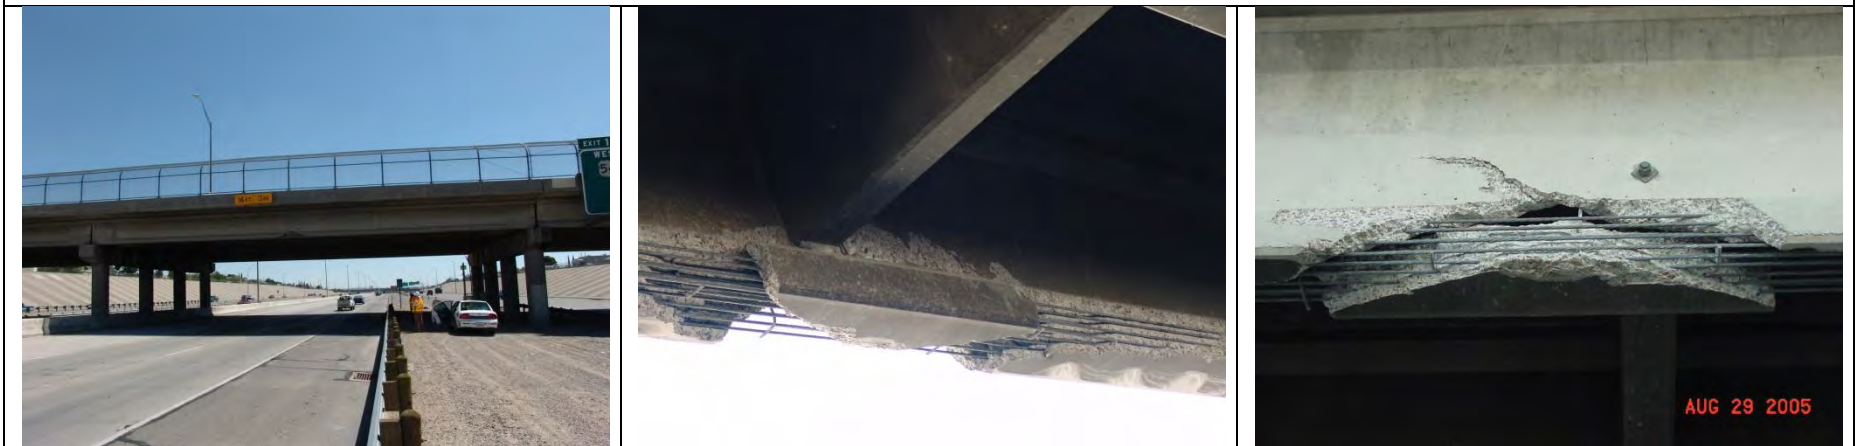
US54 at Altura Ave.
AASHTO I-girder; reportedly repaired
[Courtesy of the Texas Department of Transportation, © 2007 All rights reserved.]

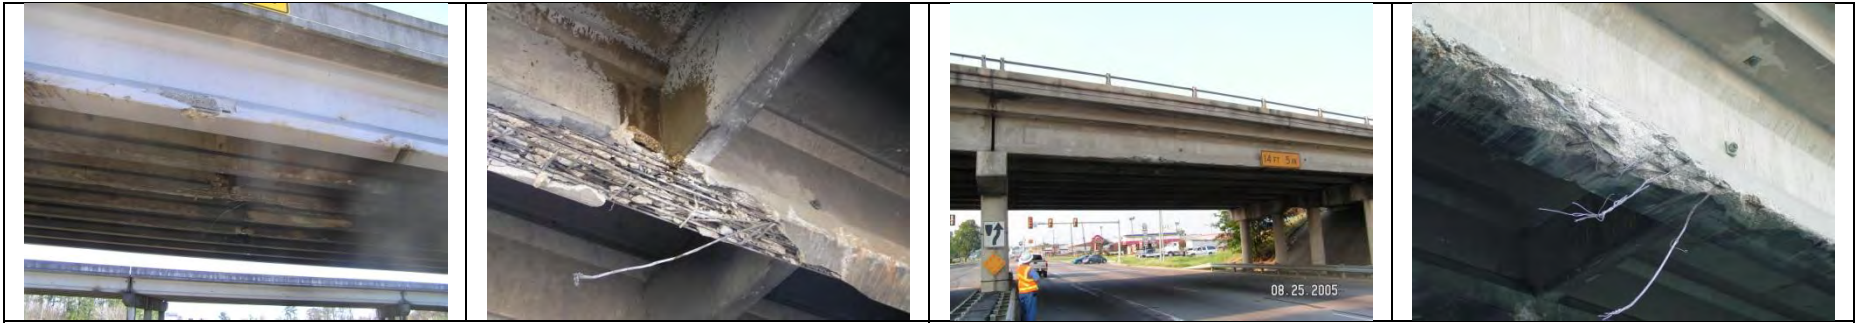
US59 over LP287 (note previous repair material in fig b)
 AASHTO I-girder; reportedly repaired
 [Courtesy of the Texas Department of Transportation, © 2007 All rights reserved.]

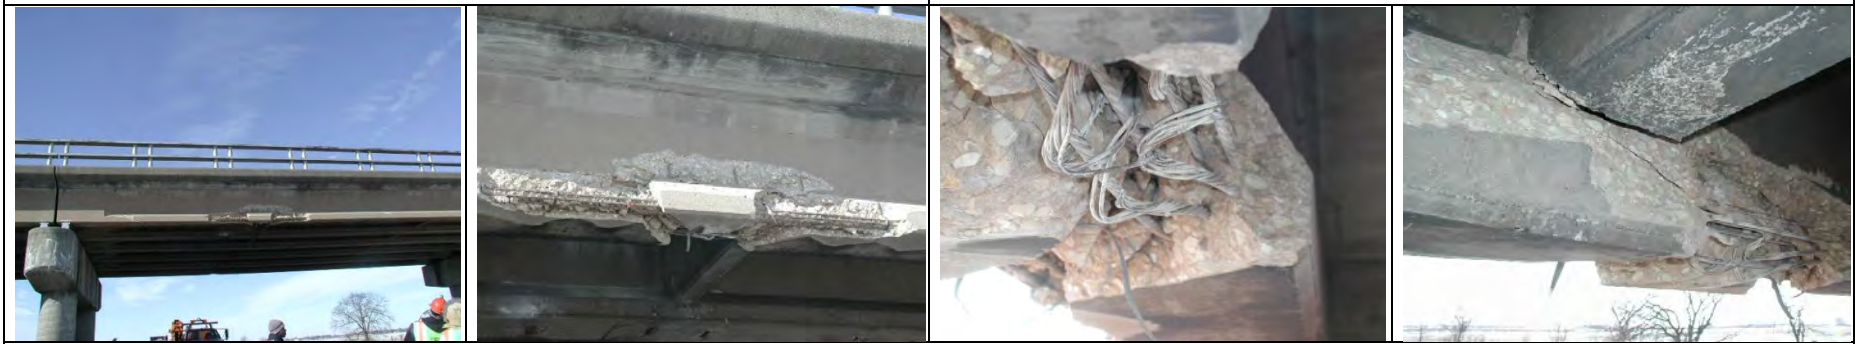
Impact damage to AASHTO I-girder
 [ILDOT]

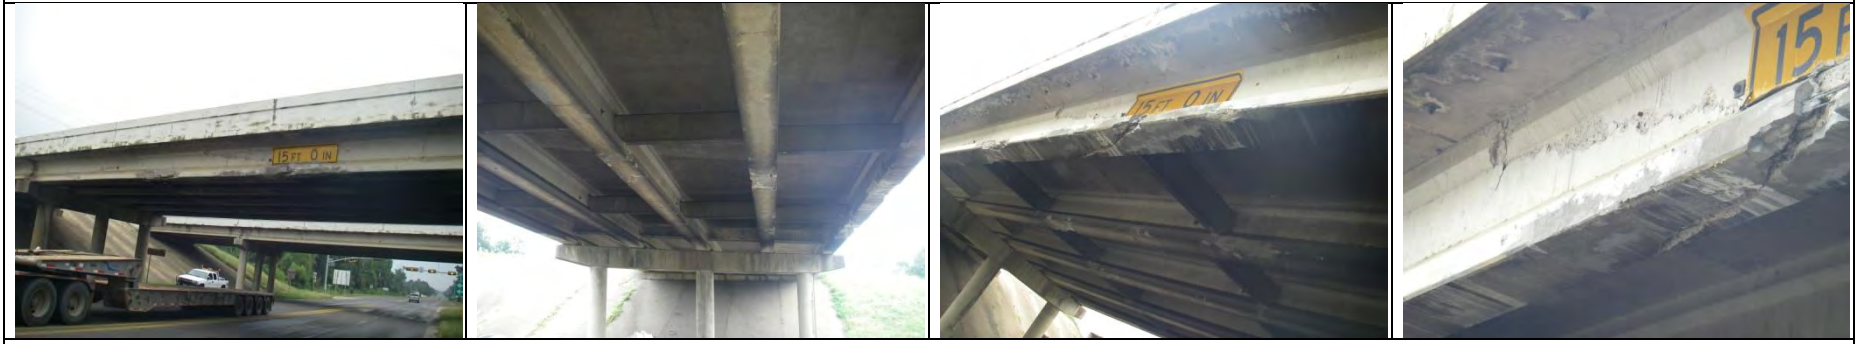
US59 over US79
 AASHTO I-girder; reportedly repaired
 [Courtesy of the Texas Department of Transportation, © 2007 All rights reserved.]

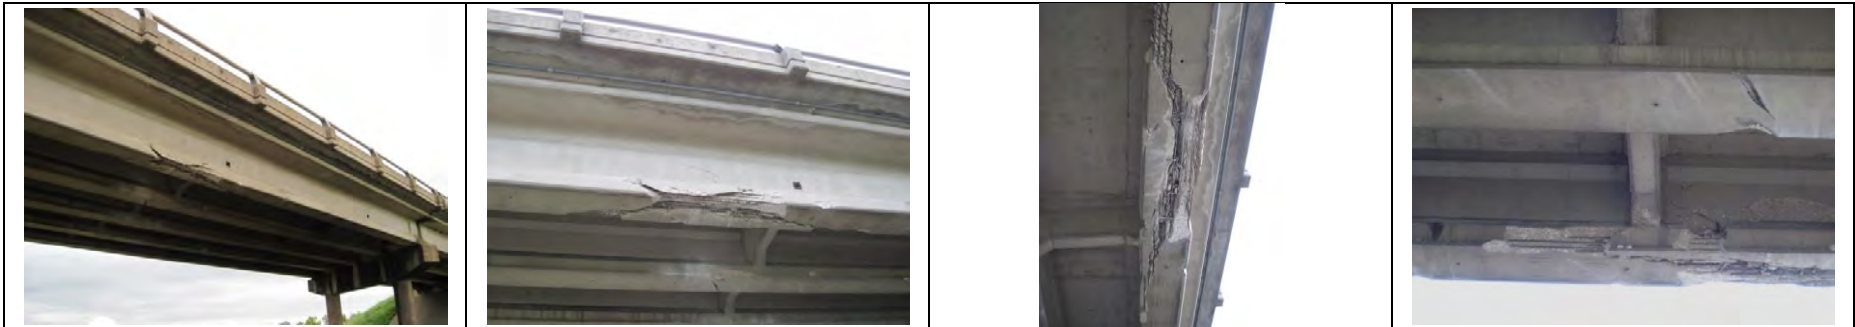
LP301 over IH30
 AASHTO I-girder; reportedly repaired
 [Courtesy of the Texas Department of Transportation, © 2007 All rights reserved.]

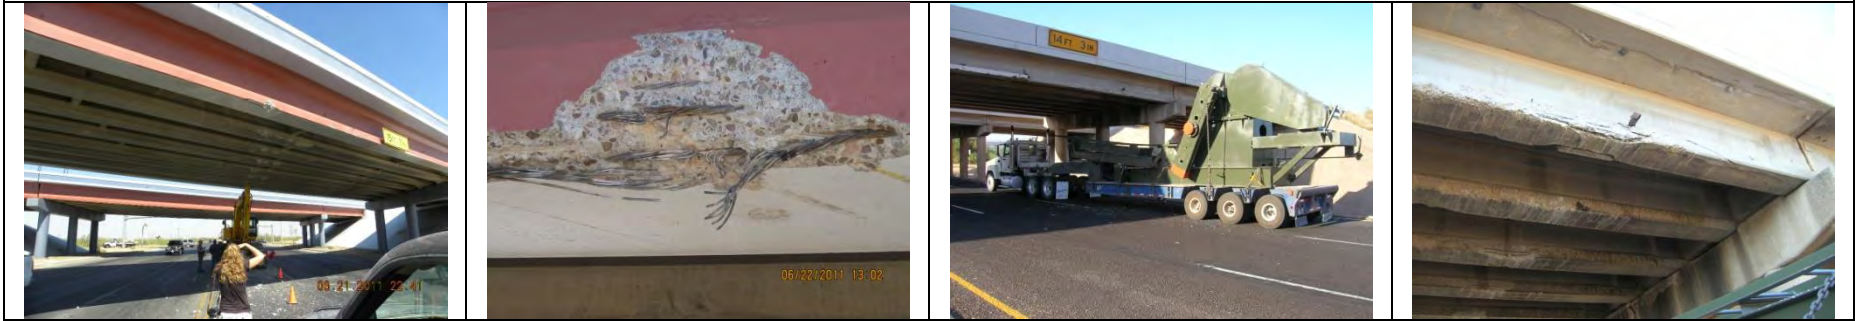
SH 302 at SP450
 AASHTO I-girder; reportedly repaired
 [Courtesy of the Texas Department of Transportation, © 2007 All rights reserved.]

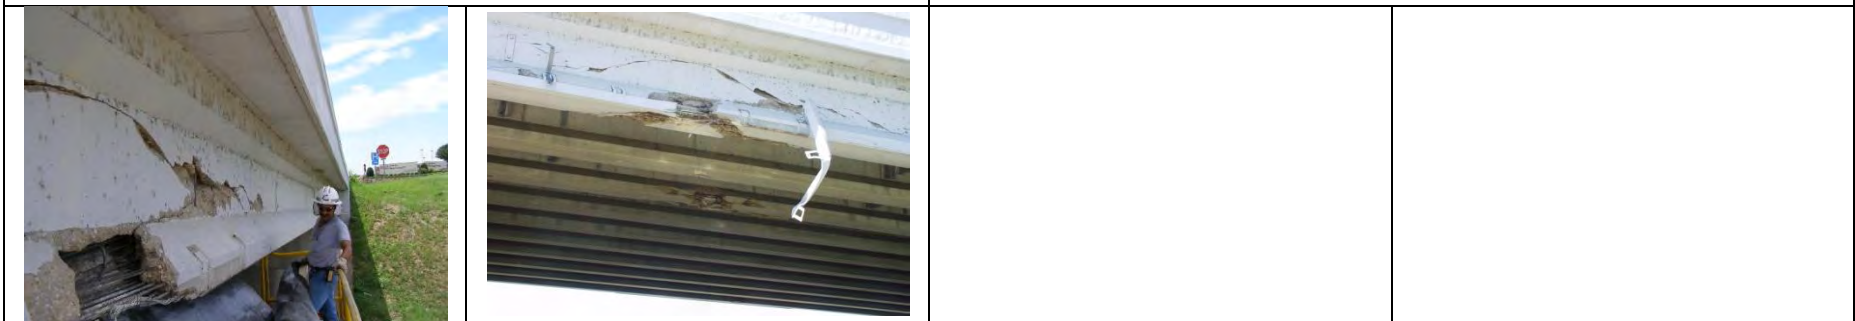
US B67 over US 67
 AASHTO I-girder; reportedly repaired
 [Courtesy of the Texas Department of Transportation, © 2007 All rights reserved.]

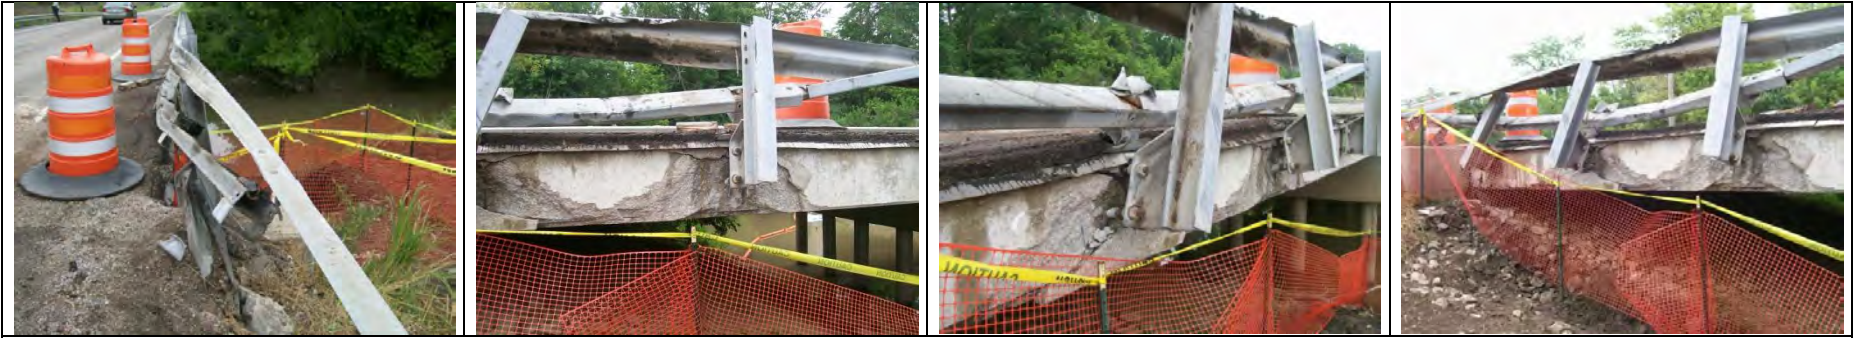
Guardrail impact.
reported by source as box beam
[ODOT]

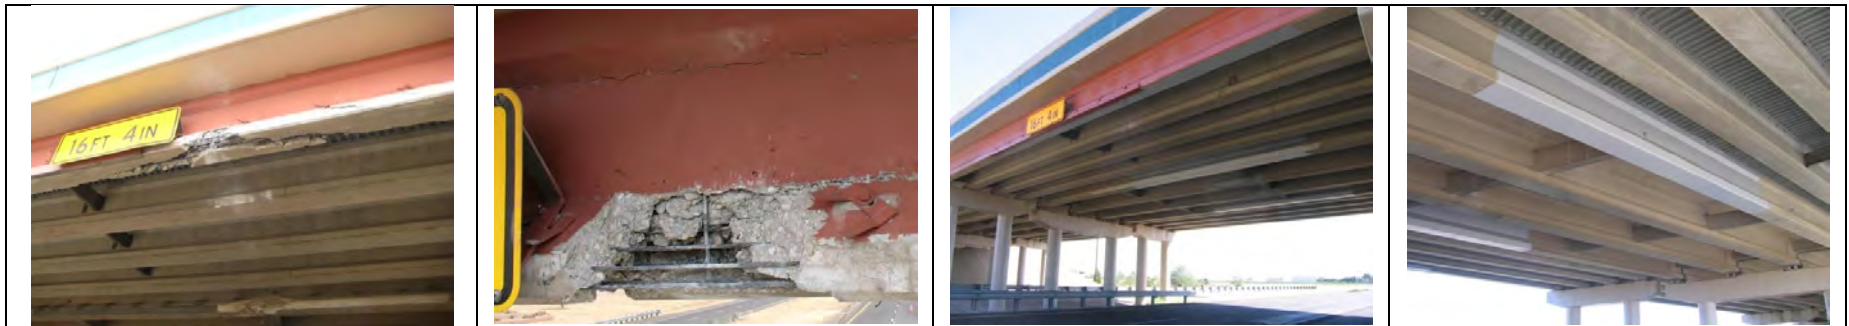
FM 1788 over IH20
AASHTO I-girder
[Courtesy of the Texas Department of Transportation, © 2007 All rights reserved.]

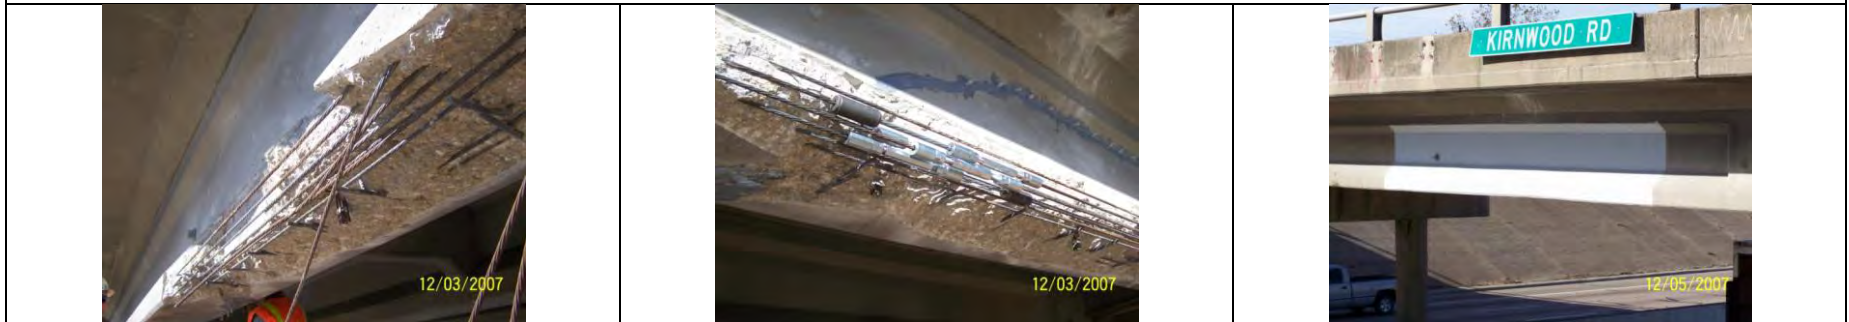
IH-35 at Kirnwood
AASHTO I-girder
[Courtesy of the Texas Department of Transportation, © 2007 All rights reserved.]

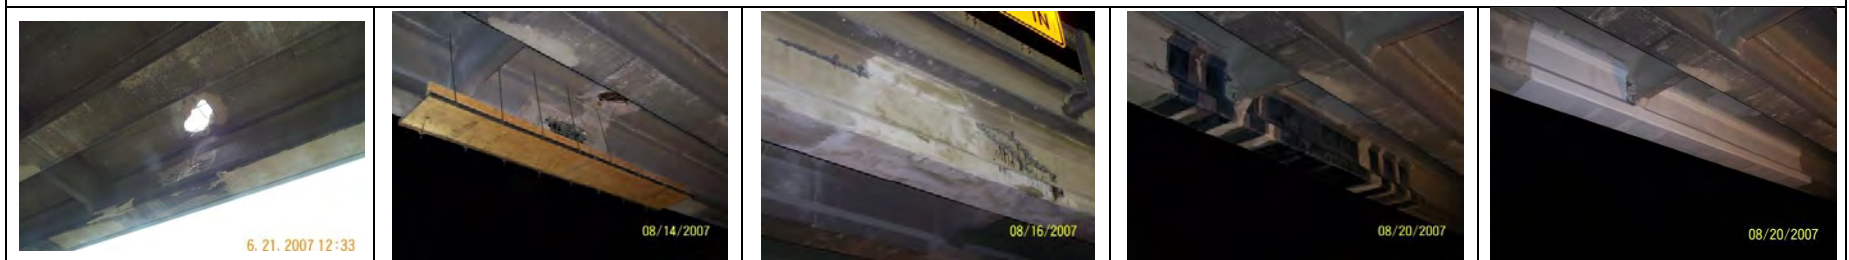
IH-35 at Corinth
AASHTO I-girder
[Courtesy of the Texas Department of Transportation, © 2007 All rights reserved.]

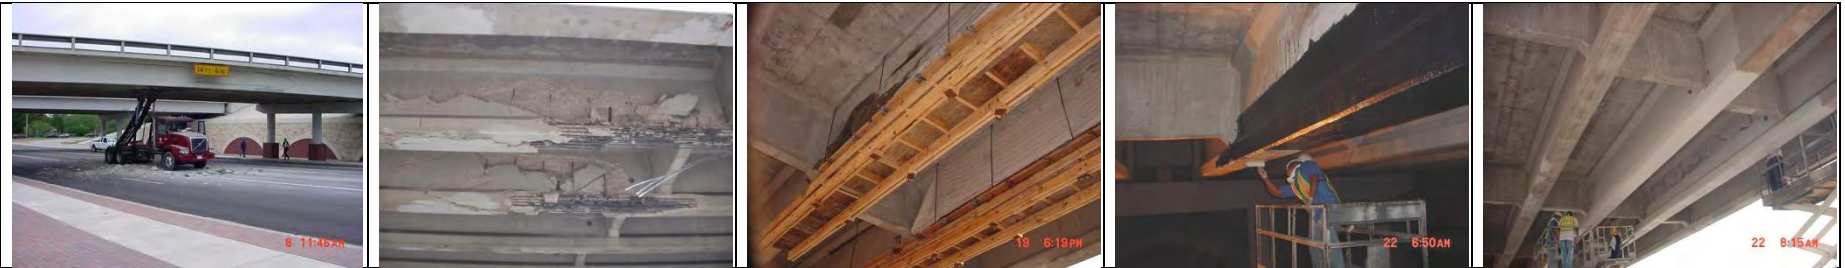
SH6 over SH30
 AASHTO I-girder
 [Courtesy of the Texas Department of Transportation, © 2007 All rights reserved.]

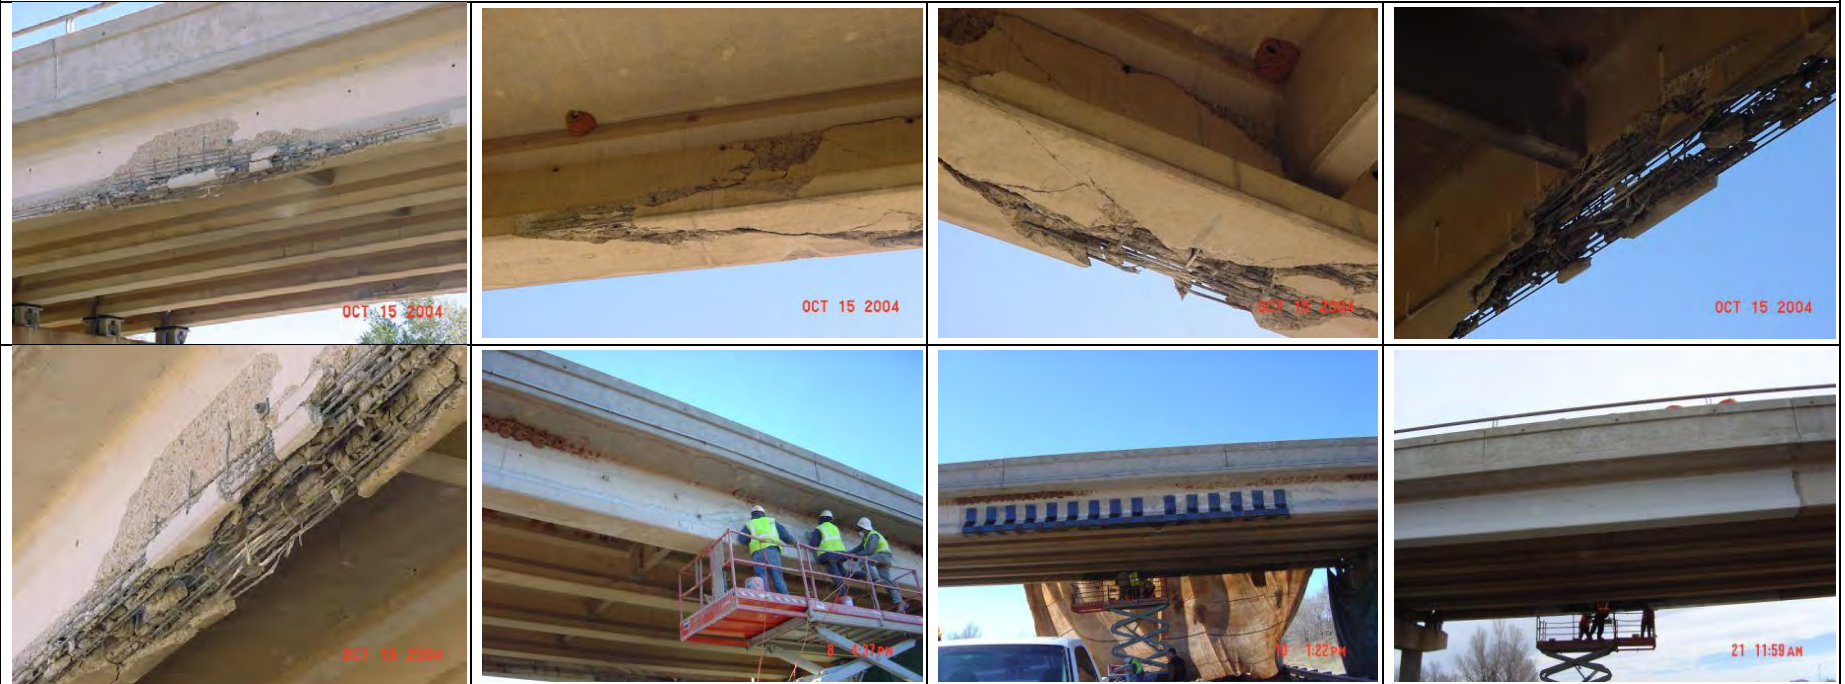
IH40 at Shamrock
 AASHTO I-girder
 [Courtesy of the Texas Department of Transportation, © 2007 All rights reserved.]

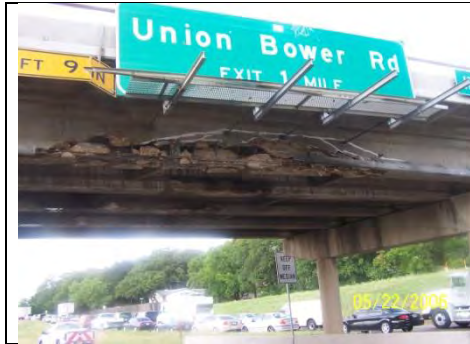
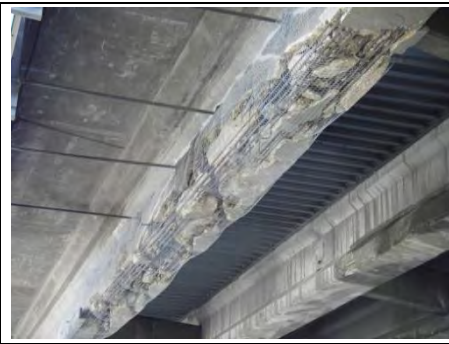
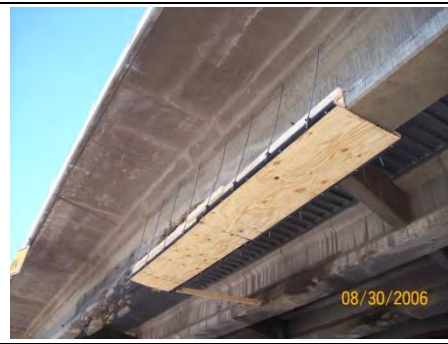
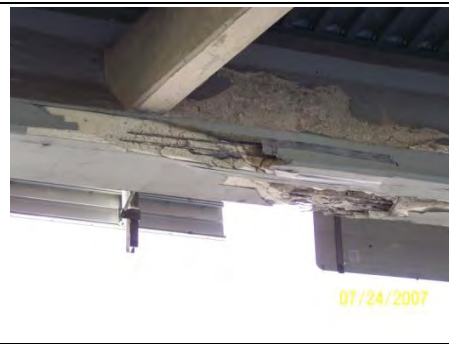
2006: vehicle impact #1

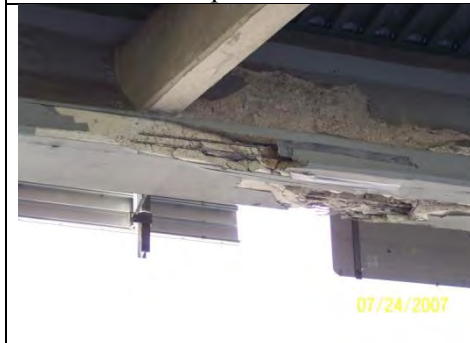
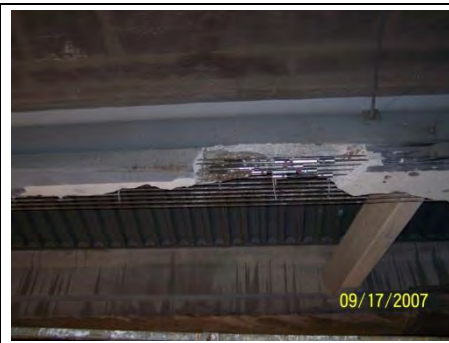
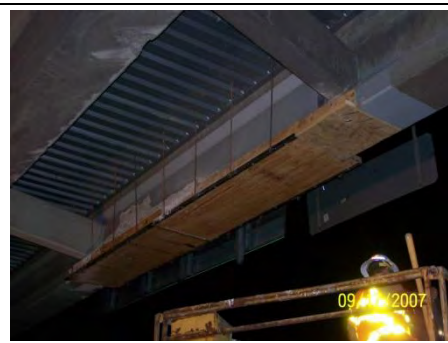
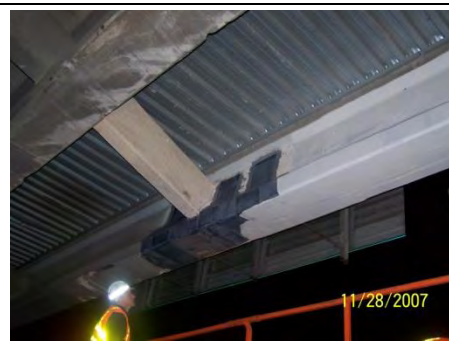
2007: vehicle impact #2

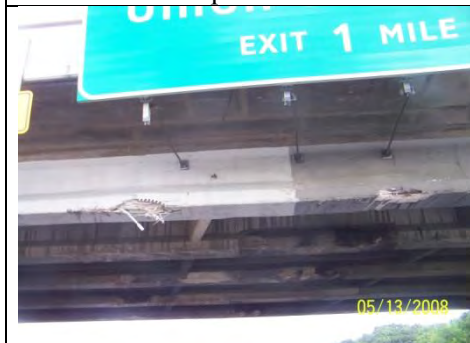
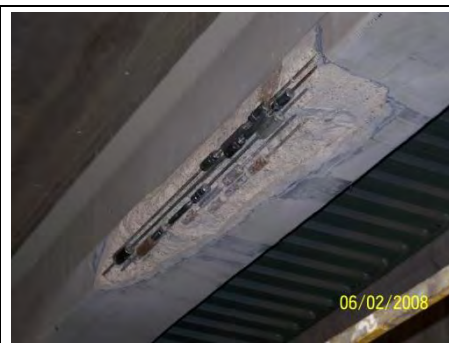
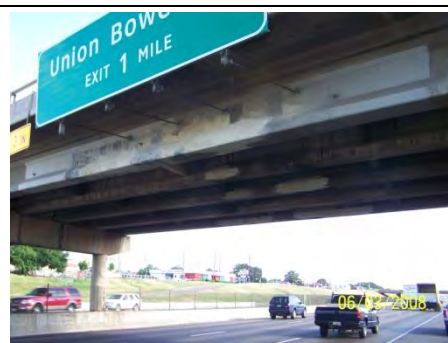
2008: vehicle impact #3

LP12 at Irving
AASHTO I-girder
[Courtesy of the Texas Department of Transportation, © 2007 All rights reserved.]

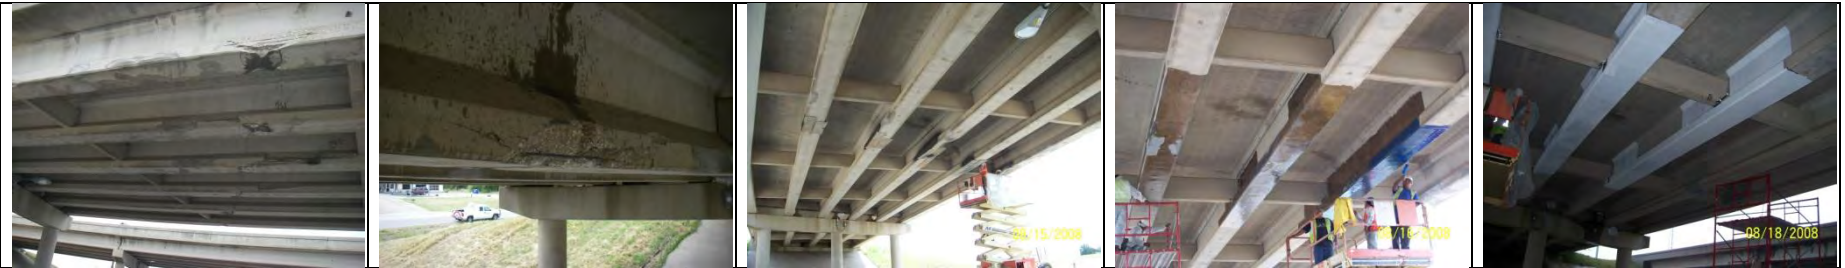
US183 over IH20
 AASHTO I-girder
 [Courtesy of the Texas Department of Transportation, © 2007 All rights reserved.]

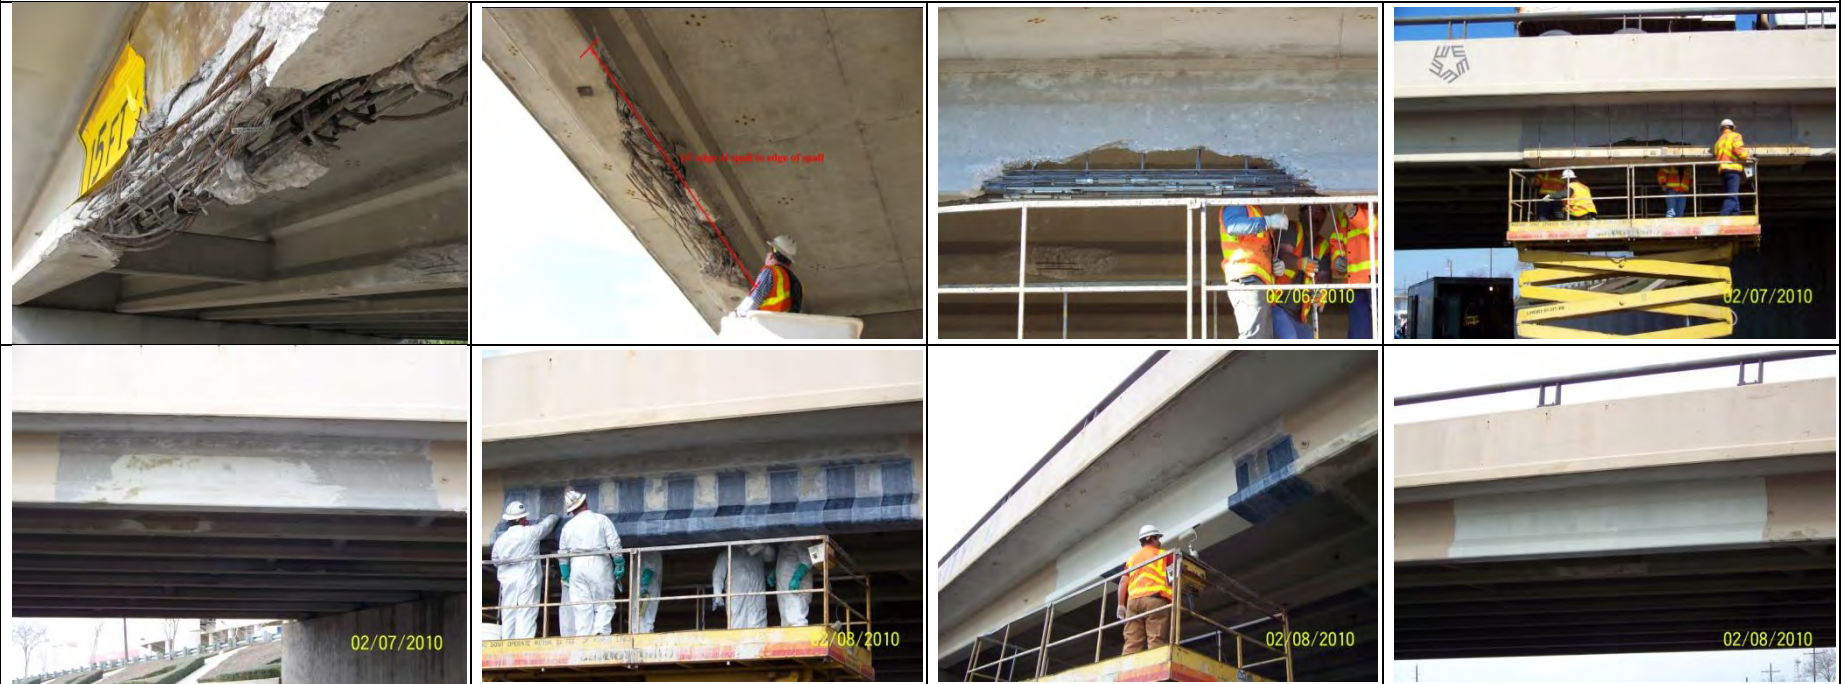
Virginia Street
 AASHTO I-girder
 [Courtesy of the Texas Department of Transportation, © 2007 All rights reserved.]

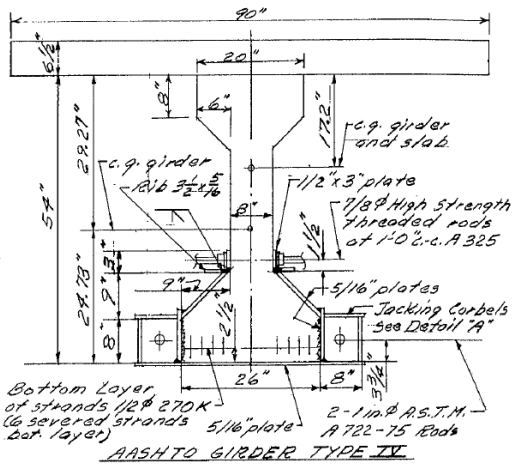
Figure 5 Repair methods presented in Shanafelt and Horn (1980).

e) Splice 5: Combination of repair methods

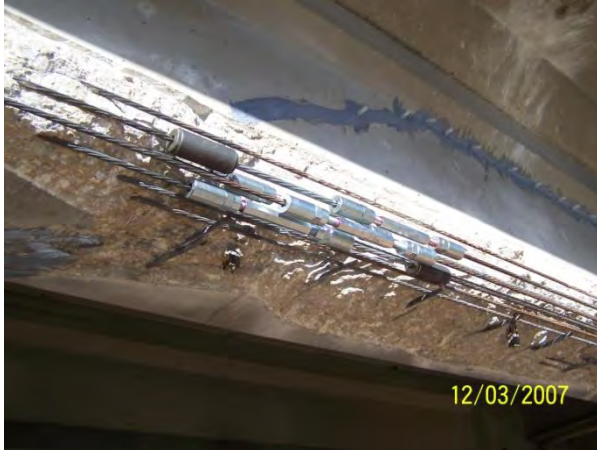
a) strand splices *in situ*
 [Courtesy of the Texas Department of Transportation, © 2007 All rights reserved.]

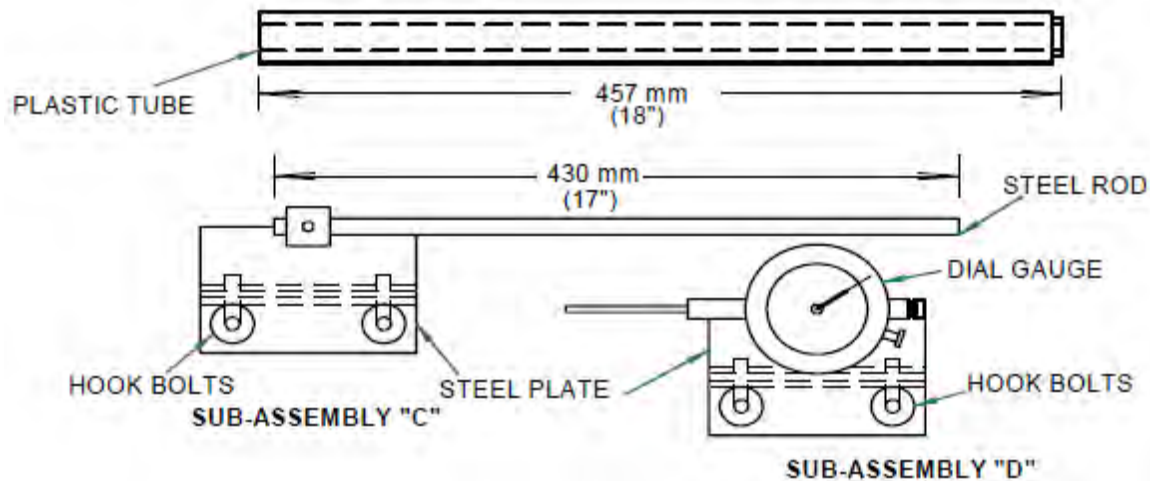
Figure 7 ABITB stressing gage (ABITB 2005).

The ABITD stressing gage consists of a 17 in. (430 mm) long steel rod mounted on a steel plate with hook bolts (sub-assembly “C” in Figure 7), an 18 in. (457 mm) long plastic tube, and a dial gauge mounted on a second steel plate with hook bolts (sub-assembly “D” in Figure 7). Sub-assembly C is mounted on the strand using the hook bolts. The plastic tube placed over the steel rod and sub-assembly D is mounted to the strand at the other end of the tube. The plastic tube must be fitted over the two sub-assemblies and each pushed tightly against the ends of the tube, as the hook bolts are tightened. The gage is oriented so that it can be read during the stressing operation. This gage verifies the amount of prestressing force which has been restored by reading the ‘strain’ over the 17 in. gage length.

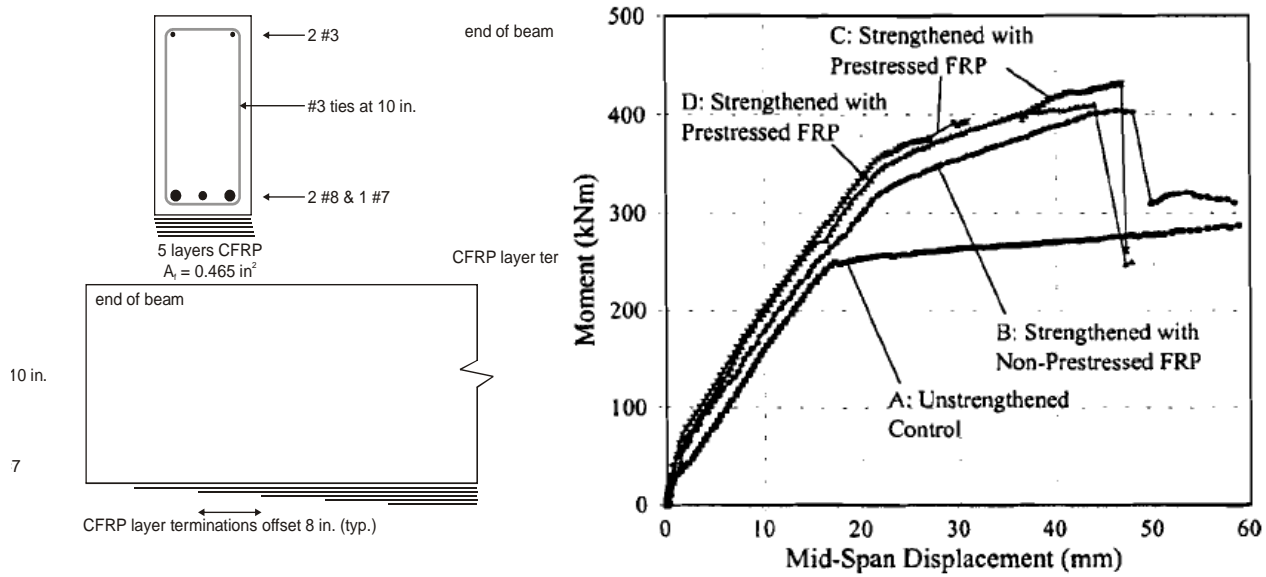
a) Specimen cross sections and elevations

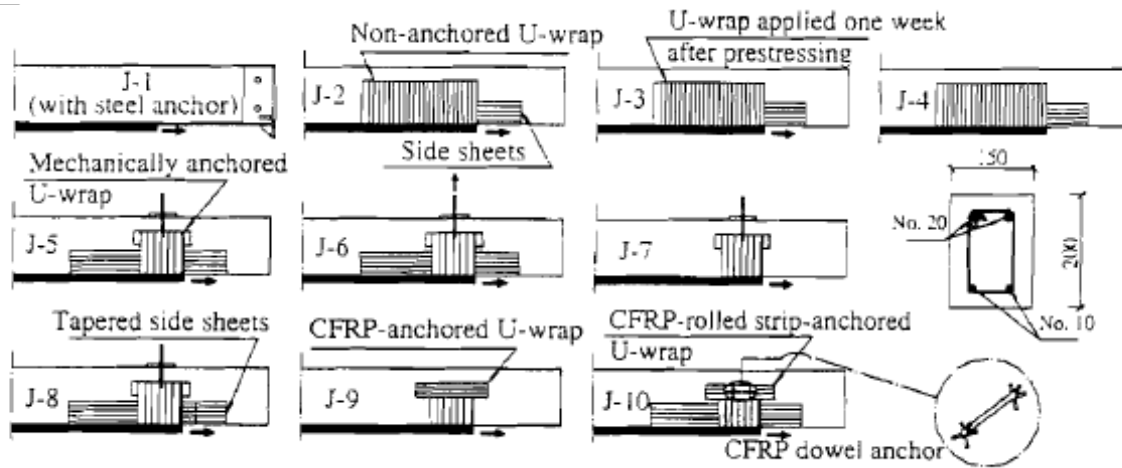
Figure 11 Nonmetallic anchoring systems (Kim et al. 2008a).

U-wrapped CFRP strips have been employed as an alternative to metallic anchorage systems (Kim et al. 2008a, Kim et al. 2008b and Yu et al. 2008b). Many nonmetallic mechanical anchoring systems for the CFRP U-wraps have been explored (Kim et al. 2008a and Kim et al. 2008b) including (see Figure 11): a) CFRP U-wrap; b) mechanical anchorage; c) prestressed CFRP U-wrap with mechanical anchorage; and d) CFRP wrap anchored systems. Test results indicated that: a) beams with nonmetallic anchors exhibited a pseudoductile failure due to the contribution of CFRP anchors, b) beams with mechanically anchored U-wraps and side sheets exhibited a capacity close to that of the control beam; and c) beams fitted with nonmetallic anchors displayed better stress redistributions compared to the beam with steel anchors (Kim et al. 2008b). Thus the ‘stiffness’ of the anchorage system tends to affect the repair behavior.
