UPDATED RESEARCH FOR COLLISION DAMAGE AND REPAIR OF PRESTRESSED CONCRETE BEAMS

Final Report

Prepared for the
National Cooperative Highway Research Program
Transportation Research Board
of
The National Academies

May 2012

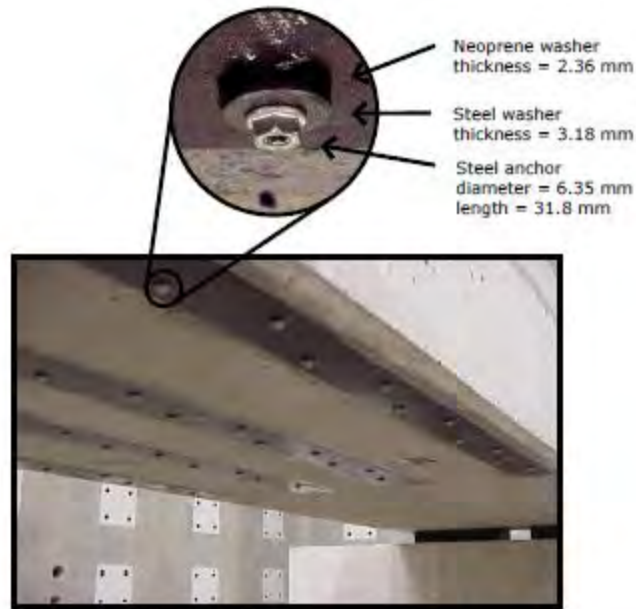
Figure 12 Mechanical anchorage (Bolduc et al. 2003).

Another system, proposed by Bolduc et al. (2003), utilized mechanical (steel) anchors to transfer force from the CFRP to the beam when the epoxy bond fails. These anchors are shown in Figure 12. This arrangement did not behave as anticipated and the CRFP strip ripped away from the anchors because the strip was unable to generate the shear resistance necessary to resist anchor tear-out. It is believed that increasing the clamping force on the strip will increase the effectiveness of similar anchors as was demonstrated by Curtis et al. (2002).

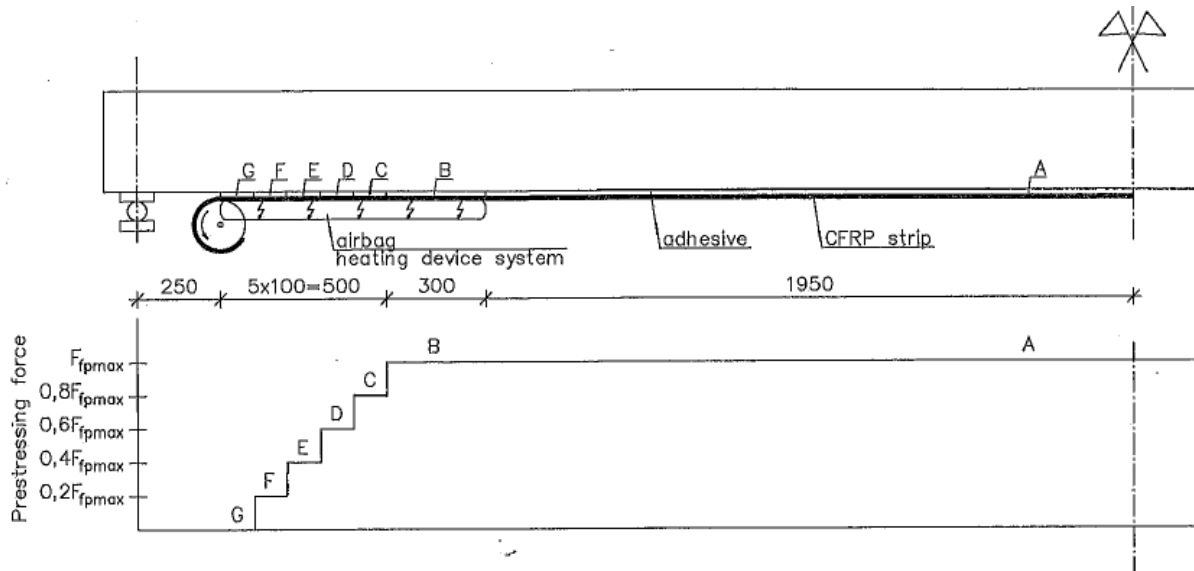
Figure 13 Gradual CFRP prestress force anchorage (Kotynia et al. 2011).

A unique approach to ‘anchoring’ P-CFRP did not use anchors at all, but rather gradually reduced the prestressing force of the strip until the force was zero at the ends of the strip (Aram et al. 2008). The concept behind this was that peeling failure of the strip could be avoided if the force at the strip termination is zero. Results show that this ‘gradient anchorage’ method was not effective and IC debonding failure occurred because the strip was anchored in a region of higher load-induced stress, rather than at the beam ends. Kotynia et al. (2011) performed a similar study on reinforced concrete slabs. CFRP strips were gradually anchored to the beam near the beam ends, with the strip terminating at a distance approximately 1.1 times the depth of the slab away from the support. In the anchorage zone, the strip was incrementally anchored, stepwise releasing 20% of the prestressing force, as shown schematically in Figure 13. This anchorage process provided better CFRP bonding behavior than that used by Aram et al. (2008) effectively mitigating plate-end debonding.

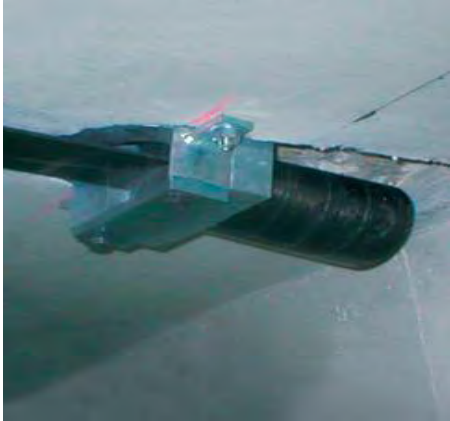
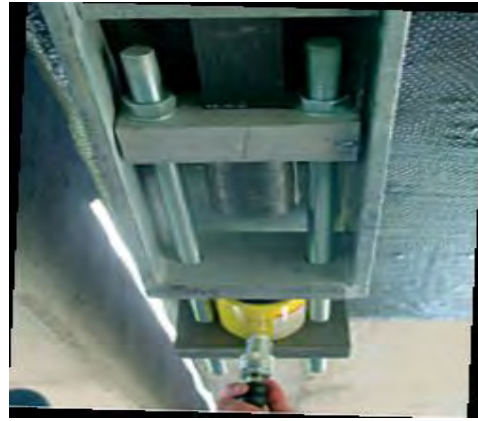
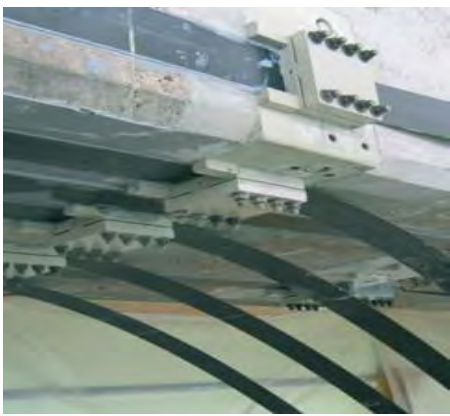
Figure 14 Sika CarboStress PT-CFRP system (SIKA 2008b).

There are only two known commercially available ‘standardized’ PT-CFRP system: one manufactured and distributed by SIKA Corporation and the other by S&P FRP Systems. Both are marketed primarily in Europe. The SIKA CarboStress system (Sika 2008b) is shown in Figure 14. The anchorage has a capacity of 67 kips (300 kN) and is intended for a maximum applied prestress force of 45 kips (200 kN). Material properties of the CFRP strips are given later in Table 7. This system is comprised of CFRP strips with ‘potted’ CFRP anchorages referred to as ‘stressheads’ manufactured on each end. These stressheads are captured by steel anchorages mounted on the concrete (Figure 14a) or by the jacking hardware (Figures 14b and d). One anchor is the fixed or ‘dead’ end (Figure 14a) while the other is the jacking end (Figure 14b). The jacking end stresshead connects into a movable steel frame which connects to a hydraulic jack, thus allowing the strip to be stressed. Once the desired stress level is reached, the jack can be mechanically locked to retain the stress in the CFRP or the CFRP strip can be anchored by ‘clamps’ (Figure 14c) near the jacking end. Anchor points can also be located at discrete intervals along the beam. The stress in the strips can vary according to structural need and is limited to the tensile strength of the strip (in many cases, the strength of the beam at the anchor location controls the amount of prestress force that can be applied). The S&P system (S&P 2011) works similarly to the SIKA system, but uses a different proprietary jacking system. An example of the dead and live end anchors for the S&P system can be seen in Figure 15a and b, respectively.

(a) dead end anchor

(b) jacking end anchor in movable frame

(c) multiple live end anchors at one location

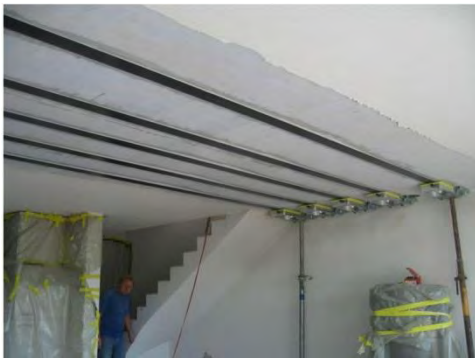
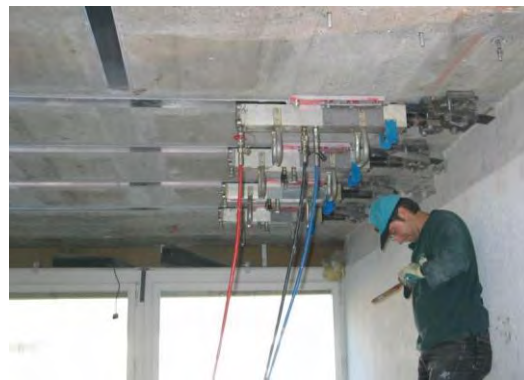
Figure 15 S&P FRP Systems PT-CFRP system (S&P 2011).

a) dead end anchor

b) live end anchors and jacking system

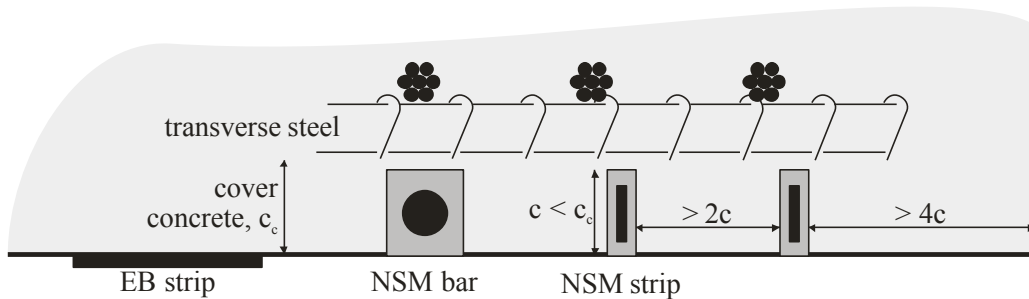
Figure 16 Schematic of externally bonded and NSM CFRP techniques.

NSM repair can be prestressed if serviceability is a concern or non prestressed if ultimate capacity is the only design consideration. It is noted, however, that prestressing NSM applications is very difficult and has only been demonstrated in laboratory applications using a stressing procedure that is not practical for use in the field (Nordin et al. 2002 and Casadei et al. 2006). An NSM CFRP repair is completely enclosed in epoxy, making it possible to achieve higher bond strength as compared to external strip bonding due to the larger surface area which is bonded. Additionally, an NSM application engages more cover concrete and is able to transfer greater stresses into the concrete substrate (Quattlebaum et al. 2005). Since bond capacity is typically the limit state associated with EB repairs, NSM repairs will typically require less CFRP material due to the enhanced bond characteristics. NSM repairs are sensitive to the amount of concrete cover and are not a viable option when cover is not sufficient. ACI 440 (2008) requires NSM slots to have a clear spacing at least twice the slot depth and an edge distance at least four times the slot depth as shown in Figure 16. Laboratory studies have shown that both prestressed and non prestressed NSM repairs have been successful in restoring ultimate girder capacity (Nordin et al. 2002 and Casadei et al. 2006).

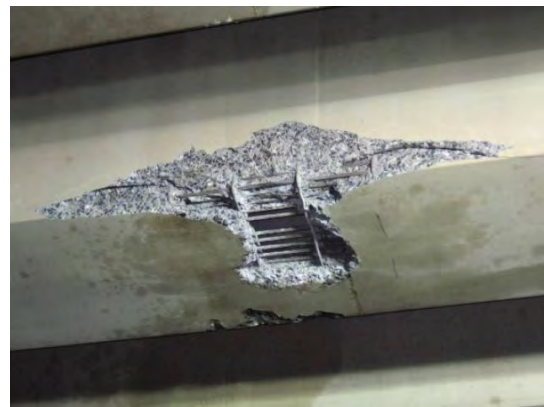
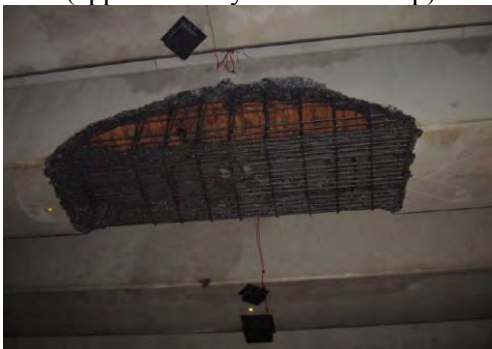
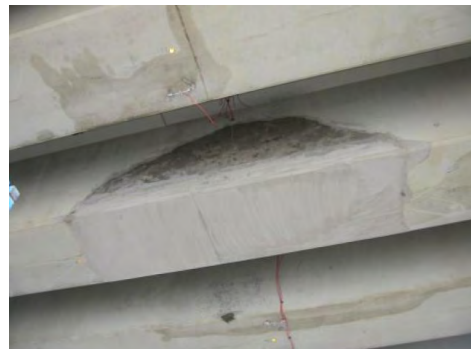
Figure 17 Brownsbarn Bridge (Pakrashi et al. (2010).

minimal concrete damage. The interior girder was significantly damaged as an appreciable volume of concrete was damaged and many strands exposed, although none were severed (Figure 17b).

b) damage to fourth interior girder

c) damaged region following hydrodemolition

d) completed repair

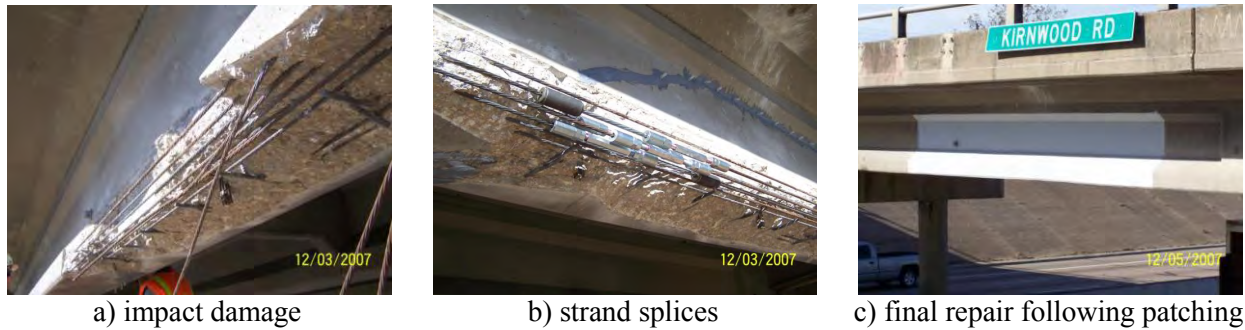
Figure 18 Strand splice repair of exterior AASHTO I-girder.

In addition to the number of previously discussed studies which utilized strand splices, there are a number of States which employ this technique (see Section 1.6). Implementation of the strand splice repair technique is based on strand displaced length and will be discussed in greater detail in Task 2.2. This repair technique can be used to splice a wide number of strands (Toenjies 2005 and Enchayan 2010) and is easily used in conjunction with other external repair techniques, including externally bonded CFRP strips (Toenjies 2005). Photos of typical strand splice repair sequence are shown in Figure 18.

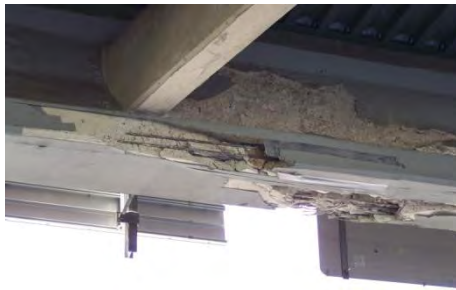
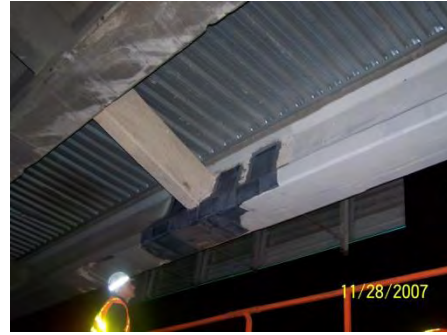
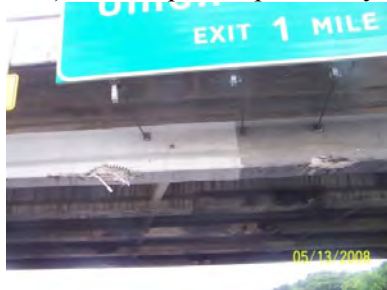
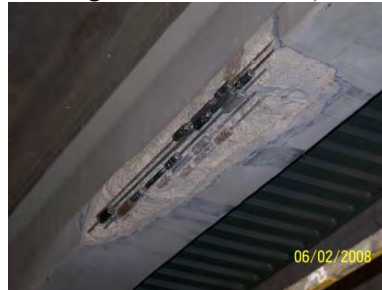
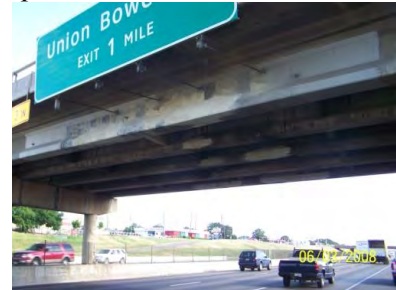
Figure 19 Exterior AASHTO I girder patched repair confined with GFRP August 2006

Considering the increasing use of FRP applications and the consequent likelihood of subsequent impact damage to the repair (see Figure 19), attention is now turning to damage tolerance of FRP repairs. In general, FRP applications result in a tougher and more damage-tolerant concrete structure (as described above), nonetheless, impact can result in loss of FRP capacity. In a recent study, Kirby and Orton (2011) concluded that impact pressure less than 3000 psi (21 MPa) applied by a cylindrical loading tup resulted in no reduction in the tension capacity of CFRP applied to a concrete substrate. These results are difficult to translate to highway bridge impacts but provide some guidance to the level of impact load that may result in CFRP damage.

a) 2007 impact to previously repaired region

b) second repair confined with CFRP

c) 2008 impact to twice-repaired region

d) strand splice repair

e) completed third repair

As described previously, preloading structures during the patching operation can draw the patch material into compression thereby mitigating effects of patch shrinkage, cracking and pop-out. Preload, however is often impractical. As an alternative, both CFRP and GFRP materials have been used to confine patches. An example repair sequence involving strand splicing, patching and patch confinement is shown in Figure 20. The externally applied FRP affords some protection to the patch and, significantly, provides some continuity or ‘bridging’ between the patch and surrounding concrete. Because all GFRP systems and most epoxy resin systems are susceptible to damage from UV light exposure, FRP systems applied to exterior girders in particular require a final protective top coat. This is also often done for aesthetic reasons. FRP applications used to confine patches have been found to be very robust (Harries 2001), even serving to reduce damage caused by subsequent vehicle impacts (Figure 19).

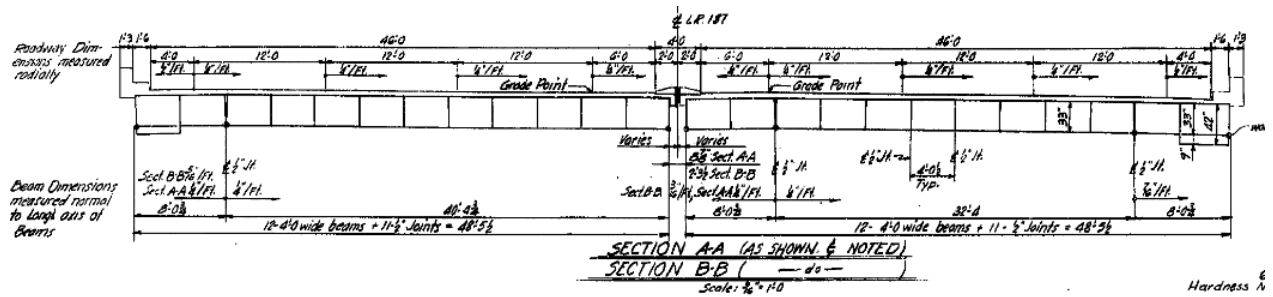
a) section of AB prototype bridge.

Material properties for prototype AB are modeled as indicated in Table 7. Concrete properties were modeled after design strength values of the prototype AB girder (American Marietta 1960). Girders of this vintage utilized Grade 250 strand and Grade 40 mild steel reinforcement, hence their use in this study. All strands were assumed to be initially stressed to $0.7f_{pu}$ (175 ksi) and to retain $0.57f_{pu}$ after all losses (based on the AASHTO 2010 prestress loss calculations), resulting in an effective prestress of 142.4 ksi. CFRP material and geometric properties are based on manufacturer's data for Sika CarboDur strips (preformed CFRP strips) (Sika 2011). These properties were used for convenience; the use of Sika-reported material properties should not be interpreted as an endorsement of these products.

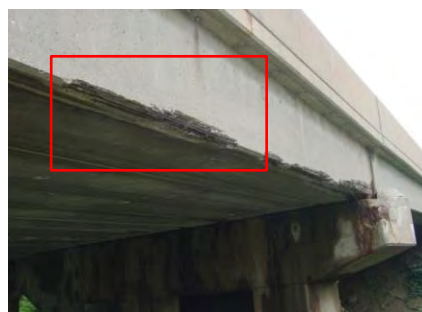
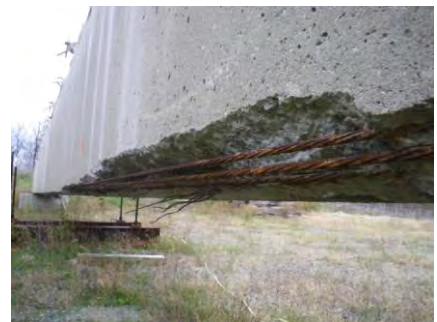
Figure 22 AB Prototype bridge and girder.

c) prototype girder *in situ* (photo from PennDOT inspection report dated August 8, 2007).

d) impact damage location (boxed location in c).

The foregoing discussion is demonstrated by the example of the AB prototype described in Section 2.2.1. The AB 3-2-0 damage (Figure 22c) extends only about 45 in. along the span centered approximately 28 feet (0.35L) along the span from the West support. The damage is located immediately above the right lane of the carriageway passing beneath the bridge. Figure 39 shows the AB prototype moment demand and capacity envelopes. The moment demand envelope includes all dead load and lane load effects and the appropriate vehicle live load moment determined at each section (i.e.: the live load determined from an influence line analysis of the HL-93 load). As seen in Appendix B, this AB girder has considerable reserve capacity (plotted on the right-hand axis of Figure 39). The damage occurring at 0.35L is mitigated as the strands are ‘redeveloped’ into the sound concrete away from the damaged region. For the damage case of AB 3-2-0 located at 0.35L, the damage barely affects the girder capacity since the midspan (0.5L) undamaged section remains critical. Greater damage (AB 6-5-2-2 shown) clearly results in the section at 0.35L becoming the critical section. In the latter case, however, the moment demand at the damaged section (0.35L) is less than the girder design moment at 0.5L. In this example, a valid argument may be made for stabilizing (patching and corrosion mitigation measures) but not repairing (in a structural sense) the AB 3-2-0 damage case, since the overall girder performance is not compromised. For the AB 6-5-2-2 damage case, structural repair may not be required if lower margin of safety (structural reliability) is acceptable since the girder capacity remains higher than demand at all sections. This latter issue is a philosophical design issue beyond the scope of the present discussion: *to what performance level does an aging damaged bridge need to be restored?*

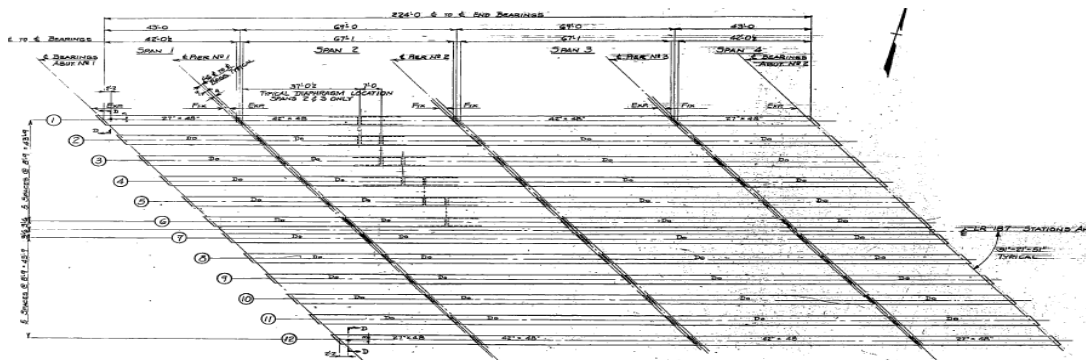
a) plan of SB prototype bridge.

The example in Appendix C was completed using member capacities calculated using either AASHTO- or ACI-prescribed analysis methods. In subsequent analyses summarized in Section 2.3, in order to rapidly analyze the girders at various damage levels, the undamaged girder cross section and all damaged and repaired sections were analyzed using a commercially available non-linear fiber sectional analysis software package XTRACT (TRC 2002) as described in Section 2.1.1. Material properties for the prototype SB girder are the same as those used for the AB girder and are given in Table 7 and discussed in Section 2.2.1.1. The PT-CFRP material properties are based on manufacturer's data for Sika CarboStress system (Sika 2008b). This system uses the same CFRP material as the EB system, although the geometry of the strip is different as indicated in Table 7.

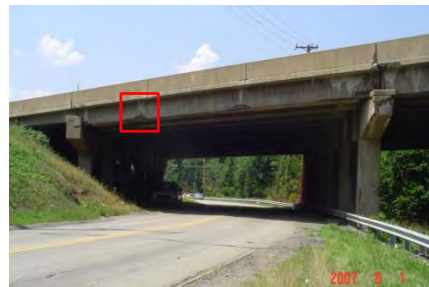
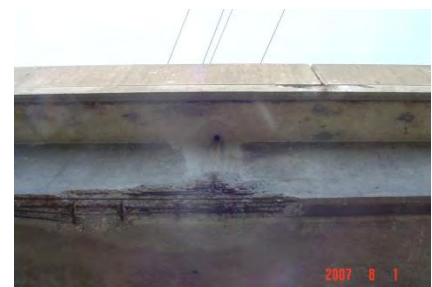
Figure 23 SB Prototype bridge and girder.

c) prototype girder *in situ* (photo from PennDOT inspection report dated August 8, 2007).

d) impact damage location (boxed location in c).

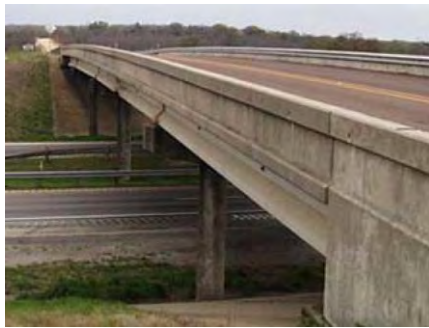
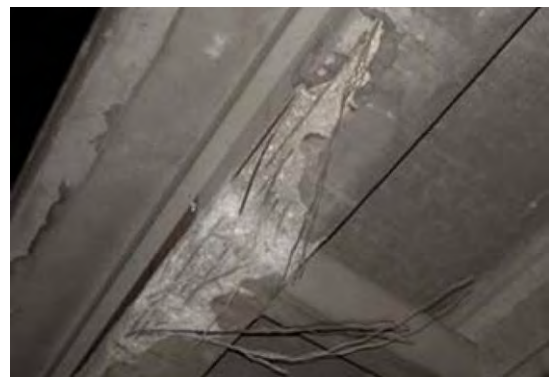
Figure 24 IB prototype bridge and girder (Yang et al. 2011).

Prototype Girder IB is based on the exterior girder of a bridge impact and repair reported by Yang et al. (2011). The bridge was erected in 1967, and impacted and repaired in 2004. The bridge, shown in Figure 24, spans 84'-8" and consists of 5 - 40 in. deep 'Type C' girders spaced at 7'-3". The Texas Type C girder falls between an AASHTO Type II and Type III in terms of section properties and is commonly used for spans between 40 and 90 feet with normal concrete strengths. The bottom flange is slightly larger than the AASHTO Type girders, accommodating up to 74 strands. The composite deck is 7 in. deep. The primary prestressing consists of 32 - 0.5" diameter Grade 270 low-relaxation strands, 8 of which are harped as shown in Figure 24c. The resulting strand profile results in a 10 foot length of girder having 32 straight strands at midspan. The damaged region was restricted to about an 8.5 ft length and was located near a diaphragm (Figure 24d). The damage shown in Figure 24d and the identification of this girder is IB 3-3-2 (see Section 2.1.3 for explanation of method of damage identification). The damaged beam had no additional deflection due to the loss of strands – an important indication that lateral support from the diaphragms and deck allowed the superstructure to redistribute the stresses to undamaged beams.

a) IB Prototype bridge.

d) damage to exterior girder.

It is clear that the undamaged girder capacity of the IB 3-3-2 ($RF_D = 0.59$) prototype cannot be restored with CFRP techniques alone. Similarly, the nature of the impact damage (Figure 24d): adjacent strands in a relatively confined region along the beam length make splicing all eight strands less practical (Section 2.3.2.4.3). Finally, recommendations (Section 2.3.3.4.1) limit the number of splice strands in a beam to about 15% (5 strands in this case). Therefore, the solution, was to splice five strands (Figure 25a), tensioning these to a stress approximately equal to the long term effective stress in the strands (Figure 25b) thereby restoring five strands. As described in Section 2.3.2.4.1, strands splices are only approximately 85% effective under ultimate load conditions. Thus, when considering the ultimate load

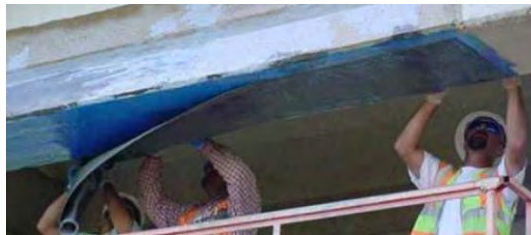
j) application of first ply of CFRP

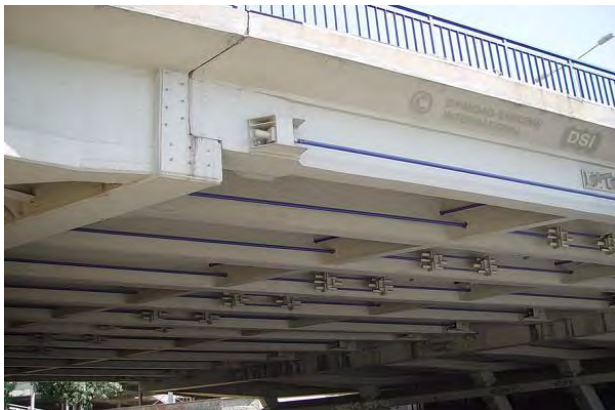
a) PT-steel anchored to girder using steel bolster bolted through girder web (second PT bolster on back of web). [DYWIDAG Systems International]

External post-tensioned systems are more easily used in bridge systems where the webs are accessible. PT-steel systems in particular, may be attached to the girder webs using bolsters (Figure 27a) or be located between girders, anchored to new or existing diaphragms (Figure 27b). In these cases, installation of king- or queen-post to harp the PT strand is feasible and may be used to improve the efficiency of the repair (the example shown in Figure 27b shows a small degree of harping between the anchorage and subsequent diaphragm supports).

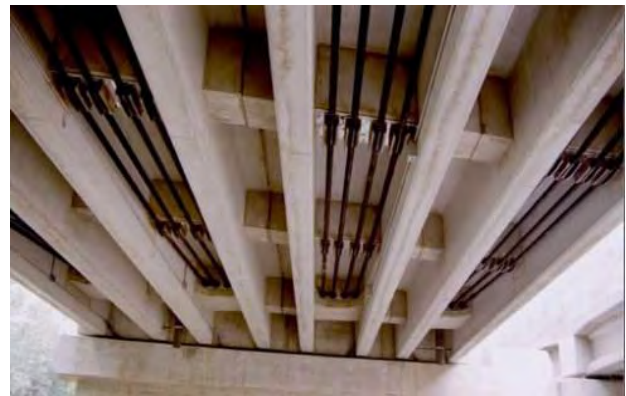
b) PT-CFRP anchored and harped by diaphragms [Mamlouk and Zaniewski *Materials for Civil and Construction Engineers* 2011]

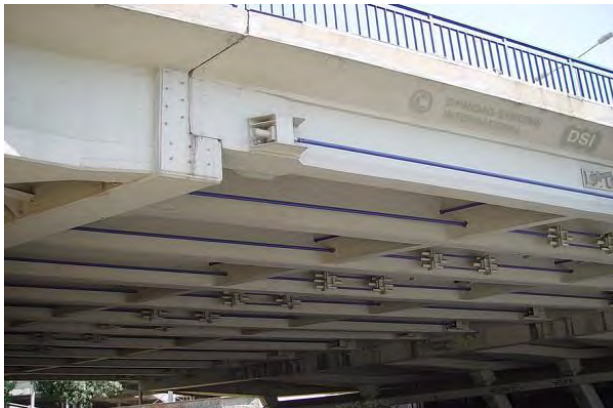
a) PT-steel anchored to girder using steel bolster bolted through girder web (second PT bolster on back of web) [DYWIDAG Systems International]

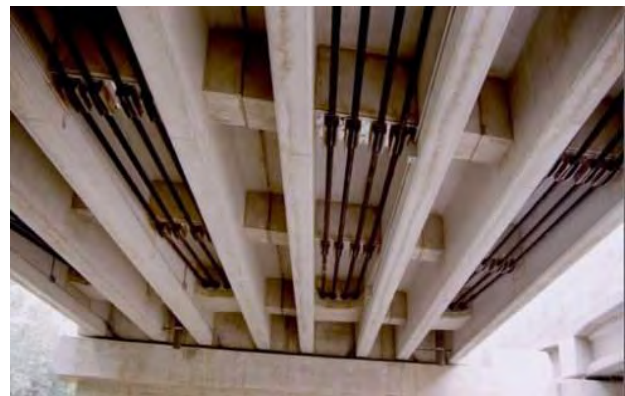
b) PT-CFRP anchored and harped by diaphragms [Mamlouk and Zaniewski *Materials for Civil and Construction Engineers* 2011]

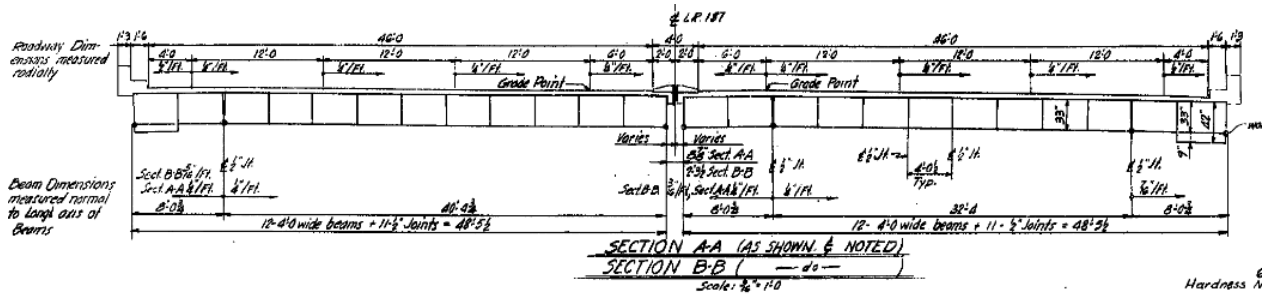
a) section of AB prototype bridge.

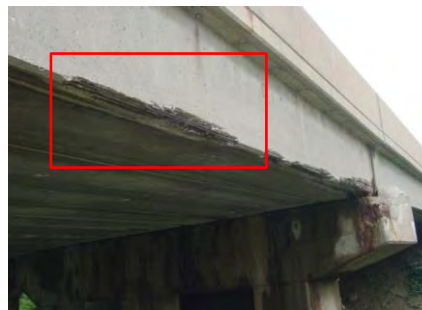
Figure B1 AB Prototype bridge and girder.

c) prototype girder *in situ* (photo from PennDOT inspection report dated August 8, 2007).

d) impact damage location (boxed location in c).

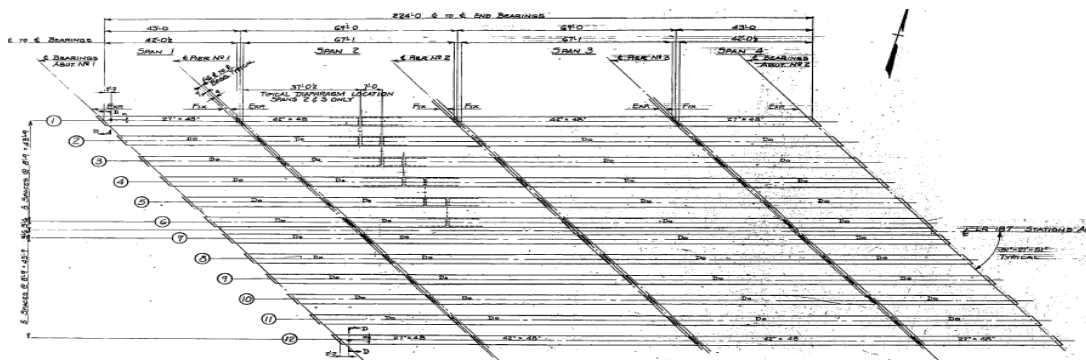
a) plan of SB prototype bridge.

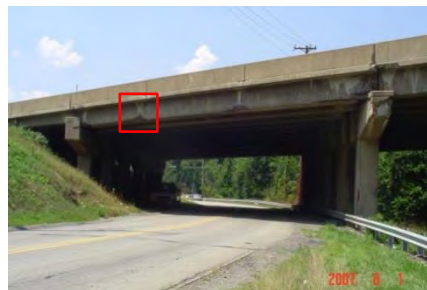
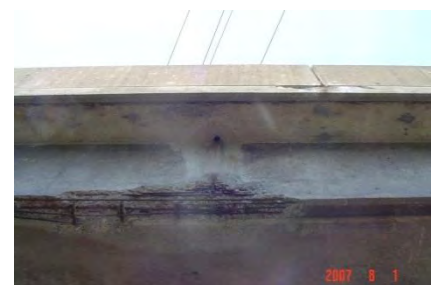
Figure C1 SB Prototype bridge and girder.

c) prototype girder *in situ* (photo from PennDOT inspection report dated August 8, 2007).

d) impact damage location (boxed location in c).

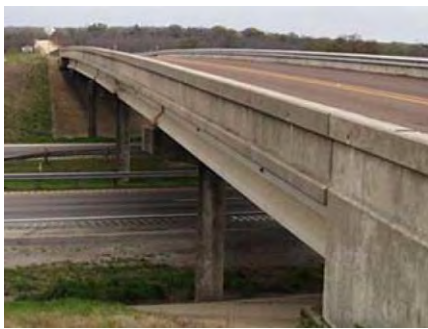
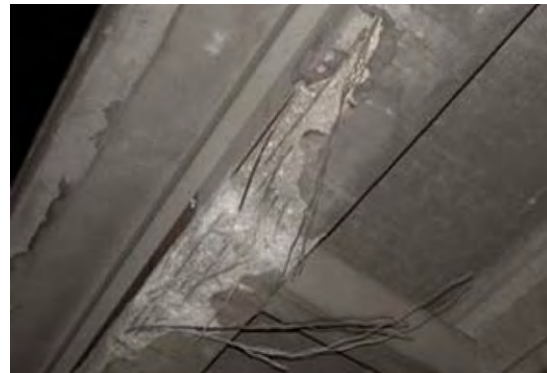
Figure D1 IB prototype bridge and girder (Yang et al. 2011).

Prototype Girder IB is based on the exterior girder of a bridge impact and repair reported by Yang et al. (2011). The bridge was erected in 1967, and impacted and repaired in 2004. The bridge, shown in Figure D1, spans 84'-8" and consists of 5 - 40 in. deep Texas 'Type C' girders (Figure D1c) spaced at 7'-3". The composite deck is 7 in. deep. The primary prestressing consists of 32 - 0.5" diameter Grade 270 low-relaxation strands, 8 of which are harped as shown in Figure D1c. The resulting strand profile results in a 10 foot length of girder having 32 straight strands at midspan. The damaged region was restricted to about an 8.5 ft length and was located near a diaphragm (Figure D1d). The damage shown in Figure D1d and the identification of this girder is IB 3-3-2.

a) IB Prototype bridge.

d) damage to exterior girder.
