**EXTEND AND VALIDATE RESULTS  
FROM NCHRP PROJECT 24-28 VIA  
IMPROVEMENTS IN NDT PROTOCOLS,  
IN SITU MEASUREMENT OF FILL  
RESISTIVITY, AND ADDITIONS TO THE  
PERFORMANCE DATABASE**

**FINAL REPORT**

**Kenneth L. Fishman, Ph.D., P.E.  
McMahon & Mann Consulting Engineers, P.C.  
BUFFALO, NY**

**June 2011**

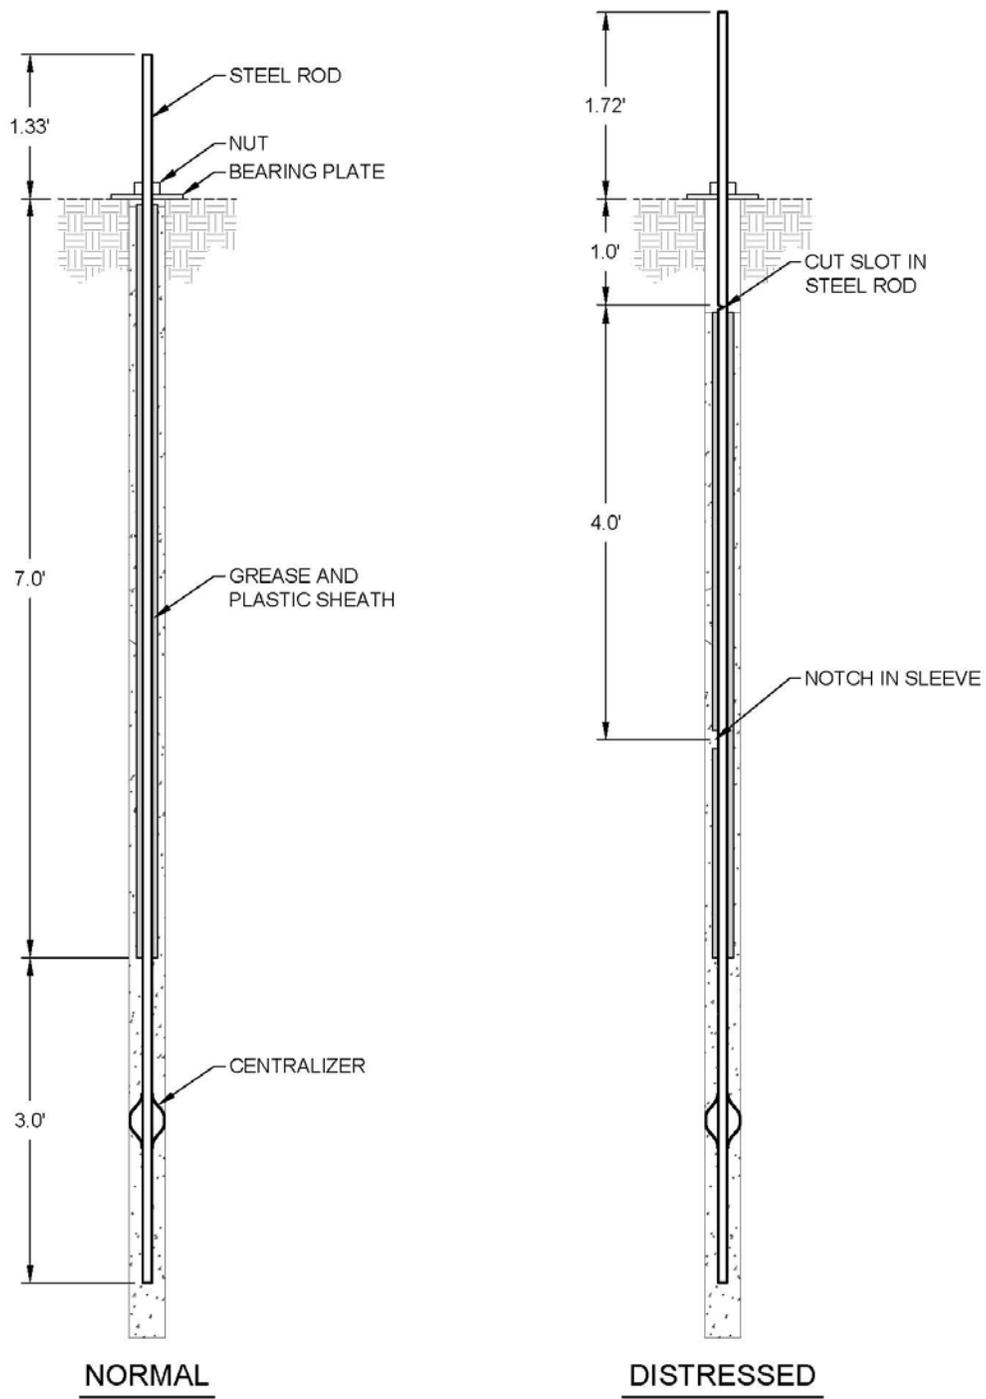
Figure 1(a) Sketch of 10' long dummy rock bolt installations.

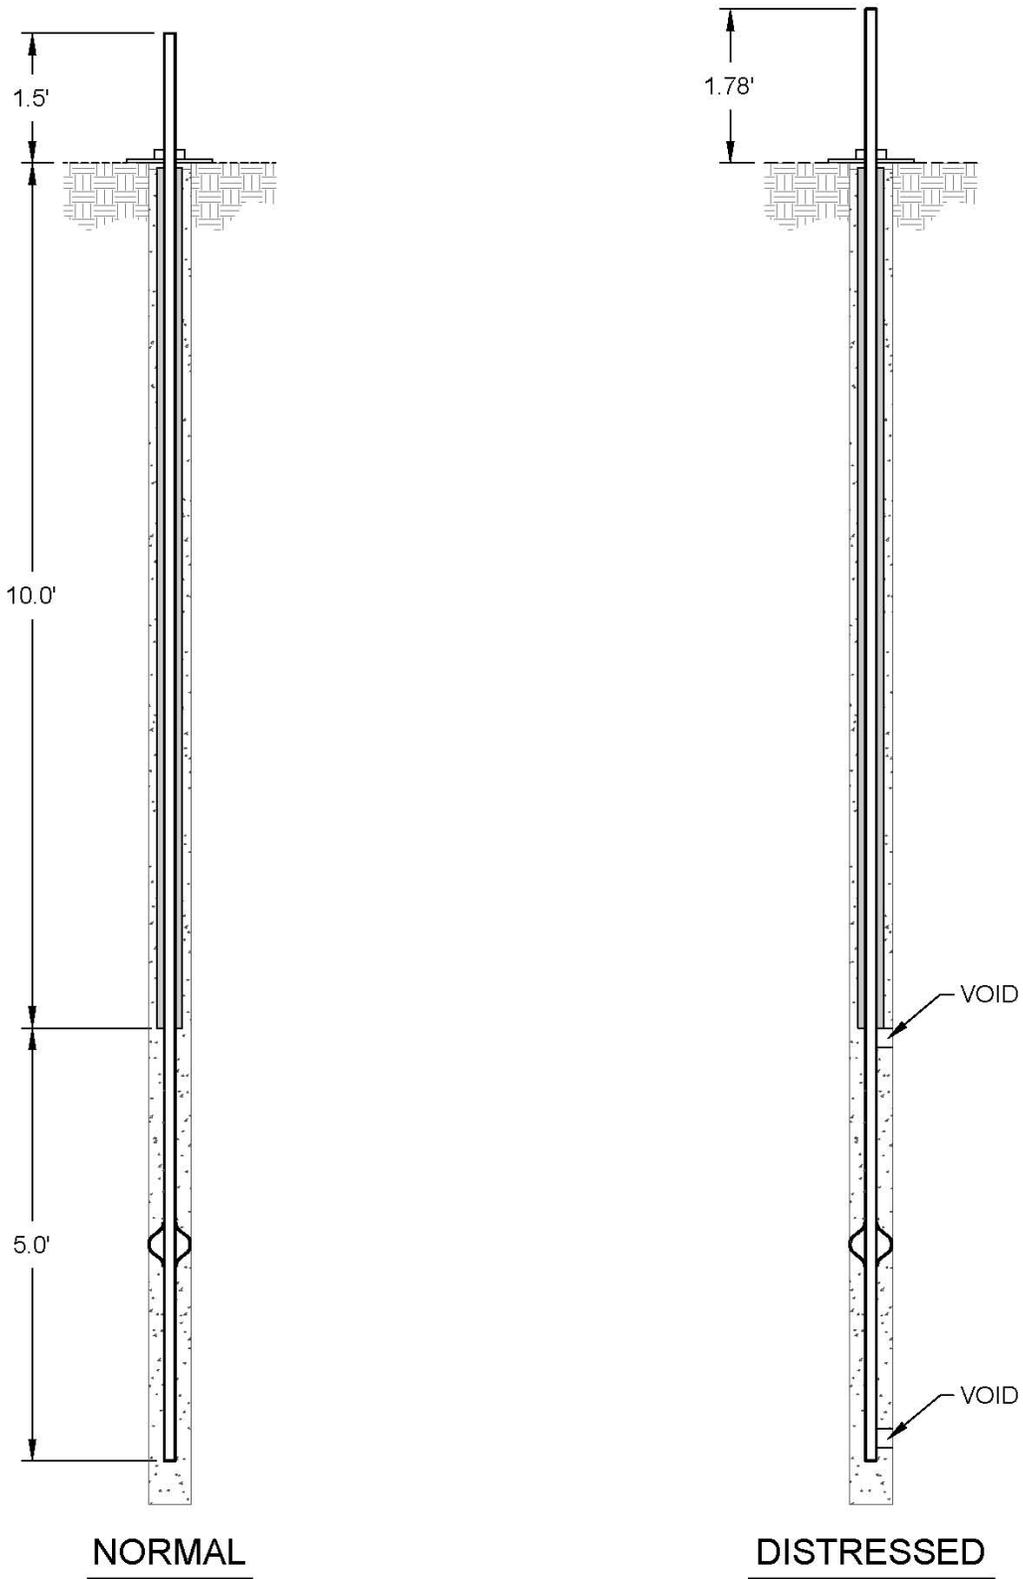
Figure 1(b) Sketch of 15' long dummy rock bolt installations.

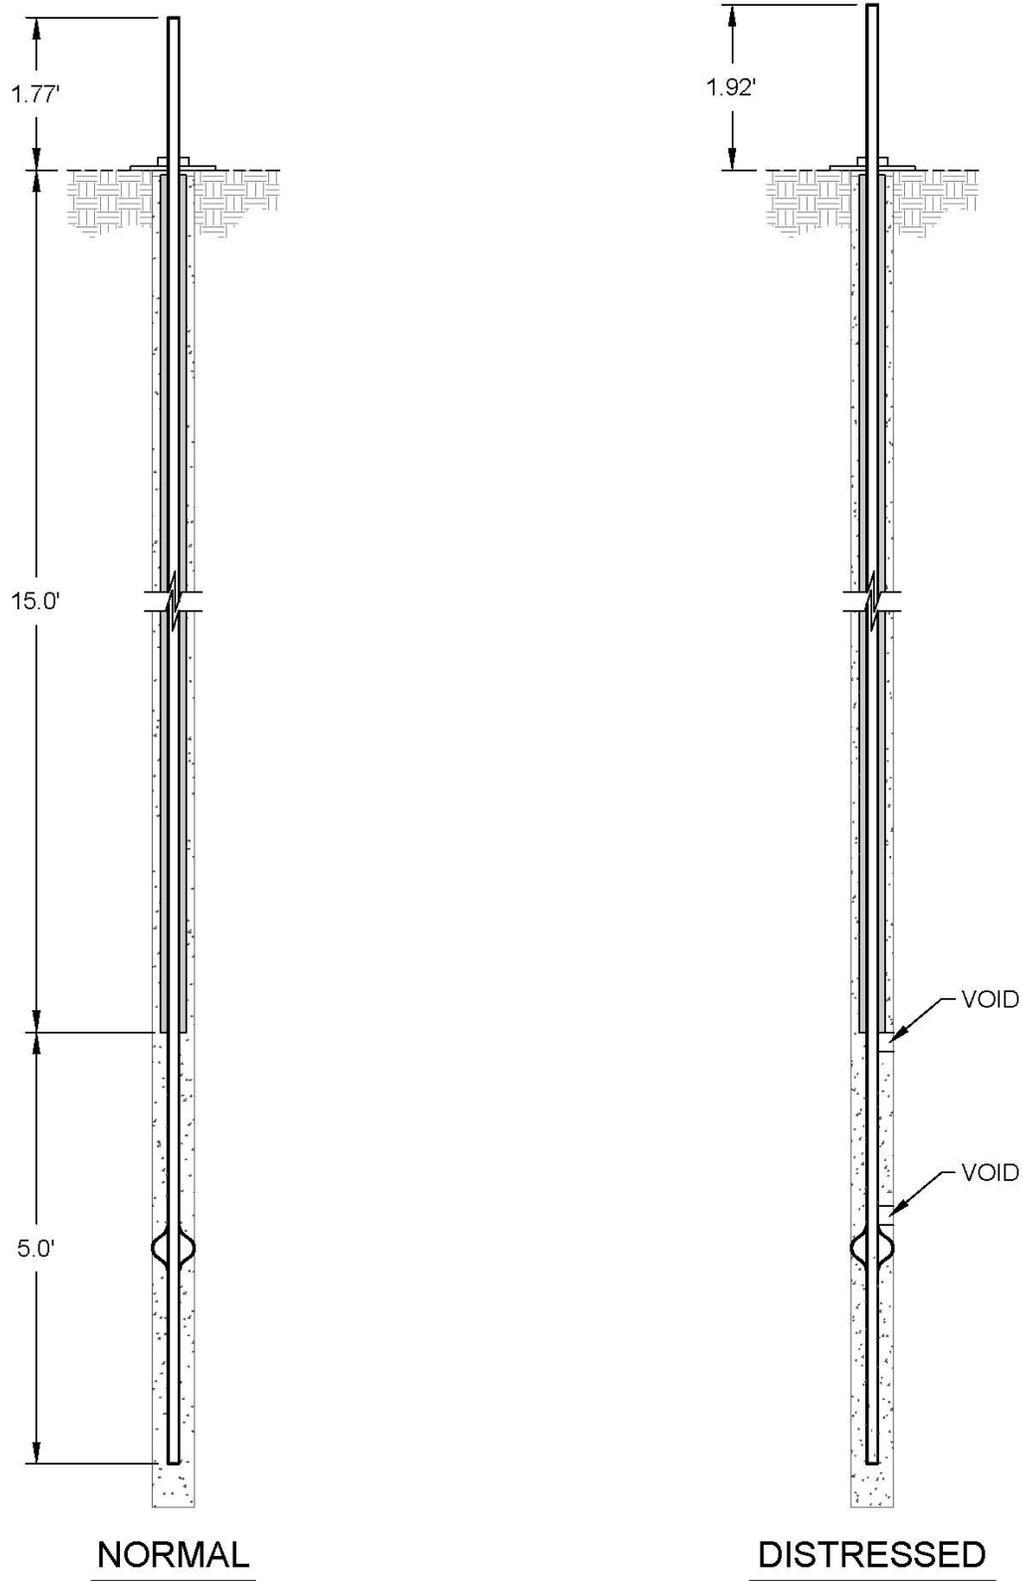
Figure 1(c) Sketch of 20' long dummy rock bolt installations.

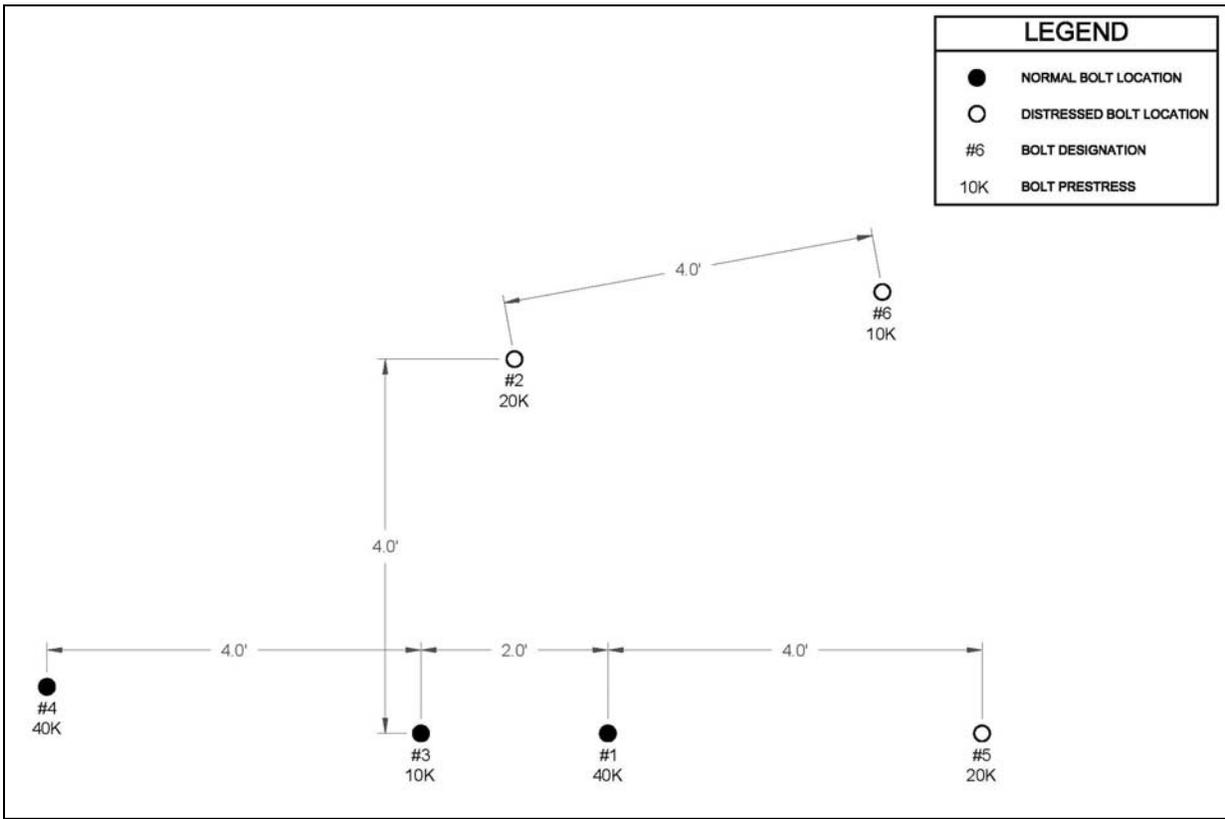
Figure 2. Locations (Elevation View) of dummy rock bolts 1-6.

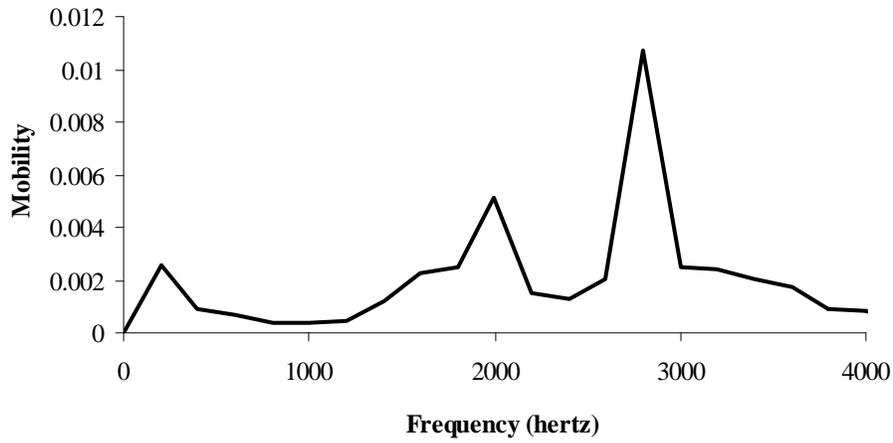
e) Mobility Plot

Figure 3. Typical IR Test Results

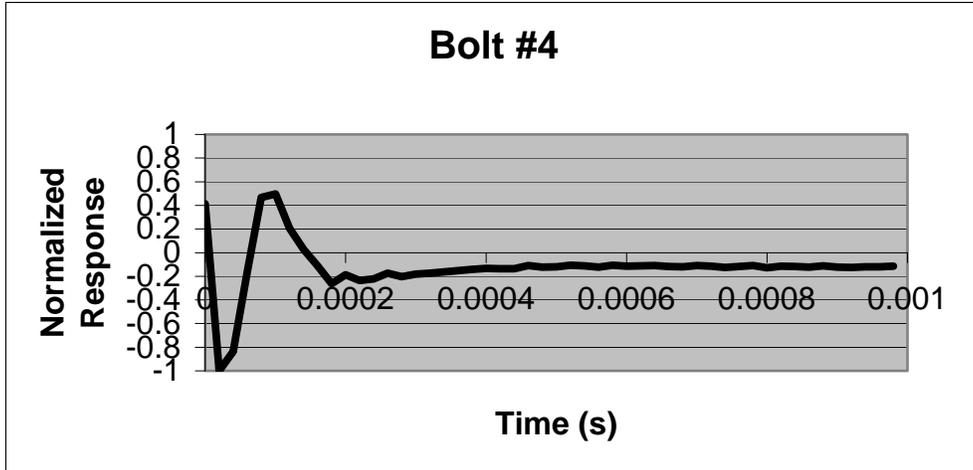
Figure 4a) UT Results for Bolt #4

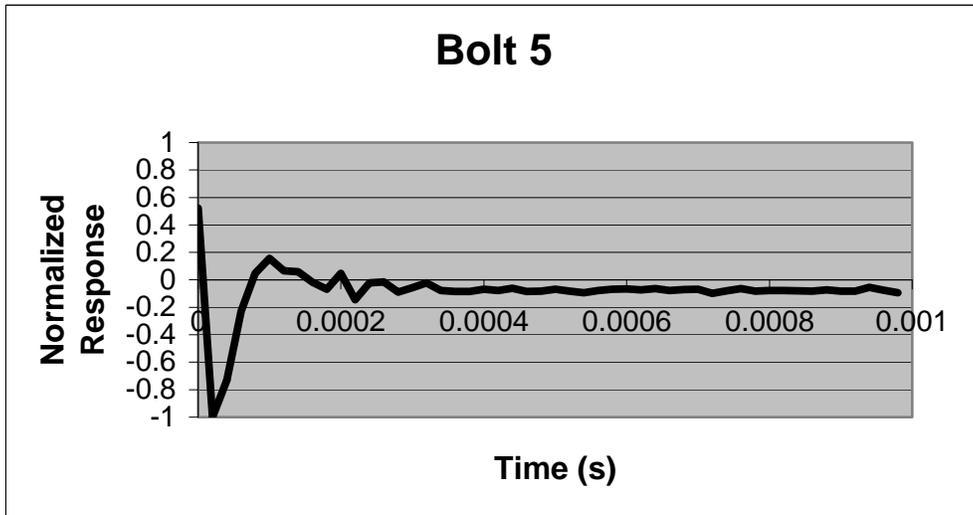
Figure 4(b). UT Test Result for Bolt #5

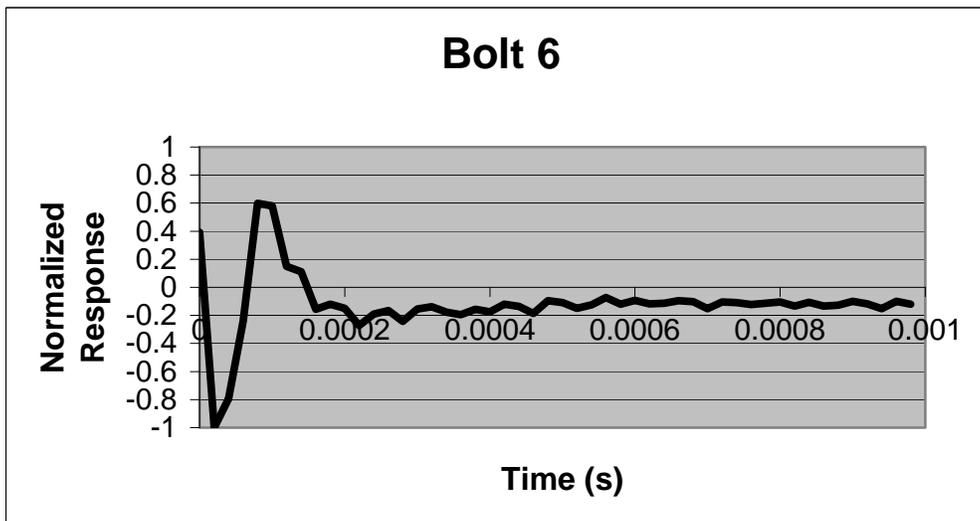
Figure 4(c). UT Test Result for Bolt #6.

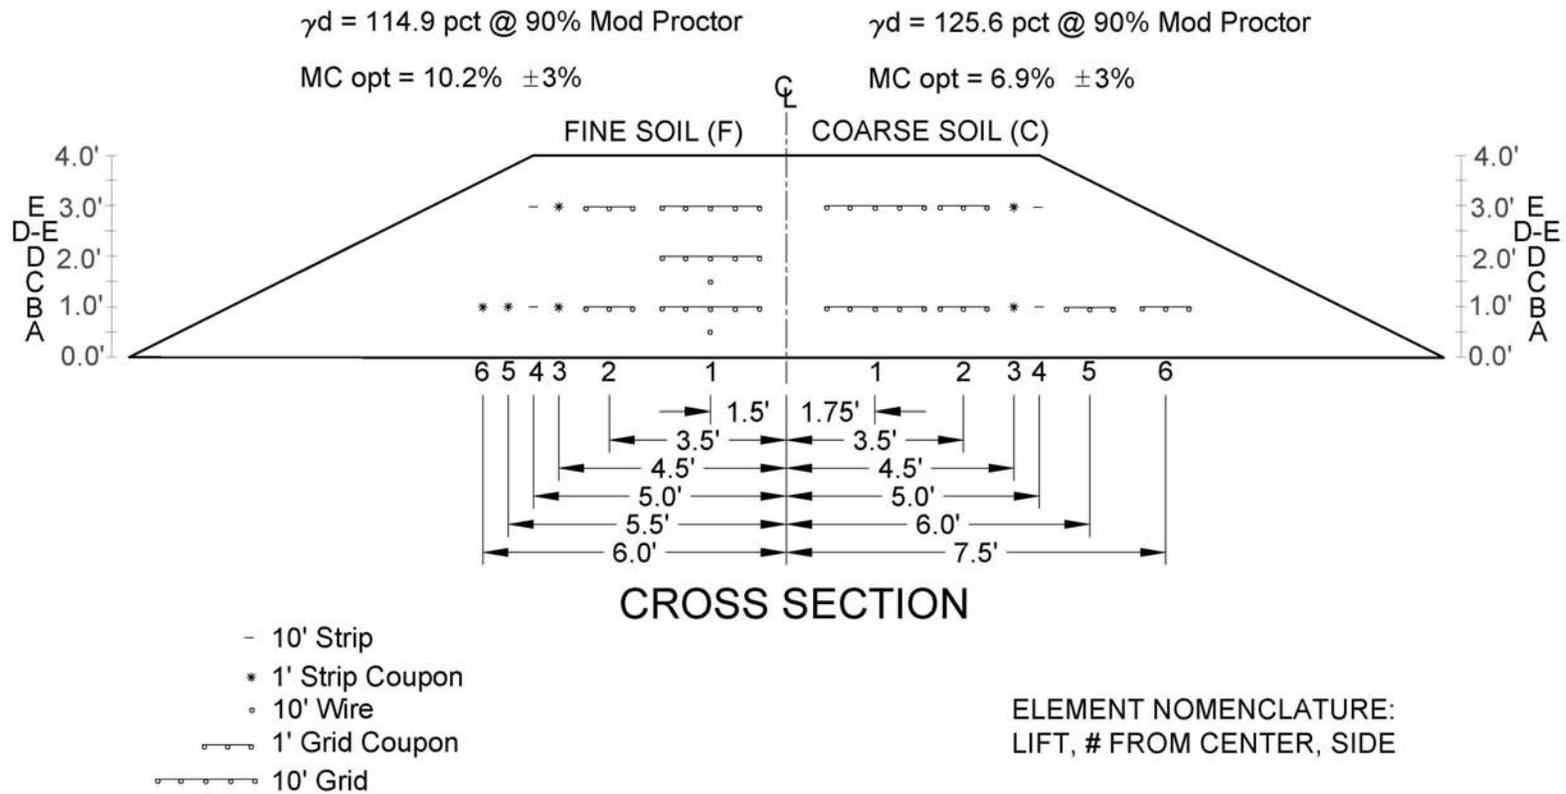
Figure 5. Cross Section of EDI Test Embankment and Placement of Dummy Reinforcements and Coupons

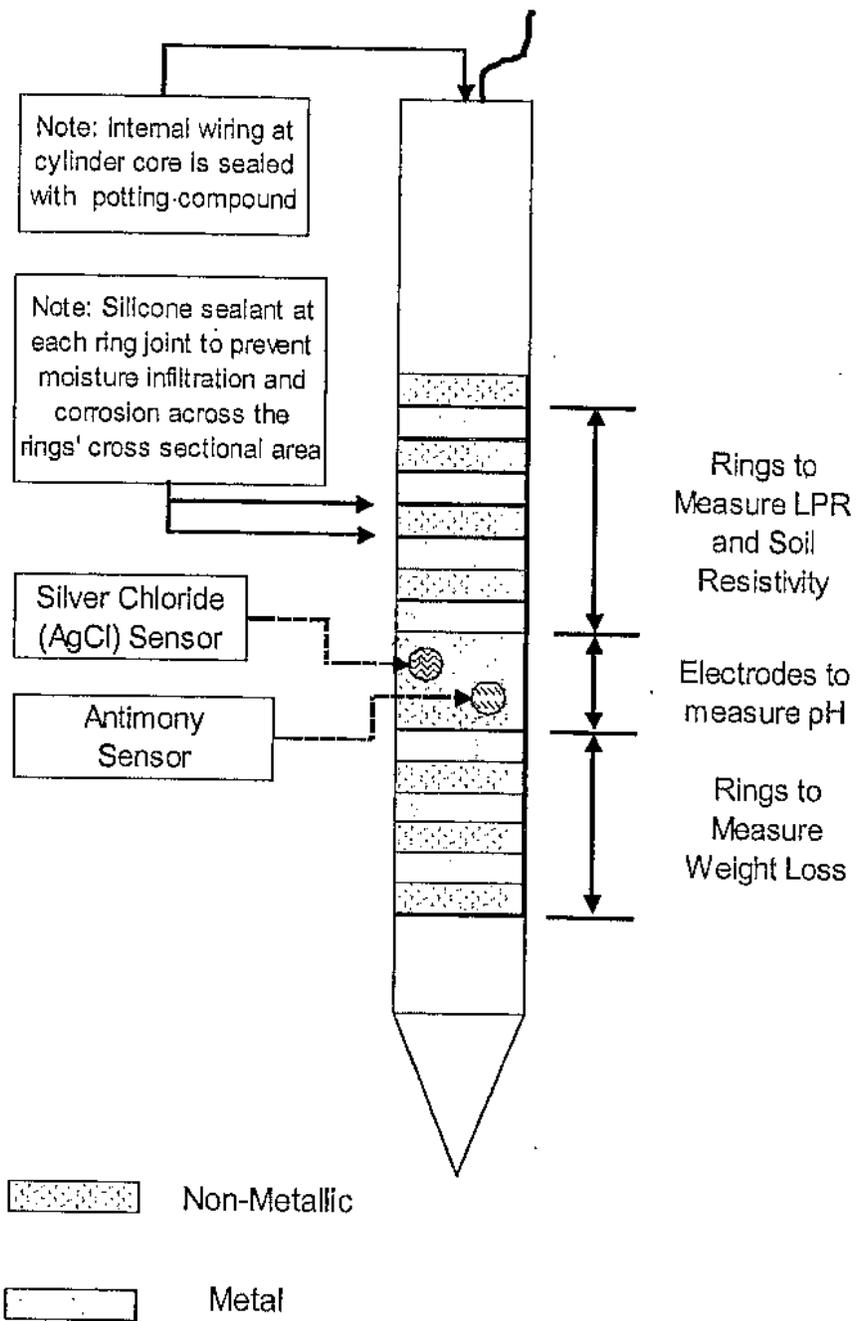
Figure 8. Illustration of Cylinder Probes Developed for NCHRP Project 21-06 (Corrpro, 2009)

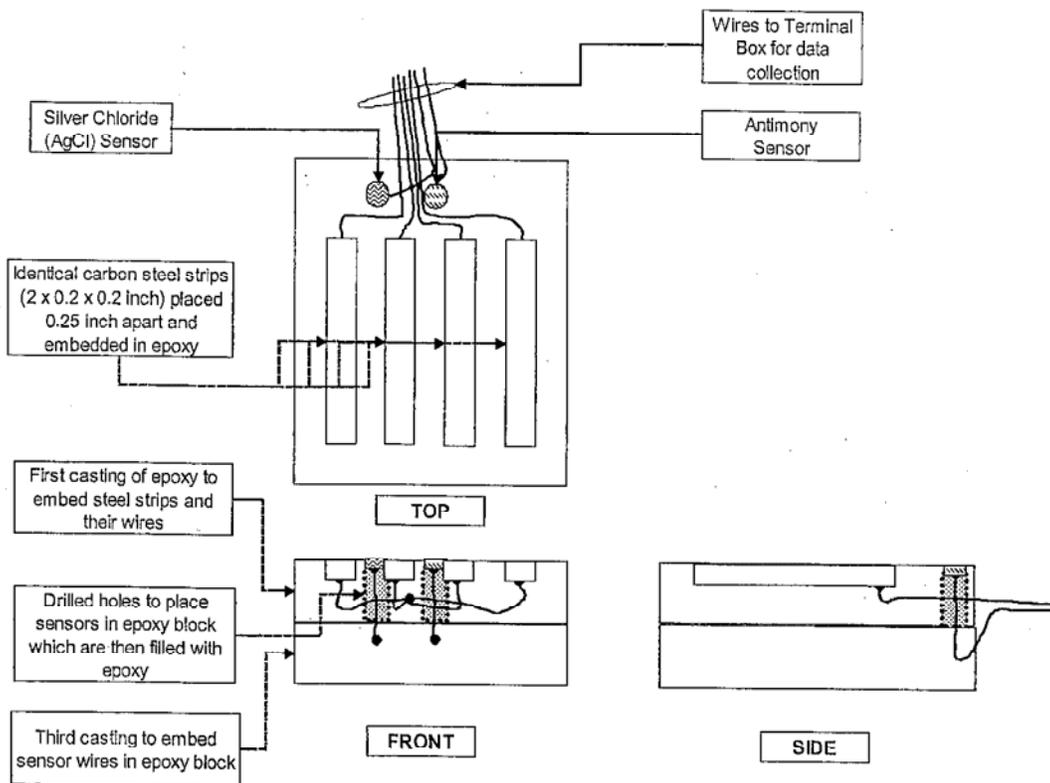
Figure 9. Illustration of DMP Developed for NCHRP Project 21-06 (Corrpro, 2009)

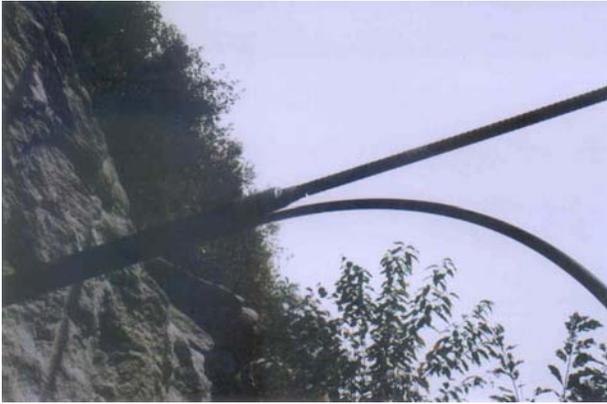
7. Sample #6 showing notch cut into prestressing steel rod near anchor head location.

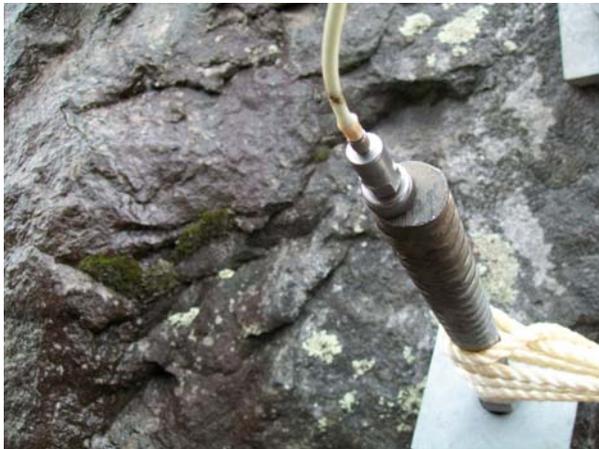
11. Accelerometer attached to end of rock bolt.

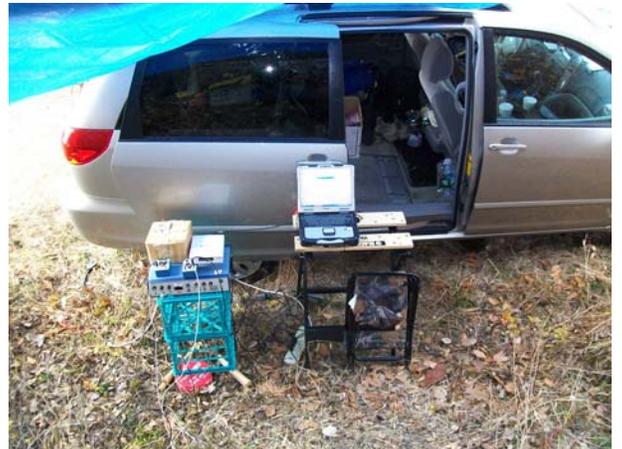
12. Signal conditioners and data acquisition equipment.

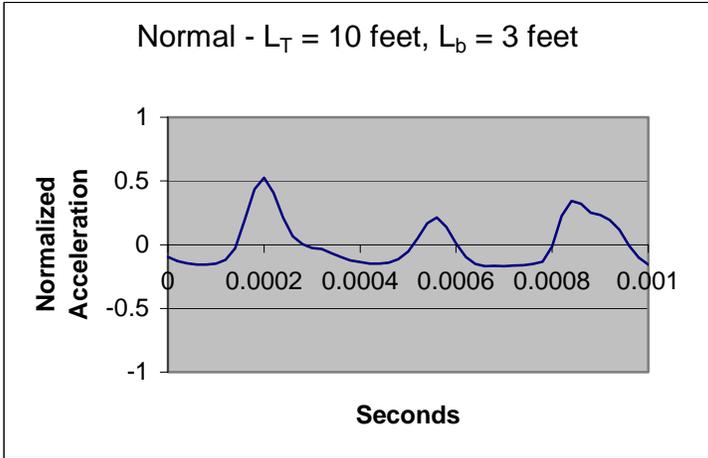
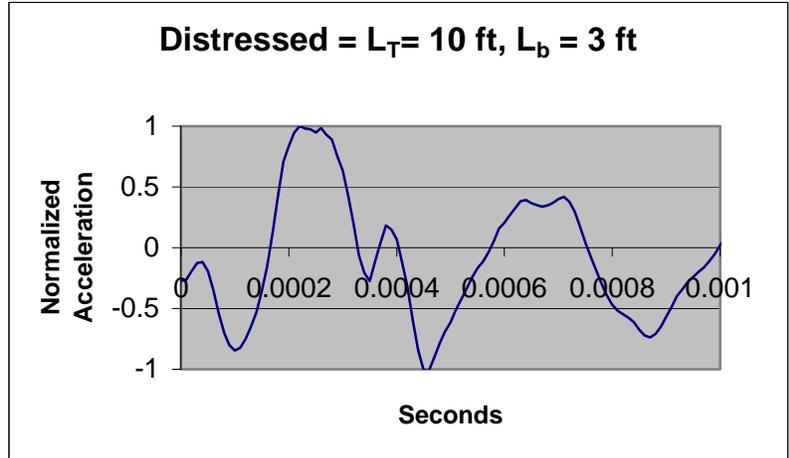
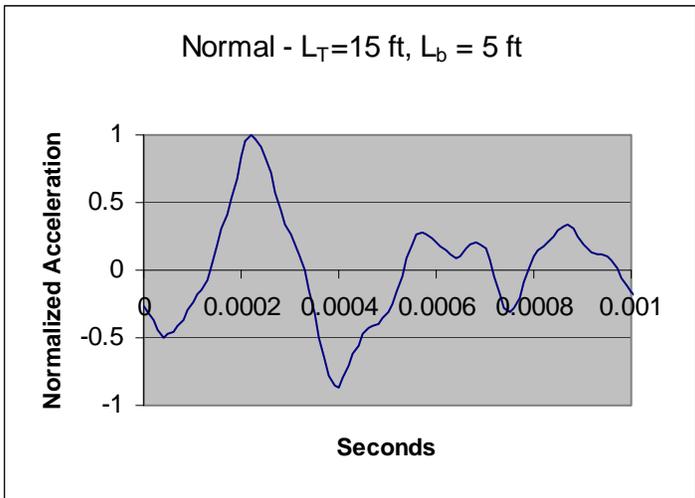
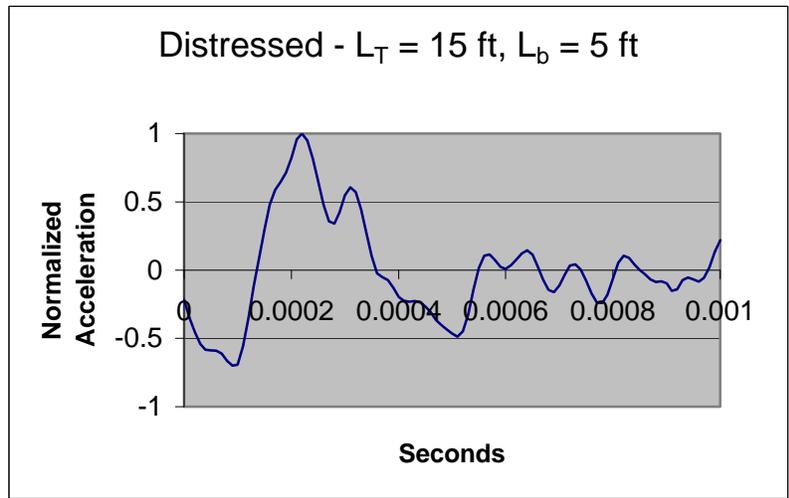
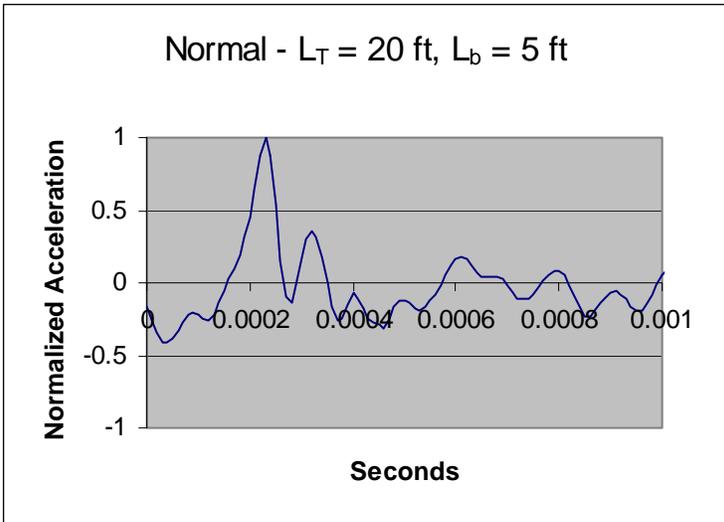
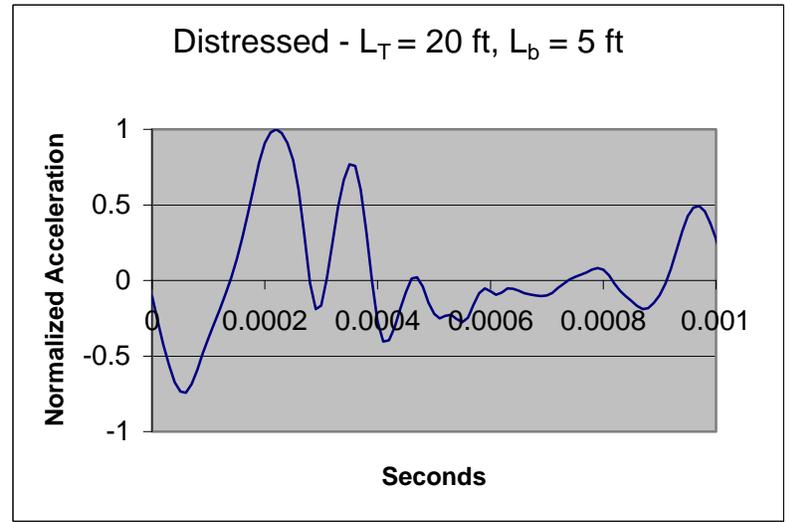
Attenuation of Impact Force Related to Prestress ( preload values are cited in Table 1)

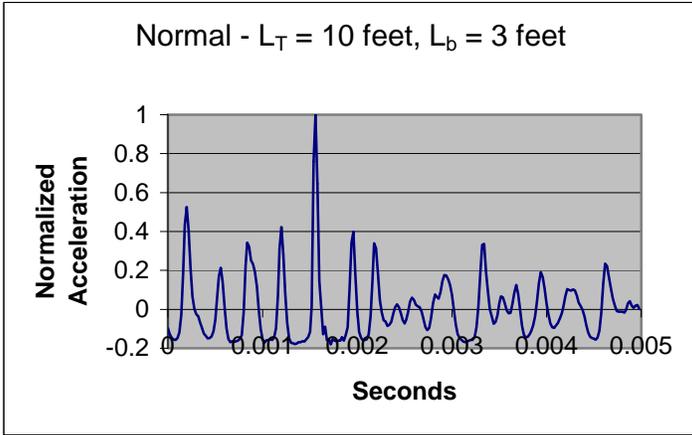
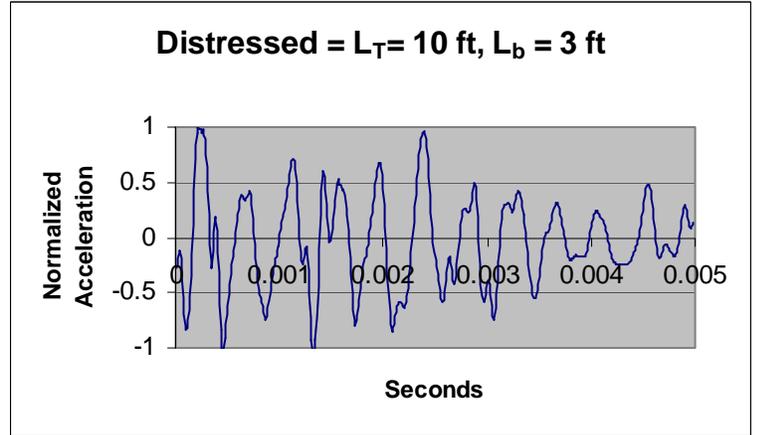
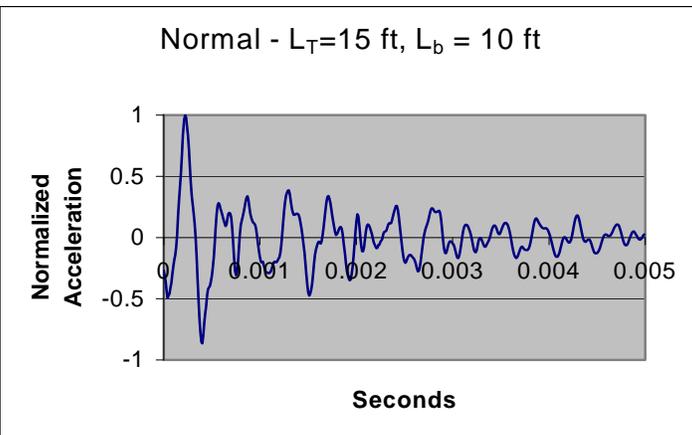
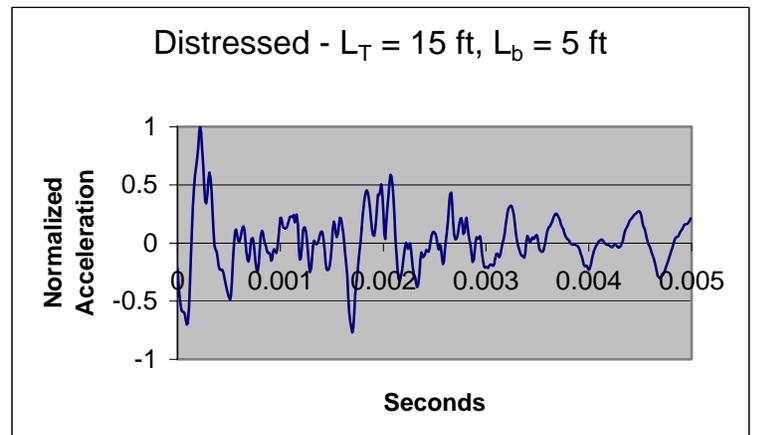
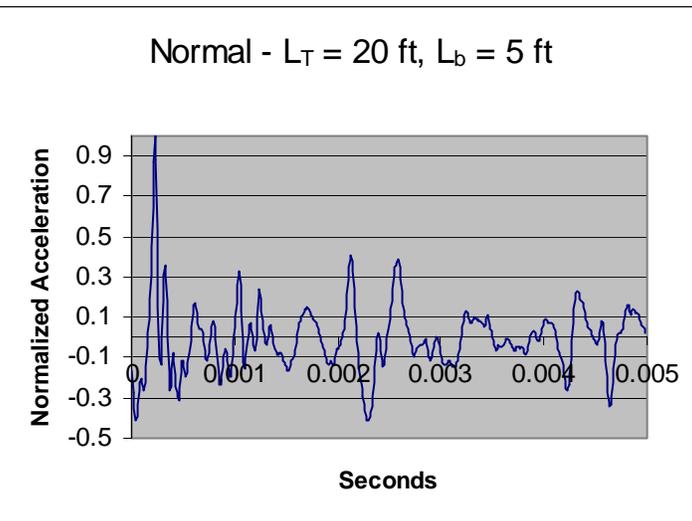
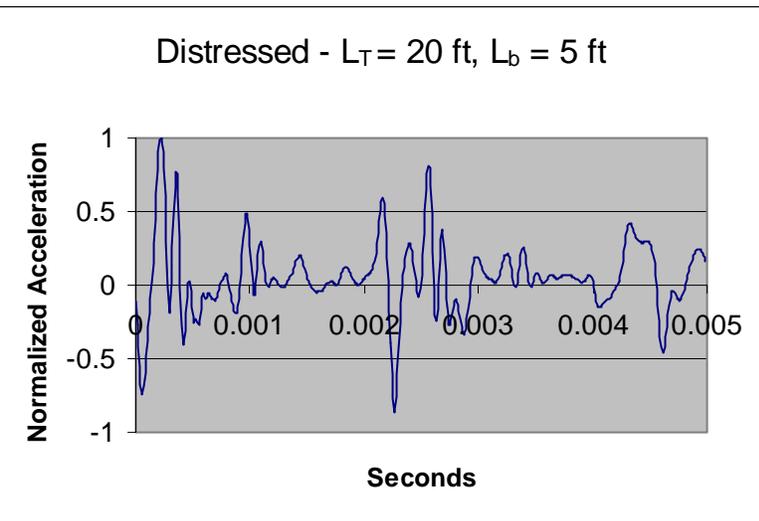
Time Histories of Impacts from Sonic Echo Tests

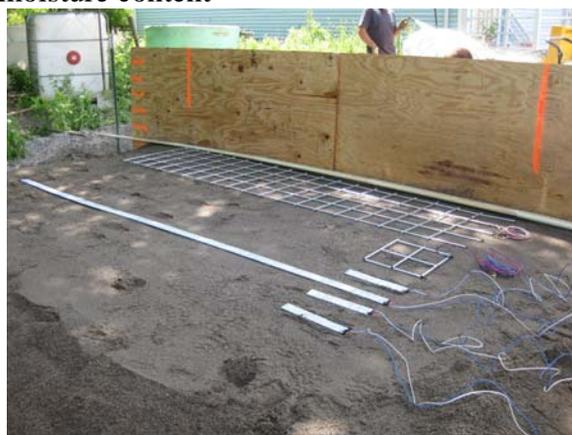
5. Set Dummy Reinforcements and Coupons on Material #1 side at Elevation 1'.

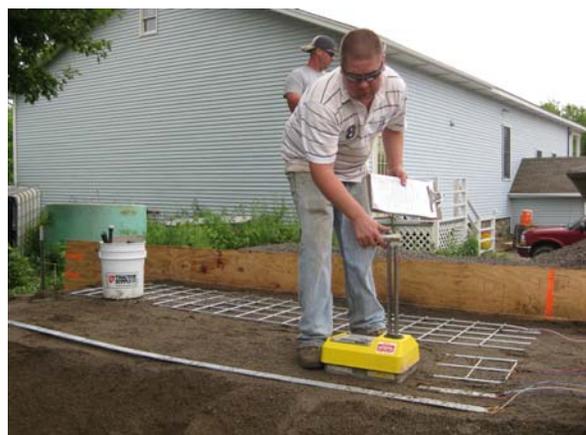
6. Nuclear density testing for in situ unit weight and moisture content.

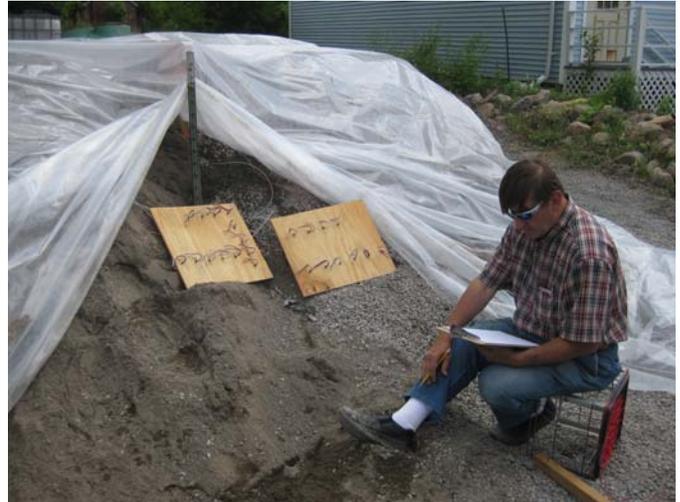
8. Prepared for electrochemical testing and soil resistance measurements.

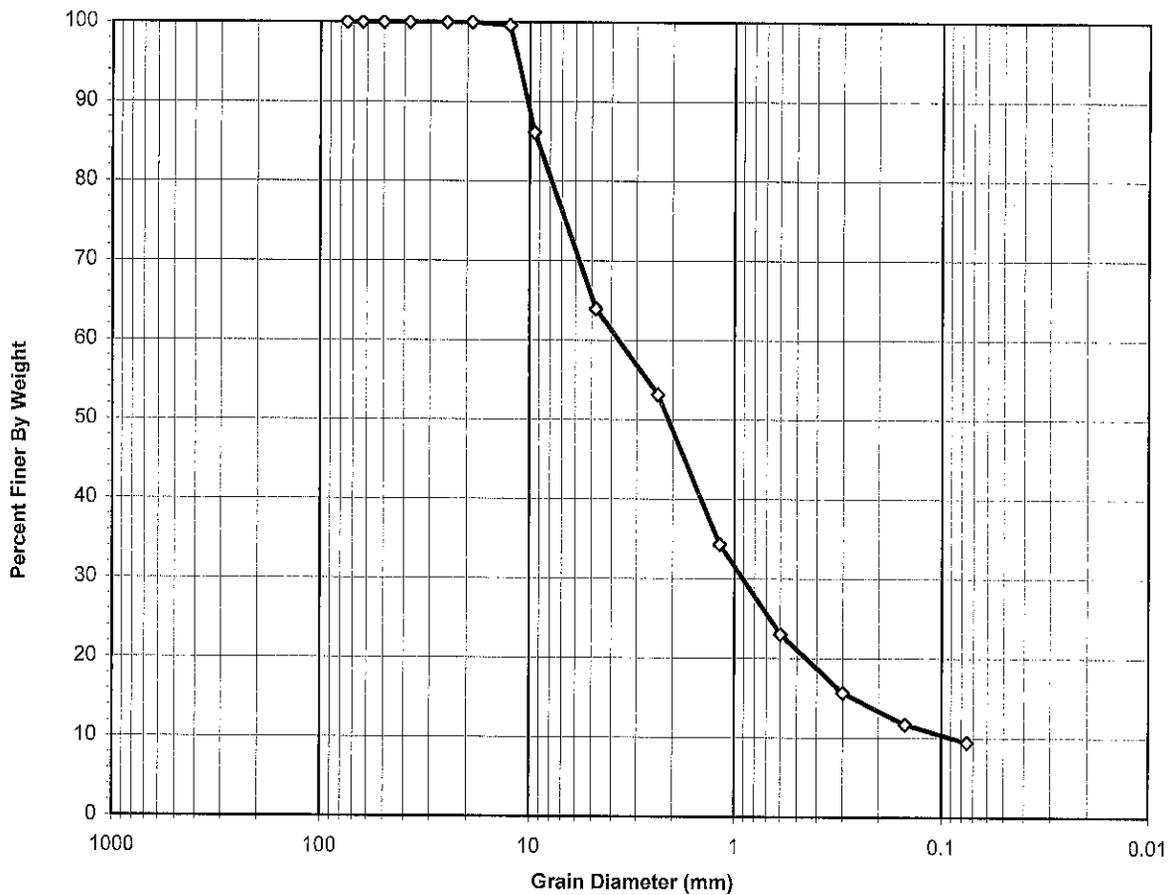
<b>USCS Symbol:</b>	<b>sw-sm, ASSUMED</b>	D60 =	3.68		
<b>Fineness Modulus:</b>	<b>4.12</b>	D30 =	0.91	CC =	2.54
		D10 =	0.09	CU =	41.38

**USCS Classification:** WELL-GRADED SAND WITH SILT AND GRAVEL

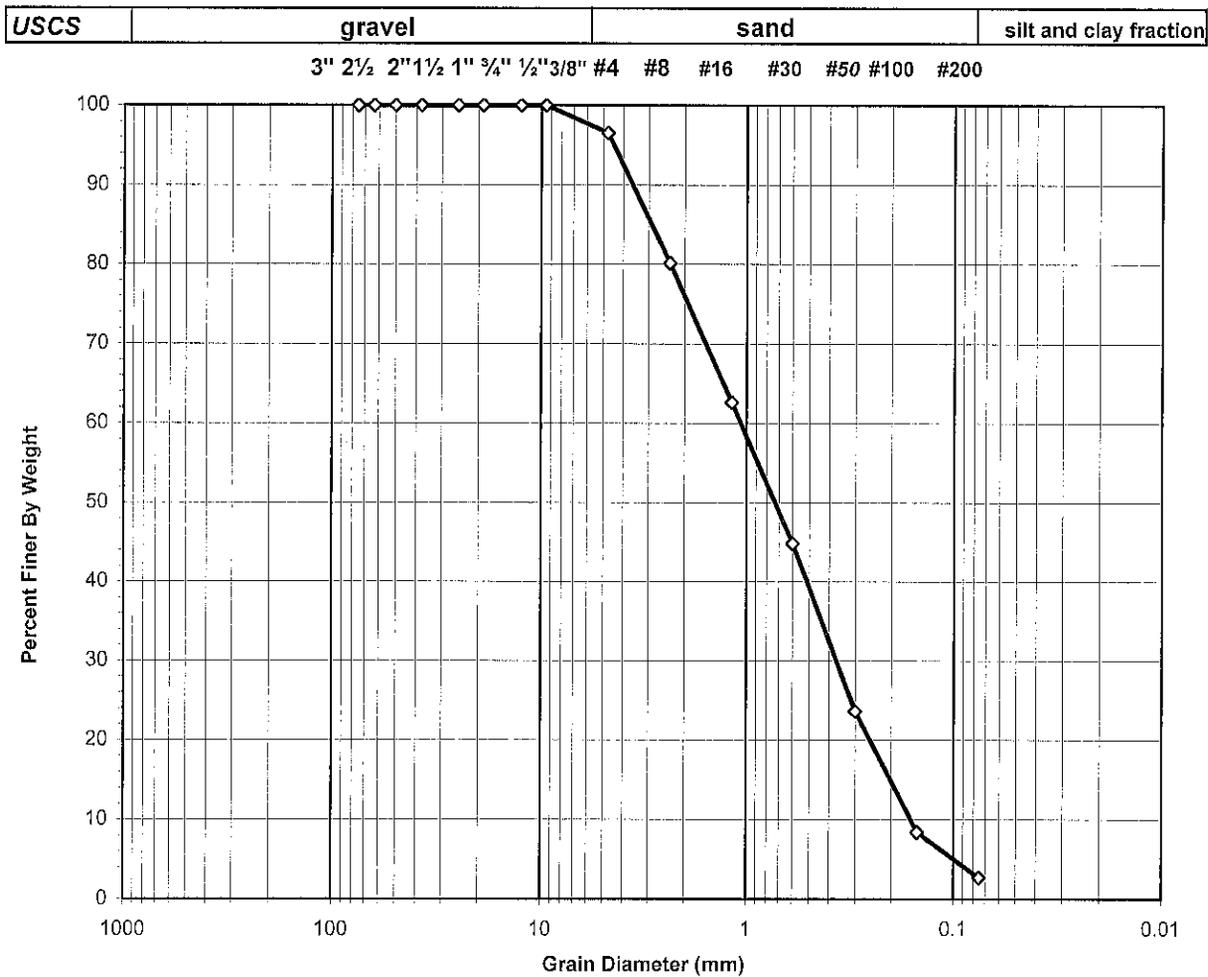
**USCS Symbol:** **SP**

D60 = 1.07

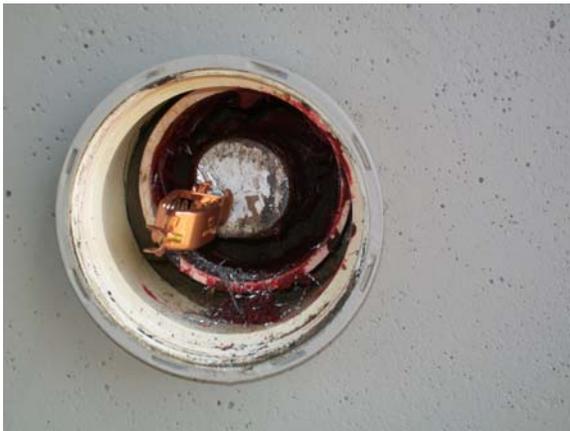
3. Gilroy – End of inspection element and clip for attaching wires for electrochemical testing.

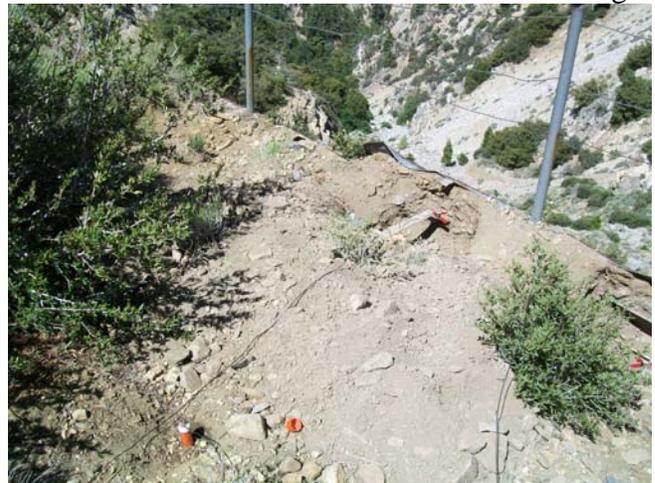
12. San Gabriel – Placement of half-cell for electrochemical testing.

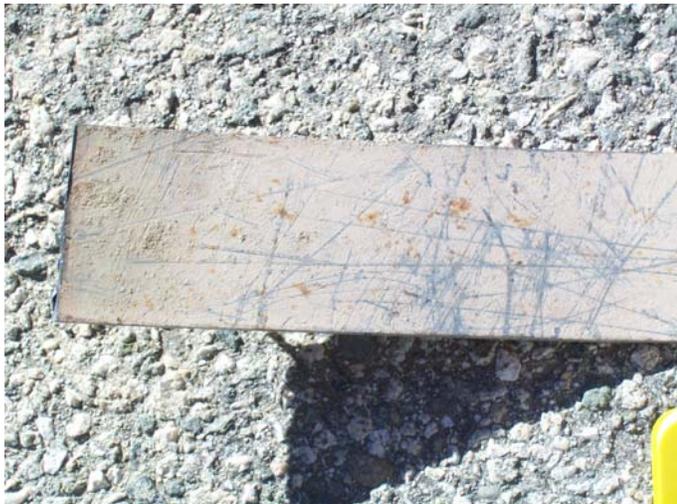
15. San Gabriel – Close-up of reinforcement specimen depicting spots of ferrous oxide.

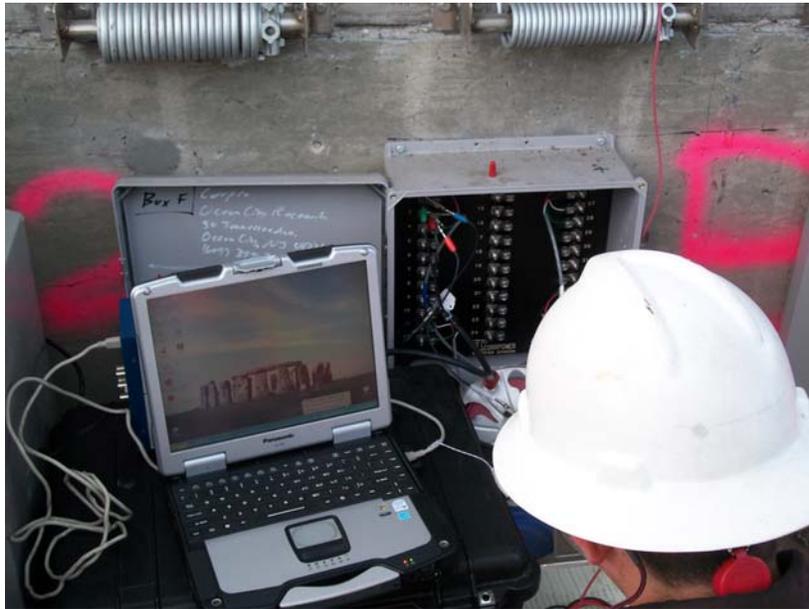
19. Emeryville – Corrosion monitoring and in situ measurement of fill resistance
