# Report 354

## Resistance of Welded Details Under Variable Amplitude Long-Life Fatigue Loading

J. W. FISHER, A. NUSSBAUMER, P. B. KEATING,  
and B. T. YEN  
Center for Advanced Technology for Large Structural Systems  
Lehigh University  
Bethlehem, Pennsylvania

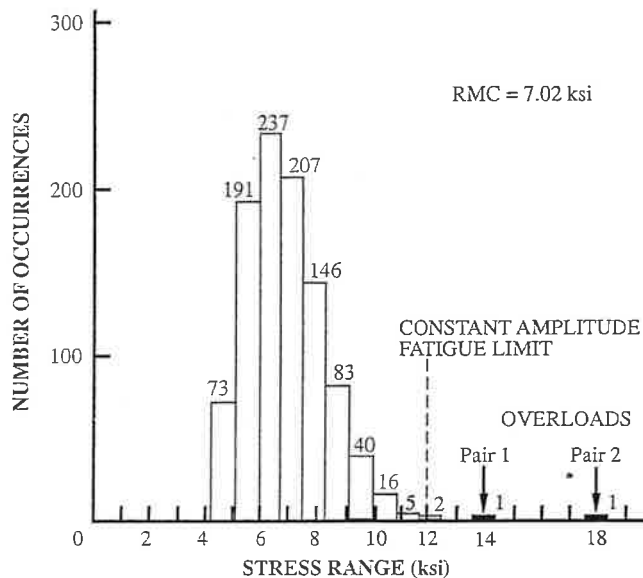
Figure 2. Stress range spectrum at stiffener details 8 and 10 for Girder Pairs 1 and 2,  $\gamma = 0.001$ .

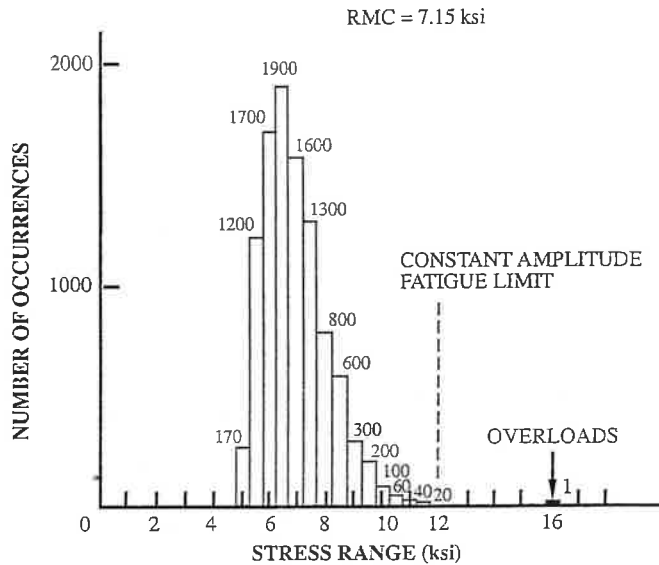
Figure 3. Stress range spectrum at stiffeners 8, 9, and 10 for Girder 3,  $\gamma = 0.0001$ .

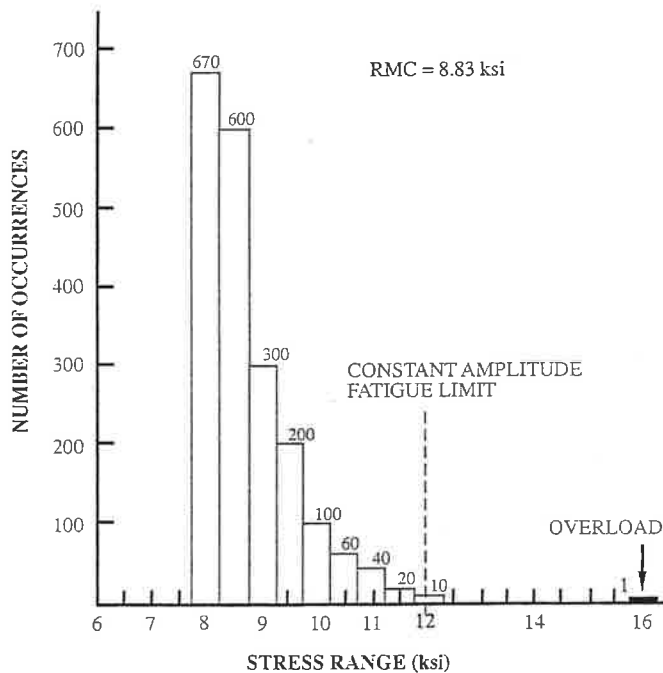
Figure 4. Stress range spectrum at stiffeners 8, 9, and 10 for Girder Pair 4,  $\gamma = 0.0005$ .

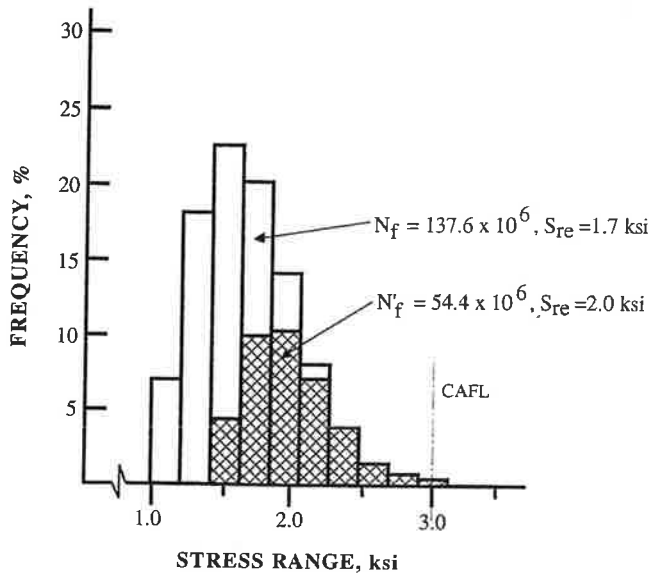
Figure 8. Web attachment cycle life, detail 3.

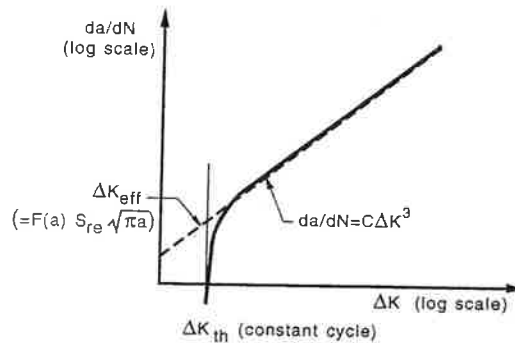
(a) Crack growth relationship for constant cycle loading and random variable loading.

(b) Comparison of predicted fatigue resistance under variable loading with test data.

Figure 9. Predicted fatigue resistance compared with design resistance curves and test data for web attachments.

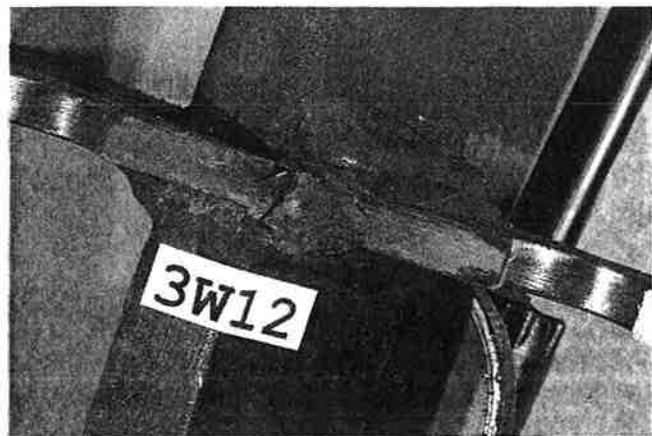
Figure 14. Typical through thickness crack arrested by retrofit holes.

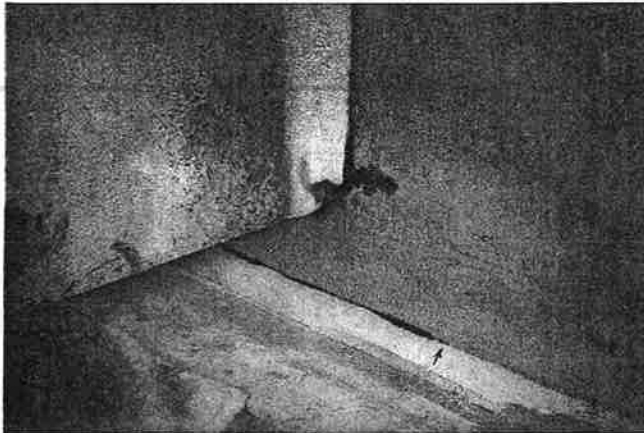
Figure 29. Fatigue cracks at web gap of 1N09.

Variable amplitude loading fatigue cracks developed quickly in the web gaps. The initial cracking was first detected at approximately 50,000 cycles, with extensive cracking at 100,000 cycles. The distortion-induced fatigue cracks developed at both the toe of the web-to-flange fillet weld and at the connection plates end, as shown in Figure 29.
