NATIONAL COOPERATIVE HIGHWAY RESEARCH PROGRAM  
REPORT

# EVALUATION OF METHODS OF REPLACEMENT OF DETERIORATED CONCRETE IN STRUCTURES

TE7  
N25  
**HIGHWAY RESEARCH BOARD 1964**

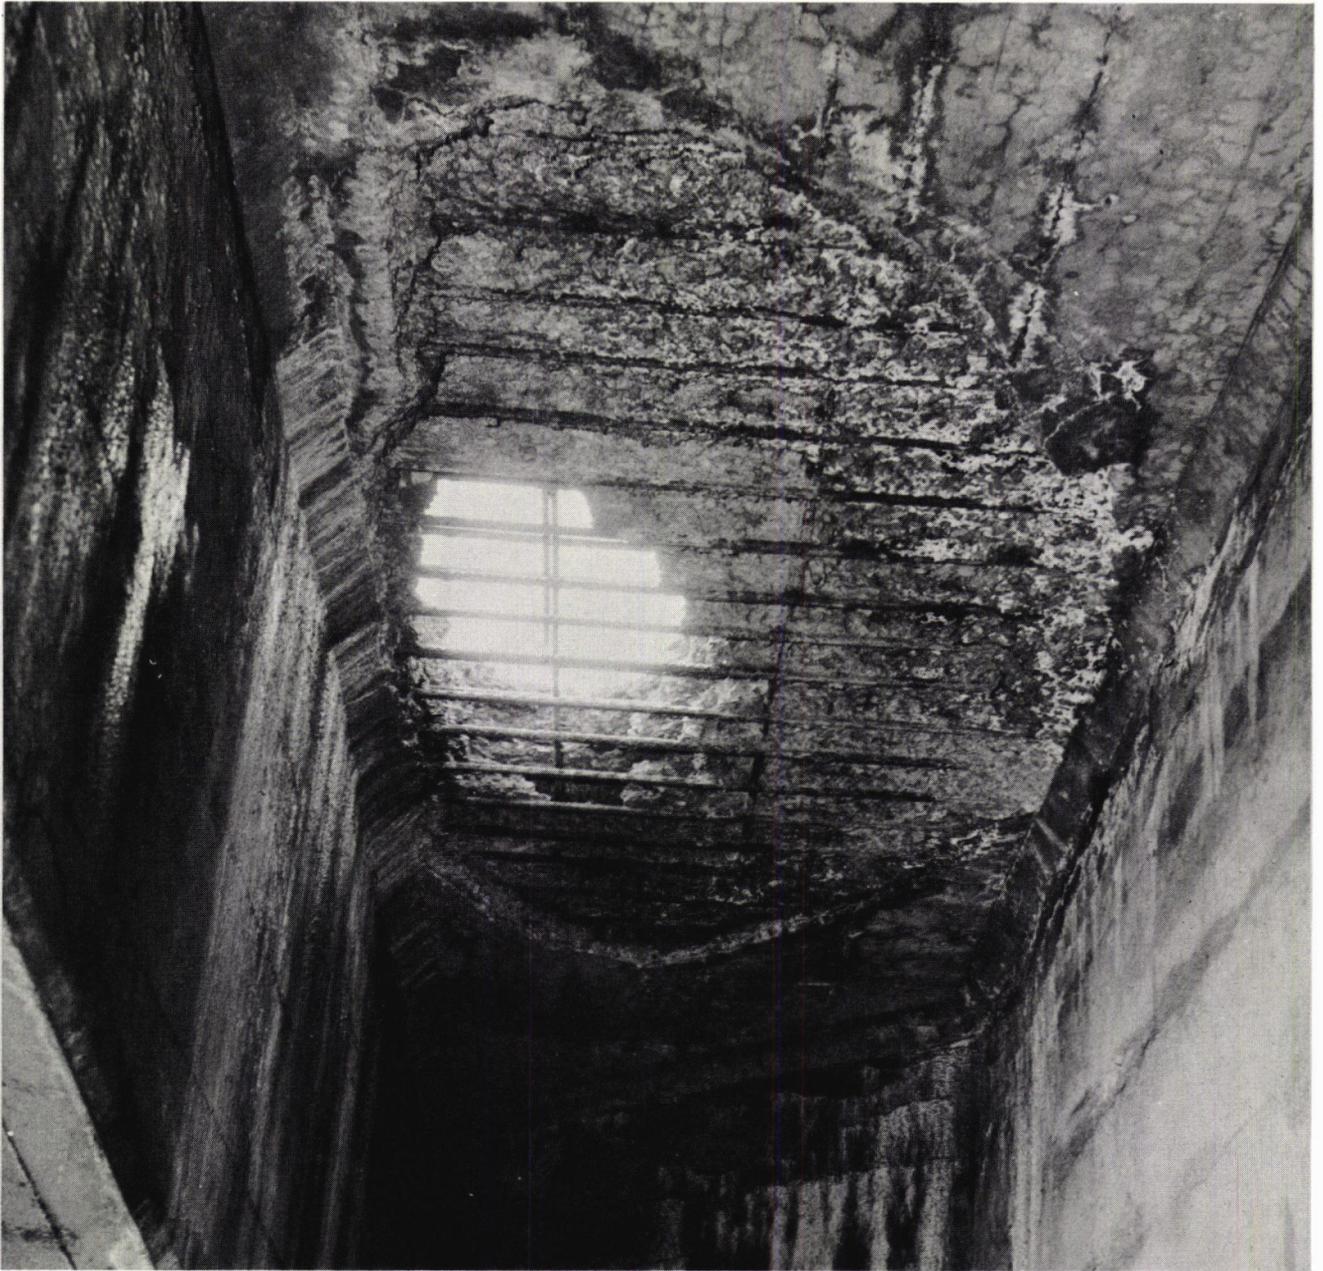
*Figure 1. Complete failure of bridge deck concrete requiring expensive full-depth replacement of slab.*

In addition, it is believed that salt solutions may increase the number of freeze-thaw cycles to which the concrete is subjected during the winter months. Where cracks in the concrete permit brine solutions to penetrate to the reinforcement, corrosion is promoted and ultimately brings about spalling (Fig. 1) as the oxidized steel expands within the concrete.

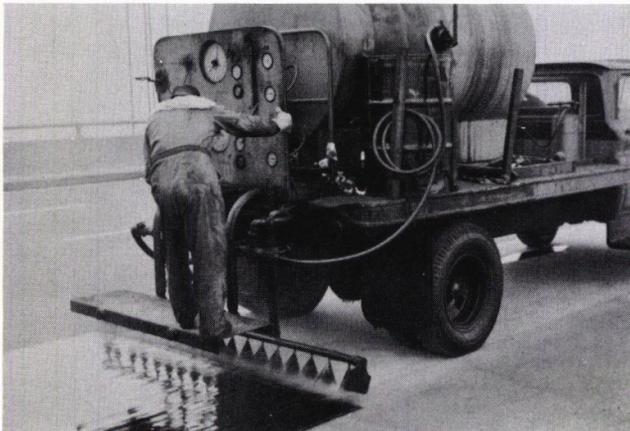
Figure 3. Special distributor unit used for application of two-component epoxy resin compounds.

The use of the two-component thermosetting bonding agents and sealants required several special types of equipment for handling. One unit was a truck distributor, similar to a conventional asphalt distributor, but specifically designed to handle the two-component epoxy resin compounds. It has separate tanks and circulating hoses for the two components which are concurrently pumped, each at a metered rate, into the distributor spray bar where they are thoroughly mixed in a mixing chamber immediately before being ejected through the spray nozzles onto the

concrete surface (Fig. 3). The mixing chamber and spray bar assembly is readily removable so that it can be quickly placed in a solvent-filled cleaning tank at the completion of the material application run, to prevent the mixed components from hardening and plugging the unit.

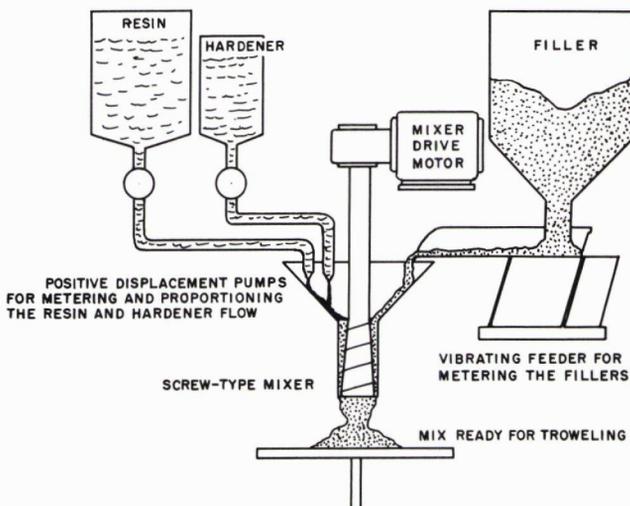
Figure 4. Schematic of continuous-type resinous patching mortar mixer system (11).

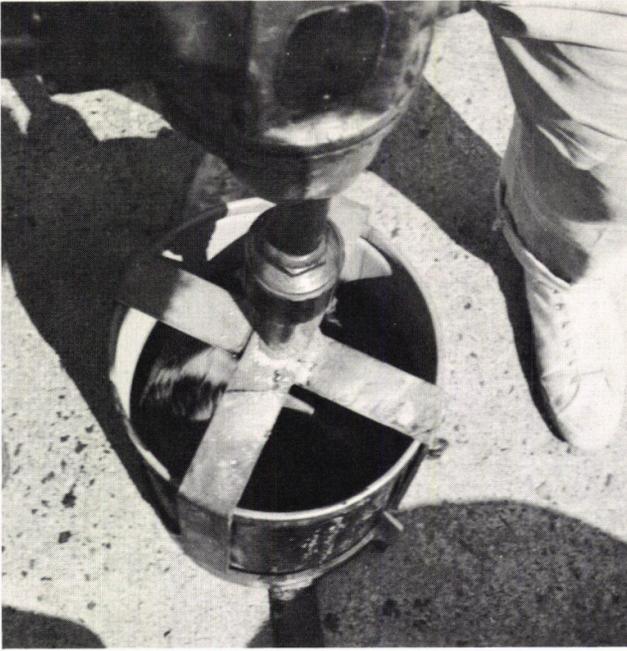
Figure 5. Electric drill-powered mixing apparatus for epoxy mortars, Connecticut State Highway Department.

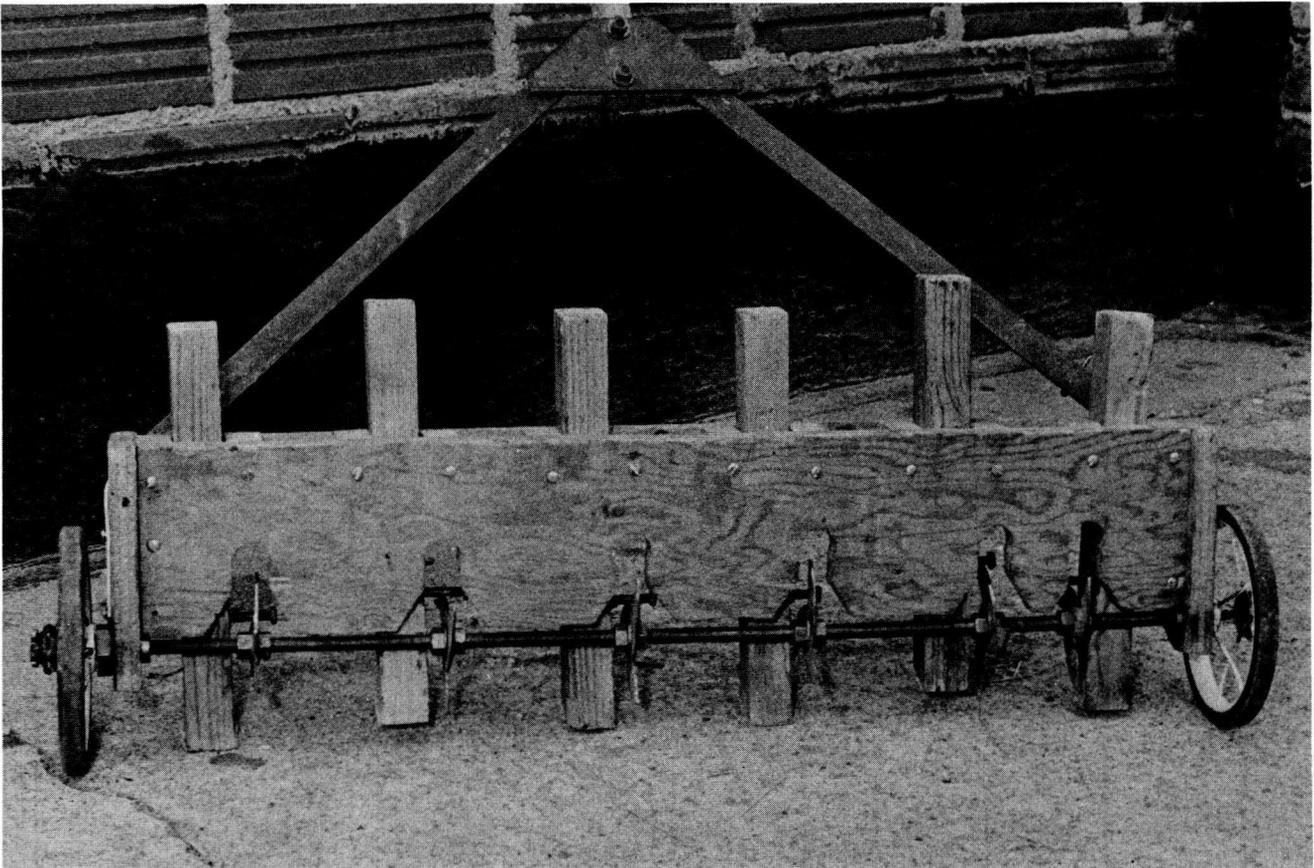
*Figure 6. Specially built sounding device to locate unsound concrete on bridge decks, Kansas State Highway Commission.*

A special unit of equipment developed by the Research Department of the Kansas State Highway Commission (Fig. 6) was being used to explore bridge decks in order to locate areas of concrete deterioration or weakness not indicated by visual inspections. Called the "thumper" by the Kansas engineers, it operates on the same principle by which a concrete surface is sounded with a tapping hammer. The thumper has the advantage of covering a 3-ft wide area and proceeding at the steady rate of a slow walk. The device consists of a series of six wooden hammer blocks mounted side-by-side along an axle fastened between two small-diameter tricycle wheels. Each hammer is alternately raised and dropped by a cam which turns

on the revolving axle of the device. As the device is moved forward the hammers sound the concrete and reveal areas of weakness or failure. The operator or an assistant can

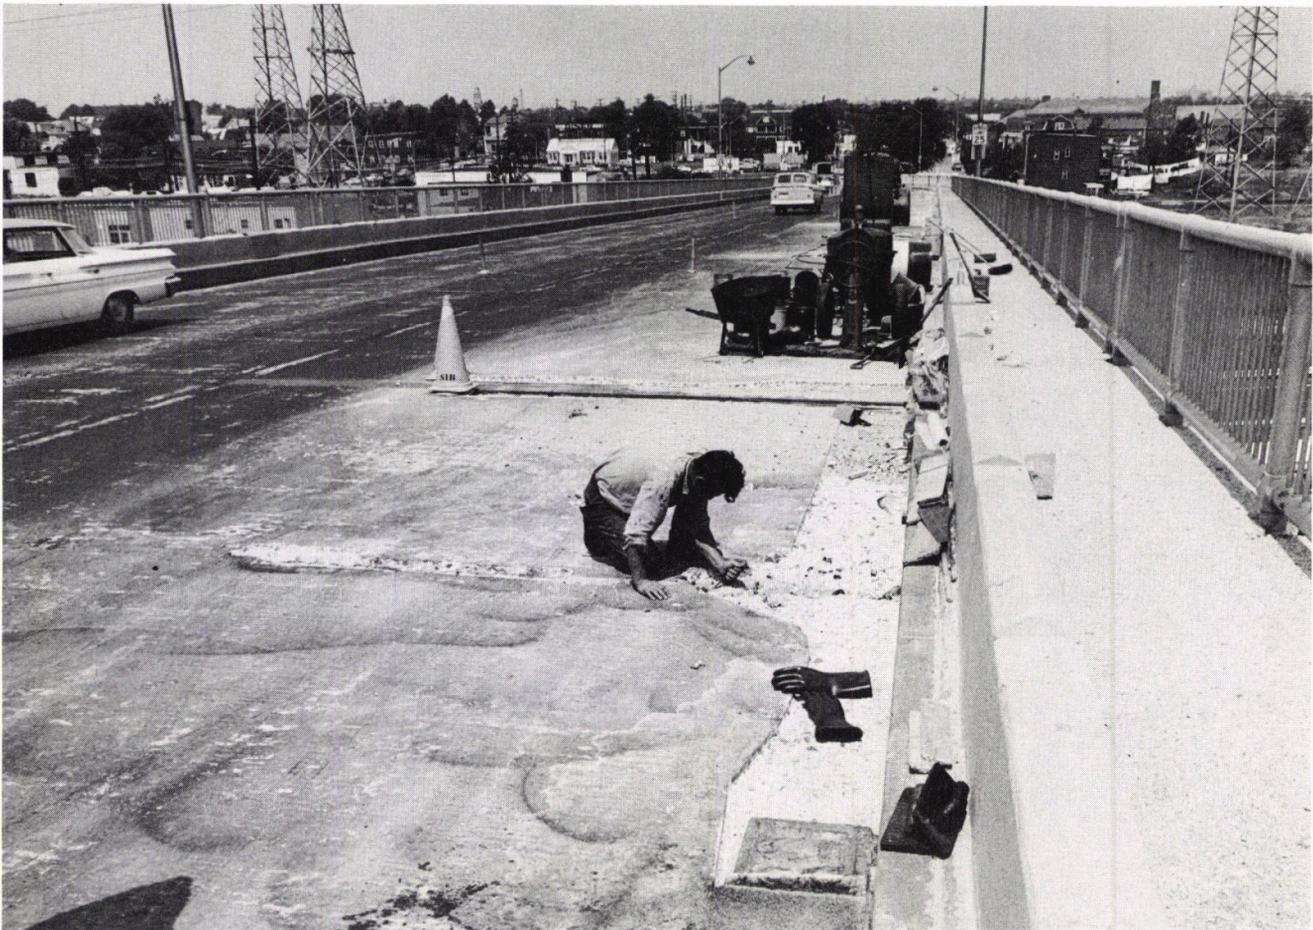
Figure 7. Final cleaning of patch area on concrete deck after removal of old bituminous surface, Goethals Bridge, Port of New York Authority.

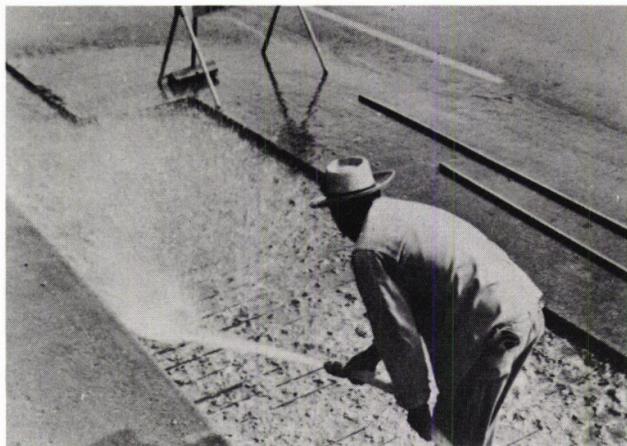
*Figure 8. Final cleaning of patch area with water pressure, Rawson-Howell overhead, Wisconsin State Highway Commission.*

struck. To prevent this oil film deposit, the department employs water pressure for final cleaning instead of air (Fig. 8).

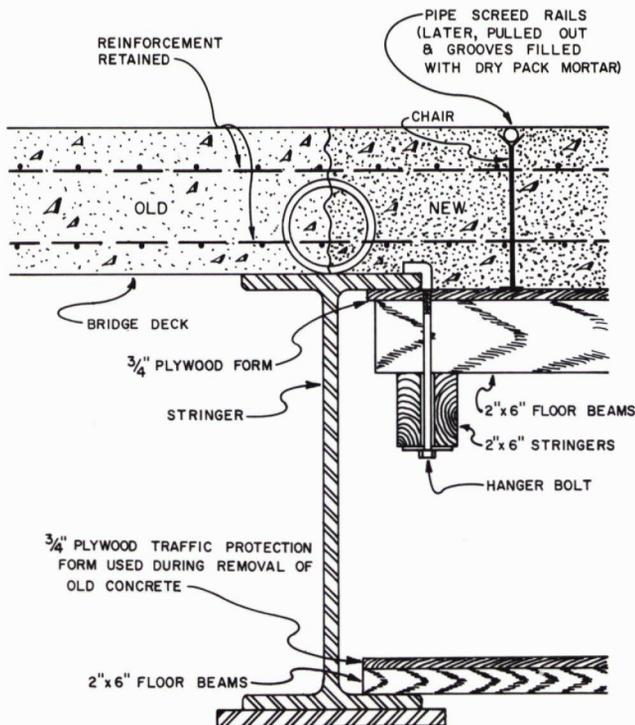
Figure 9. Removable bridge deck forming procedure, New York State Thruway Authority.

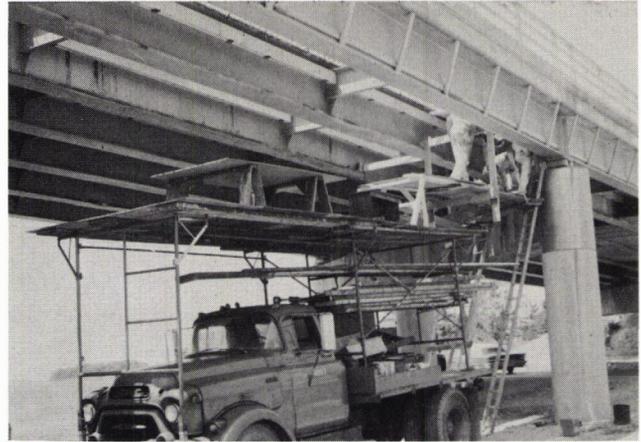
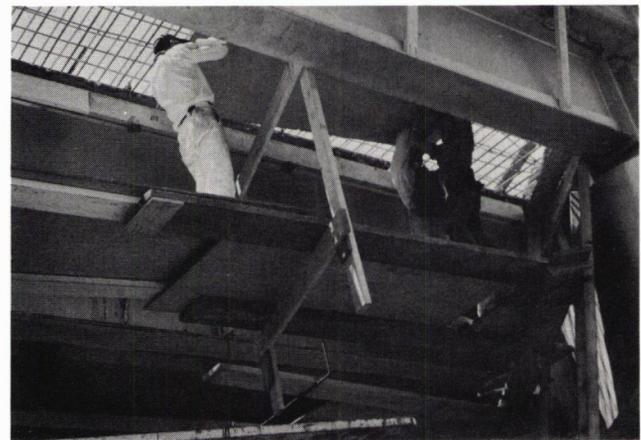
Figure 10. Deck forming for slab replacement, New York Thruway.

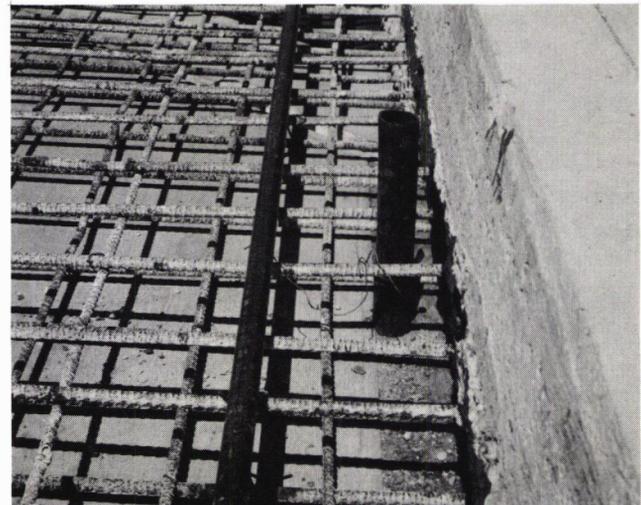
Figure 11. Forming and reinforcing steel in place on structure; vertical pipe provides weep hole in new deck slab, New York Thruway.

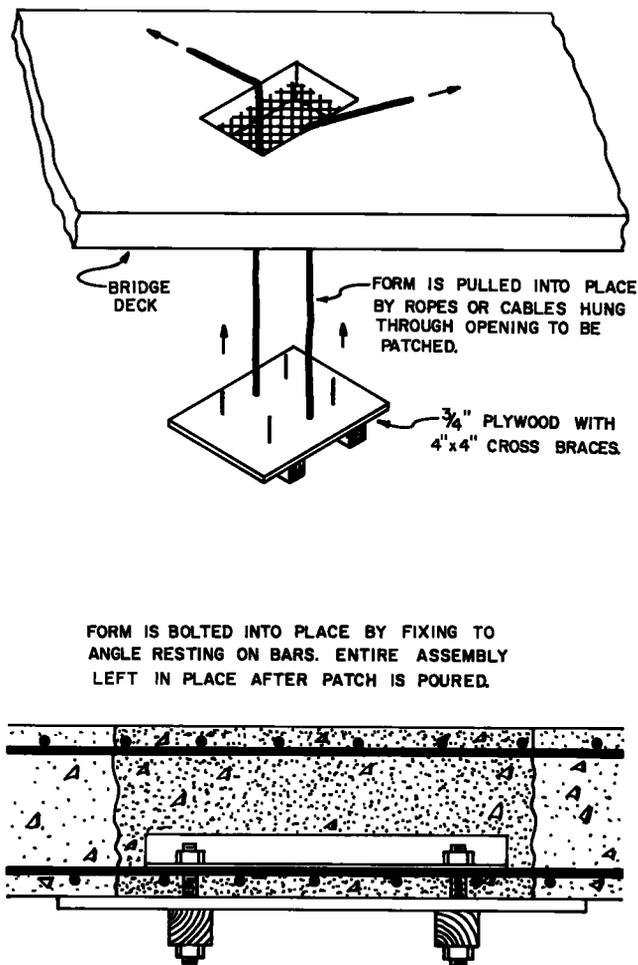
Figure 12. Stay-in-place deck forming procedure used where bridge underface is difficult of access, D.C. Department of Highways and Traffic.

One project (13) employed a system whereby the bottom forms of full-depth internal patches were placed

without access to the immediate underside of the bridge deck (Fig. 12). Ropes were lowered through the hole in the deck to the ground where they were fastened to vertical steel bolts extending through the form panels. The panel was then pulled up against the underside of the bridge

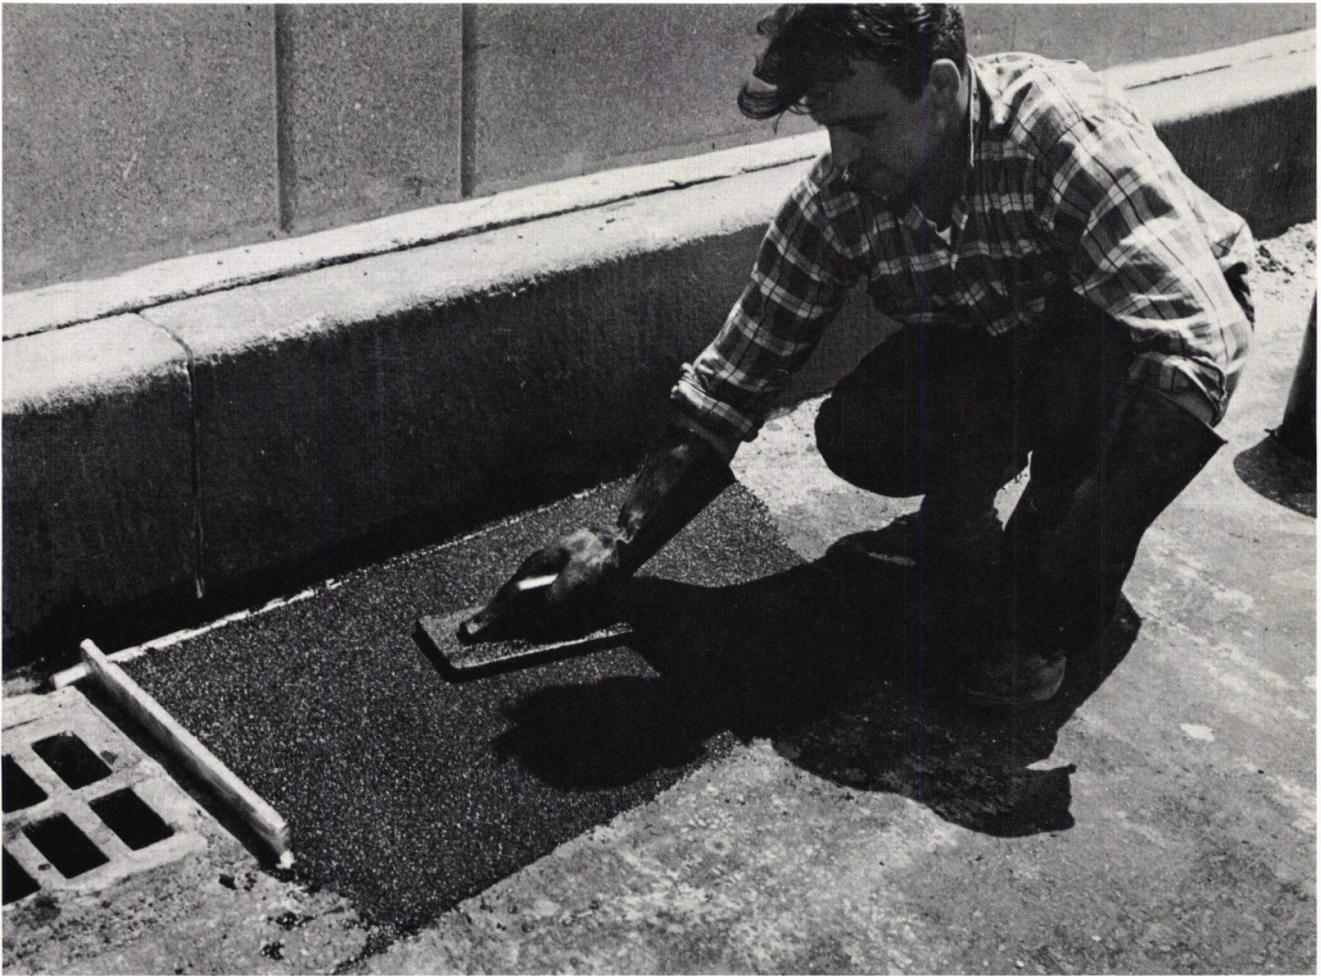
Figure 13. Finishing epoxy mortar deck patch, Goethals Bridge, Port of New York Authority.

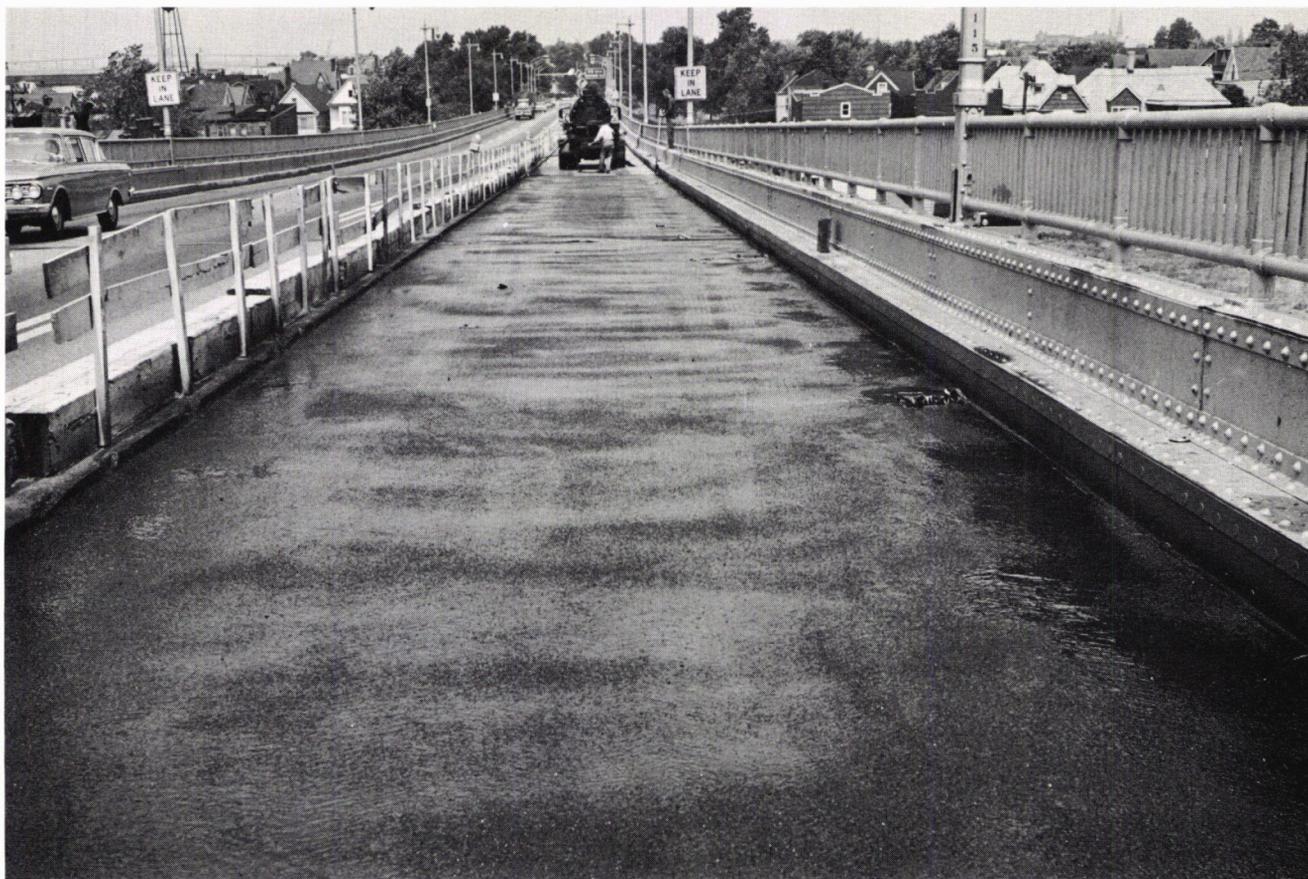
Figure 14. Applying coal tar pitch emulsion membrane to repaired deck, Bayonne Bridge, Port of New York Authority.

The coal tar pitch emulsion was applied either alone or as a sand slurry (Fig. 14). Where sand was incorporated in the emulsion, it was thoroughly mixed in a mixing drum and agitated until application so that the sand was retained in suspension. Typical proportioning of the sand slurry was three parts of emulsion mixed with two parts of sand by volume. The fine aggregate specified by one authority (28) was a sharp, angular, uncrushed natural silica sand with nothing retained on the No. 6 sieve and 100 percent retained on the No. 20 sieve.

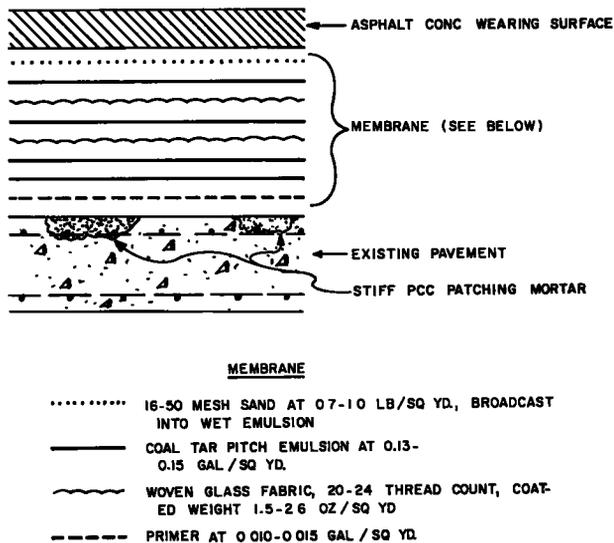
Figure 15. "Exploded" section of membrane waterproofing and separate wearing course installed on repaired deck of Lake Champlain Bridge, Crown Point, N.Y.

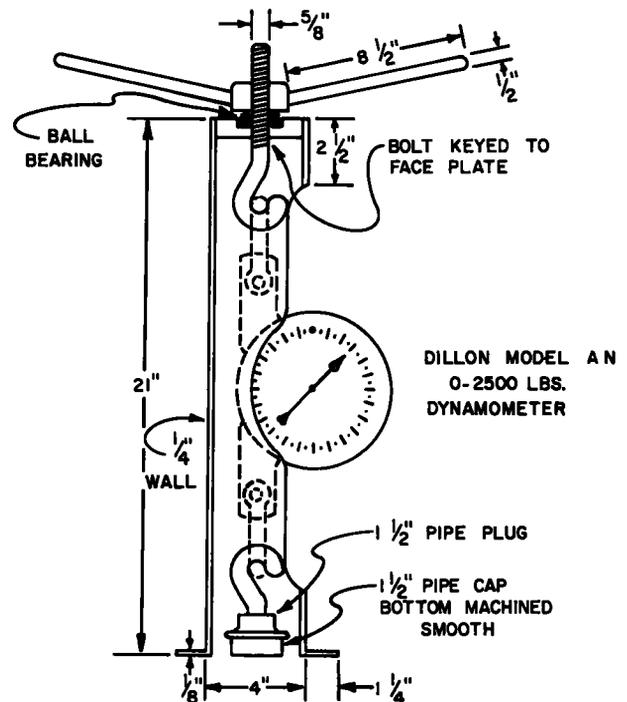
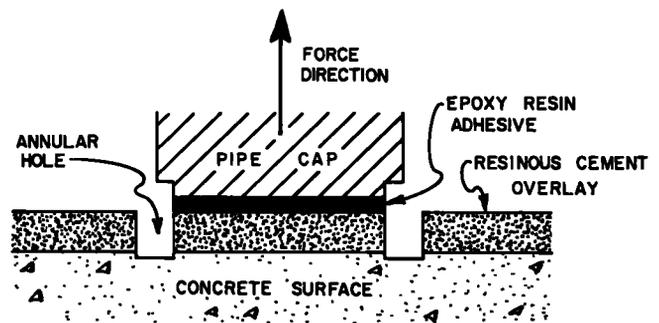
Figure 16. Apparatus for testing adhesion of resinous cement overlay, or cohesion of overlay or portland cement surface.

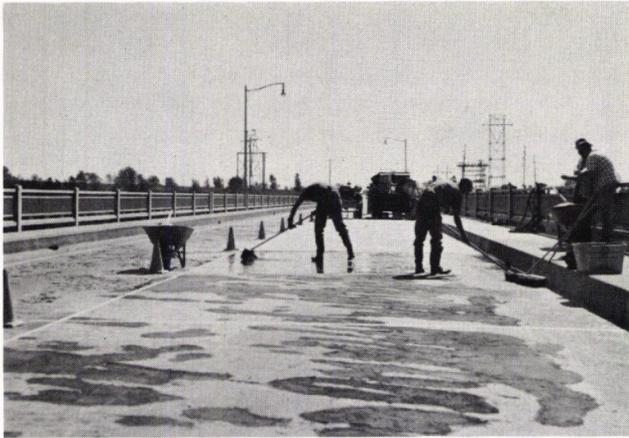
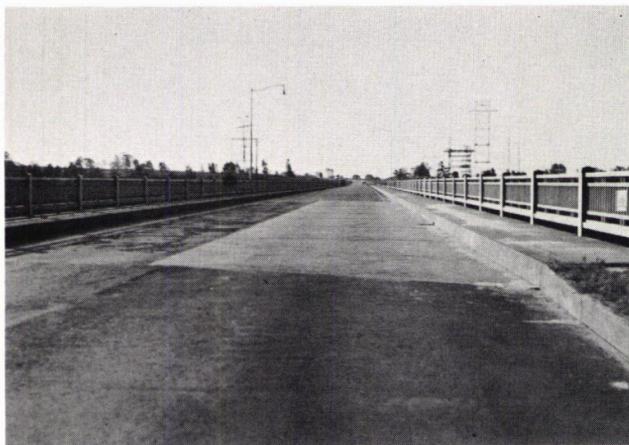
Figure 17. Epoxy resin surface seal over epoxy-mortar patched deck, Rt. 12, Chippewa River Bridge, Wisconsin State Highway Commission.

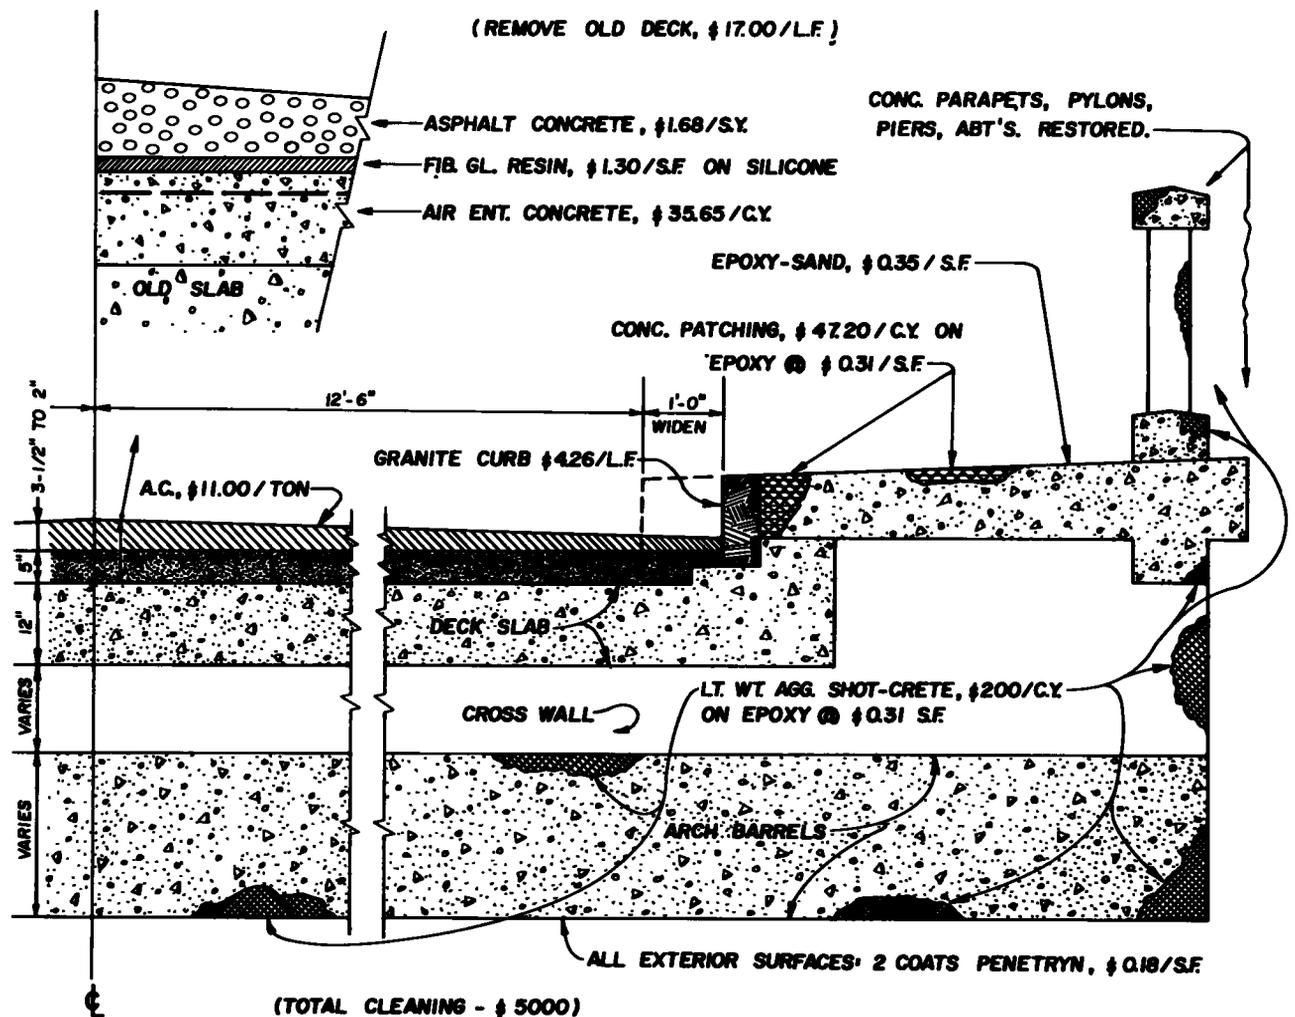
Figure 18. Section of arch structure deck with restoration details and costs, Troy, N.Y.

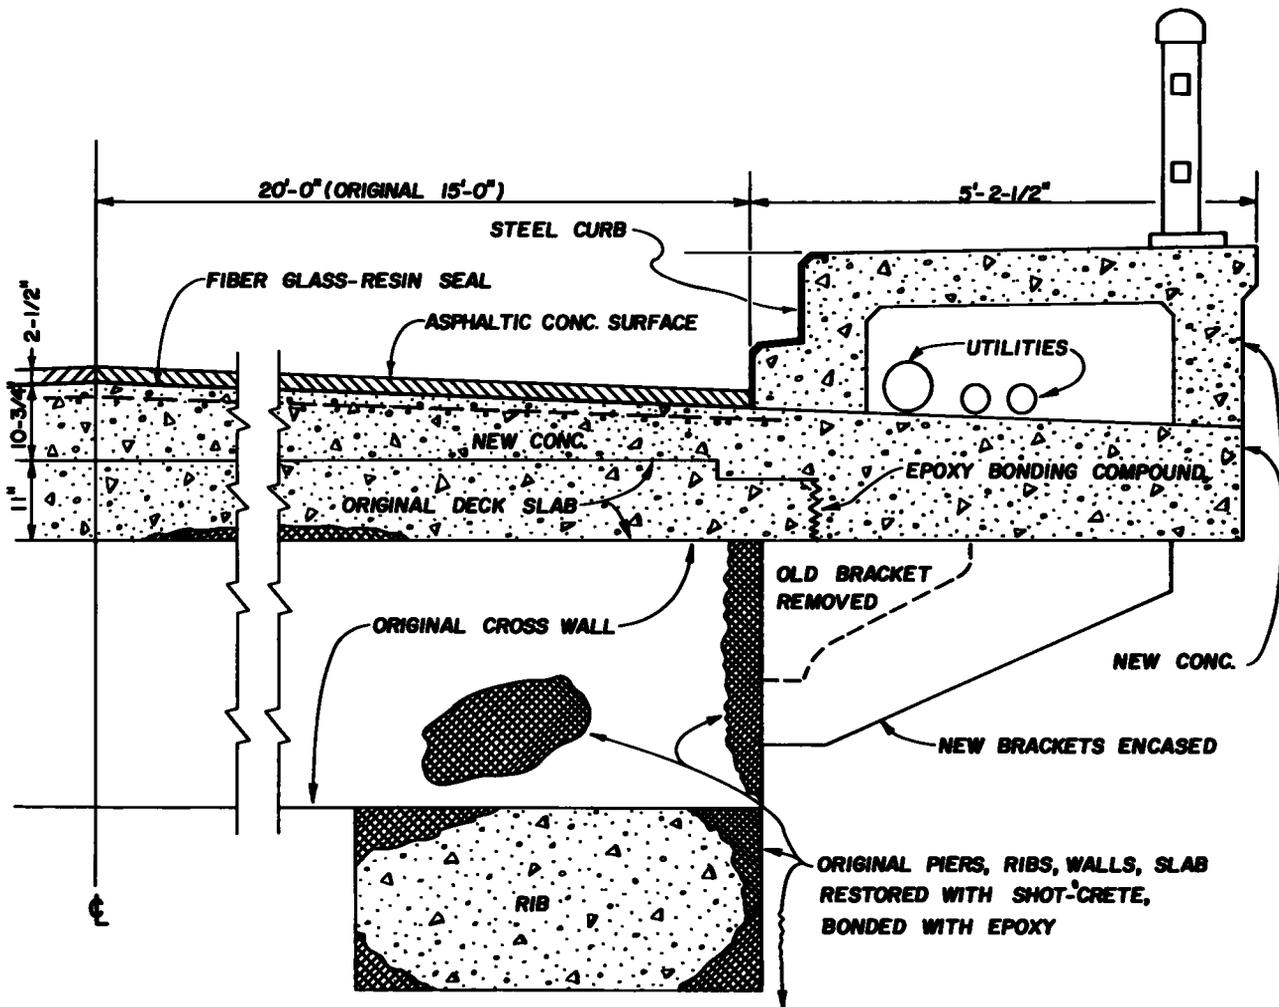
Figure 19. Section of arch structure deck with restoration details, Glens Falls, N.Y.

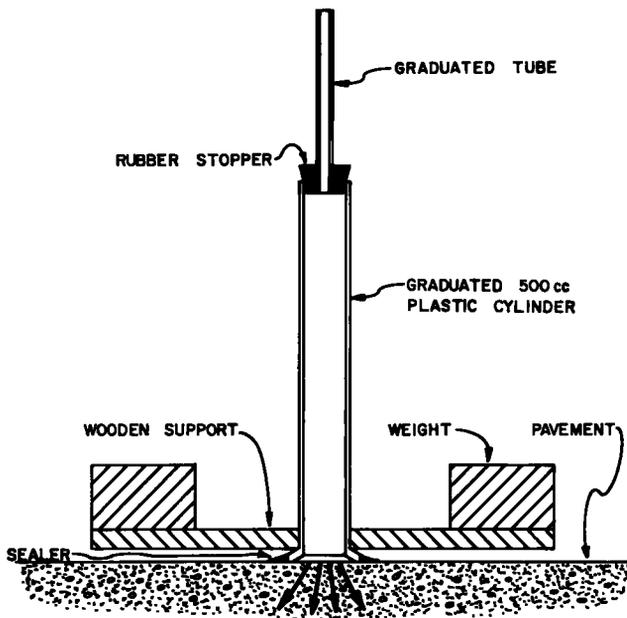
Figure 20. Apparatus developed to measure water permeability of a pavement surface in place (37), based on earlier testing procedures of the California Division of Highways.

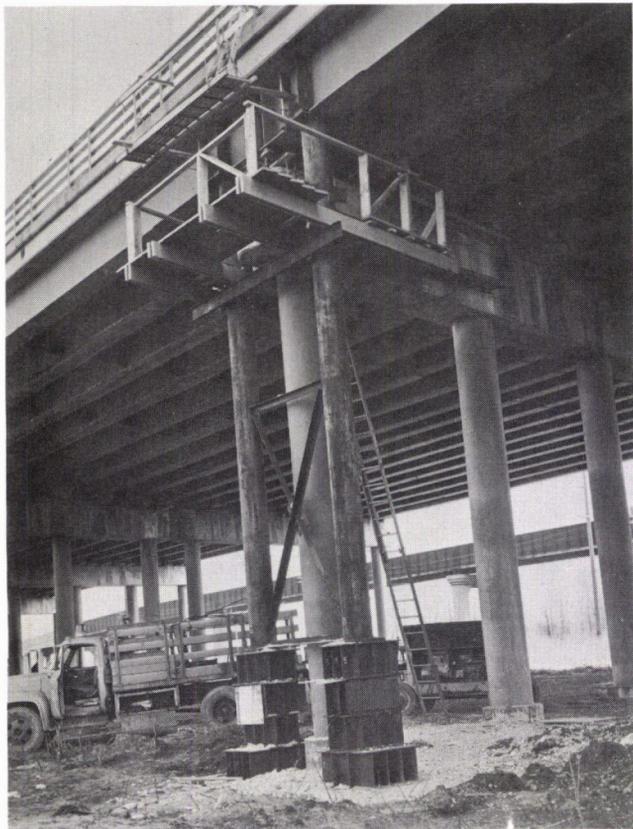
Figure 21. Temporary columns resting on existing footer support deck, New York Thruway.

Several systems were employed to lift and support deck spans while repairs were being made to bearing pads and pier caps. One method involved lifting and supporting the deck on temporary columns based on the pier foundation (Fig. 21). Another system (Fig. 22) employed a tem-

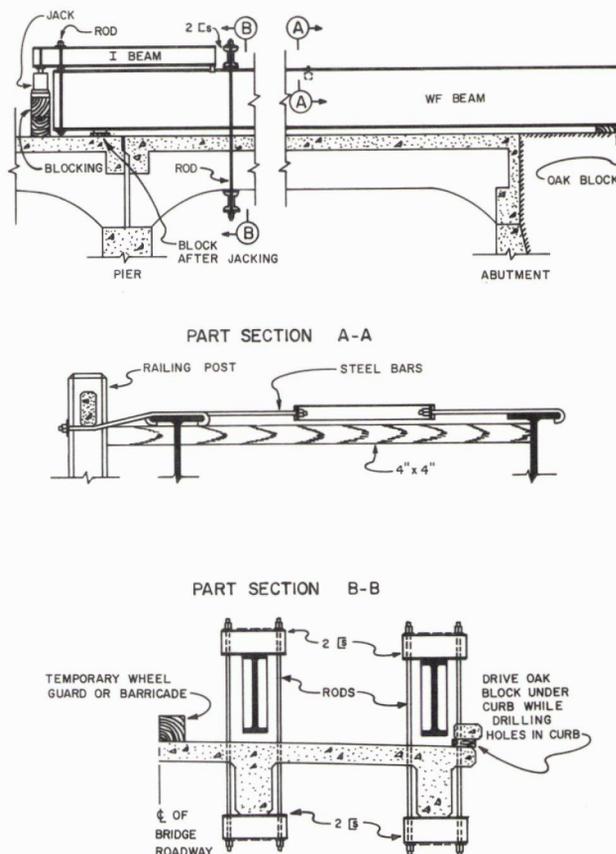
Figure 22. System to lift deck span while making repairs to pier caps or bearing pads, Virginia Department of Highways.

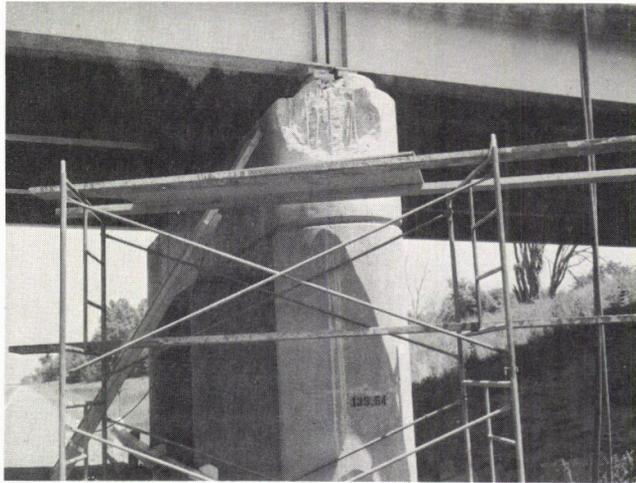
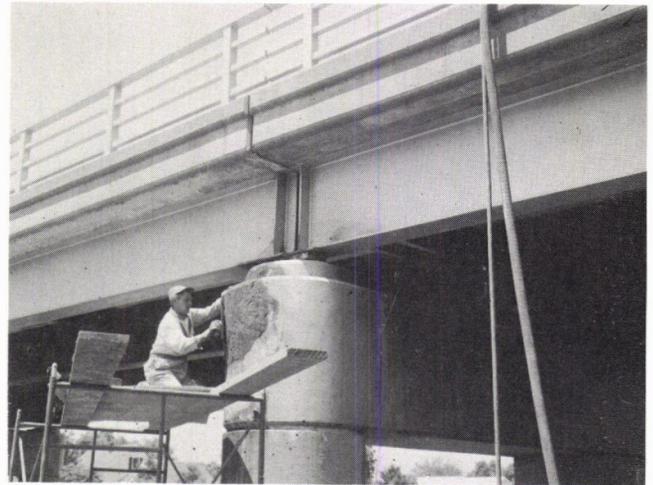
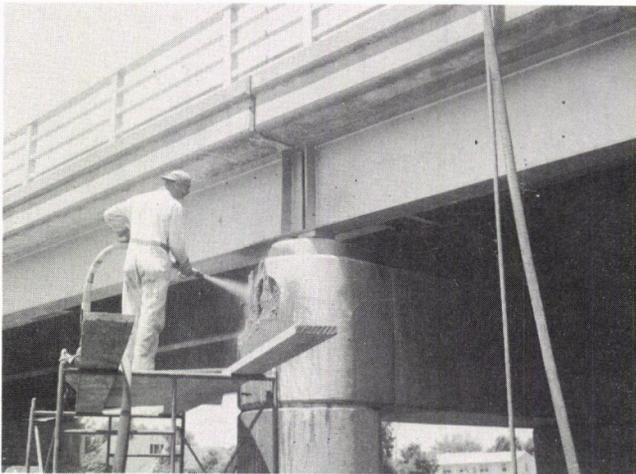
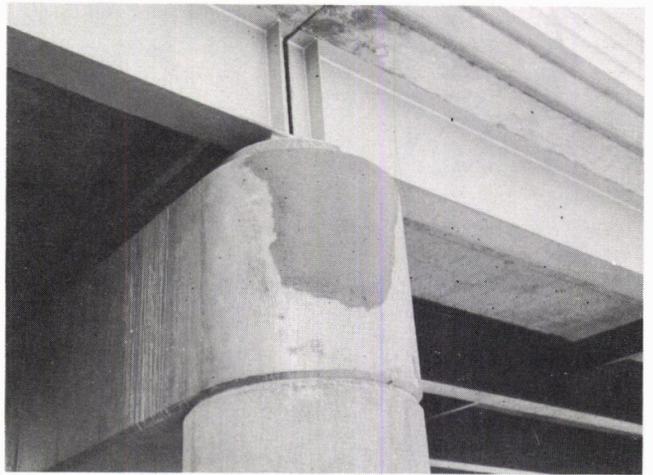
Figure 23. Shotcrete repairs to pier cap, New York Thruway.

The most widely used method of repair of vertical and overhead faces of structural concrete involved the use of pneumatically placed concrete (Fig. 23). Materials em-

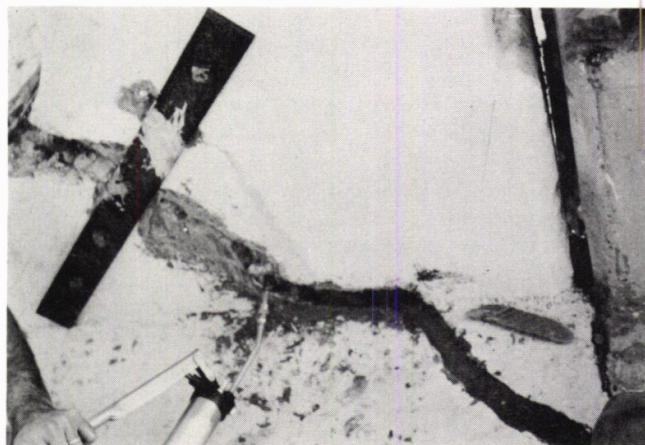
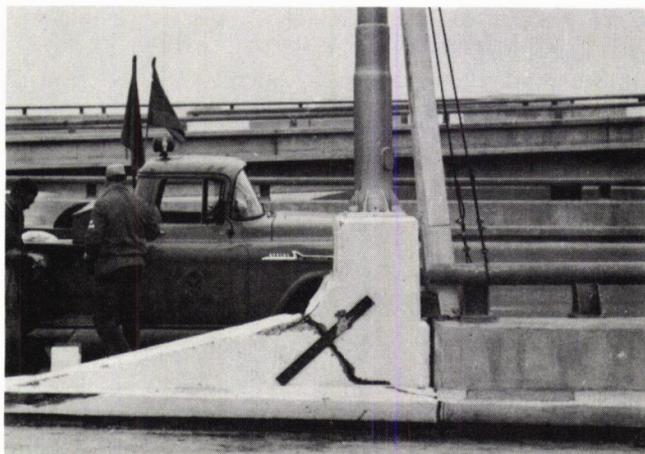
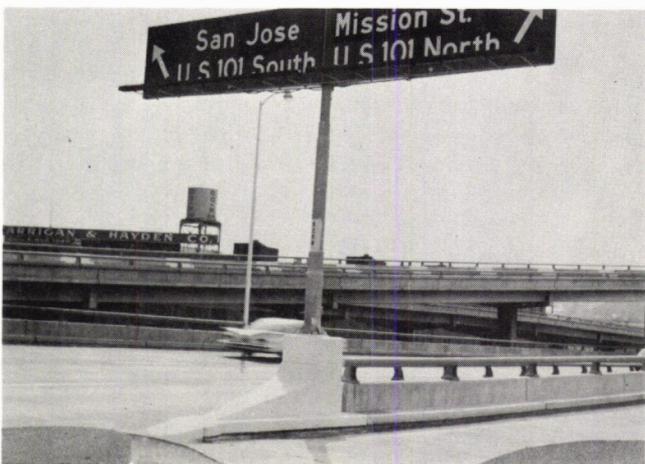
Figure 24. Epoxy grout pumped into crack with grease gun to bond broken faces of median barrier, Bayshore viaduct, San Francisco, Calif.

and for bonding old concrete to old concrete. A technique developed and refined by a western highway department (52) involved the use of liquid epoxy resin compounds pumped into cracks or fractures in structural concrete sections to reestablish a bond between the cracked faces. Examples of this procedure involved repair to a concrete bridge parapet, cracked as a result of an accident, and to a traffic divider (Fig. 24). The parapet was straightened and the outside face of the cracks sealed with a polysulfide-epoxy resin compound containing a thixo-

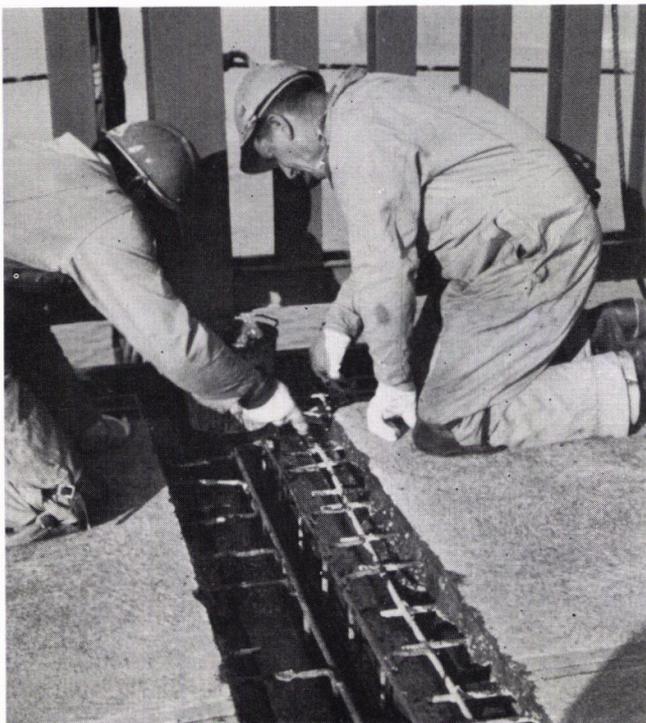
Figure 25. Painting patch area with epoxy bond coat before repouring concrete deck joint, Golden Gate Bridge, San Francisco, Calif.

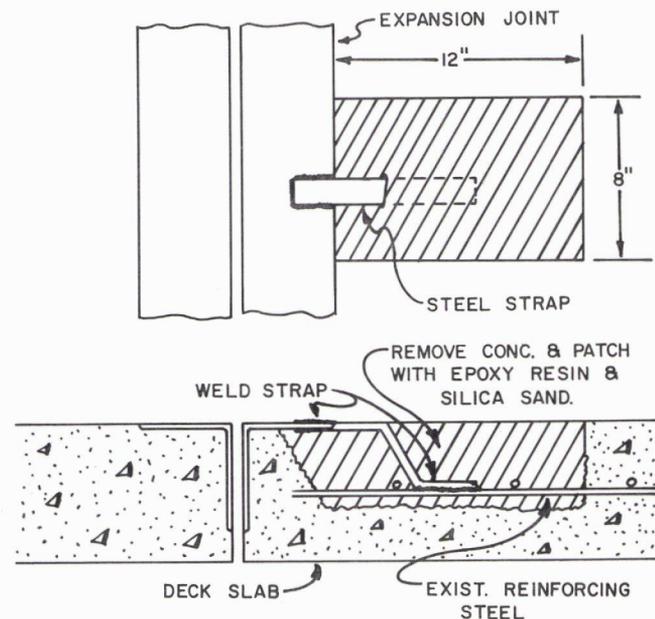
Figure 26. Method of repairing loosened expansion dam, Illinois State Toll Highway Commission.

One toll road commission (27) restored loosened expansion dams by breaking away old concrete down to the upper layer of reinforcing steel in rectangular sections about 8 by 12 in. at 18-in. intervals across the full width of the roadway section or that portion where the dam was loose and rattling (Fig. 26). These rectangular sec-

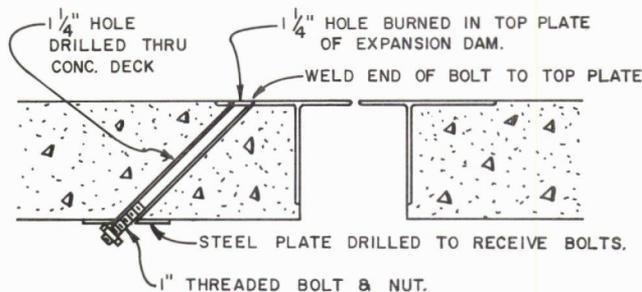
Figure 27. Method of repairing loosened expansion dam, Indiana Toll Road Commission.

Another toll road commission (56) developed a system for refastening steel expansion dams by burning a hole through the horizontal flange of the dam and drilling a 1¼-in. hole through the concrete deck slab below the burned hole (Fig. 27). The holes were burned and drilled

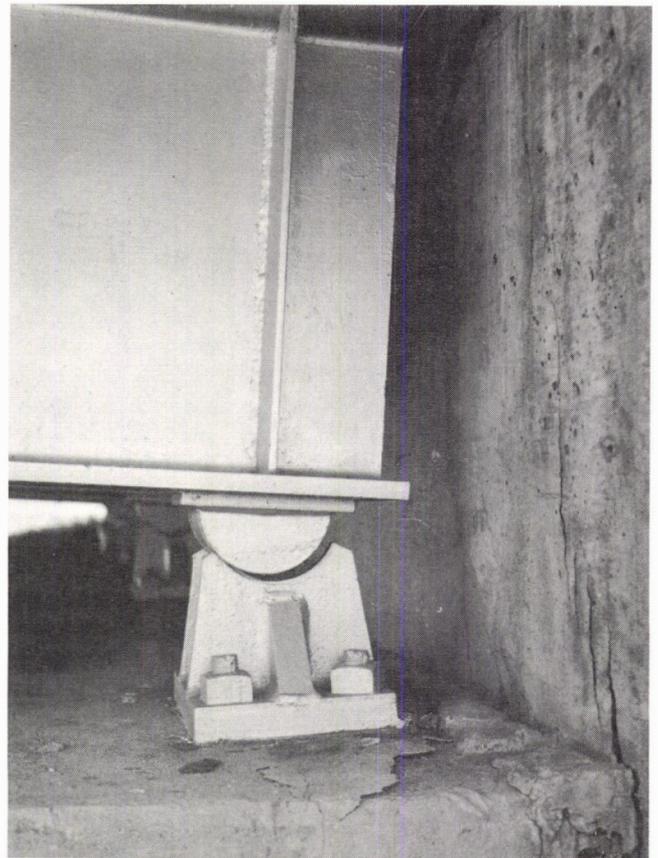
Figure 28. Bearing pad dislodged and rocker displaced by pressure against structure from growth or creep of approach pavements.

quently included as a basic part of bridge repair programs. Numerous instances were encountered where the need for bridge repairs resulted in part from compressive stresses exerted on the structure by the adjacent pavement sections (Fig. 28). The phenomenon of pavement movement or

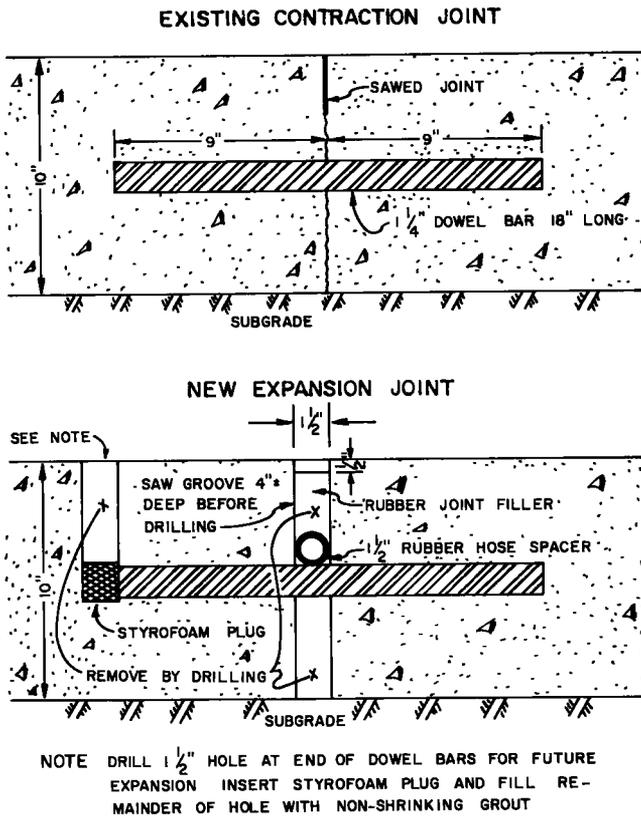
Figure 29. Conversion of contraction joints to expansion joints, Indiana Toll Road.

Another agency (56) developed a system whereby new expansion joints were constructed at the site of the contraction joint nearest to the structure. This system involved the conversion of a contraction joint to an expansion joint by sawing and removing a 1½-in. section of the concrete slab full depth and full width (Fig. 29). The load transfer dowel bars in the existing contraction joint remained

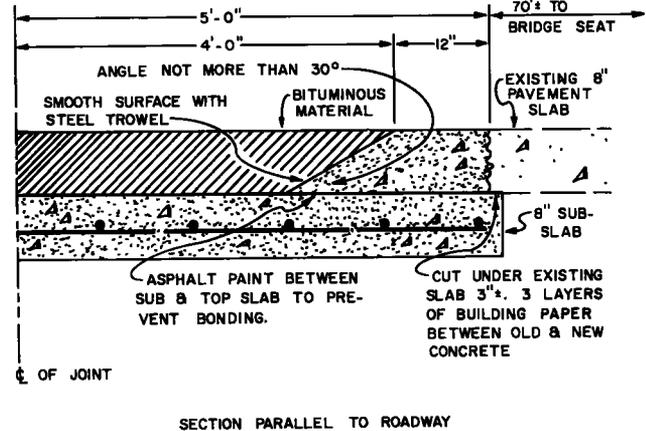
Figure 30. Design of supplemental expansion joints at structure approaches, Virginia Department of Highways.

with bituminous concrete. The asphalt paint on top of the subslab prevented bonding of the new portland cement concrete slab to the subslab while the 8-ft section of bituminous concrete provided a compressible material to absorb any slab movement resulting from creep or growth of the adjoining roadway pavement.

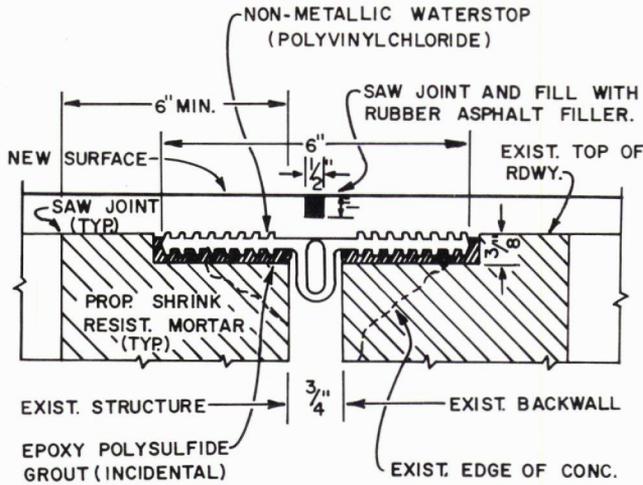
Figure 31. Cross-section of a nonmetallic waterstop installation as a part of a deck resurfacing project, Michigan State Highway Department.
