NATIONAL COOPERATIVE HIGHWAY RESEARCH PROGRAM  
REPORT

# EVALUATION OF METHODS OF REPLACEMENT OF DETERIORATED CONCRETE IN STRUCTURES

TE7  
N25  
**HIGHWAY RESEARCH BOARD 1964**

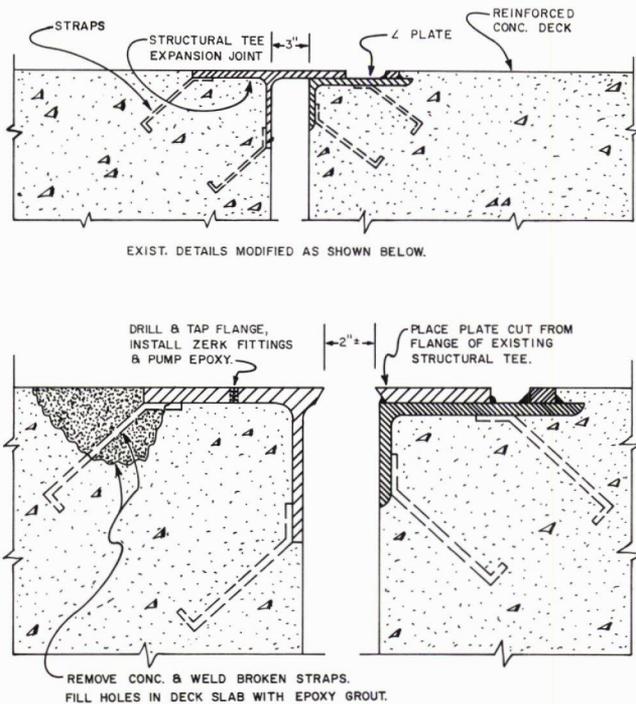
Figure 32. Repair and conversion of an expansion joint—closed to open, California Division of Highways.

To avoid the problem of providing and maintaining an effective joint seal, a number of agencies have converted sealer joints to open joints and have provided for handling the water in gutters and downspouts, drip ledges, or with protective coatings over the exposed surfaces (Figs. 32 and 33) beneath the joint.

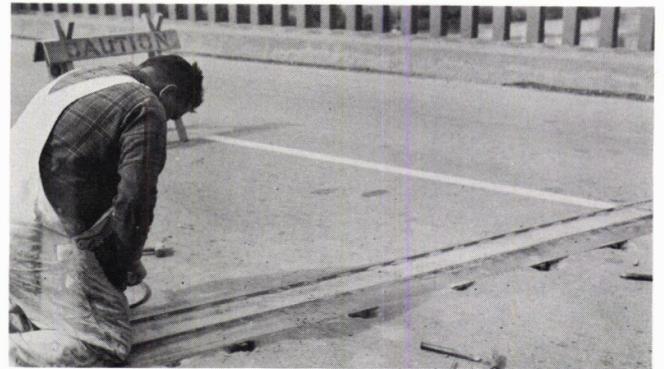
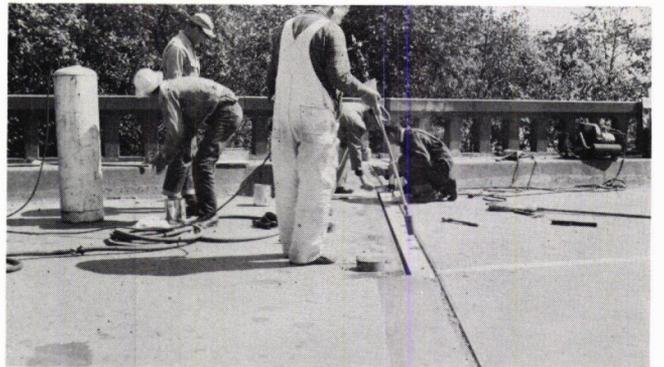
Figure 33. Expansion joint repair shown in Figure 32; acetylene torch used to accelerate curing of epoxy materials.
