NATIONAL COOPERATIVE HIGHWAY RESEARCH PROGRAM
REPORT

333

GUIDELINES FOR EVALUATING CORROSION EFFECTS IN EXISTING STEEL BRIDGES

J. M. KULICKI, Z. PRUCZ, D. F. SORGENFREI, and D. R. MERTZ
Modjeski and Masters
Harrisburg, Pennsylvania

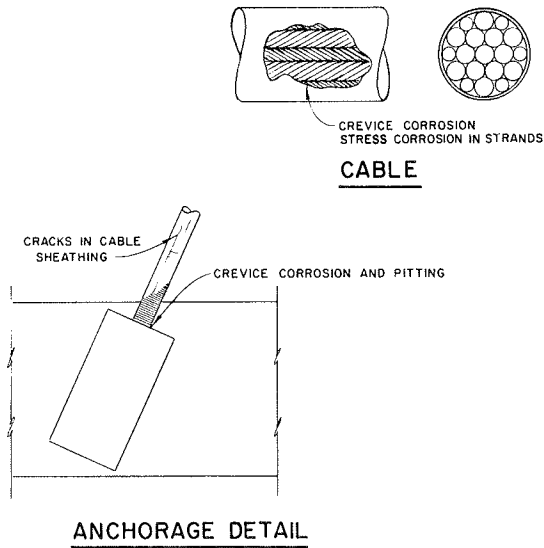
Figure 33. Cable-stayed bridge.

Figure 33 shows location of potential corrosion attack on cable-stayed bridges. For these structures, particular attention should be given to the cables. Cracks in the cable sheathing can allow moisture to attack the cables. Crevice corrosion can form

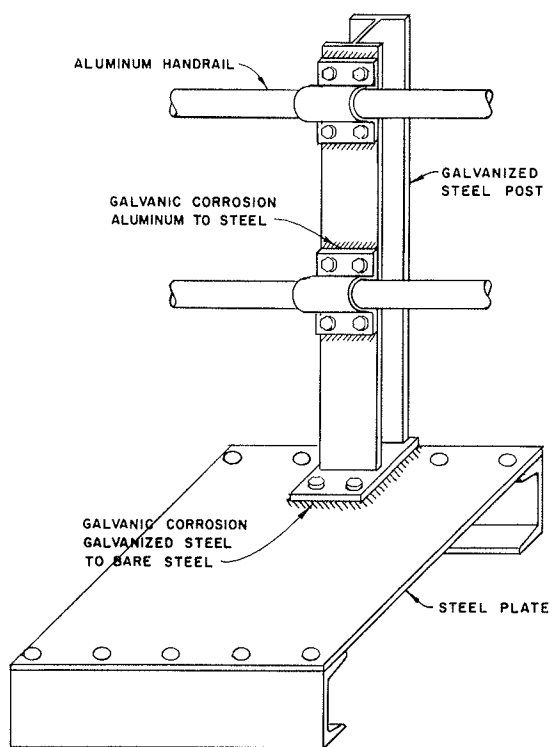
Figure 46. Galvanic corrosion.

Figure 46 shows potential locations of galvanic corrosion on a bridge. Galvanic corrosion is possible at any location where dissimilar metals are connected. In this case, galvanic corrosion may occur where the aluminum handrail is fastened to the steel post. Galvanic corrosion can also occur where galvanized steel is fastened to bare steel, especially where galvanized steel is fastened to weathering steel.

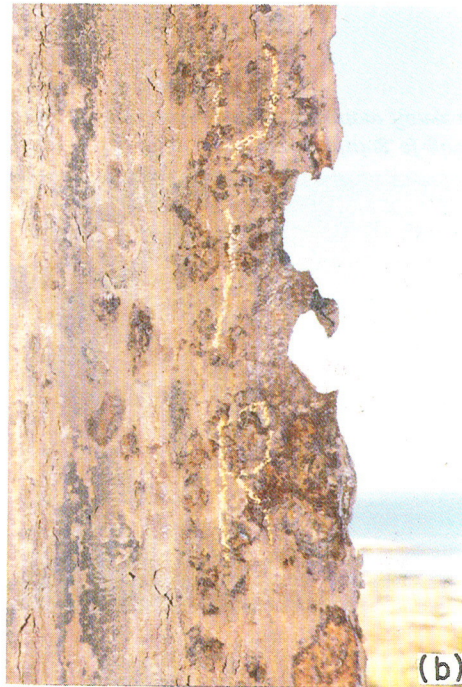
Figure 4. Photographs illustrating the effects of environmental exposure on corrosion. Opposite sides are shown of the same vertical member at the same level. The angle in (b) is on the windward side of the member, exposed to the prevailing wind carrying salt mist from the ocean. The angle in (a) is on the leeward side of the member, protected from the wind.

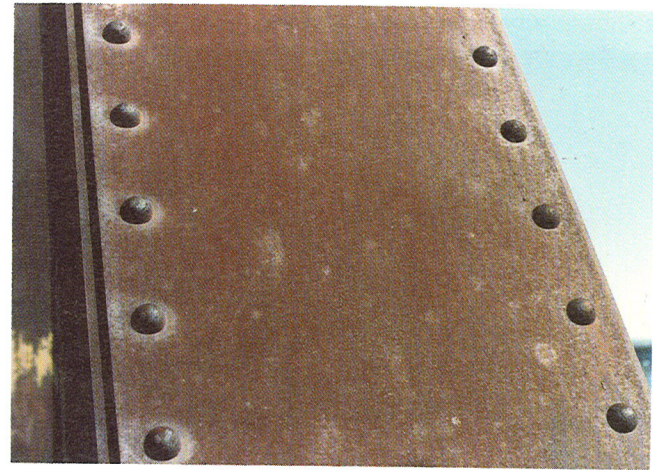
Figure 5. Photograph shows uniform corrosion of bridge member.

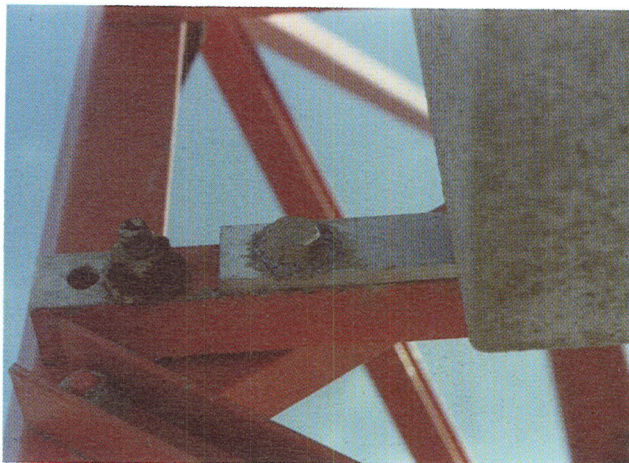
Figure 6. Photograph shows galvanic corrosion—aluminum bracket with carbon steel bolt.

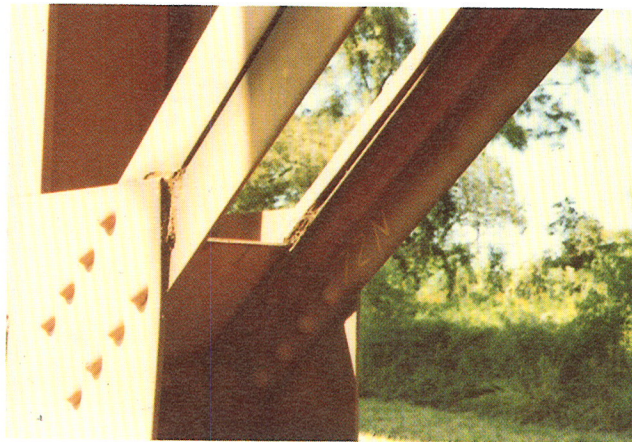
Figure 7. Photograph shows crevice corrosion between back to back angles and gusset plate.

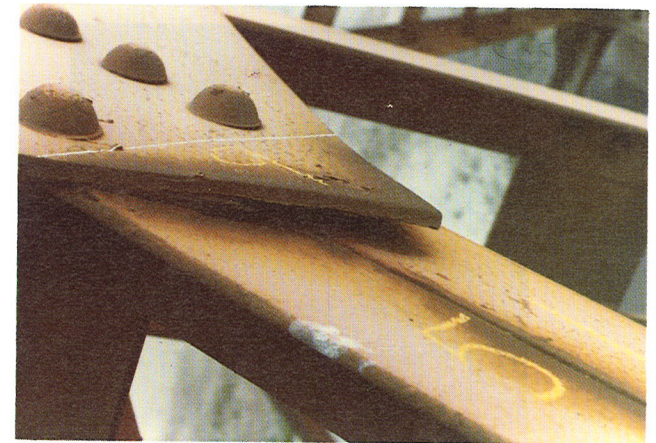
Figure 8. Photograph shows crevice corrosion—pack rust causing bending of gusset plate. Excessive edge distance of rivets contributed to this condition.

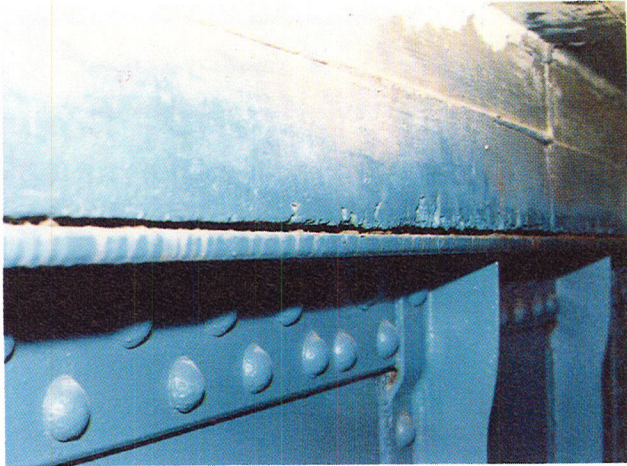
Figure 9. Photograph shows crevice corrosion between concrete haunch and steel beam.

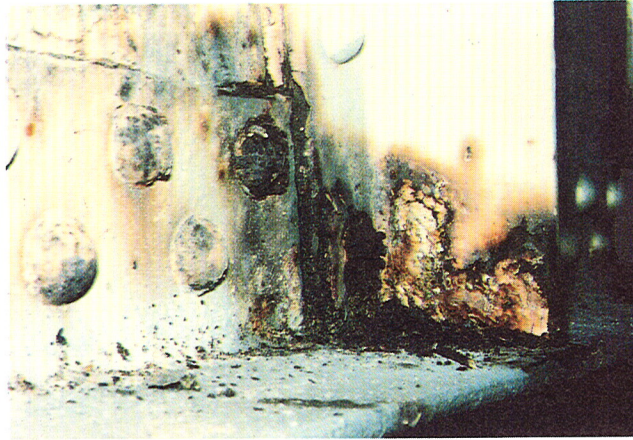
Figure 10. Photograph shows corrosion due to deposit attack at stiffener-to-flange connection. Debris accumulation was removed for photograph.

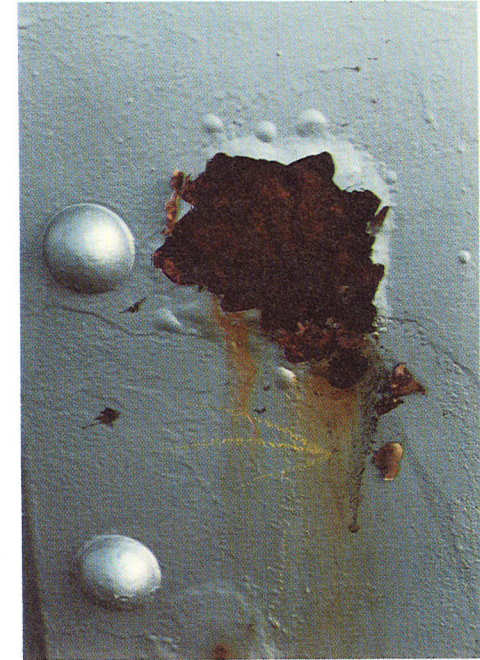
Figure 11. Photograph shows paint blistering due to underfilm corrosion.

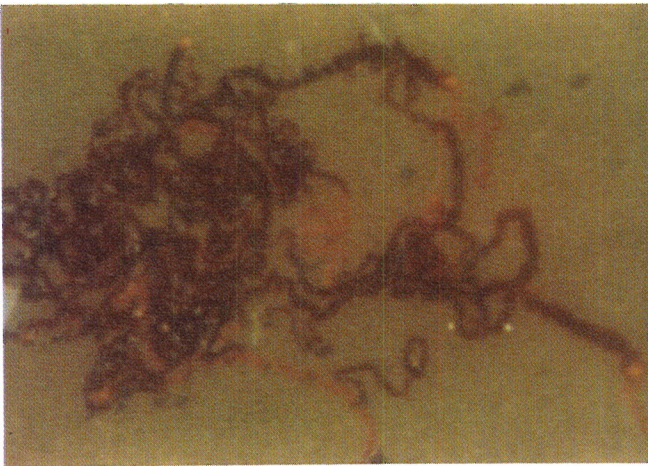
Figure 12. Photograph shows filiform corrosion.

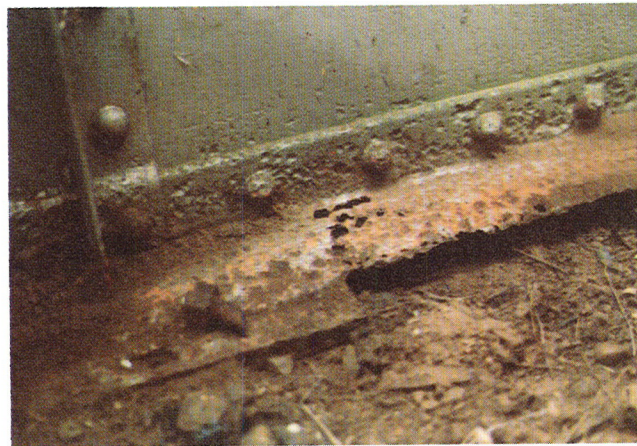
Figure 13. Photograph shows pitting of girder web and bottom flange. Note active pitting on bottom flange as well as old pits on web that has been painted.

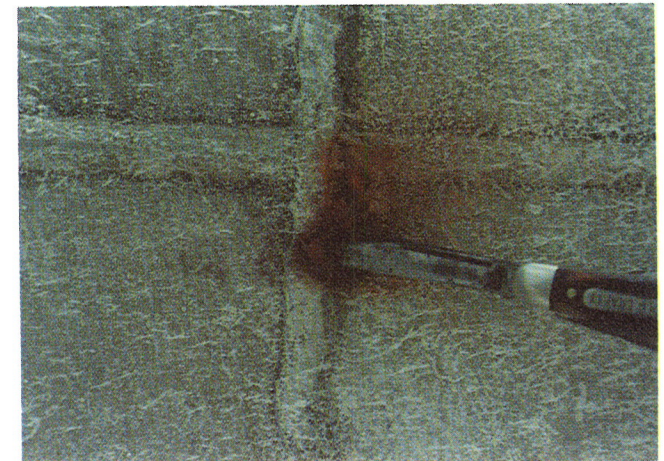
Figure 14. Photograph shows weld decay.

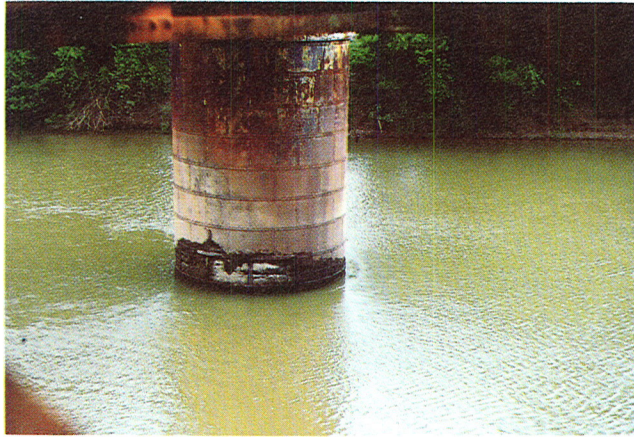
Figure 15. Photograph shows potential erosion corrosion location of a steel-encased pier in a river carrying abrasive particles.

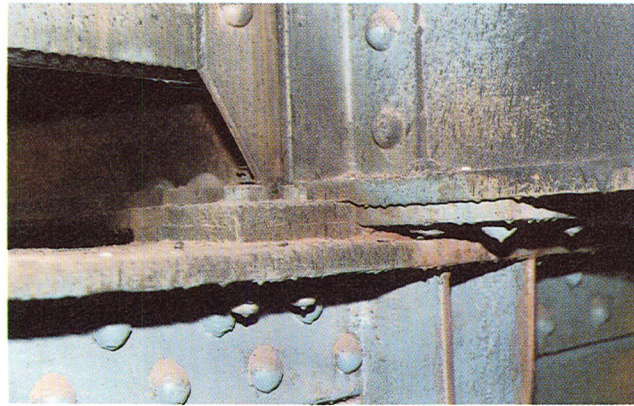
Figure 16. Photograph shows fretting corrosion at stringer joint.

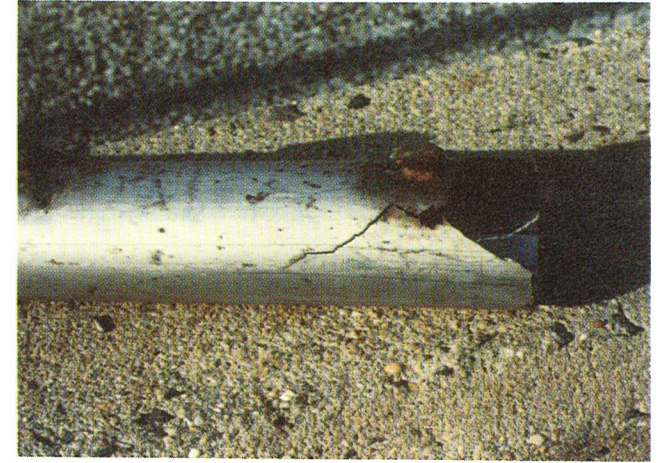
Figure 17. Photograph shows stress corrosion cracking.

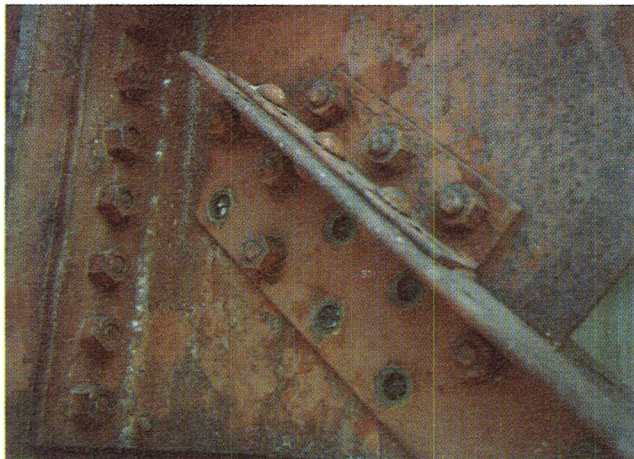
Figure 18. Photograph shows corrosion cracking of bolts in industrial environment.

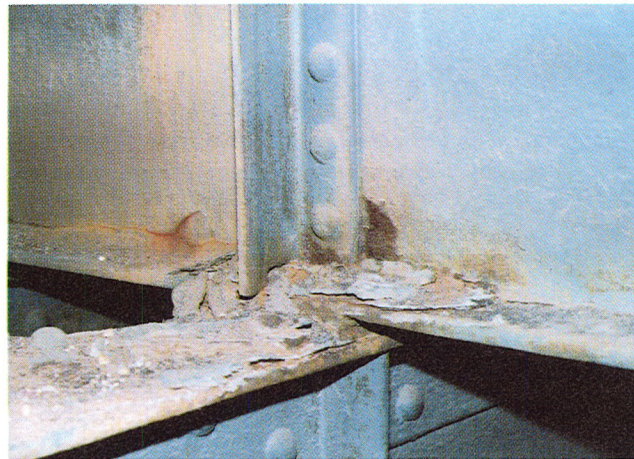
Figure 48. Photograph shows stringer with corrosion and debris accumulation.

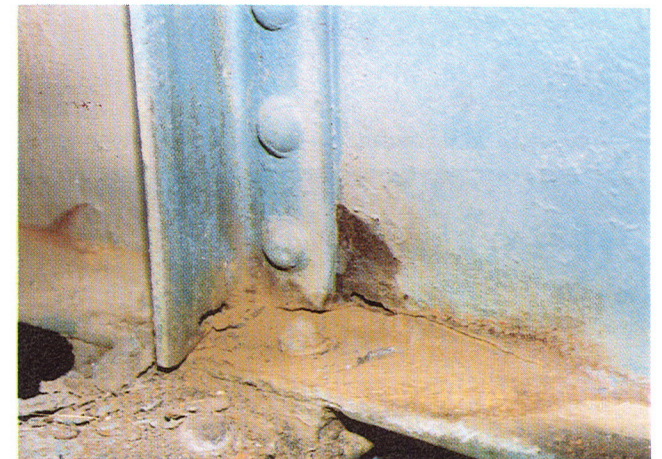
Figure 49. Photograph shows same stringer after cleaning, revealing crack and hole.

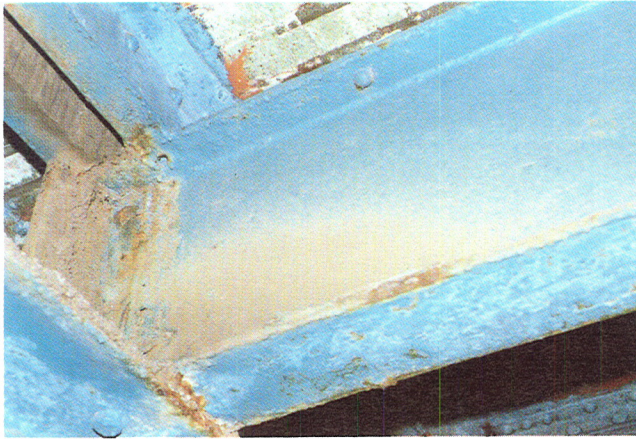
Figure 50(a). Photograph shows progression of deterioration—rating 6.

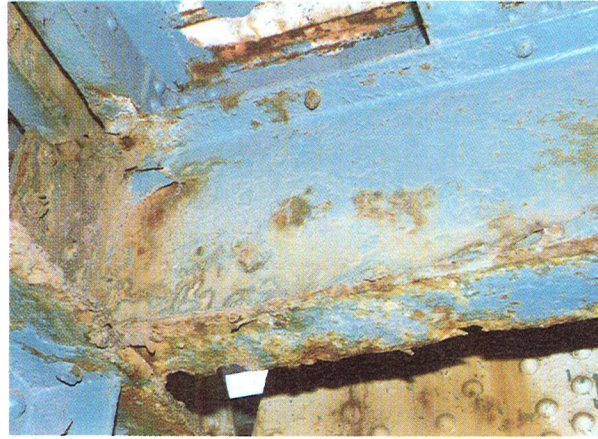
Figure 50(b). Photograph shows progression of deterioration—rating 5.

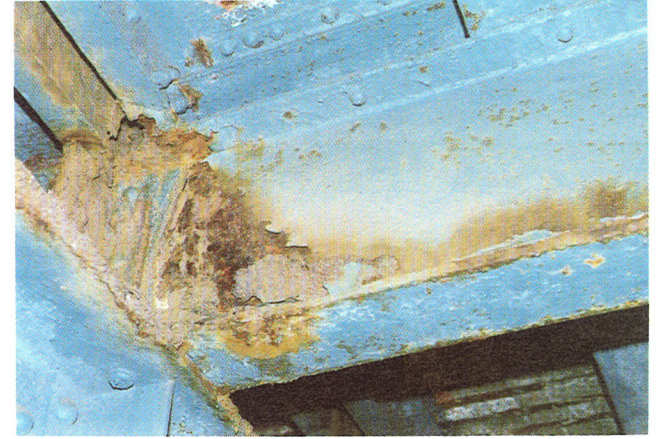
Figure 50(c). Photograph shows progression of deterioration—rating 4.

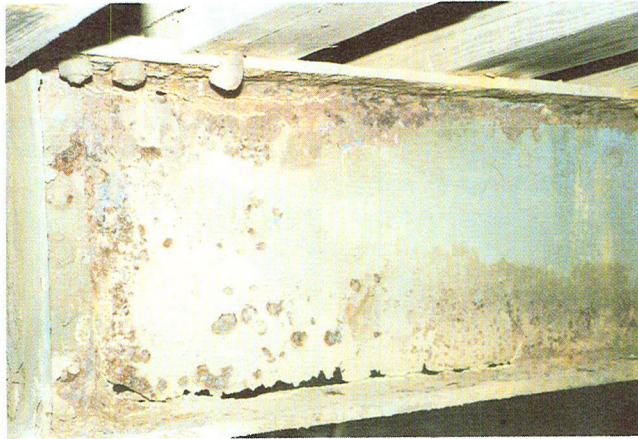
Figure 50(d). Photograph shows deterioration of web at support—rating 1.

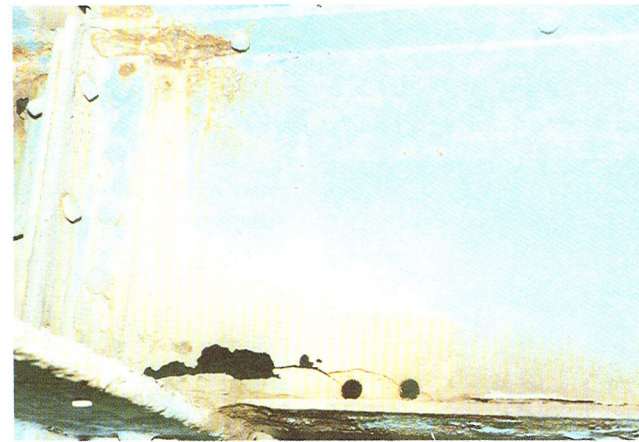
Figure 50(e). Photograph shows poor stringer condition but adequate shear capacity at support—rating 3.

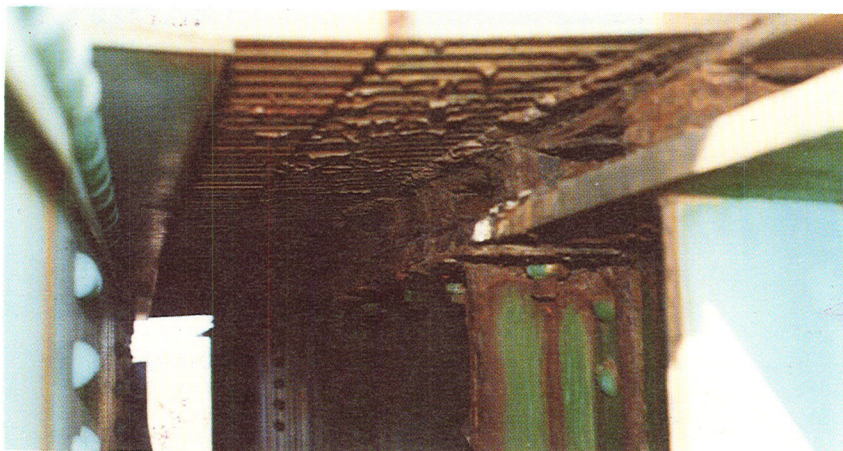
Figure 55(c). Photograph 1 shows typical condition of top flange and web of end floor beams beneath expansion dams. (See also cursory reports—Figures 55a, 55b)

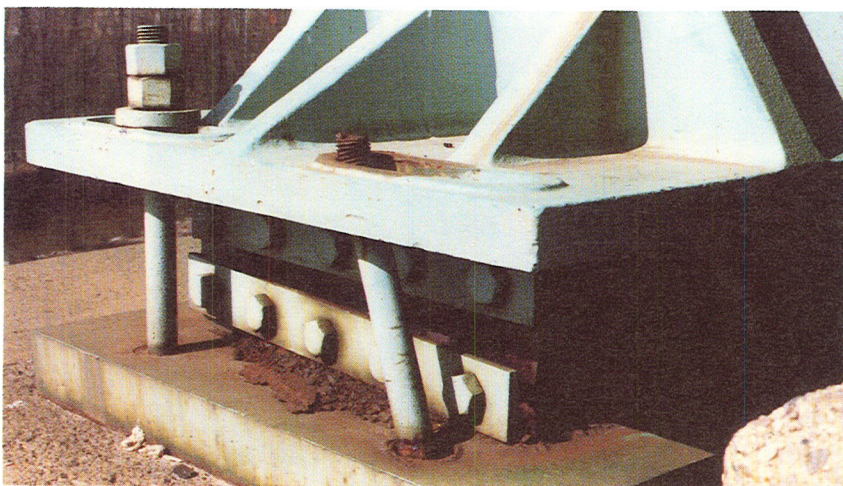
Figure 55(d). Photograph 2 shows typical condition of anchor bolts on expansion bearings. Many bolts have sheared off just below the nuts. Note the extent of corrosion in the roller nest. (See also cursory reports—Figures 55a, 55b)

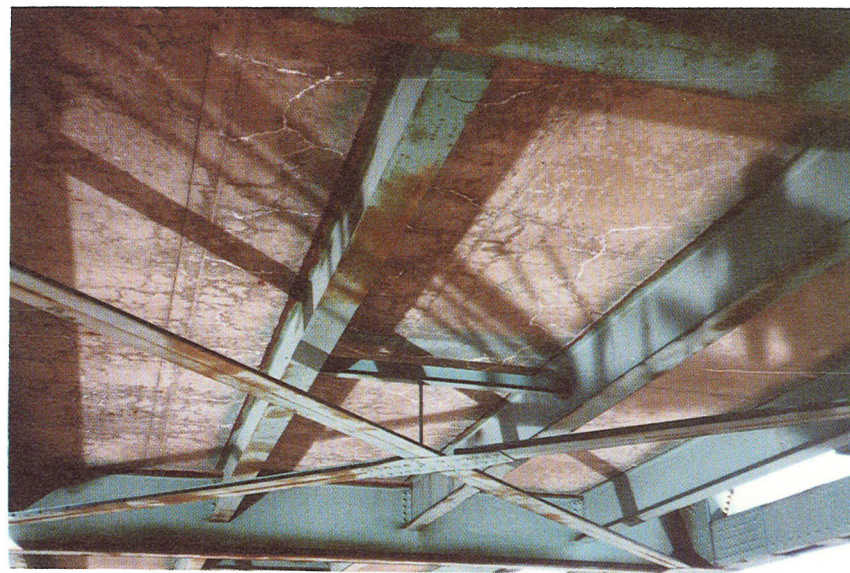
Figure 56(e). Photograph 1 shows typical cracking of main bridge deck. (See also general reports—Figures 56a, 56b, 56c)

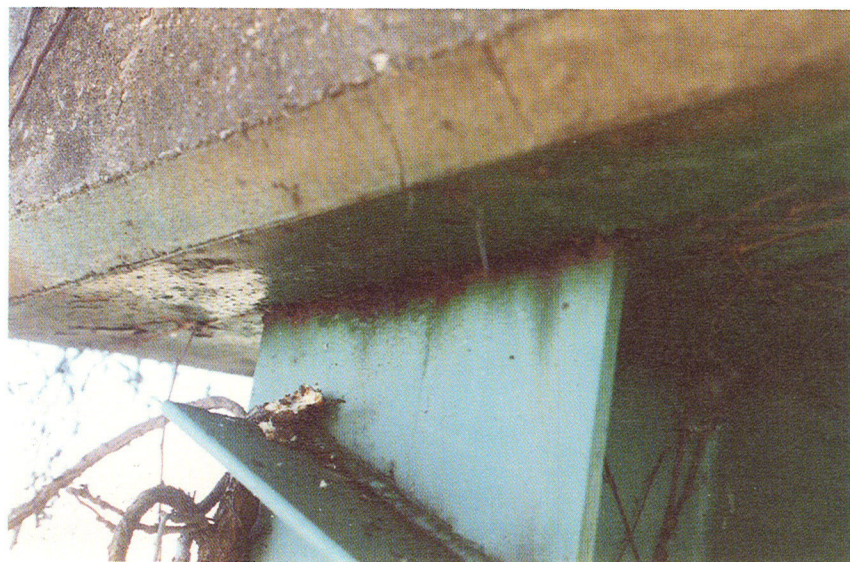
Figure 56(f). Photograph 2 shows typical area of deteriorating metalwork at bottom of bent cap concrete. (See also general reports—Figures 56a, 56b, 56c)

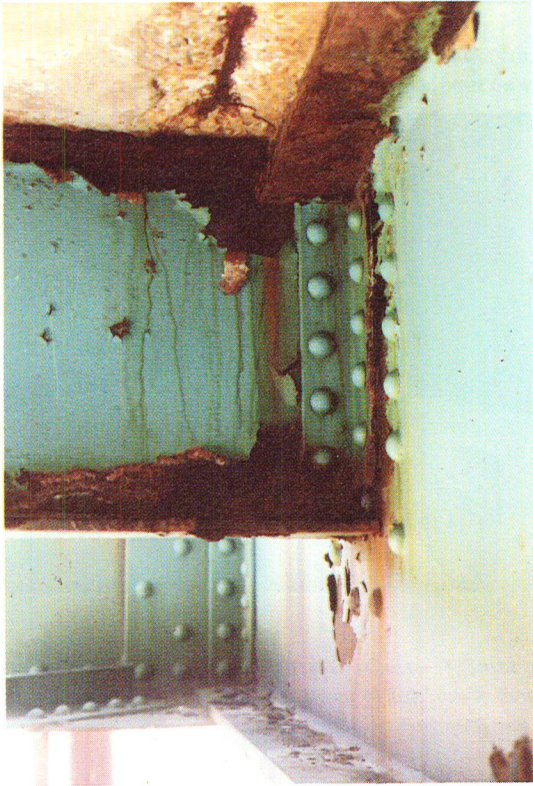
Figure 56(g). Photograph 3 shows typical areas of section loss to stringer flanges and web. (See also general reports—Figures 56a, 56b, 56c)

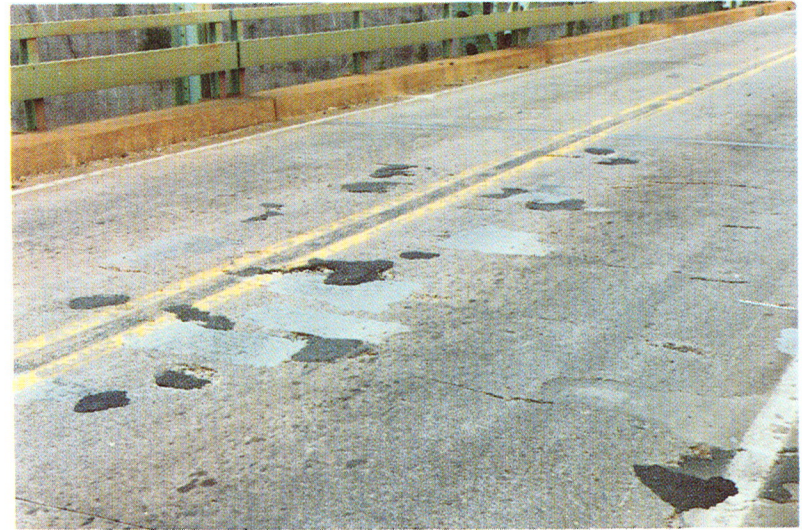
Figure 57(f). Photograph 1 shows typical patched, cracked condition of concrete deck on approaches, which allows leakage. (See also detailed reports—Figures 57a through 57e)

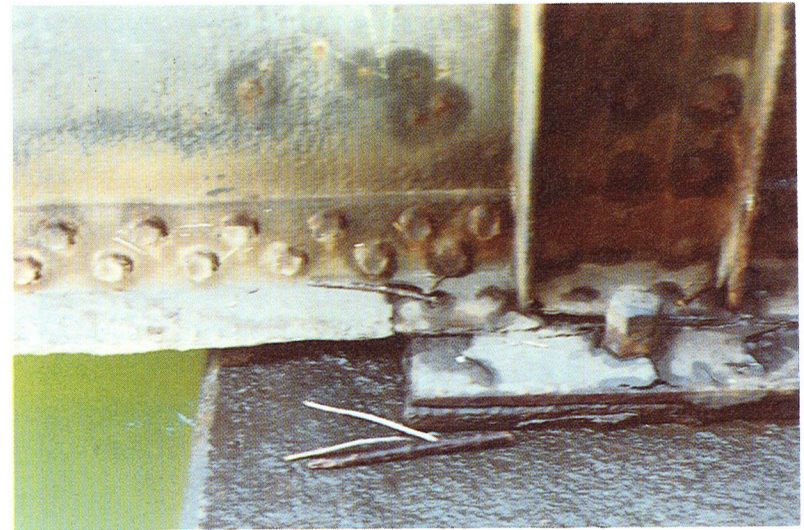
Figure 57(g). Photograph 2 shows deteriorated expansion bearing on approach spans. (See also detailed reports—Figures 57a through 57e)

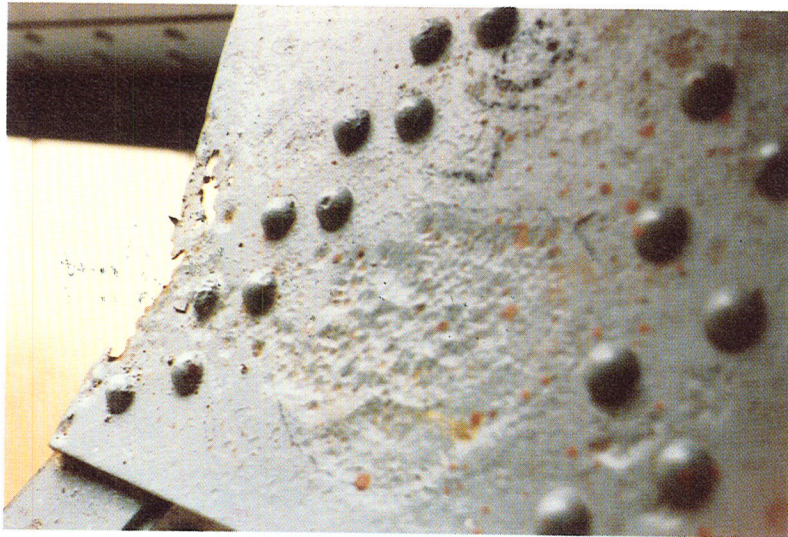
Figure 57(h). Photograph 3 shows pitting of lateral connection plate. (See also detailed reports—Figures 57a through 57e)

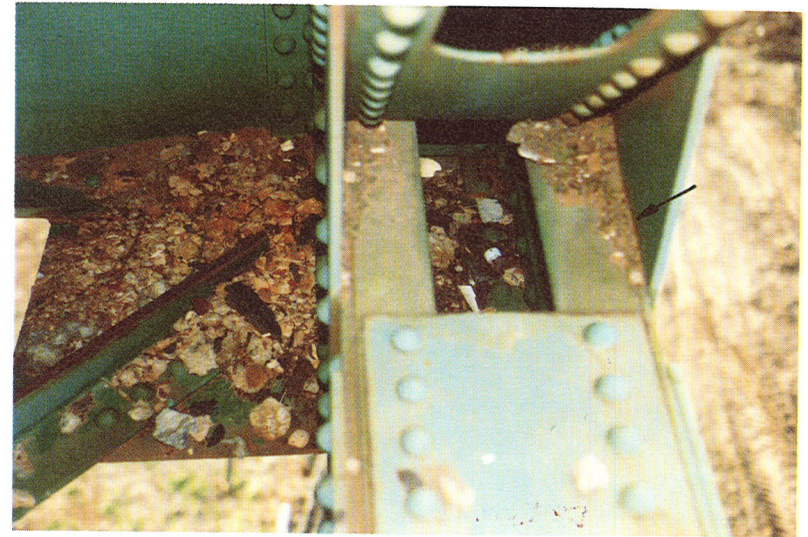
Figure 57(j). Photograph 5 shows typical debris accumulation in bottom chord connections. Arrows point to area of deteriorating metalwork. (See also detailed reports—Figures 57a through 57e)

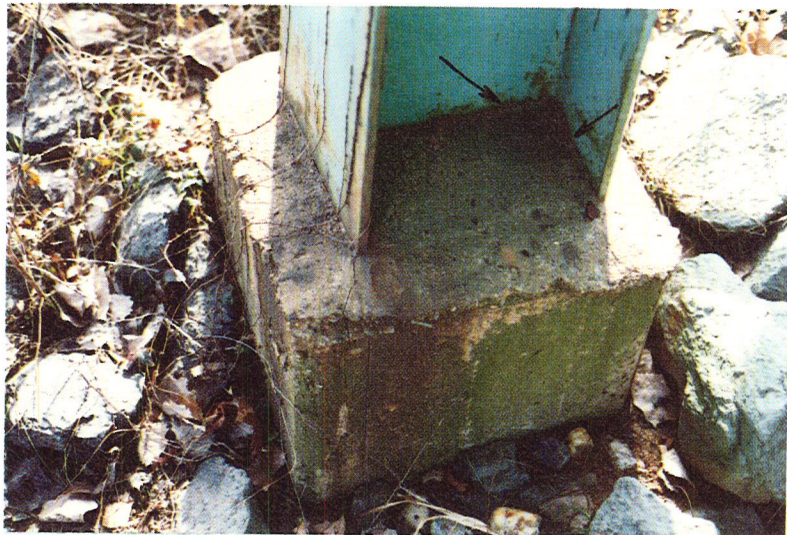
Figure 57(i). Photograph 4 shows typical area of metalwork deterioration at H-pile encasements. Crack in concrete from flange of H-pile is from expansion of deteriorating flange metalwork at interface with the concrete. (See also detailed reports—Figures 57a through 57e)

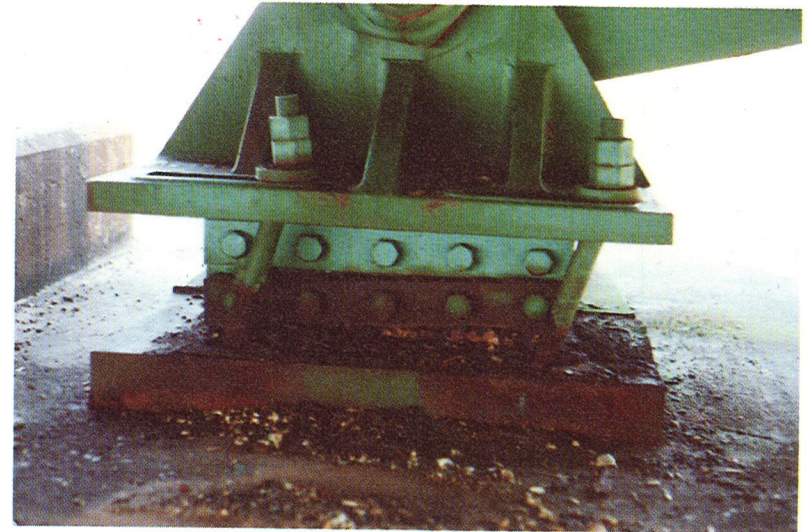
Figure 57(k). Photograph 6 shows typical condition of expansion bearings. Many bolts have bent or sheared off. Note the extent of corrosion in the roller nest. (See also detailed reports—Figures 57a through 57e)

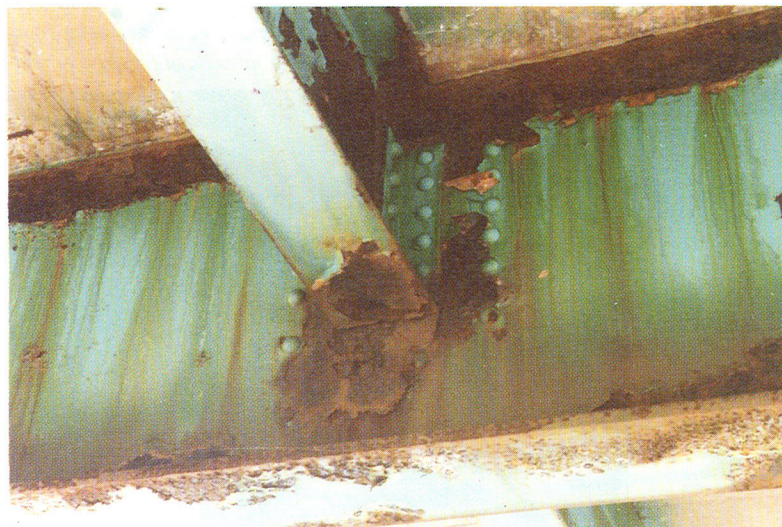
Figure 57(l). Photograph 7 shows typical area of deterioration of floorbeams, top flange and web at stringer connections. (See also detailed reports—Figures 57a through 57e)

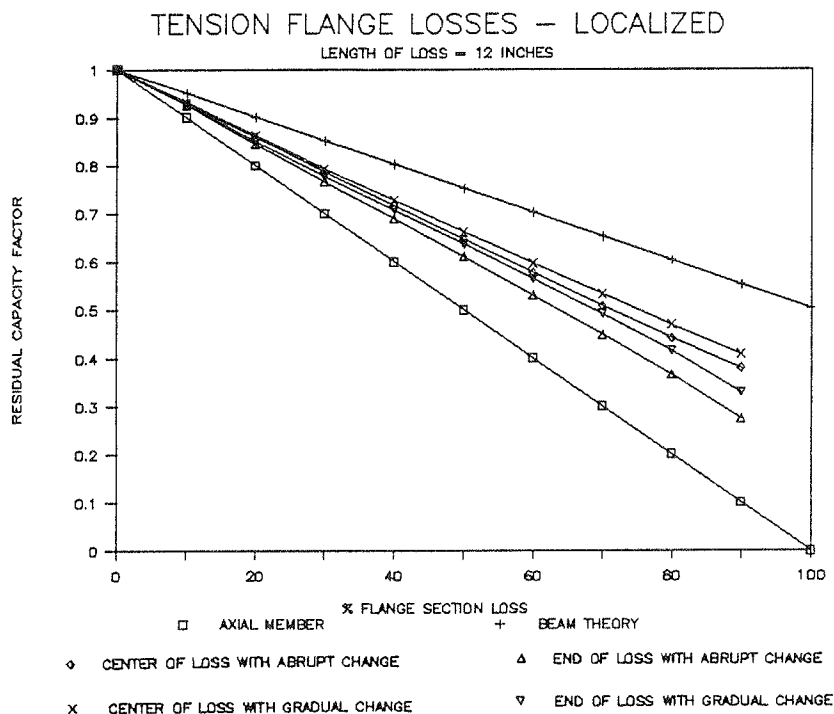
Figure 76. Residual capacity factors for beams with localized flange losses.

As the length of flange loss along the beam decreases, the effect of the loss on beam deflection also decreases. For example, in the case of the built-up beam model studied, a 30 percent loss over 25 percent of the length of the flange in the central portion of the beam increased the deflection by only about 4 percent. Therefore, localized flange losses will have a negligible effect in terms of shedding load into adjacent structural members.

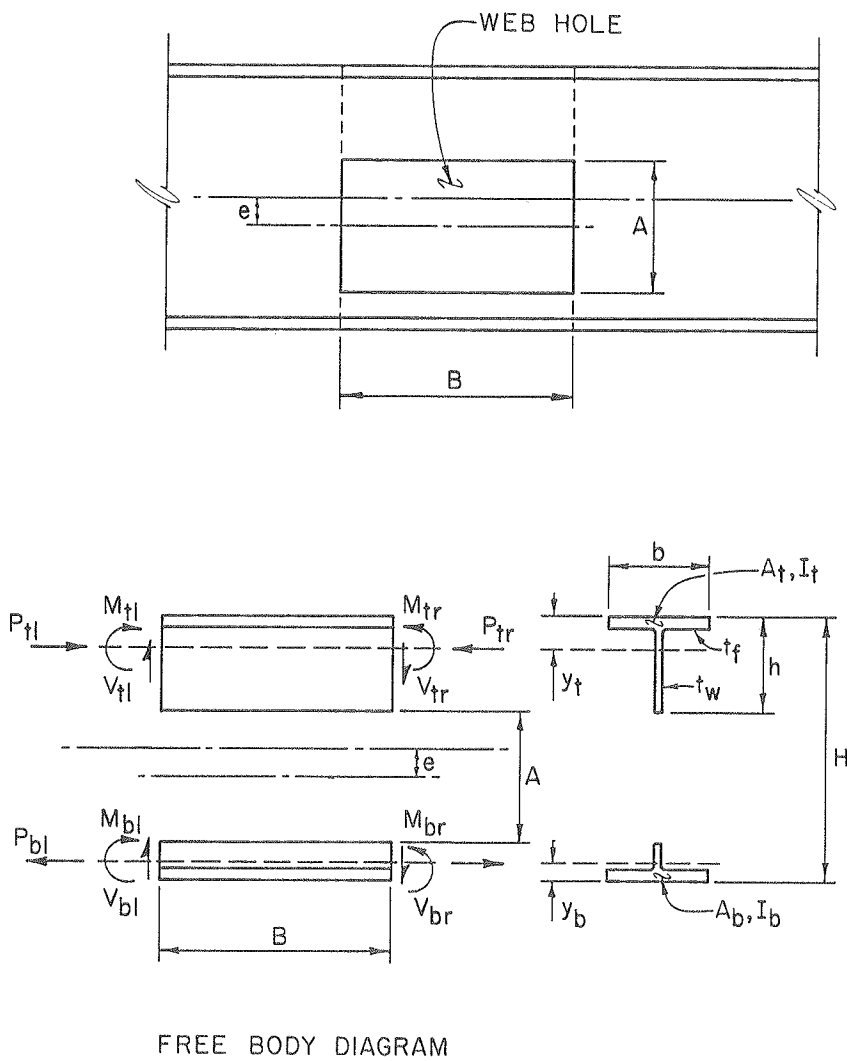
Figure 77. Model of analysis for beams with web holes.

According to the Vierendeel analogy, the sections of the beam above and below the hole are assumed to behave like two independent beams rigidly connected at their ends to the rest of the beam. The shear forces on these sections produce secondary bending stresses that are maximum at the ends of the hole. Thus, the total bending stress distribution in the beam will include, in addition to the primary bending stresses caused by beam bend-

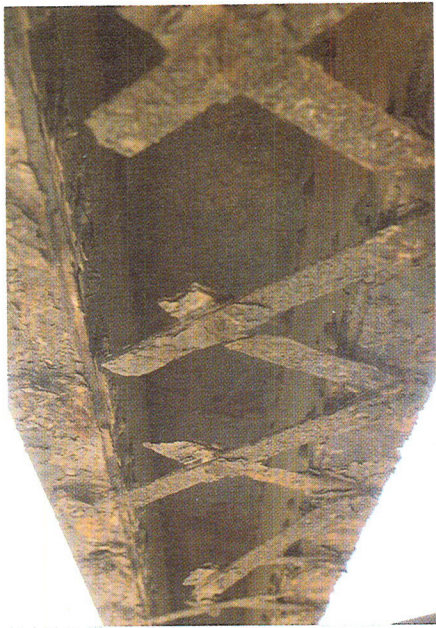
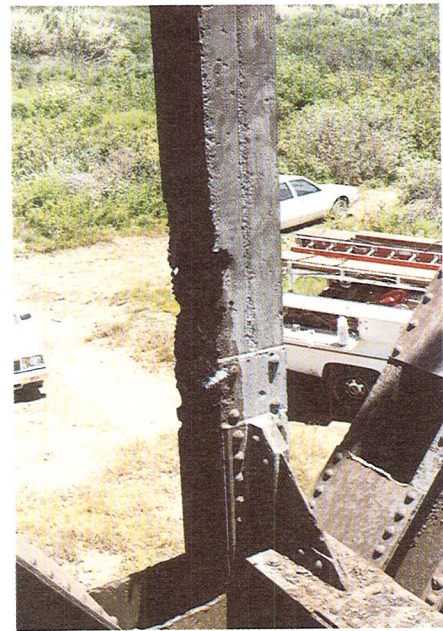
Figure 80. Photographs show truss bridge losses.

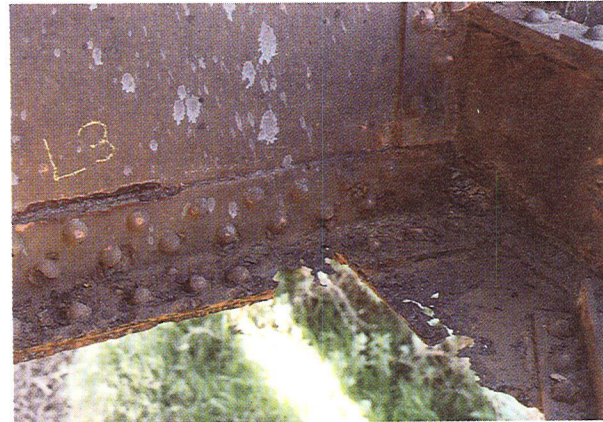
Figure 81. Photographs show flange losses.

(see Figures 81 and 82), effects of frozen bearings (see Figure 83), and effects of frozen pin and hanger assemblies.

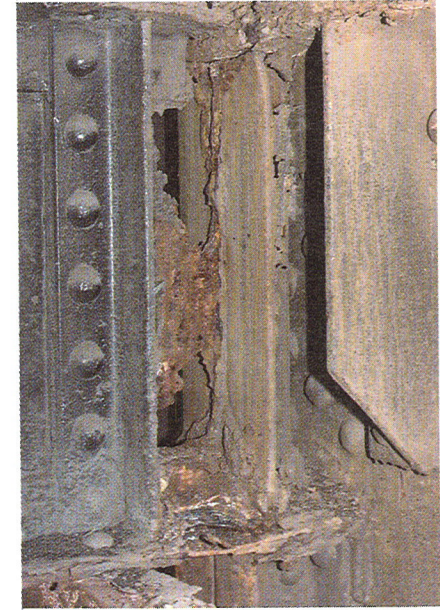
Figure 82. Photograph shows web losses.

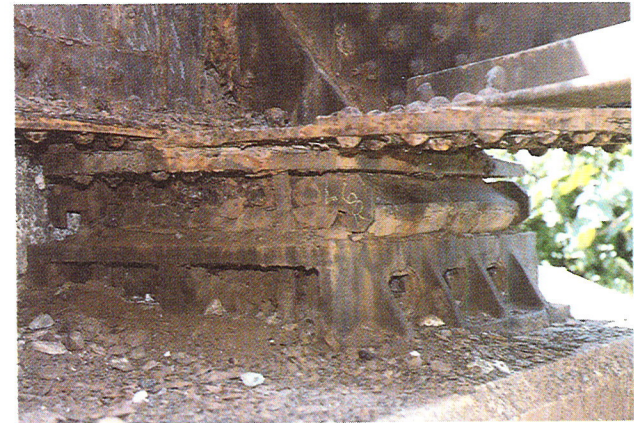
Figure 83. Photograph shows frozen bearings.

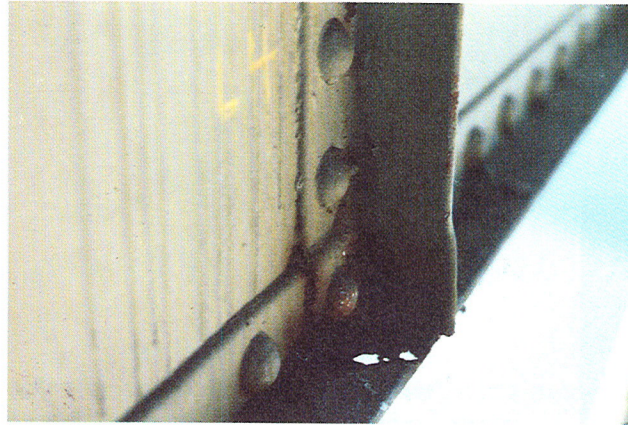
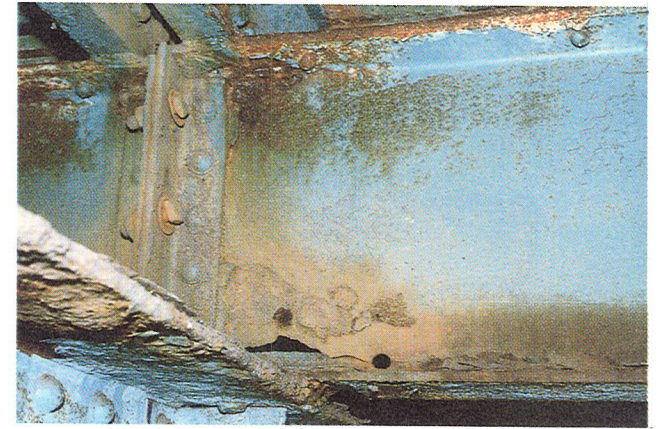
Figure 84. Model of analysis for studying web losses. Top photograph shows floorbeam elevation; bottom diagram illustrates finite element idealization for web losses.

1. A finite element model of a built-up riveted floorbeam with a refined mesh in its end panel, for studying web losses (see Figure 84).
2. A finite element model of a built-up riveted floorbeam with a refined mesh in its center panel for studying flange losses (see Figure 85).

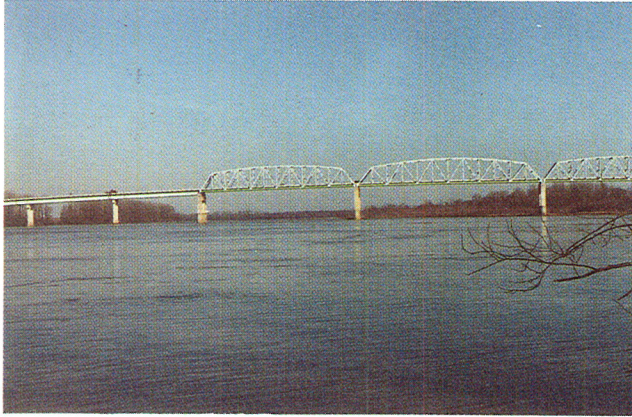
Figure 86. Model of analysis for studying web losses and frozen bearings. Top photograph shows girder elevation; bottom diagram illustrates finite element idealization for web losses and frozen bearing.

3. A finite element model of a continuous welded girder with a refined mesh near a bearing, for studying effects of frozen bearings (see Figure 86).
4. A two-dimensional model of a simple truss, for studying effects of material loss and frozen bearings (see Figure 87).
