NCHRP

REPORT 467

Performance Testing for Modular Bridge Joint Systems

Under NCHRP Project 10-52, the University of Minnesota developed performance requirements for modular bridge joint systems and developed test methods and test equipment for the prequalification and acceptance of such systems to meet these requirements. In addition, critical issues relating to design, fabrication, installation, and construction inspection were identified to ensure that these requirements provide a suitable service life. This report provides full details of the research methods. Recommended performance test specifications; materials, fabrication, and construction guidelines; and an anchorage design example are included in appendixes. Many of the guidelines are also applicable to strip seals.

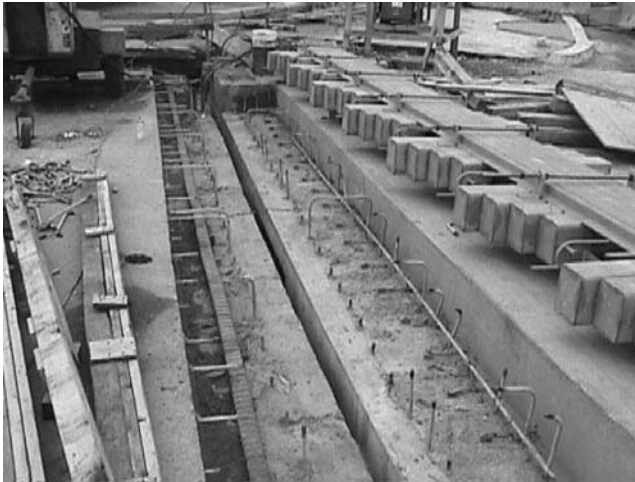
Figure 2.6. Reinforcement steel cut to allow MBJS placement, St. Paul, MN.

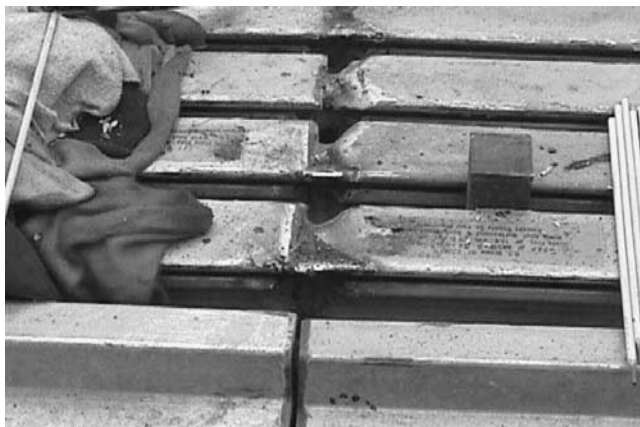
Figure 2.8. Partial field splice of centerbeams.

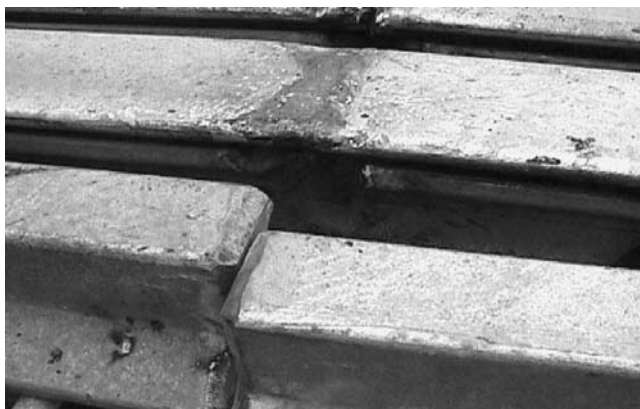
Figure 2.9. Complete field splice of centerbeams and mismatch of edgebeam.

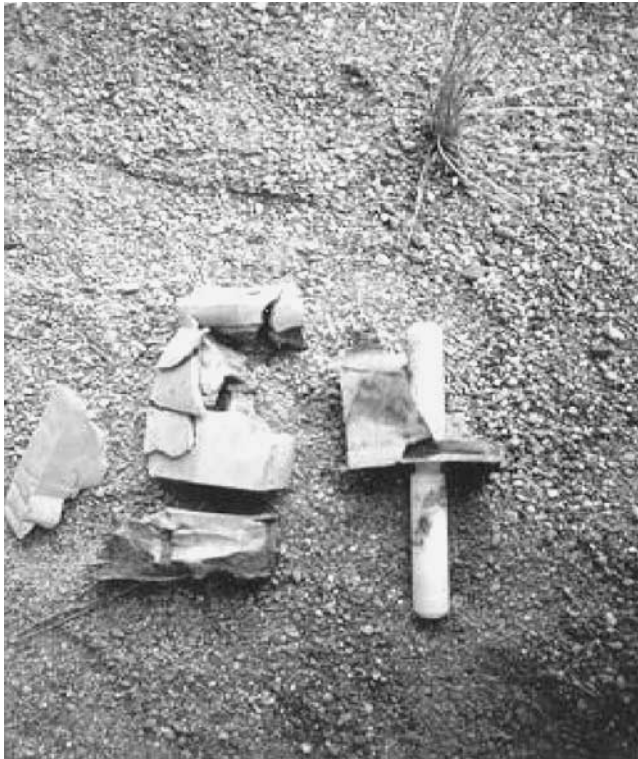
Figure 2.12. Broken elastomeric control spring in Umatilla, OR.

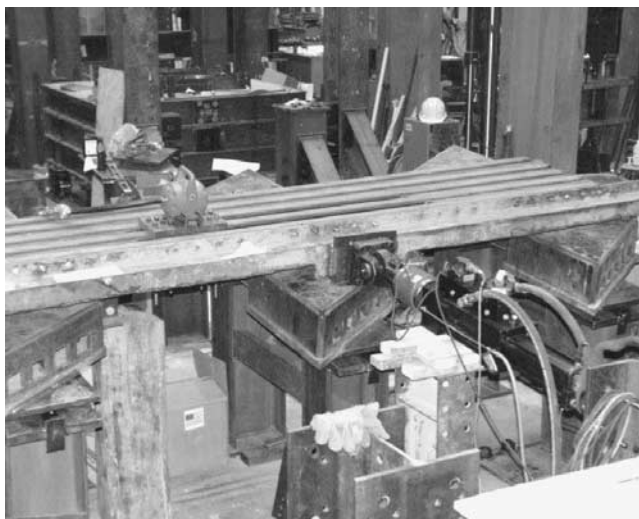
Figure 2.21. No skew OMV test set up for Specimen 1.

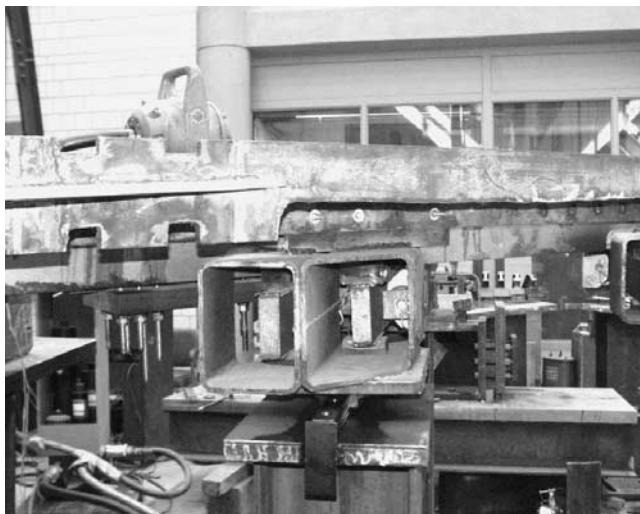
Figure 2.24. Linear bearing placement in relation to stand and Specimen 5.

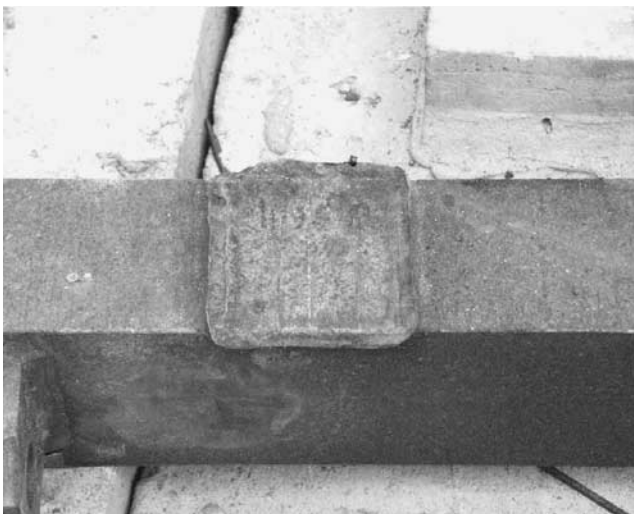
Figure 2.35. Fatigue weld failure of centerbeam/support bar connection.

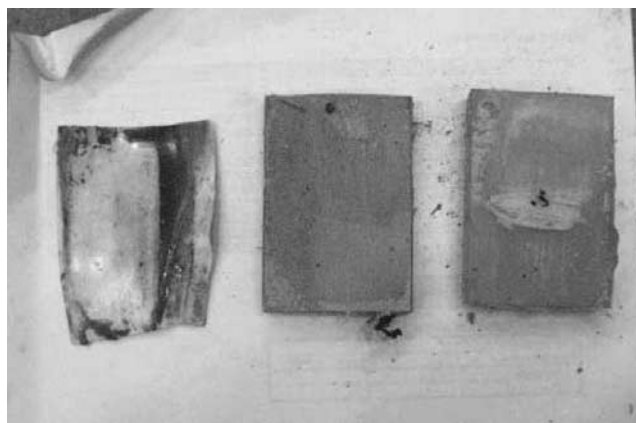
Figure 2.38. First failed support bar bearing.

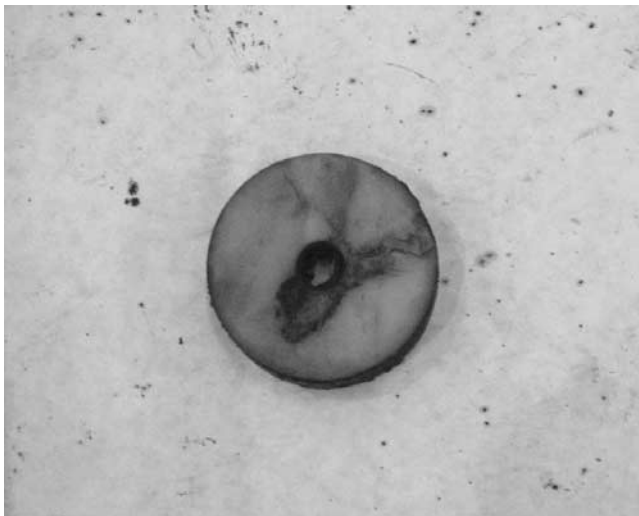
Figure 2.43. Failed support bar bearing.

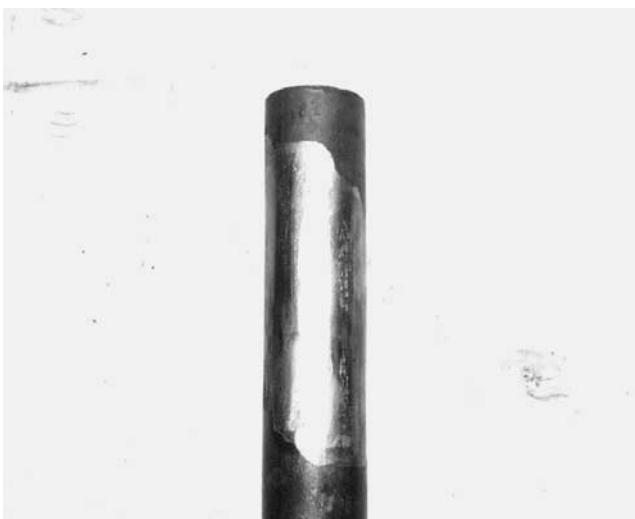
Figure 2.47. Wear on equidistant control spring keeper rod.

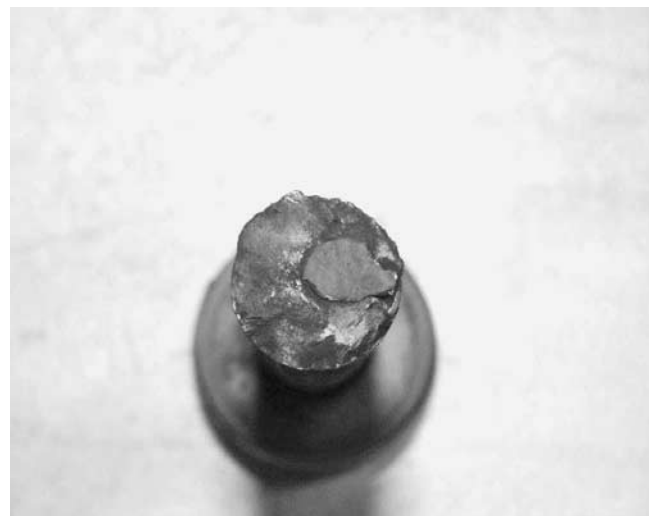
Figure 2.48. Weld failure of equidistant control spring keeper rod.

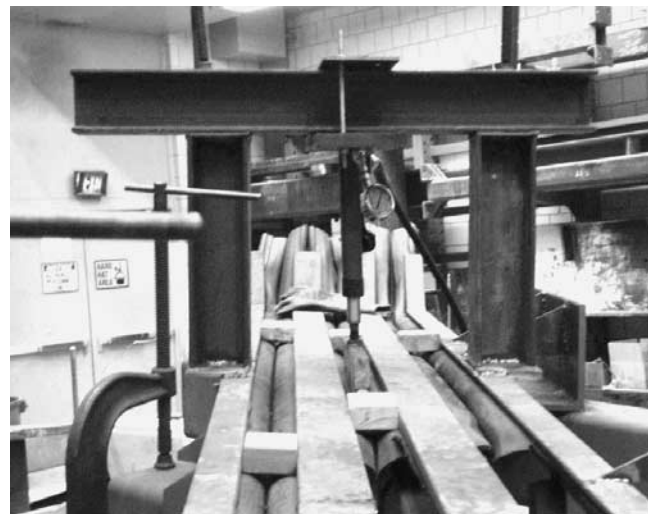
Figure 2.56. Seal Push Out Test set up.
