**APPENDIX C**

**RECTANGULAR BEAM SUMMARIES—STRAND D**

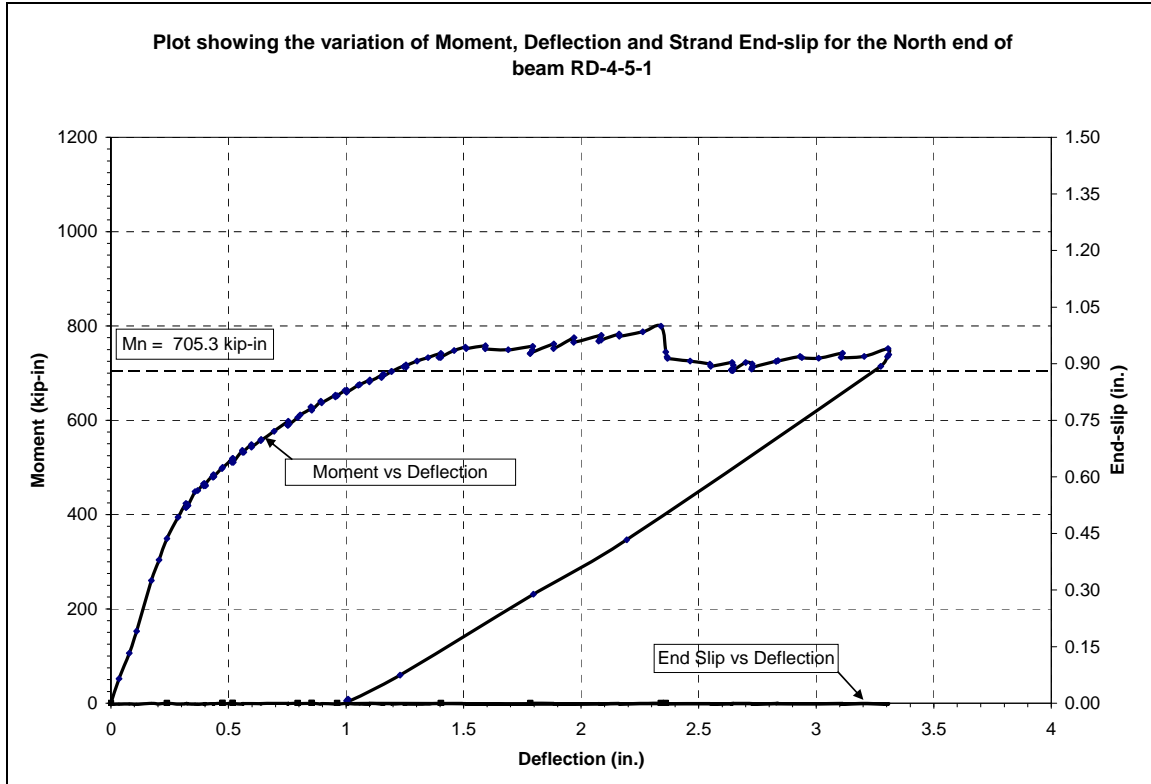
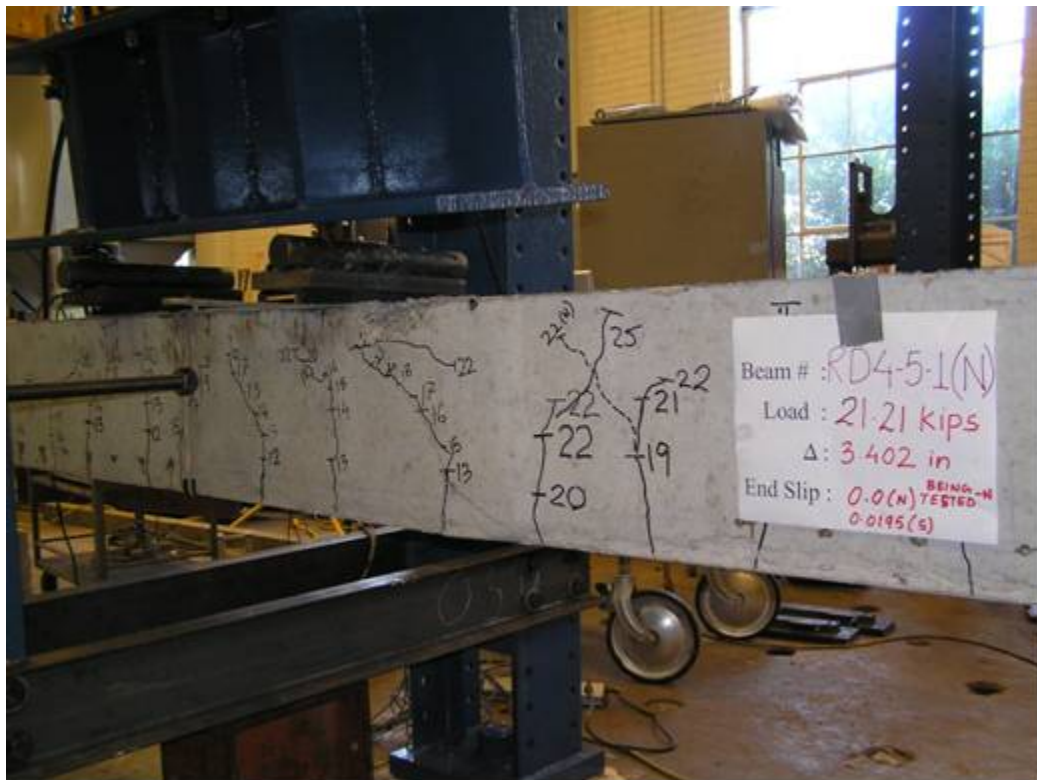
Cracking pattern included 9 cracks in the middle 60 in. span with average crack spacing of 7.5 in. No inclined flexural crack was noticed.

Cracking pattern for Beam RD-4-5-1 being loaded at North end.

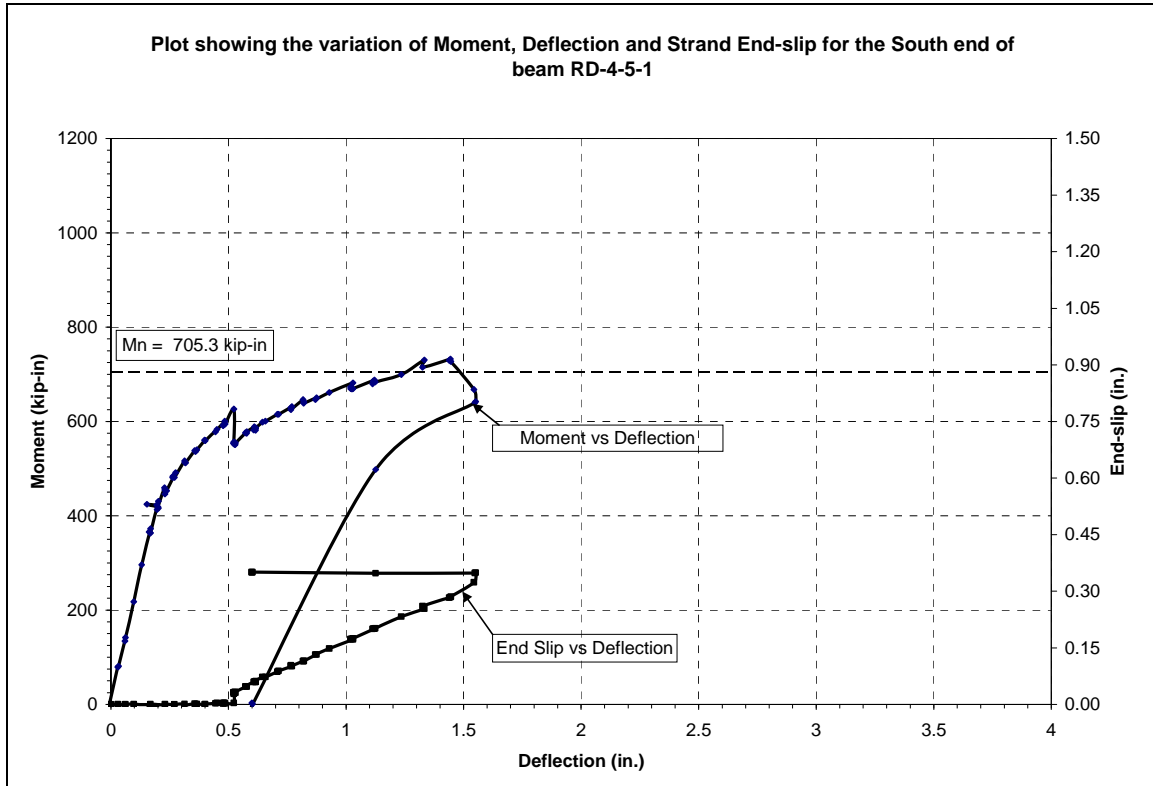
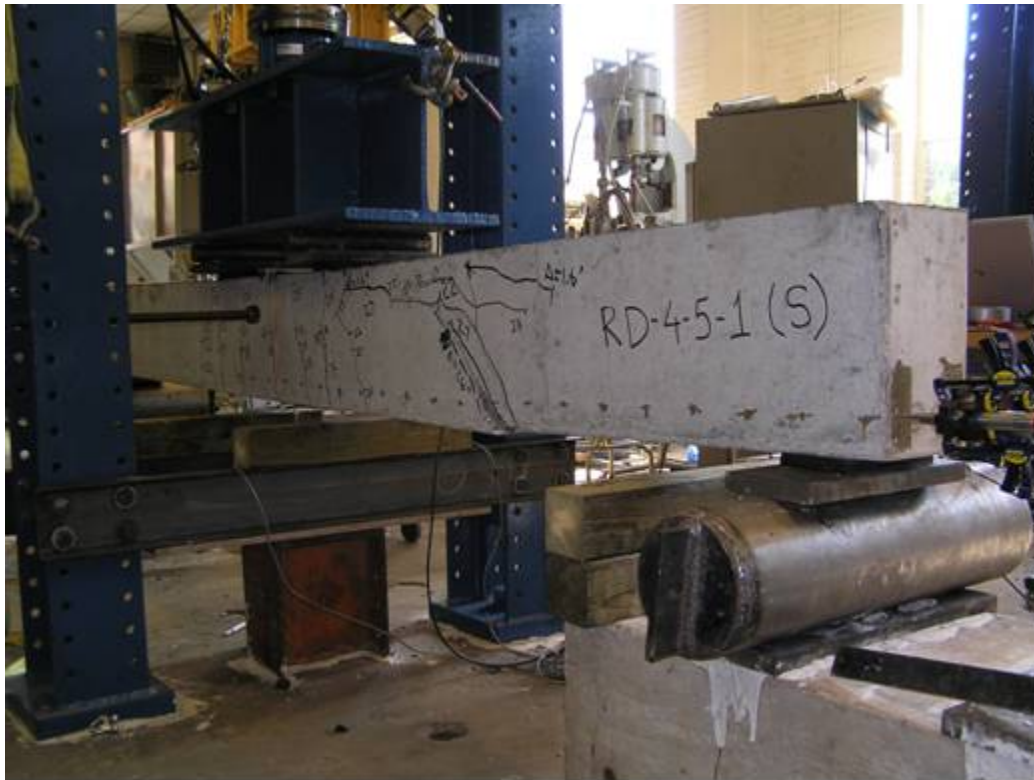
Crack pattern shows 7 flexural cracks in the middle 40 in. span with average crack spacing of 6.7 in. An inclined flexural crack was observed rising from Stn. 29 and Stn 32 and joining at approx. 3 in. from bottom to form a single crack.

**Photo Showing cracking pattern for Beam RD-45-1 being loaded at South end.**

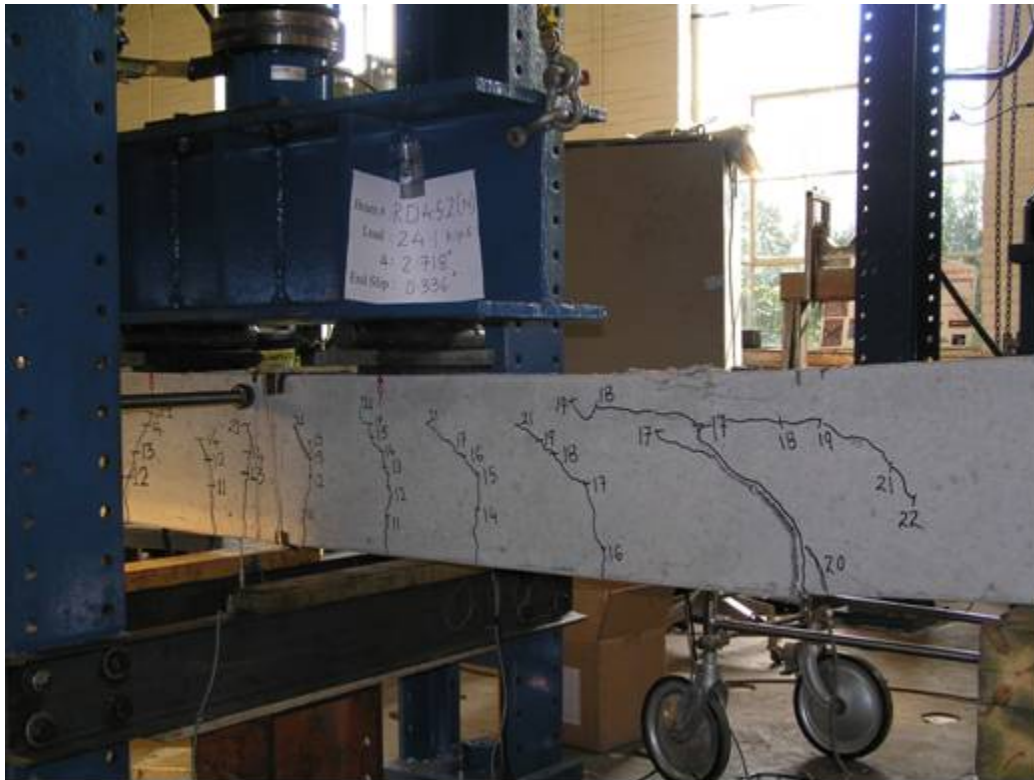
Cracking pattern included 9 flexural cracks in middle 59 in. span with average crack spacing of 7.4 in. An inclined flexural crack was noticed rising from Stn. 42 which later bifurcated (approx. 3 in. from the bottom) to Stn. 33.

**Cracking pattern for Beam RD-4-5-1 being loaded at North end.**

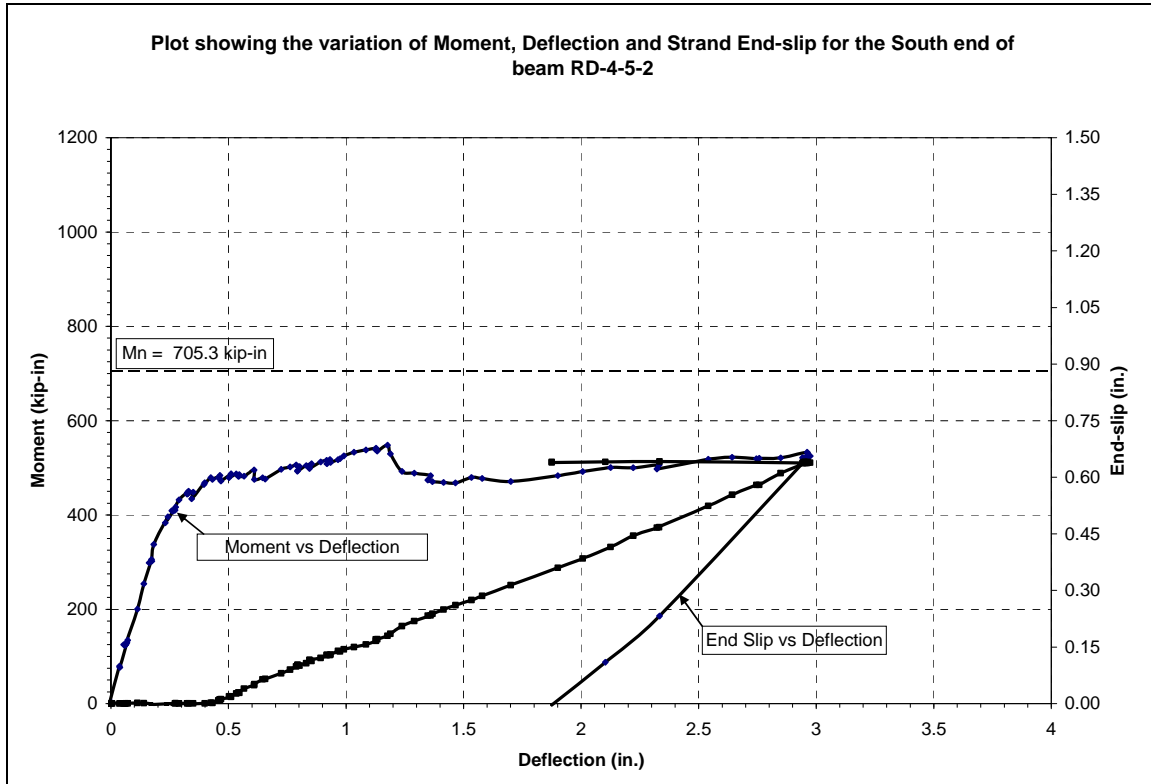
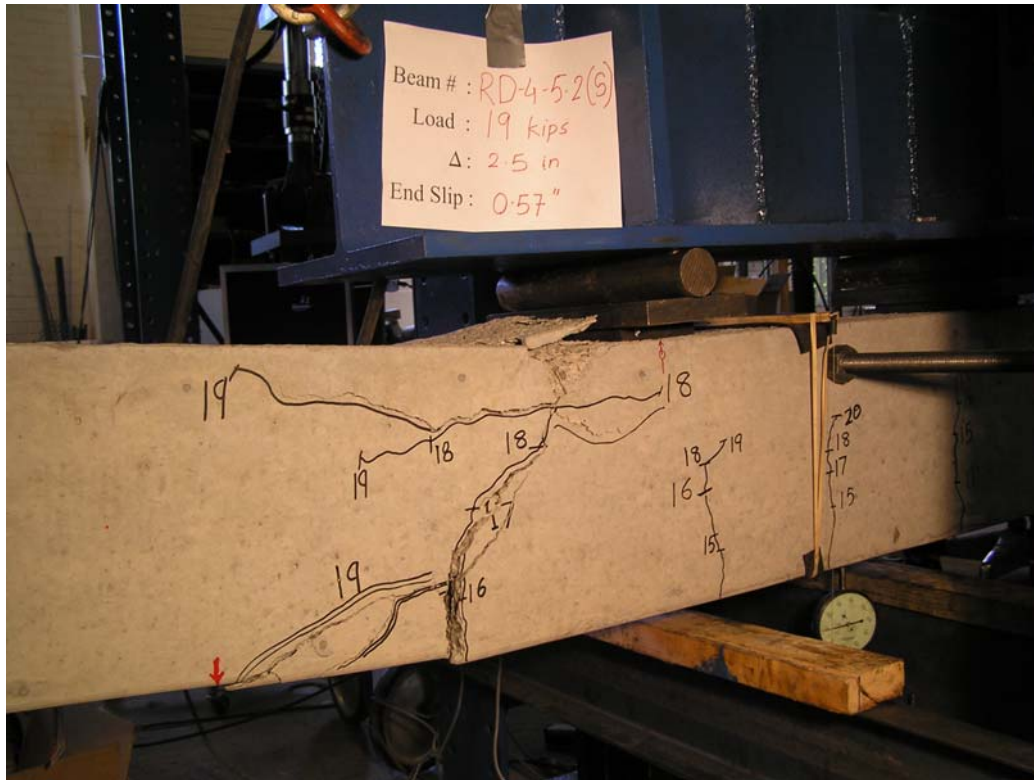
There were 7 cracks in the middle 58 in. span with average crack spacing of 9.7 in. An inclined flexural crack was noticed at Stn. 47 which later bifurcated (approx. 4 in from the bottom) to Stn. 38.

**Cracking pattern for Beam RD-4-5-2 being loaded at South end**

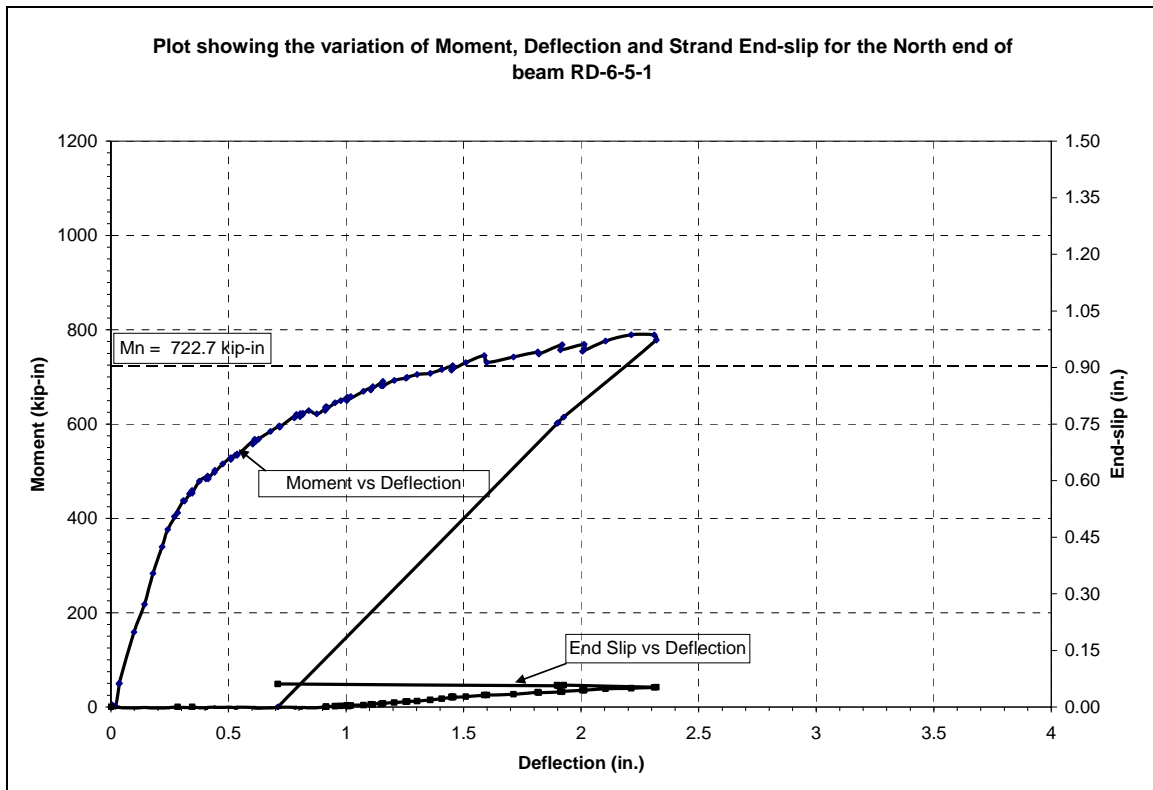
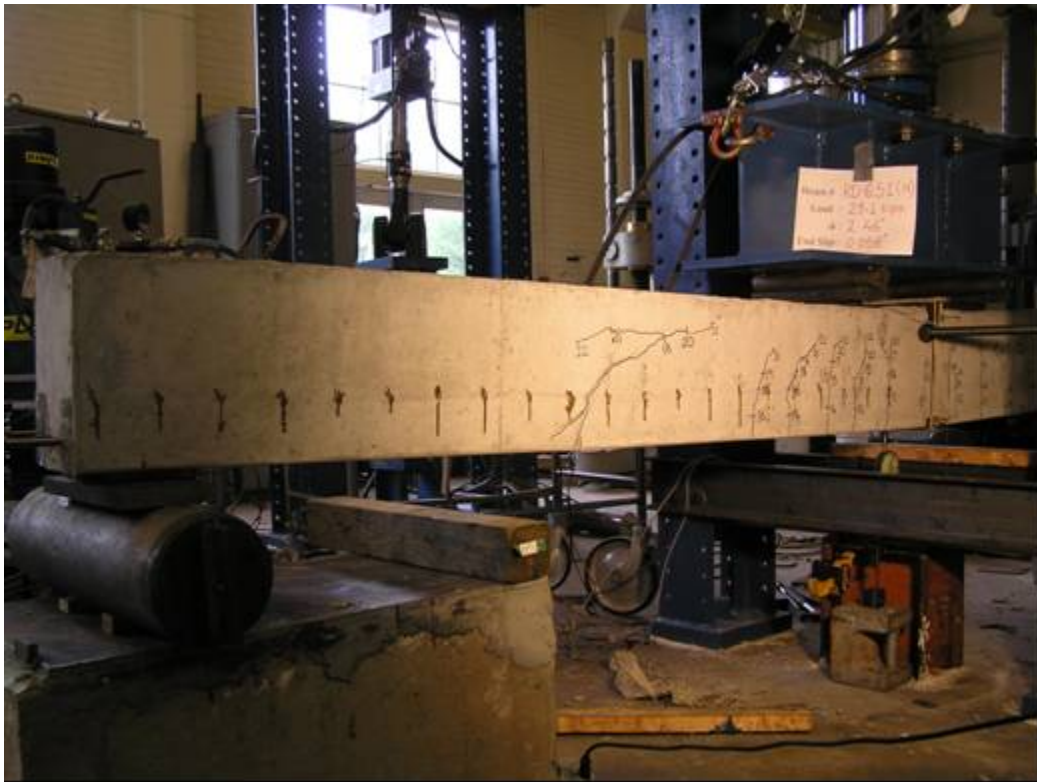
Cracking pattern included 11 cracks in the middle 59 in. span with average crack spacing of 5.9 in. An inclined flexural was noticed at Stn. 38

**Cracking pattern for Beam RD-6-5-1 being loaded at North end.**

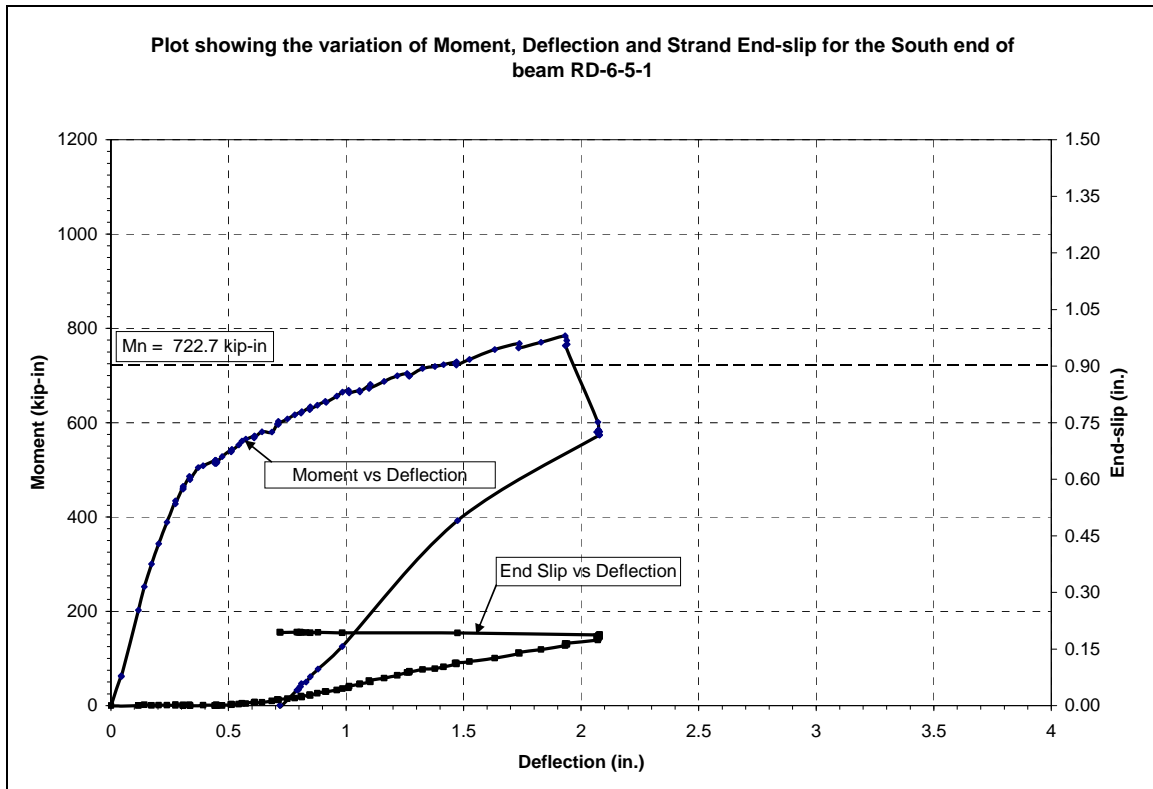
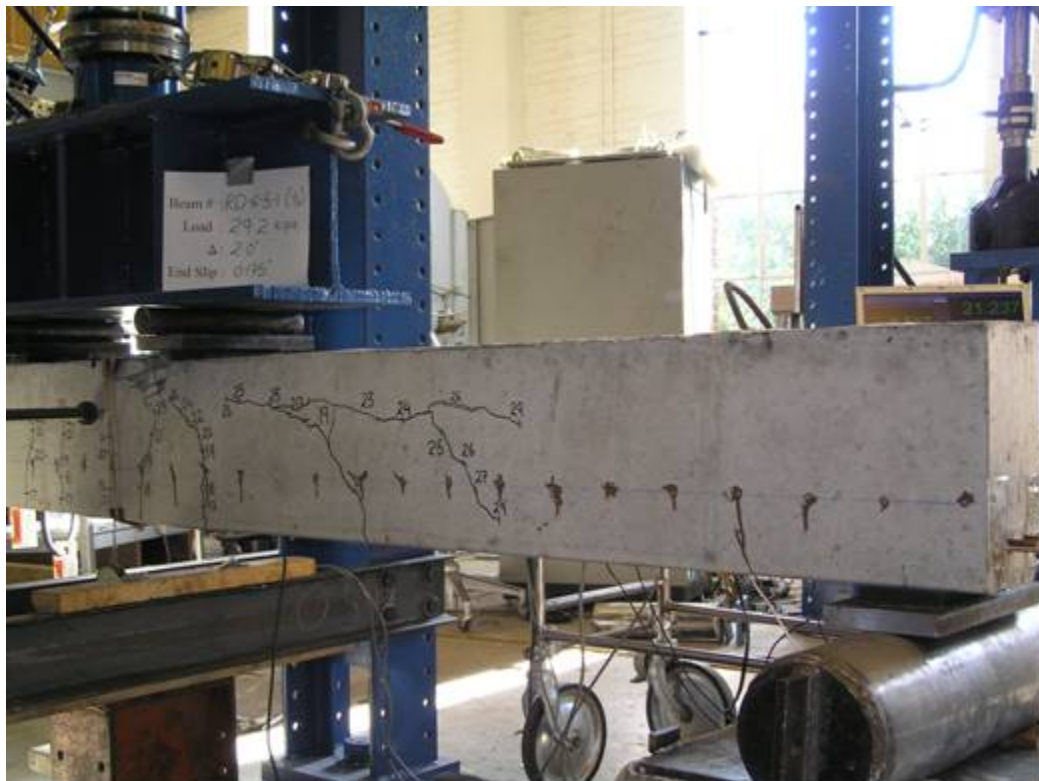
Cracking pattern shows 5 cracks in the middle 25 in. span with average crack spacing of 6.3 in. An inclined flexural crack was observed at Stn. 41. This crack went on to form a crack similar to another inclined flexural crack which did not reach the bottom surface. Distance between these two similar cracks was 16.5 in.

**Cracking pattern for Beam RD-6-5-1 being loaded at South end.**

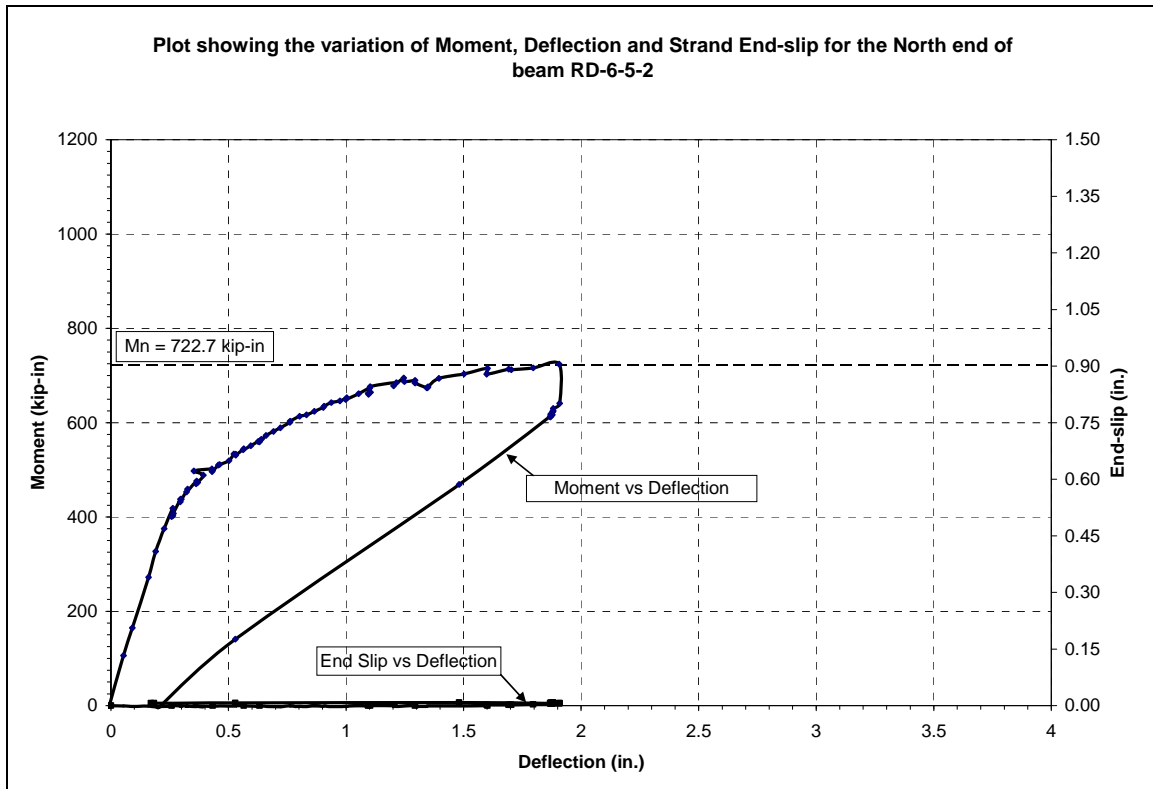
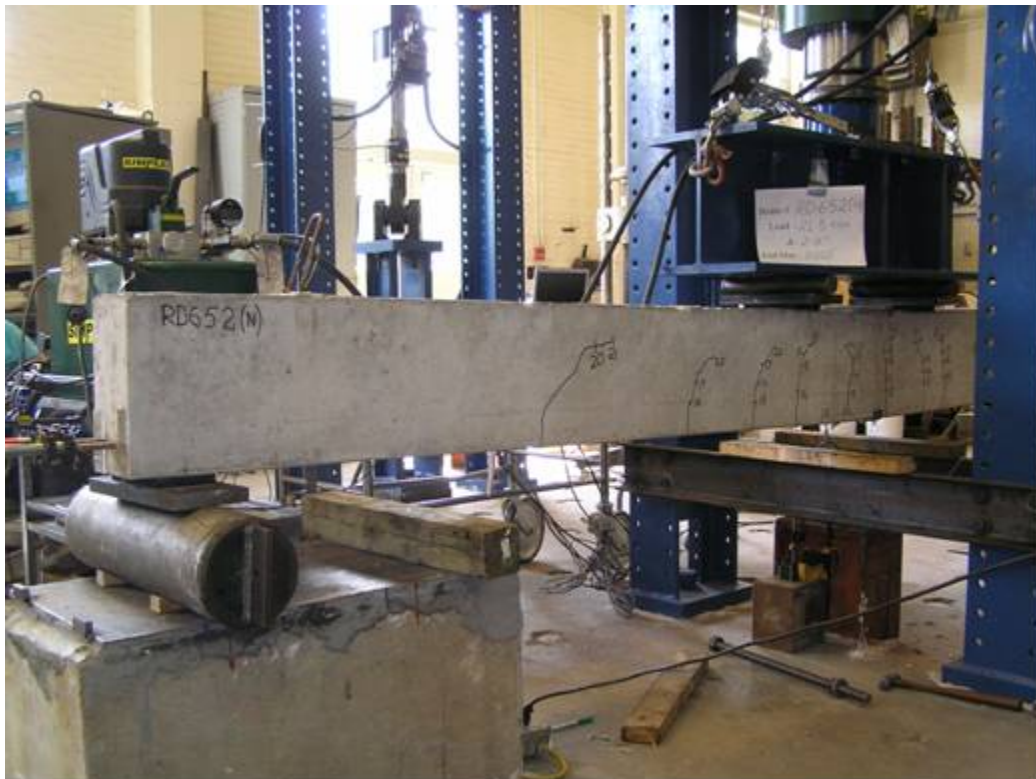
Cracking pattern included 8 cracks in the middle 56 in. span with average crack spacing of 8 in. Also an inclined flexural crack was noticed at Stn. 36.

**Cracking pattern for Beam RD-6-5-2 being loaded at North end.**

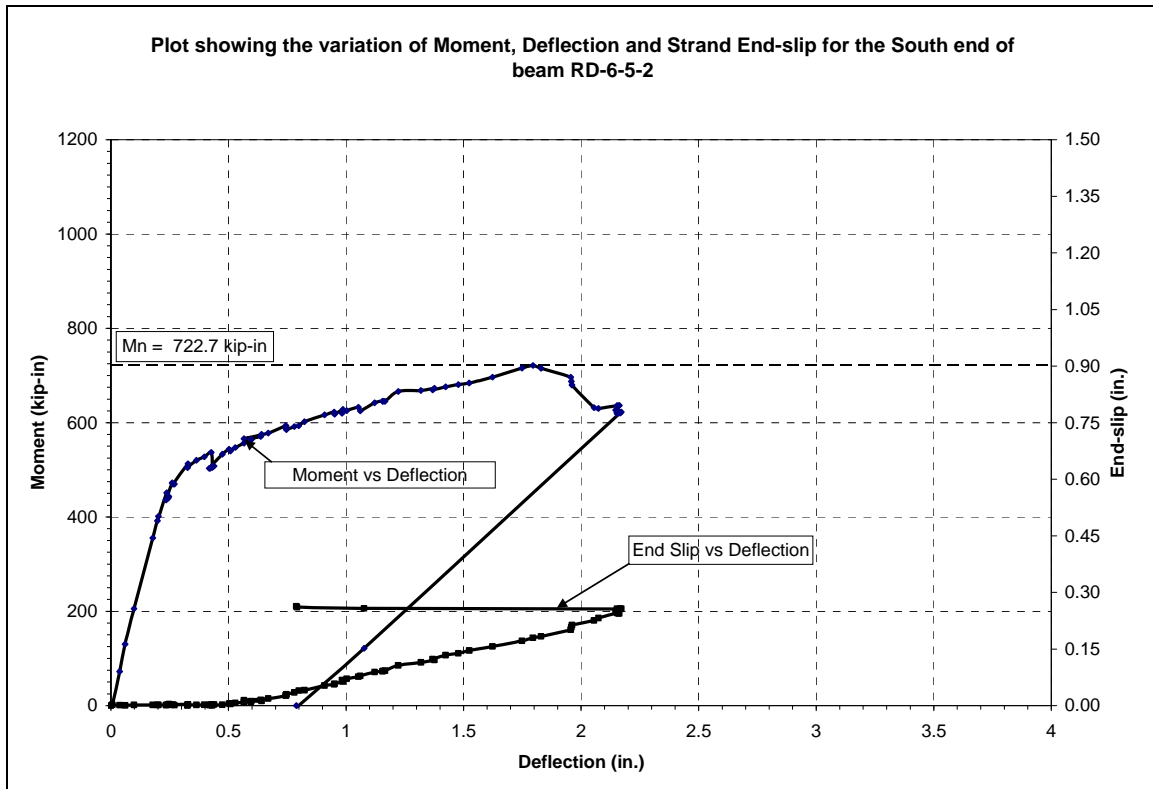
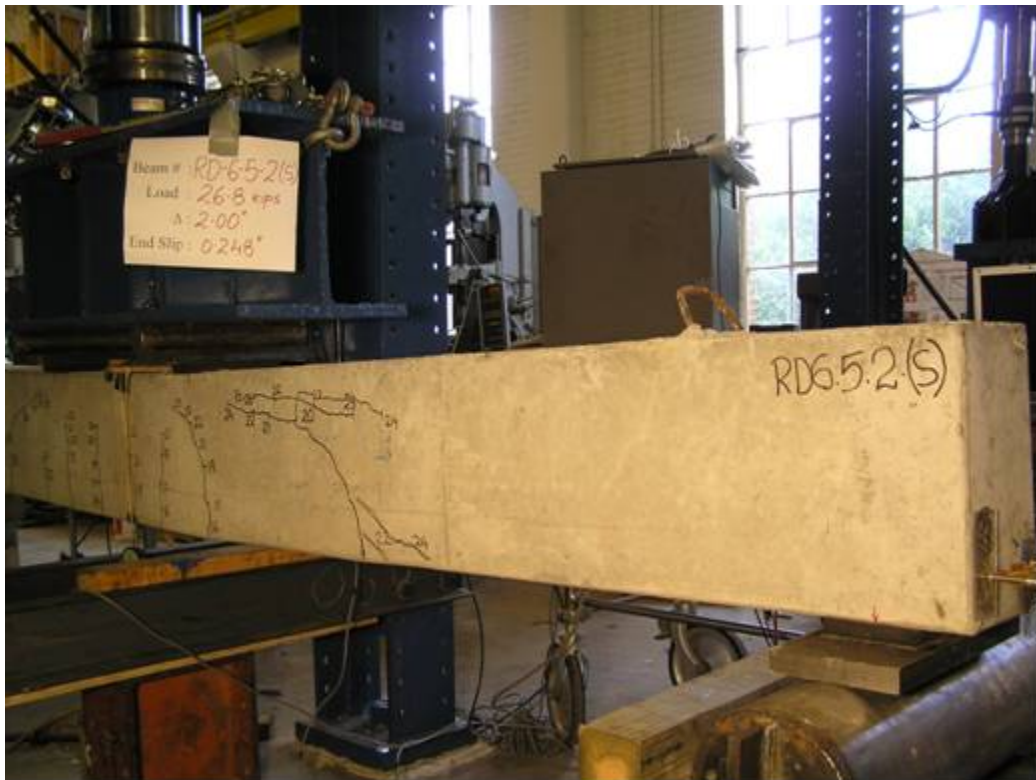
Cracking pattern included 7 cracks in the middle 38 in. span with average crack spacing of 6.3 in. Also an inclined flexural crack was noticed at Stn. 38.

**Cracking pattern for Beam RD-6-5-2 being loaded at South end.**

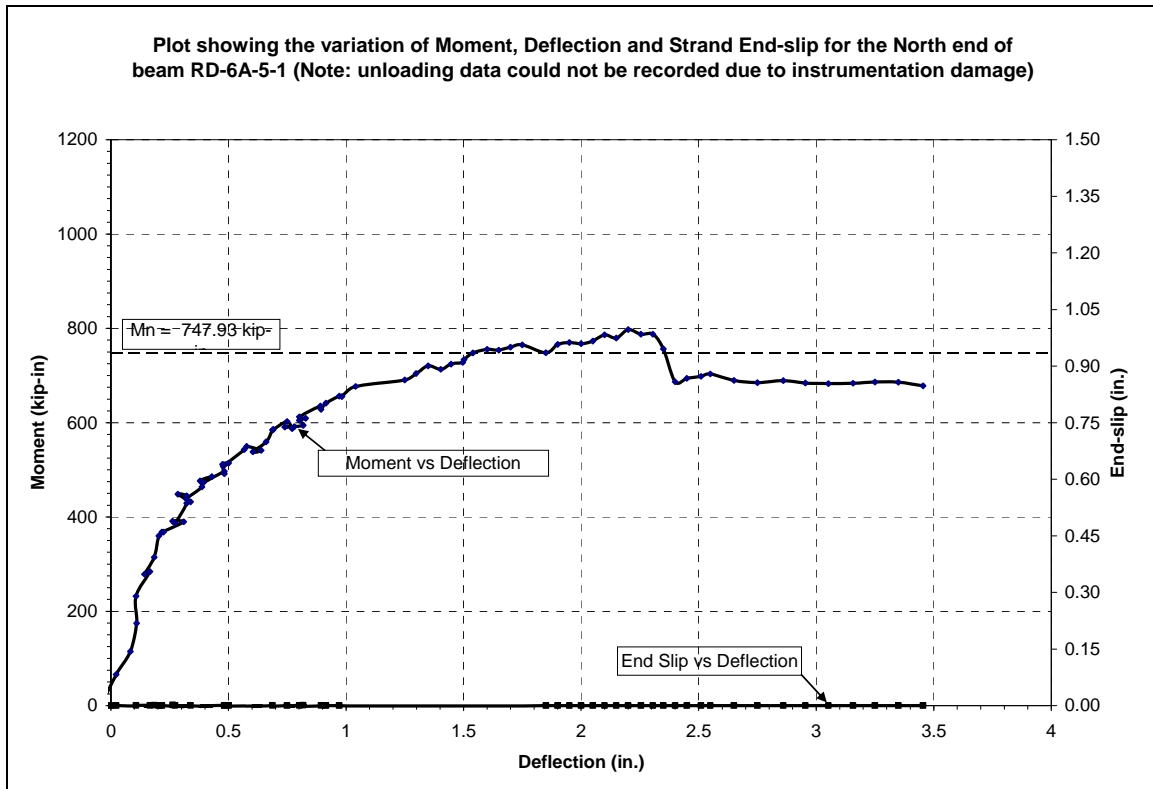
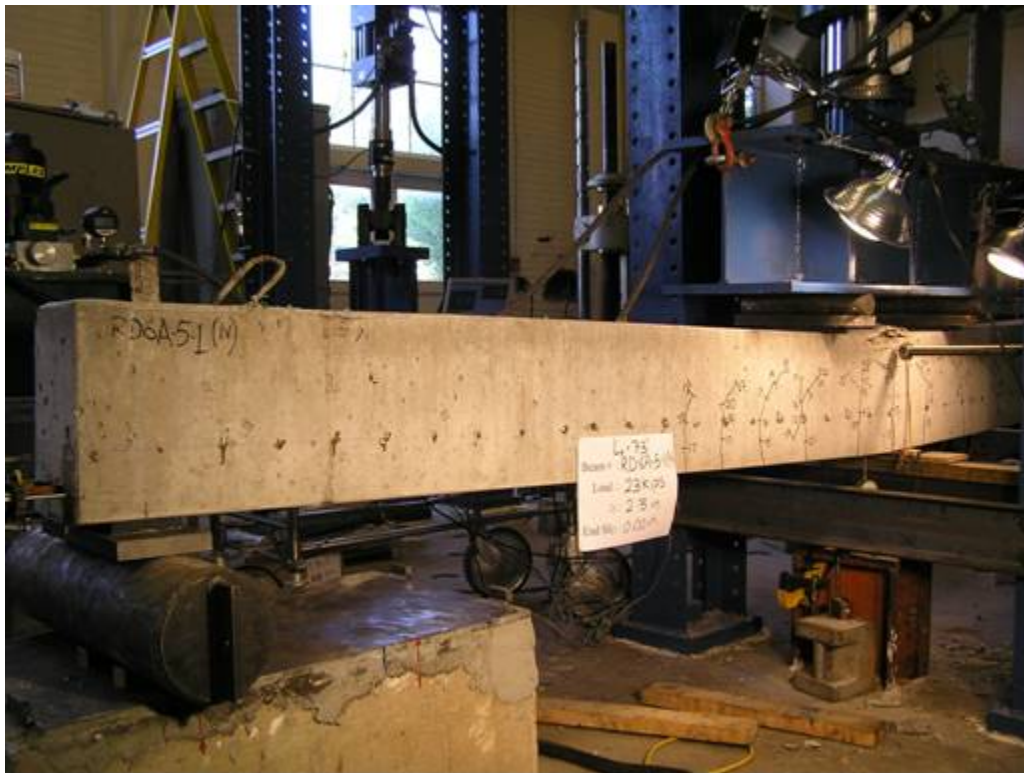
End-slip readings at both ends were 0.00 throughout loading and unloading of the beam. Cracking pattern included 10 cracks in the middle 66 in span with average crack spacing of 6.6 in. First flexural crack was at 51 in from the North end.

**Cracking pattern for Beam RD-6A-5-1 being loaded at North end.**

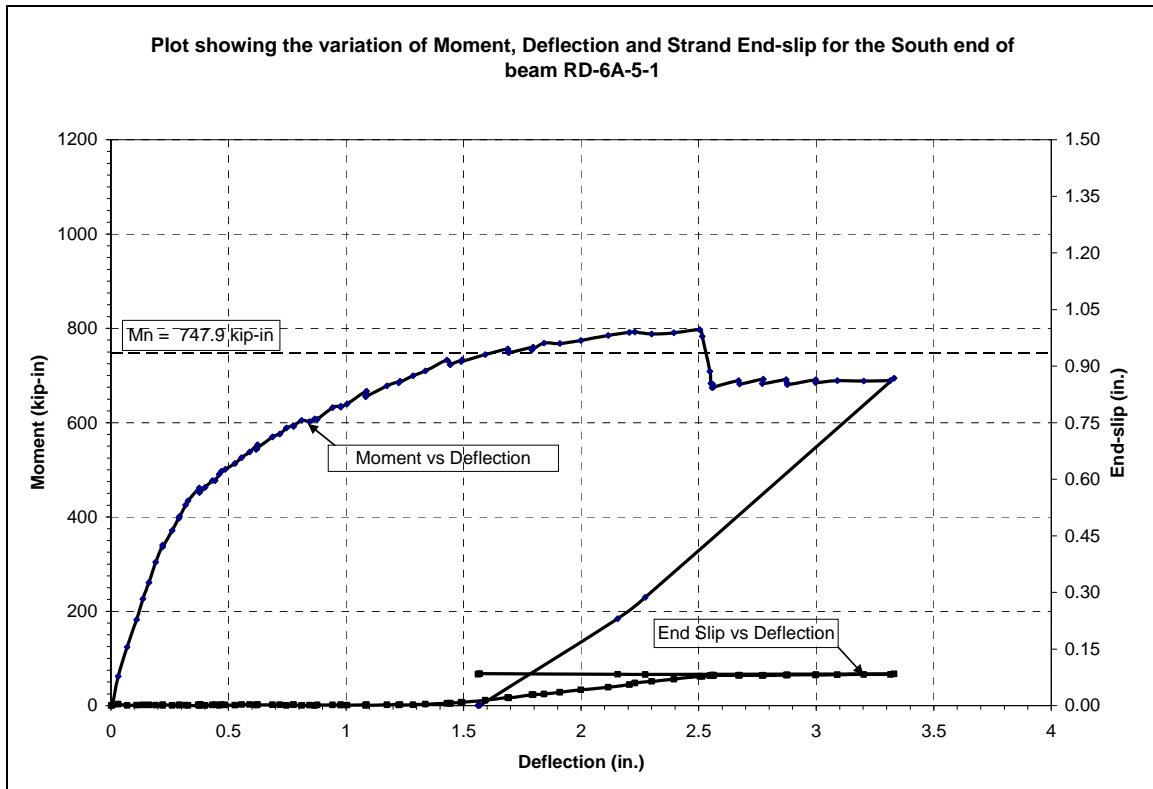
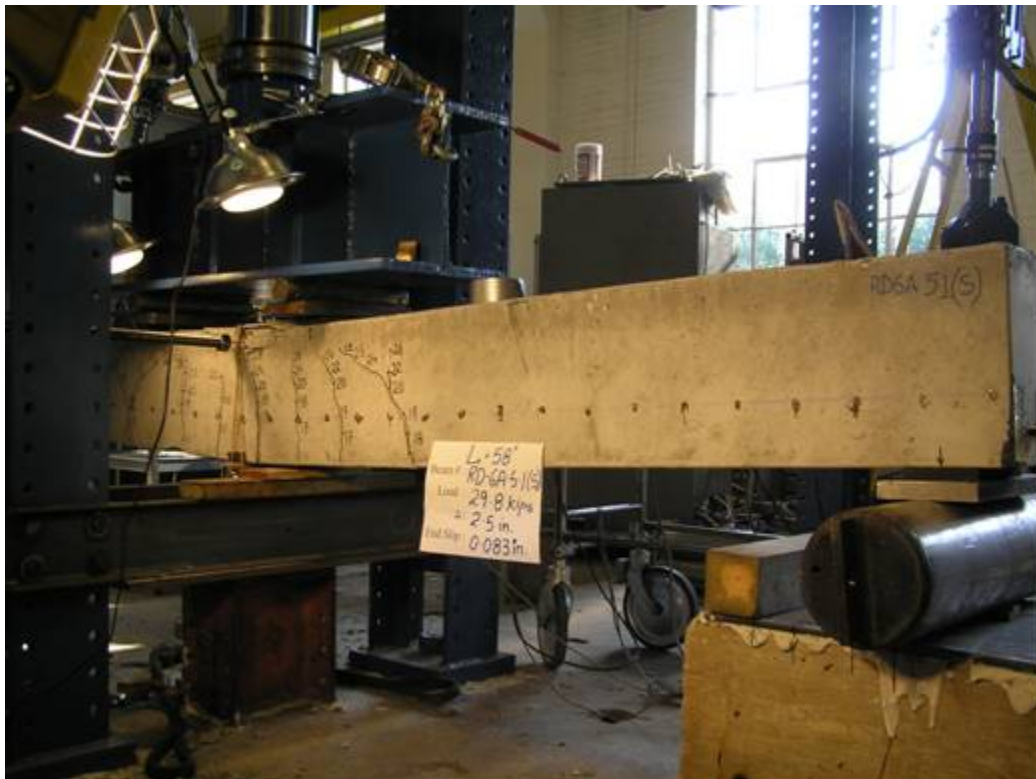
Pattern of cracks demonstrates 8 cracks in the middle 51 in. span with average spacing = 6.4 in. First flexural crack was seen at 45 in. from the South end. No inclined flexural crack was noticed. Crack width of the central crack was  $3/8^{\text{th}}$  in. while width of the outermost cracks =  $1/4$  in each.

**Cracking pattern for Beam RD-6A-5-1 being loaded at South end.**

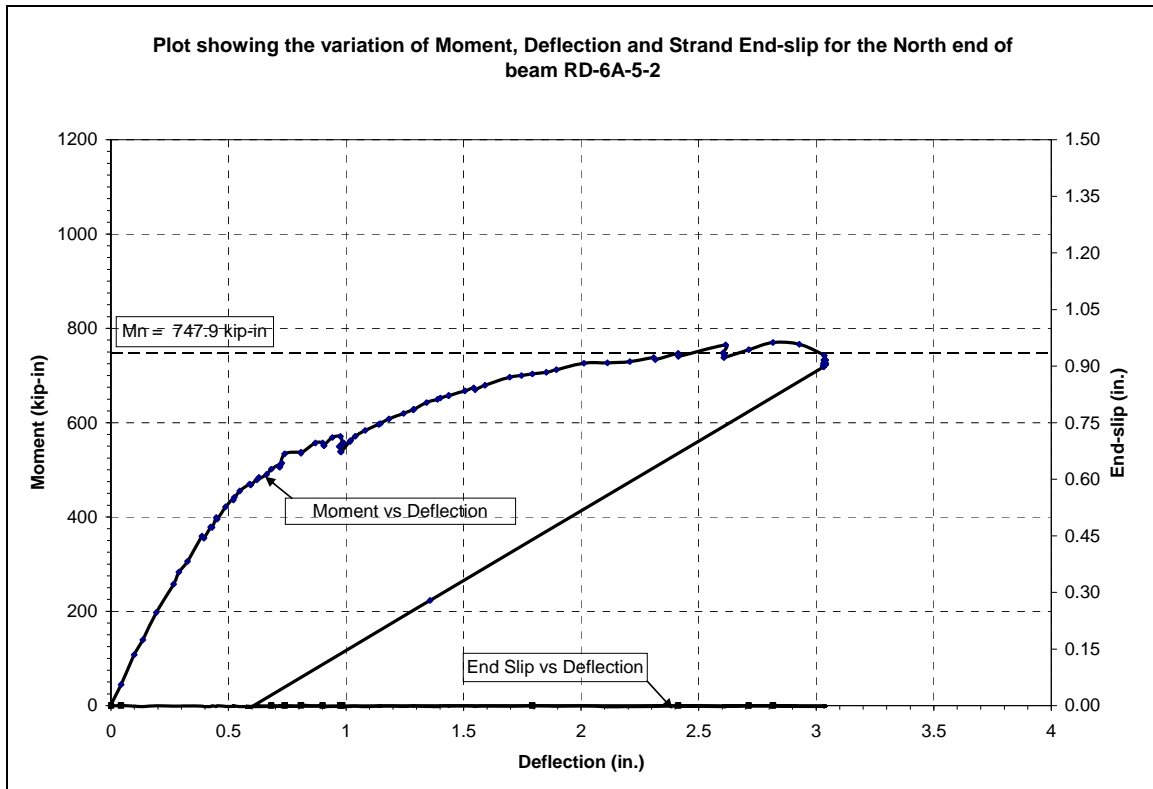
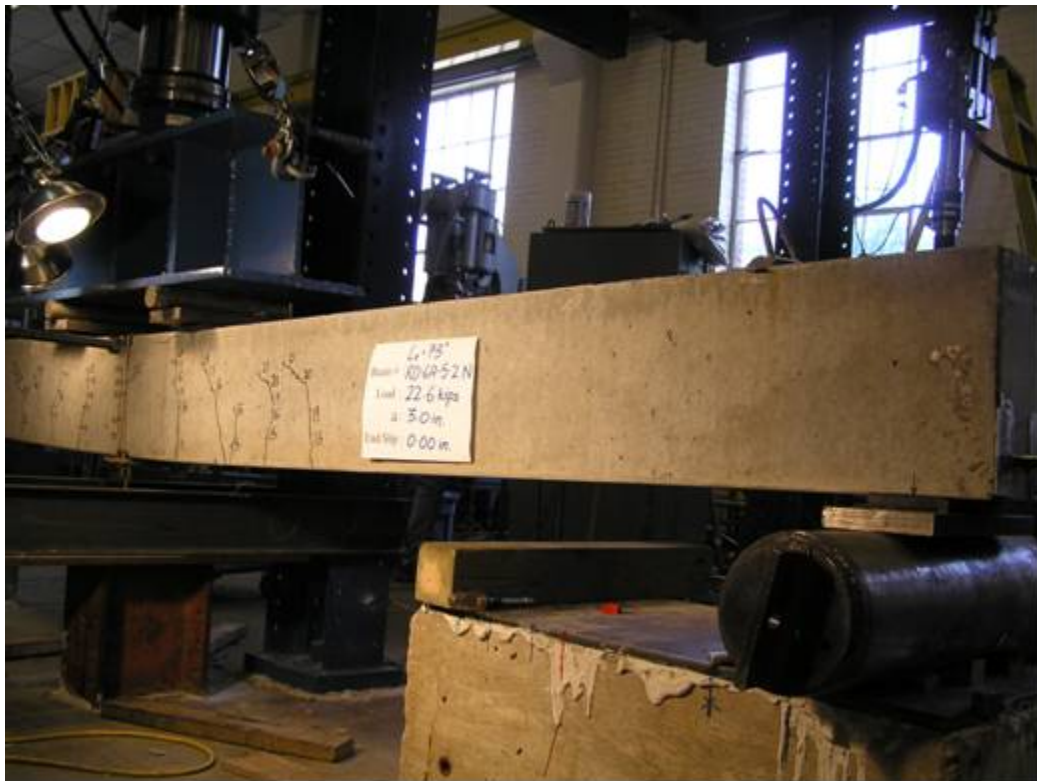
Cracking pattern included 8 cracks in the middle 52 in. span. No inclined flexural crack was noticed in the shear zone. First flexural crack was at Stn. 52 from the North end.

**Cracking pattern for Beam RD-6A-5-2 being loaded at North end**

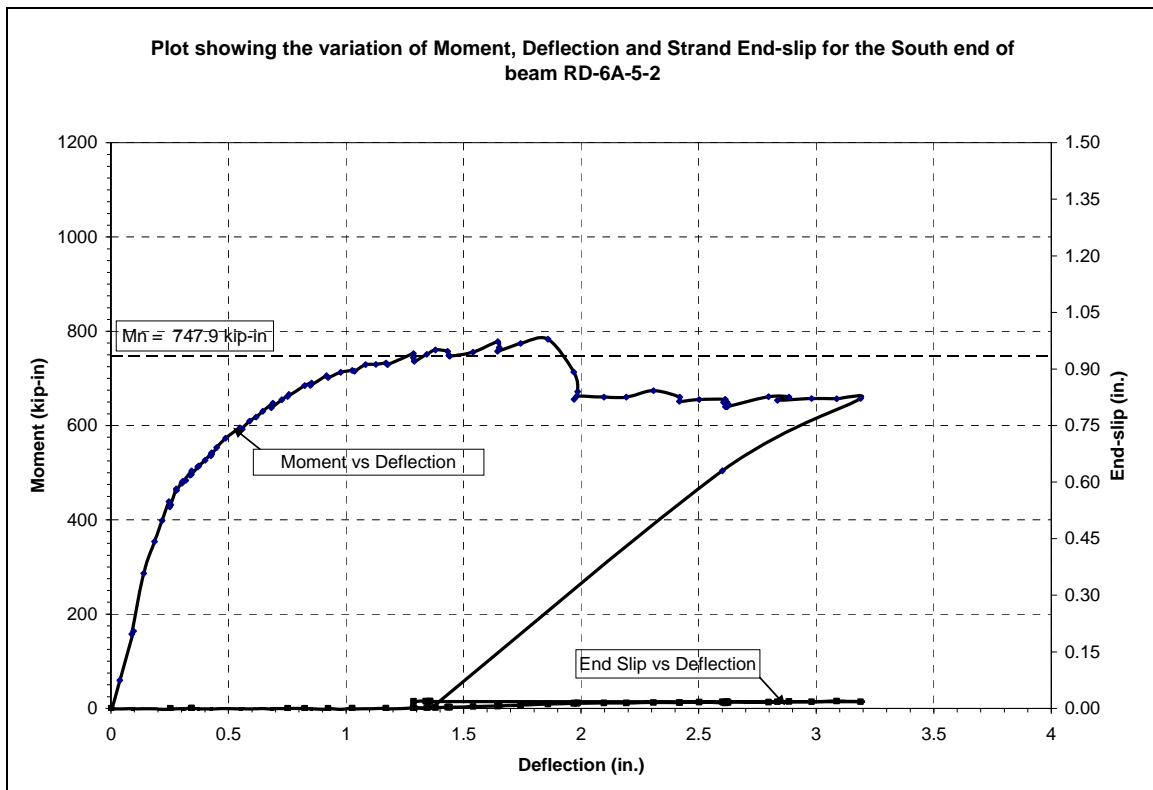
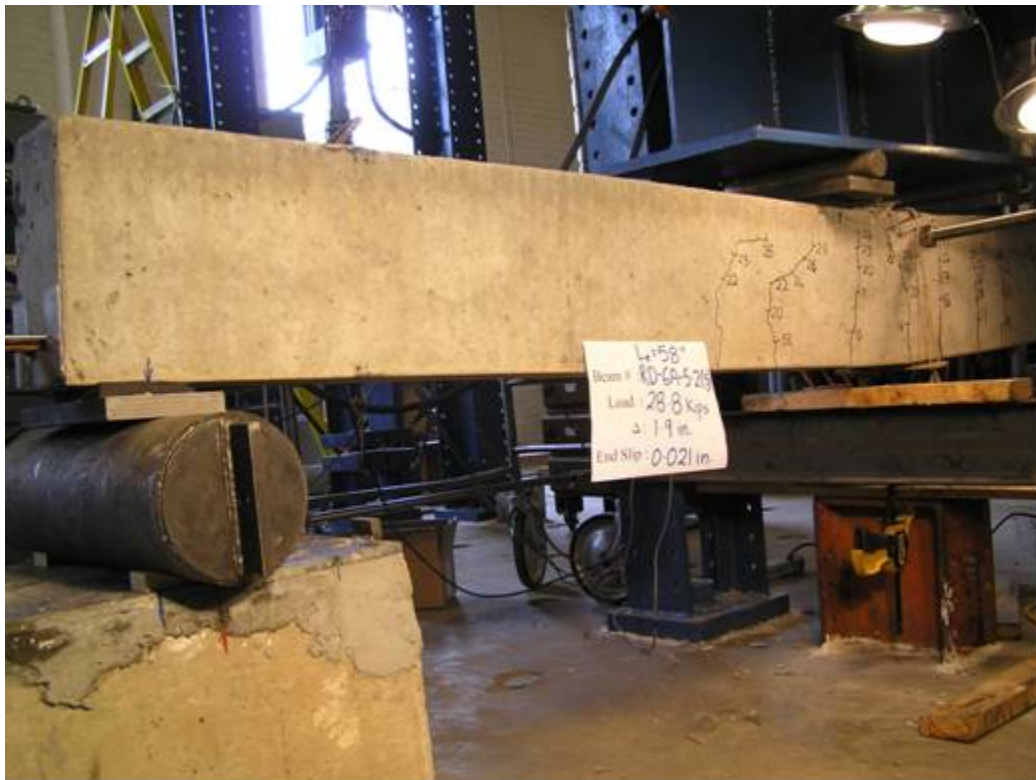
Cracking pattern shows 8 cracks formed in the middle 51 in span with average crack spacing = 6.4 in. No inclined flexural crack was observed in the shear zone. First flexural crack from the South end occurred at Stn. 42.

**Cracking pattern for Beam RD-6A-5-2 being loaded at South end**

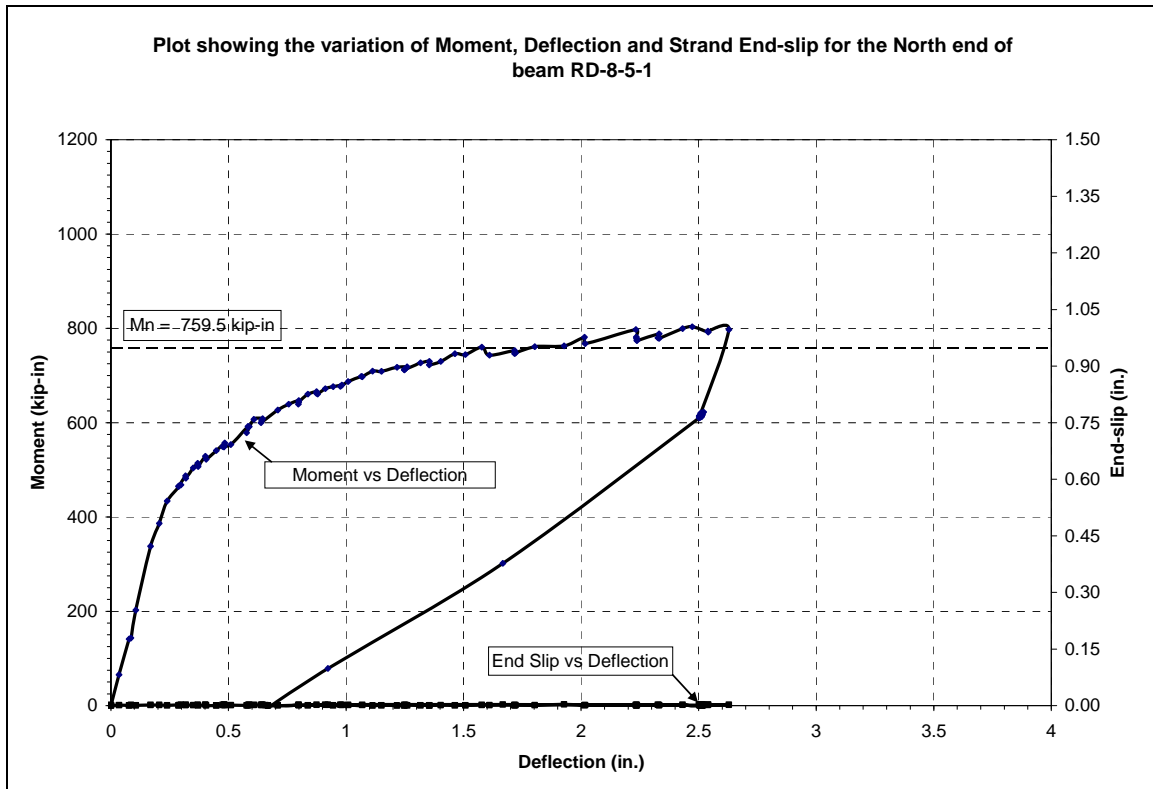
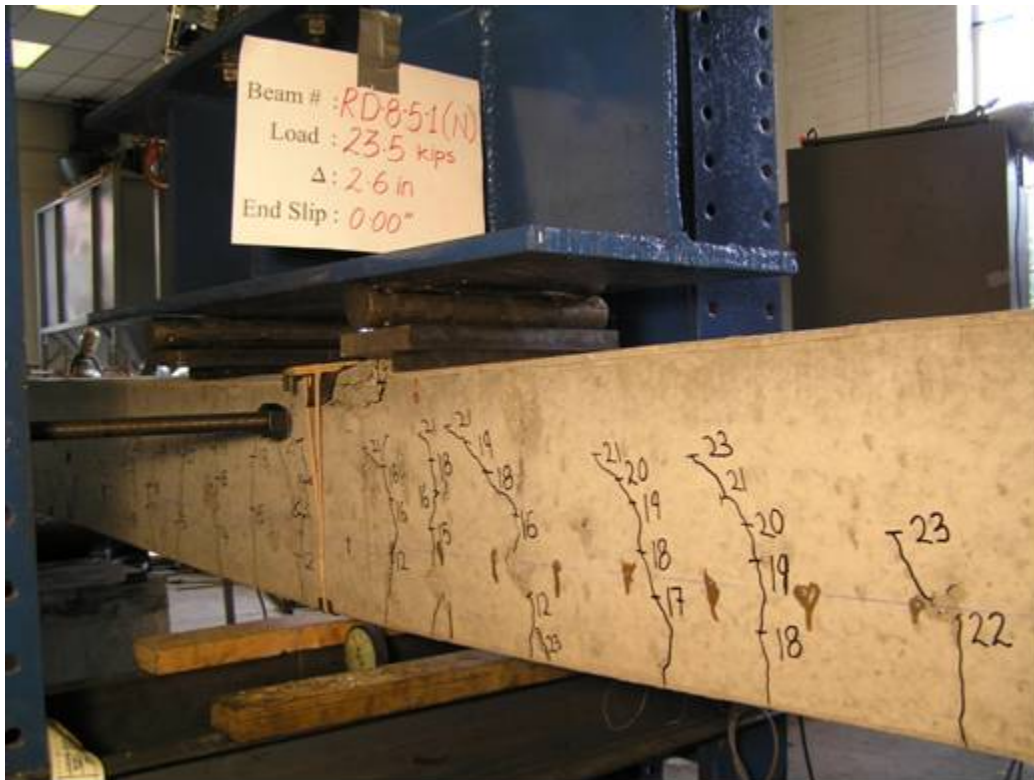
**Cracking pattern for Beam RD-8-5-1 being loaded at North end**
