**APPENDIX C**

**RECTANGULAR BEAM SUMMARIES—STRAND D**

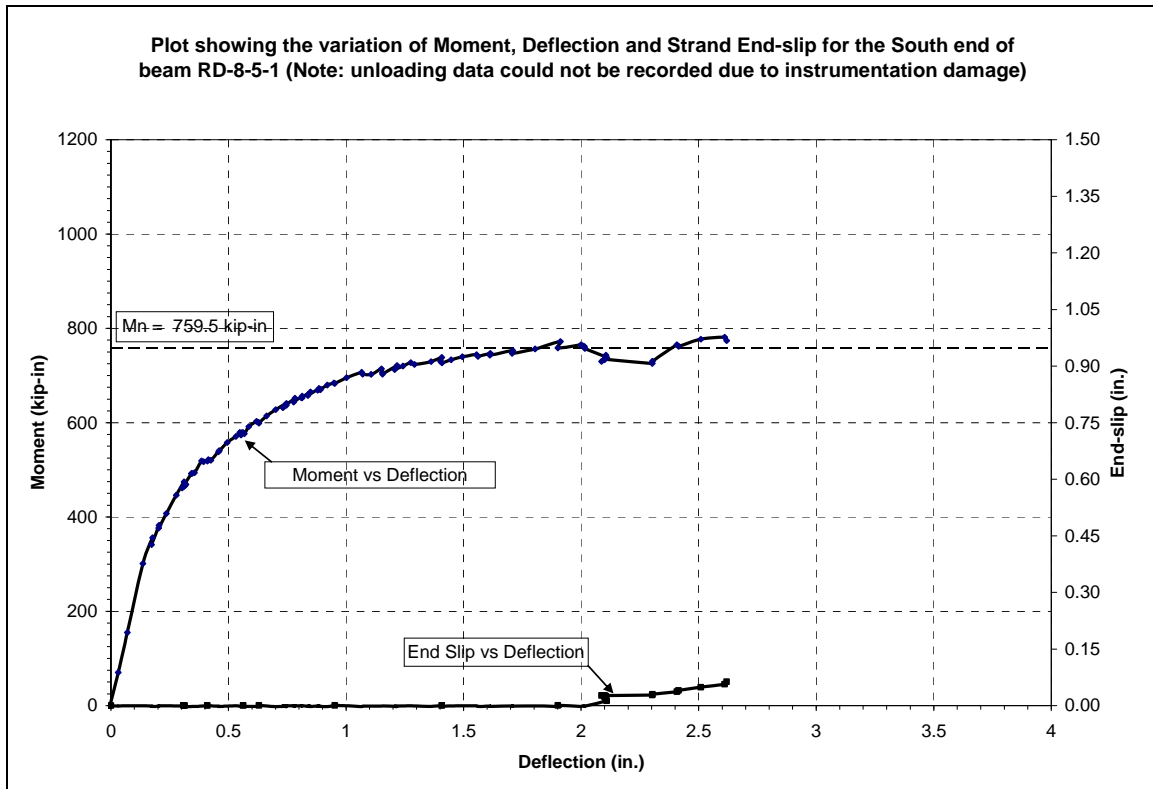
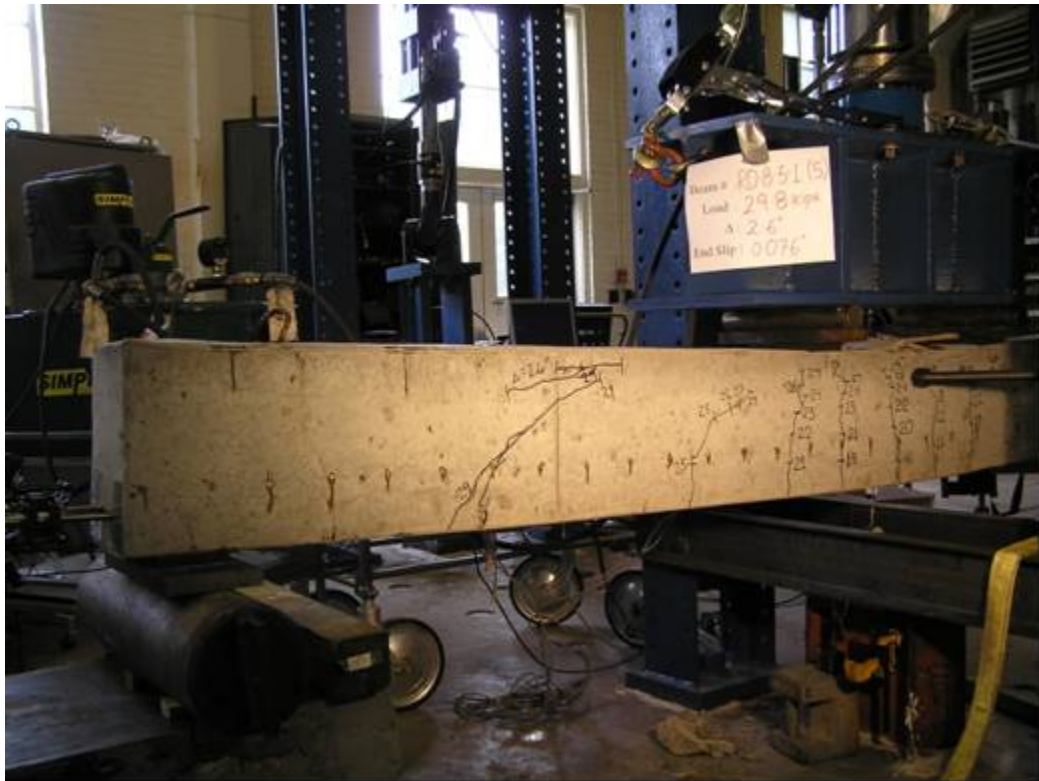
At 29 kips, a large inclined flexural crack was discovered, rising from Stn. 24 and Stn 21 and joining at 3 in. from bottom to form one single crack.

**Cracking pattern for Beam RD-8-5-1 being loaded at South end**

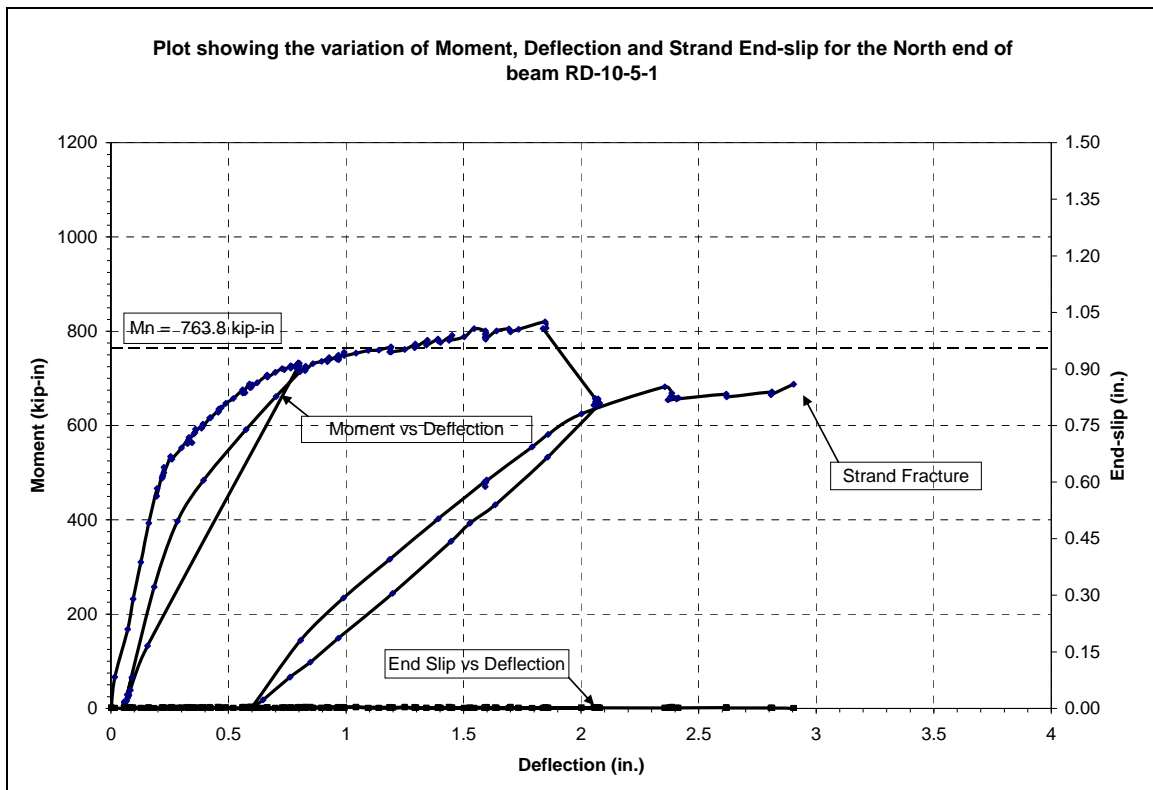
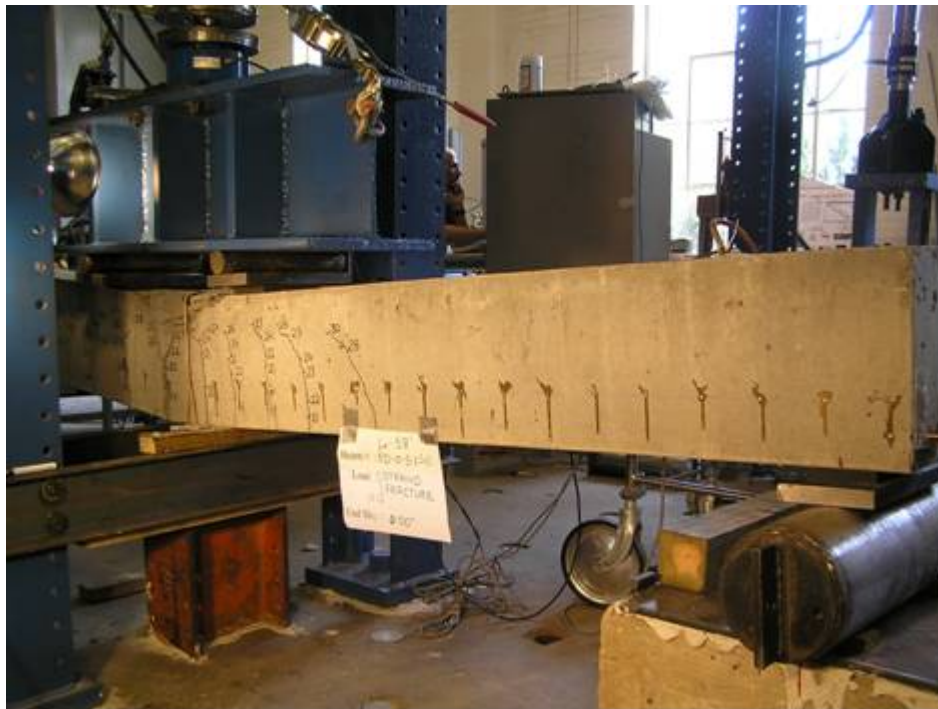
Cracking pattern demonstrated 10 cracks in the middle 58 in. of the beam span with average spacing of cracks 5.8 in.

**Cracking pattern for Beam RD-10-5-1 being loaded at North end**

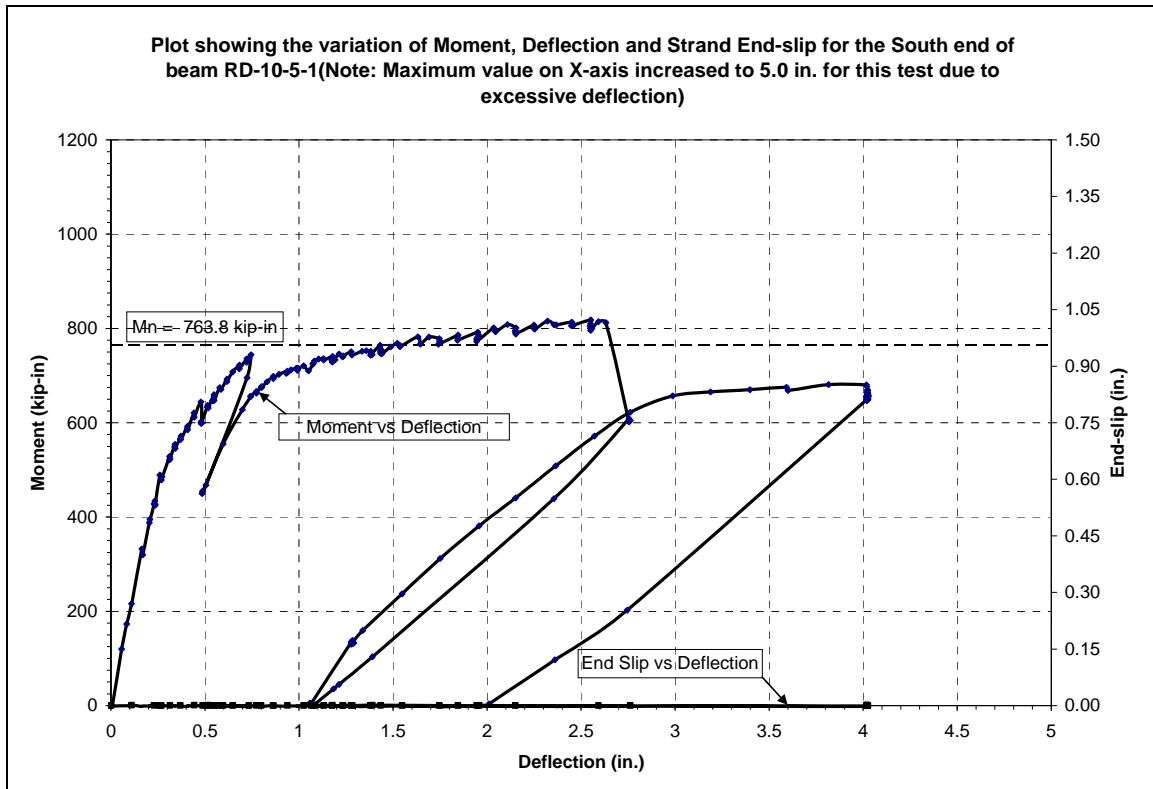
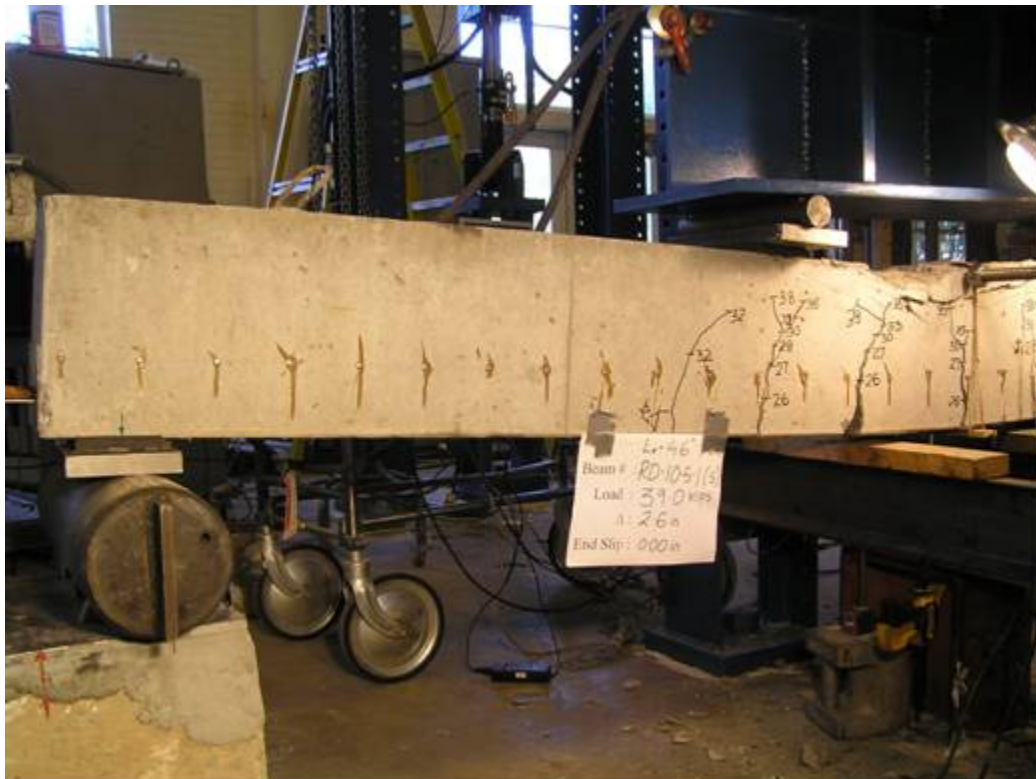
Cracking pattern demonstrated 7 cracks in the middle 48 in. In addition to these flexural cracks, 2 inclined flexural cracks (@ Stn. 8 and Stn. 26) were observed in the shear zone at the North side.

**Cracking pattern for Beam RD-10-5-1 being loaded at South end** **BEAM NAME:**  
**RD-10-5-2**  
**END: NORTH**  
**DATE: 08/02/2005**

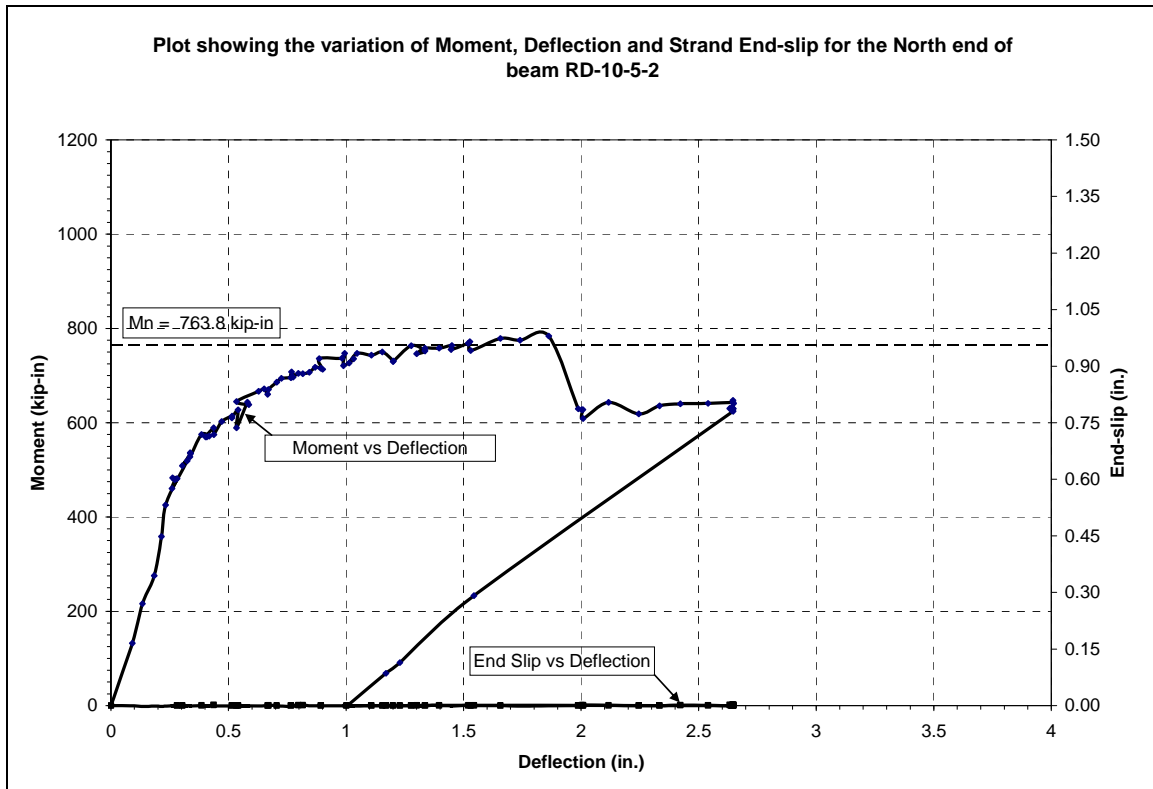
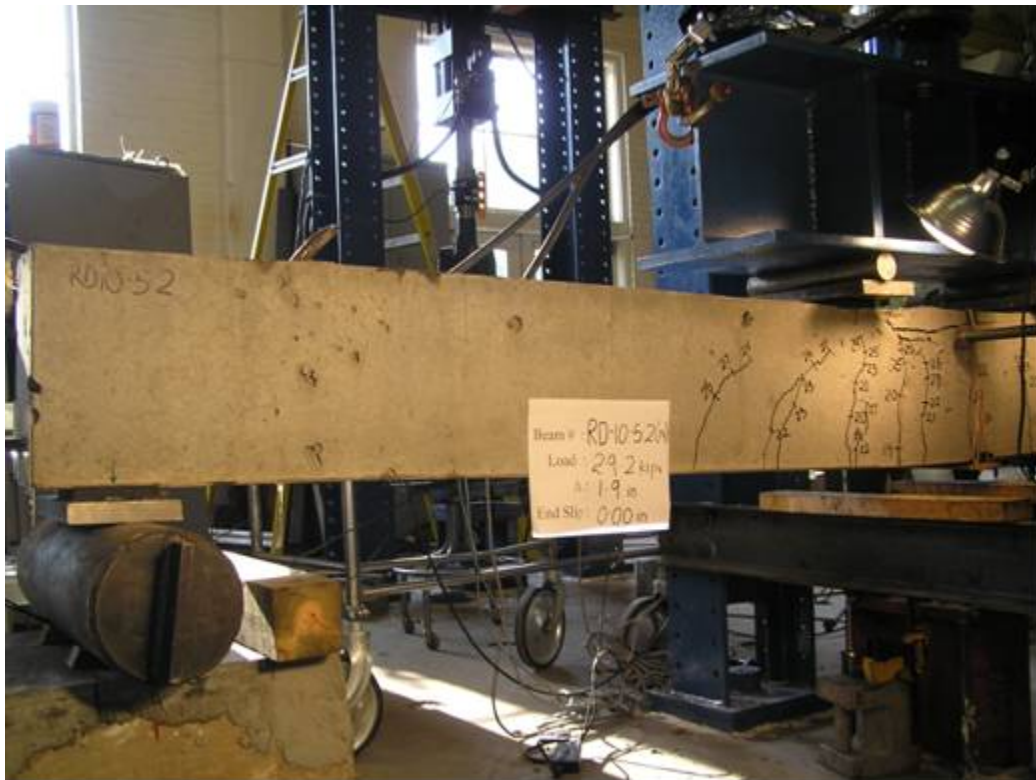
Crack observed crack pattern included 9 cracks in the middle 53 in span with average spacing of cracks = 5.9 in. No inclined flexural cracks were noted.

**Cracking pattern for Beam RD-10-5-2 being loaded at North end**

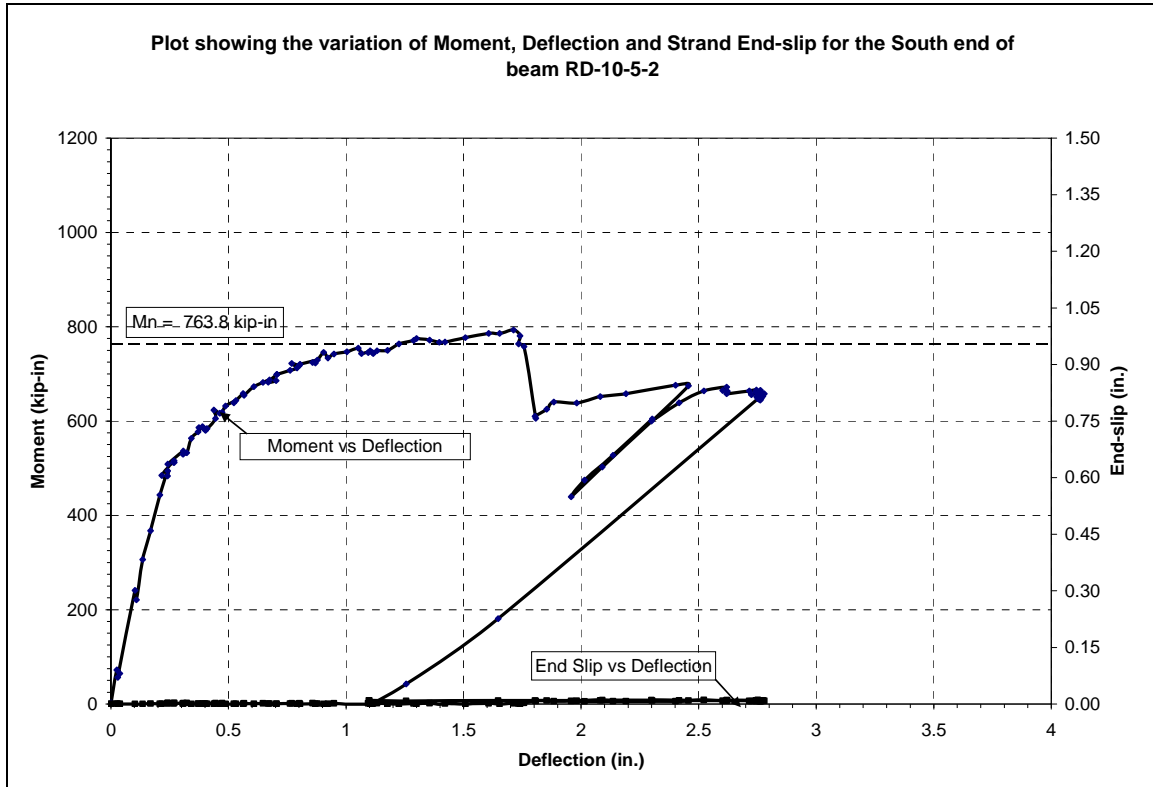
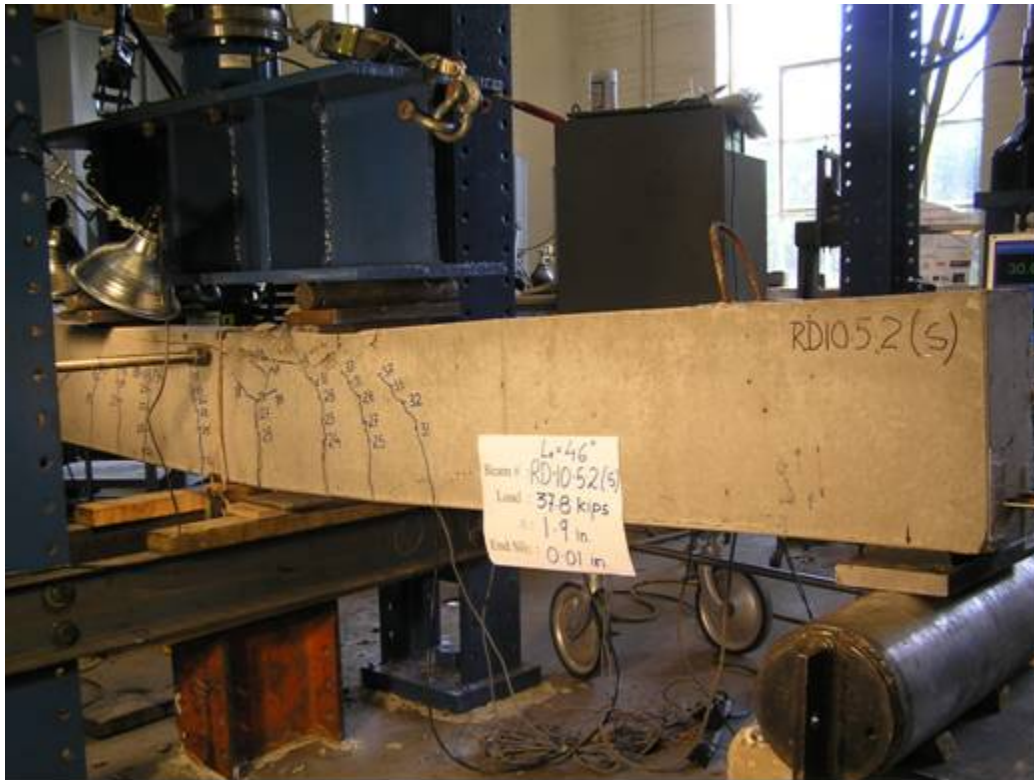
Cracking pattern included 9 cracks in the middle 58 in. span. No inclined flexural cracks were seen in the shear zone. Width of the central crack was 3/8<sup>th</sup> in. Location of the first flexural crack from the South end was 37 in.

**Cracking pattern for Beam RD-10-5-2 being loaded at South end**
