Guidelines for Dowel Alignment in Concrete Pavements

APPENDIX A REVIEW OF LITERATURE AND OTHER RELEVANT INFORMATION

Prepared for
NATIONAL COOPERATIVE HIGHWAY RESEARCH
PROGRAM (NCHRP)
Transportation Research Board
of
The National Academies

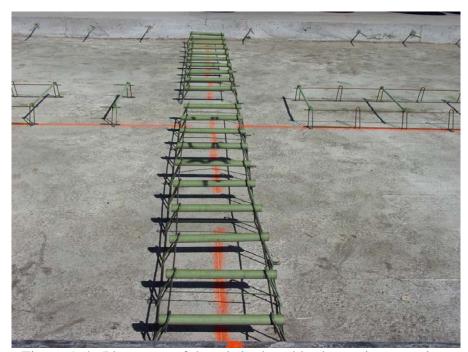
Figure A.4. Placement of dowels in dowel baskets prior to paving.

The method of dowel bar placement determines which factors are more critical. In current practice, the dowel bars are placed using either pre-fabricated dowel baskets or a DBI, as shown in figures A.4 and A.5, respectively.

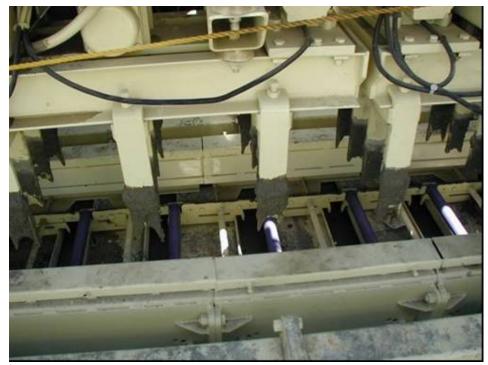
Figure A.5. Placement of dowels using a DBI.

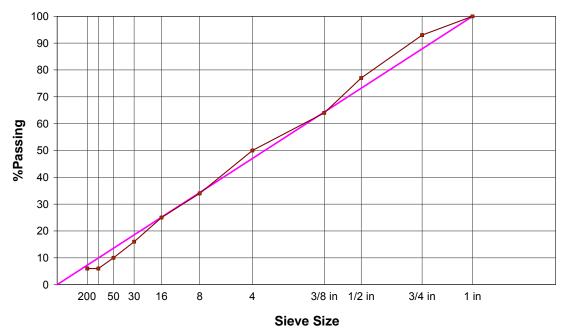
Figure A.8. The 0.45 power grading chart (Shilstone and Shilstone, 2002).

For grading, Shilstone recommends using the 0.45 power grading chart. Figure A.8 shows the 0.45 power chart for maximum aggregate size of 1 in (Pedro and Fowler, 2004). In this chart the horizontal axis scale is obtained by raising the sieve opening size to the 0.45 power. A good grading is one that does not deviate significantly from the straight line, as in the case of the example gradation shown in figure A.8.
