Attachment H. North American Strand Producers (NASP) Test

Fundamental Explanation of NASP Test

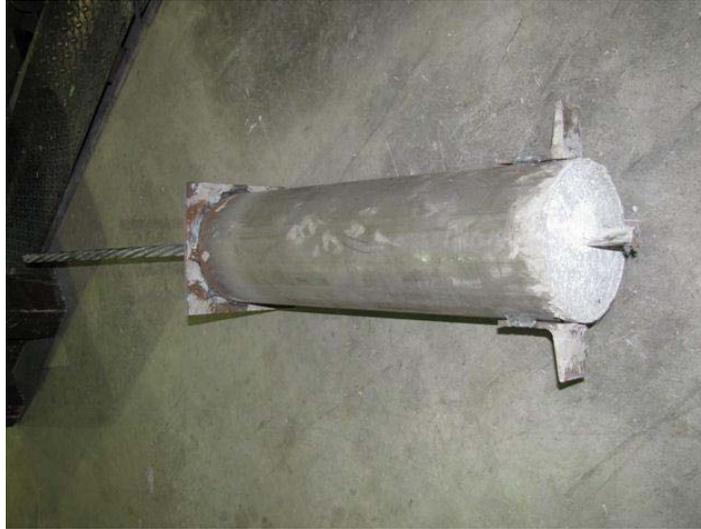
A NASP test specimen (see Figure 1) is made of an 18 in. long steel pipe, 5 in. in diameter and 0.375 in. in thickness. A 1/4 in. thick steel plate, 6 in. wide and 6 in. long is welded to the bottom end of the steel pipe. A 9/16 in. hole is made in the plate for a 0.5 in. strand and an 11/16 in. diameter hole is made for 0.6 in. prestressing strand. A pair of angles at least 2 in. wide is welded to the other end of the steel pipe to which the LVDT is mounted. The length of the strand is 45 in. and it passed through the steel pipe and the plate. Approximately 2 in. of strand protrudes above the steel pipe (opposite end from the welded steel plate) with 2 in. bond breaker inside the steel pipe at the welded plate end. Thus, the bonded length inside the steel pipe is 16 in. with 2 in. unbonded length at the bottom of the specimen.

Figure 1. NASP Test Specimen

The strands to be tested were cut to a length of 45 in. each. A 2 in. bond breaker was attached to the strand such that the bond breaker was applied 18 in. from one of the ends as explained previously. A piece of duct tape was used as a bond breaker. The strand was passed through the steel pipe and the 1/4 in. thick plate welded to its bottom face such that the bond breaker was at the bottom of the steel pipe but above the steel plate. The strand projected approximately 2 in. from the top of the steel pipe. Precautions were taken during pouring of the grout so that the strand was vertical. Figure 1 is a photo of the completed specimen and Figure 2 is a photo of the empty “can”.

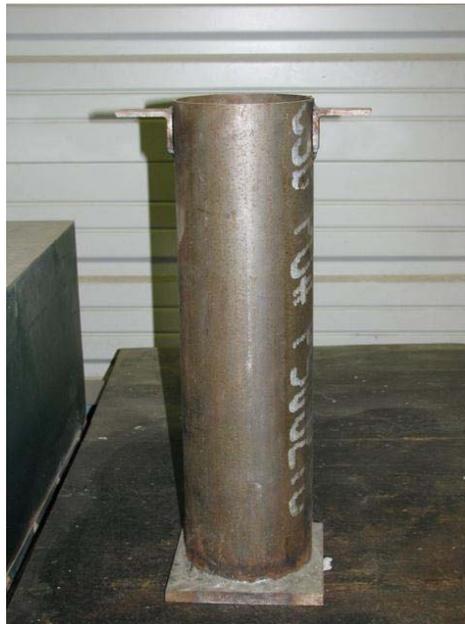
Figure 2. NASP specimen before filling (welded plate, angles are visible)

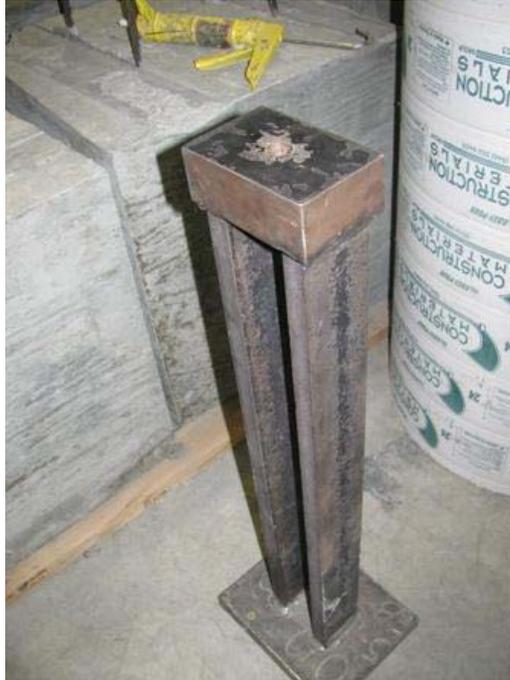
The NASP test specimens were tested in the Satec universal testing machine. The NASP test protocol suggests that the strand be tensioned (gripped for applying tensile force) approximately 6 in. from the bottom of the strand. In this regard, the frame used by Loflin (2008) was used for the test. The frame can resist load of about 65 kips which is the breaking tensile strength of a 0.6 in. diameter regular prestressing strand. The frame is approximately 3 ft high and made of steel plates (see Figure 3). The strand passes through the 11/16 in. hole located on the top plate. A prestressing chuck is used to hold the strand in the position and apply the tension. A spacer, 4 in. long is also inserted between the bottom of the top plate and the prestressing chuck. This aids in the removal of the sample from the Satec after the test is completed. The prestressing chuck bears against the spacer and spacer bears on the bottom of the top plate.

Figure 3. Steel frame used for loading

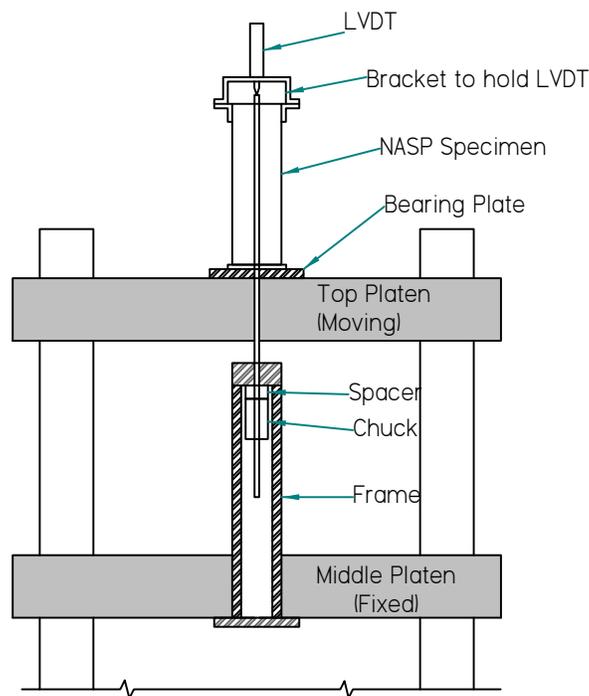
An MTS 407 controller was used to control the tensile force that was applied to the specimen. A Linear Variable Displacement Transformer (LVDT) was used to measure the dead end slip which is the slip at the end of the strand which was not attached to the prestressing chuck. A System 5000 data acquisition system was used to record the readings and then reduce the data to excel spreadsheets. The StrainSmart system software recorded the applied load, crosshead displacement and the dead end slip through the LVDT. The NASP protocol requires that the test be carried out at a rate of 0.1 in/min. It also requires that the load rate shall not exceed 8000 lb/min. The test was load rate controlled as suggested by NCHRP Report 621 and the load rate was 7500 lb/min. The test setup is shown in the Figure 4.

Figure 4. Schematic of NASP Test Setup

The specimens were moist cured for 24 hours. The specimens were inspected for radial cracking on the surface. This was done in accordance with NASP test protocol which suggests that the specimens cannot be tested if radial cracks are observed. The free end of the strand, that is the end from which the LVDT was to be suspended, was leveled and smoothed using a circular grinder. The overhead crane was used to position the specimen on top of the top crossframe of the Satec. The strand was passed through a 1 in. thick plate placed on the top platen to avoid damage to the platen. The strand also passed through the platen. The height of the small frame was adjusted using a 4 in. actuator so that the chuck can be positioned approximately 6 in. from the end of the strand (see Figure 4). The spacer was inserted accordingly. The central crosshead was adjusted such that the top of the bottom plate of the frame was flush with the bottom of the middle platen. A small bracket was used to suspend the LVDT from the free end of the strand. The frame was made of 1/4 in. thick plates and a nut was welded at the top of the frame to thread in the LVDT. The LVDT rested on to this frame. The frame is shown in Figure 4. The LVDT was threaded in such that the plunger would be close to the calibrated 0 in. reading.
