A Modified Foundation for Breakaway Cable Terminals

*A digest of recent developments on breakaway cable terminals by
M. E. Bronstad, Southwest Research Institute, San Antonio, Texas.*

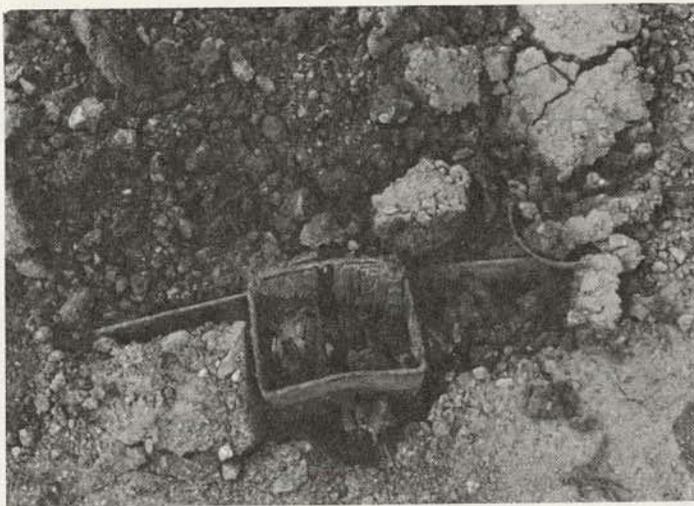
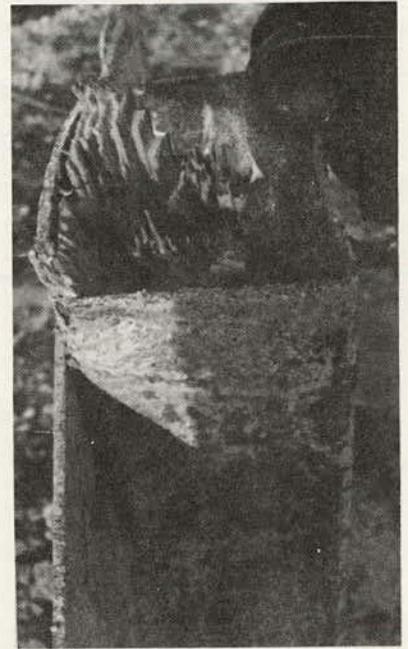
Figure 3. Tests 3 and 4 photographs.

(a) After Test 3

(b) After Test 3

Test 3. Modification of the test equipment to raise the pendulum drop height resulted in increased tension in the cable. In this test, the post fractured after reaching a maximum horizontal load of 36 kips (16,300 kg) and a soil displacement of 2.0 in. (50 mm). Unacceptable damage to the tube resulted, as shown in Figure 3.

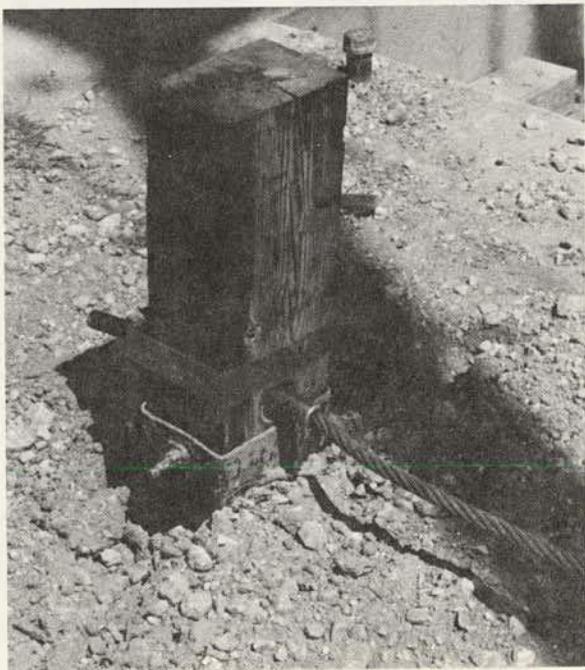
(c) After Test 4

(d) After Test 4

Test 4. In the second modification to the Illinois detail, the foundation tube was extended 2 in. (50 mm) above grade to permit the bearing plate to overlap it (see Fig. 2). This is considered a significant improvement because the greater part of the cable load is transferred directly to the tube. Although the full breaking strength of the cable was not developed in this test, a cable load of 39 kips (17,700 kg) was successfully anchored with a residual soil displacement of 3 in. (75 mm).
