NCHRP

SYNTHESIS 353

Inspection and Maintenance of Bridge Stay Cable Systems

A Synthesis of Highway Practice

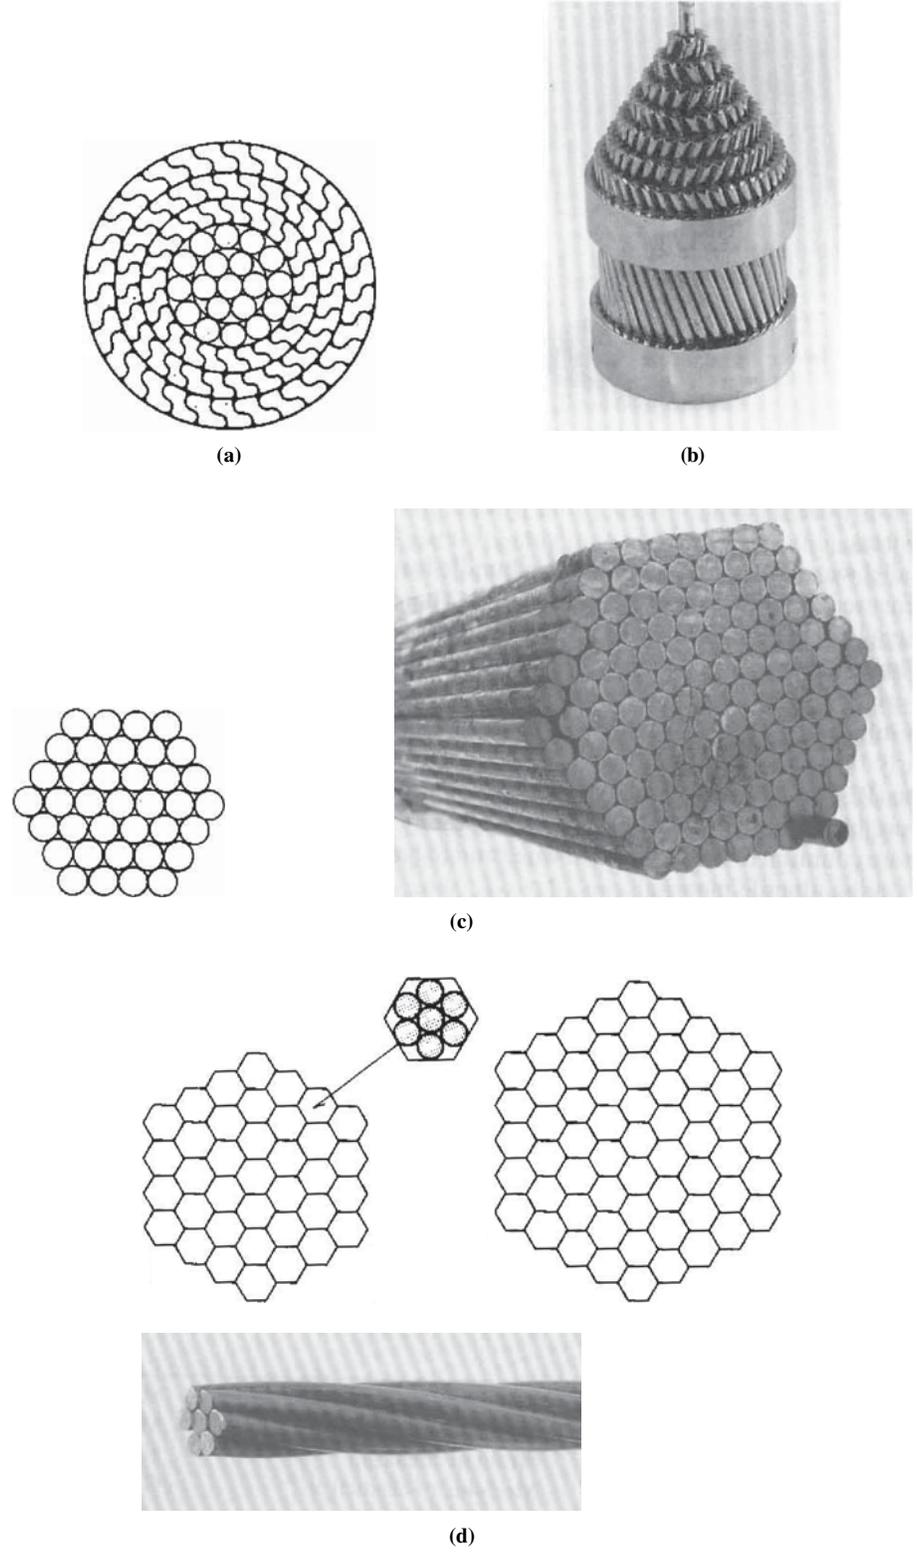
FIGURE 5 Various MTE cross sections: (a) locked coil, (b) helical strand, (c) parallel wire, (d) parallel seven-wire strands (Gimsing 1998).

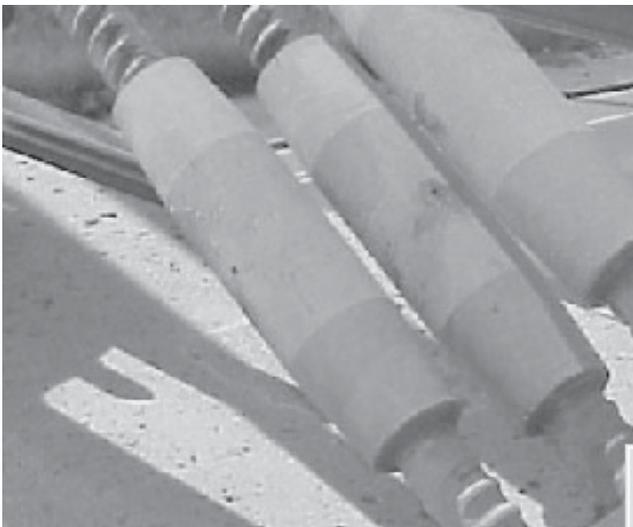
FIGURE 7 Typical bar couplers in stay cables.

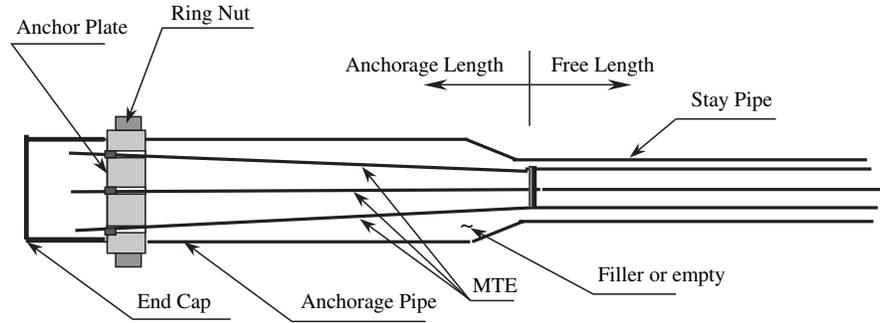
FIGURE 8 Point (wedge) anchorage concept.

In the multistrand system with point anchorages, the cable can be assembled in the field by stressing all strands at the same time, or it can be stressed one strand at a time (using a system to ensure equal distribution of stress). The gripping wedges create notches on the strands, which could become fatigue initiation points. However, stay cable systems

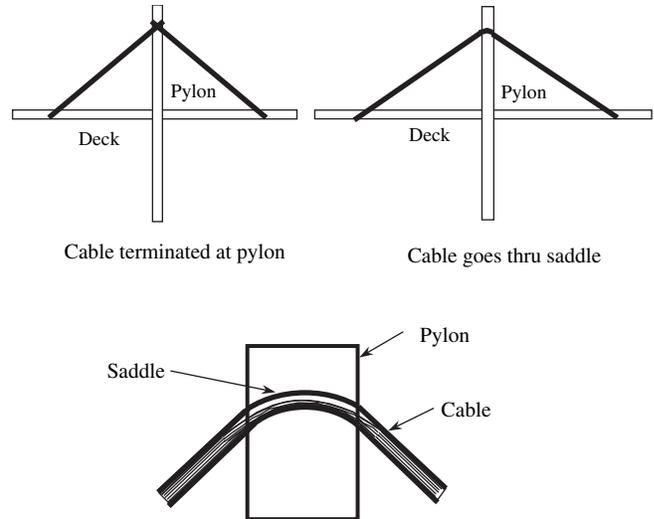
FIGURE 13 Saddles in stay cables.

given is that the pylon can be smaller (narrower) when there are no anchorages (Figure 13). However, large transverse forces are generated on the cable and individual strands in the saddles, especially at the entrances to the pylon. As the strands enter the saddle, they begin to move to the bottom of the pipe and large interstrand forces can develop, particularly when bare strands are used. Changes in cable tension can result in fretting and fatigue. Such fatigue fractures have been observed on at least one qualification test of a saddle system (Tabatabai et al. 1995). In that test, bare strands were used and fractures were initiated at oval-shaped fretting marks at interstrand contact points.

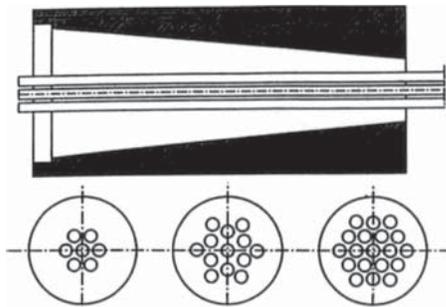
FIGURE 15 One type of CFRP anchorage (Roos and Noisternig 1999).

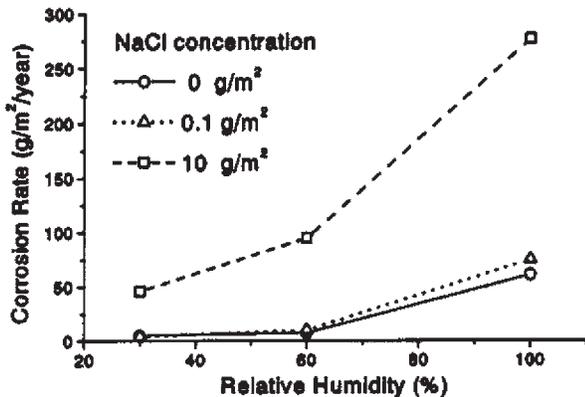
FIGURE 17 Corrosion rate for galvanized wire (Suzumura and Nakamura 2004).

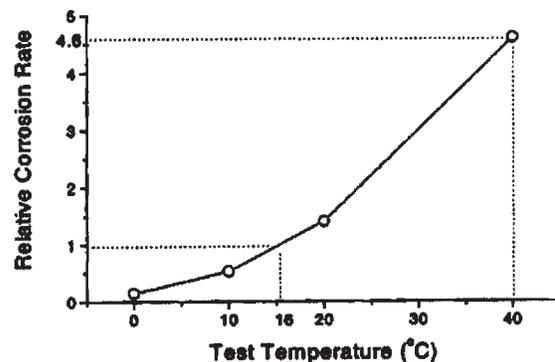
FIGURE 18 Relative corrosion rate—wet condition without chloride exposure (Suzumura and Nakamura 2004).

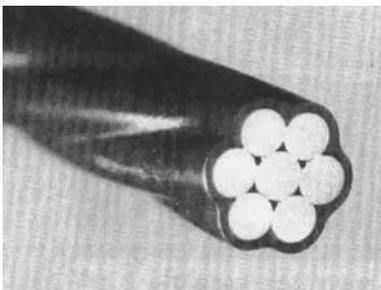
FIGURE 19 Epoxy-coated strand (Funahashi 1995).

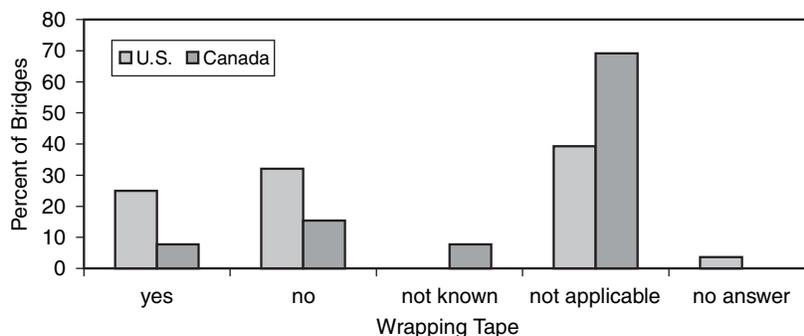
FIGURE 21 Damage to wrapping tape.

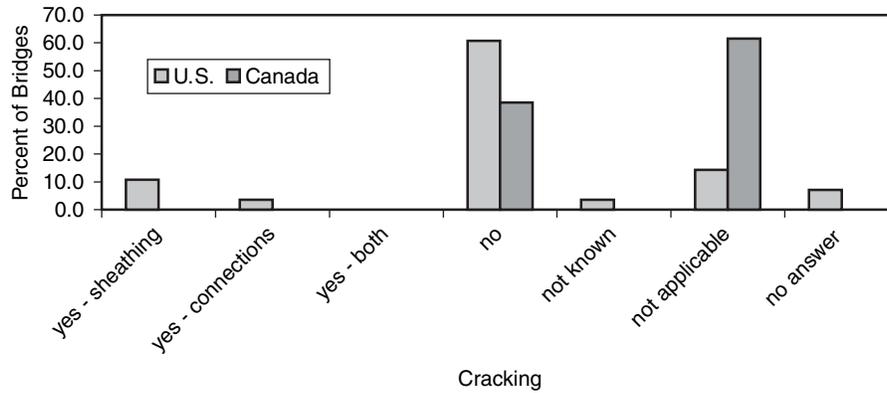
FIGURE 22 Cracking of cable sheathing and connections.

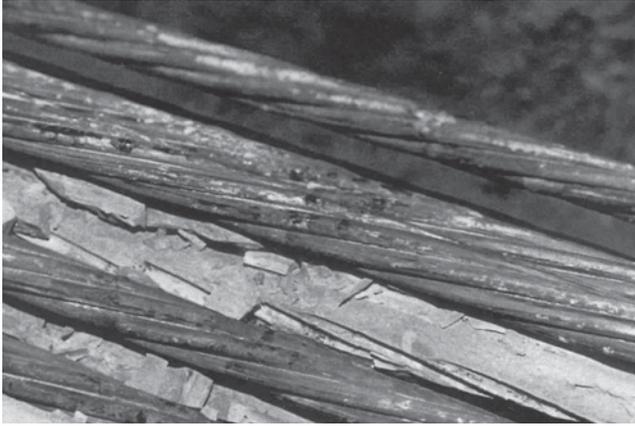
FIGURE 23 Corrosion of strand at transverse crack in grout.

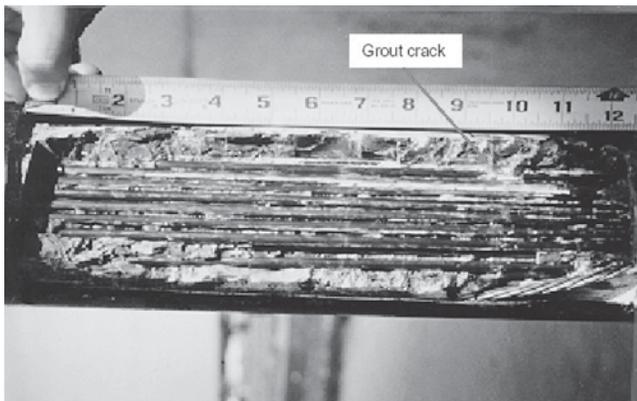
FIGURE 24 Exposed cable on the Pasco–Kennewick Bridge (Frank and Breen 1994).

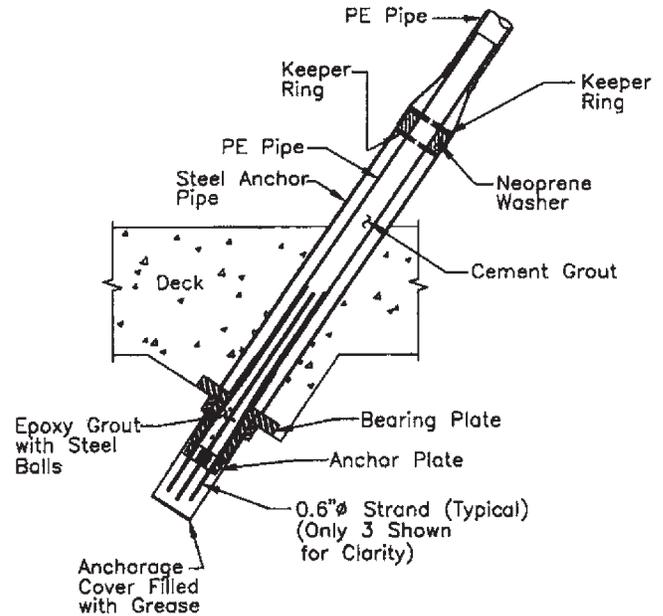
FIGURE 25 Anchorage detail including neoprene washers for the Cochrane Bridge (Alabama) (Telang et al. 2000).

In addition to reducing bending stresses at the anchorages, the neoprene rings also contribute to the vibration damping of the cables. Although the level of damping (attributed to the

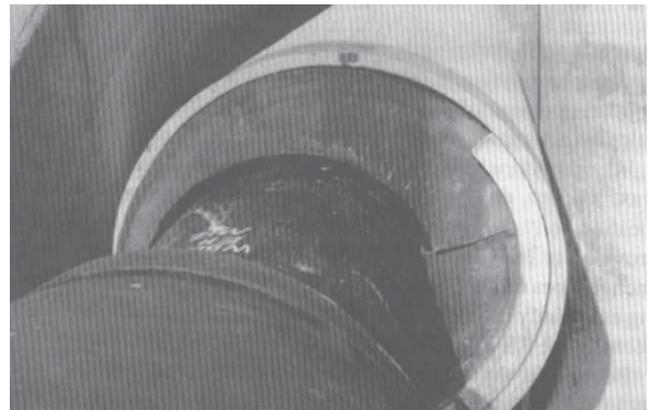
FIGURE 26 Cap between cable and neoprene washer (Telang et al. 2000).

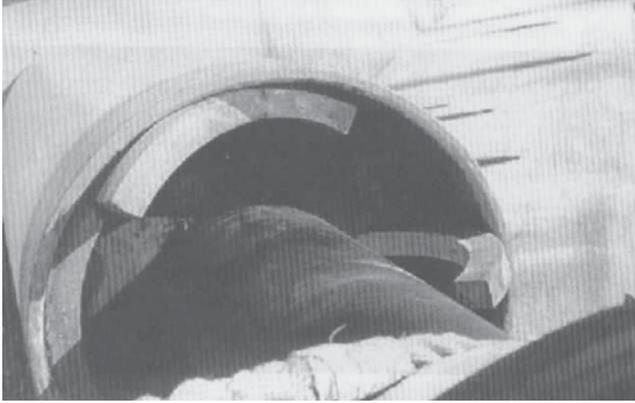
FIGURE 27 Failure of the keeper ring and dislocation of neoprene washer (Telang et al. 2000).

The steel rings that typically hold the washers in place (“keeper rings”) can fail and result in the dislocation and misalignment of the neoprene ring (Figure 27).

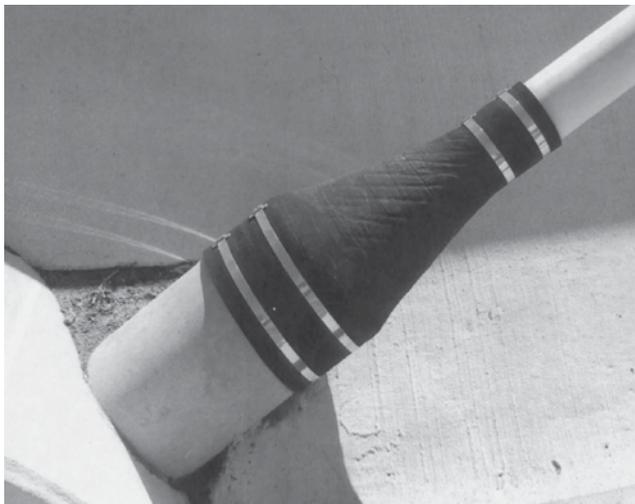
FIGURE 30 Neoprene boot (courtesy: Indiana DOT).

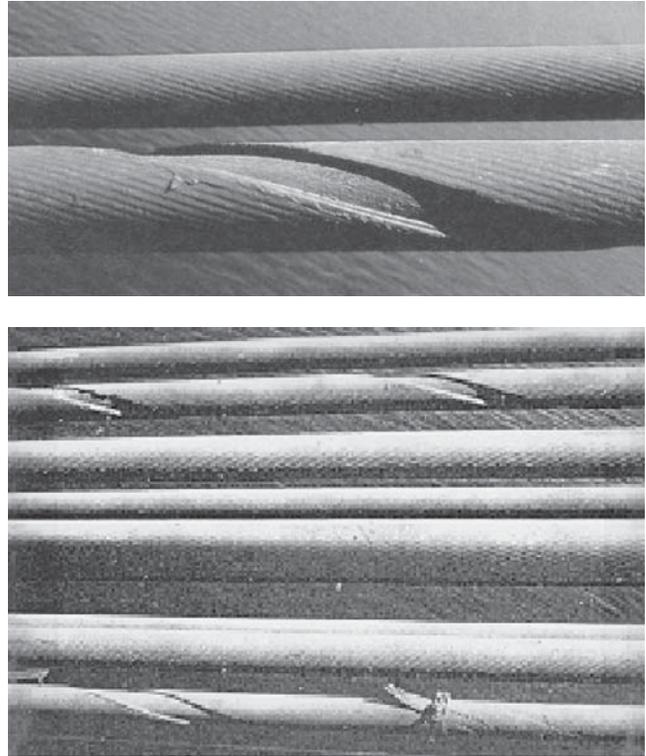
FIGURE 32 Corrosion of locked coil cables of the Lake Maracaibo Bridge in Venezuela (Frank and Breen 2004).

Sarcos-Portillo et al. (2003) reported that inspections carried out in 1997–1999 revealed “corrosion in both cables and sockets, as well as considerable settling in the sockets” of the new cables. A “significant” amount of water was also found in most sockets. Vibration-based tension force measurements indicated major force changes. Deck profile changes were also noted. The cables were retensioned, and they recommended painting the cables and waterproofing and lubricating the sockets.

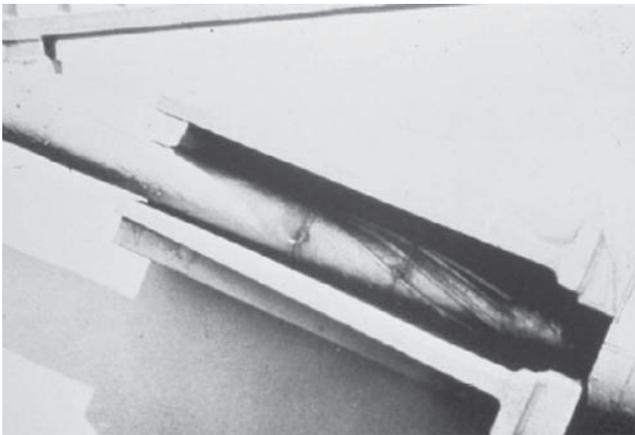
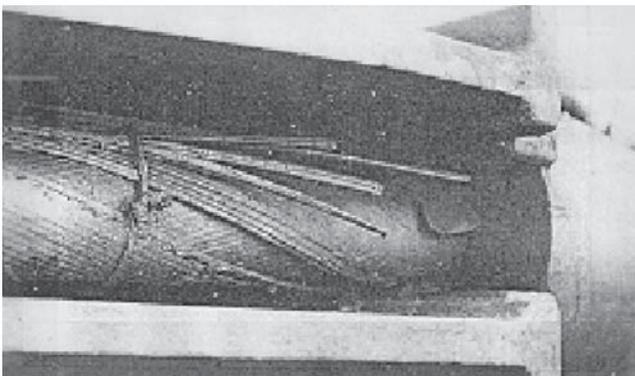
FIGURE 31 Corrosion and rupture of locked coil cable on the Kohlbrand Bridge in Germany (Frank and Breen 2004).

Saul and Svensson (1991) discussed some of the damage observed on cable-stayed bridges. In the case of the Kohlbrand Bridge in Germany, they reported on the detection during inspections of 25 broken wires on the nongalvanized locked coil cables that were protected with red lead and linseed oil

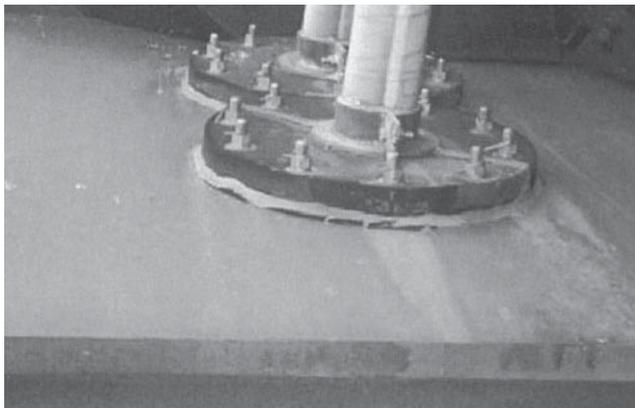
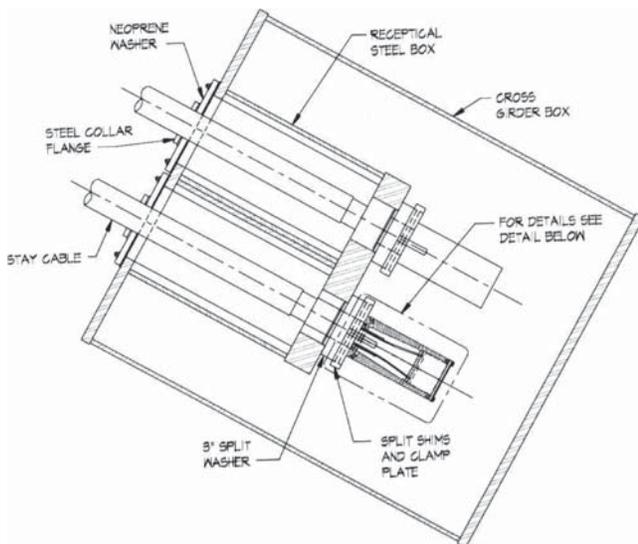
FIGURE 33 Neoprene washers on the Luling Bridge at the exit point of cables from the steel box (Telang et al. 2004).

The caulk that was used around the washers was weathered, cracked, or missing at some locations. Neoprene washers were removed and a video boroscope (videoscope) examination was performed. Accumulated water was found surrounding the cable inside the box. The end caps of sockets were removed to expose the button end of the wires. Figure 34 shows water

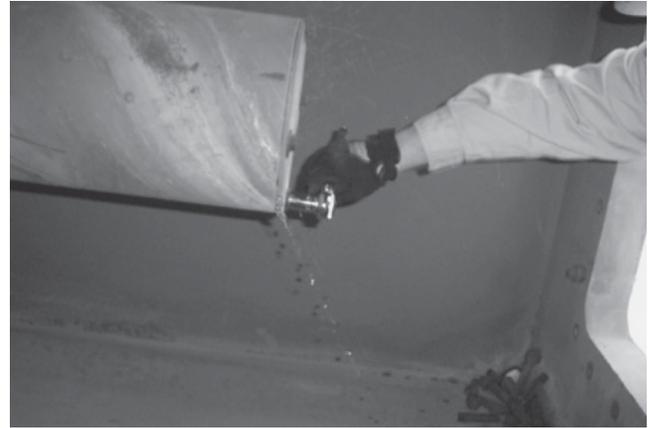
FIGURE 34 Water exiting the end cap of one anchorage (Telang et al. 2004).

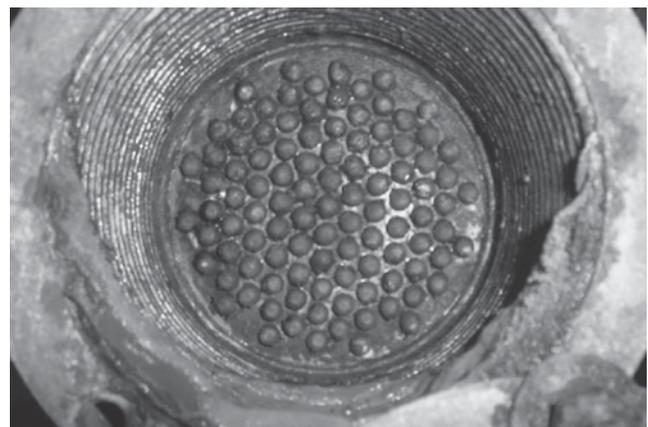
FIGURE 35 Corrosion at the end plate of one socket with wire button ends (Telang et al. 2004).

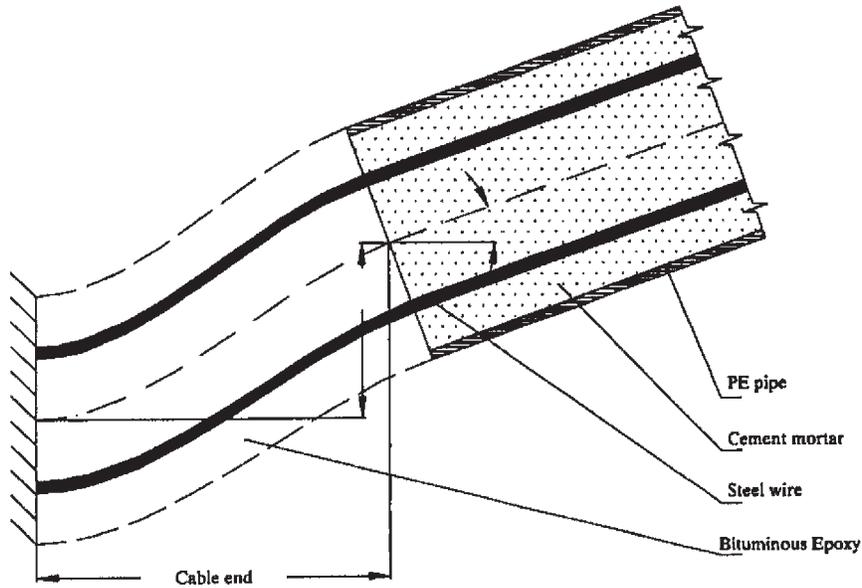
FIGURE 38 Deformations near cable anchorages with discontinuous grout (Prato and Ceballos 2003).

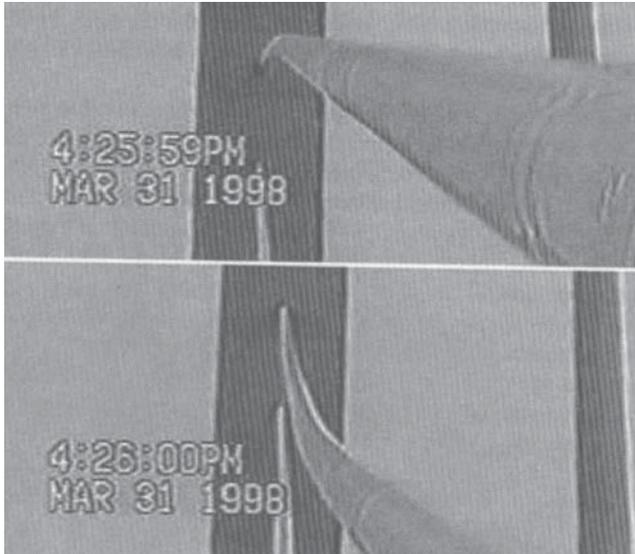
FIGURE 40 Large amplitude vibrations of the Cochrane Bridge (Alabama) (Telang et al. 2000).

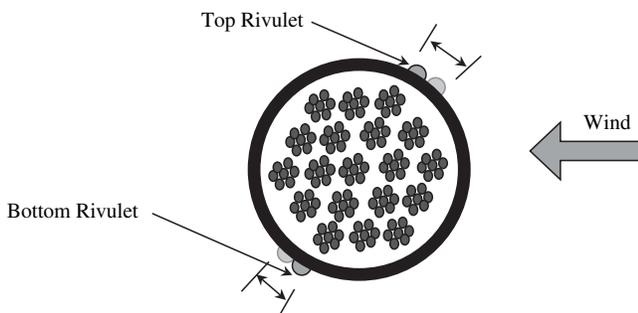
FIGURE 41 Position and movements of water rivulets during rain-wind vibrations.

Larose and Wagner Smitt suggest that the “wetable” of the cable surface is important in the formation of rivulets. They noted that a slightly eroded surface with dust particles is more “wetable,” and thus can form the rivulets more easily. This may be the reason why some bridges do not experience rain–wind vibrations for the first few years of their service. According to Swan (1997), “a very smooth surface may initially avoid the problem, until atmospheric deposits allow just enough roughness to hold the rivulet.”

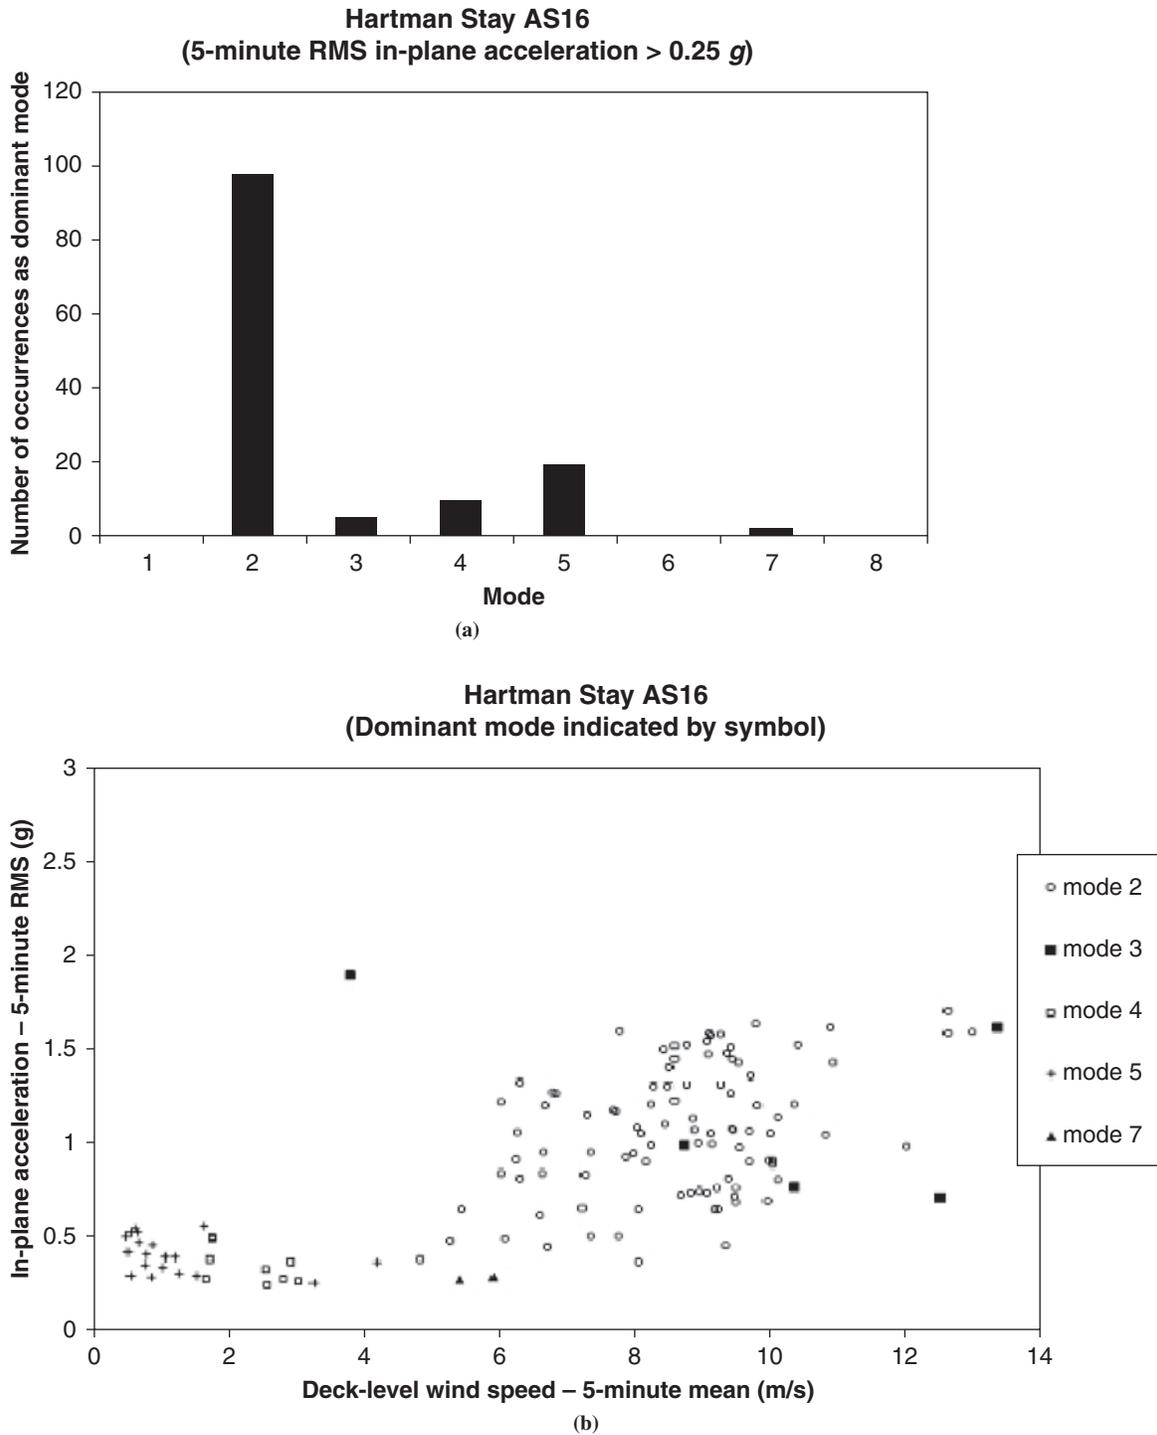
FIGURE 42 Vibration data from Fred Hartman Bridge: (a) histogram of modes, (b) vibration amplitudes (Main and Jones 2000).

Main and Jones (2000) concluded that the highest amplitude responses (which occurred during rainfall) were in the lower modes and “seemed to ‘lock-in’ to a specific mode of vibration over a wide range of wind speeds.” High-frequency vibrations over narrow wind ranges were also observed, which

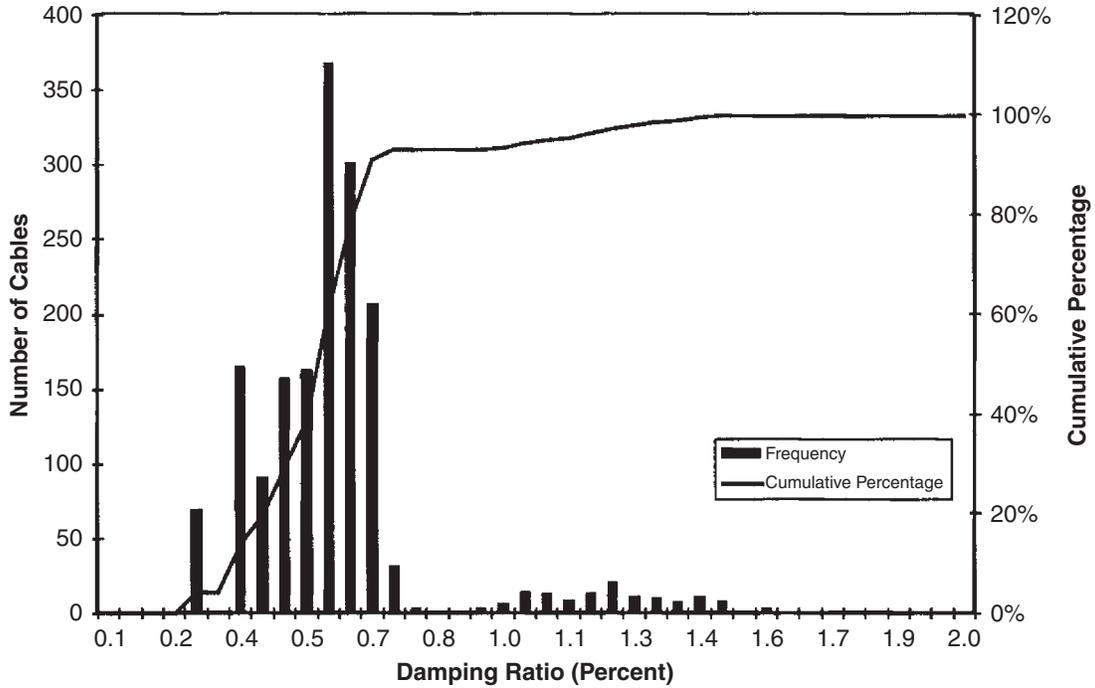
FIGURE 43 Histogram of required damping ratio for controlling rain-wind vibrations (Tabatabai and Mehrabi 2000).

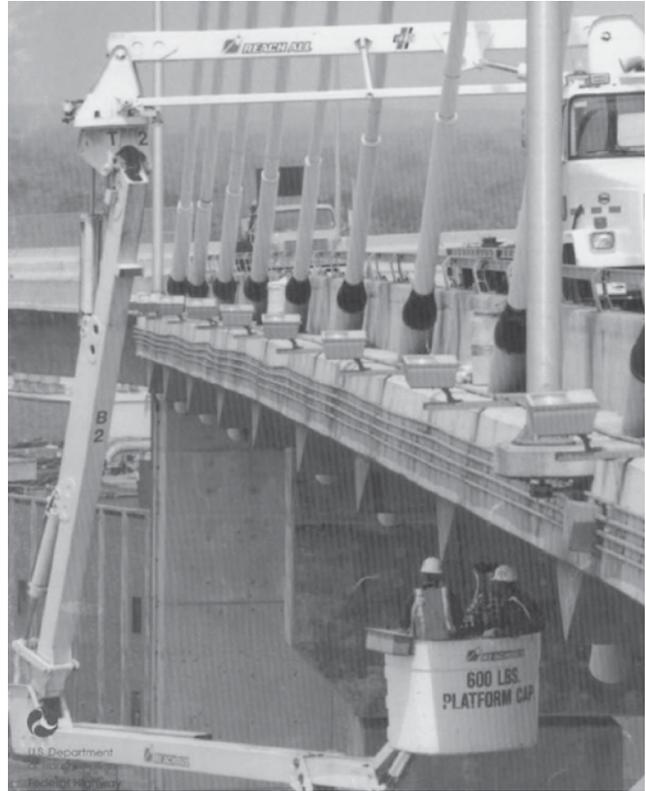
FIGURE 48 Access to cable bottom anchorage for ultrasonic testing.

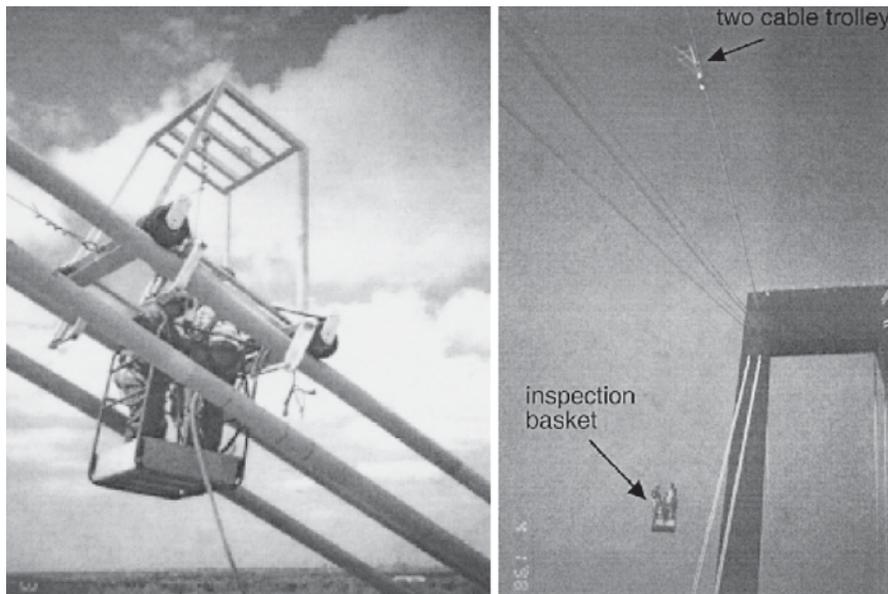
FIGURE 55 Trolley used for inspection of Luling Bridge cables (Elliott and Heymsfield 2003).

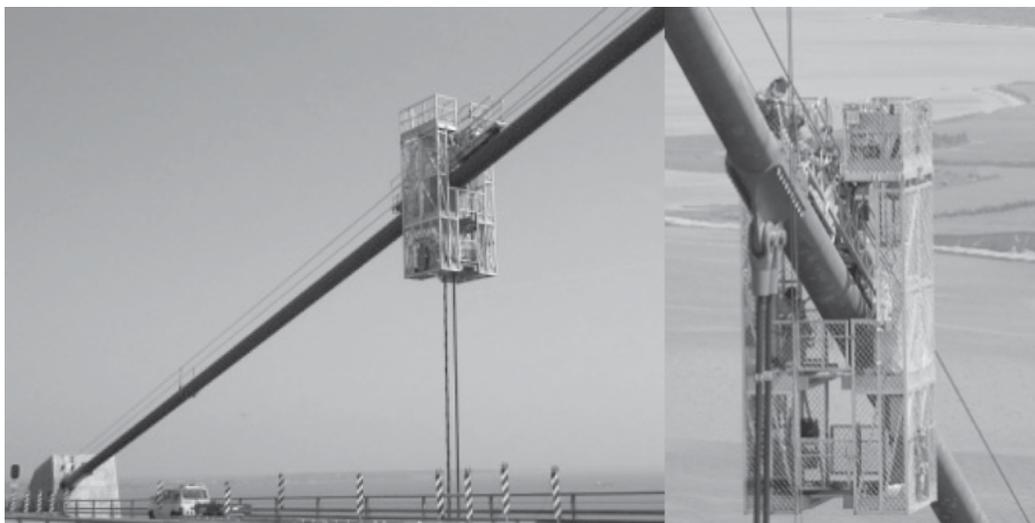
FIGURE 57 Carrier for inspection of main cable of suspension bridge in Denmark.

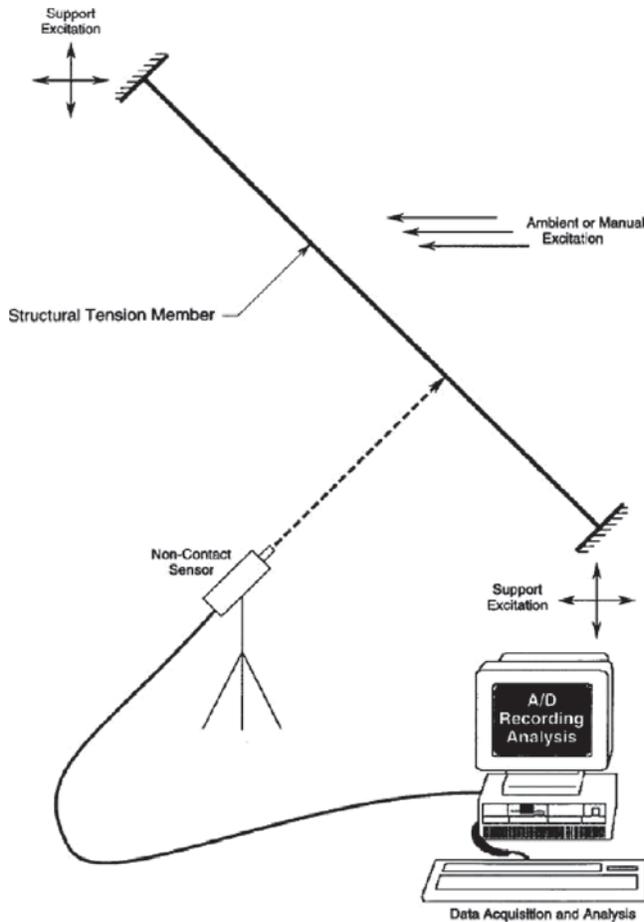
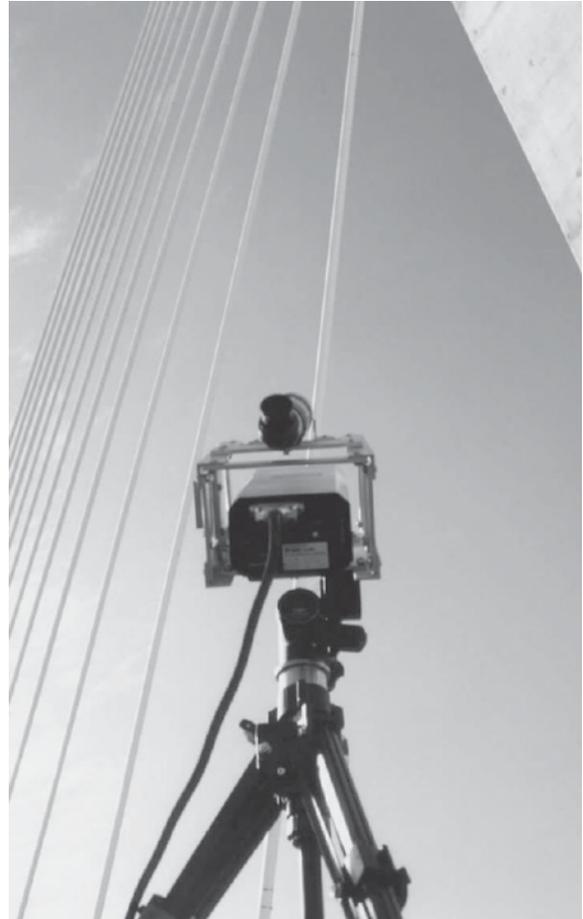
FIGURE 58 Use of laser doppler vibrometer for stay cable vibration and force measurements.

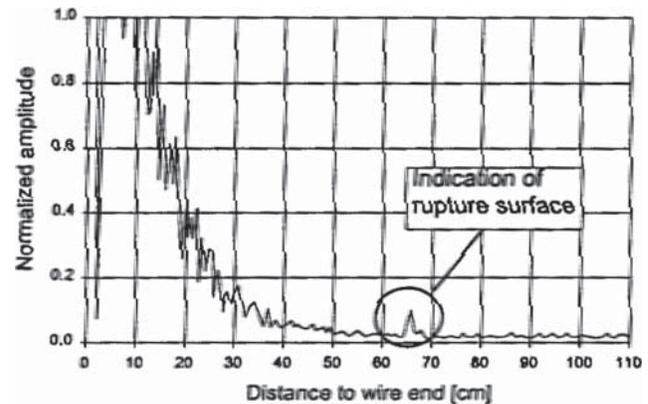
FIGURE 59 Typical ultrasonic test record of broken wire (Prato et al. 1997).

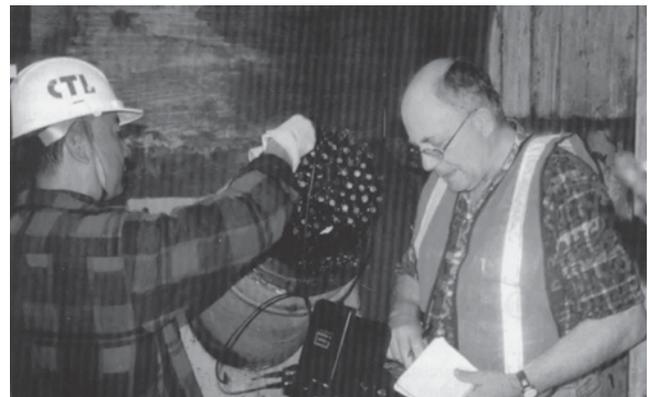
FIGURE 60 Ultrasonic testing of cable anchorage (Ciolko and Yen 1999).

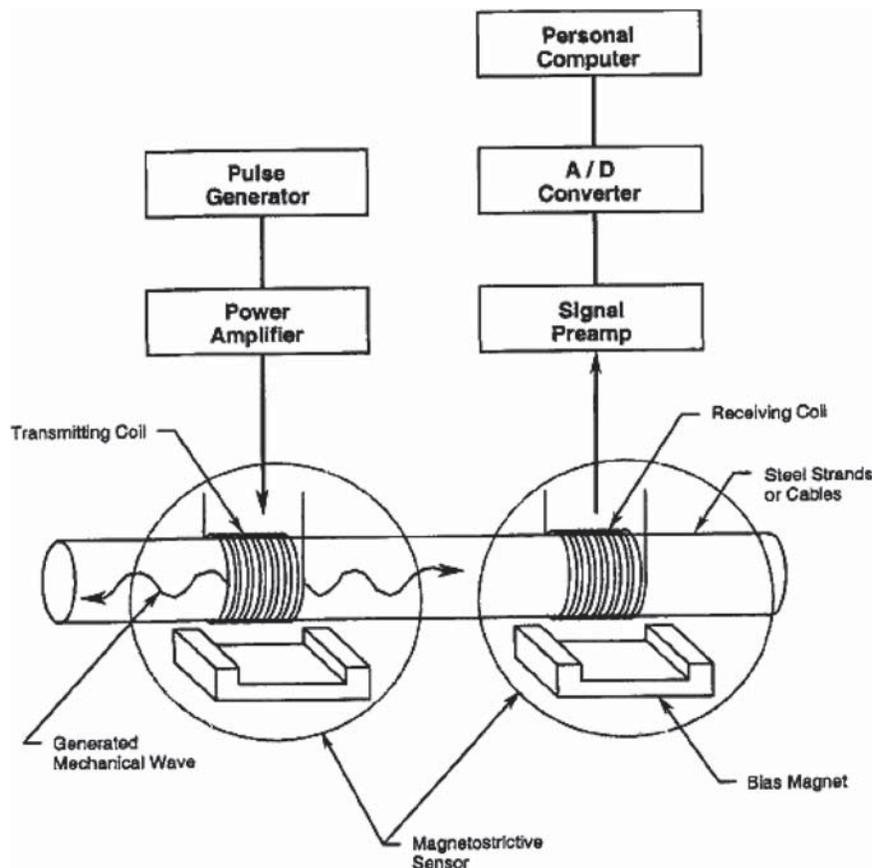
FIGURE 62 Schematic diagram of MsS sensors (Bartels et al. 1996).

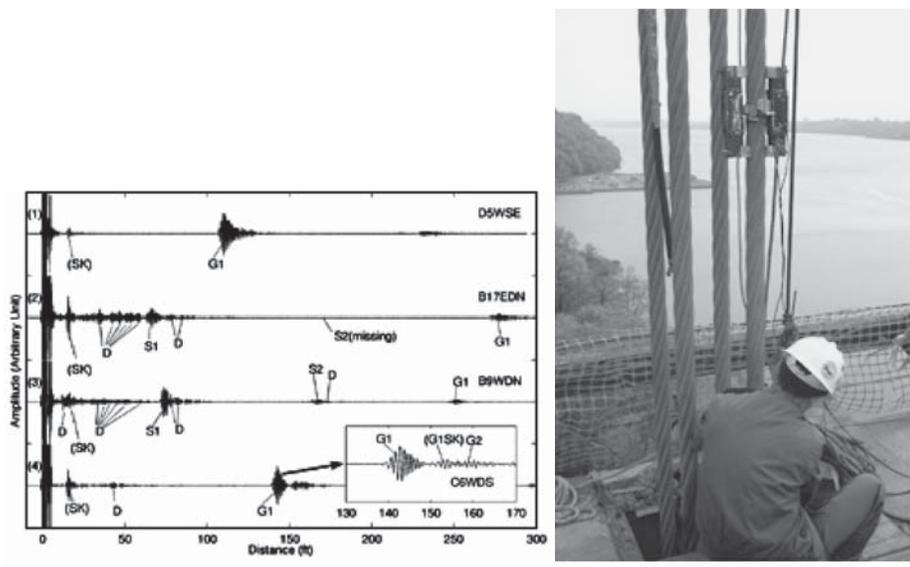
MsS technology can effectively inspect the approximately 3-inch-diameter suspenders of the George Washington Bridge. The image above left compares the data collected from four wires in the suspenders on the bridge. "D" represents a defect. "SK" represents a socket and "G" represents a gatherer, both of which are normal components of the suspender. Suspender 1 had been recently replaced, and thus showed a clean signal with no defect indications.

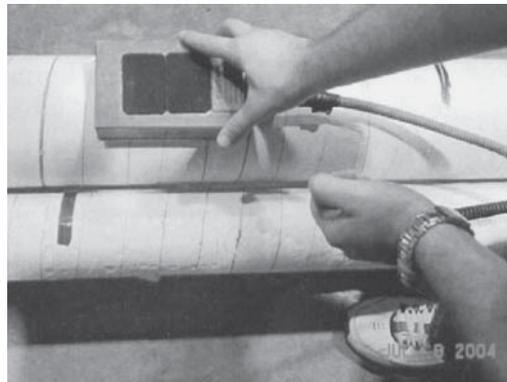
FIGURE 64 Sample impulse radar survey (Telang et al. 2004).

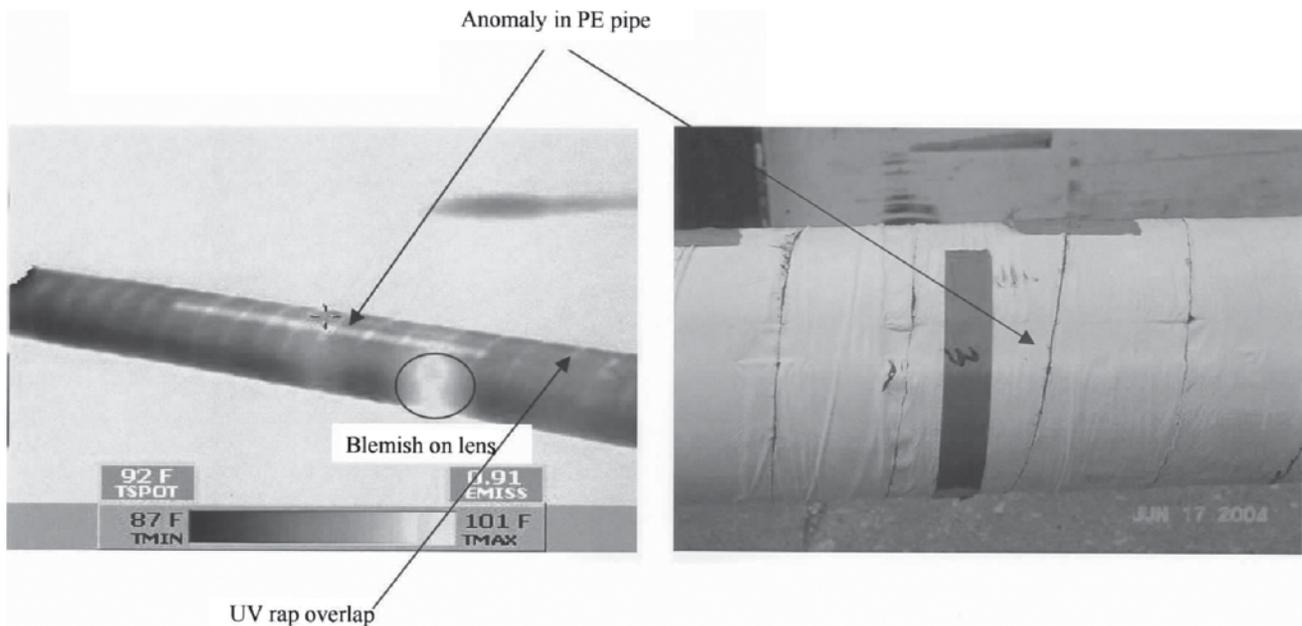
FIGURE 65 Infrared thermography image for detection of HDPE splits under tape (Telang et al. 2004).

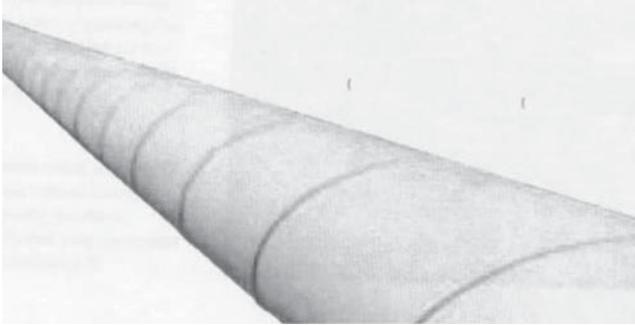
FIGURE 67 Spiral strakes on the surface of HDPE pipe to control rain–wind vibrations.

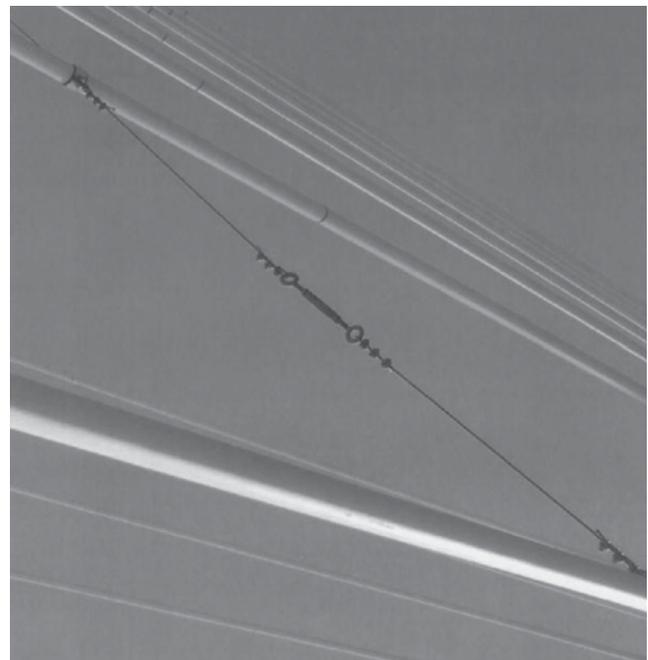
FIGURE 70 Cross cable installed on a bridge in Indiana (courtesy: Indiana DOT).

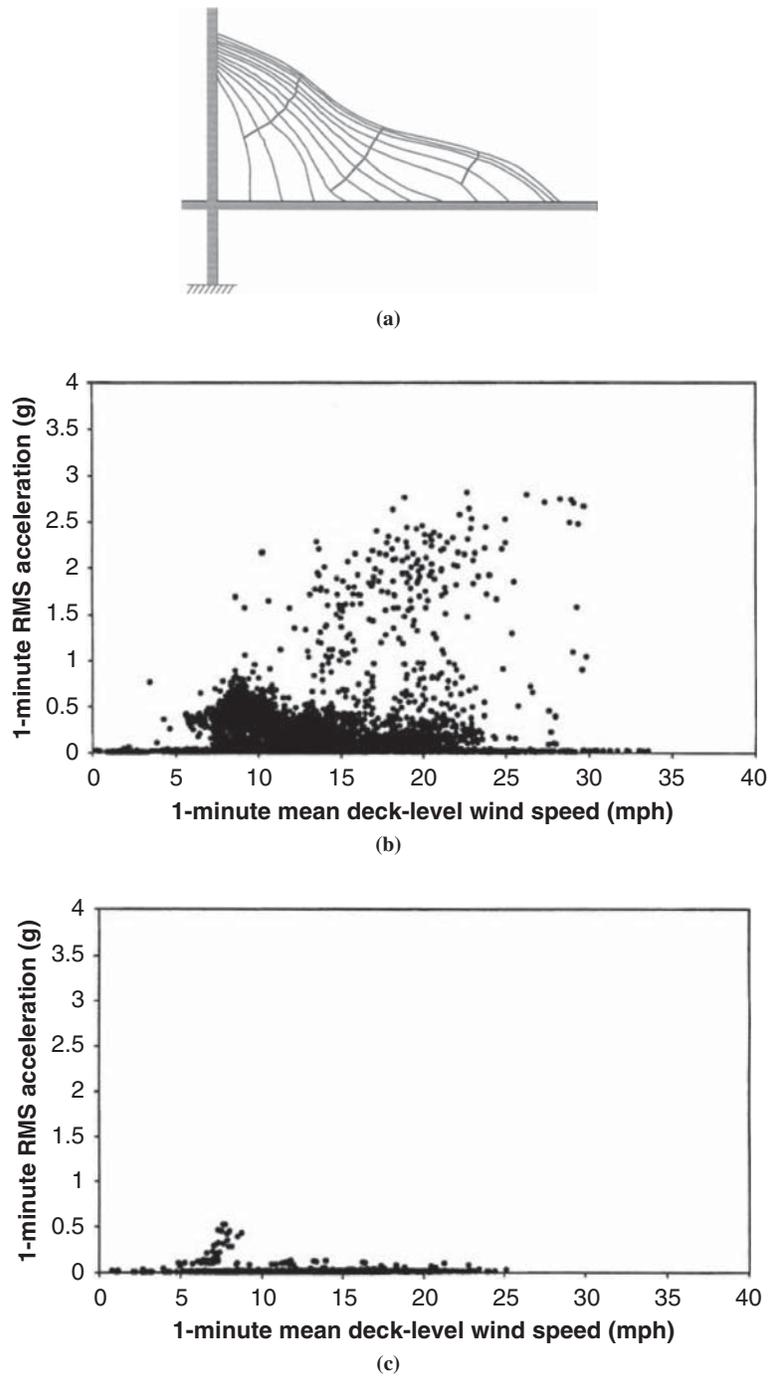
FIGURE 71 (a) Cable restrainer, (b) vibrations before installation of cross cables, (c) vibrations after installation of restrainers (Poston 2002).

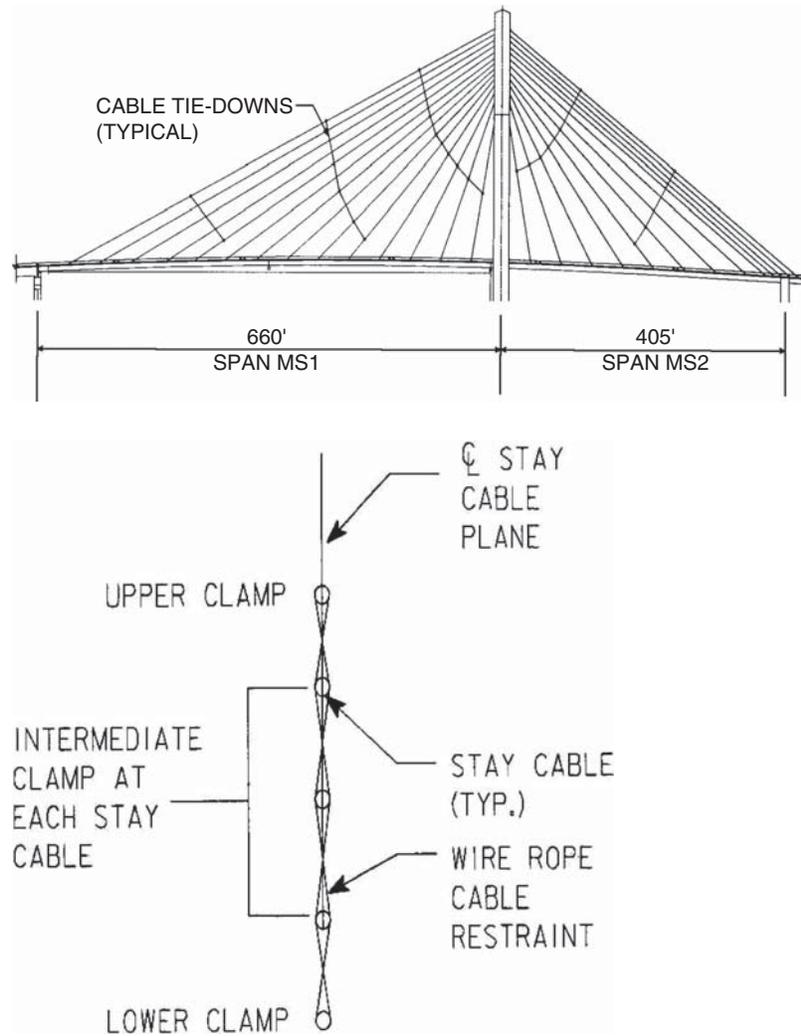
FIGURE 72 Cable restraint system for the Burlington Bridge in Iowa (Bierwagen no date).

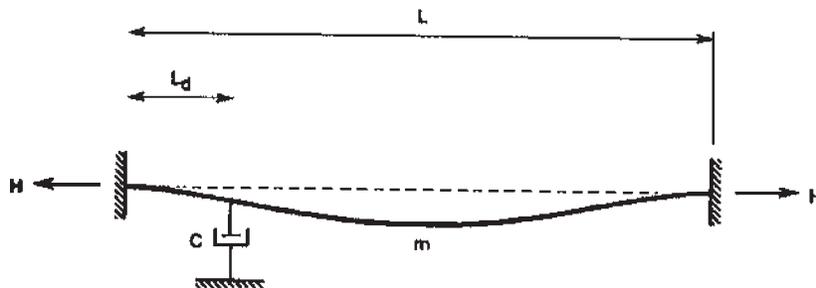
FIGURE 74 Idealized cable with viscous damper (Tabatabai and Mehrabi 2000).

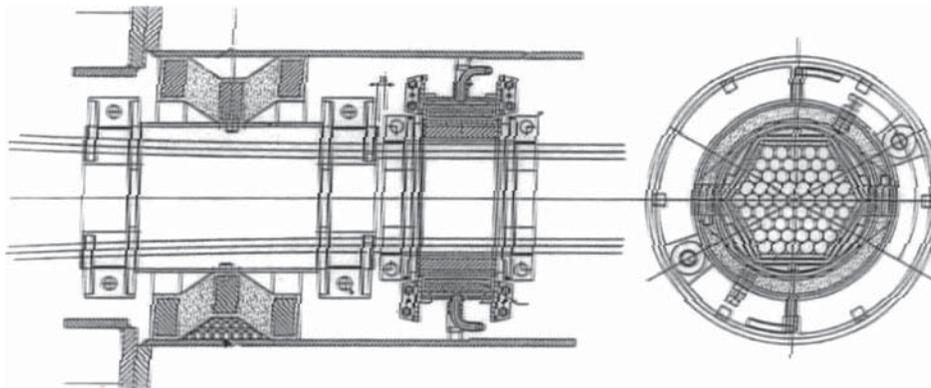
FIGURE 75 Viscoelastic and hydraulic dampers (Stubler et al. 1999).

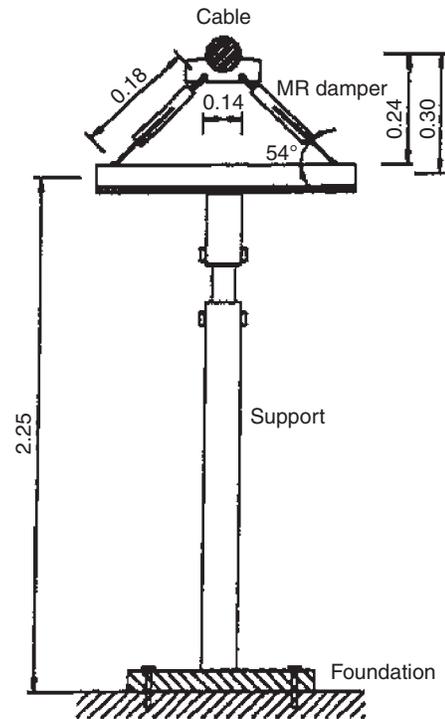
FIGURE 78 MR damper installation on bridge cable in China (Ko et al. 2002).
