**Culvert Rehabilitation to
Maximize Service Life while
Minimizing Direct Costs and Traffic Disruption**

Literature Review

Transportation Research Board (TRB)
National Cooperative Highway Research Program (NCHRP)
Project Number 14-19

July 2010

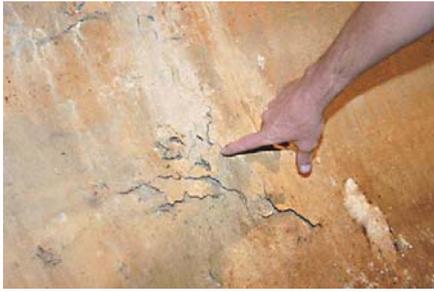
Figure 7. Light spalling that can be removed with fingers (Linabond, 2008)

Spalls are caused by pressure or expansion within the concrete, bond failure in two-course construction (new concrete poured over old concrete), impact loads, fire, or weathering (PCA, 2001). In precast concrete culverts, spalls may occur along the edges of cracks that had been caused by overloading or poor support (rather than tension cracking) or may be caused by corrosion of steel reinforcing when water reaches the steel through the cracks (Ballinger and Drake, 1995). If unrepaired, spalls can accelerate concrete deterioration.

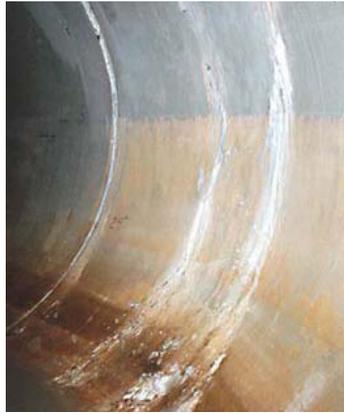
Figure 8. Circumferential spalling (Linabond, 2008)

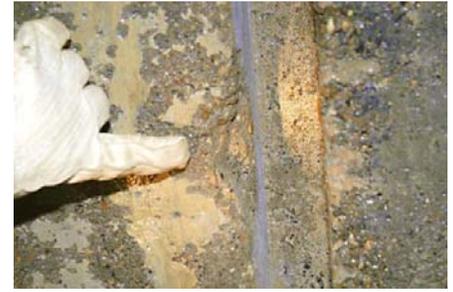
Figure 9. Spalling at the joint that is open more than 2 in. (Linabond, 2008)

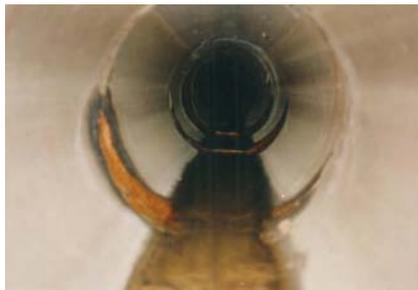
Figure 10. Vertical misalignment. Every joint is leaking (Courtesy of CNA Consulting Engineers)

In rigid concrete culverts, misalignment occurs at pipe joints when pipe sections cease to be lined up relative to each other and exhibit a disjuncture (offset joints, Figure 10). Vertical misalignment includes sags, heaving and faulting (pipe sections have a difference in elevation i.e., a drop or a step, Figure 11). Horizontal misalignment entails impaired straightness or smooth curvature for culverts constructed with a curved alignment. Misalignment can be caused by improper installation, undermining, uneven settlement of fill, or soil infiltration into the culvert through an opened joint.

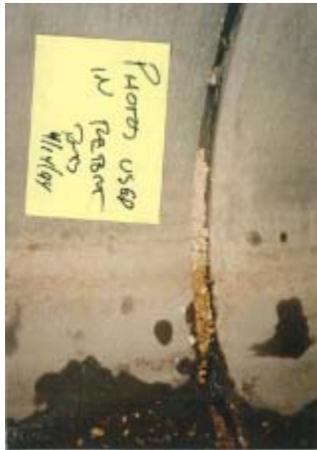
Figure 12. Separated joints (Courtesy of CNA Consulting Engineers)

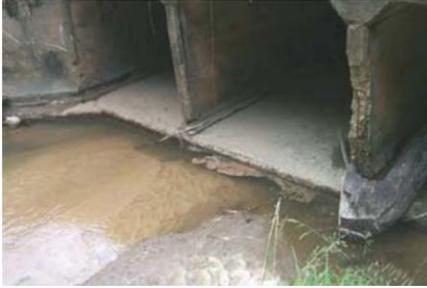
Figure 14. Stream flowing underneath the culvert as the soil beneath the culvert has been washed away (Uretex USA, 2008).

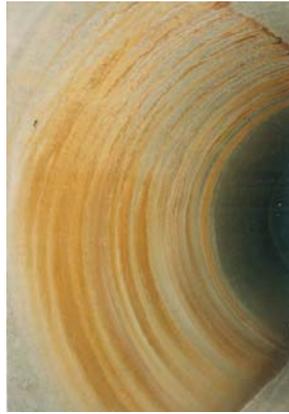
Figure 18. Stains from a longitudinal crack indicate corrosion of steel reinforcement (Courtesy of CNA Consulting Engineers)

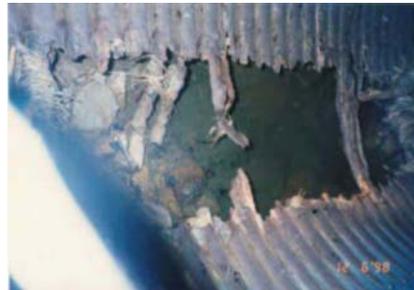
Figure 26. Holes in the corrugated steel pipe from corrosion (Caltrans, 2003, detail)

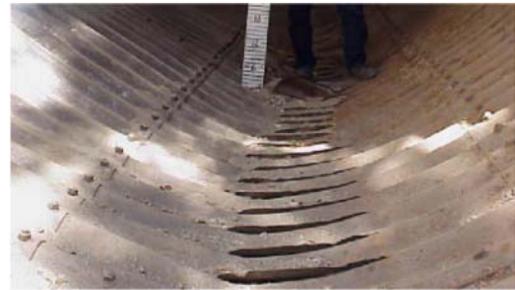
Figure 27. Worn invert due to abrasion (Caltrans, 2003, detail)

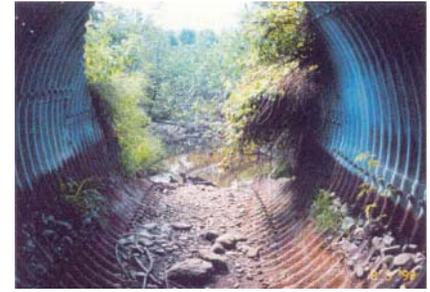
Figure 33. Bad seams that allow leakage and undermining of backfill (Wyant, 2002)

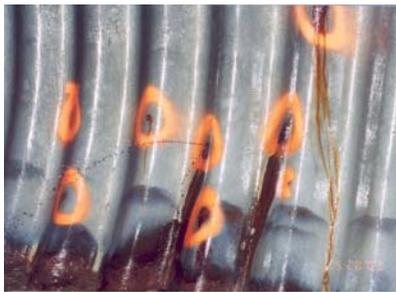
Figure 37. Seepage water flowing in through pinhole (Mitchell et al., 2005, detail)

Defects in metal pipe wall such as creases, bulges, dents, cracks, pinholes (Figure 37), large holes (Figure 38), or tears can impair the structural integrity of the barrel in ring compression or permit infiltration of backfill. Dents in corrugated steel culverts may be accompanied by cracking or debonding of the protective coating (Figure 25).

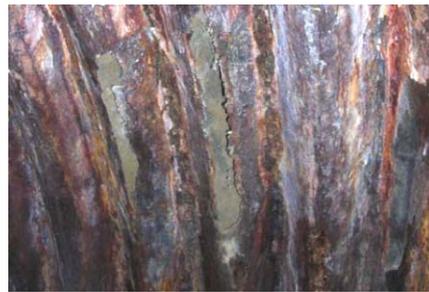
Figure 38. Elongated holes with gray backfill soil visible (Mitchell et al., 2005, detail)

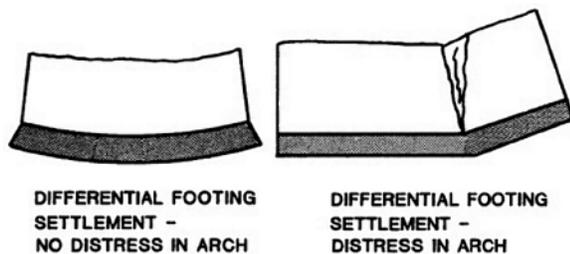
Figure 39. Differential footing settlement (Arnoult, 1986)

Metal culverts built on concrete footings (e.g., corrugated metal structural plate arches, metal long-span culverts) can develop defects such as wrinkling, cracking, spalling, compression or stretching of the corrugations in the culvert barrel due to differential footing settlement (one footing section settles more than the rest of the footing) or rotation of footing due to undermining (Figure 40). Flexible corrugated metal culverts can tolerate some differential settlement but get damaged from extensive ones. The severity of damage increases with the degree of differential footing settlement, decrease in the length over which it is spread, and decrease in the arch height (Figure 39).

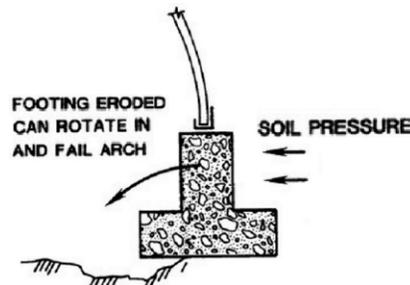
Figure 40. Rotation of footing due to undermining (Arnoult, 1986)

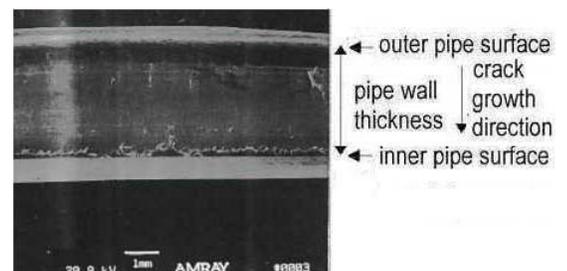
Figure 47. Fracture surface of crack (Hsuan and McGrath, 1999)

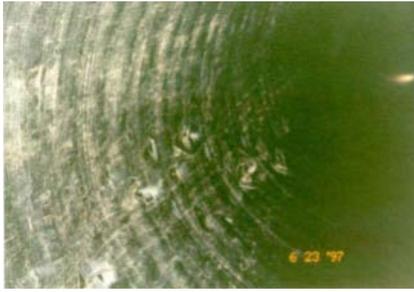
Figure 48. Buckling and elliptical cracking along springline in type S-honeycomb HDPE pipe (Hsuan and McGrath, 1999)

Another type of cracks that can develop as result of SCG failure mechanism is associated with buckling: elliptical cracks around the buckles. An example of this cracking was found in Type S-honeycomb HDPE pipe (Hsuan and McGrath, 1999, Site E). The pipe (42 in. ID) experienced deflection and localized buckling through much of its length. (The buckling commonly occurred with a short wavelength sinusoidal pattern and within the liner, around the circumference of pipe - see section 2.1.4.3 for discussion on buckling). The majority of cracks occurred around the localized buckling regions (Figure 48). The cracks were initiated from the inner surface and grew through the thickness of the liner. In addition, circumferential splitting cracks occurred at the corrugation/liner intersection (Figure 49).

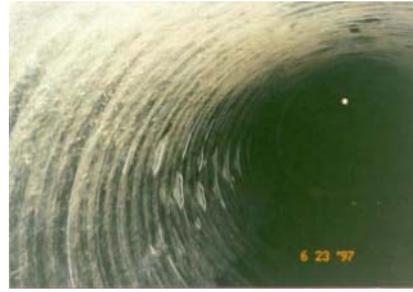
Figure 49. Circumferential cracks in form of splitting cracks along the liner and corrugation (Hsuan and McGrath, 1999)

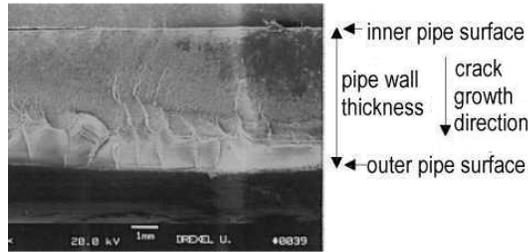
Figure 51. Fracture surface of crack due to RCP (Hsuan and McGrath, 1999)

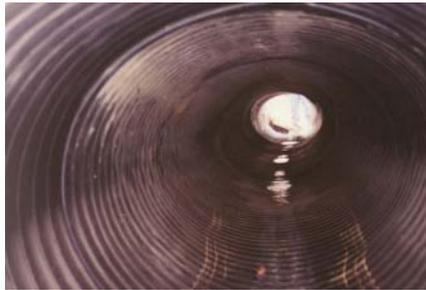
Figure 55. Ovality in a 42 in. HDPE pipe (Nelson and Krauss, 2002)

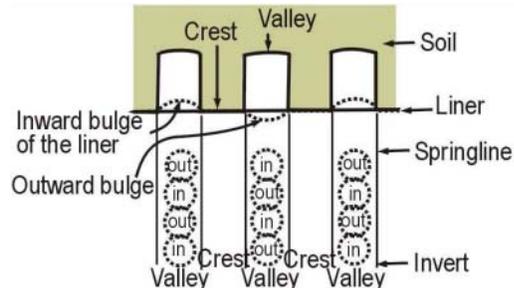
Figure 59. Liner buckling in lined HDPE pipe. Terminology is kept as in the original reference. (Redrawn from Selig, 1995)

A study of a deeply buried corrugated HDPE test culvert for PennDOT was conducted by Selig (1995). This examined both lined and unlined corrugated HDPE pipes under a deep embankment. Buckling was only observed in the lined corrugated pipe, where it occurred in the liner, and was typically observed in the bottom part of the pipe, between the springline and the invert. The buckle waves appeared in a consistent pattern (Figure 59), as seen in the laboratory (Selig et al., 1994; Moore and Laidlaw, 1997). The study also reported how the extent and degree of buckling increased throughout the six years of field investigation.

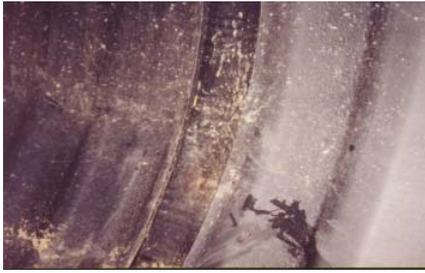
Figure 60. Separated joint (UDOT, 2008)

Defective joints in plastic culverts typically involve open joints (Figure 60, Figure 61) with adjacent pipe sections misaligned (i.e., pipe sections are not lined up relative to each other, exhibiting a disjuncture) or they remain aligned but separate (displaced longitudinally). With partially open joints, one pipe section develops more ovality than the other and a drop in the pipe crown is visible (Figure 61). Joint defects can be caused by improper installation, undermining, uneven settlement of fill, or soil infiltration into the culvert through an opened joint).

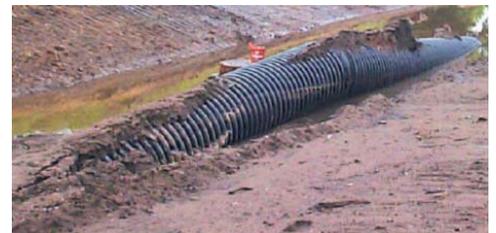
Figure 64. Example of buoyancy problems (UDOT, 2008)

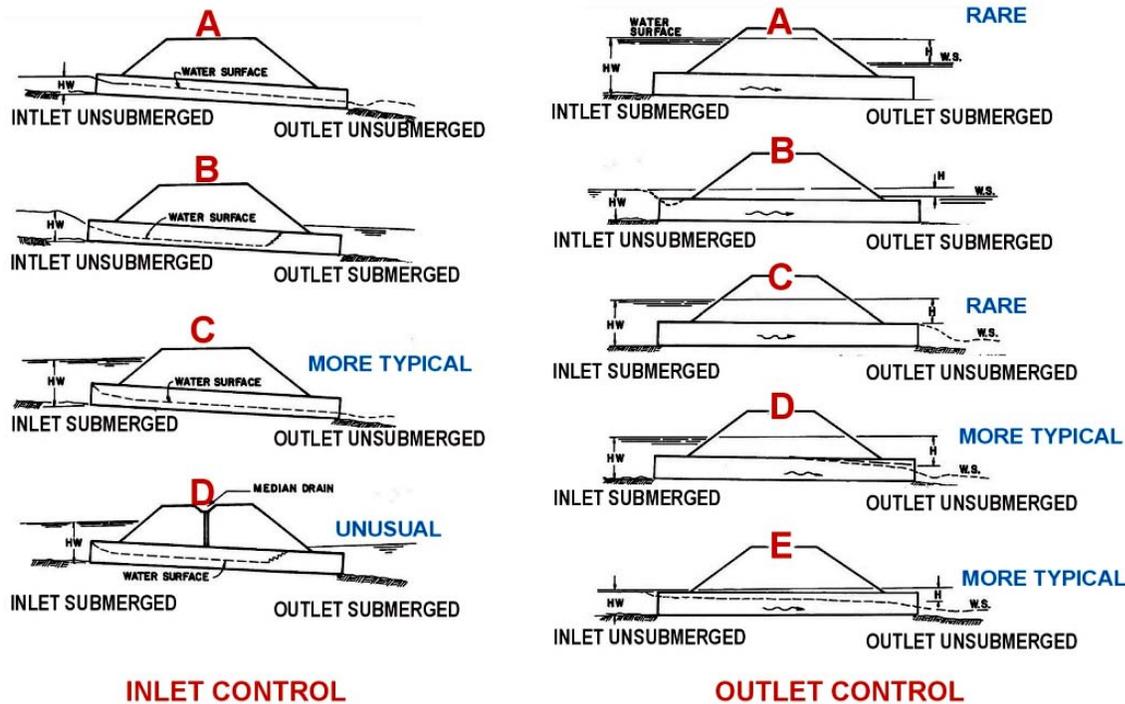
Figure 67. Some examples of flow conditions in culverts operating under inlet control and outlet control (Redrawn from Norman et al. 2005)

For most situations in mountain streams, inlet control prevails because culverts are often short and slopes relatively steep, so the length and barrel slope can be ignored (Douglas, 1974).

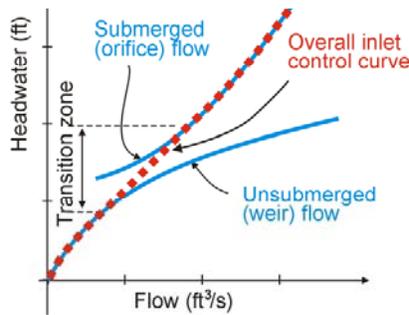
Figure 68. Inlet control curves (Redrawn from Norman et al., 2005)

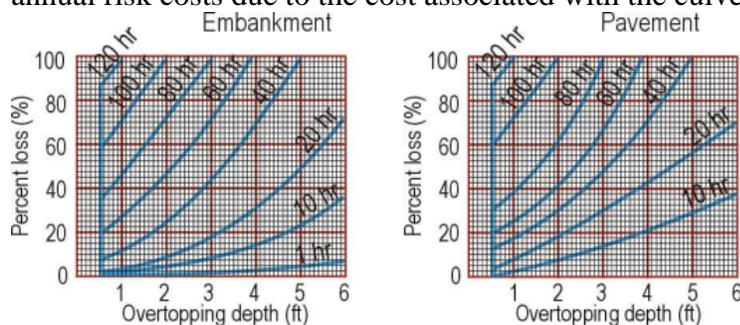
Figure 73. Embankment and pavement losses (Redrawn from Corry et al., 1981)

An example in Appendix B of Corry et al. (1981) illustrates the application of risk analysis to the design of a culvert. A circular culvert 100 ft long should be designed under a two-lane highway, with average traffic 3,000 vehicles per day, discount rate 7.125% and culvert's useful life 35 years. Six floods were used in the analysis (return interval 5, 10, 20, 40, 80, 160 years) and four alternative culvert diameters (48 in., 54 in., 60 in., and 66 in.). The economic losses (traffic interruption, backwater and damage to the embankment) were calculated, as well as annual capital and maintenance costs. The annual risk cost for alternative designs shows that 48 in. is the LTEC design if assuming the culvert does not fail under any flood condition, and it is 54 in. if assuming the culvert fails when embankment losses are greater than 50%. Embankment loss is an estimated volume of embankment that is lost due to erosion during the roadway overtopping; it depends on the duration of overtopping, in hours, and the height of overtopping, in feet (see Figure 73). These estimates are generally based on experience accumulated in some highway agencies; the available datasets are typically incomplete, especially for larger overtopping heights. In this example, the 50% embankment loss was estimated to occur only if a 48 in. culvert was constructed and floods were 170 cfs or greater, which corresponds to a 20-year return interval or longer. Such embankment loss would yield culvert damage and result in an additional cost in the computation of the annual risk costs due to the cost associated with the culvert replacement.

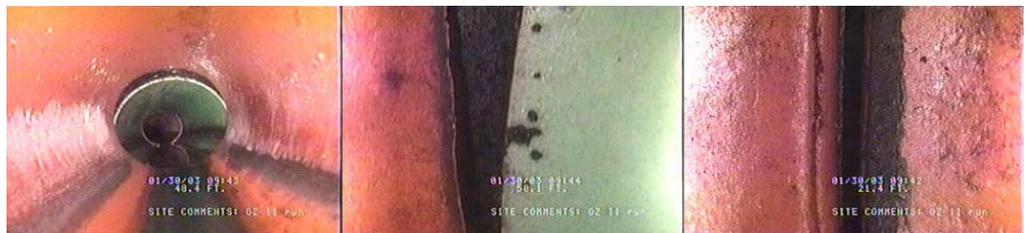
Figure 77. Images obtained with a pan-and-tilt camera: front view and two side close-up views (Courtesy of CUES Inc)

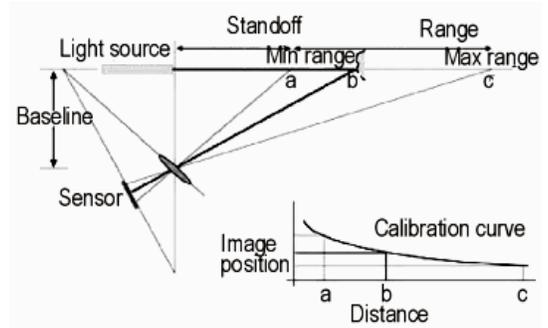
Figure 91. Geometry of optical triangulation (Redrawn from OMC, 2001b)

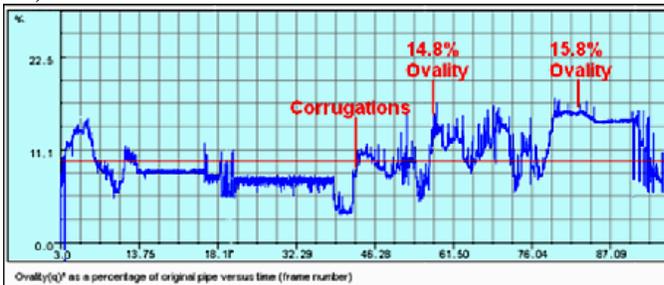
Figure 93. Ovality Analysis Report for a corrugated HDPE pipe (Detail from Bennett and Logan, 2005)

Bennett and Logan (2005) referenced several case studies in which laser profiling was utilized thus demonstrating capabilities of the method to detect different defects in pipes (i.e., ovality, corrosion, a failed CIP liner). For example, in Louisville, KY, a 36 in. corrugated HDPE stormwater pipe was inspected for ovality one year after the installation. The Ovality Analysis Report (Figure 93) showed major shape variation throughout the entire length of pipe (Figure 94, with maximum ovality of 15.8% and minimum of 5.7%). In addition, cracking of the internal wall was detected along the pipeline (Figure 95).

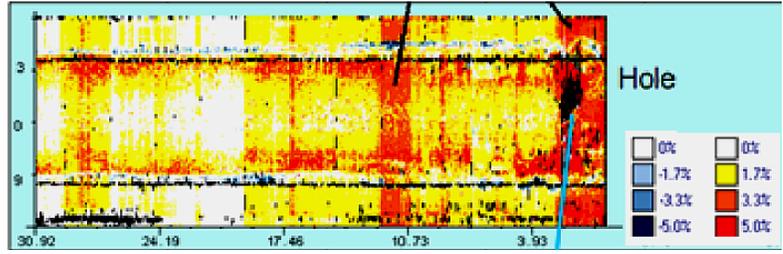
Figure 97. Corrosion in the concrete pipe is depicted in color that indicates the severity (Detail from Bennett and Logan, 2005)

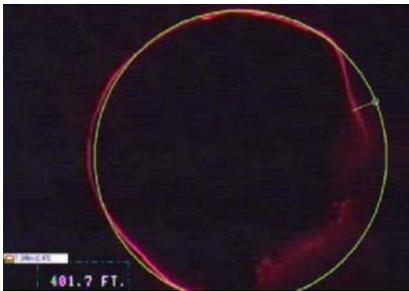
Figure 98. The lift of the CIP liner – an example of location with max lift (Detail from Bennett and Logan, 2005)

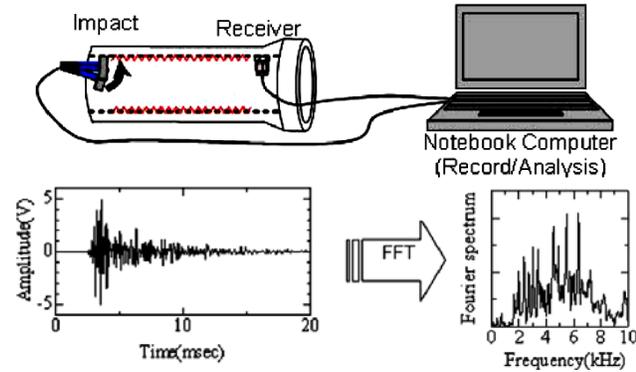
Figure 103. Outline of impact echo testing in a pipeline (Kamada and Okubo, 2005)

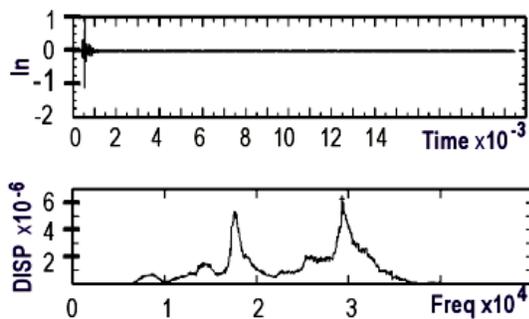
Figure 107. Typical record from delaminated conditions (Redrawn from Sack and Olson, 1998)

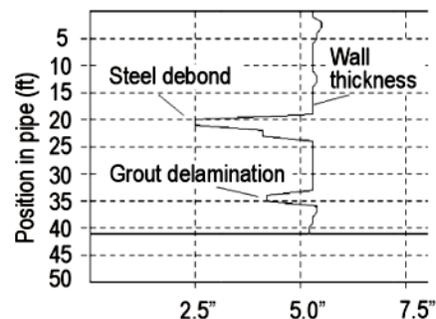
Figure 108. Overall results from the single point testing: wall thickness vs. location (Redrawn from Sack and Olson, 1998)

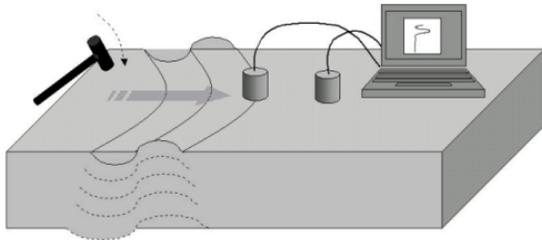
Figure 109. Principle of testing with SASW kit (Force Technology, 2007)

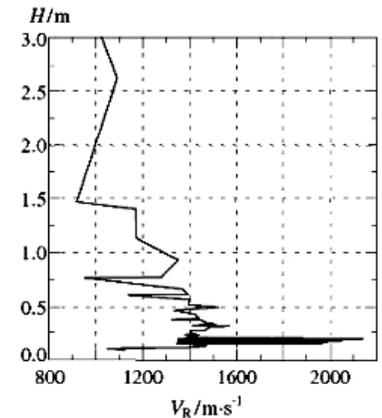
Figure 113. Phase velocity vs. depth curves, at x=127 ft (Sun et al., 2007)

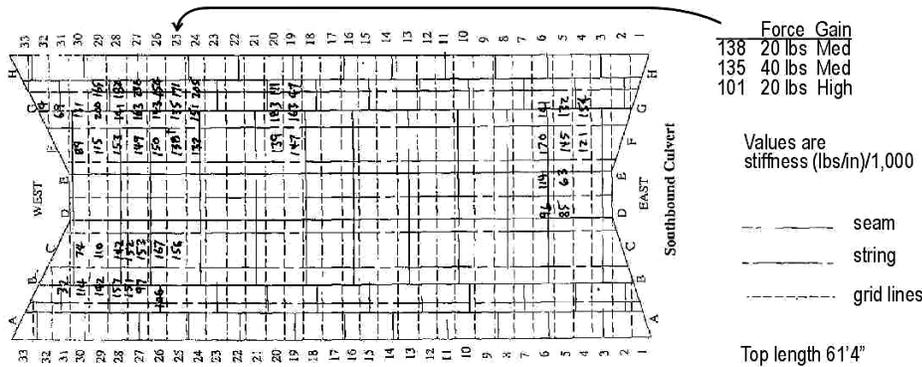
stiffness values between 760,000 and 1,720,000 lbs/in.

Figure 116. Stiffness values in grid points in the MN 1995 test (Redrawn from Sterling et al., 1997)

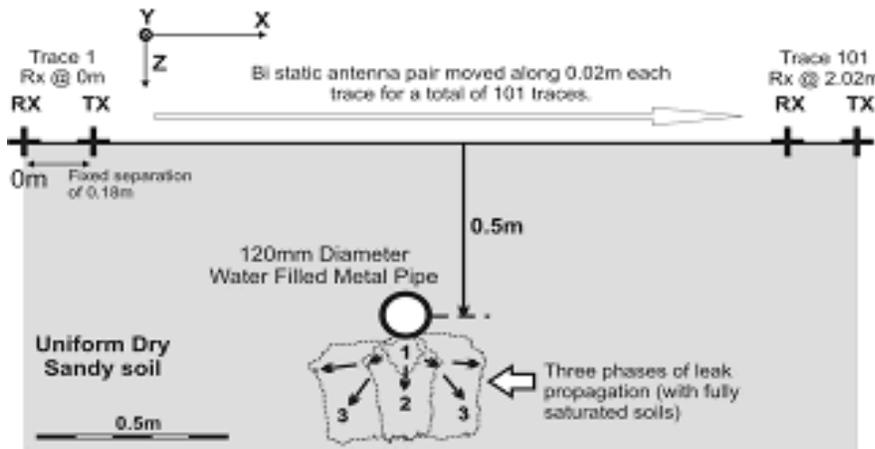
Figure 123. Basic geometry used in the study showing three phases of leak propagation (Nuzzo et al., 2008)

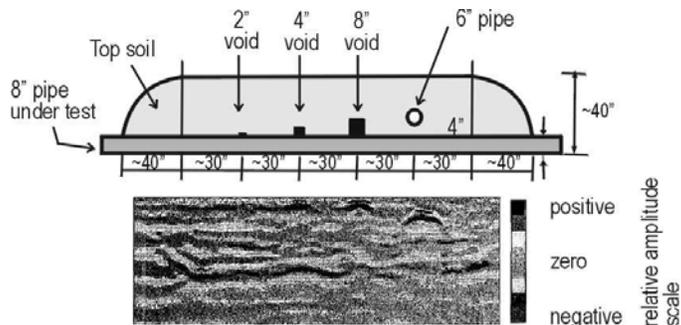
Figure 124. Test rig for GPR testing from within the pipe and radar image of defects adjacent to the pipe. i.e. voids in the soil (Redrawn from Daniels, 1996a)

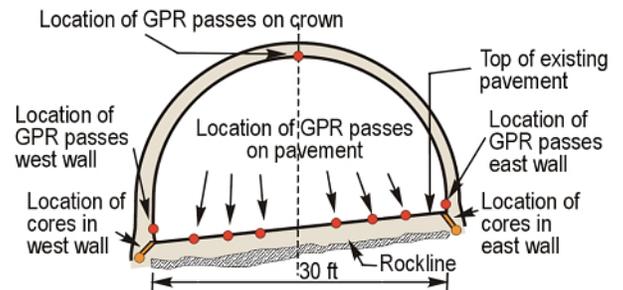
Figure 130. Location of GPR passes and cores (Redrawn from Thiel et al., 2008)

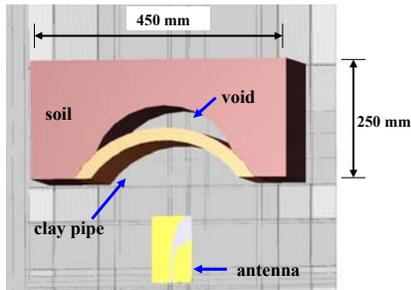
Figure 133. 3D numerical model of pipe inspection with soil void (Jaganathan et al., 2009)

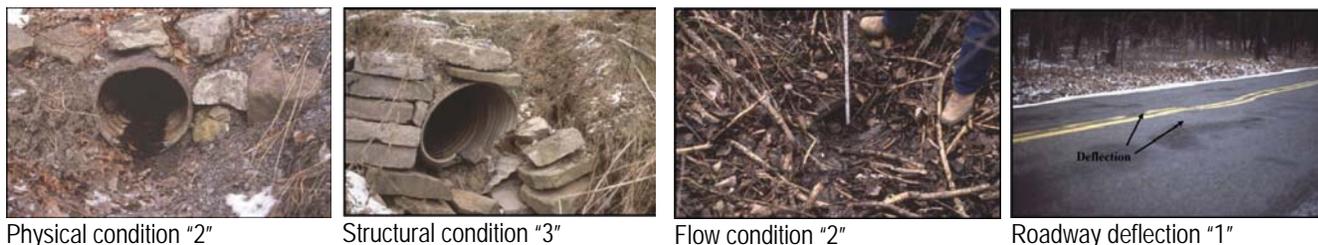
Figure 141: Some examples of PennDOT condition rating for different parameters (PennDOT, 2008).

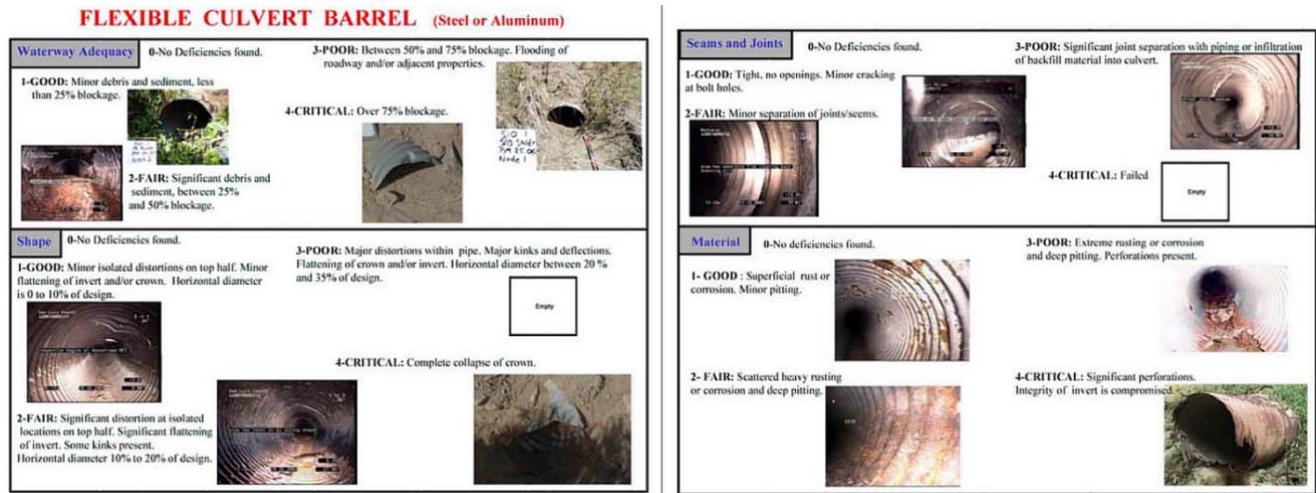
Figure 142: Caltrans criteria for condition rating of corrugated metal culvert barrel (Caltrans, 2003).

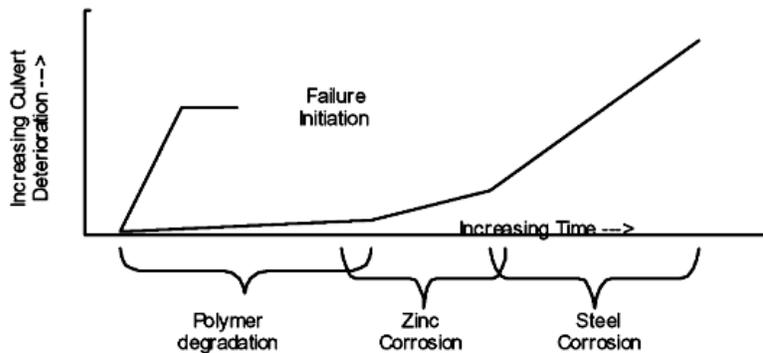
Figure 147. Service life model for polymer coated CSP (Ault, 2003)

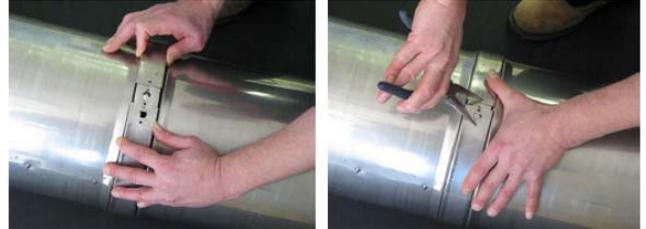
Figure 158. Connecting stainless sleeves into a continuous liner (LINK-PIPE, 2008c).

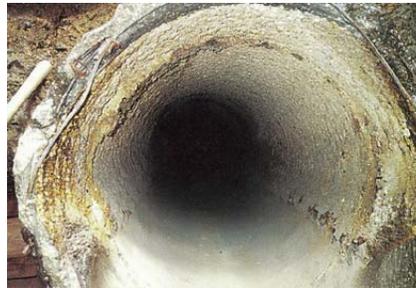
Figure 163. A corroded pipe can cause thickening of the grout due to excessive fluid loss (Stephens, 1996)

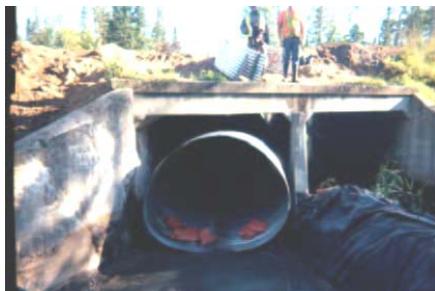
Figure 165. Sliplining of concrete box culvert (CONTECH, 2002)

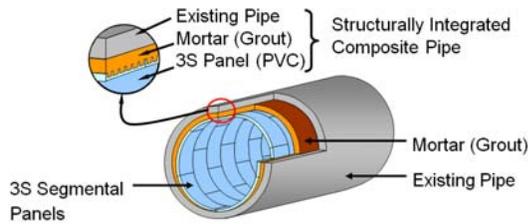
Figure 208. Segmental lining can create a structurally integrated composite pipe consisting of the existing pipe, high strength grout and panels (Kampbell, 2009)

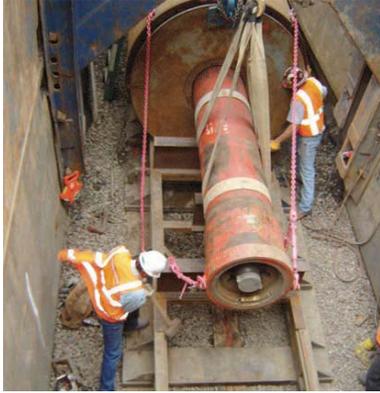
Figure 254. Pneumatic hammer is attached to the rear of the casing or pipe (Schill, 2007).

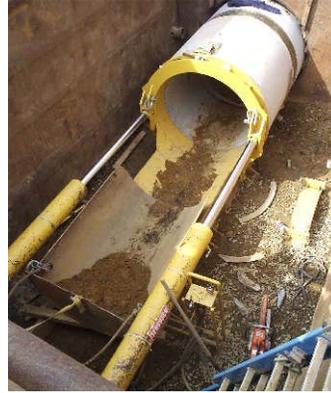
Figure 255. Jacking unit inside the pit (Tenbusch and Tenbusch, 2008)

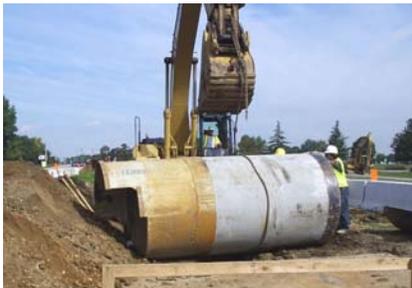
Figure 256. A protective shield attached to a new RCP for protection of workers during removal of CMP and soil excavation (Tenbusch and Tenbusch, 2008)

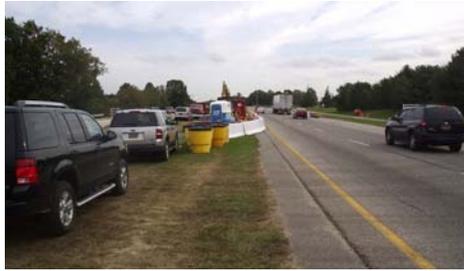
Figure 259. The traffic along the highway was not affected as the existing 48 in. CMP culvert was replaced with a new 54 in. concrete pipe (Tenbusch et al., 2009).

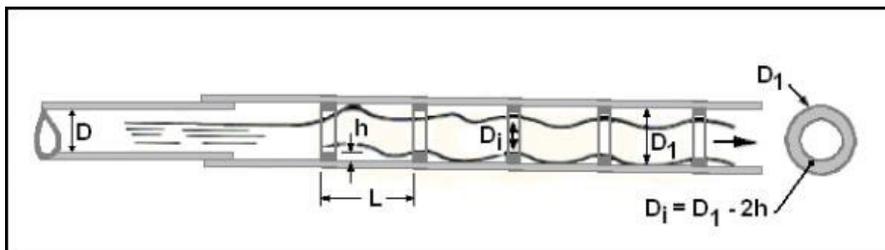
Figure 280 Circular rings inside the barrel (Thompson and Kilgore, 2006)

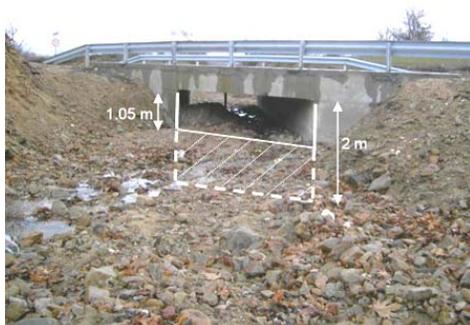
Figure 289. Reduction of the culvert height from original 6.5 ft to 3.5 ft due to debris (Pelivanoski and Ivanoski, 2010)

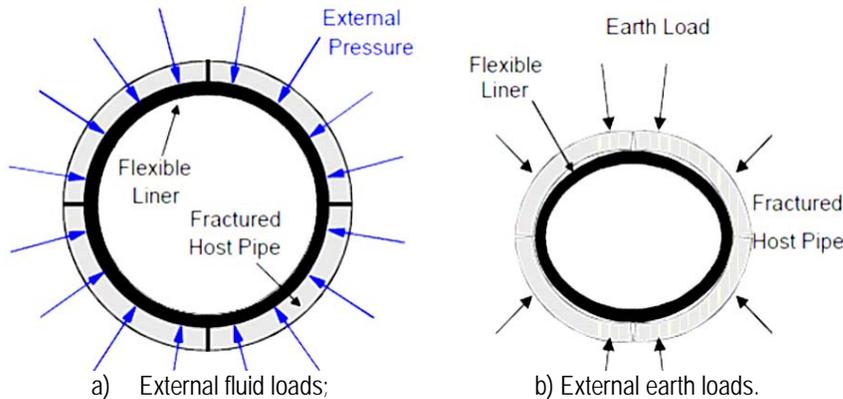
Figure 295. Two loading conditions requiring consideration (Moore, 2005)

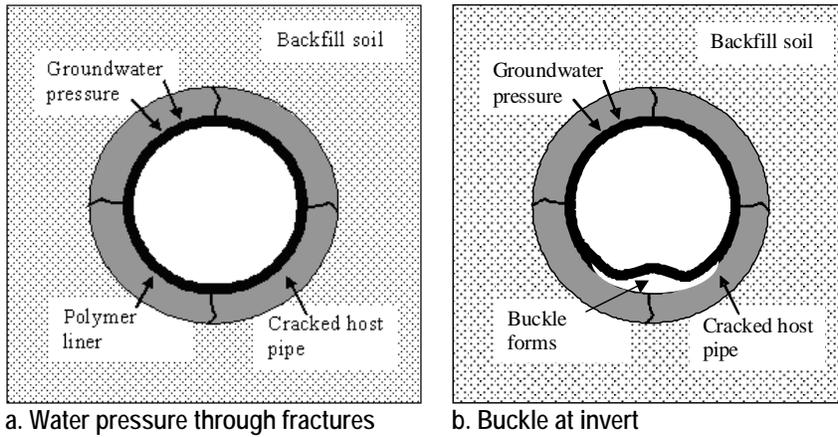
Figure 296. Cause and outcome of fluid pressure buckling (Moore, 2005)

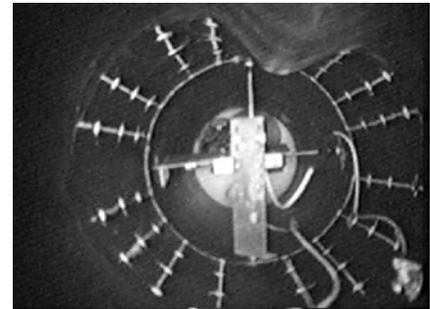
Figure 297. Buckle observed during a laboratory test (Santamaria, 2003)

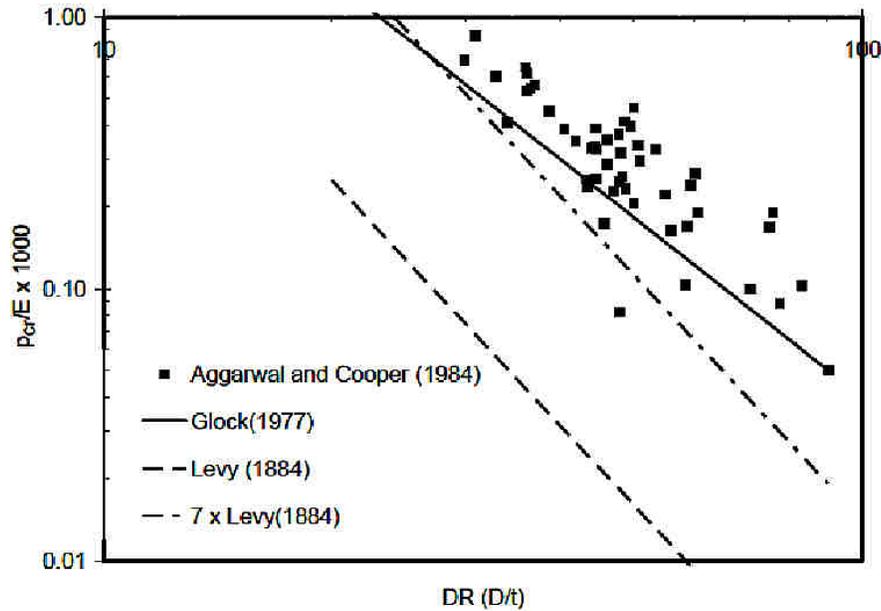
Figure 298. Experimental data, unfactored and factored Levy theory, and the nonlinear restrained shell buckling theory of Glock (1977) reported by Moore (2005).

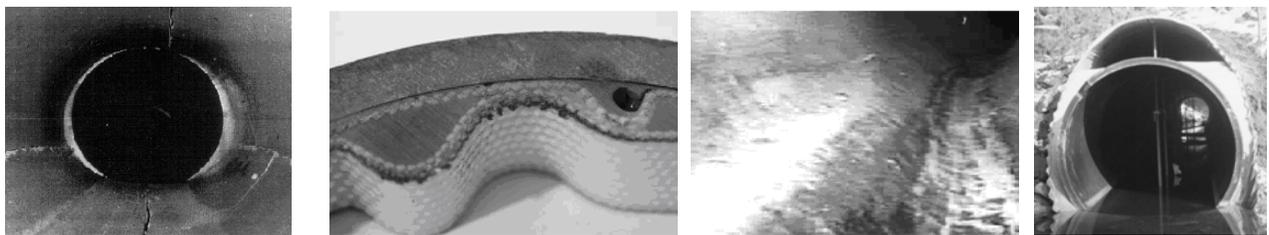
a. Ovality (Law and Moore, 2007b)

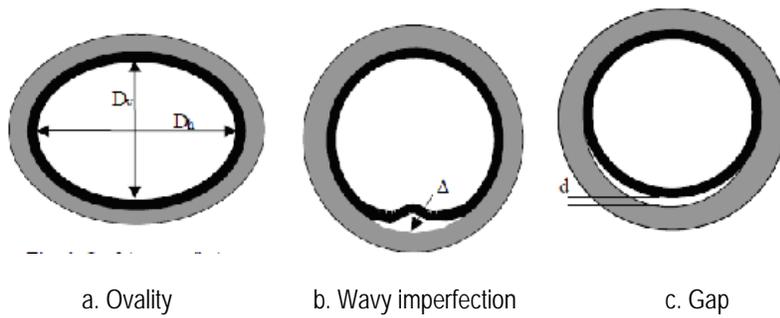
Figure 300. Idealized imperfection geometries (Moore, 2005; Gumbel, 2001)

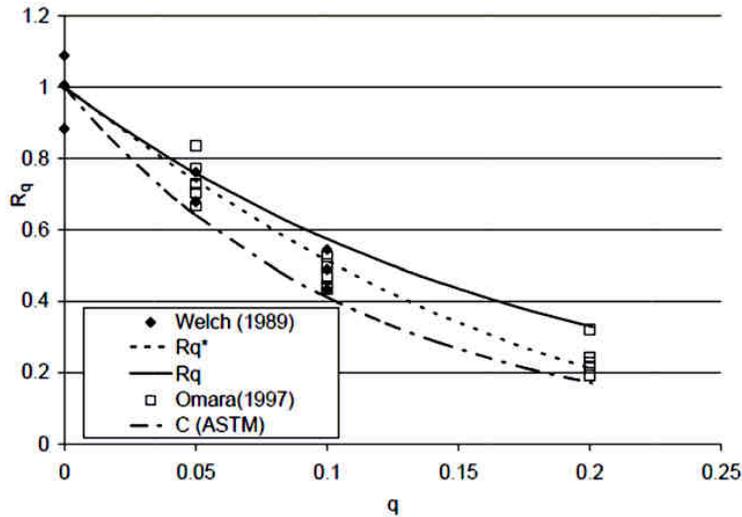
Figure 301. Comparison by Moore (2005) of the buckling theory for elliptical structures (El Sawy and Moore, 1997; ASTM F1216) against the test measurements of Welch (1989) and Omara (1997).

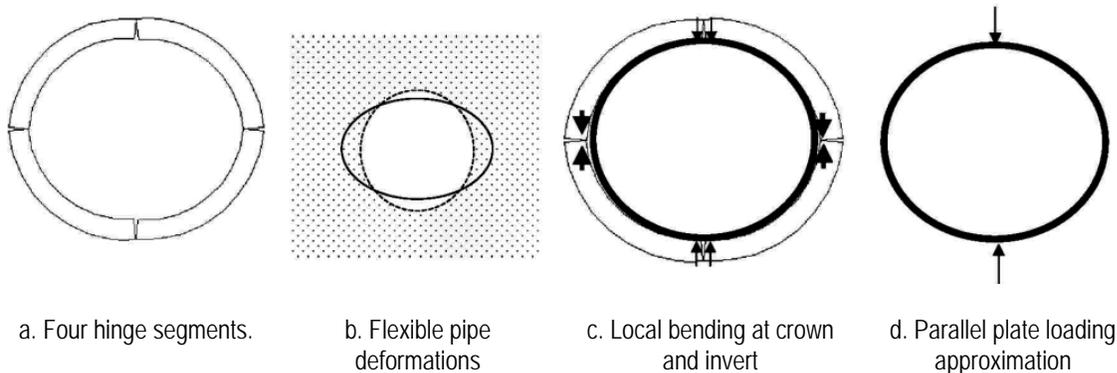
Figure 302 Fractured pipe kinematics and statics under earth loads (Law and Moore, 2003b)

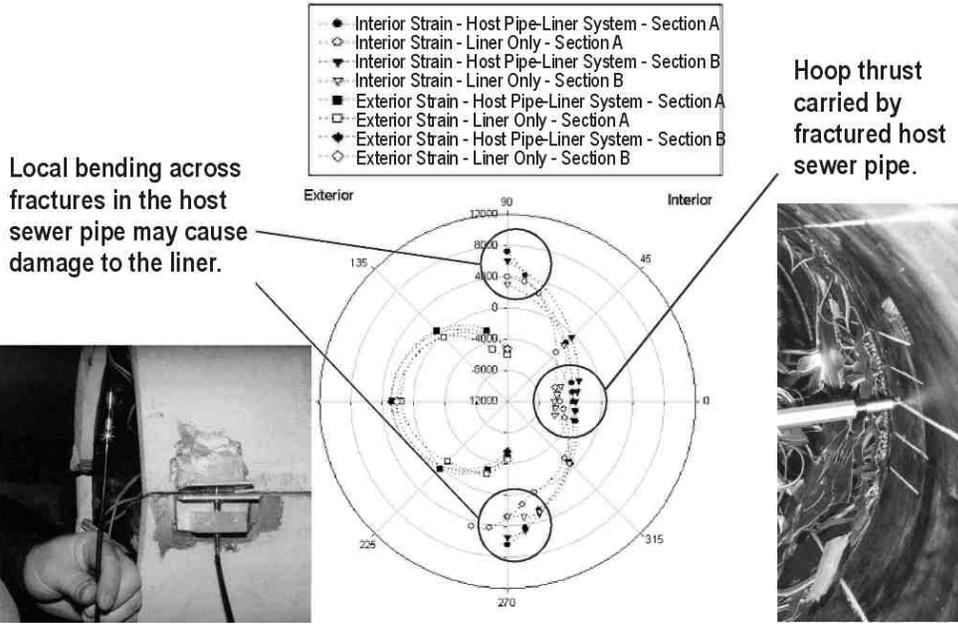
Figure 303. Lined pipe specimen tested under earth loading (Law and Moore, 2003b)

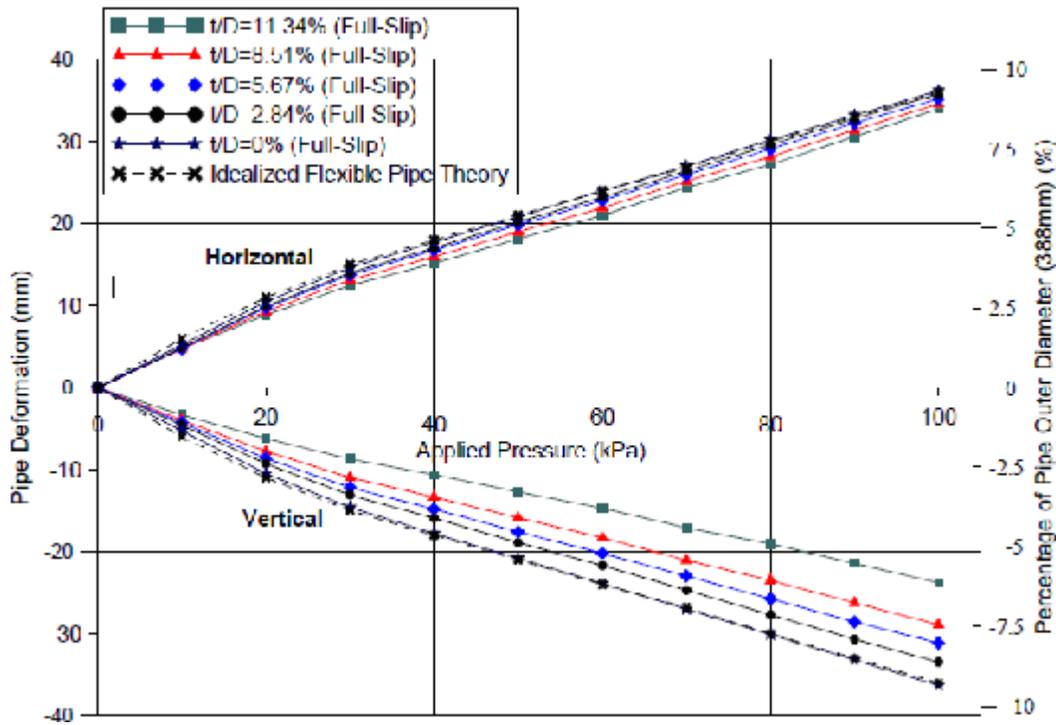
Figure 304. Finite element calculations for fractured rigid pipe deflection versus flexible pipe theory, Moore (2008).

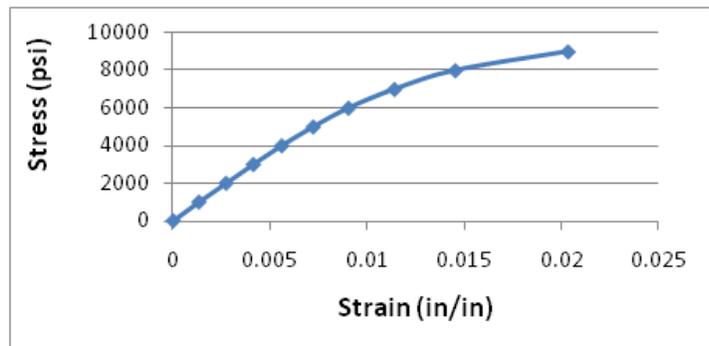
Figure 306: Nonlinear stress versus strain relationship of a spray-on polyurethane coating product (Allouche and Steward, 2009)

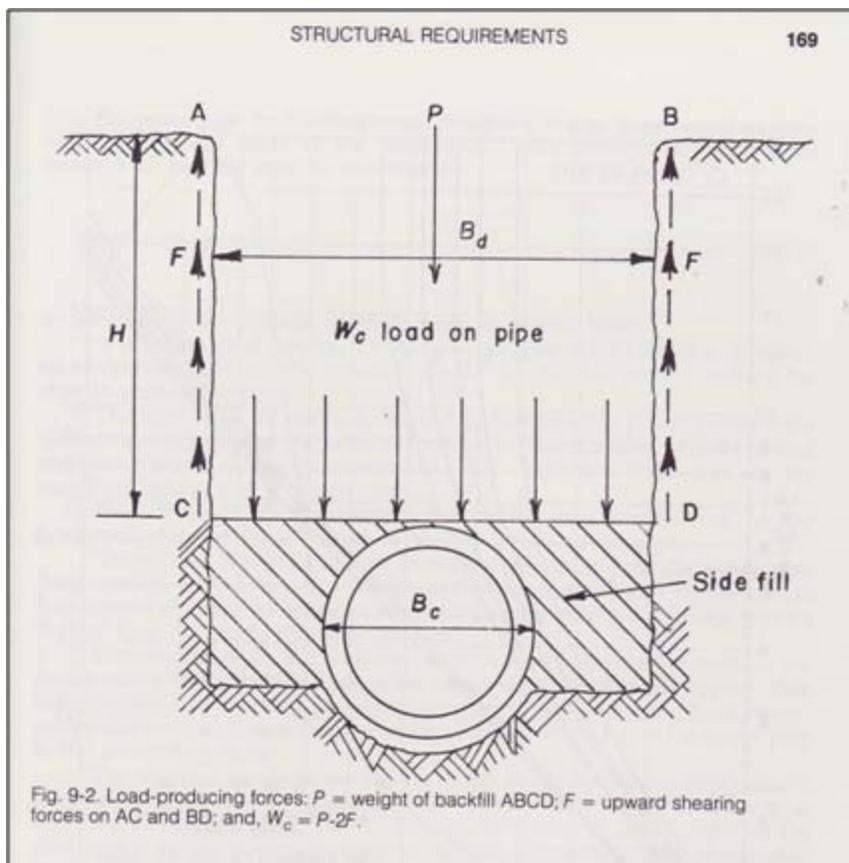
Figure 307: Loads in liner thickness design for centrifugally cast concrete pipe process (Henning, 2010).

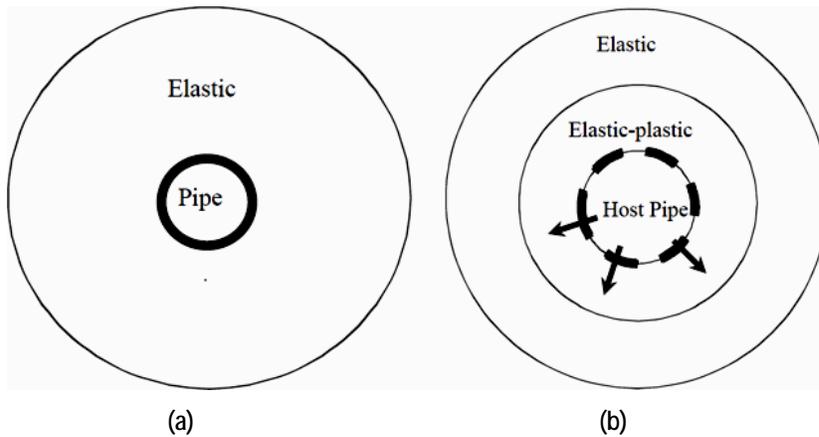
Figure 308: Ground conditions (a) before bursting and (b) during bursting (Fernando and Moore, 2001)

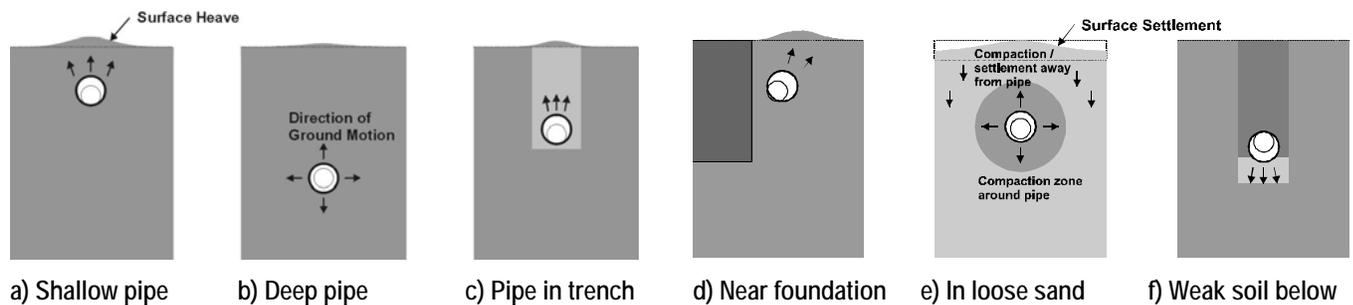
Figure 309: Conceptual ground movements (Sterling et al., 1999)

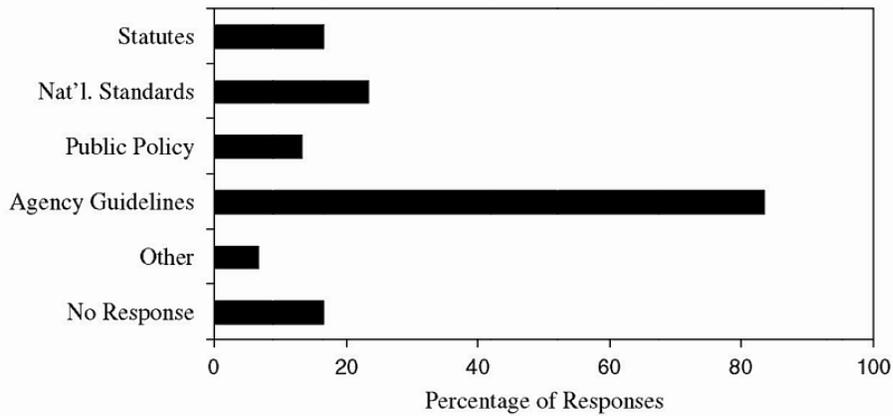
Figure 312. Technical management guidance for maintenance and rehabilitation of culverts. (Markow 2007)
