SHRP-S/FR-92-106

Condition Evaluation of Concrete Bridges Relative to Reinforcement Corrosion

Volume 4: Deck Membrane Effectiveness and a Method for Evaluating Membrane Integrity

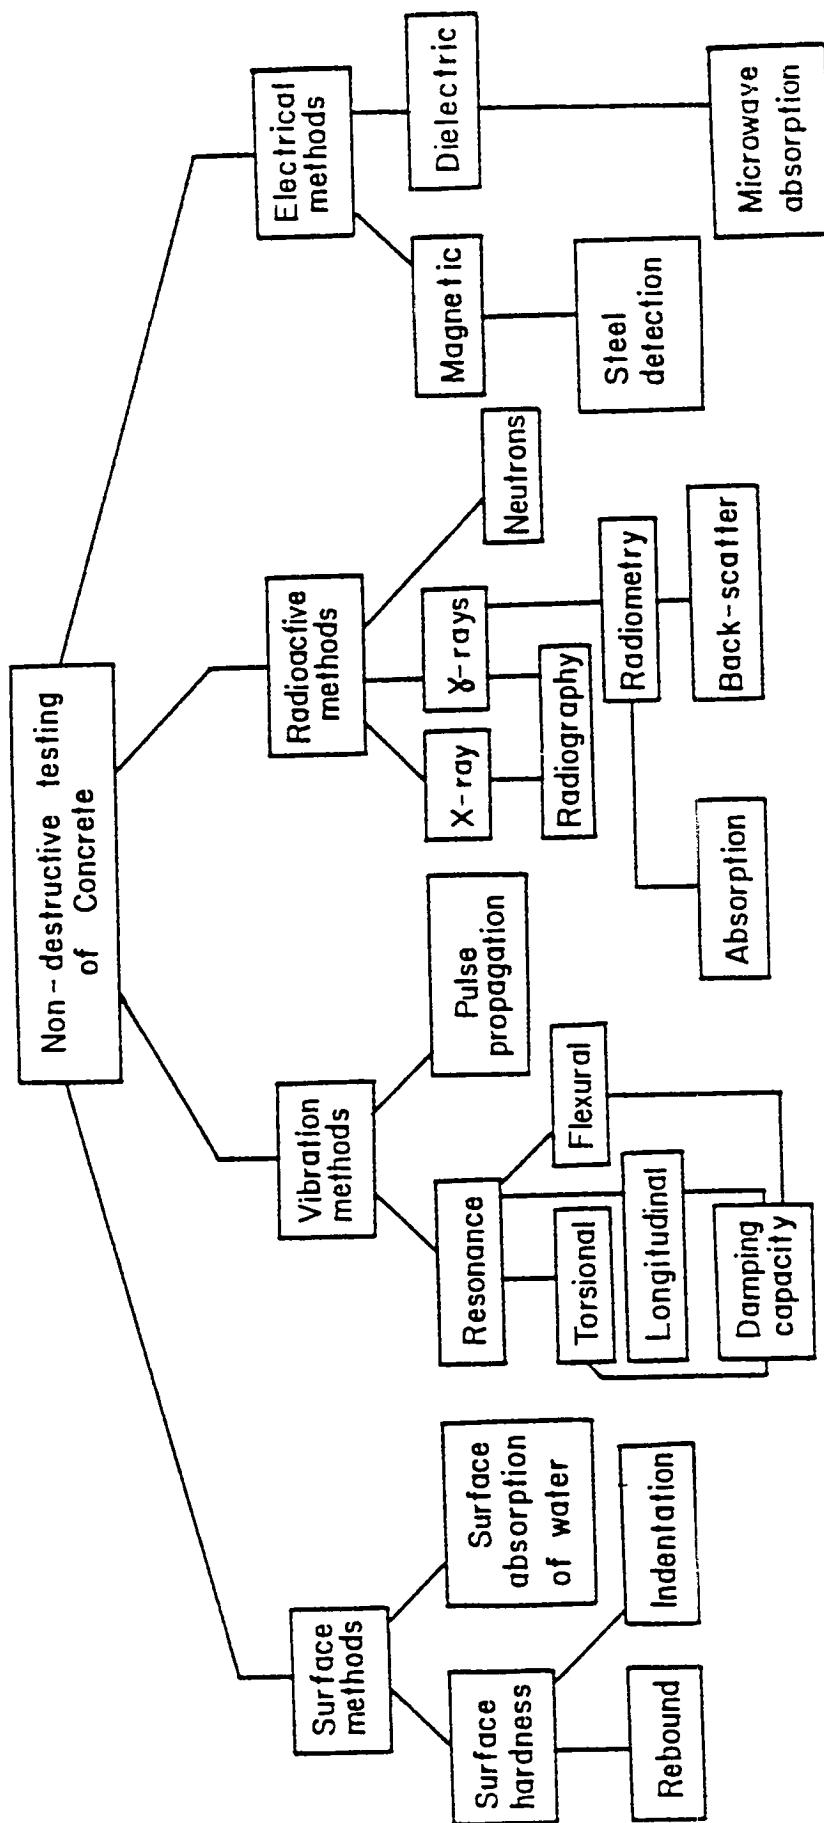
Figure 2-1. Range of techniques that have been investigated or developed for nondestructive testing of pavement systems (11).

Nondestructive testing of pavement systems can be divided into four categories: surface methods, vibration methods, radioactive methods, and electrical methods. These four categories can be further divided into the methods shown in Figure 2-1 (11). However, not all of the techniques presented in Figure 2-1 can be applied in the field, and there are some other technologies that may be applied to pavement systems like laser technology, infrared thermography, and image processing (12). The technologies that can be used to detect defects in pavement systems are discussed below, along with the feasibility of using these techniques for detecting defects in membranes.

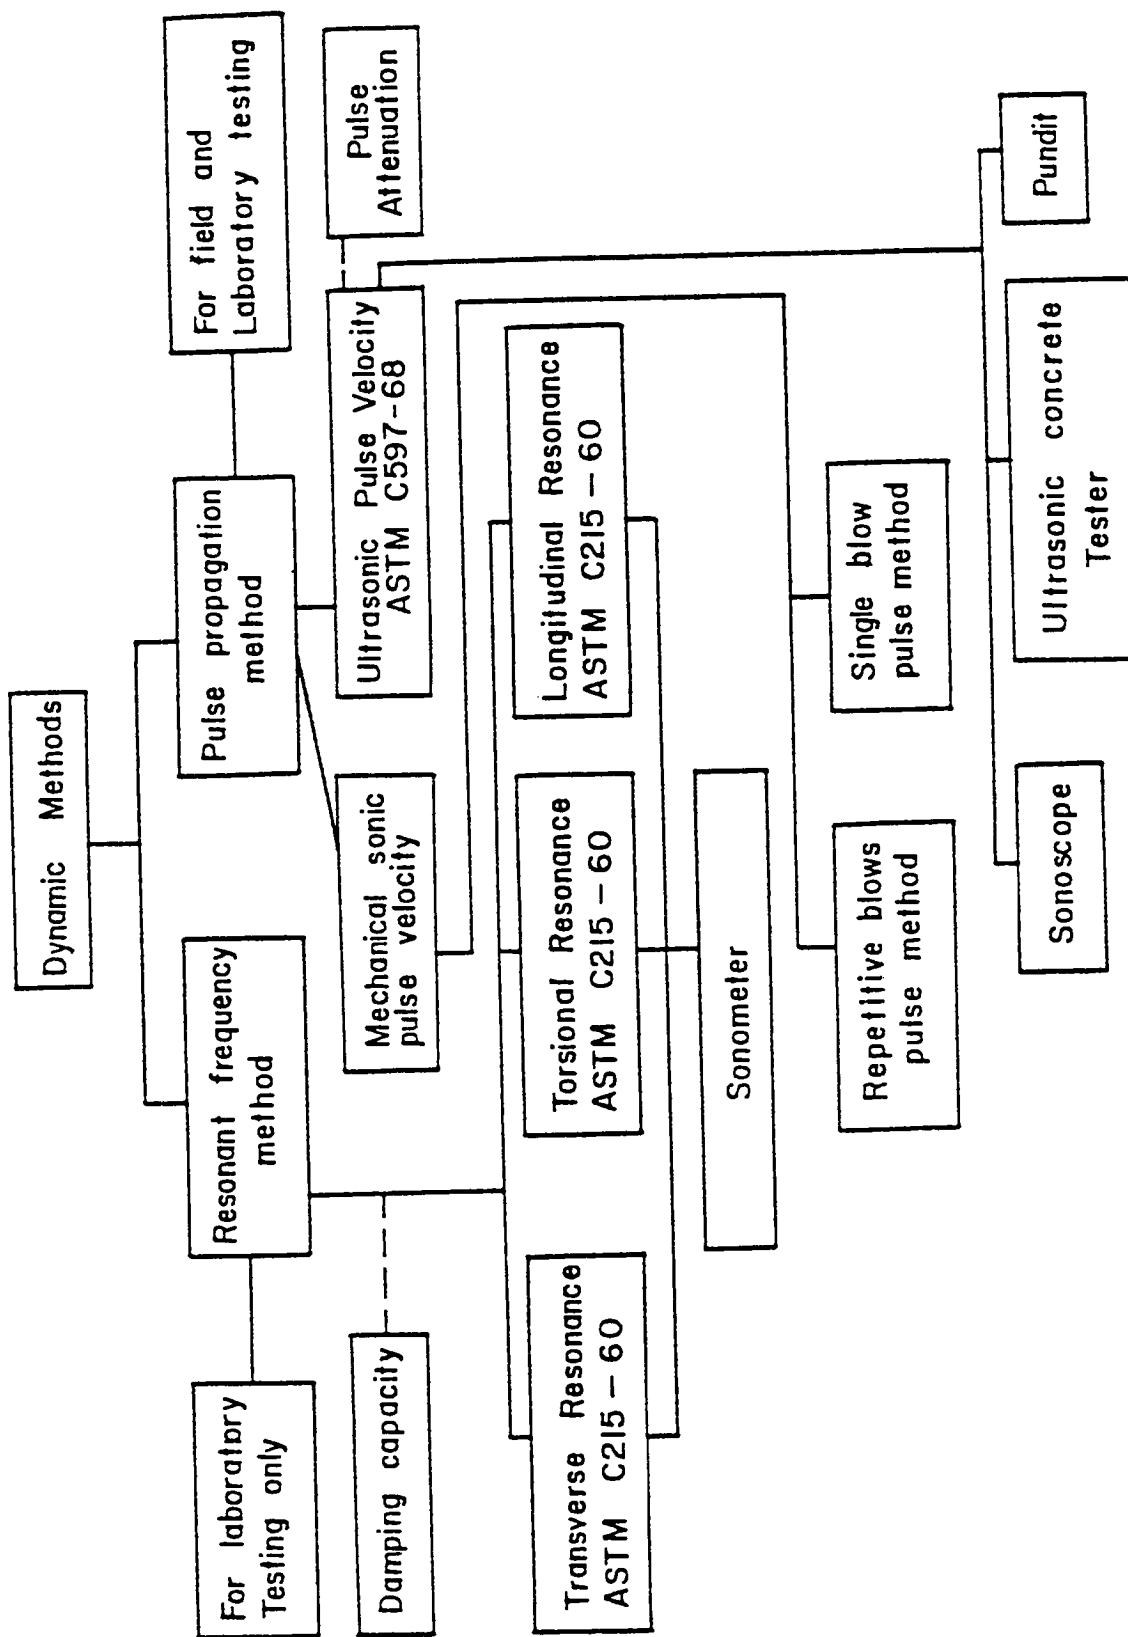
Figure 2-2. Dynamic methods (22).

The dynamic (vibration) test methods have been used in concrete testing (in the laboratory and in the field) for the past five decades. This method has been used to measure the fundamental properties of concrete in the laboratory, and check the quality of concrete in bridge piers, pavements, and hydraulic structures (2). This method can be categorized as either a resonant frequency method or a pulse velocity method, as shown in Figure 2-2. The resonant frequency method is based on the determination of the fundamental resonant frequency of the vibration of a specimen, which is generated electromechanically. The application of this method, which has been standardized by the American Society for Testing and Materials (ASTM), has been limited to laboratory testing. The pulse velocity method can be either a mechanical sonic pulse velocity or ultrasonic pulse velocity method. The mechanical sonic pulse velocity method involves the measurement of the travel time of longitudinal or compressional waves generated by a single-impact hammer blow or repetitive blows. The ultrasonic pulse velocity method involves measurement of the travel time of

electronically generated mechanical pulses. The transit time is measured by a digital meter and the electronic pulse is detected by an oscilloscope. This method has been standardized by ASTM as C597-83.

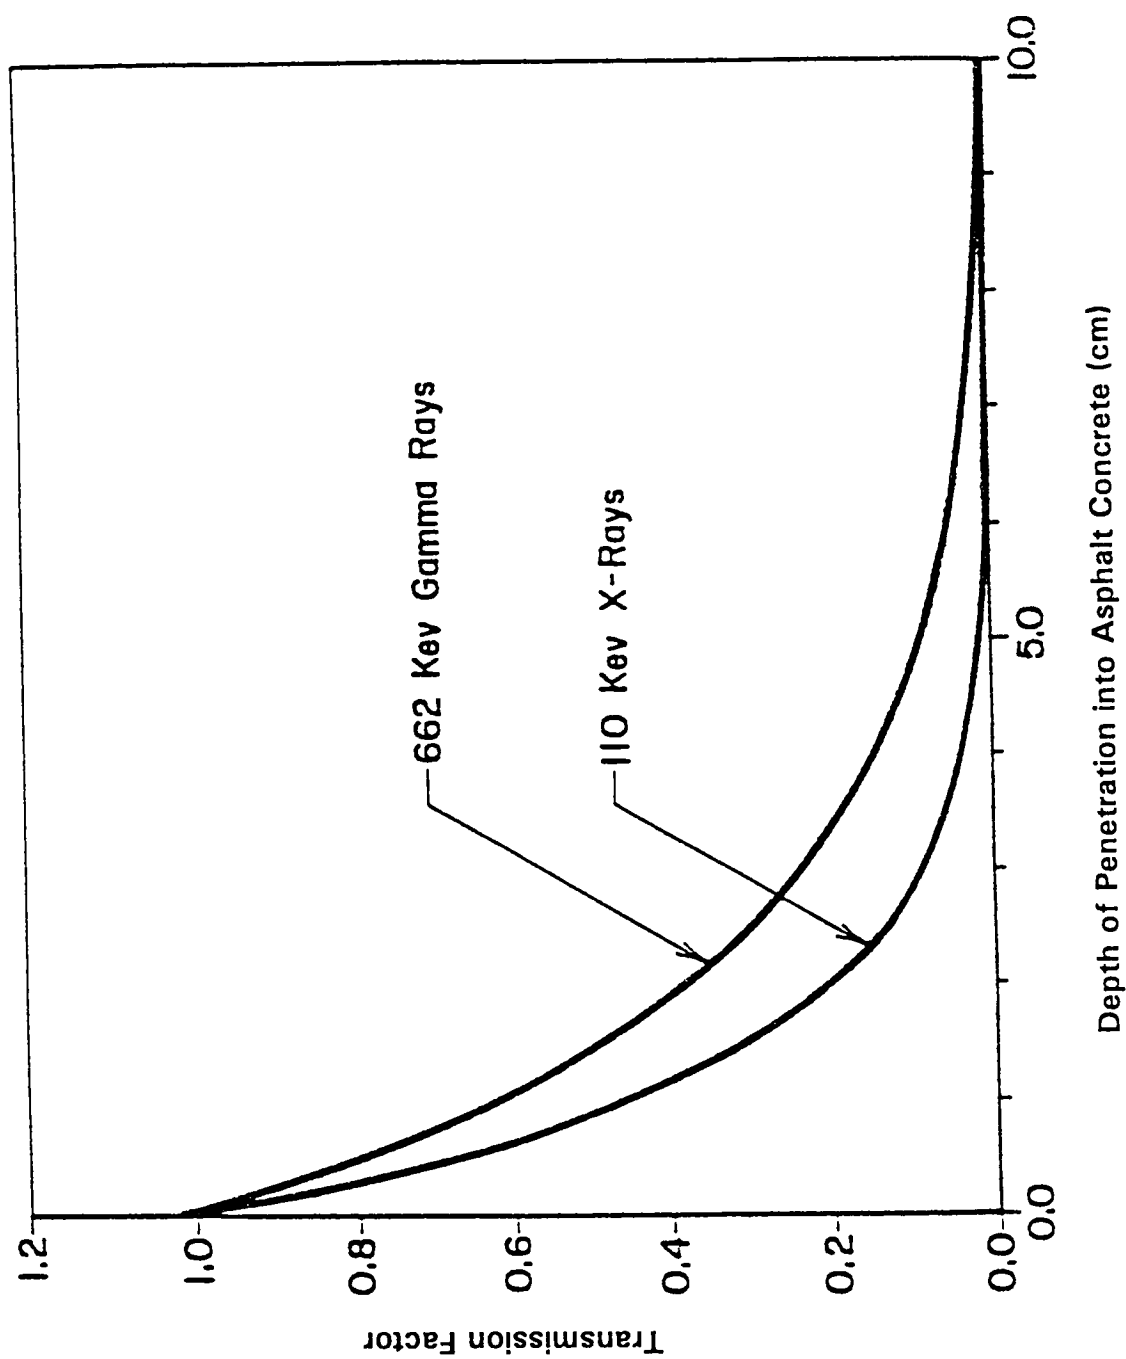
Figure 2-3. Relationship between depth of penetration and transmission factors for gamma rays and X-rays (12).

Gamma radiography is believed to be a beneficial tool for the inspection of concrete, and it provides a permanent record of defects (25). The principle of gamma radiography is the observation of the difference in attenuation of incident radiation resulting from the difference in the thickness and density of the material, as well as the energy of the radiation used. The observation is made by the interaction of the emergent radiation with a suitable photographic film. The developed film shows light and dark areas corresponding to the presence of steel and voids in the concrete. The steel produces more attenuation, and consequently less interaction, while the voids produce more interaction. It was used successfully, during the late 1950s, for locating steel and voids in concrete, and voids in the grouting of post-tensioned and prestressed concrete (26-28). However, the main use, so far, has been to detect the extent of internal faults and failures in structures. This technique has an advantage over X-rays, since it has the possibility of using high energy radiation without extensive danger of high voltage equipment and at low cost for the radiation production. However, the main disadvantages are the shielding requirements and the difficulty of obtaining a small high-intensity source in order to produce a good resolution in the radiograph.

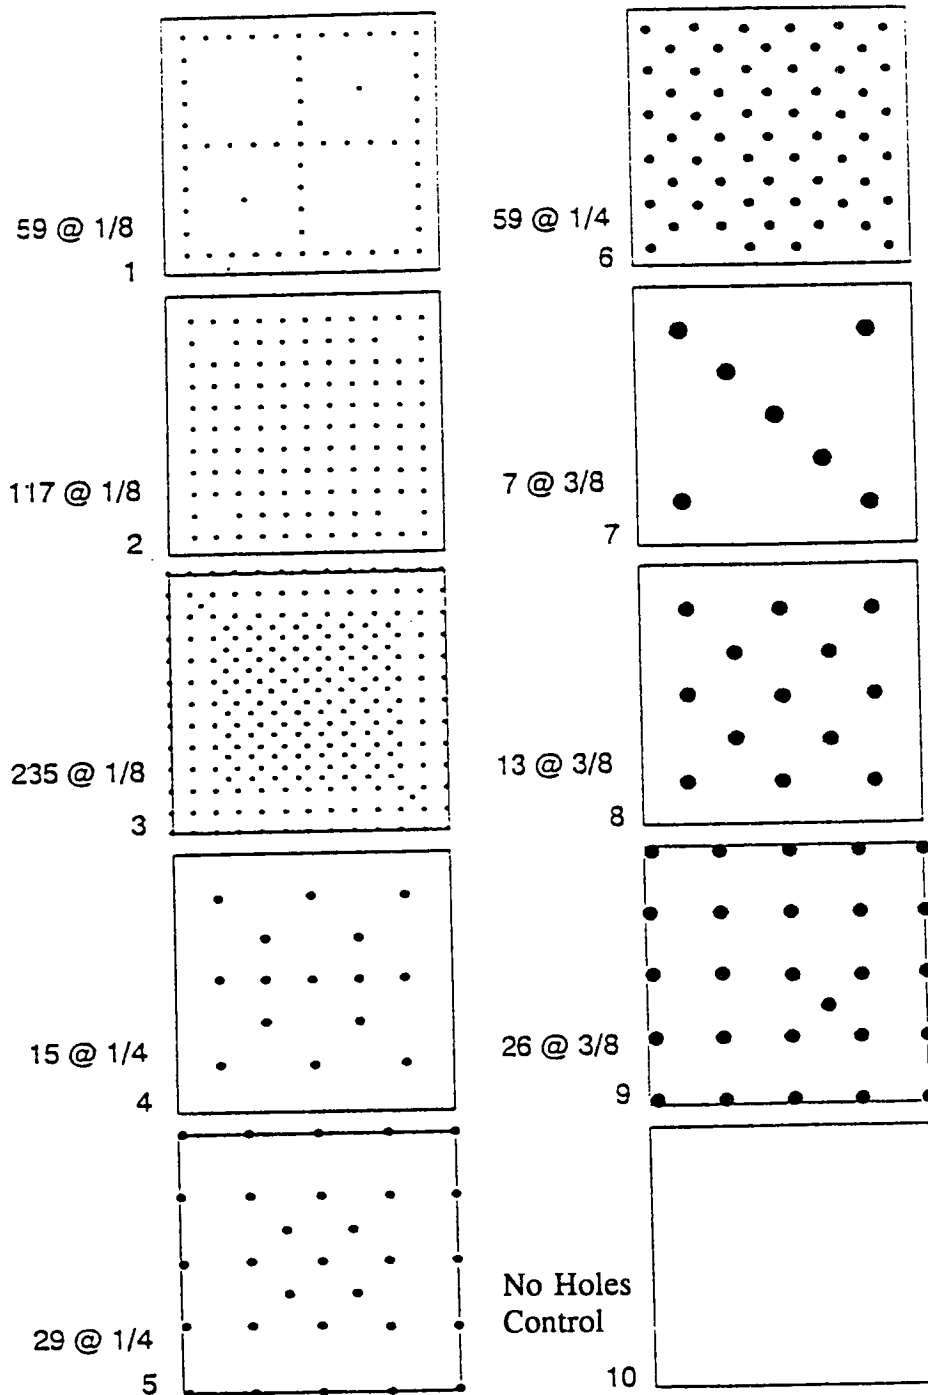
Note: each square represents a square foot (0.093 m^2) of material.

Figure 3-1. Schematic diagram of the perforation frequencies and sizes.

The second phase involved the preparation of 12 Marshall specimens overlaying membranes with different hole sizes and patterns. A 1/4-in.-thick plexiglass sheet, which is temperature resistant up to 350°F, was placed on the mold base. The membrane was placed on the plexiglass piece. The following hole patterns were used in the membrane: 1 x 1/8 in. (25 x 3 mm), 5 at 1/8 in. (ϕ) (3 mm [ϕ]), 1 x 3/8 in. (25 x 9 mm), and 3 at 3/8 in. (ϕ) (9 mm [ϕ]). The hot-mix asphalt, with the same mixture as the slab overlays, was placed and compacted for 50 blows using an automatic Marshall compactor.

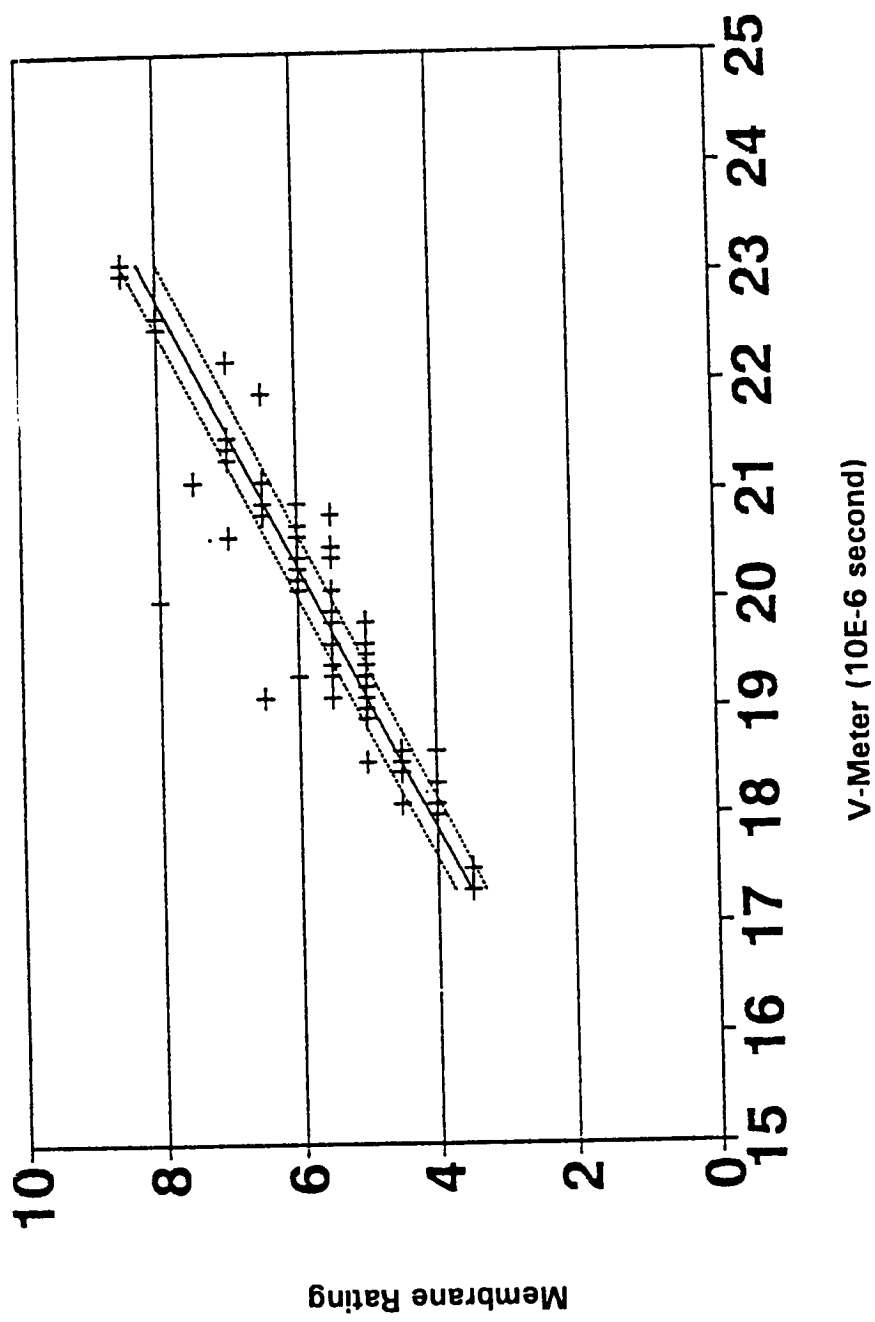
Figure 4-1. The membrane rating model with 95-percent confidence interval (laboratory slabs).

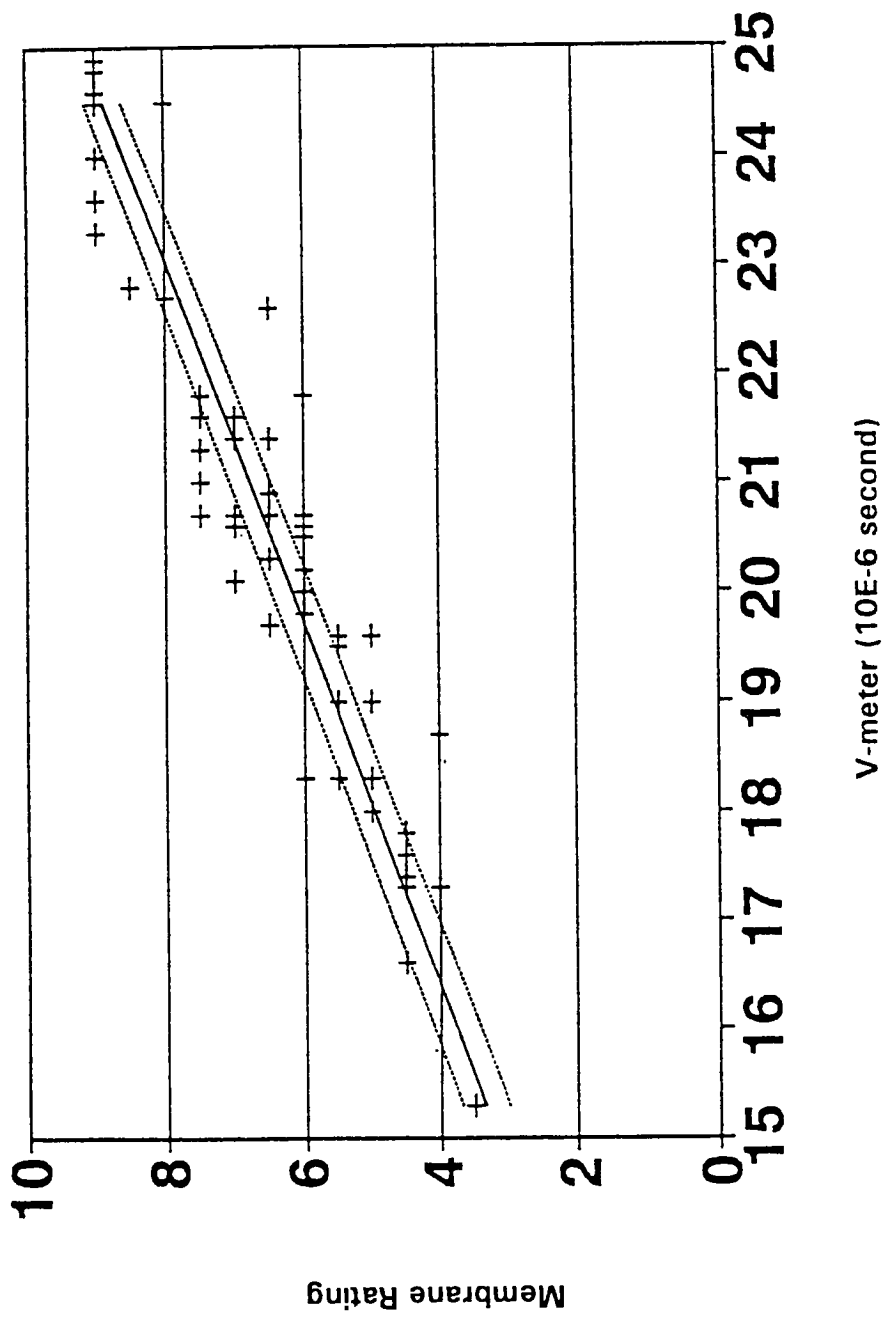
Figure 5-3. The membrane rating model with 95-percent confidence interval for New Hampshire bridges.

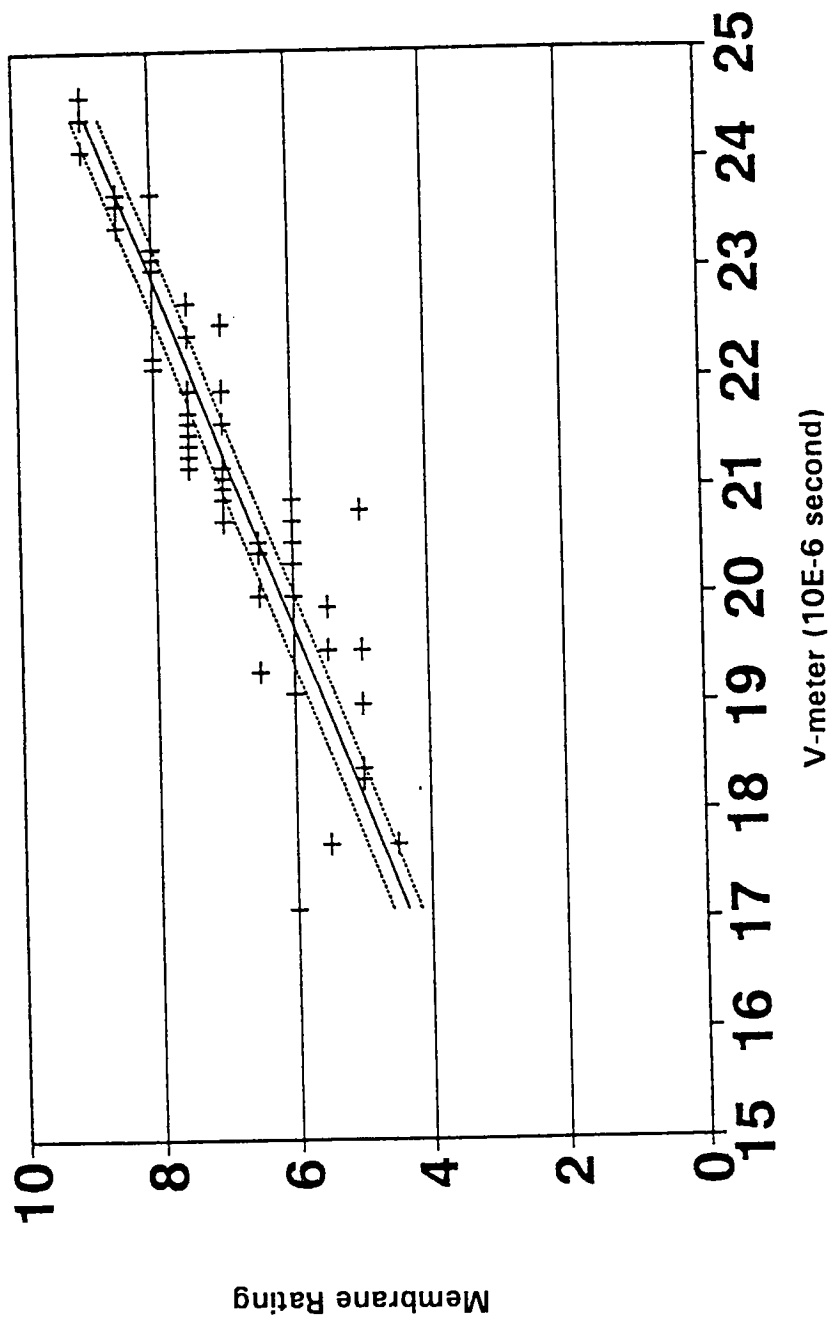
Figure 5-4. The membrane rating model with 95-percent confidence interval for Maine bridges.

A coefficient of determination (R^2) value of 91.6 percent was obtained, indicating a good correlation between the V-meter measurements and the membrane rating. Also, a root mean square error of 0.447 supports this conclusion. A two-tail 95-percent significance t-test indicated that the two coefficients of the model are significant. The 95-percent confidence interval is presented in Figure 5-4.

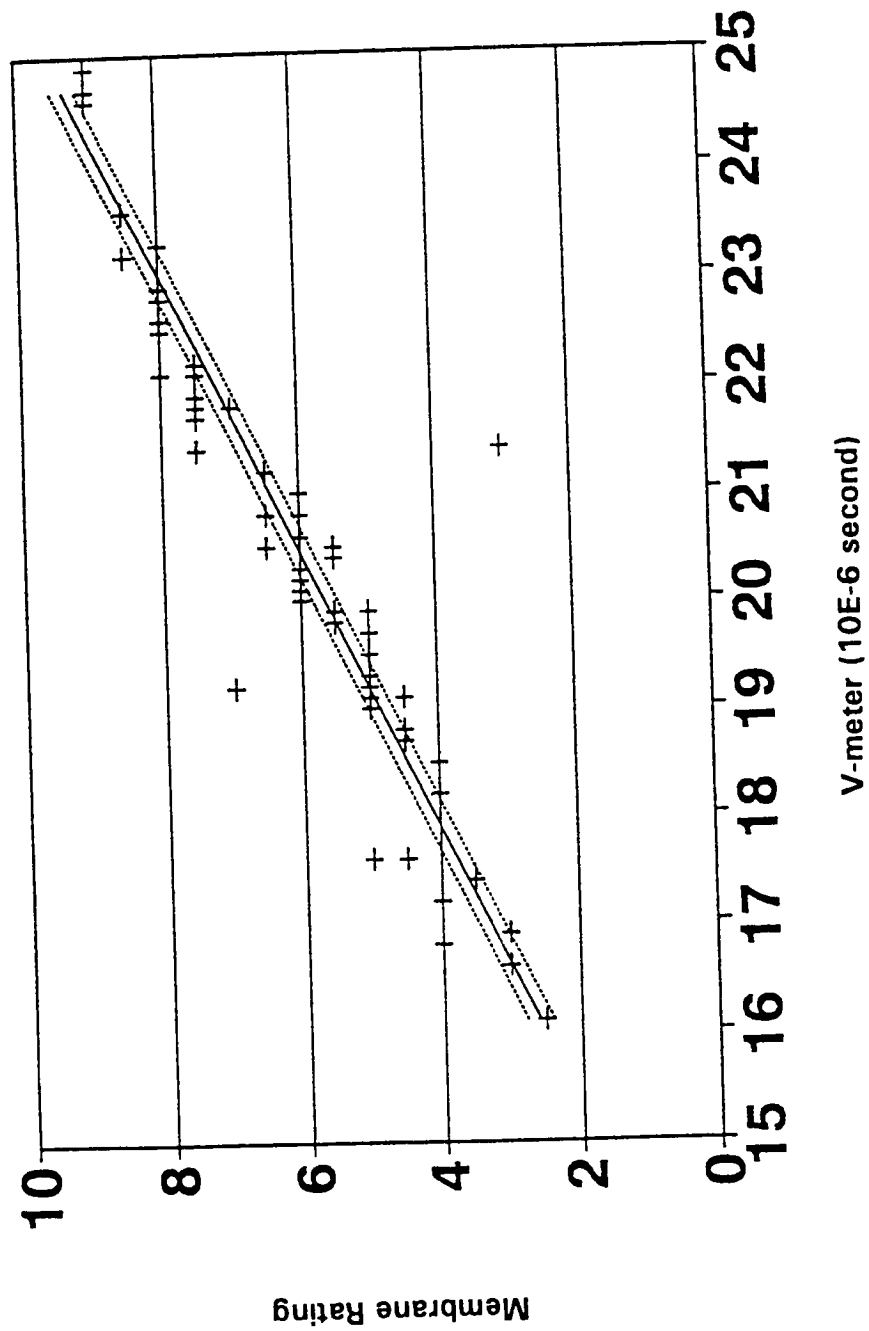
Figure 5-5. The membrane rating model with 95-percent confidence interval for Vermont bridges.

A coefficient of determination (R^2) value of 96.1 percent indicates a good correlation between the V-meter measurements and the membrane rating. The root mean square error was found to be 0.316, which supports this conclusion. The two-tail 95-percent significant t-test indicates that the model's two coefficients are significant. The 95-percent confidence interval is presented in Figure 5-5. In general, the model developed from Vermont's data gave the strongest correlation among all the evaluated bridge decks.

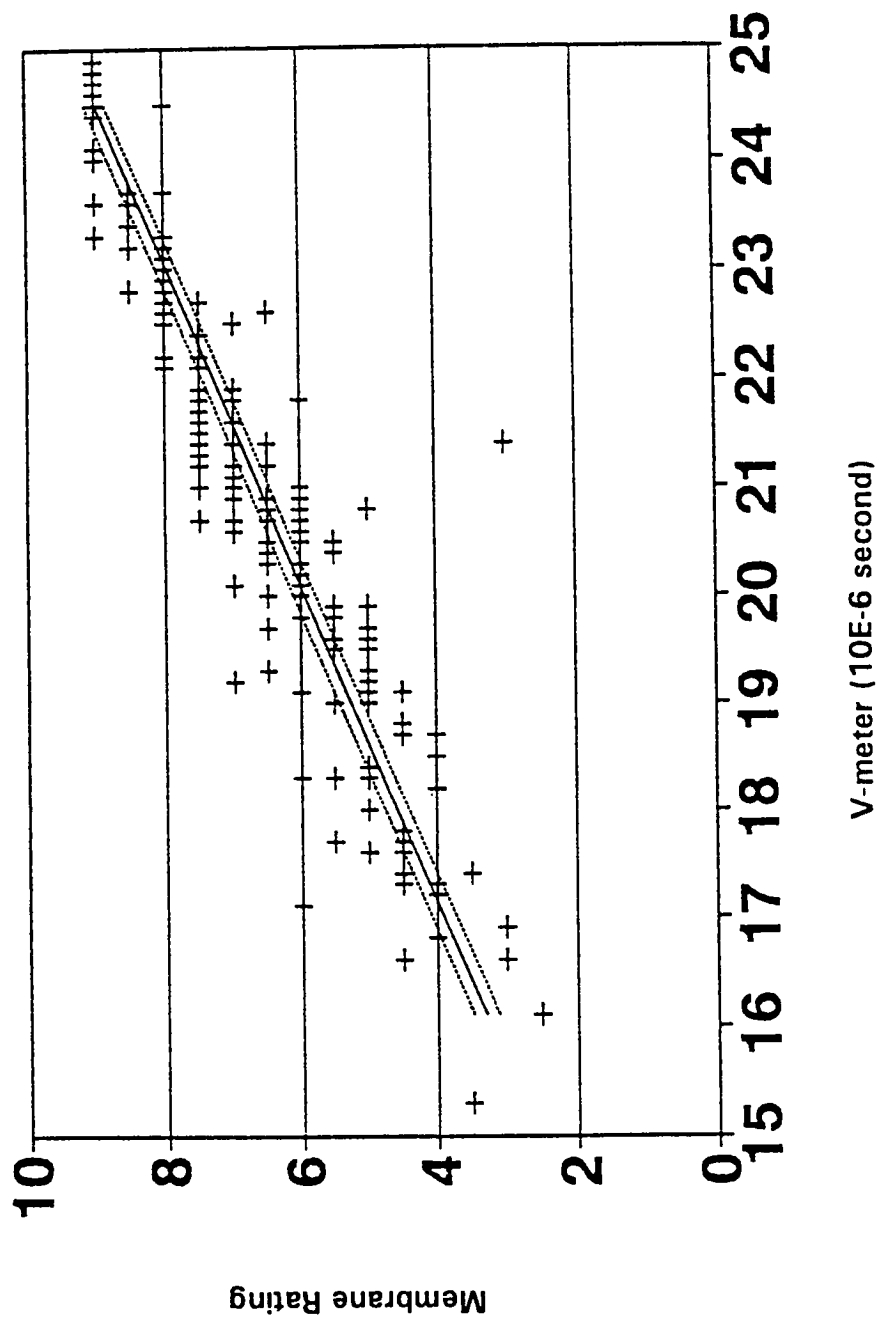
Figure 5-6. The membrane rating model with 95-percent confidence interval for all of the New England states.

The coefficient of determination (R^2) value of 89.3 percent obtained in this analysis indicates a strong correlations between the V-meter measurements and the membrane rating for different states and different membrane types. The root mean square error is found to be 0.520, which supports this conclusion. The two-tail 95-percent significance t-test indicates that the two coefficients of the developed model are significant. The 95-percent confidence interval is presented in Figure 5-6. A statistical analysis was performed to identify the factors that influence the degree of chloride contamination of the concrete. The independent variables include sample location, membrane type, membrane rating, AADT, annual snowfall, and total salt application. The correlations between the chloride content at Depths

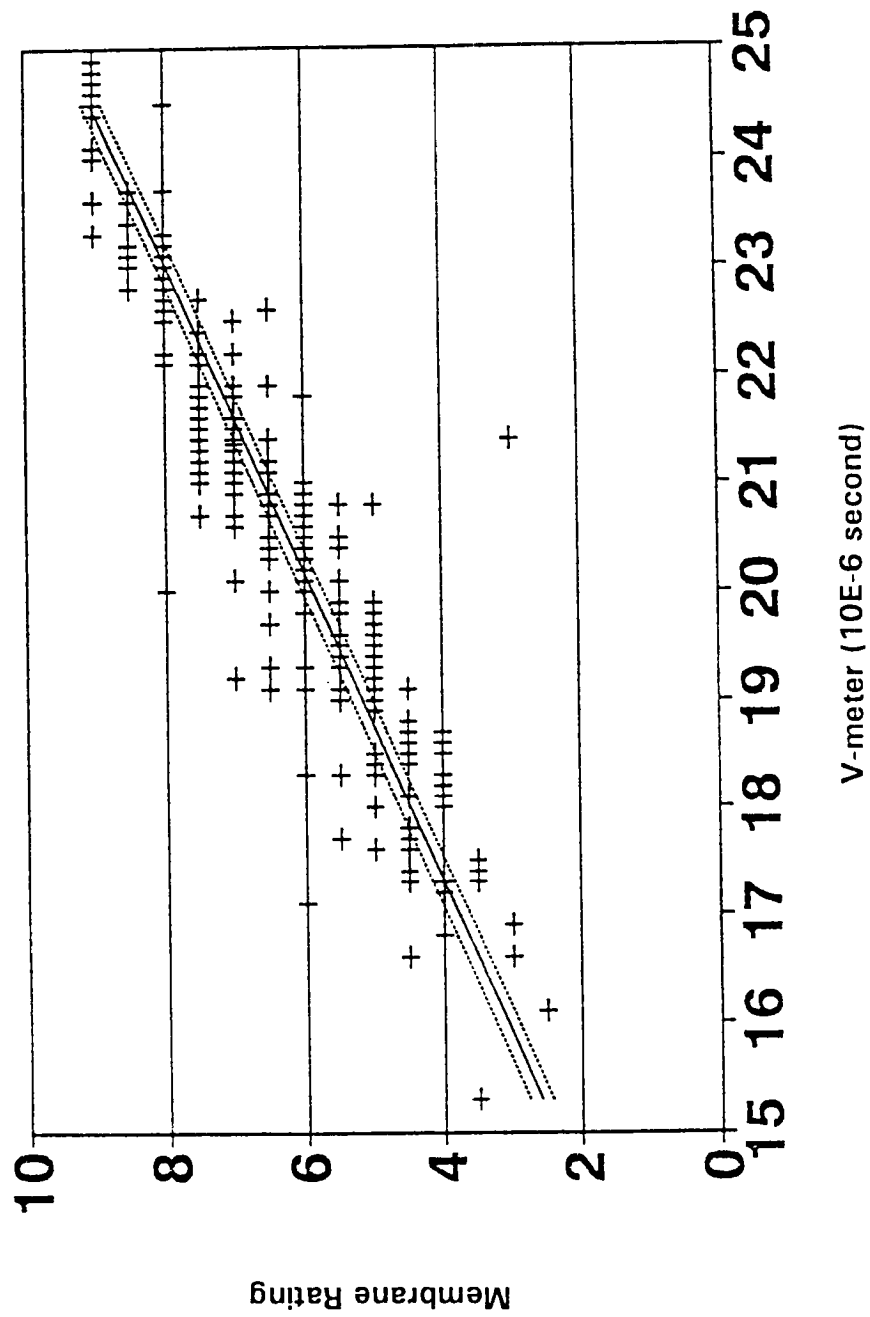
Figure 5-7. The membrane rating model with 95-percent confidence interval slab and bridge data.

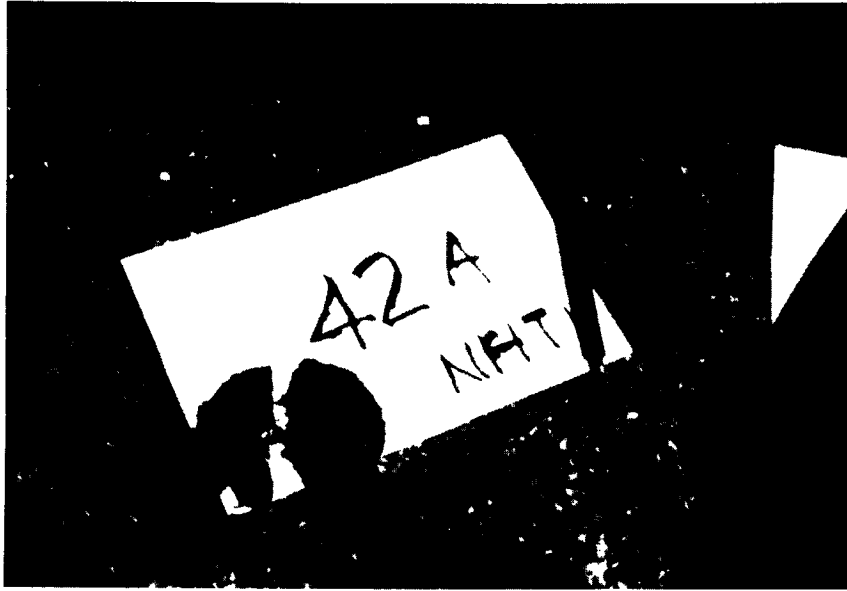
Figure 5-10. Crack through asphaltic overlay reflected through membrane.

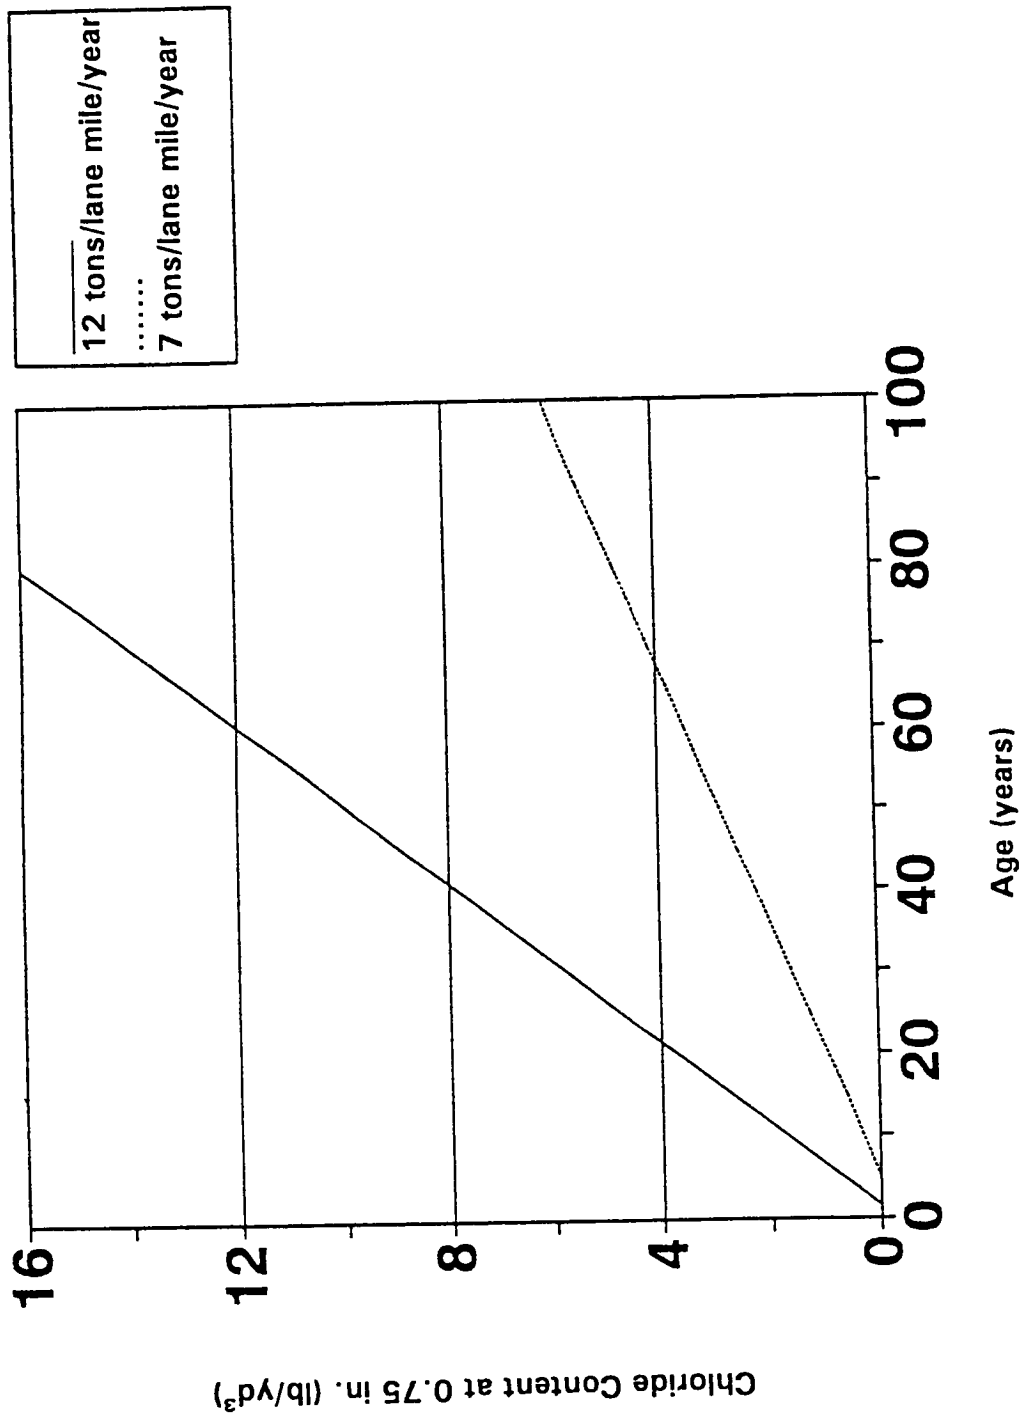
Figure 5-12. Effect of salt application on chloride content-age relationship.

The effect of salt application, snowfall, membrane type, and AADT on the chloride content-age relationship was investigated, using the model represented by equation 5-6. The results are presented in Figures 5-12 through 5-15, respectively. The following information was used as a reference to variables that are constant for a specific variable effect: snowfall is 60 in./yr (1.52 m/yr), membrane type is Bituthene, salt application is 9 tons/lane-mi/yr (5.1 mt/lane-km/yr), and AADT is 5,000. Figure 5-12 indicates that salt application is the most pronounced variable while the effect of membrane type (Figure 5-14) is minimal, confirming the results of the laboratory tests. Using equation 5-6 or Figures 5-12 through 5-15, one can estimate the time when corrosion may initiate for a specific bridge deck, based on corrosion threshold chloride concentrations.

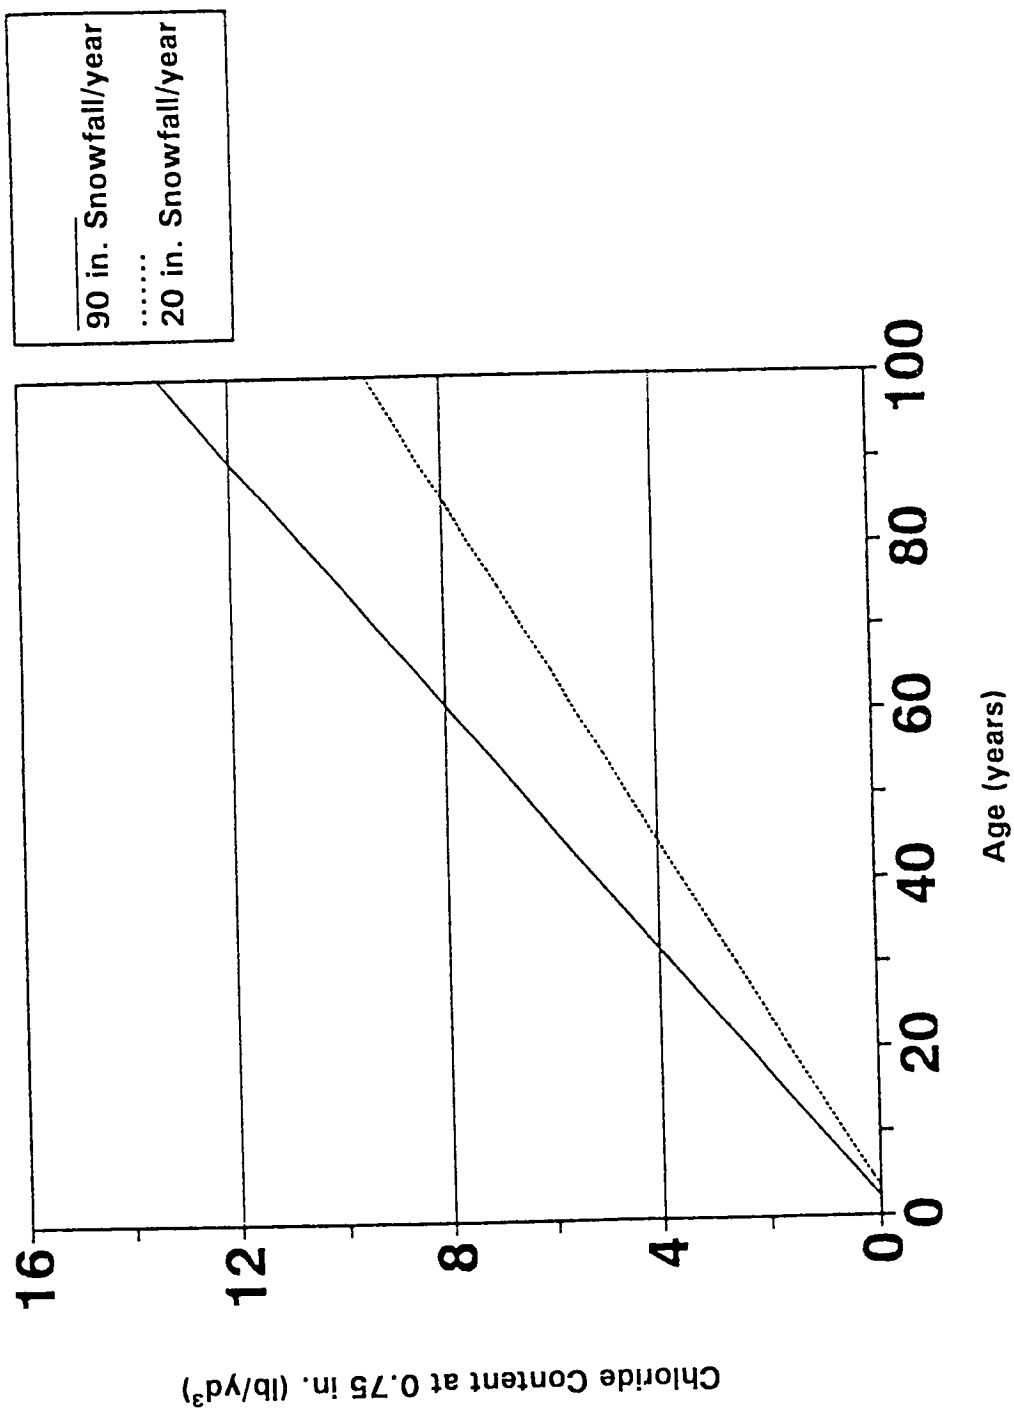
Figure 5-13. Effect of snowfall on chloride content-age relationship.

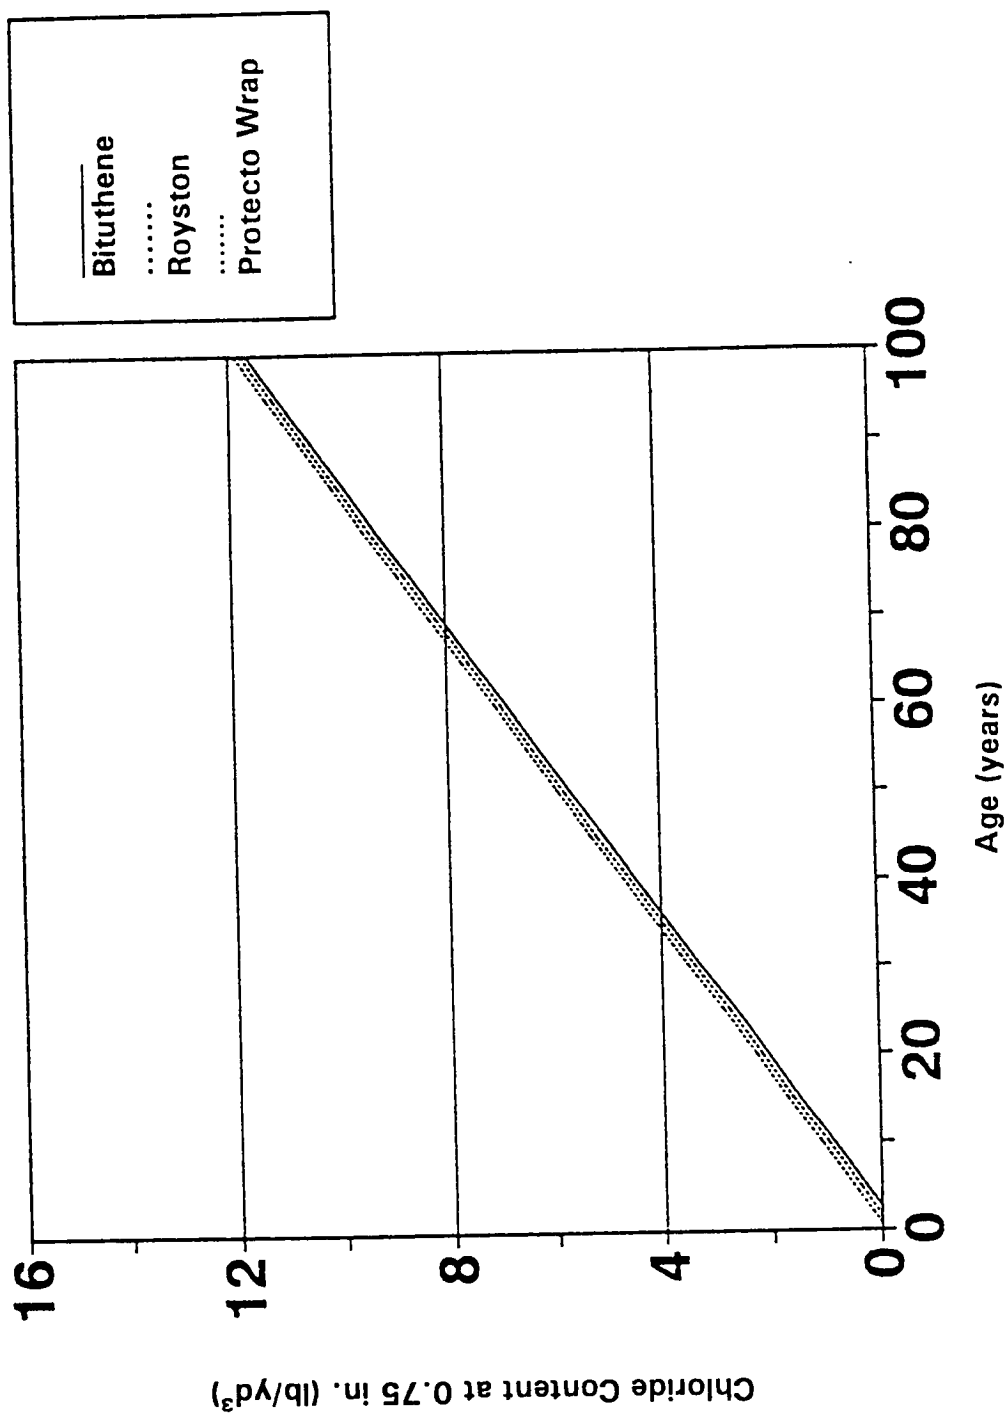
Figure 5-14. Effects of membrane type on chloride content-age relationship.

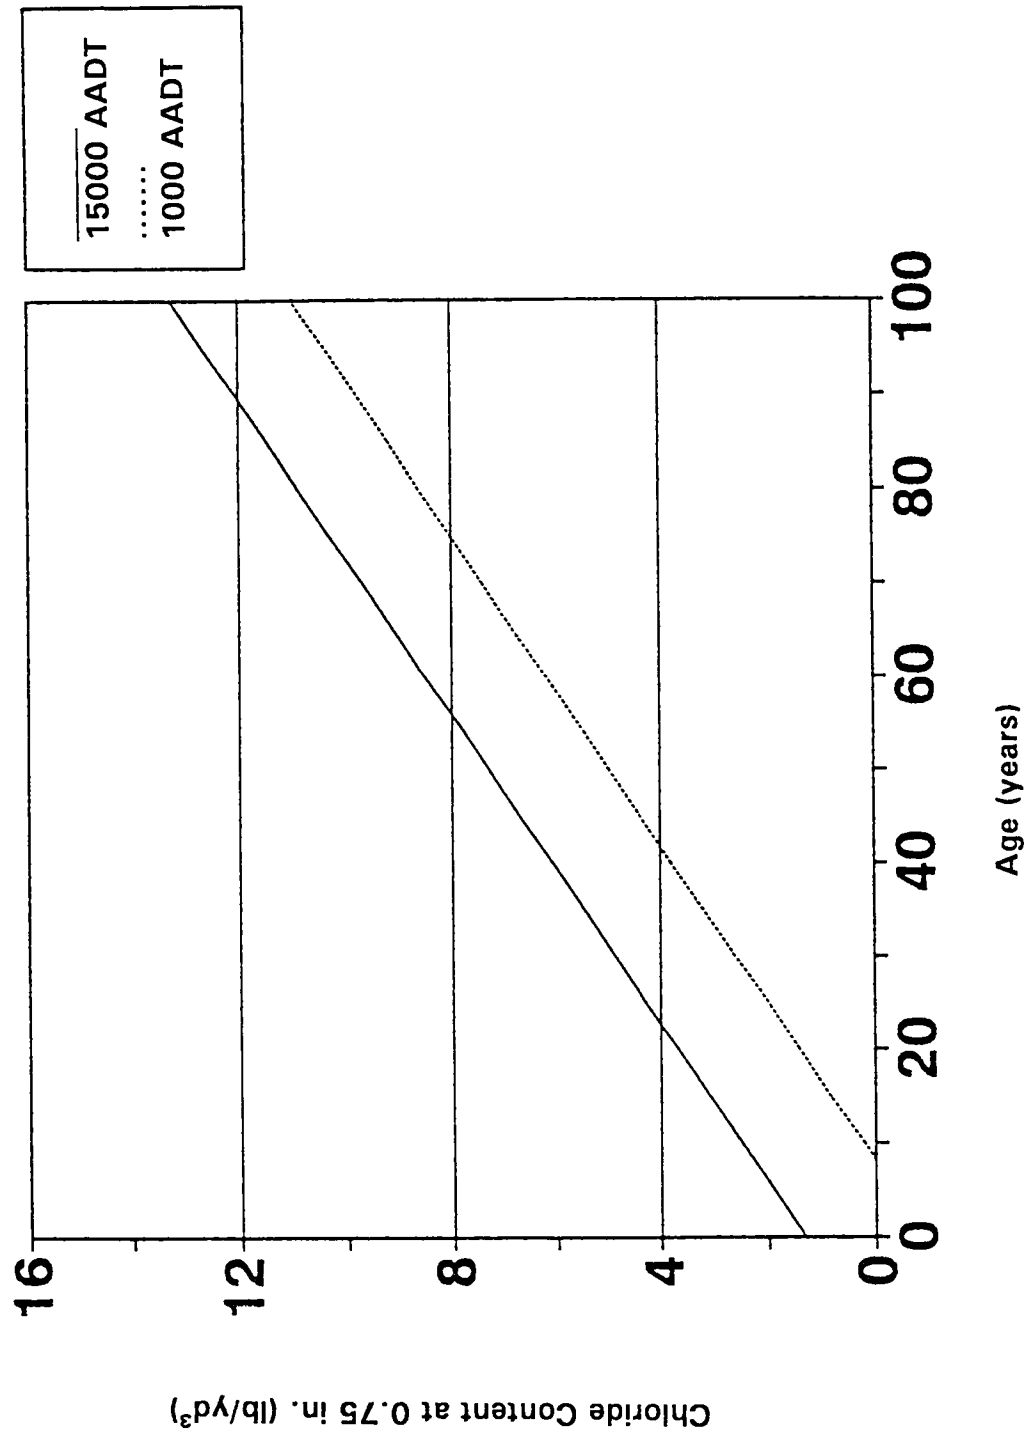
Figure 5-15. Effect of AADT on chloride content-age relationship.
