SHRP-H-371

Maintenance Work Zone Safety Devices Development and Evaluation

Strategic Highway Research Program
National Research Council
Washington, DC 1993

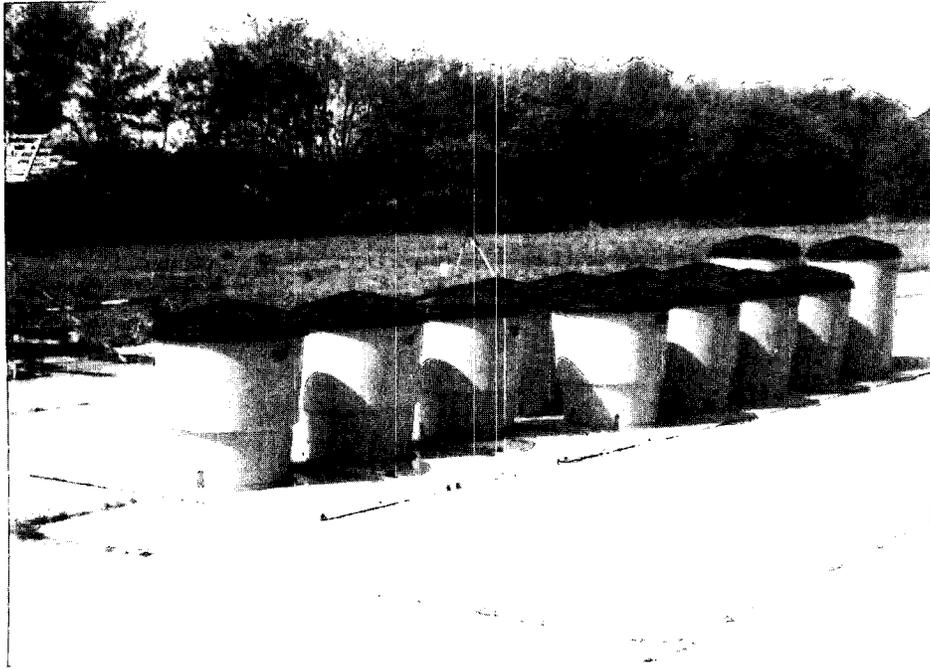
Figure 3. Portable Crash Cushion

The operational and lab testing efforts on the portable crash cushion was extensive. The pallet system was tested to ensure that the sand barrels would not fracture or rupture during roadway transport conditions. A sample pallet was constructed and a 1400-lb (636-kg) barrel and a 2100-lb (955-kg) barrel were attached to the pallet. The pallet was then statically raised to an angle of 50 degrees. This was performed to ensure that the washer/bolt attachment method would not fail or cause failure in the sand barrel. The pallet was then oscillated in an approximate one-half -Hz, 1-ft to 2-ft (0.3-m to 0.6-m) cycle to check for any road vibration and/or

movement failure in the barrels. To check the ultimate strength of the sample system, the pallet was raised to 80 degrees before the sand barrels failed.

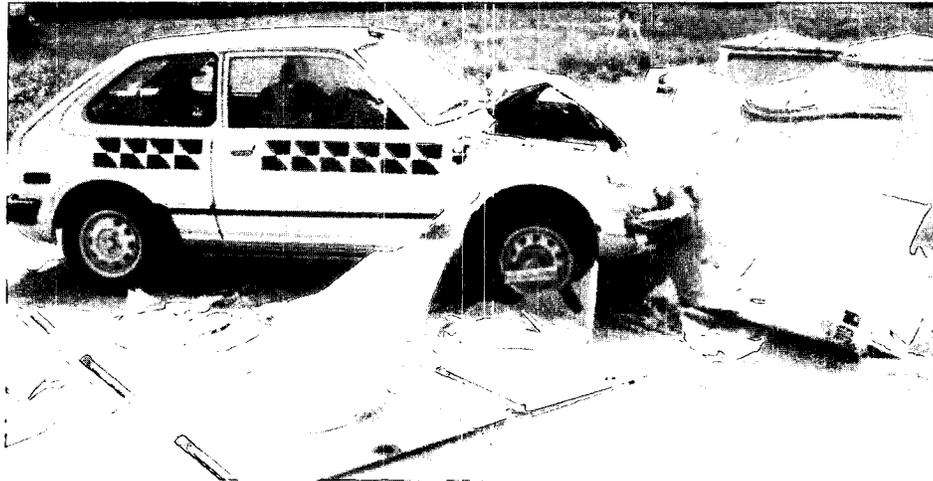
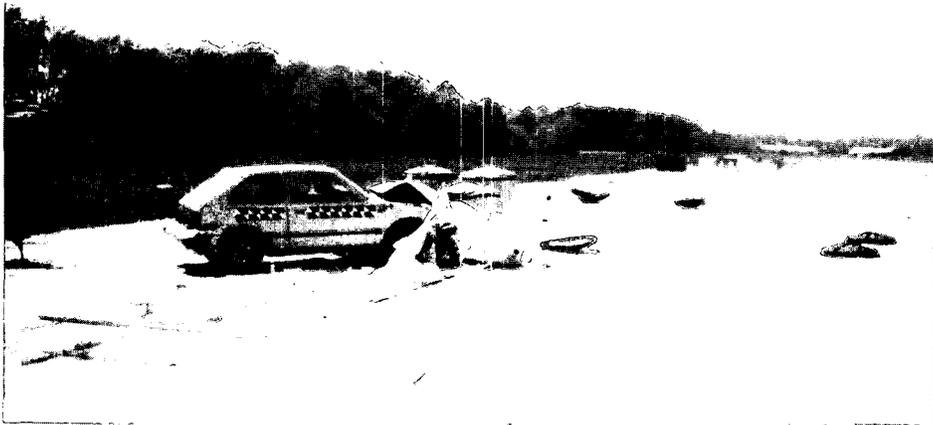
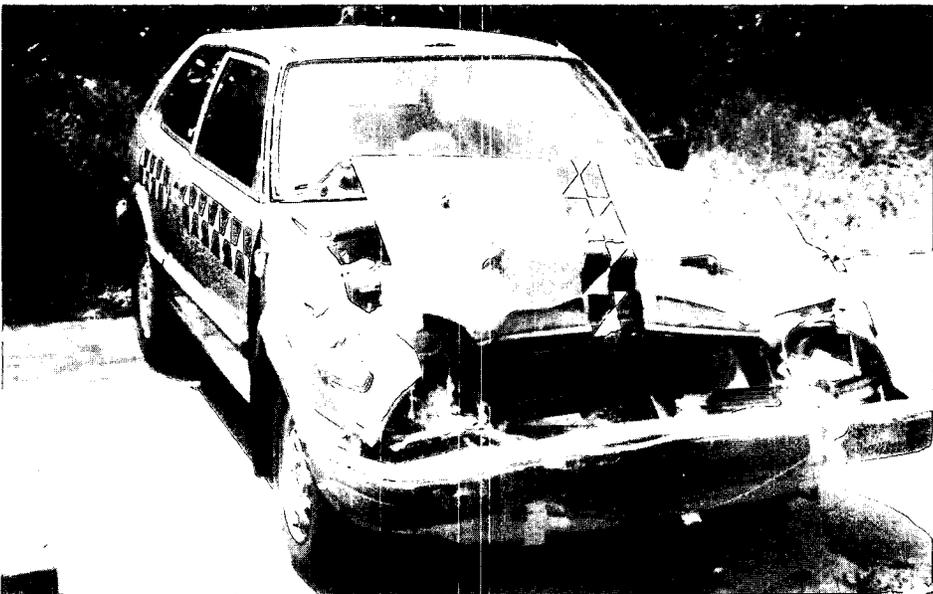
Figure 9. Photographs of the Vehicle After the Crash of the Portable Crash Cushion, Test 2036-FS1-92

Damage occurred only to the front end of the vehicle. The crush was uniform across the front of the vehicle. Most of the damage occurred above the bumper. The vehicle hood and front fenders were buckled. The vehicle grill and radiator were pushed back into the engine. The vehicle sustained little suspension damage. The windshield was broken 3 in (7.6 cm) from the top due to the impact of the dummy's head. Photographs of the vehicle after the crash test are shown in figure 9.

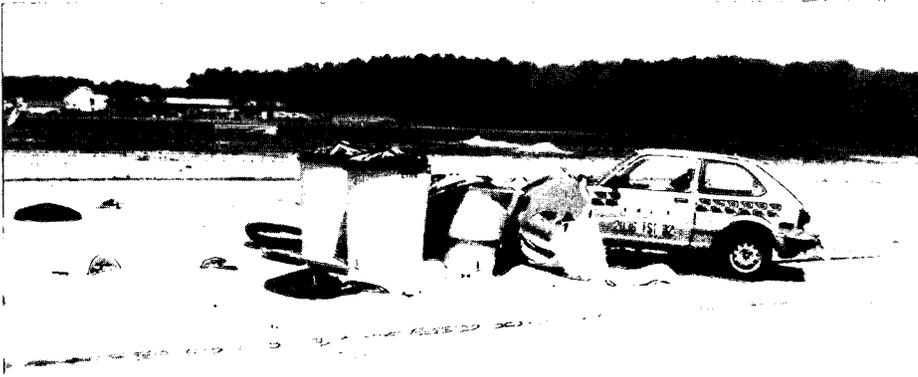
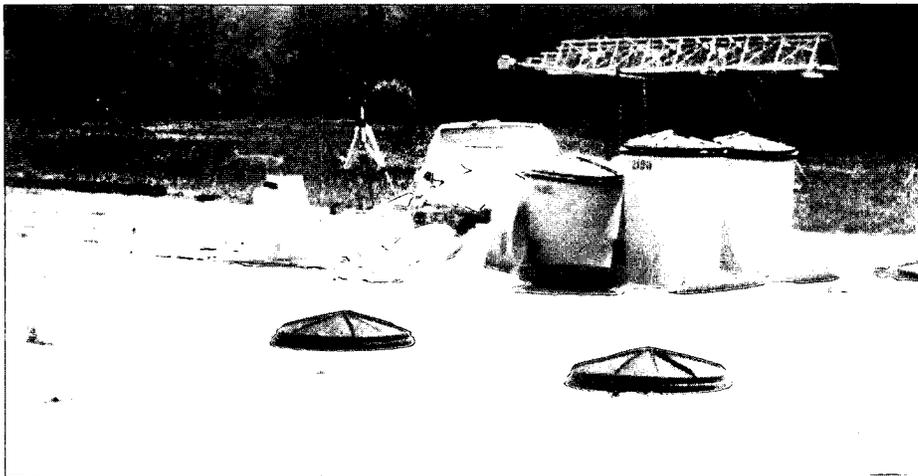
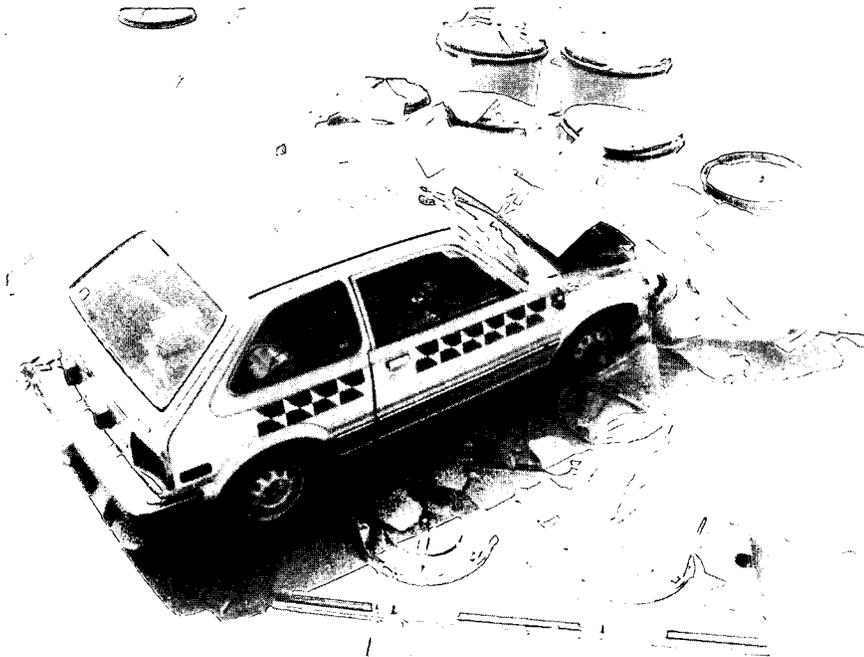
Figure 10. Photographs of the Portable Crash Cushion After Crash, Test 2036-FS1-92-91

The impact attenuator performed as designed. The sand modules in rows 1 through 5 were destroyed completely. The modules broke apart just above the module retaining rings. The bottom portion of the modules were still attached to the pallets. The pallet system itself and the three washers were undamaged and reusable. The sand modules on pallet 6 were broken and pushed over, but were not shattered. The sand modules on pallet 7 were deformed and cracked, but still contained most of their sand. The left sand module on pallet 8 was cracked at the top but was still filled with sand, and the right sand module was undamaged. Photographs of the impact attenuator after the crash test are shown in figure 10.

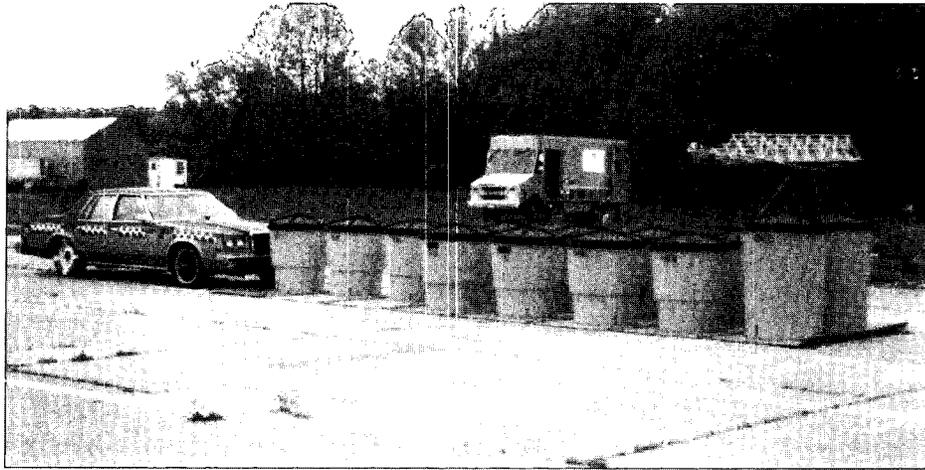
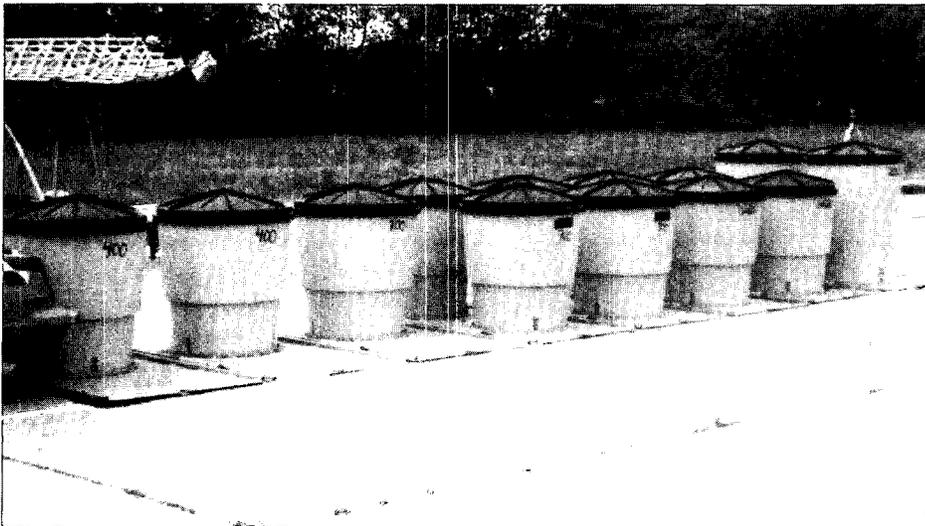
Figure 12. Photographs of the Portable Crash Cushion Prior to Crash, Test 2036-FS2-92

The Portable Crash Cushion attenuator system was the test device, as described previously. Figure 11 shows the test site layout. Figure 12 shows pretest photographs of the impact attenuator system.

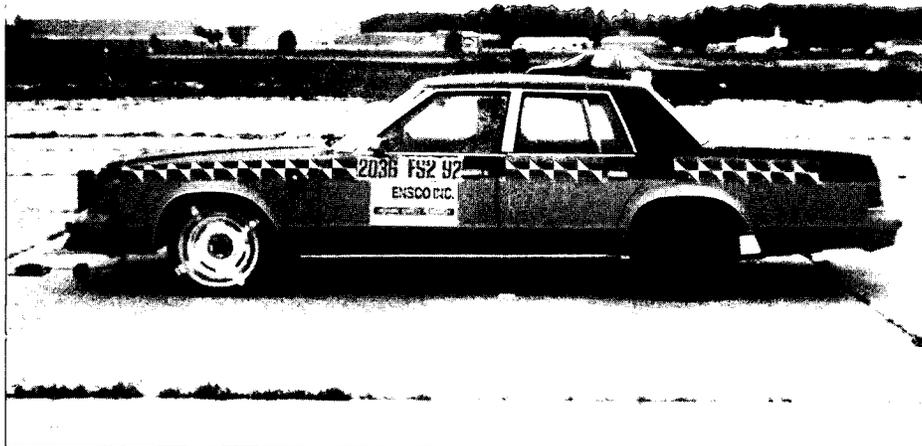
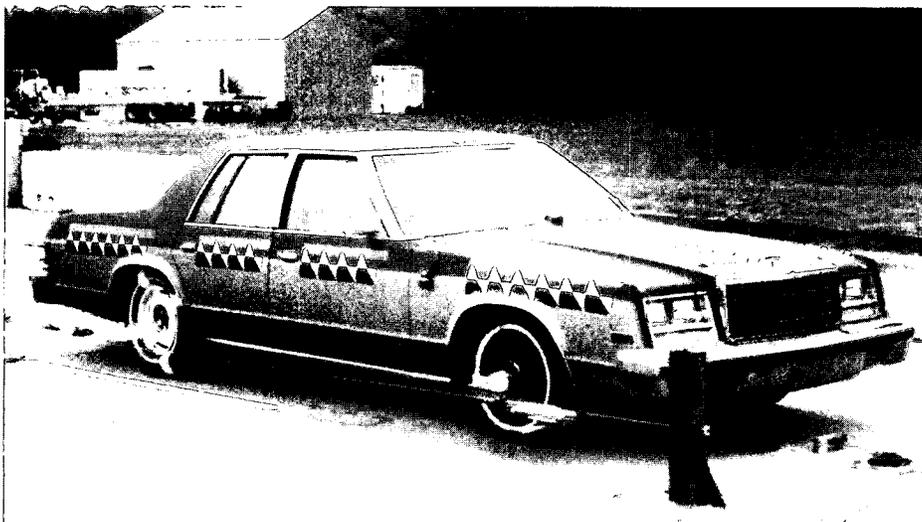
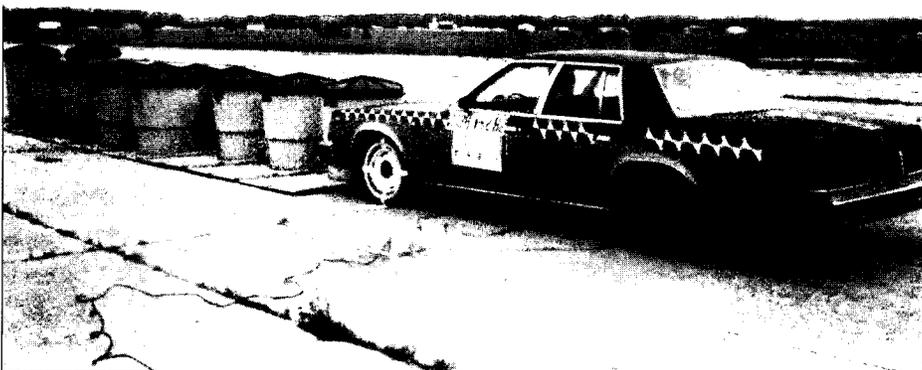
Figure 13. Photographs of the Test Vehicle Prior to Crash, Test 2036-FS2-92

Two dummies were placed in the vehicle. The driver dummy was unrestrained while the passenger dummy was restrained. The target gross vehicle weight was 4500 ± 300 lb (2045 ± 136 kg). The gross weight of the vehicle including the dummies was 4685 lb (2130 kg). X-, y- and z-axis accelerometers were mounted in the car as well as roll and yaw rate gyroscopes. Photographs of the vehicle before the crash test are shown in figure 13.

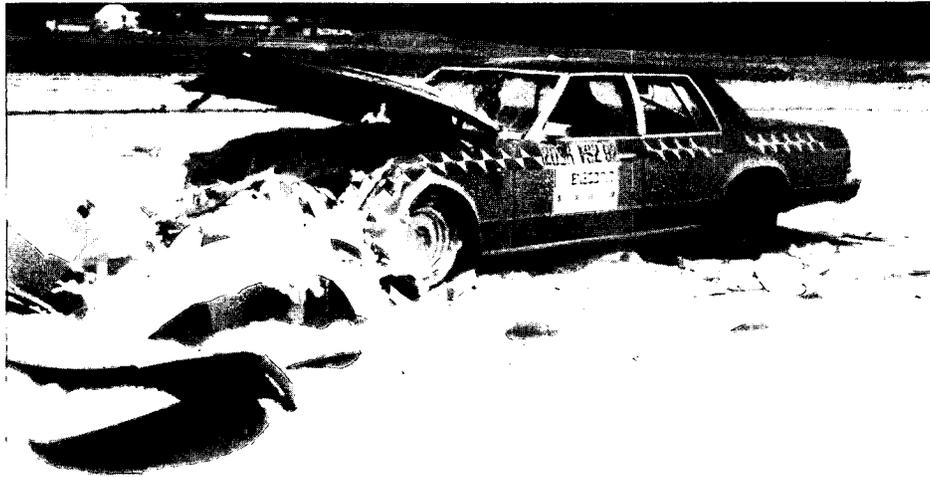
Figure 16. Photographs of Test Vehicle After Crash Test 2036-FS2-92

Damage occurred only to the front end of the vehicle. The crush was uniform across the front of the vehicle. The vehicle hood and front fenders were buckled. The vehicle grill and radiator were pushed back into the engine. The vehicle sustained little suspension damage. The windshield broke because the hood hit it. Photographs of the vehicle after the crash test are shown in figure 16.

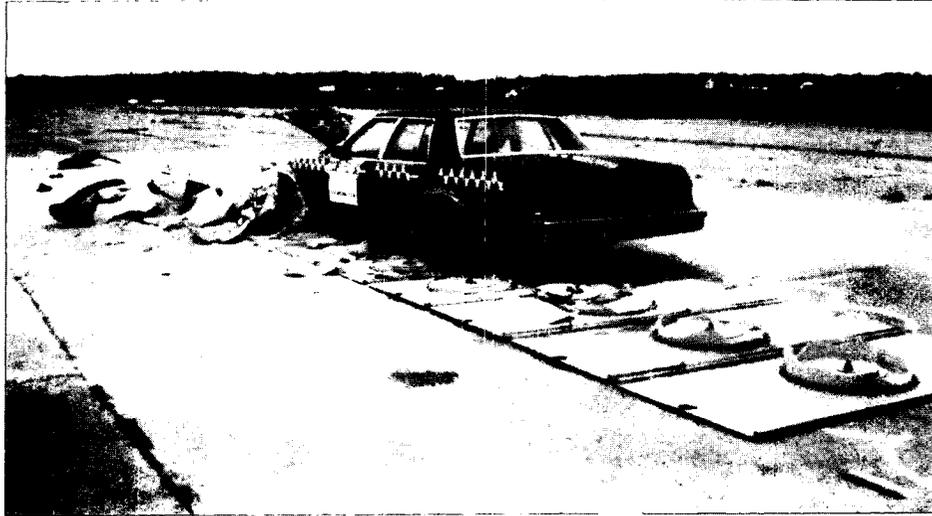
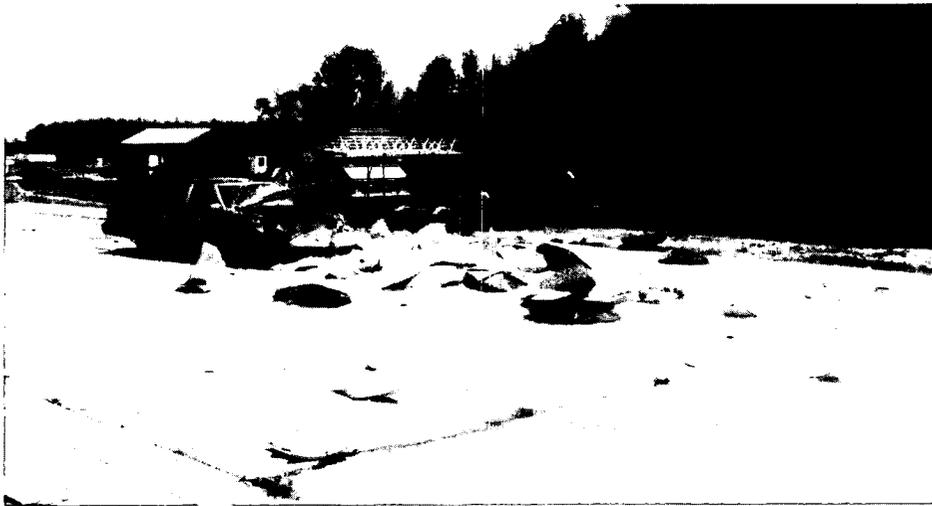
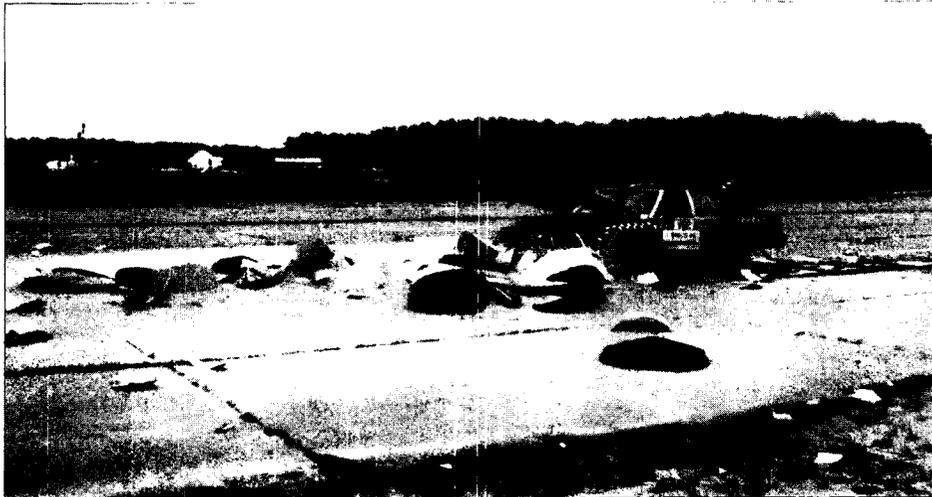
Figure 17. Photographs of the Portable Crash Cushion After Crash, Test 2036-FS2-92

The impact attenuator performed as designed. The sand modules in all 8 rows were destroyed completely. The modules broke apart just above the module retaining rings. The bottom portions of the modules were still attached to the pallets. The pallet system itself, and the three washers for each module, were undamaged and reusable. The bulk of the attenuator debris (sand and module pieces) came to rest within an area 25 ft (7.6 m) behind the pallet system. Photographs of the impact attenuator after the crash test are shown in figure 17.

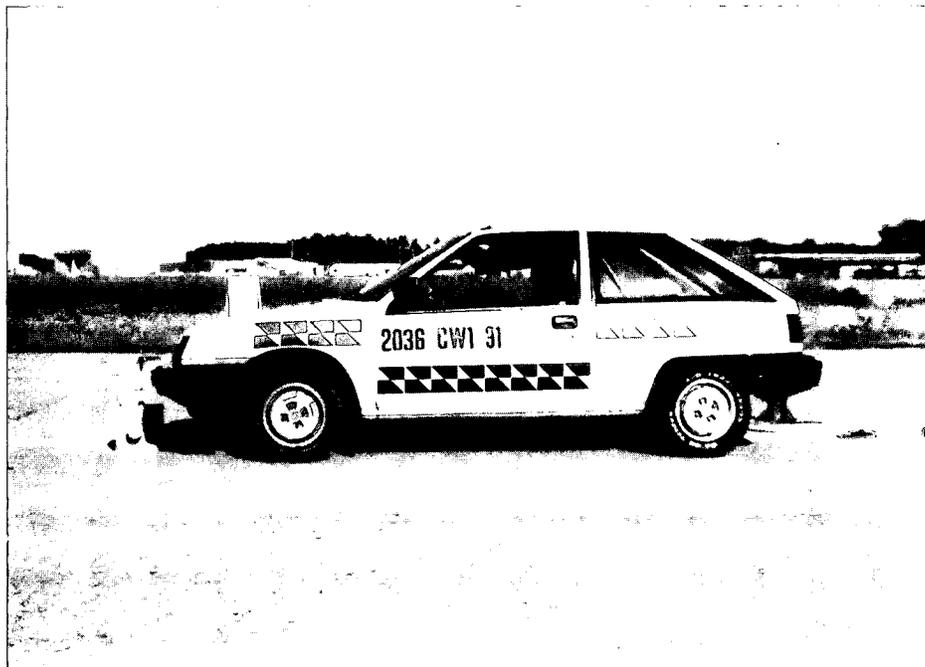
Figure 21. Ultrasonic Detection Alarm Before Test, Test 2036-CW1-91

The crashworthiness of this device was determined by using only the aluminum housing ballasted with the correct mass to simulate the distribution of electronic components. The electronic failure mode testing was conducted as fail-safe bench testing with calculated damage (i.e., the worst case of damage to ensure reliability). This test was conducted at 60 mi/h (26.8 m/s), with the impact centered on the vehicle. Photographs taken before test 2036-CW1-91 are shown in figure 21.

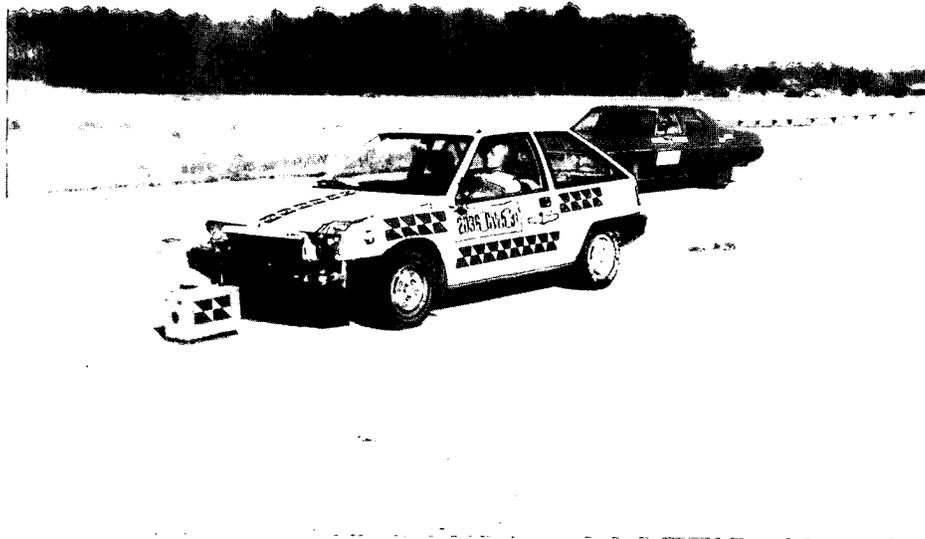
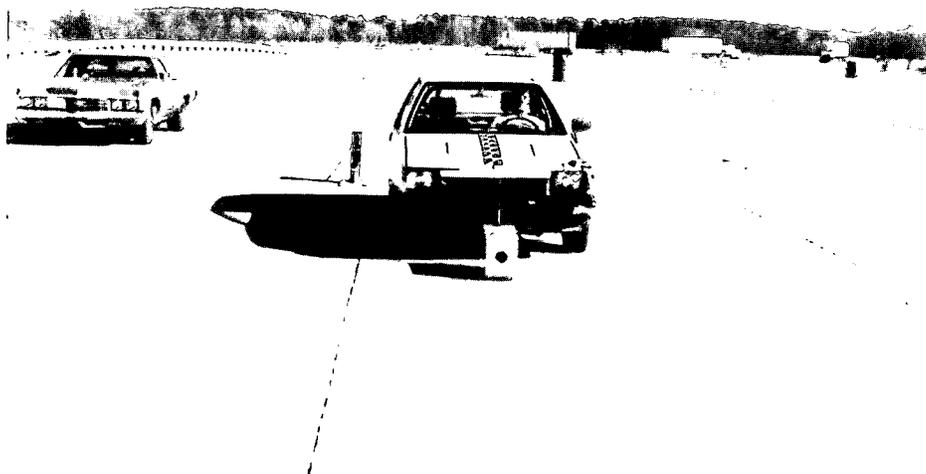
Figure 25. Infrared Intrusion Alarm Before Test, Test 2036-CW5-91

This test was conducted at 60 mi/h (26.8 m/s), with the impact centered on the vehicle.

Photographs taken before test 2036-CW5-91 are shown in figure 25.

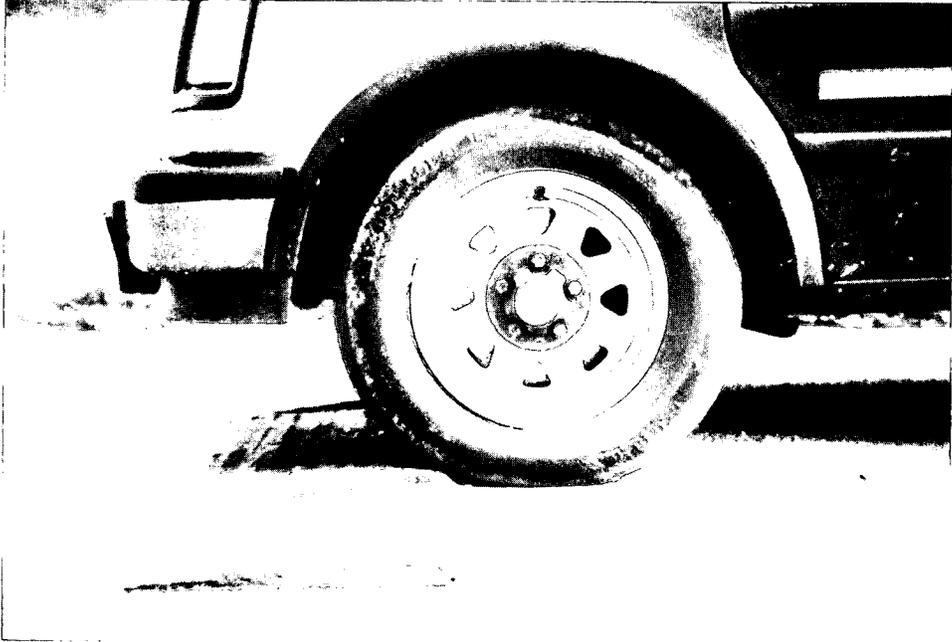
Figure 28. Portable Rumble Strip

Tests were conducted to determine whether the PRS would alert a driver, create vehicle handling problems, or move from its location on the road. These tests also assessed the durability of the PRS. It should be noted that these original operational tests were conducted on the original design of the device. This design consisted of a row of raised pavement markers, glued to a rubber mat, and covered with permanent pavement marking tape. The revisions that occurred to this design, and the reasons for making these changes, are discussed below in the "Open Highway Testing" section.

Three types of tests were done. A professional driver performed each test which consisted of a series of runs from 20 to 70 mi/h (8.9 to 31.3 m/s) in 10 mi/h (4.5 m/s) increments. The driver first drove on the road without the PRS present in order to record ambient noise levels at each speed. The drivers then drove over the PRS. Last, the driver skidded vehicles over the PRS. Four vehicle types were used for each test: small car, large car/pickup truck, tractor-trailer combination, and motorcycle. The motorcycle used was of the type designed for highway travel, not a dirt bike. The driver drove each vehicle over the open road and then the PRS. Two video cameras and two noise meters were used to record data. One video camera and noise meter were inside the vehicle. The camera videotaped the test runs from the driver's point of view in order to document vehicle jolting, vehicle control, and to record comments by the test driver. The noise meter recorded the increase in noise that occurred from the use of the PRS. The motorcycle was not outfitted with the camera or the noise meter.

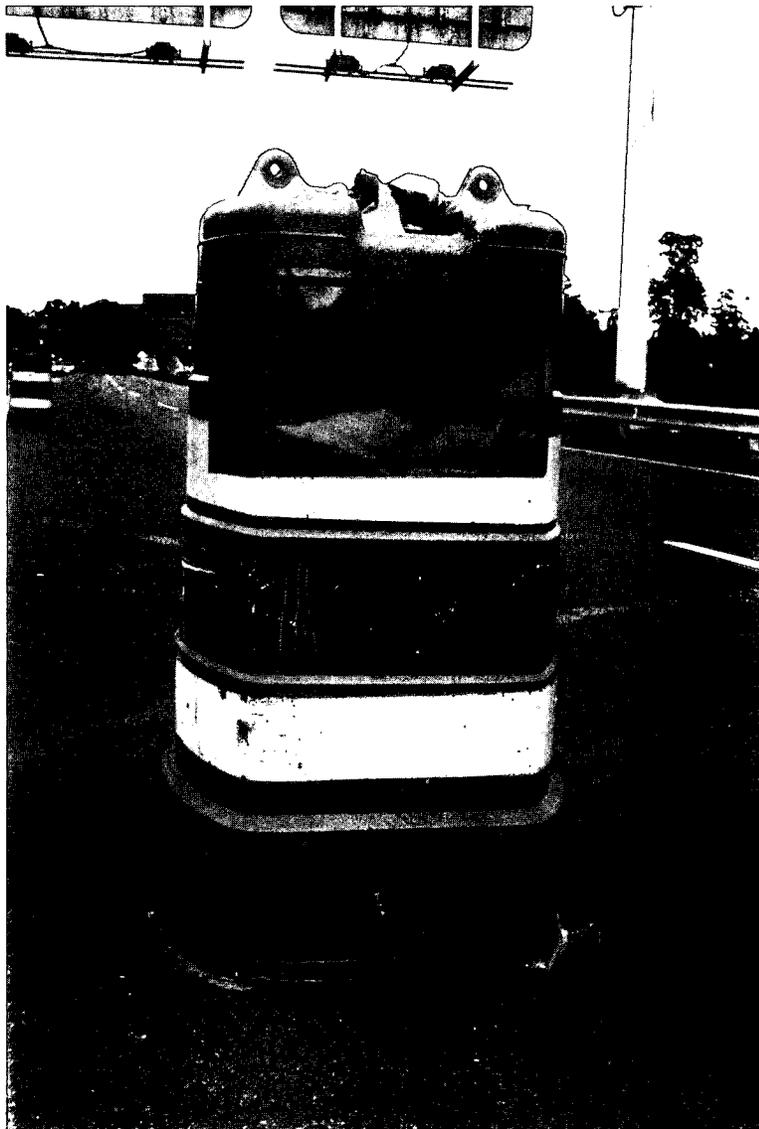
Figure 33. Directional Indicator Drum

The reversible-direction arrow panel could be incorporated into directional indicator drum, by attaching the arrow panel to the upper portion of the drum. In this manner, the panel can be inverted so as to present either a left- or right- facing directional message. The directional indicator drum is illustrated in figure 33. A variation of the DIB used by the Pennsylvania Department of Transportation consisted of a standard black-on-orange arrow panel (MUTCD designation, W1-6) combined with striped panels and mounted on PVC barricades. The devices pictured in figure 34 were deployed on I-295 south of Philadelphia.

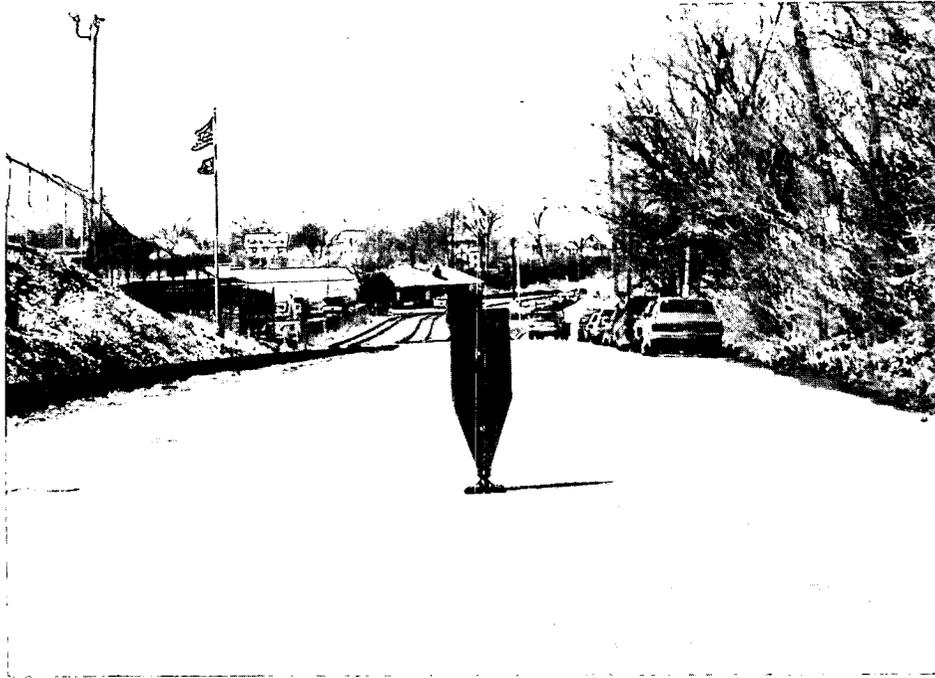
Figure 35. Opposing Traffic Lane Divider

The Opposing Traffic Lane Divider (OTDL) is shown in figure 35.

Operational testing of the OTLD was performed at the closed track test facility in Georgetown, Delaware. The operational tests determined the device's stability in the wind, and also the device's response when impacted by a vehicle. Crashworthiness testing of this device was not performed, since the operational testing included this factor.

Several problems occurred with this design. There were functional and durability problems with the springs as they were fabricated. The costs were considerably higher than anticipated, and the FHWA felt that the sign was too close to the ground to be effective. More information about the evaluation of this design can be found below in the open highway testing section. The design shown in figure 35 was adopted as a result of that evaluation process.

The research team redesigned the device after observing the results of the open highway testing. After a prototype had been fabricated, they learned that a device nearly identical to the prototype was already in production by a manufacturer in Texas (figure 35). It was obviously more cost-effective to use this device for further testing. The Mississippi DOT agreed to open highway test this new design of the device along a seven-mile construction zone on I-20 west of Jackson, Mississippi.

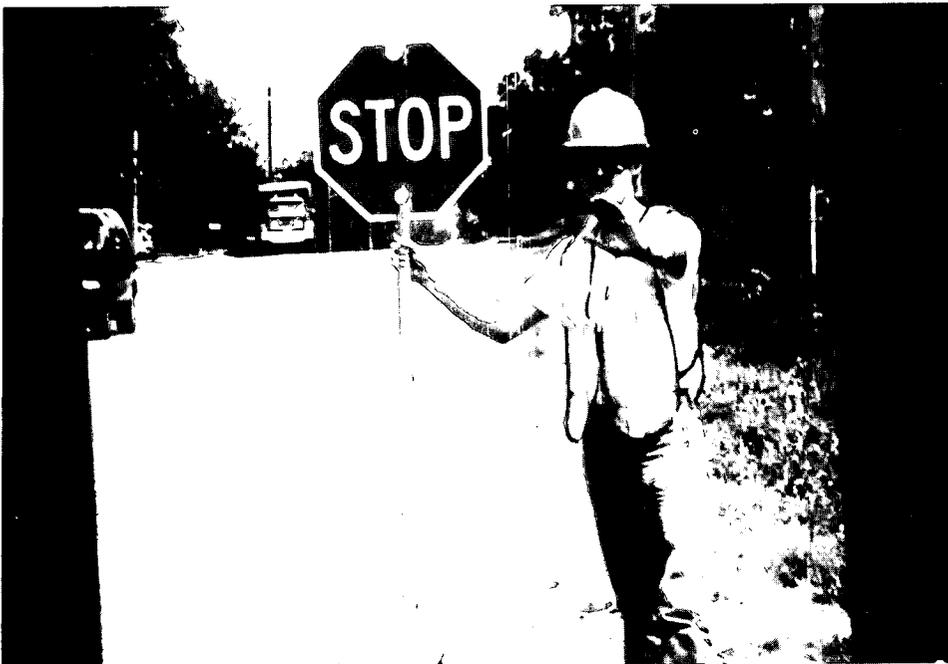
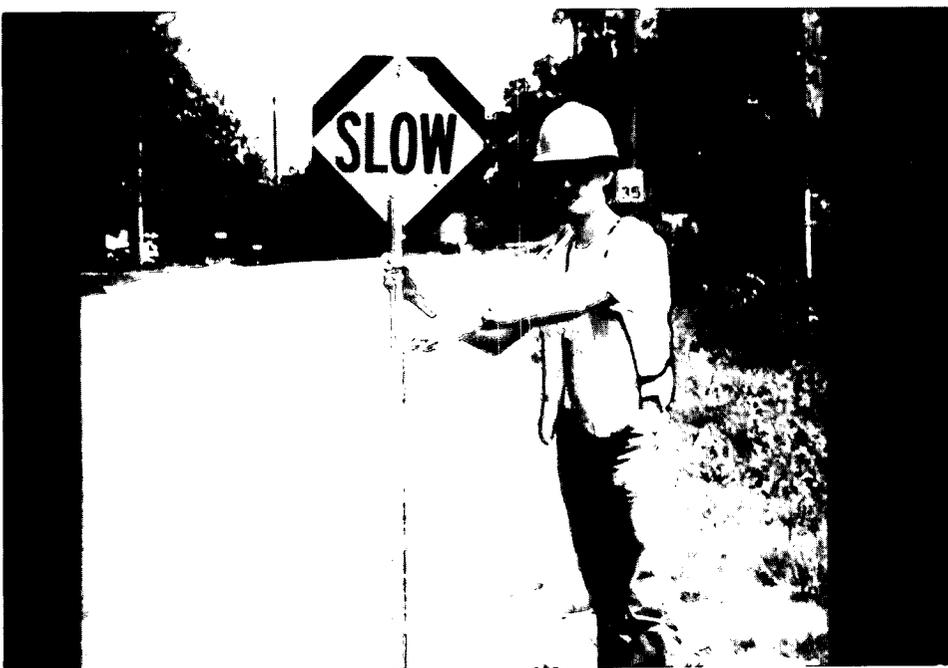
Figure 37. Flashing Stop/Slow Paddle

The Flashing Stop/Slow Paddle (FSSP) is shown in figure 37.

Weight:	7.2 lb (3.3 kg)
Overall Height:	74 in (188 cm)
Sign Size:	18 in by 18 in (45.7 cm by 45.7 cm)
Battery Life:	
Standard Batteries:	350 cycles
High Capacity:	1,400 cycles
Lamp Life:	2,000 hours

In these specifications, battery life indicates the number of cycles of operation before requiring recharge. One cycle equals 2 lamps flashing, alternately, 10 times each for a total of 20 flashes. In terms of actual hours of operation, this means that, if the sign cycled every 2 minutes, standard batteries would last for approximately 11.5 hours before requiring a recharge, and high-capacity batteries would last about 46 hours.

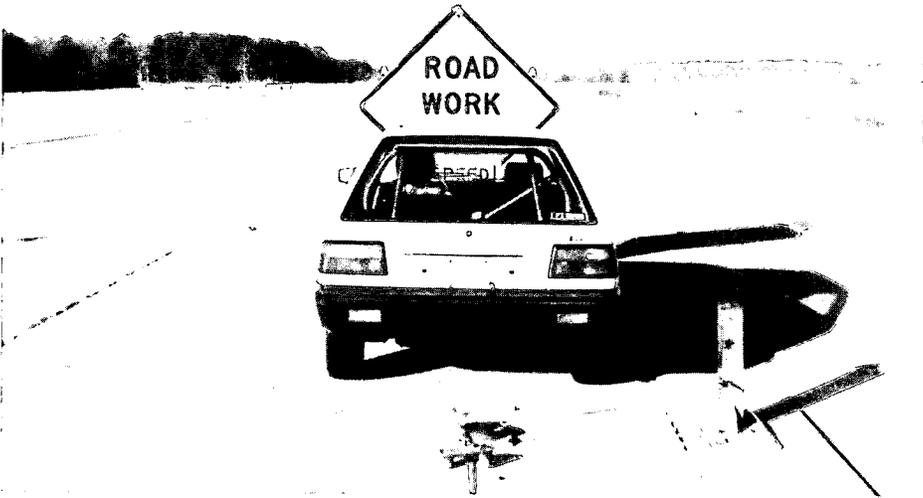
Figure 39. Portable Sign and Stand

The Portable Sign And Stand (PSS) is shown in figure 39.

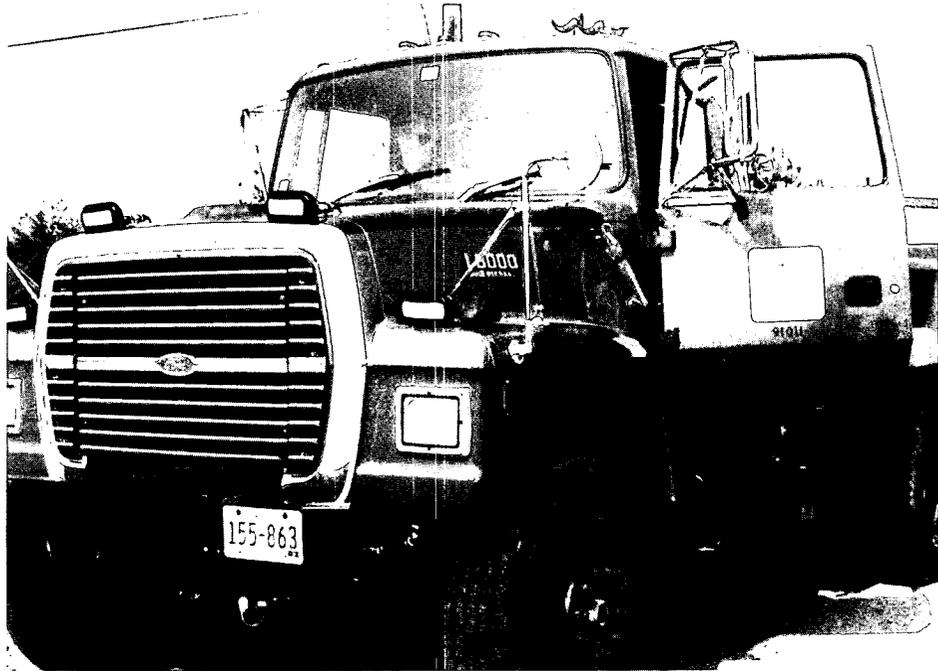
Figure 42. Remotely Driven Vehicle

The Remotely Driven Vehicle (RDV) is shown in figure 42.

The radio control system implements the following vehicle functions from the hand-held transmitter:

- steering - full steering from lock to lock.
- brakes - proportional brake control.
- throttle - control vehicle throttle throughout its whole range.
- transmission - three position switch for neutral, park and drive.
- horn
- headlights
- parking brake
- flashers

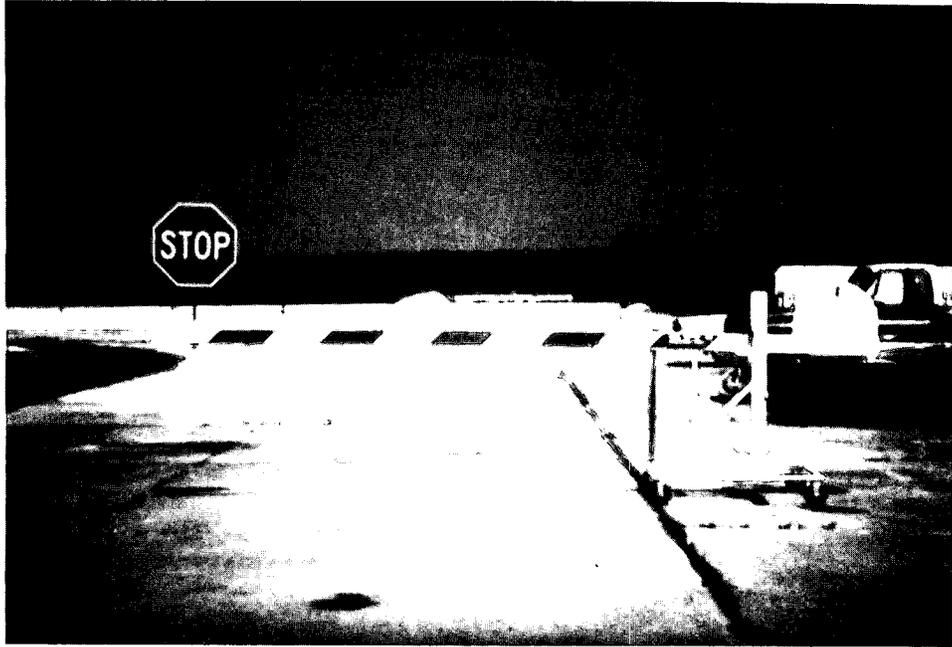
Figure 45. Flagger Gate

The Flagger Gate was compared to the standard Stop/Slow paddle. Driver response to the Flagger Gate showed an increase in information processing time. This was probably due to the novelty effect of the Flagger Gate. The difference in the response was only 1.4 seconds. This additional time is not viewed as consequential since driver attention to the driving task was not diverted during this time.

Subject drivers did have trouble interpreting the Flagger Gate. Only three of 96 subjects associated the Flagger Gate with road work; others noted close resemblance to a railroad protection crossing gate. However, subjective ratings by drivers showed that the Flagger Gate was judged to be more helpful and more conducive to increased highway safety than standard devices. The Flagger Gate easier to recognize at night than the standard flagger device.

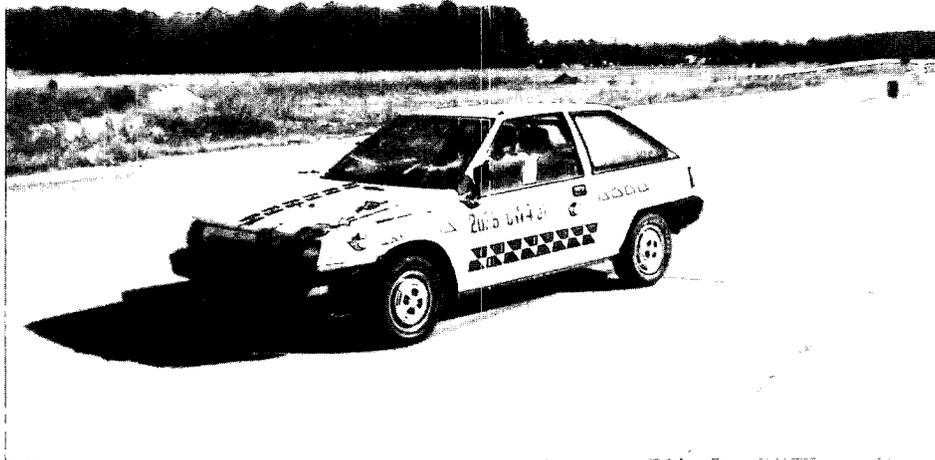
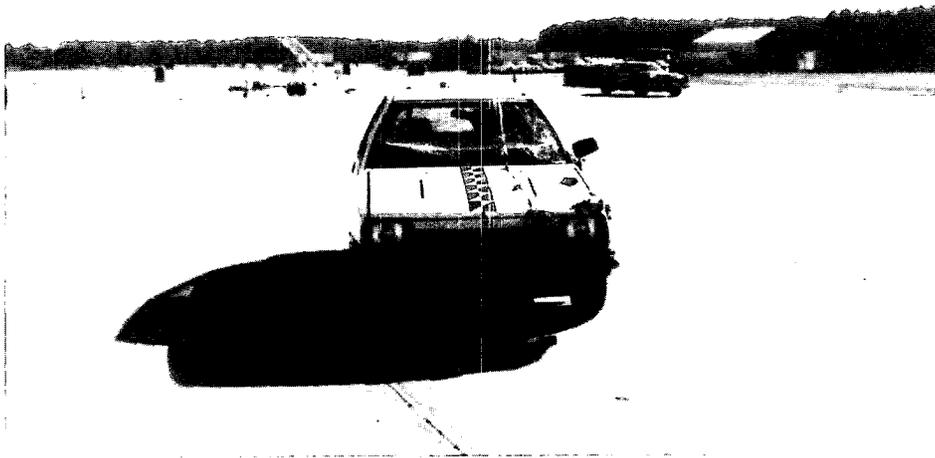
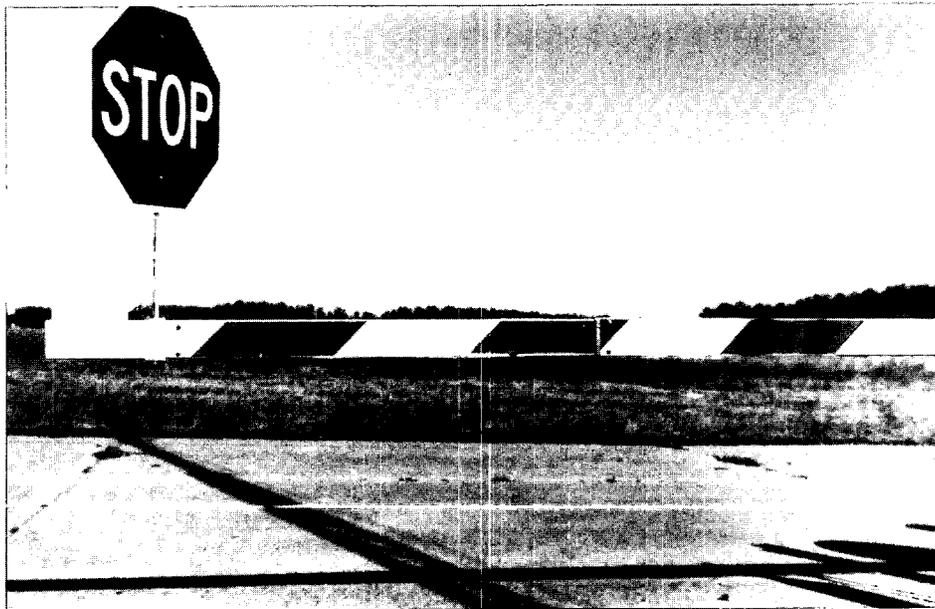
Figure 47. Flagger Gate After Test, Test 2036-CW4-91

Photographs of the Flagger Gate and the vehicle after test 2036-CW4-91 are shown in figure 47.

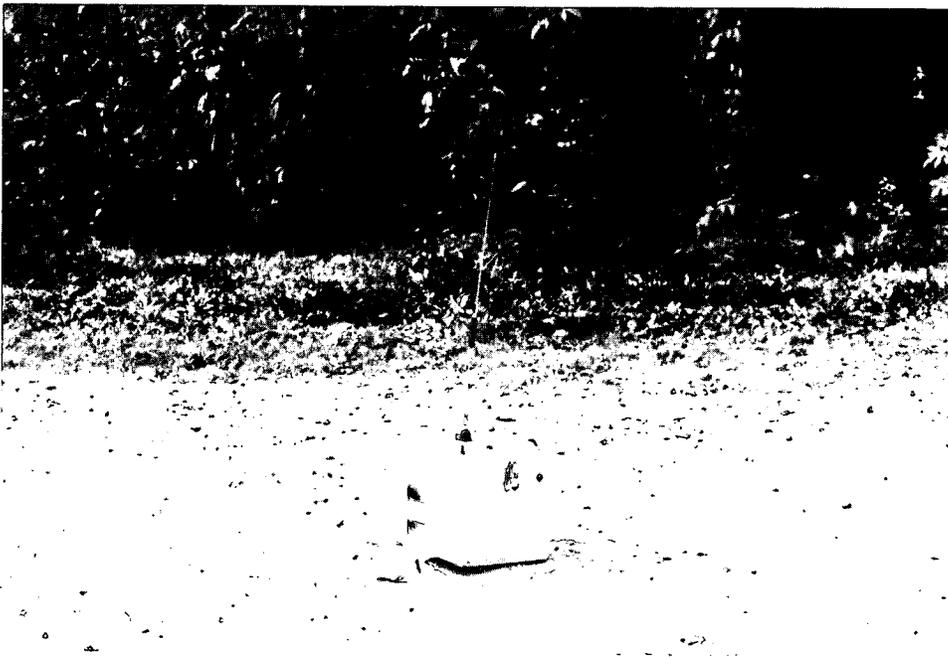
Figure 57. Pressurized Pneumatic Tube Alarm

A sensor with an analog output for different pressure settings is needed, but the price of such a sensor must be considered.

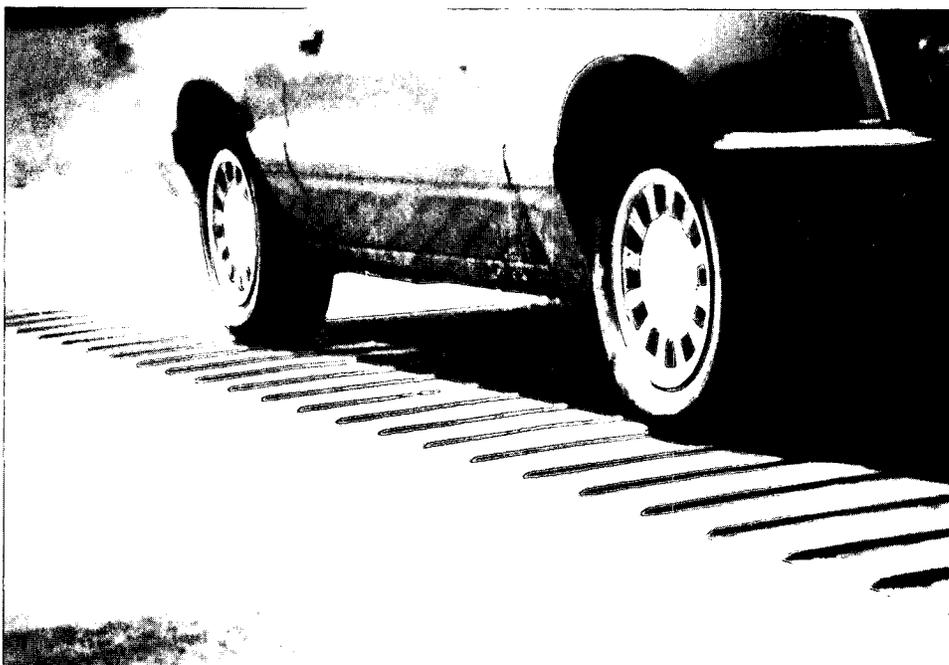
Figure 59. Rumble Stripe

The Rumble Stripe alerts motorists that they are driving off of the traveled way. A typical shoulder rumble strip design relies more on tactile stimuli rather than audible stimulus and may be

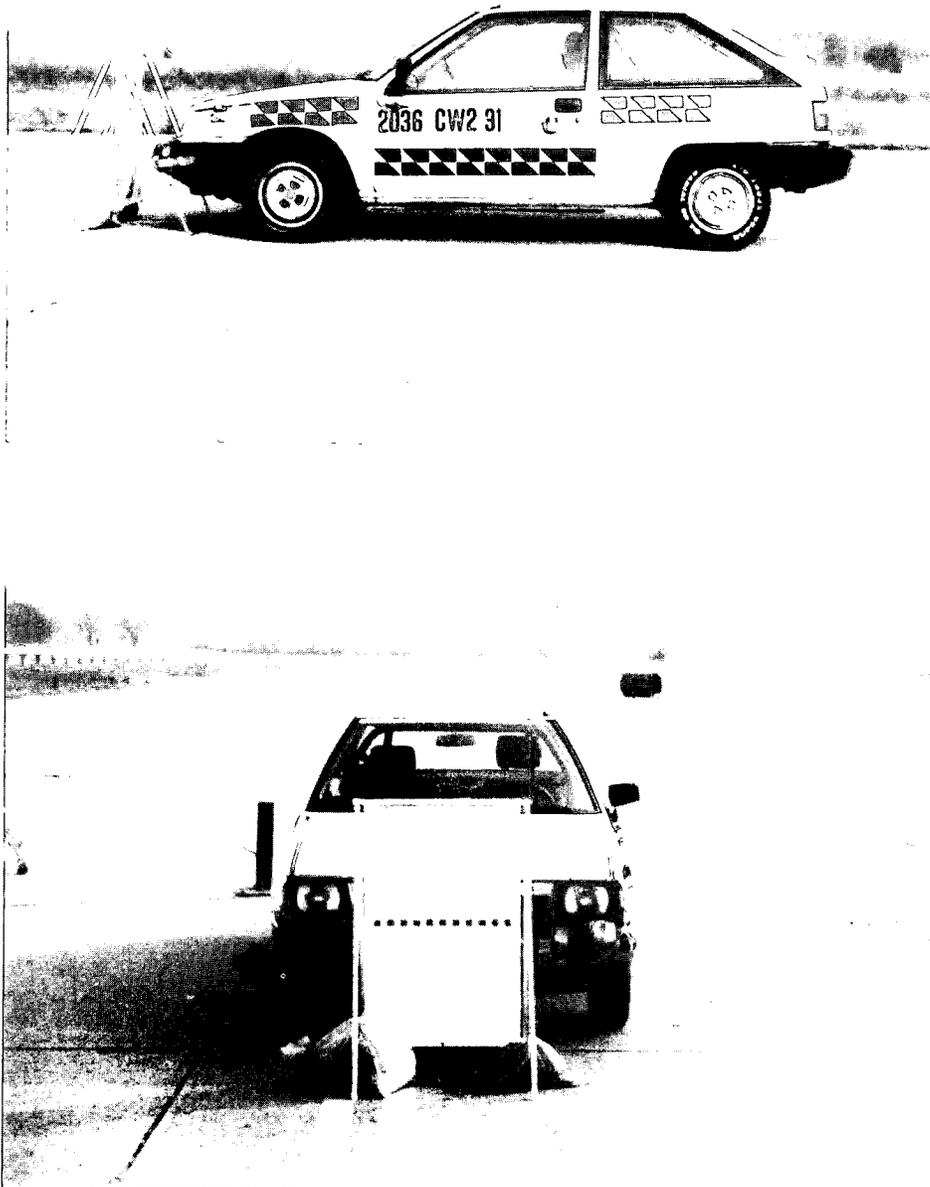
Figure 62. Portable Soft Barricade Before Test, Test 2036-CW2-91

This test was conducted at 45 mi/h (20.1 m/s), with the impact centered on the vehicle. Photographs taken before test 2036-CW2-91 are shown in figure 62.
