SHRP 2 Reliability Project R07

Earthwork Performance Specification Integrating Proof Mapping and Alternative In Situ Testing

EARTHWORK PERFORMANCE SPECIFICATION INTEGRATING PROOF MAPPING AND ALTERNATIVE IN SITU TESTING

Demonstration Project Report: SHRP 2 R07
MoDOT Hwy 141, Chesterfield, MO
November 2010 – December 2011

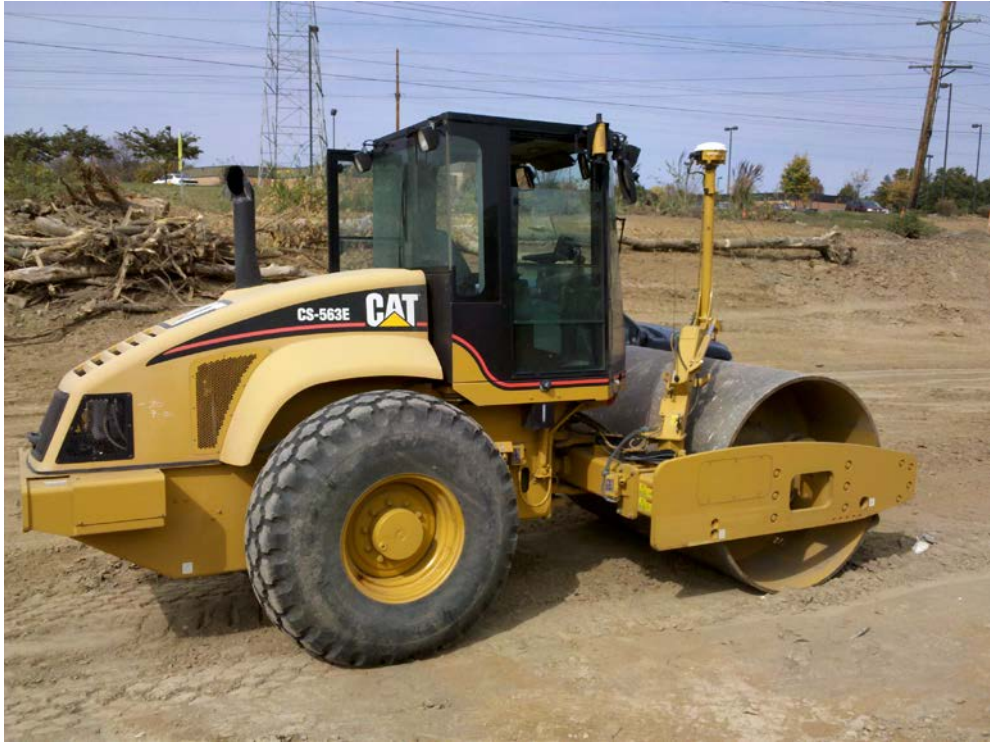
Figure 3. Caterpillar CS-563E Smooth drum roller.

The Caterpillar CS-563E smooth drum IC roller was used on the project. The roller is shown in Figure 3. A digital display unit employing proprietary software is mounted in the roller cabin for onboard visualization of roller position, IC-MVs, coverage information, amplitude/frequency settings, speed, and so on. The rollers were outfitted with a real-time kinematic (RTK) global positioning system (GPS) to continuously record the roller position information. Some key features of the rollers are summarized in Table 2. Caterpillar CS-563E roller recorded machine drive power (MDP_{40}) and compaction meter value (CMV). A brief description of the IC-MVs are provided in the following discussion.

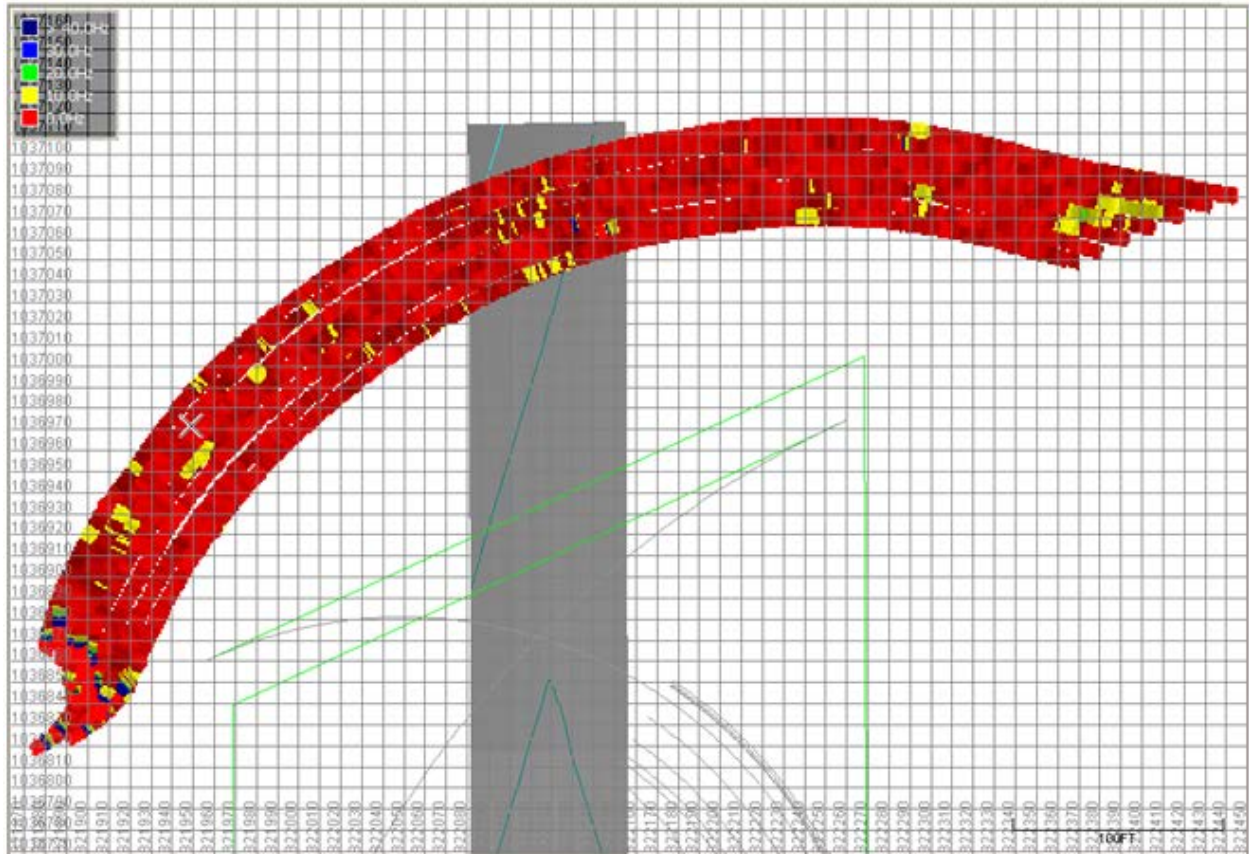
Figure 12: Test area #2 CMV results showing relatively low values reflecting the low strength underlying subgrade

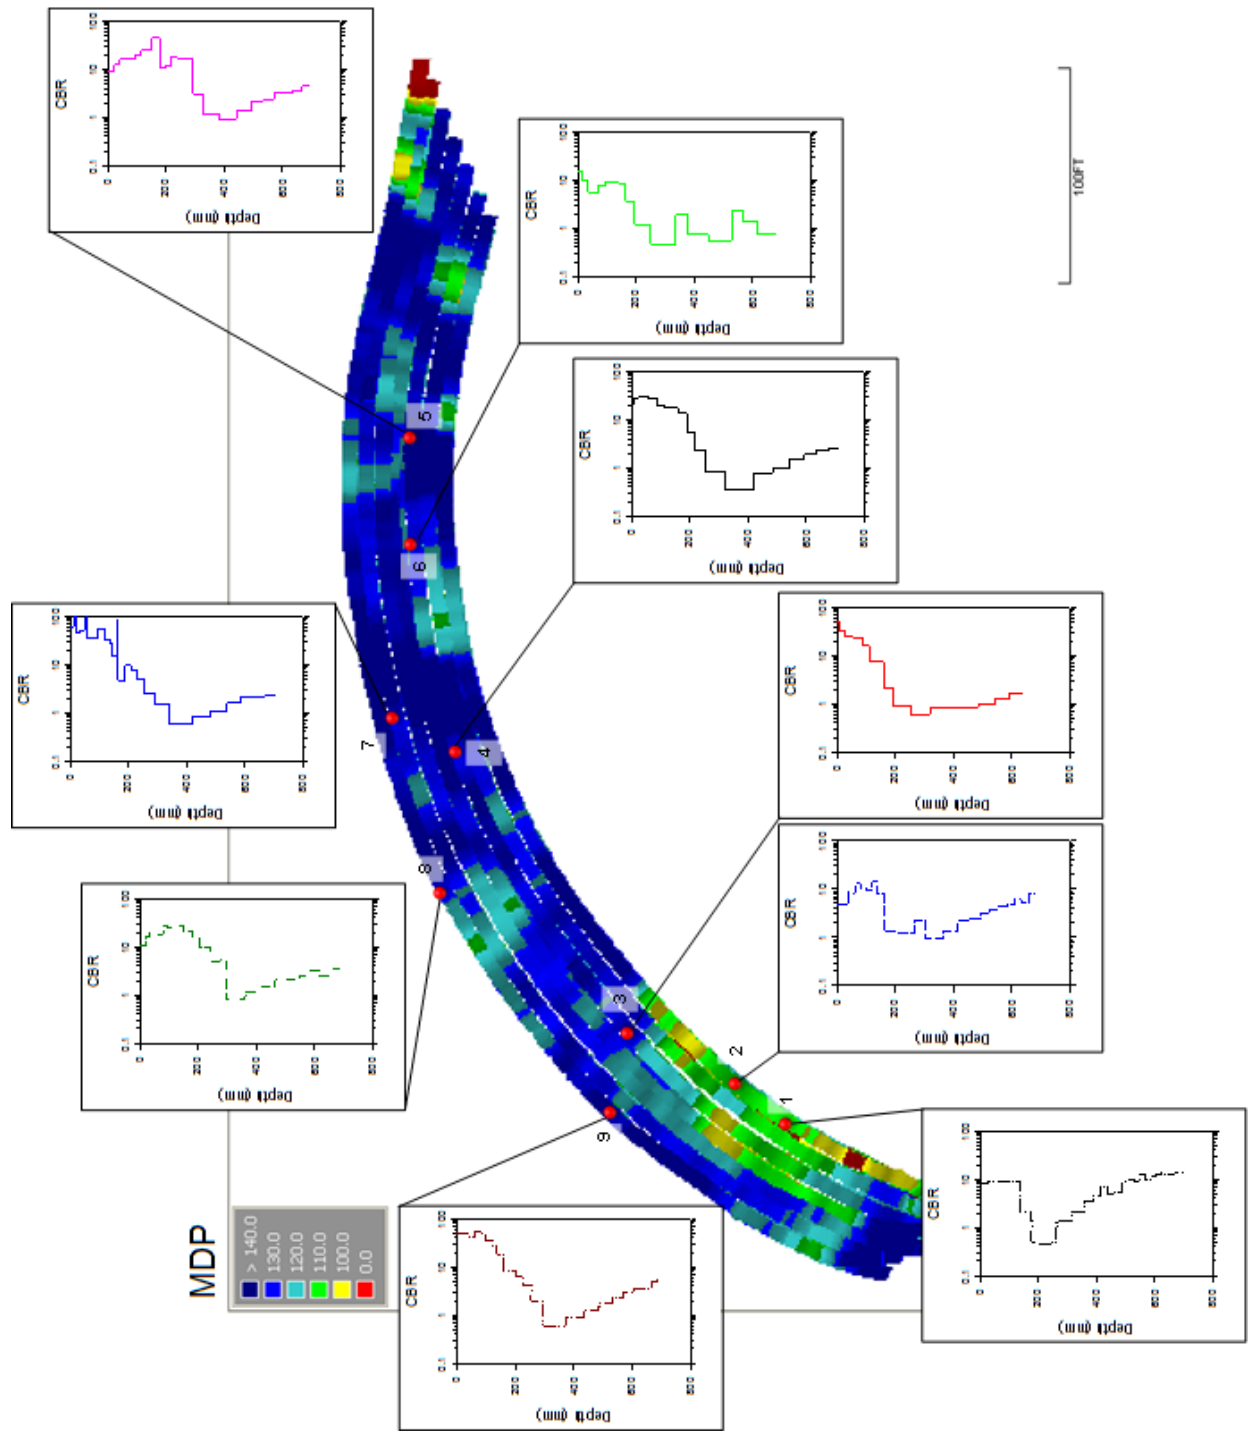
Figure 13: Test area #2 showing MDP values and DPC test locations and results

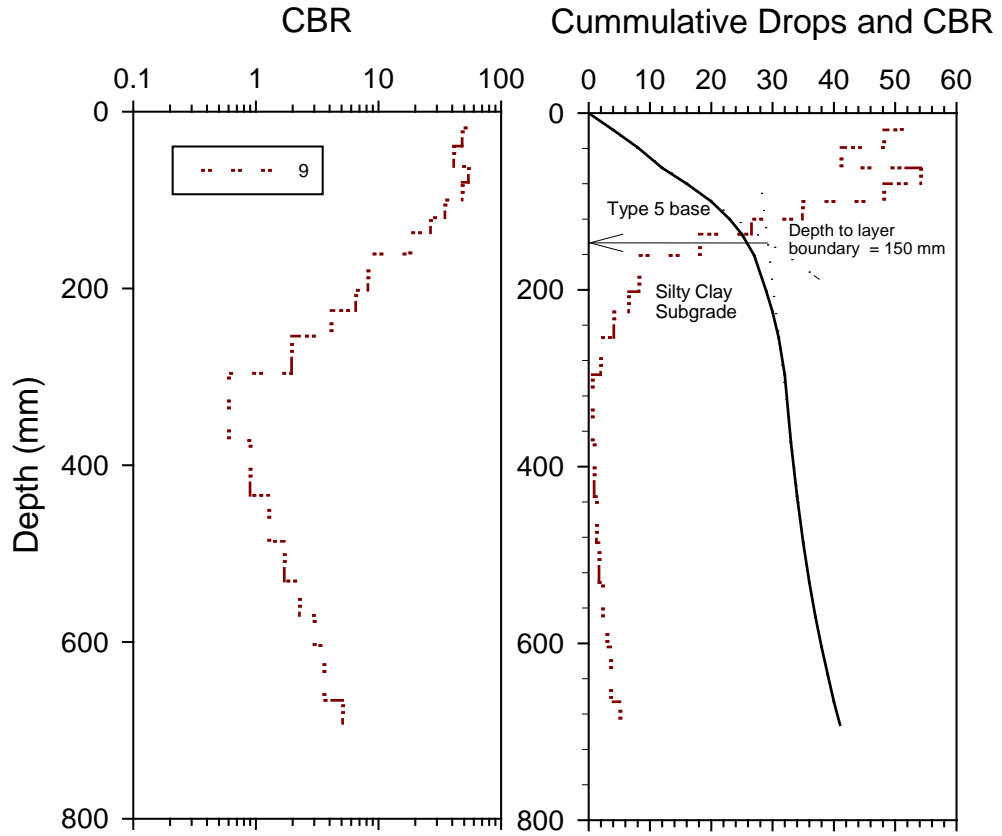
Figure 15: Test area #2 DCP test for no. 9 showing thickness determination for Type 5 aggregate base

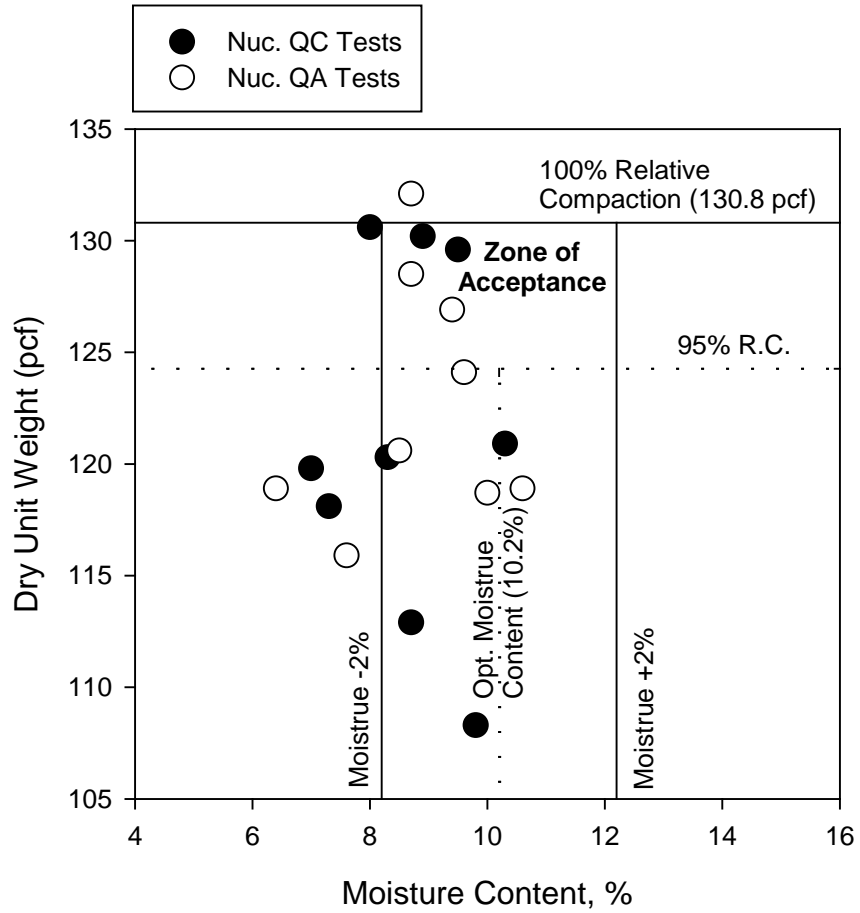
Figure 16: Test area #2 QA/QC nuclear density gauge test results

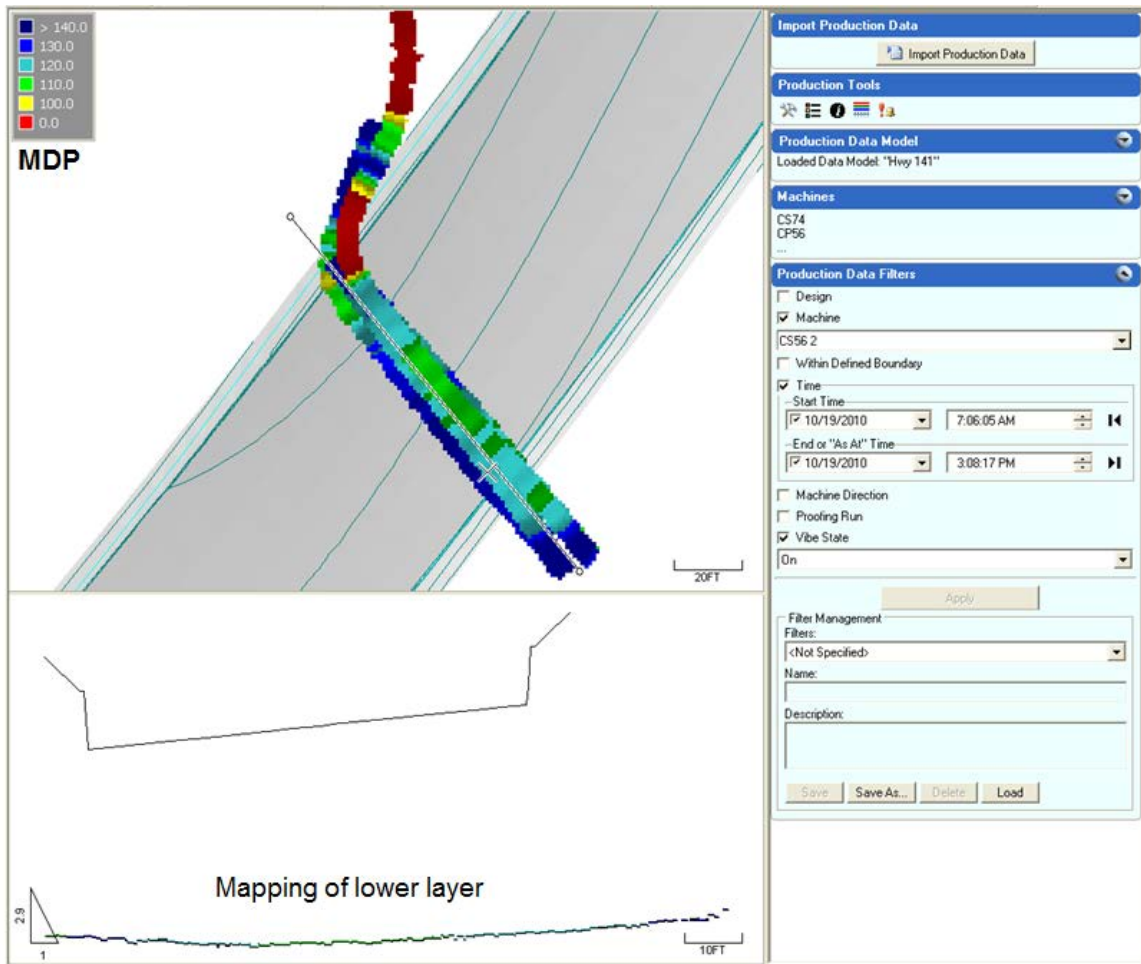
Figure 24: Initial mapping Test Area #3

Figure 25: Lift #1 mapping Test Area #3

Figure 26: Lift #2 mapping Test Area #3

Figure 27: Lift #3 mapping Test Area #3

Figure 28: Lift #4 mapping Test Area #3

Figure 29: Lift #5 mapping Test Area #3

Figures 24 to 30 show the time history of MDP values and layer lift thicknesses. Using RTK-GPS allows for a relatively accurate assessment of compacted lift thickness. Figure 31 shows the results of detailed analysis of the compaction history in this area. For 42 measurement points analysis the average lift thickness was 0.88 ft and the average number of roller passes was 5. Both parameters, however, have significant variation. This result is particularly interesting because lift thickness and pass coverage are extensively used in current specifications, but often with great difficulty to document and measure. Here the IC system provided a great deal of data and only required relatively simple investigation on a computer to determine field values.

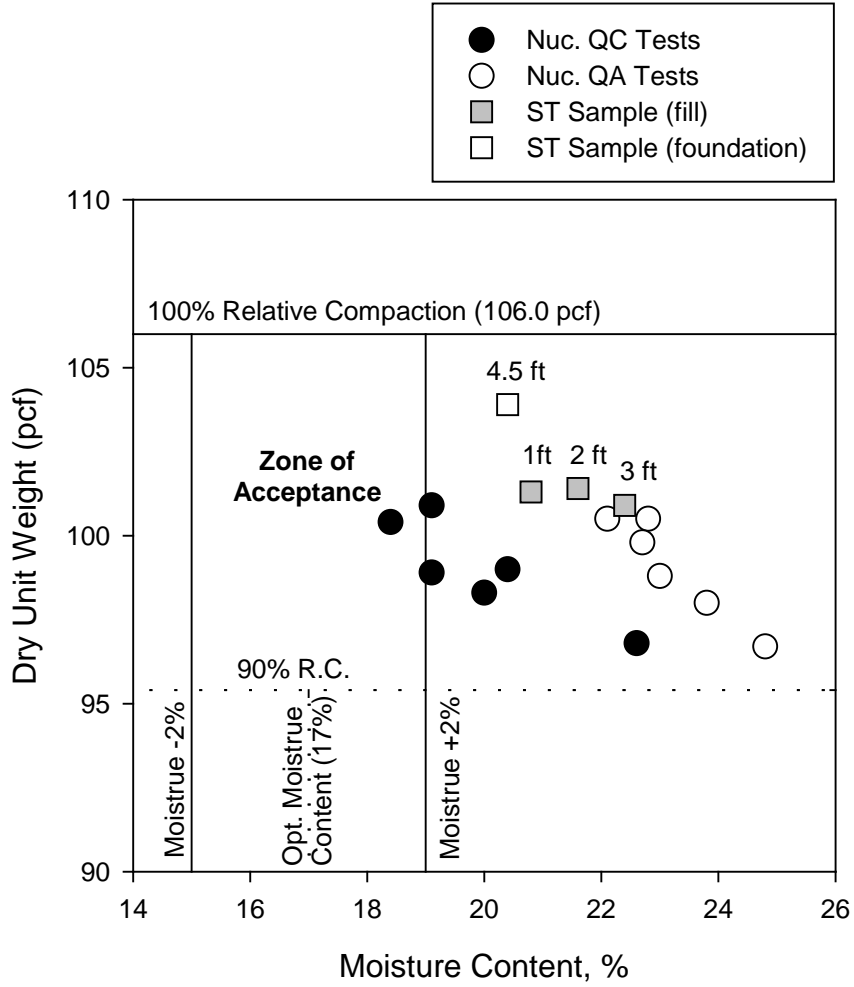
Figure 32: Tets area #3 results from QC/QA nuclear gauge tests and independent Shelby tube samples adjacent to box culvert

Figure 32 shows the moisture-density zone of acceptance for QC/QA nuclear density testing independent Shelby tube samples collected by the research team. The results show relatively high moisture content and confirm the low CBR as determined from the DCP tests. In one of the Shelby tube holes, an in situ borehole shear test (BST) was performed to measure the effective stress shear strength parameters values. Figure 33 shows that the friction angle was 23.5 degrees and the cohesion was about 4 kPa. Figure 34 shows real-time display of the coverage area for a pass.

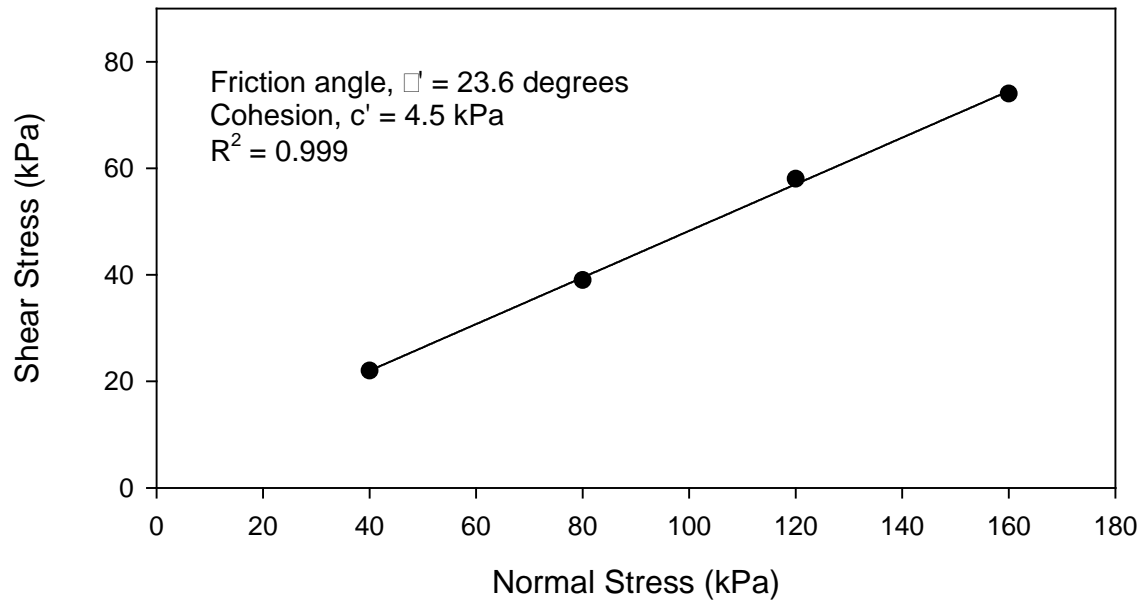
Figure 33: In situ borehole shear test (BST) in compacted box culvert backfill

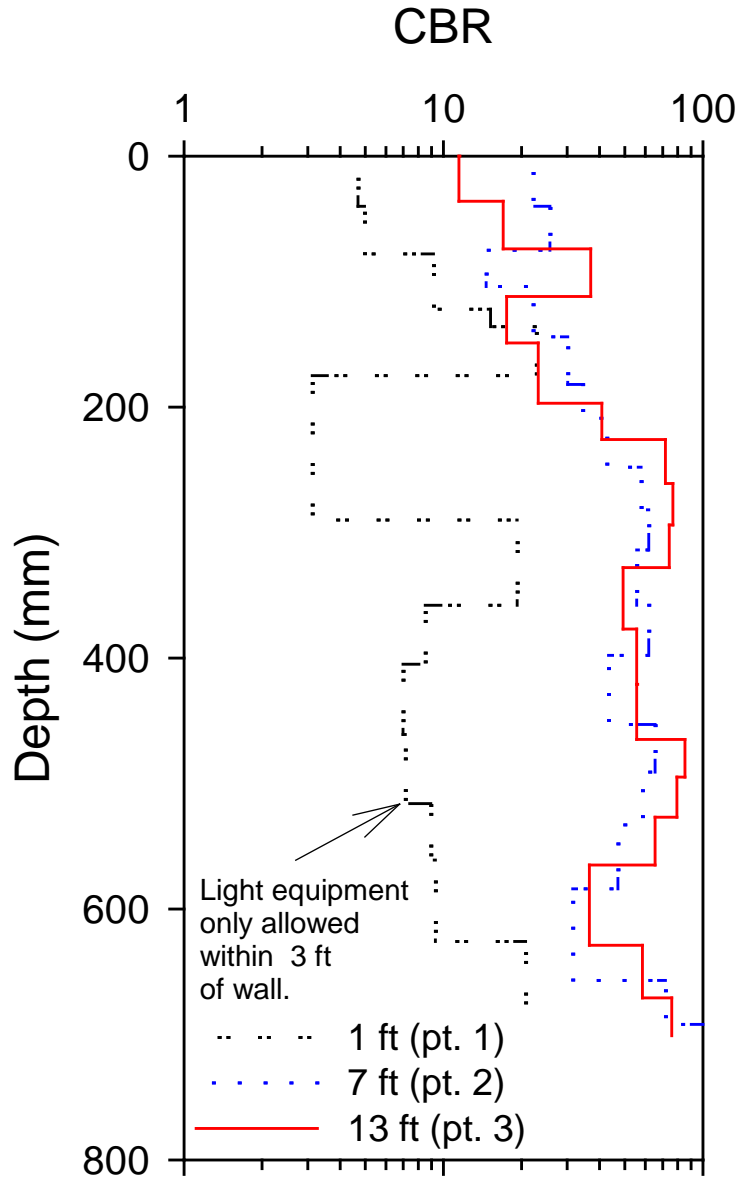
Figure 41: DCP test results for test are #5 at differnet distances form the MSE wall

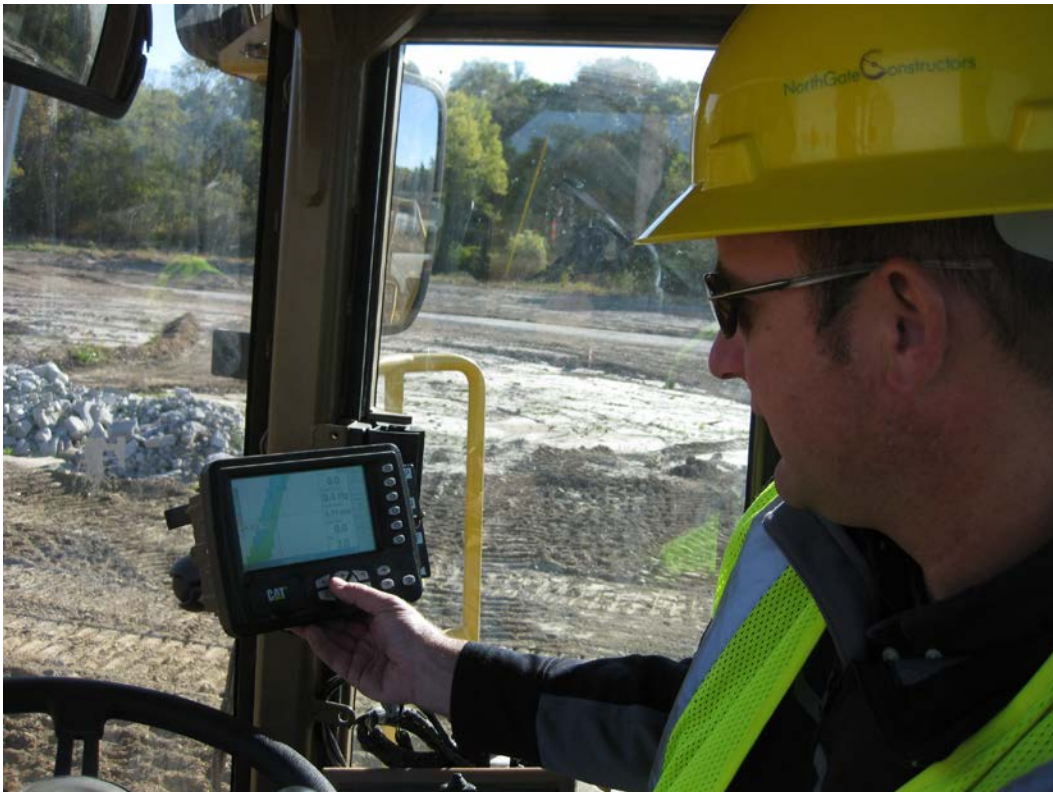
Figure 59: 815F operator display

The 815F roller (Figures 58 and 59) also mapped this area and the results are shown in Figure 60 and 61. The variation in color of the MDP values helped identify areas of wet soil conditions (see MDP scale in upper left corner and notes on w%). Static plate load tests were conducted in this test area (see Figures 62 and 63) at several locations based on the variations observed on the MDP map and confirmed soft and wet areas of noncompliance. Figure 64 shows that some rolling operations occurred in what were later determined to be cut areas. Figure 65 shows the embankment geometry and location of the test area being rolled. Compared to the CS-563E roller IC-MVs. The 815F MDP map shows similar geospatial variations in ground stiffness.

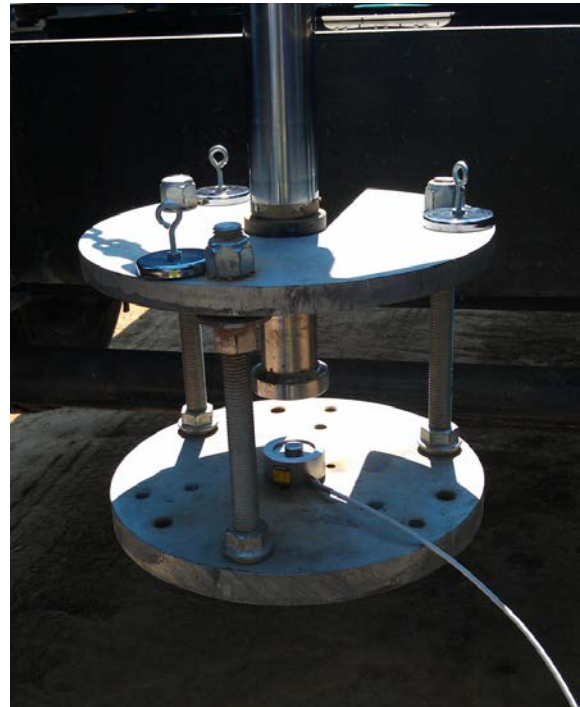
300 mm plate load test setup

Figure 62: GPS location and PLT test setup to calibrate 815F roller

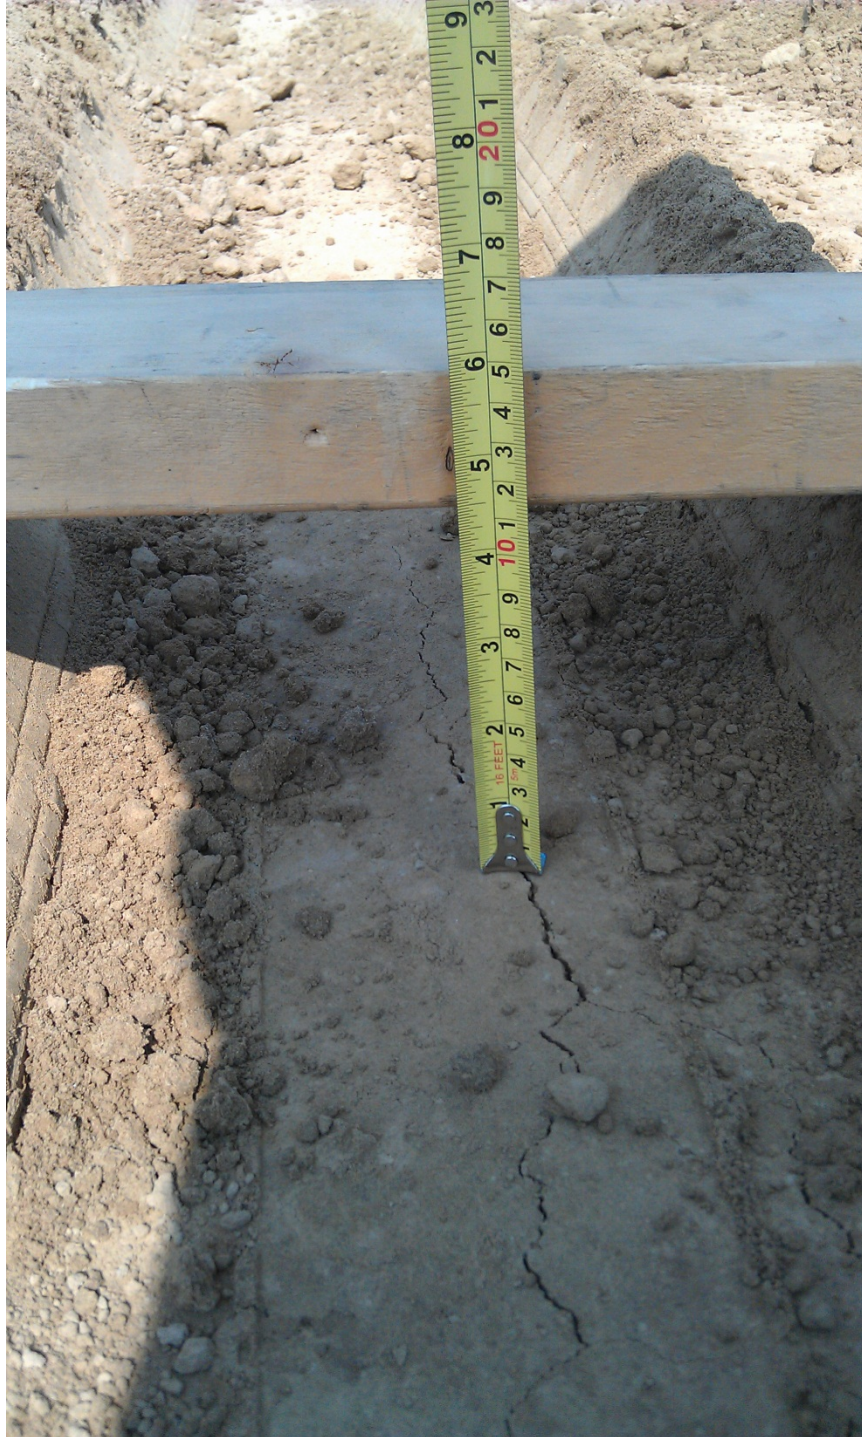
Figure 68: Test area #2—rut measurement

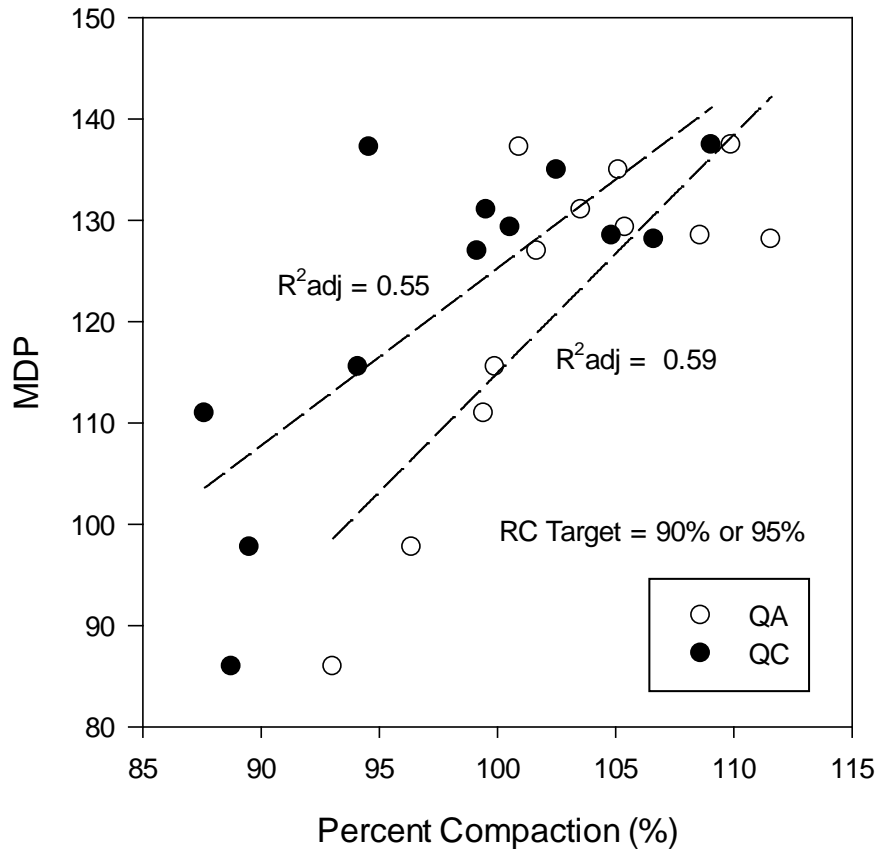
Figure 73: Correlation analysis for 815F impact roller for percent compaction

- Areas of non-compliance based on the IC maps were primarily areas of high moisture content.
- The RICM-MVs are not well correlated to percent relative compaction or moisture content, particularly compared to percent compaction from nuclear moisture-density gauge testing.

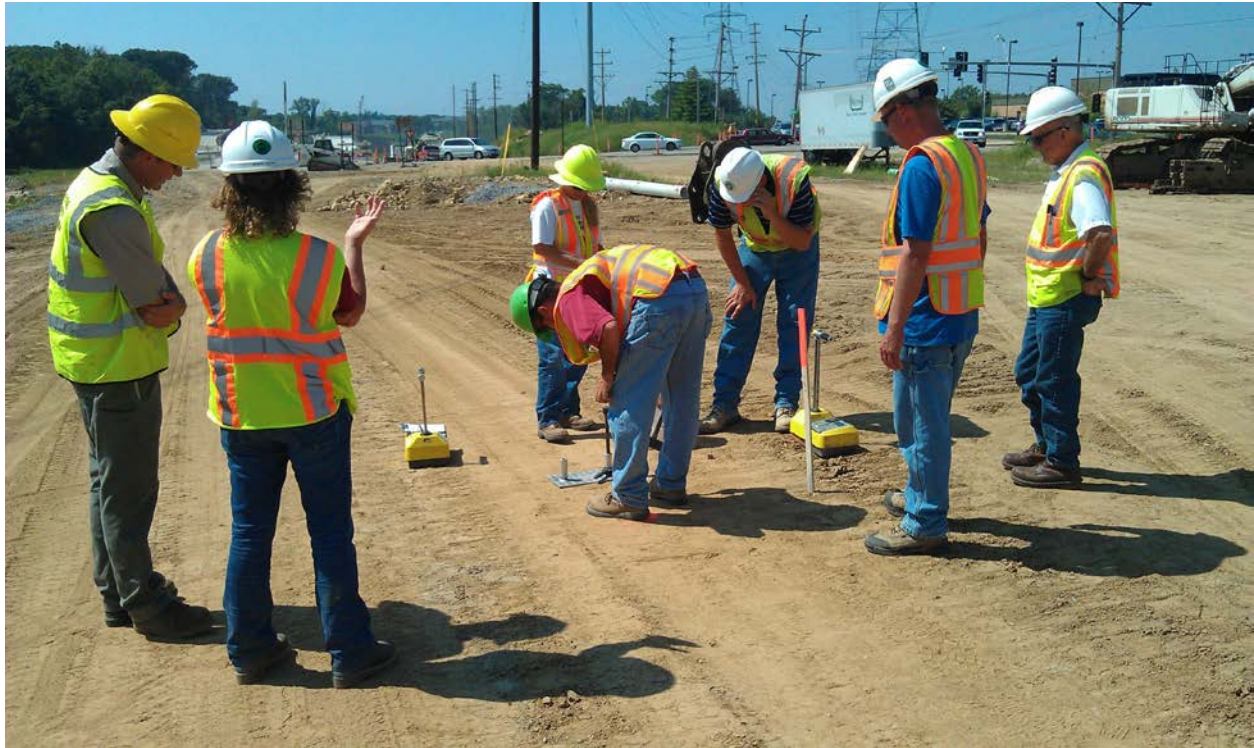
Figure 83: QA/QC operations to conduct nuclear density tests

This project provided an excellent opportunity to analyze the measurement error of side-by-side nuclear density gauge results for QA and QC. Special effort was put into a testing plan by the inspectors to generate sufficient data to perform a statistical analysis of the results. The QA/QC data also provided the opportunity to characterize the reproducibility of results between QC and QA. Figure 83 shows the field equipment and effort to perform these side-by-side tests. Figure 84 shows the project level maps of IC values. Figure 85 shows a comparison between QA and QC in terms of wet density, moisture content, and percent compaction. All tests were performed using the direct transmission method and using the same probe penetration depth and measurement duration. Analysis of the difference between side-by-side measurements shows that the root mean square error (RMSE) of wet density, moisture content, and percent compaction for these measurements equals 4.2 pcf, 2.4% (dry soil basis), and 2.7% (relative to
