REPORT S2-R21-RW-4

Composite Pavement Systems: Appendices

S H R P 2 R E N E W A L R E S E A R C H

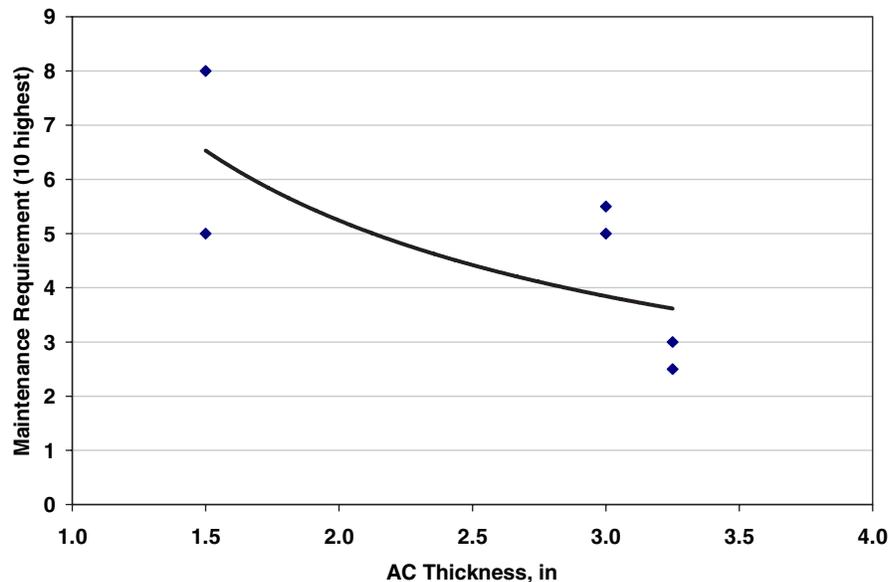
Figure A.1. Effect of HMA (AC) thickness on maintenance requirements (10 is highest maintenance requirement and 0 is none).

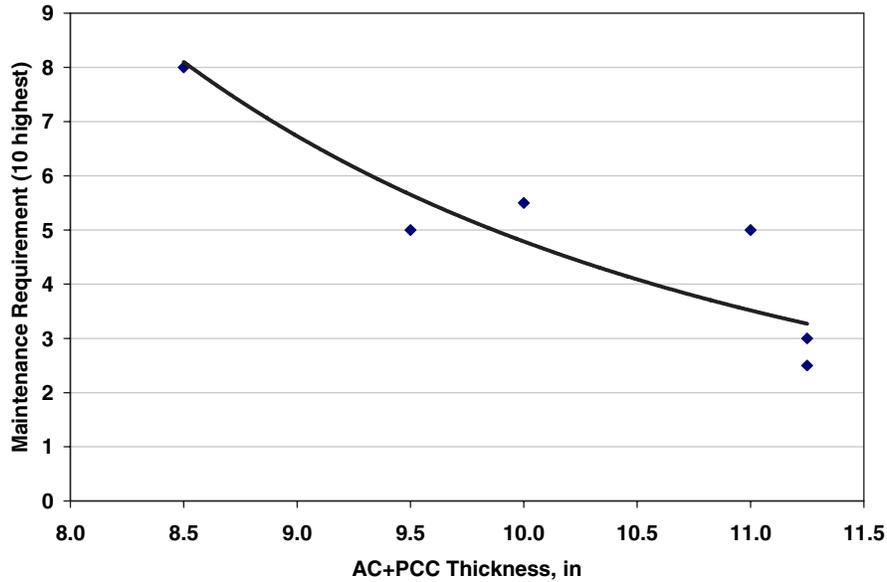
Figure A.2. Effect of HMA (AC) + PCC thickness on maintenance requirements (10 is highest maintenance requirement and 0 is none).

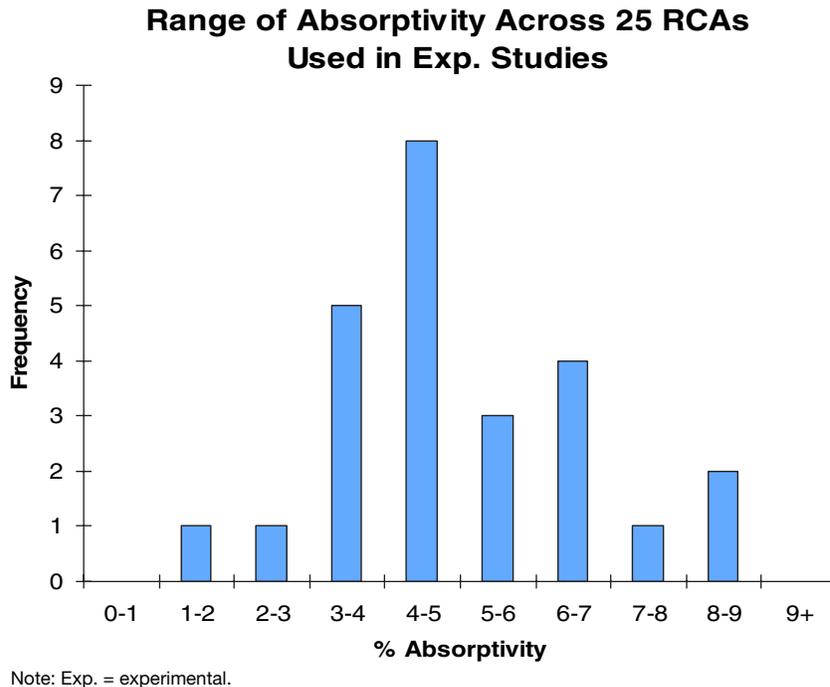
Figure E.1. Range of absorptive capacities of RCA encountered across 17 research references.

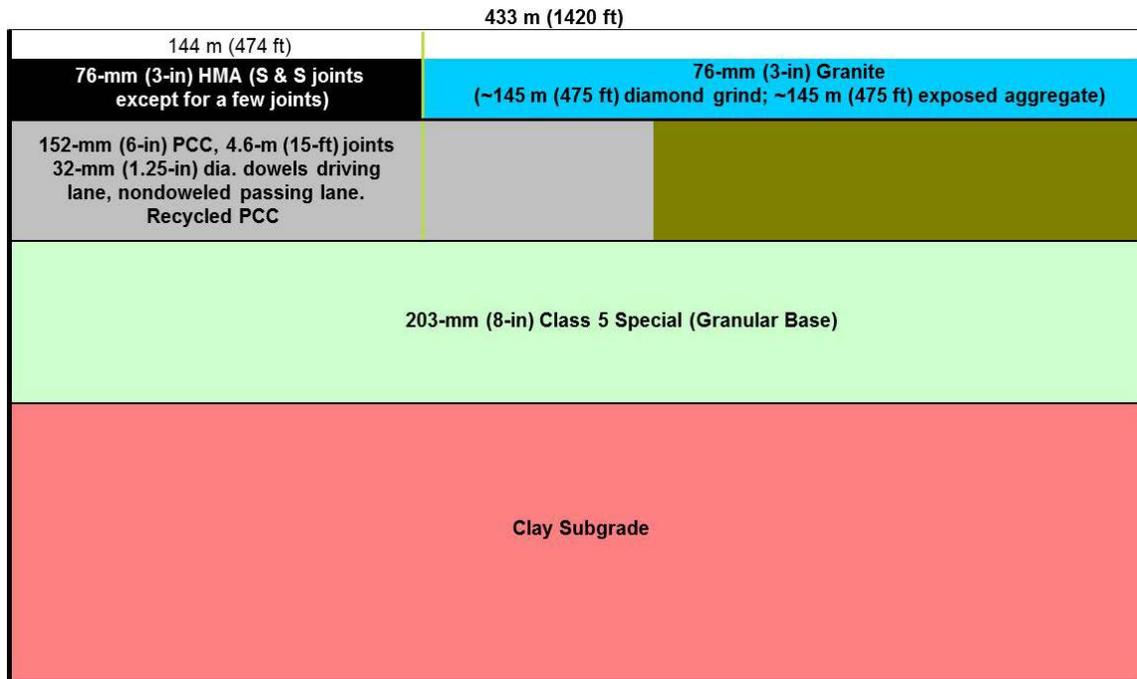
Figure F.3. Layout of test sections (Cell 70, HMA/PCC; Cell 71, PCC/RCA PCC; Cell 72, PCC/low-cost PCC) at MnROAD.

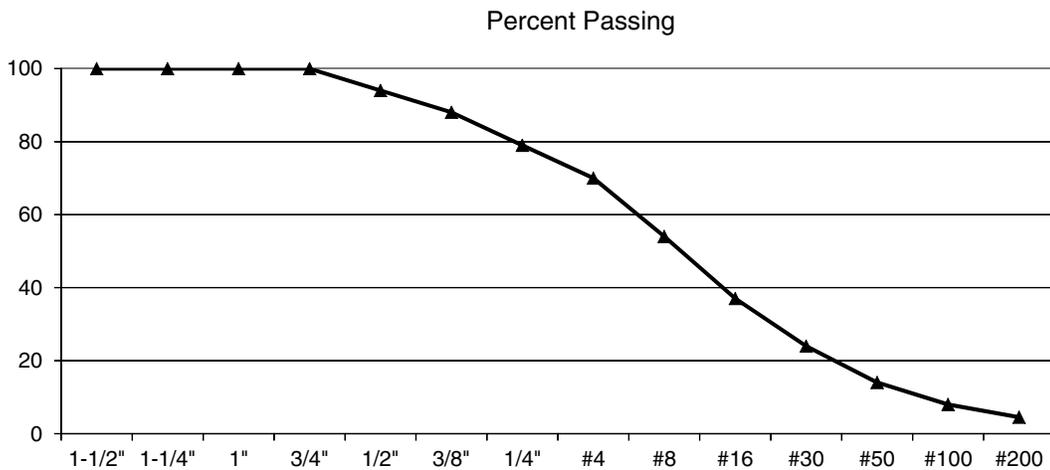
Figure F.19. Final approved JMF aggregate blend gradation for HMA mix.

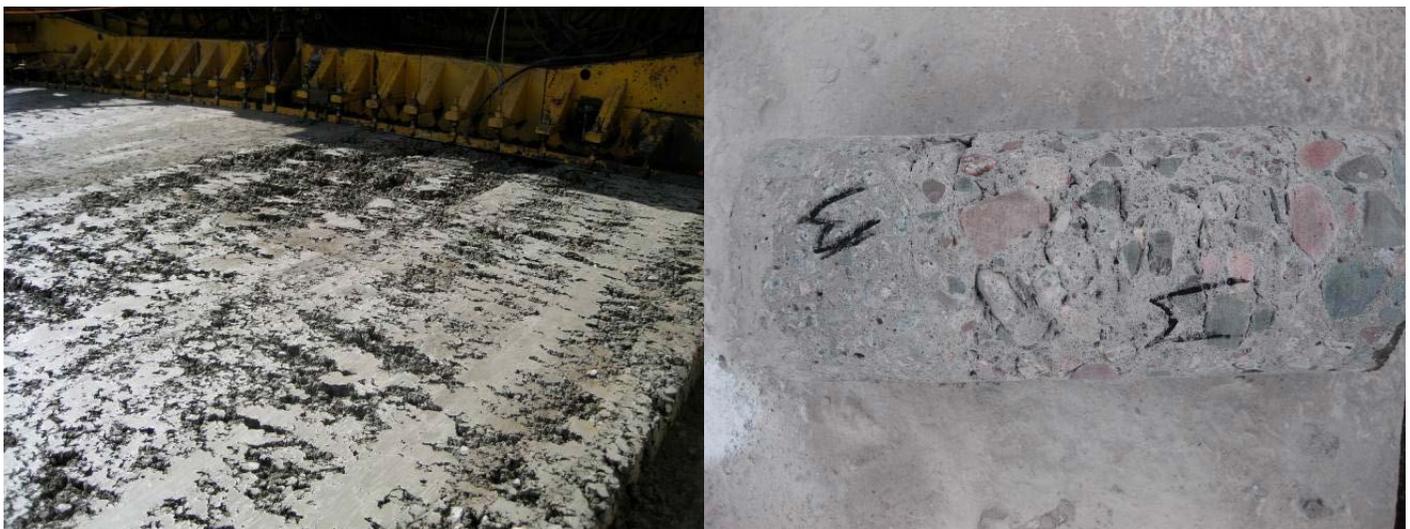
Figure F.26. At left, “torn” edges and surface caused by concrete setting on various parts of the paver; at right, coring showed poor mix consolidation in the lower PCC at select locations.

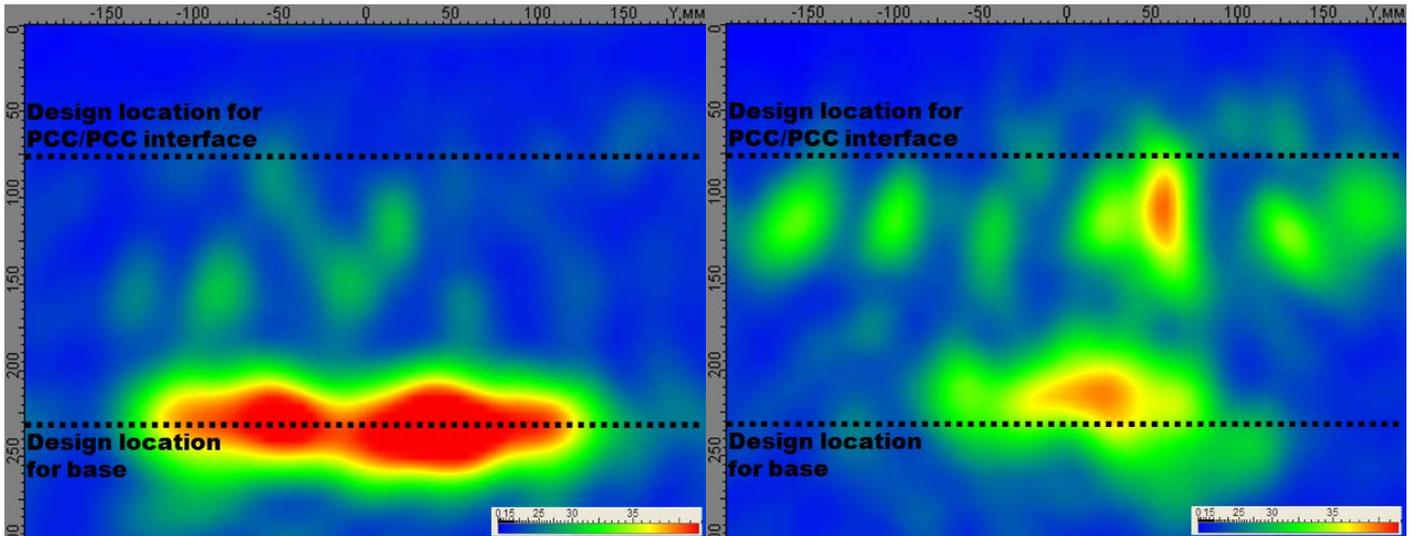
Figure F.27. At left, a typical tomogram from the PCC/PCC demonstration slab at MnROAD; at right, tomogram with ultrasonic reflection near the depth of the PCC/PCC interface.

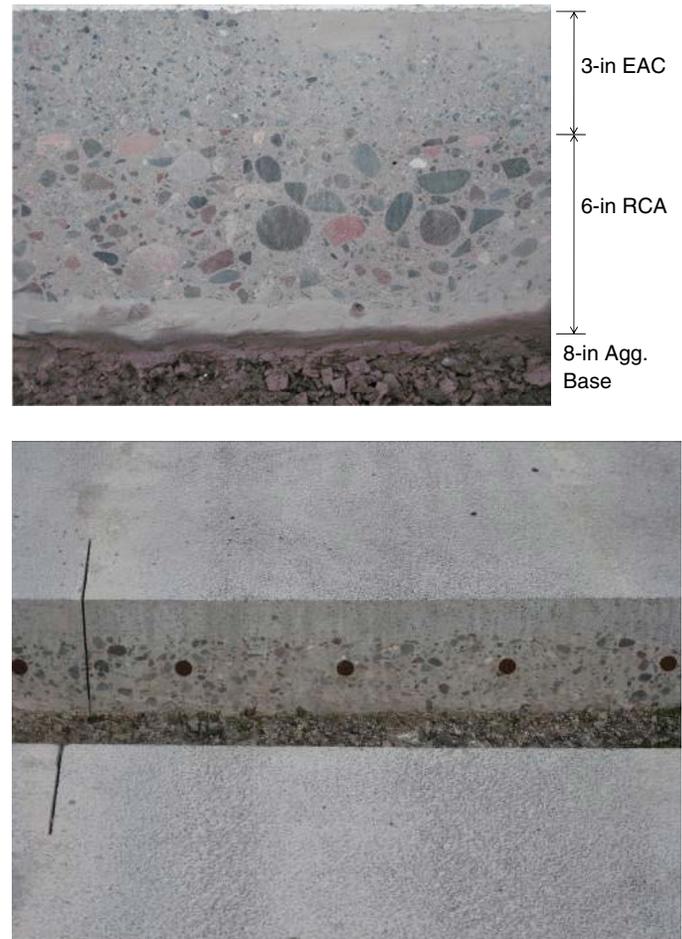
Figure F.28. Cross section of the PCC/PCC demonstration slab constructed at MnROAD showing very good integrity and bond between the two PCC layers.

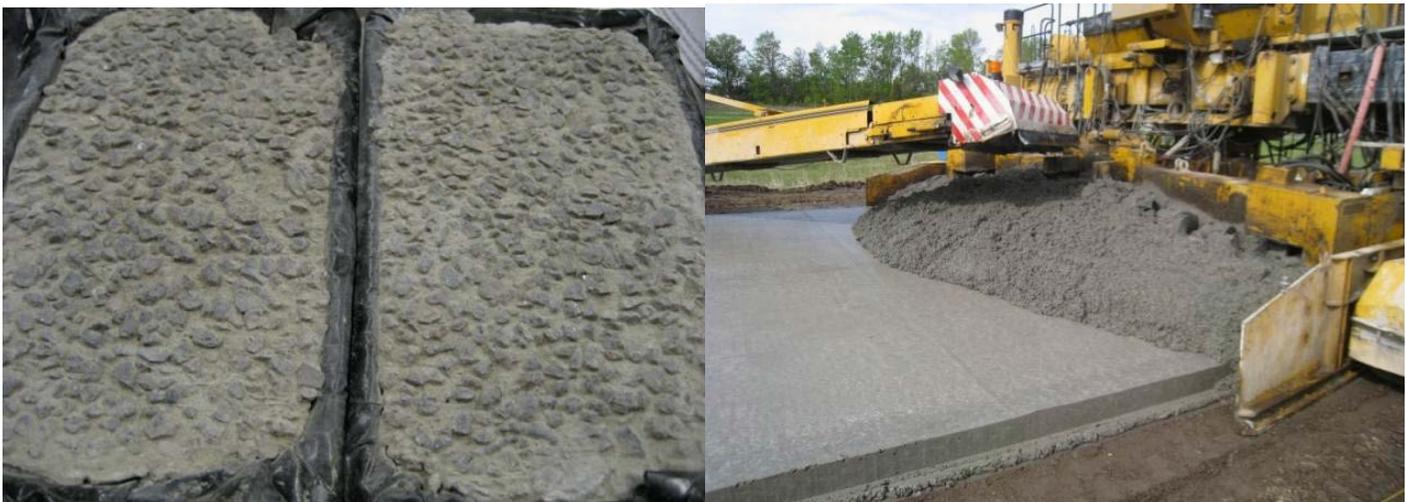
Figure F.29. At left, PCC specimens cast in preparation for the paving and brushing of the PCC/PCC demonstration slab. At right, top surface PCC mix being placed in front of the second paver on site at MnROAD.

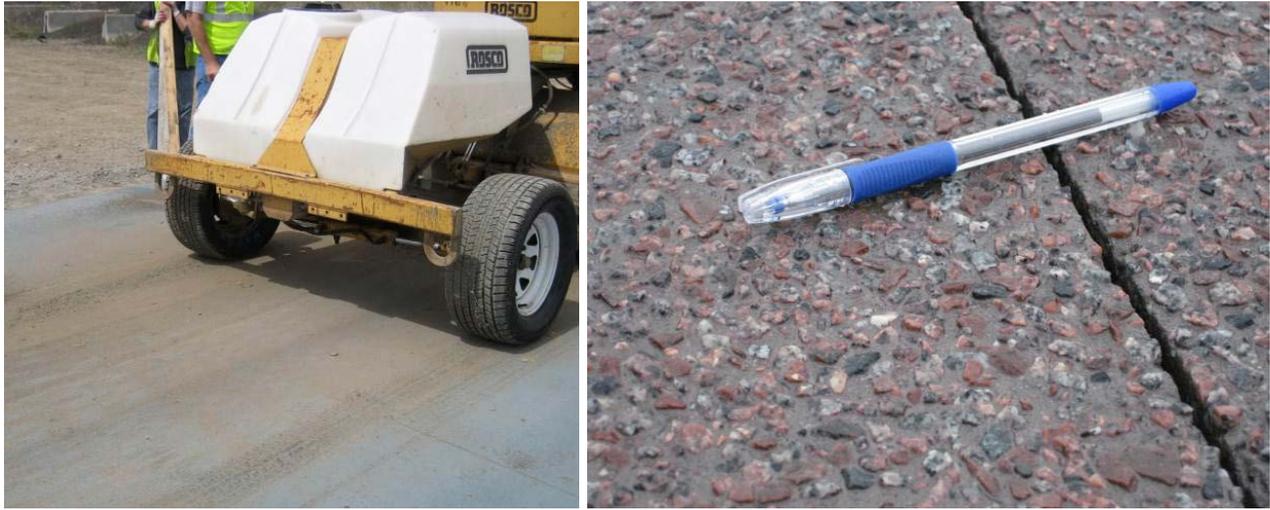
Figure F.35. Surface after first pass with brush (left); finished EAC surface after wash (right).

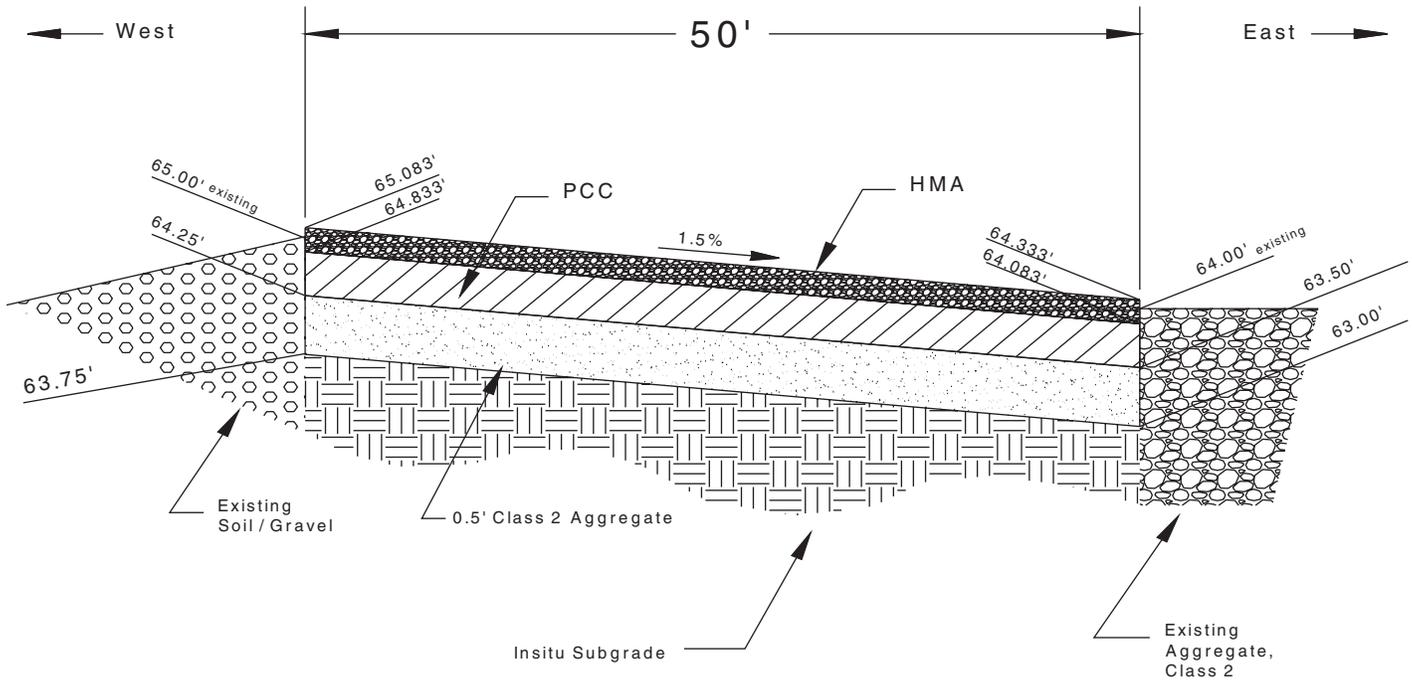
Figure G.4. Typical transverse cross section of test track showing elevations and cross slopes.

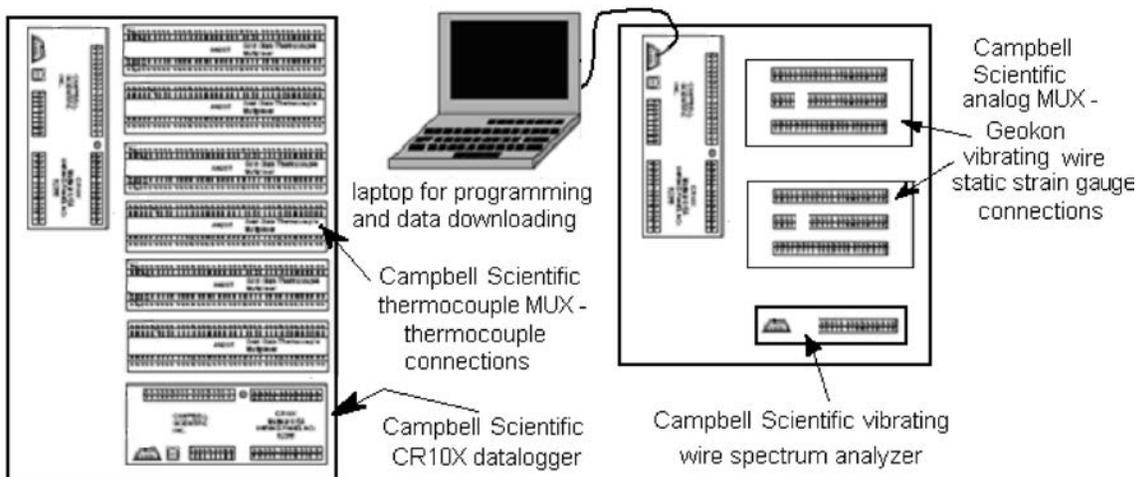
Figure G.22. Schematic of datalogger-based data acquisition system.

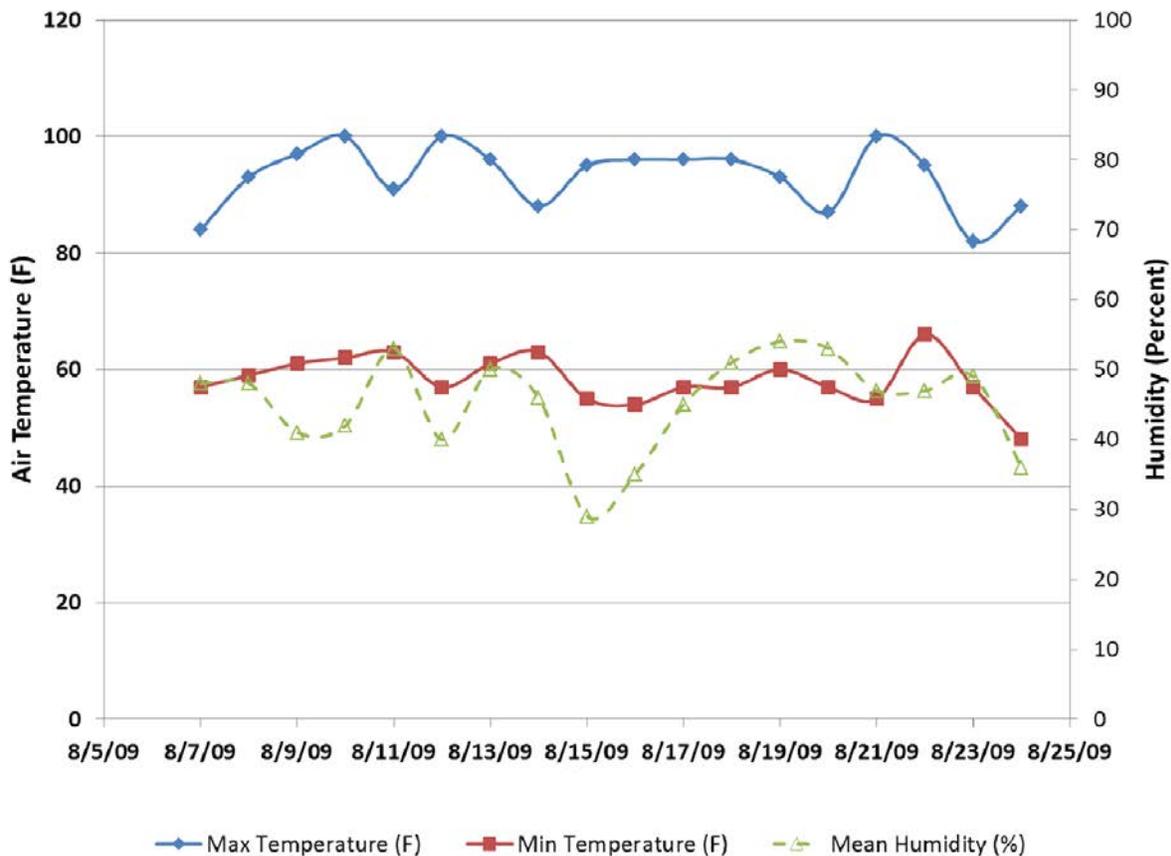
Figure G.34. Air temperature and humidity during first 3 weeks of the PCC curing period.

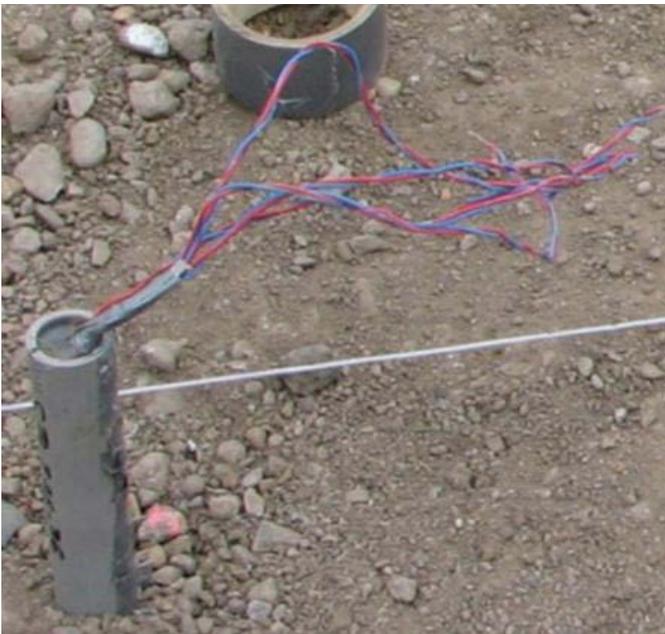
Figure H.4. Thermocouples installed in Cell 70.

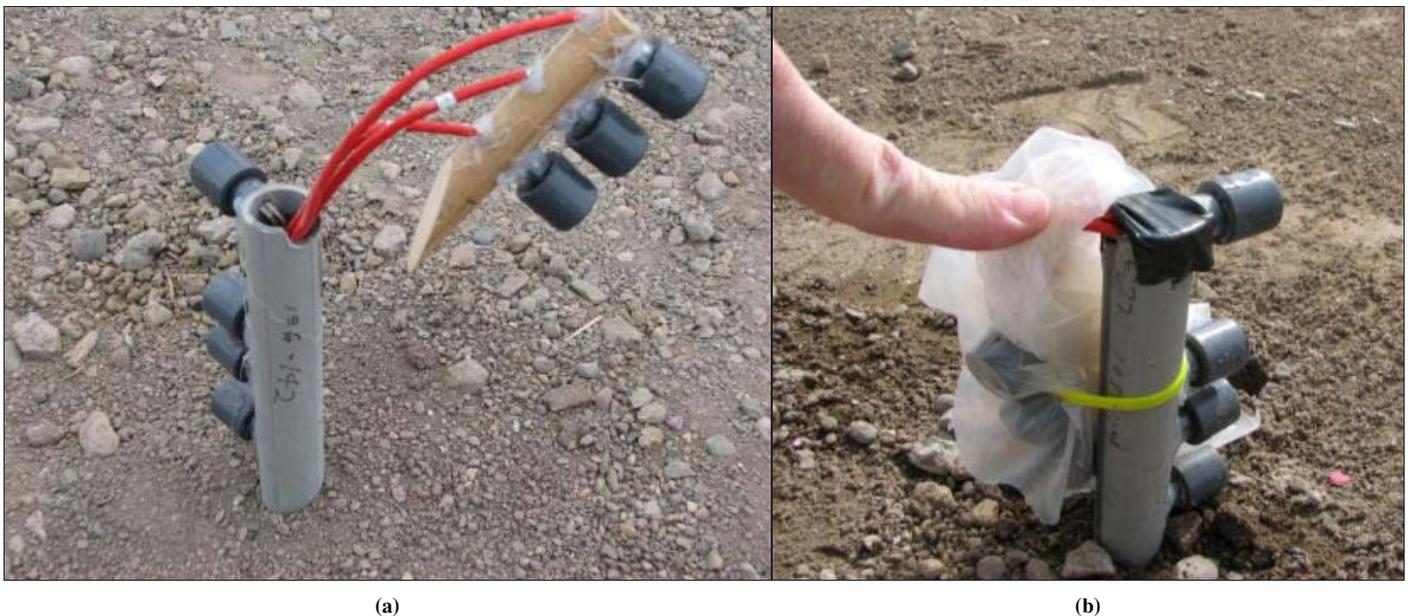
Figure H.9. Concrete relative humidity sensors installed in Cells 71 and 72. (a) Sensors to be installed in the upper and lower PCC layers and (b) installation just before the passing of the first paver.

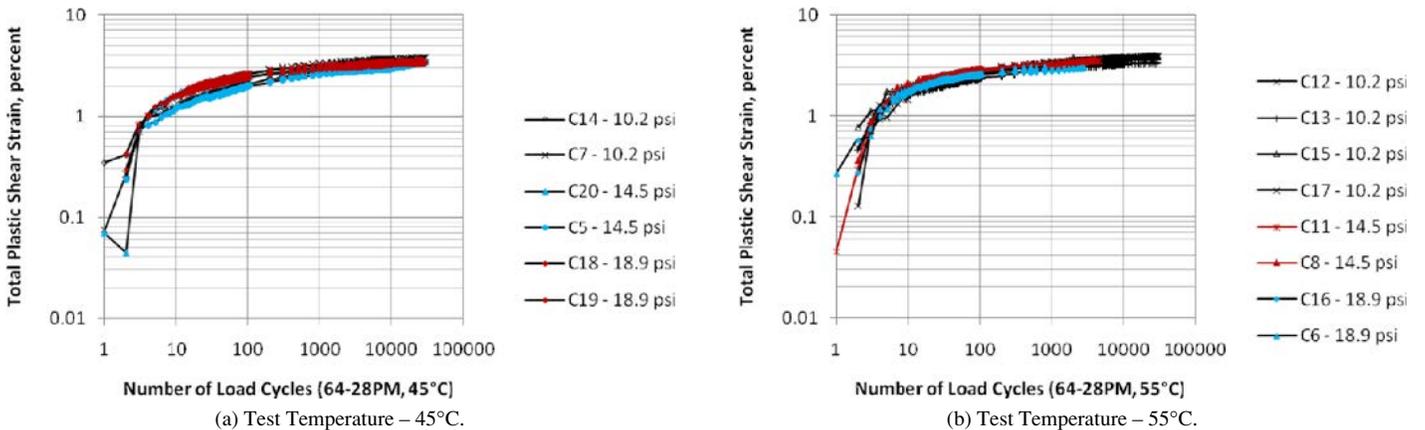
Figure I.8. Repeated load plastic shear strain for the PG 64-28PM mixture.

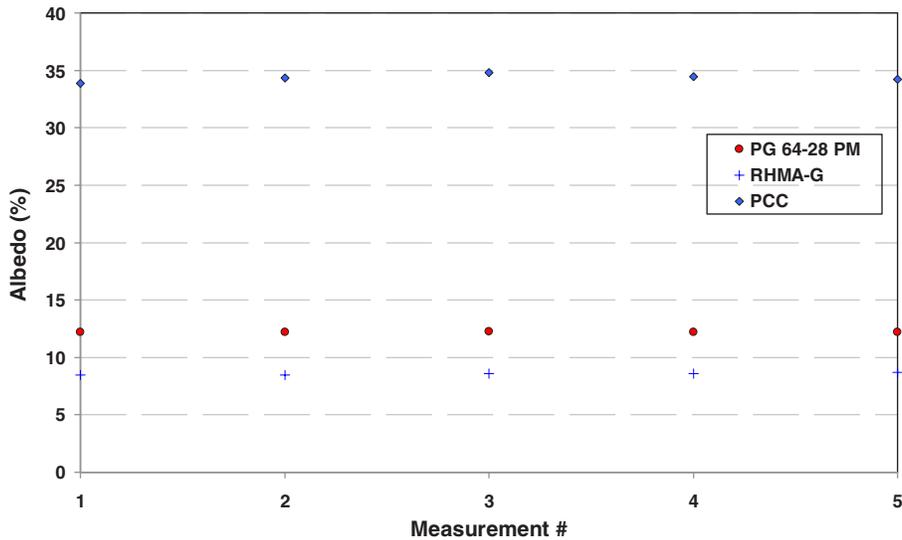
Figure J.5. Measured albedo for the Heavy Vehicle Simulator test sections.

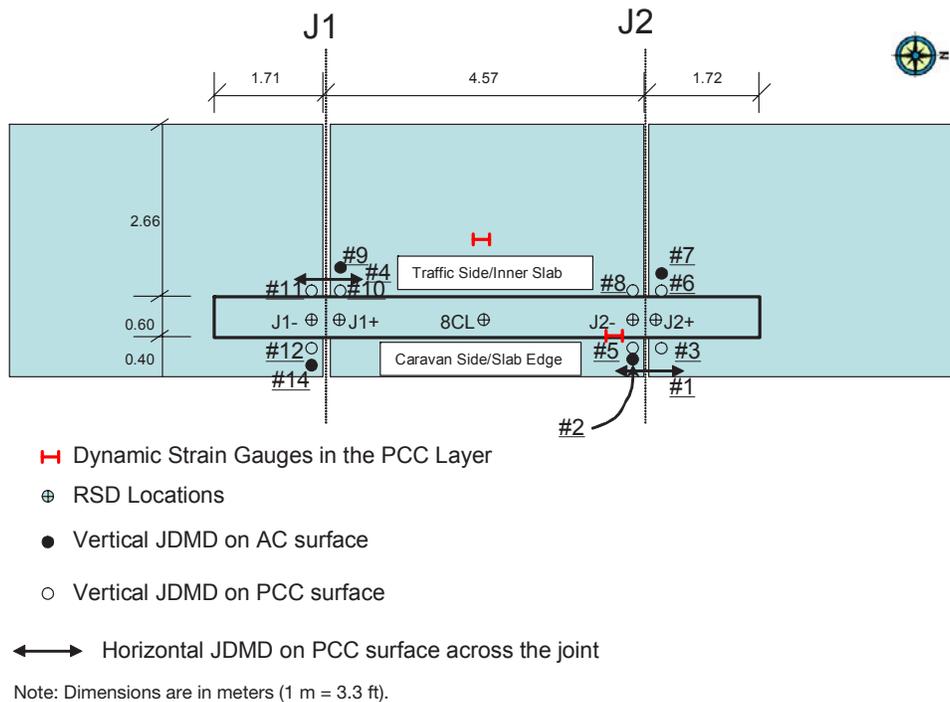
Figure K.7. Section 614HB: Section and instrument layout (JDMD No. 13 did not work properly during the testing).

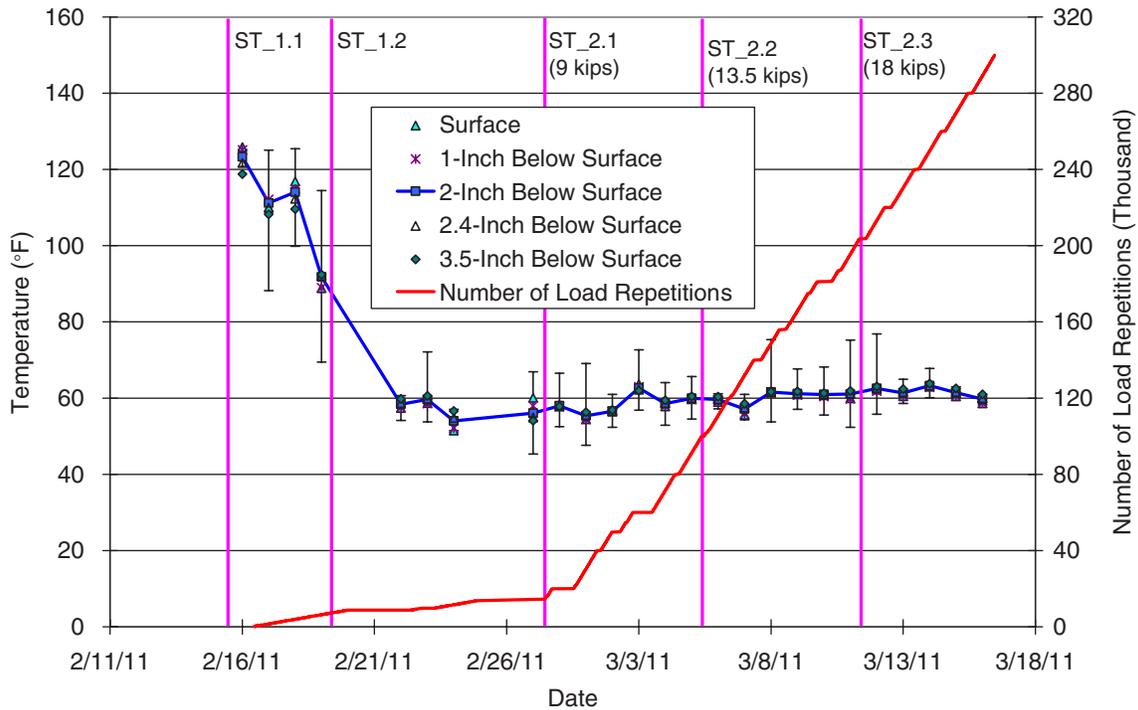
Figure K.11. Section 613HB: Daily average temperatures at pavement surface (i.e., top of HMA layer) and various depths during HVS trafficking. The last thermocouple measures PCC temperature.

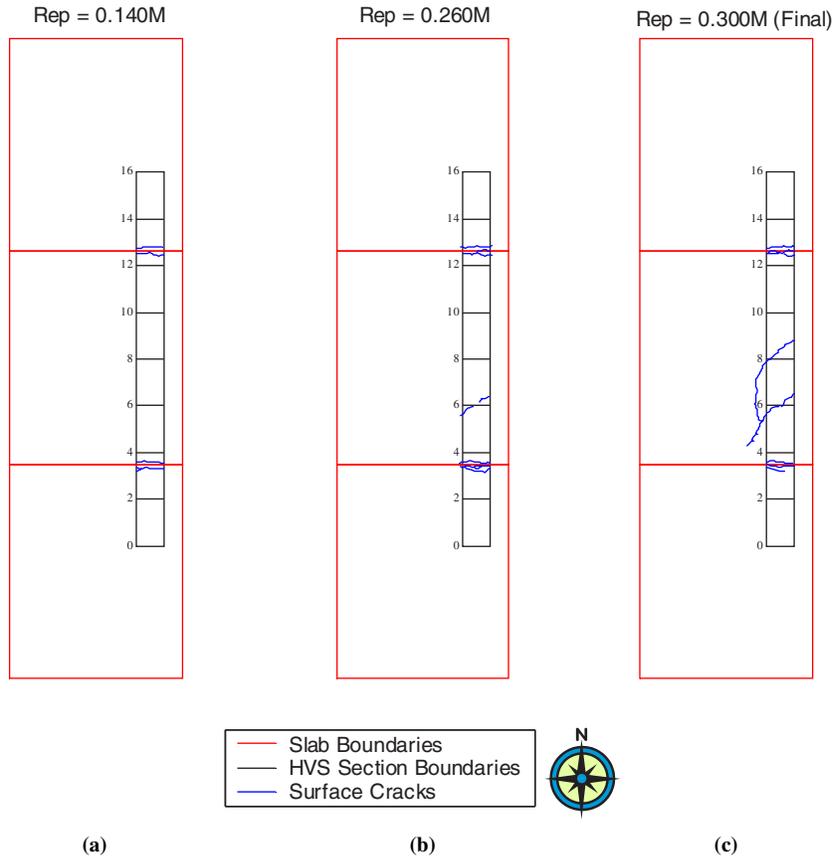
Figure K.13. Top views of surface cracks after different numbers of load repetitions: (a) Repetition = 0.14 million and crack length = 2.5 m (8.3 ft); (b) repetition = 0.26 million and crack length = 4.4 m (14 ft); and (c) repetition = 0.30 million and crack length = 6.4 m (21 ft).

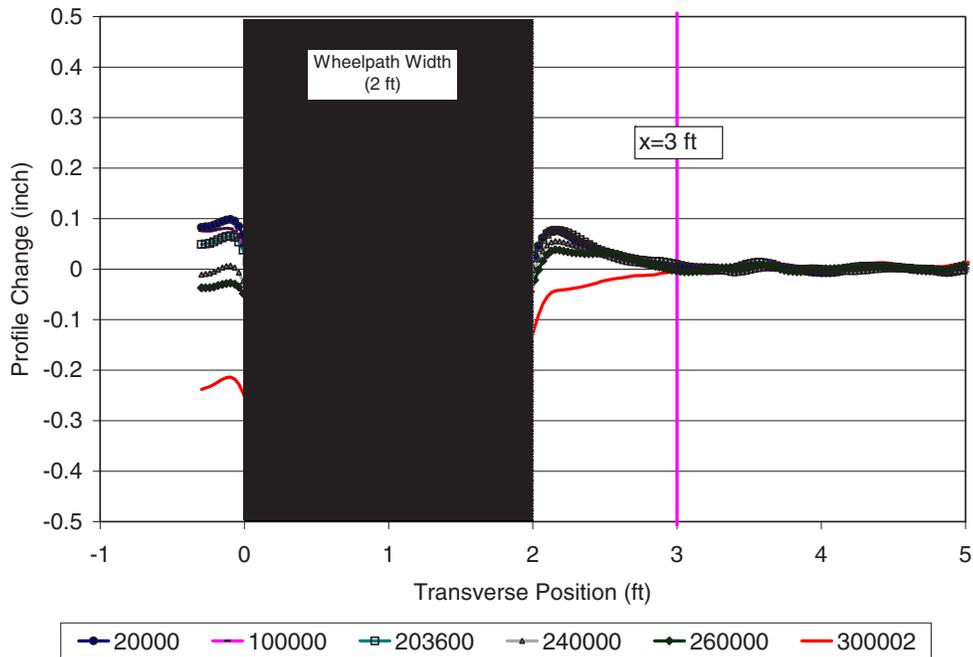
Figure K.14. Average profilometer cross section at various load repetitions for Section 613HB.

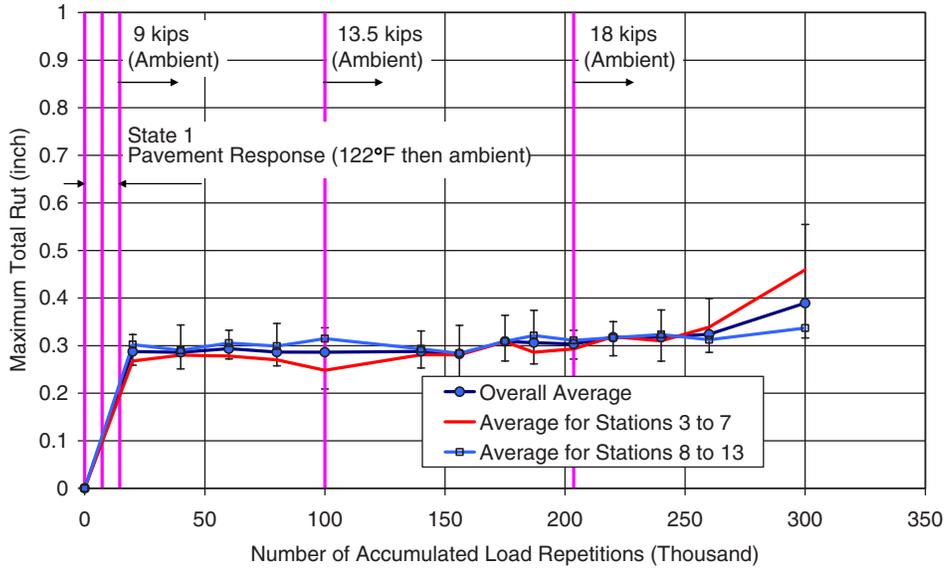
Figure K.15. Development of maximum total rut for Section 613HB.

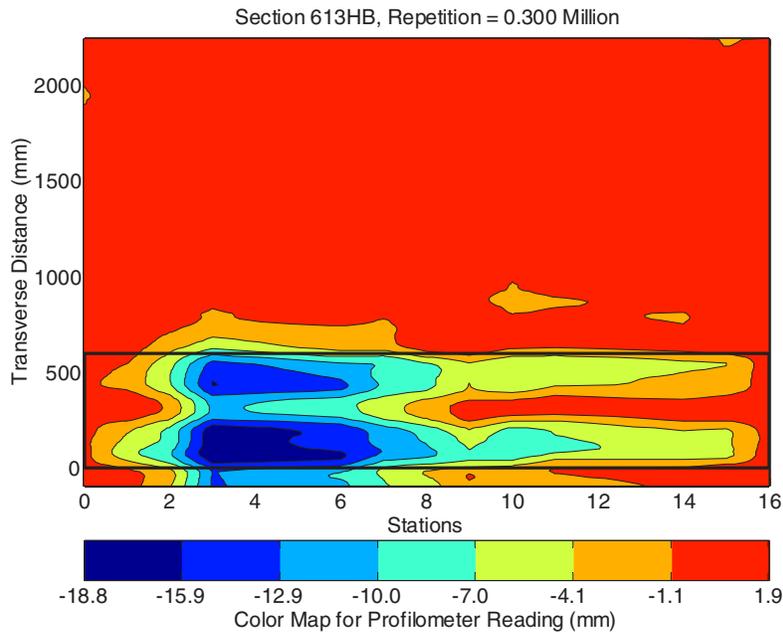
Figure K.16. Two-dimensional contour plot of change in surface elevation relative to untrafficked condition at end of test for Section 613HB (1 in. = 25.4 mm).

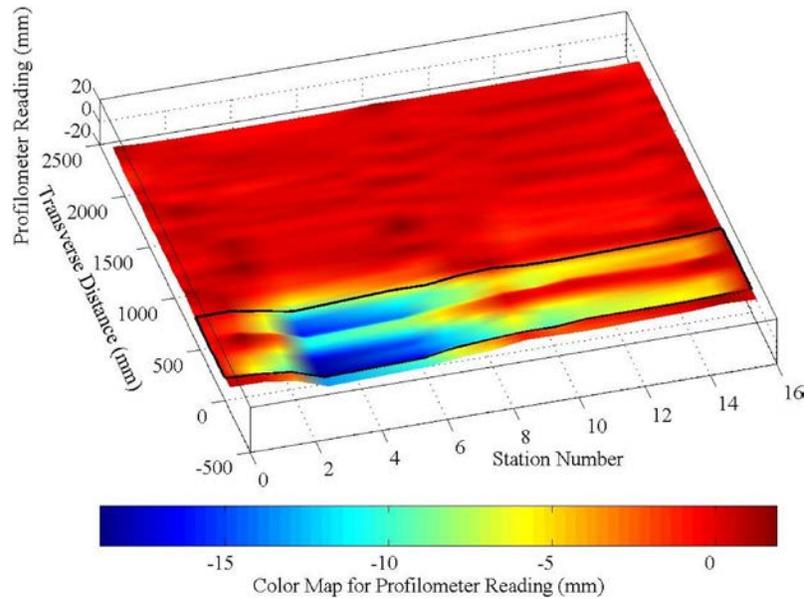
Figure K.17. Three-dimensional contour plot of change in surface elevation relative to the untrafficked condition at the end of the test for Section 613HB (1 in. = 25.4 mm).

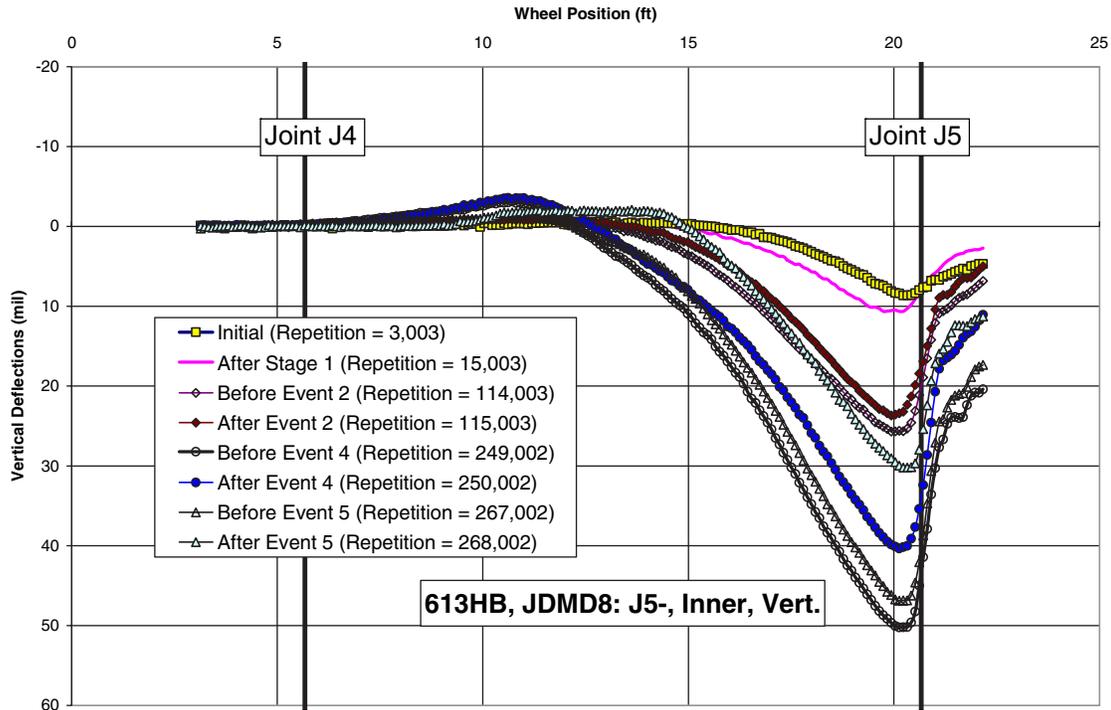
Figure K.49. Selected vertical deflection bowls for JDMD No. 8 in Section 613HB.

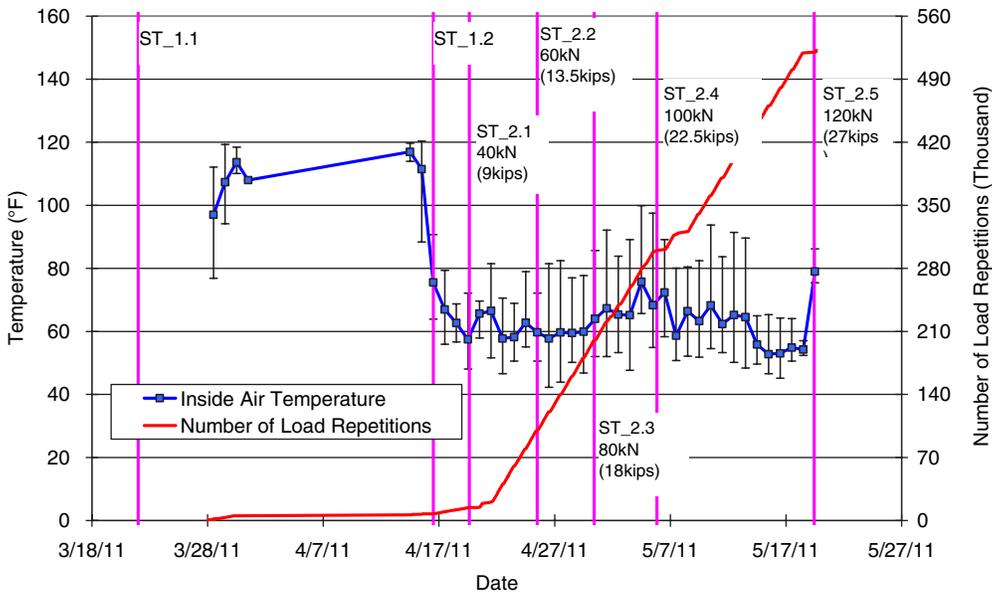
Figure K.53. Section 614HB: Daily average inside air temperatures during HVS trafficking.

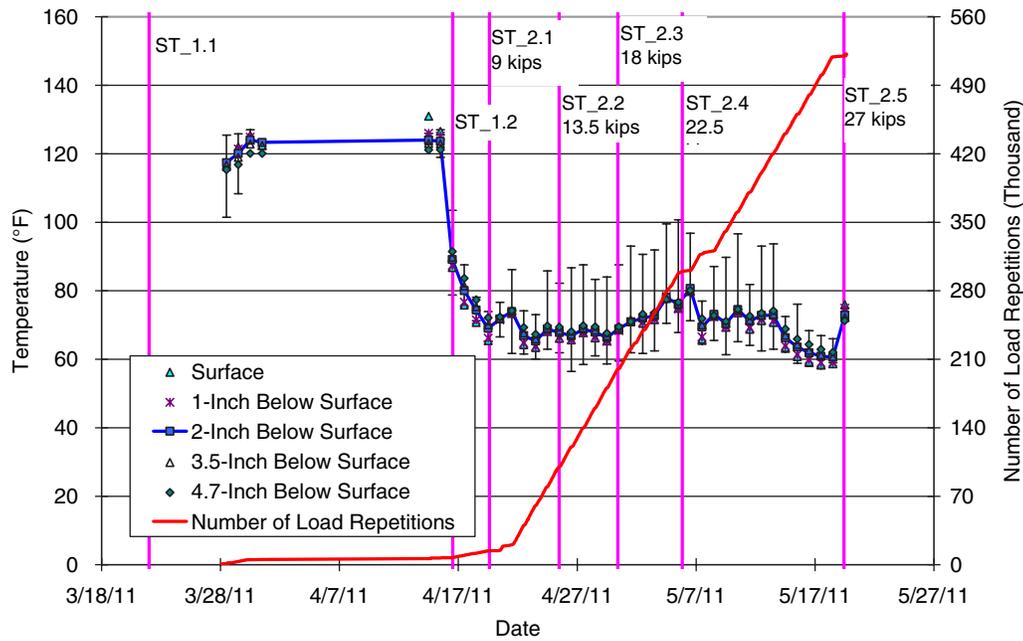
Figure K.54. Section 614HB: Daily average temperatures at pavement surface (i.e., top of HMA layer) and at various depths during HVS trafficking temperature. The last thermocouple measures PCC temperature.

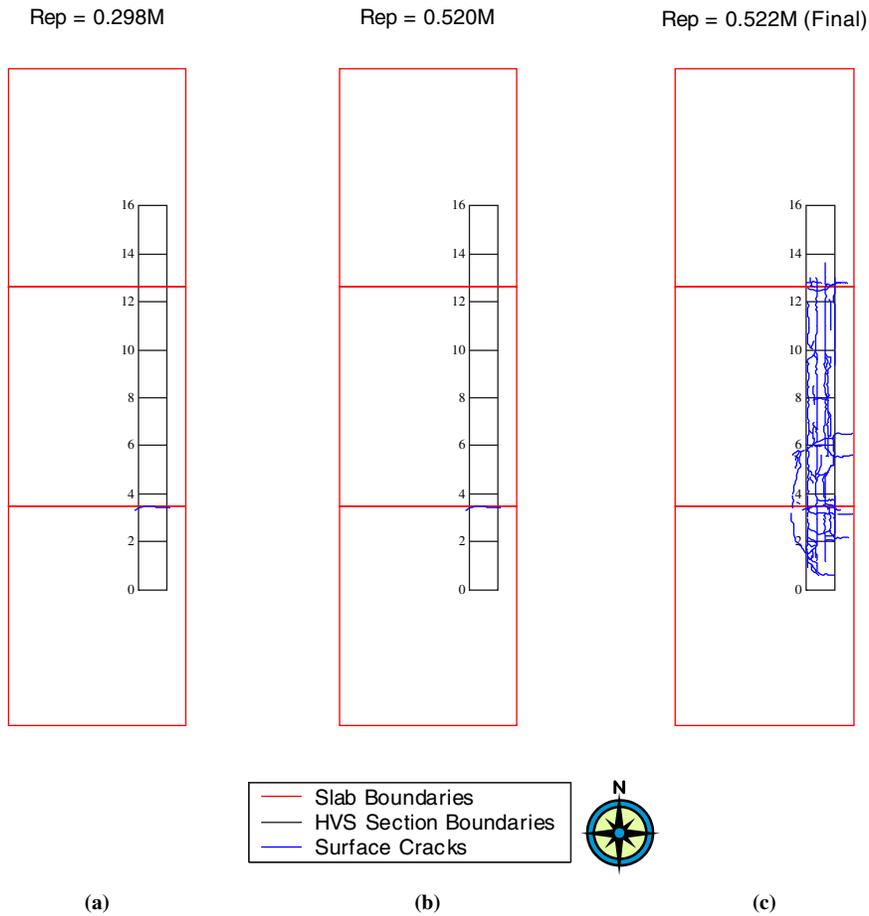
Figure K.56. Top views of surface cracks after different numbers of load repetitions: (a) Repetition = 0.298 million and crack length = 0.8 m (2.5 ft); (b) repetition = 0.520 million and crack length = 0.8 m (2.5 ft); and (c) repetition = 0.522 million and crack length = 17.8 m (58.5 ft).

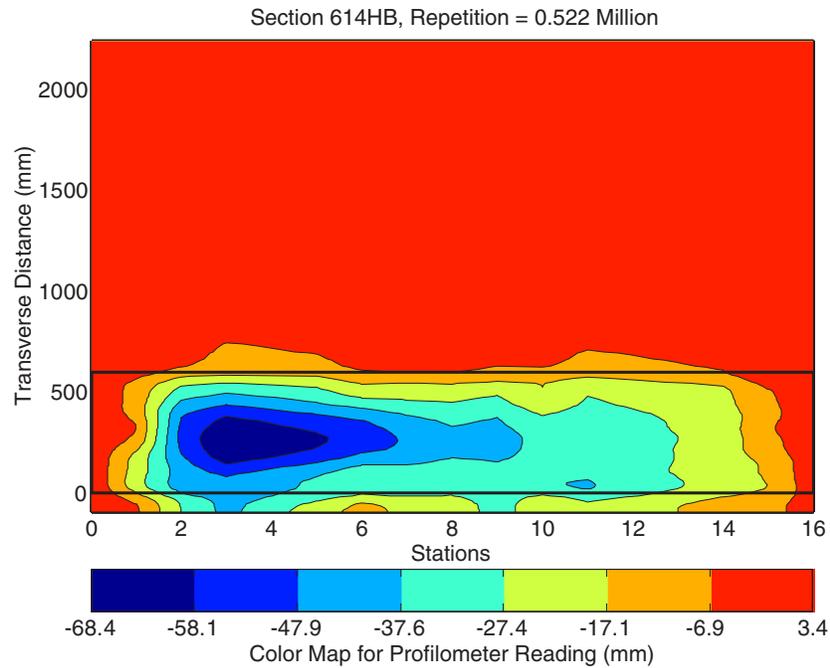
Figure K.60. Two-dimensional contour plot of change in surface elevation relative to the untrafficked condition at the end of test for Section 614HB (1 in. = 25.4 mm).

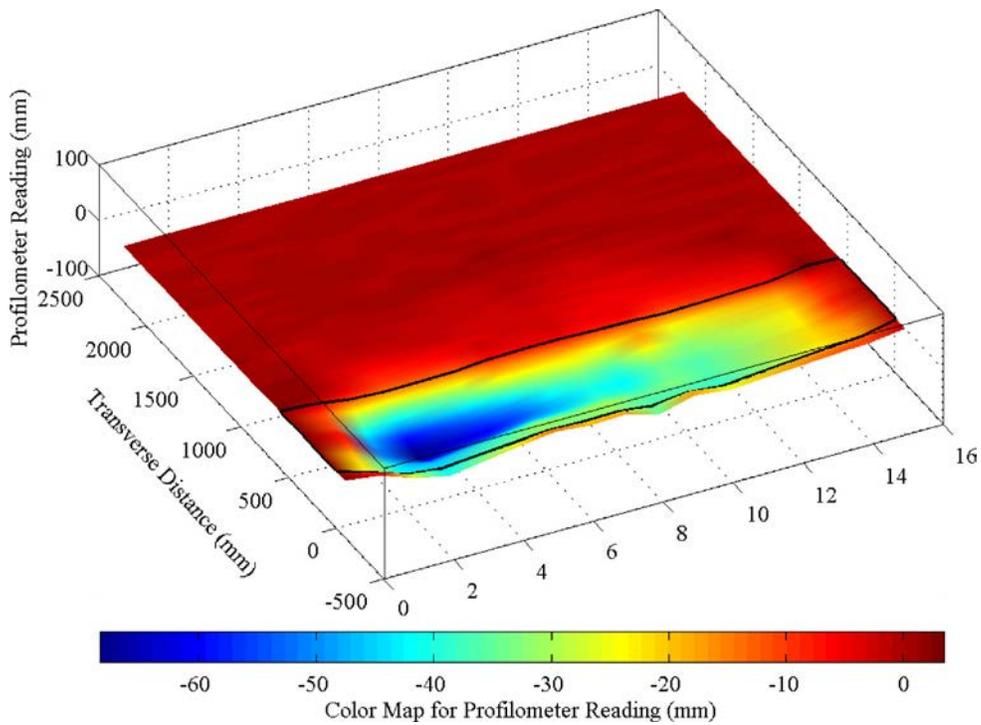
Figure K.61. Three-dimensional contour plot of change in surface elevation relative to the untrafficked condition at the end of the test for Section 614HB (1 in. = 25.4 mm).

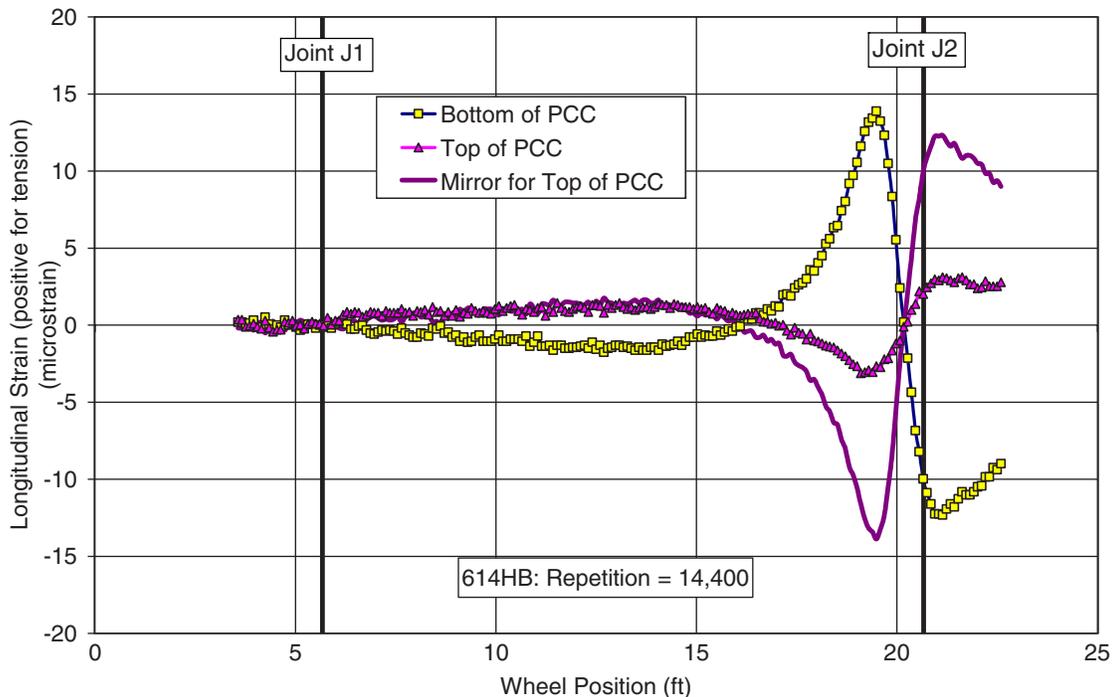
Figure K.80. Section 614HB: Initial strain bowls for dynamic strain gauges in the PCC layer, measuring longitudinal strain in the horizontal direction. The mirror for the strain bowl for the top of PCC matches almost exactly the bowl for the bottom of PCC in shape but not in strain value.

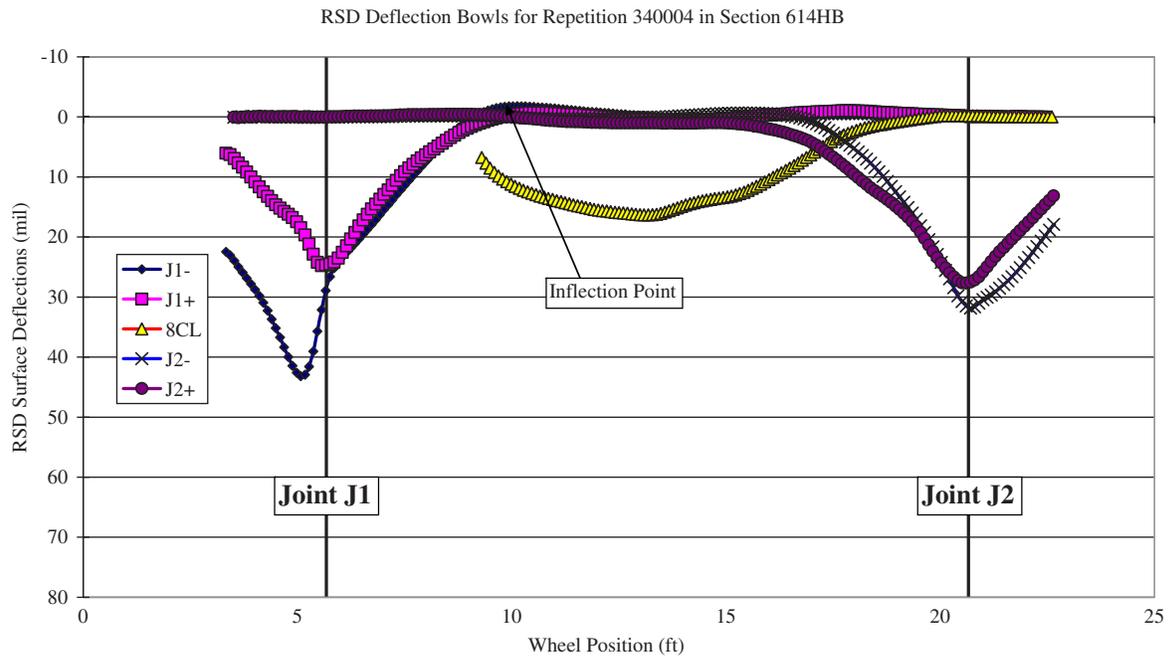
Figure K.91. Section 614HB: RSD deflection bowls after 340,004 load repetitions under 9-kip (40-kN) load in manual mode.
