REPORT S2-R21-RW-4

Composite Pavement Systems: Appendices

S H R P 2 R E N E W A L R E S E A R C H

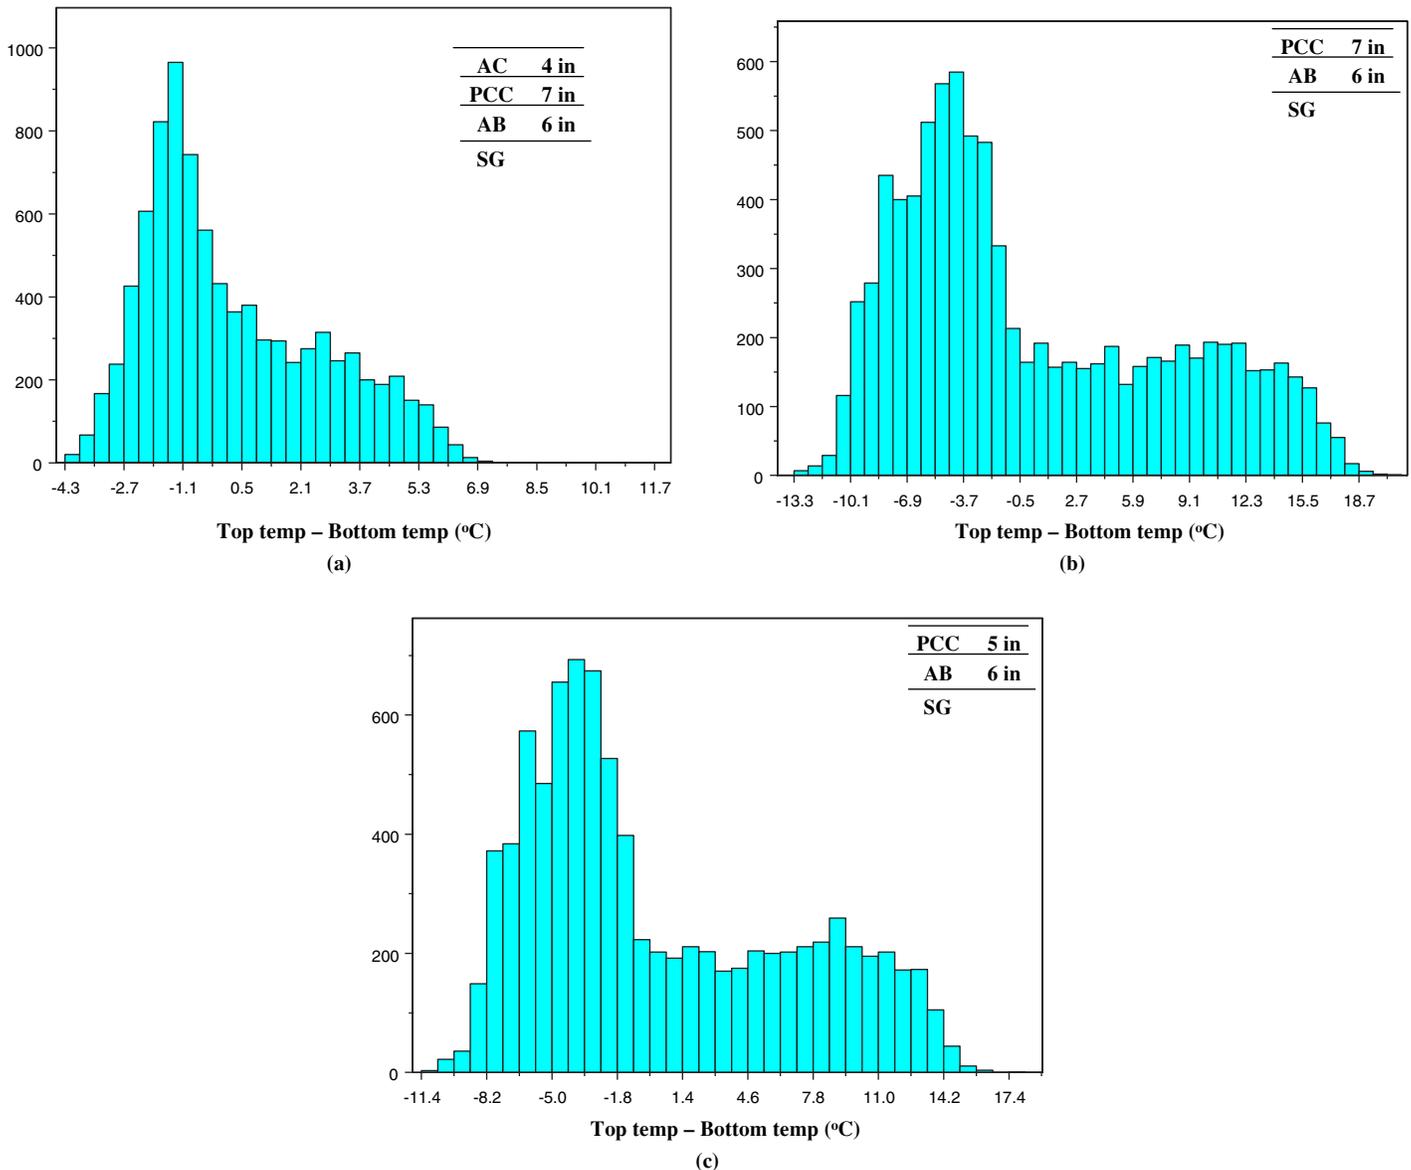
Figure L.1. The calculated temperature gradient distributions from EICM for the HVS test sections for Davis climate: (a) section with thick HMA layer (4 in.), (b) section with thick concrete layer (7 in.) without HMA layer, and (c) section with thin concrete layer (5 in.) without HMA layer.

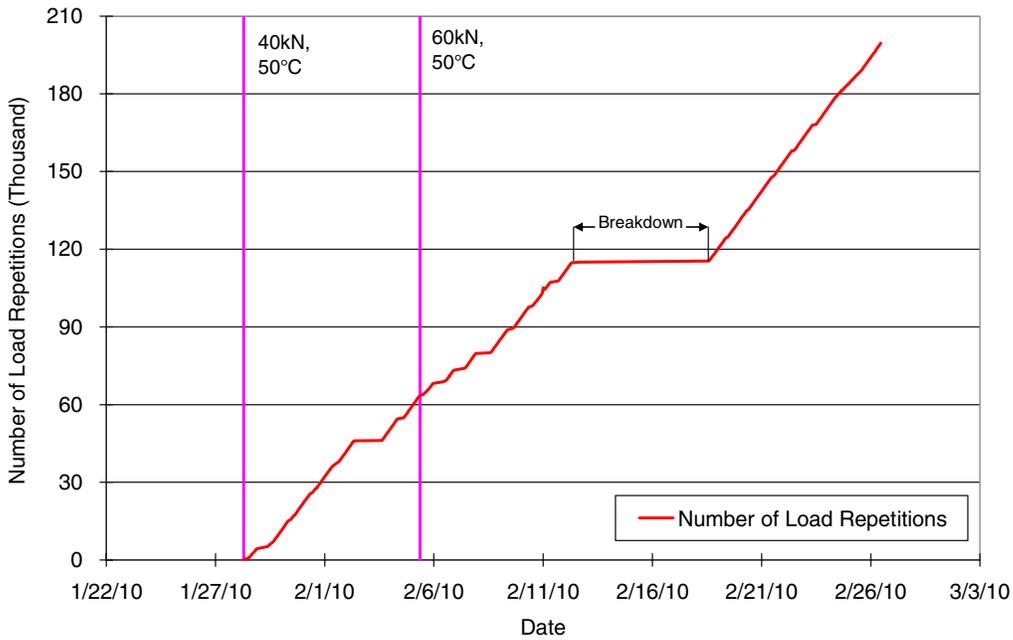
Figure L.11. Load history for Section 609HB, PG 64-28 PM, 114 mm.

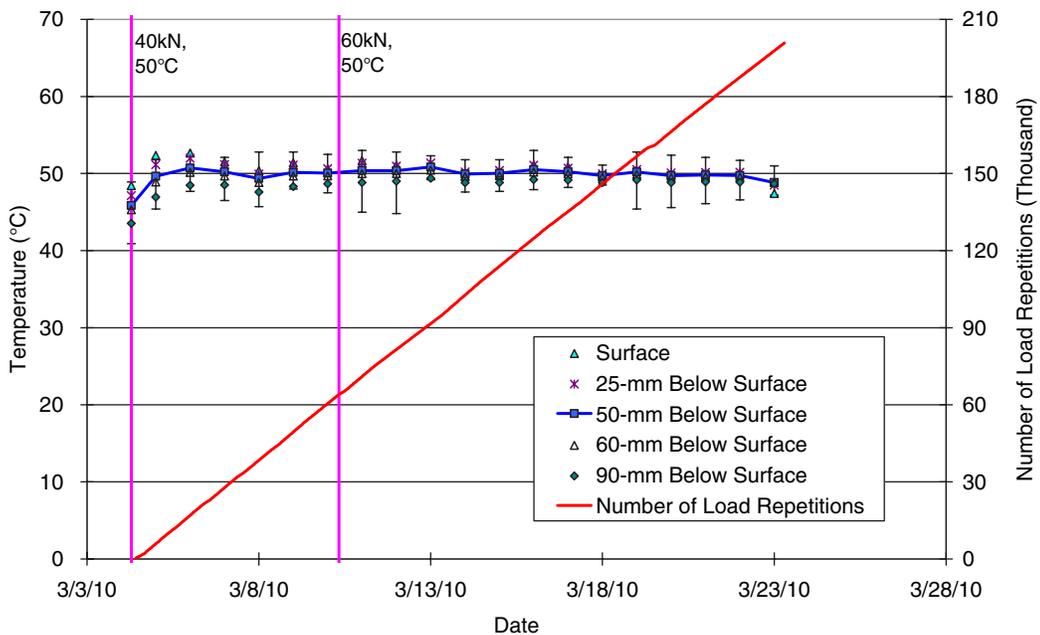
Figure L.24. Daily average temperatures at pavement surface and various depths for Section 610HB, PG 64-28 PM, 64 mm.

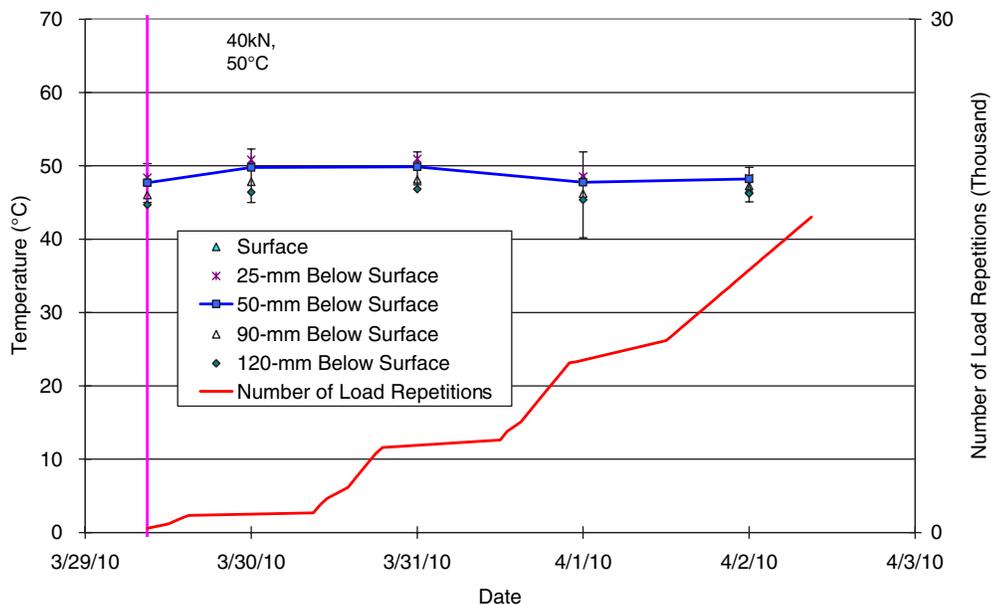
Figure L.35. Daily average temperatures at pavement surface and various depths for Section 611HB, RHMA-G, 114 mm.

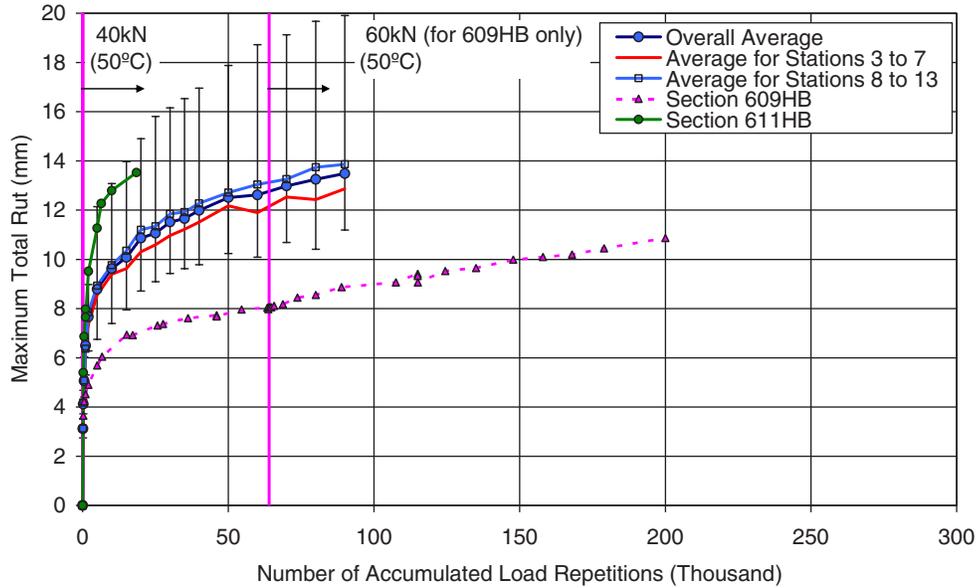
Figure L.49. Average maximum total rut after excluding data for Stations 4, 5, 11, and 13, which are close to CT blocks, for Section 612HB, RHMA-G, 64 mm. Note that data for Section 609HB, PG 64-28 PM, 114 mm, and Section 611HB, RHMA-G, 114 mm, also are shown.

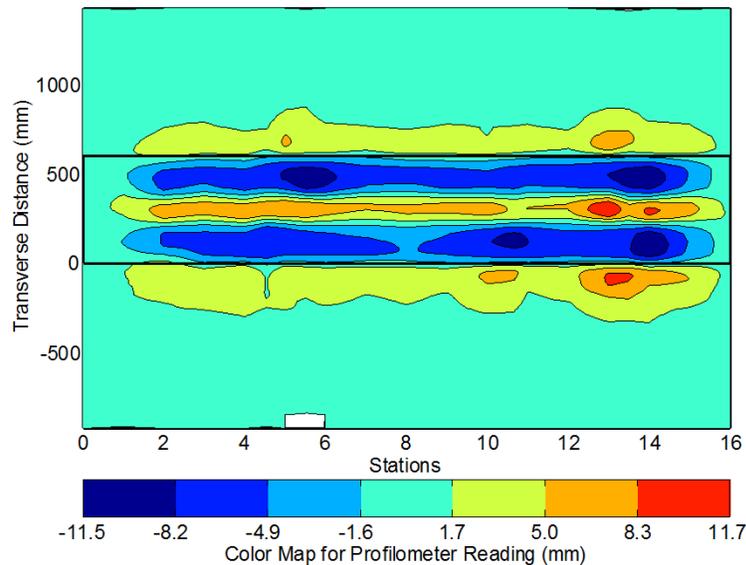
Figure L.51. Contour plot of permanent surface deformation at the end of the test for Section 612HB, RHMA-G, 64 mm.

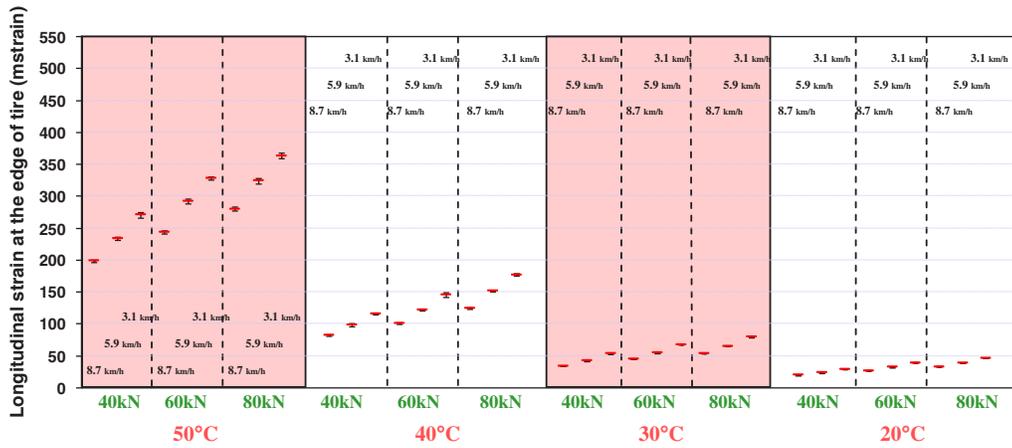
Figure L.62. Results for the sensitivity study for Section 609HB, longitudinal strain at the edge of the tire. Fahrenheit = Celsius × 9/5 + 32; 1 kN = 225 lb; 1 km/h = 0.62 mph.

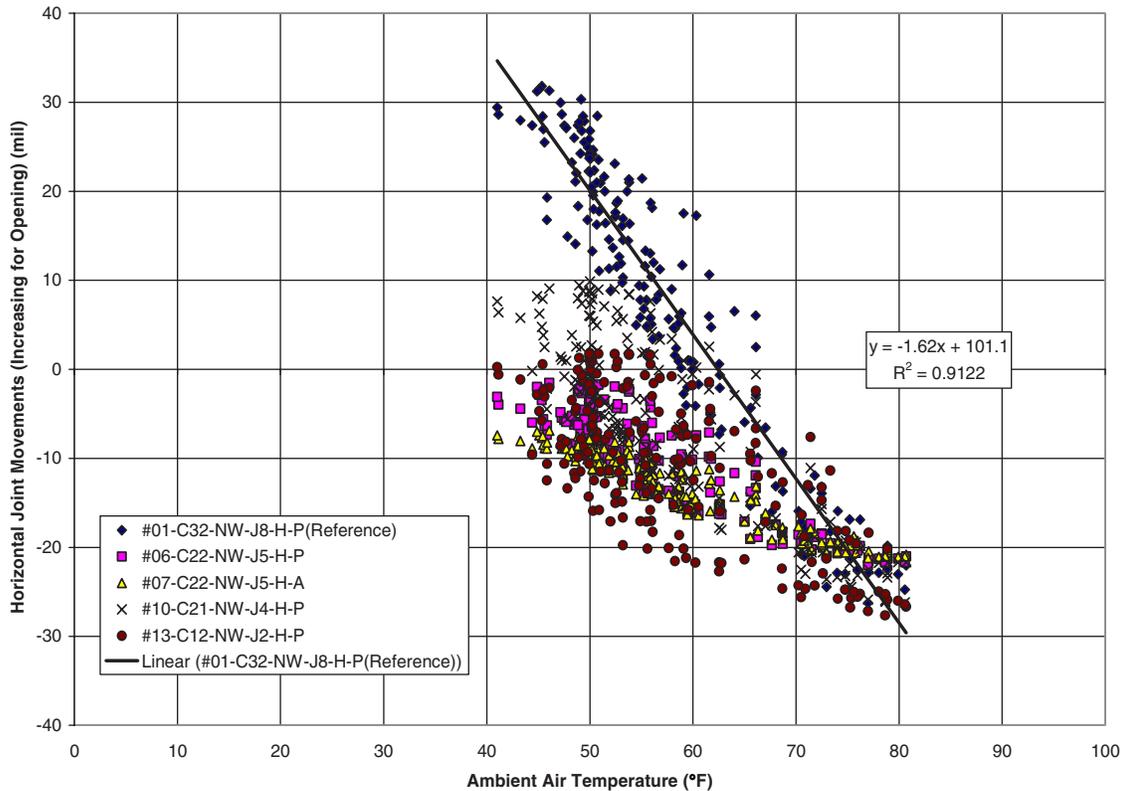
Figure M.45. Example variation of horizontal joint movement with ambient air temperature for Batch 10, Lane C, after HMA placement. A linear regression line is shown for the reference JDMD. The joint movement rate (JMR) is defined as the slope of each individual linear regression line. $JMR = -1.62 \text{ mil}/^\circ\text{F}$ for the reference case in this batch.

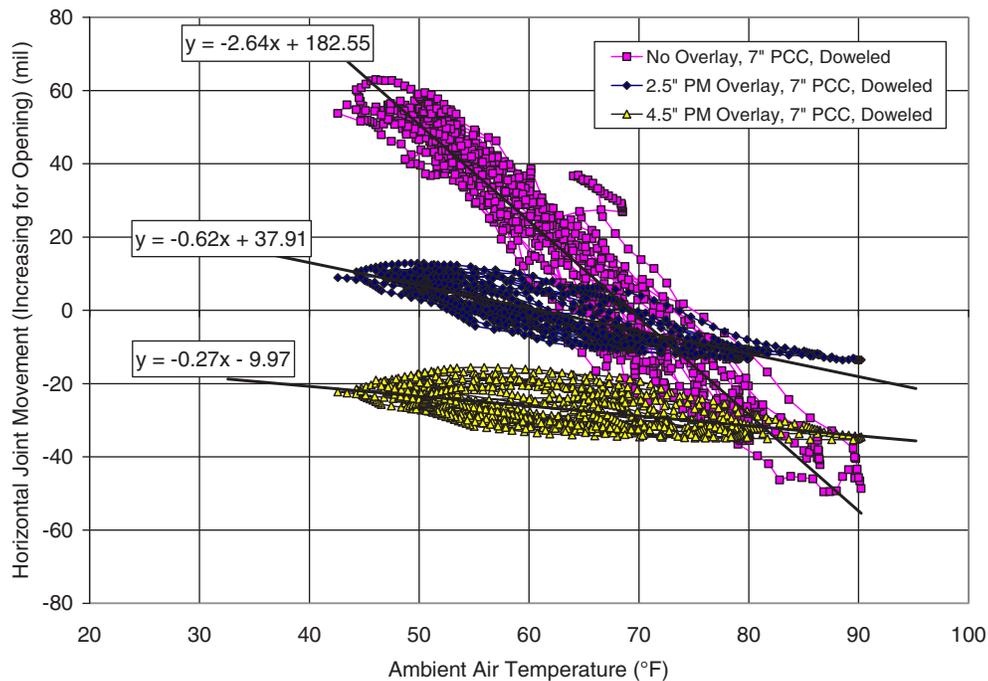
Figure M.53. Horizontal joint movement versus air temperature plots for Lane A after HMA placement.

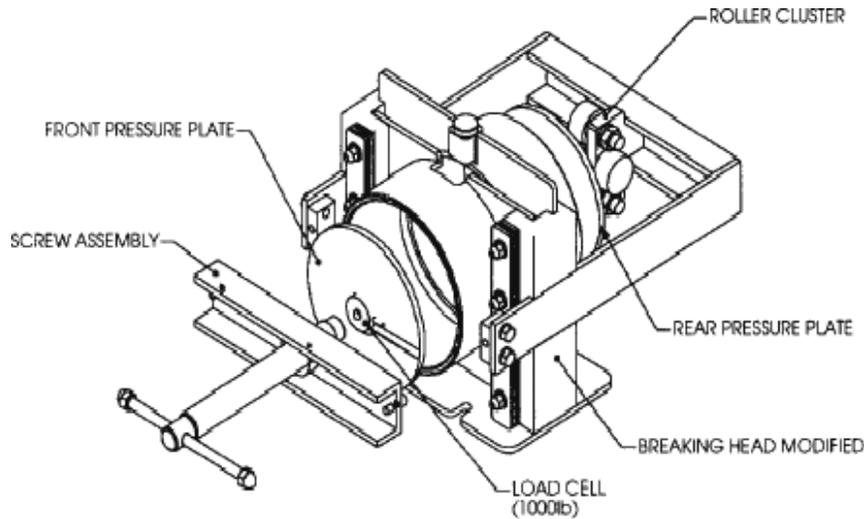
Figure O.2. Diagram of NCAT bond strength device.

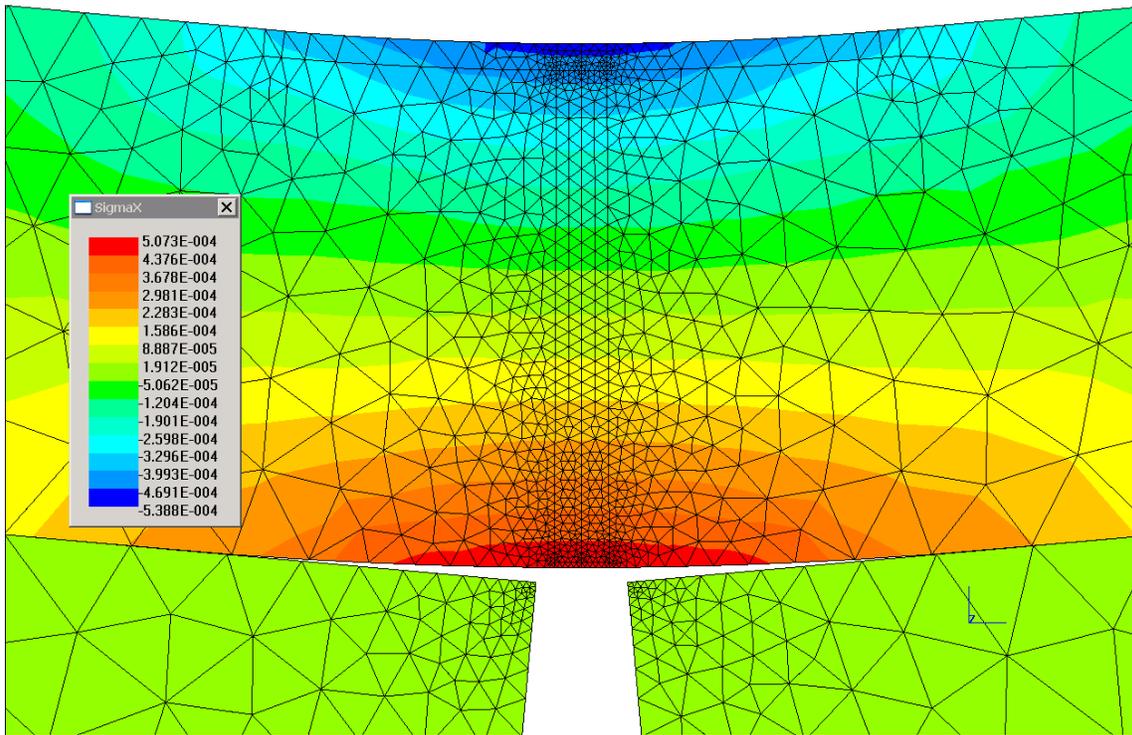
Figure P.12. Bending strain contour around the tip of the joint, axle load applied right over the joint, HMA layer debonded from the underlying PCC slab around the joint.

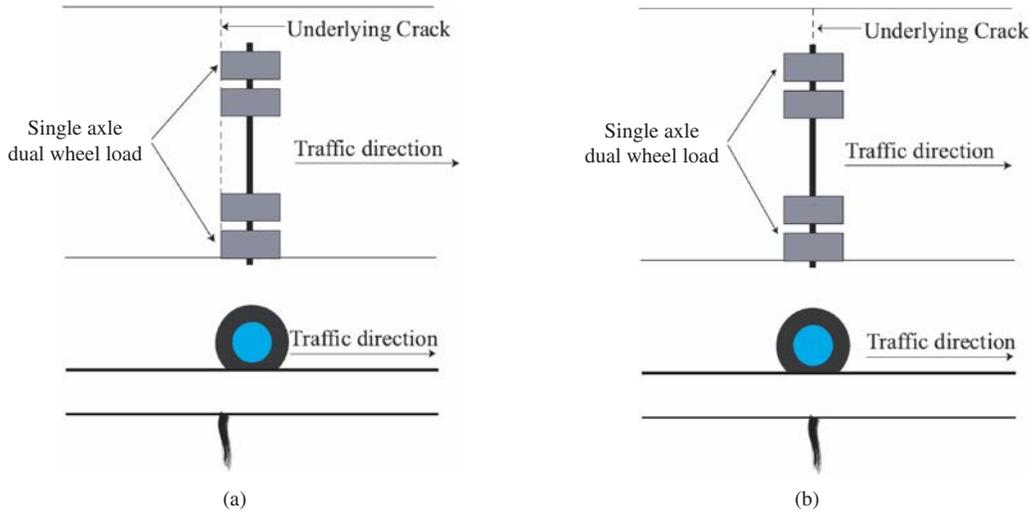
Figure P.13. Different loading positions relative to the underlying joint: (a) shear loading, wheel load on one side of the underlying joint, and (b) normal loading, wheel load symmetric about the underlying joint.

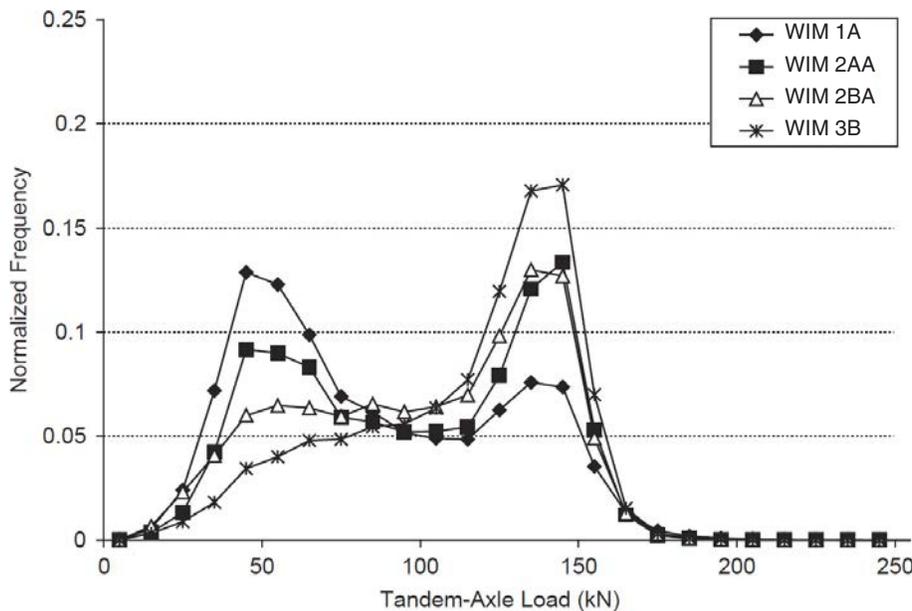
Figure P.25. Tandem axle load spectra averaged by group (Lu et al. 2009)
 (1 kN = 225 lb).

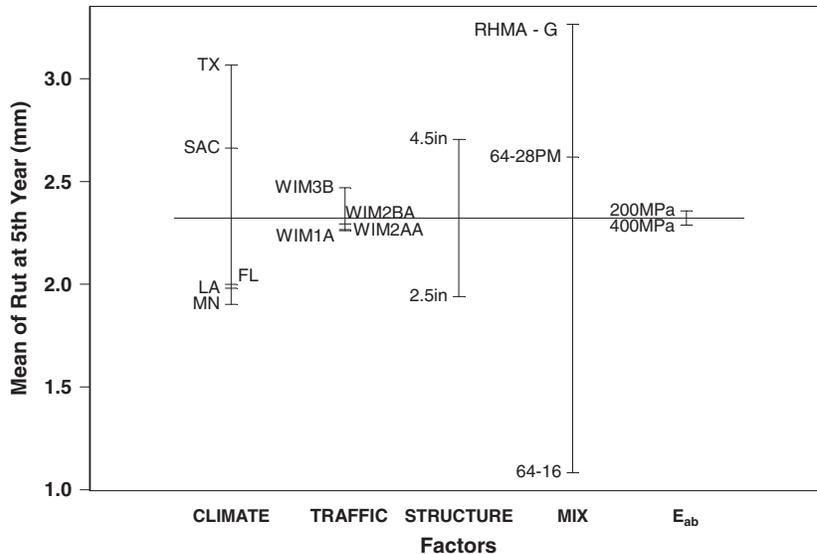
Figure P.26. Design plot of 5th year rutting (downward rut) showing effects of climate, traffic, structure, mix type, and aggregate base stiffness (E_{ab}) (25.4 mm = 1 in.).

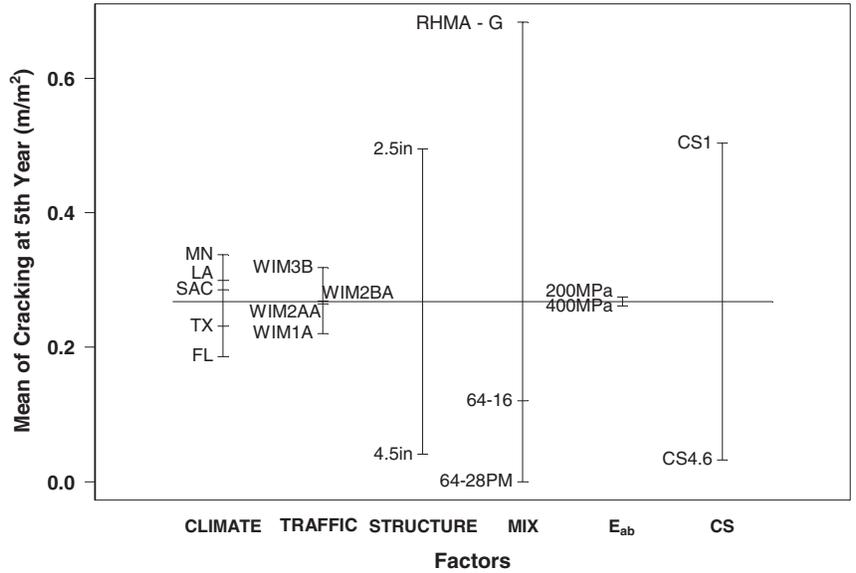
Figure P.27. Design plot of 5th year cracking showing effects of climate, traffic, structure, mix type, aggregate base stiffness, and crack spacing (1 m = 39.37 in.).

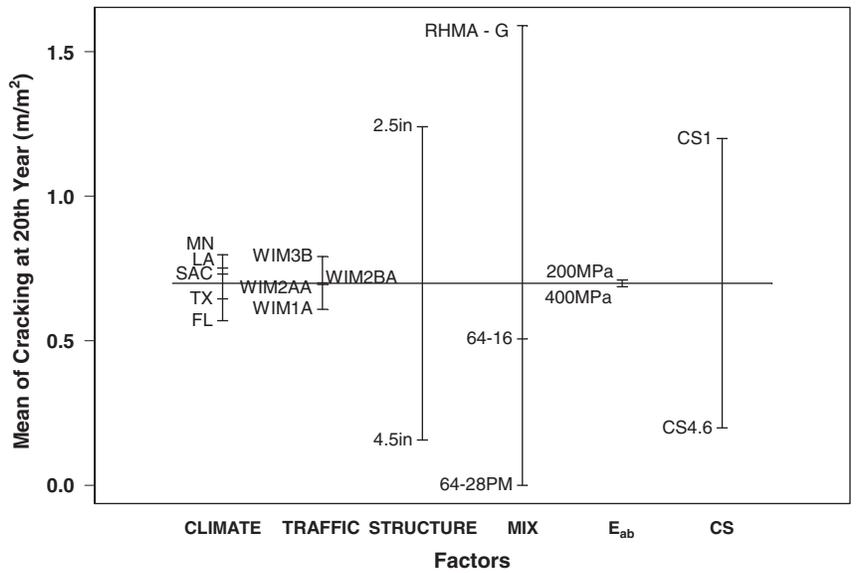
Figure P.28. Design plot of 20th year cracking showing effects of climate, traffic, structure, mix type, aggregate base stiffness, and crack spacing (1 m = 39.37 in.).

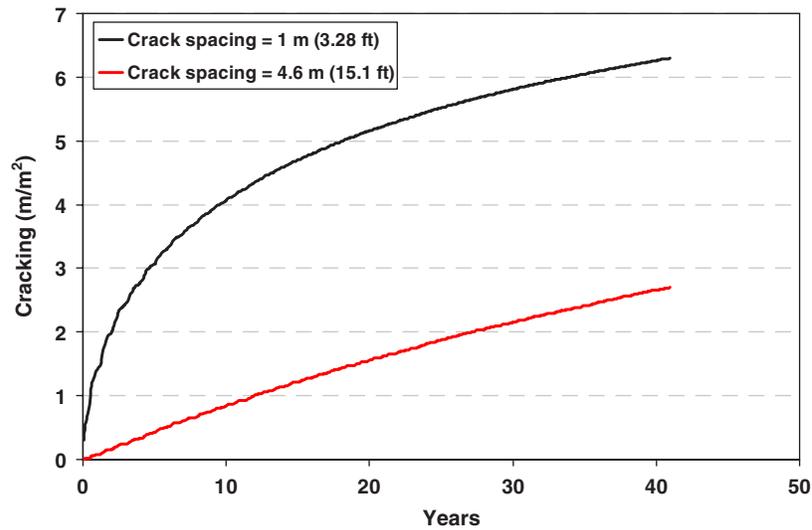
Figure P.29. The effect of crack spacing on predicted cracking for the Minnesota climate case: (a) structure: HMA thickness is 2.5 in., PCC thickness is 7 in.; (b) mix type: RHMA-G; and (c) aggregate base stiffness is 200 MPa (the only difference between the two cases is the crack spacing).

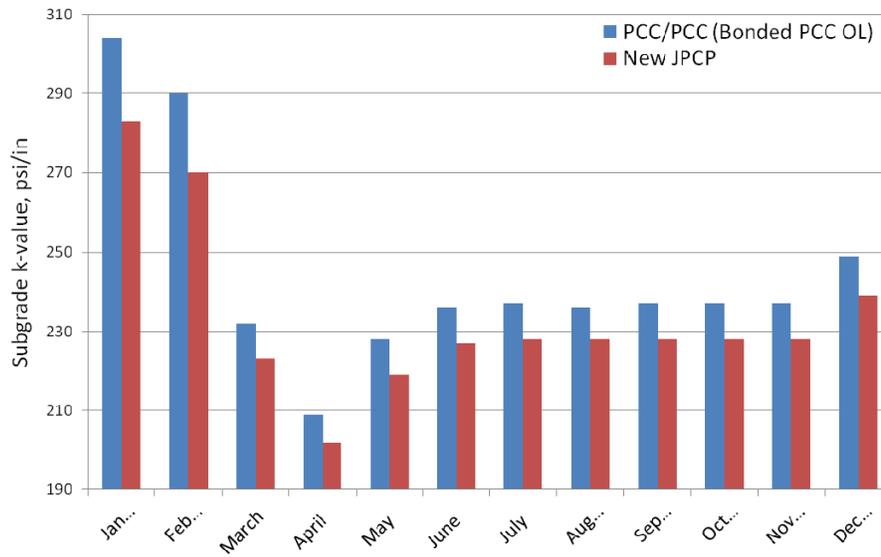
Figure R.1. Subgrade k-value calculation for a PCC/PCC pavement and its JPCP single-layer structural analog (MEPDG versus 1.206:R21). (OL = Overlay.)

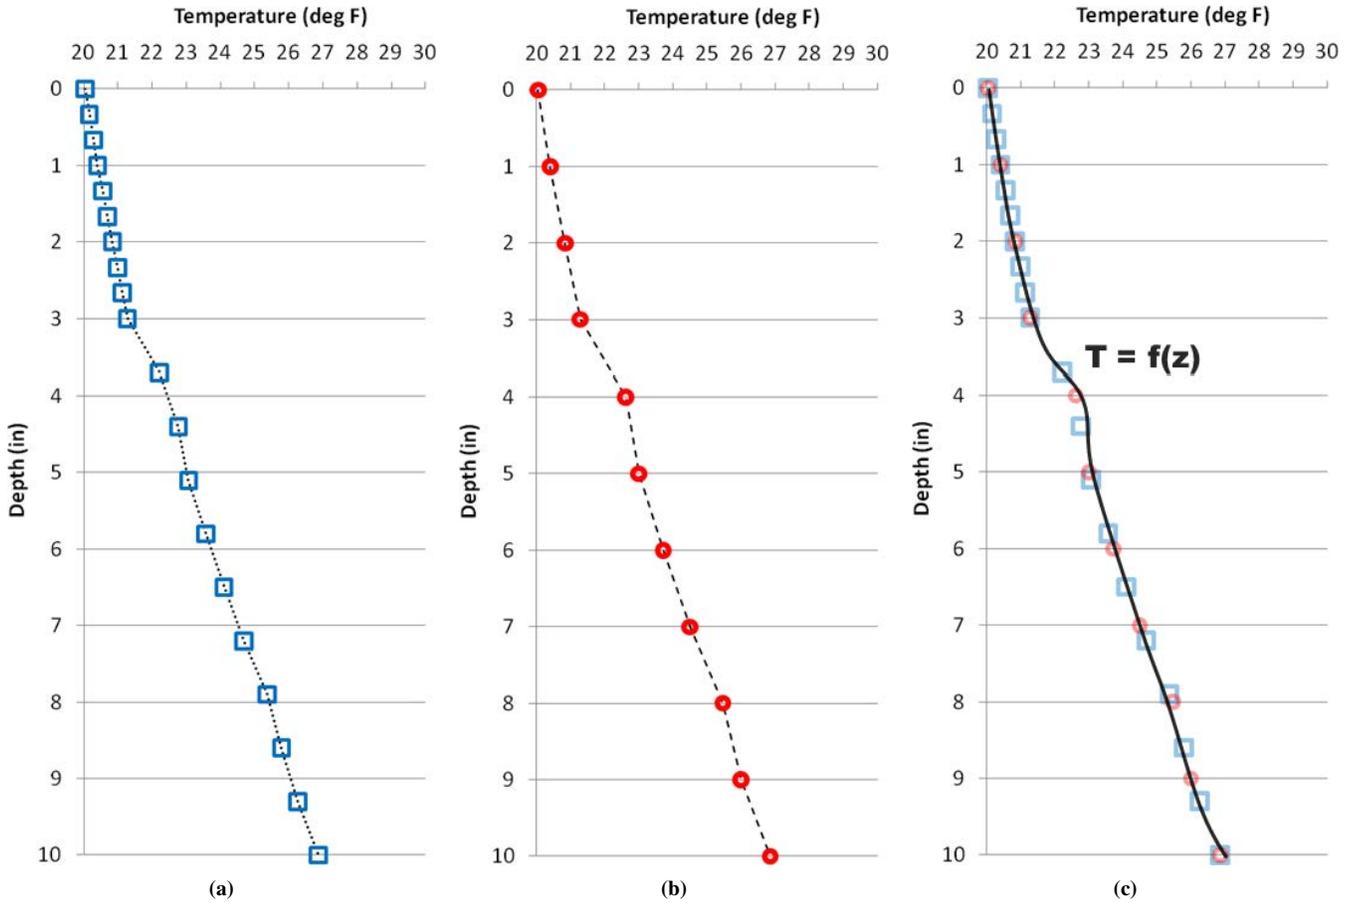
Figure R.2. Modified thermal nodes through slab thickness in MEPDG for (a) MEPDG 1, (b) recommended by R21, and (c) both approximations relative to nonlinear thermal gradient.

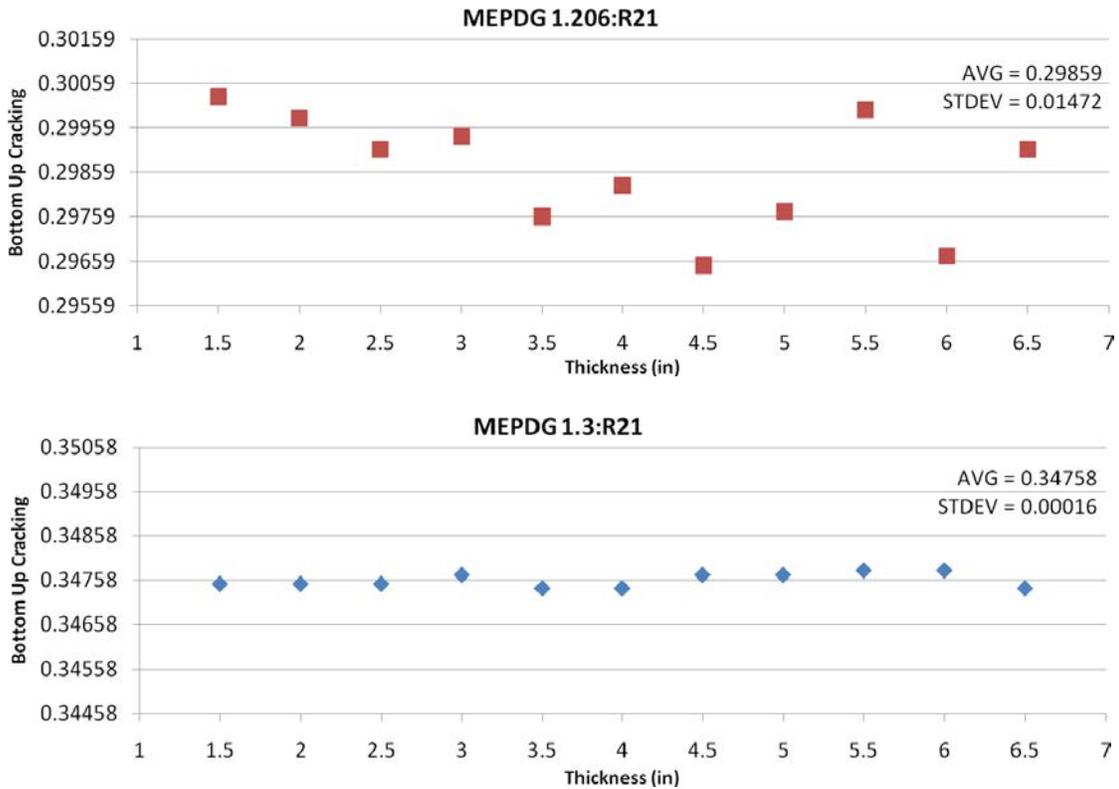
Figure R.3. MEPDG sensitivity to top-lift (PCC overlay) thickness in terms of bottom-up cracking for MEPDG using original EICM (top) and revised EICM (bottom).

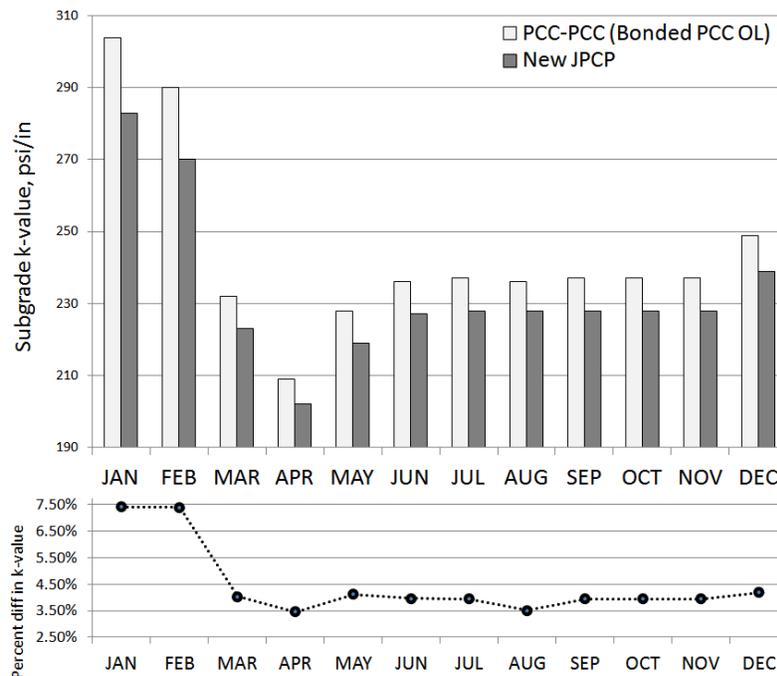
Figure R.5. Subgrade k-value calculation for a PCC/PCC pavement and its JPCP single-layer structural analog (previous versions of *MEPDG*). (OL = Overlay.)

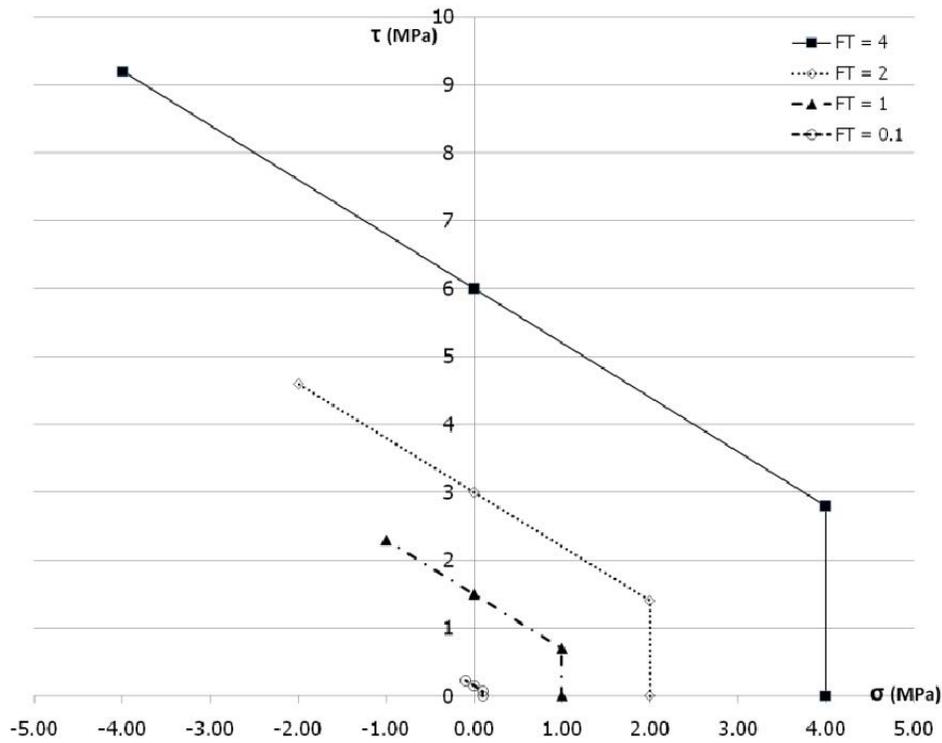
Figure S.5. Selected fracture criterion curves representing factorial of 40 cases investigating variable f_t with constant fracture criterion $\rho = 1.5$ and $\rho_2 = 0.7$.

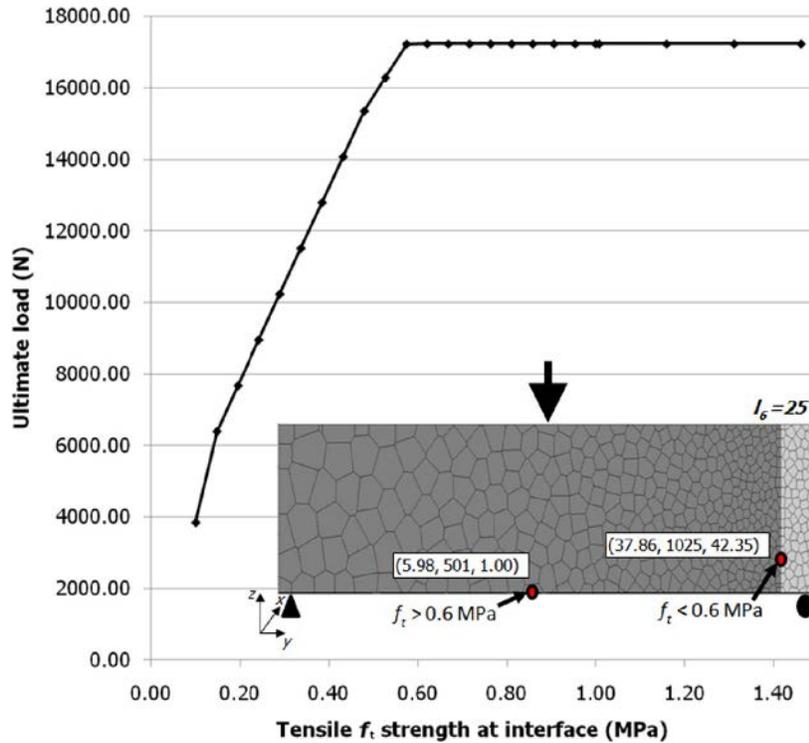
Figure S.6. Relationship between ultimate load and tensile strength f_t at interface for cases with interface nearest support ($l_6 = 25$ mm) and location of fracture initiations in red (inset).

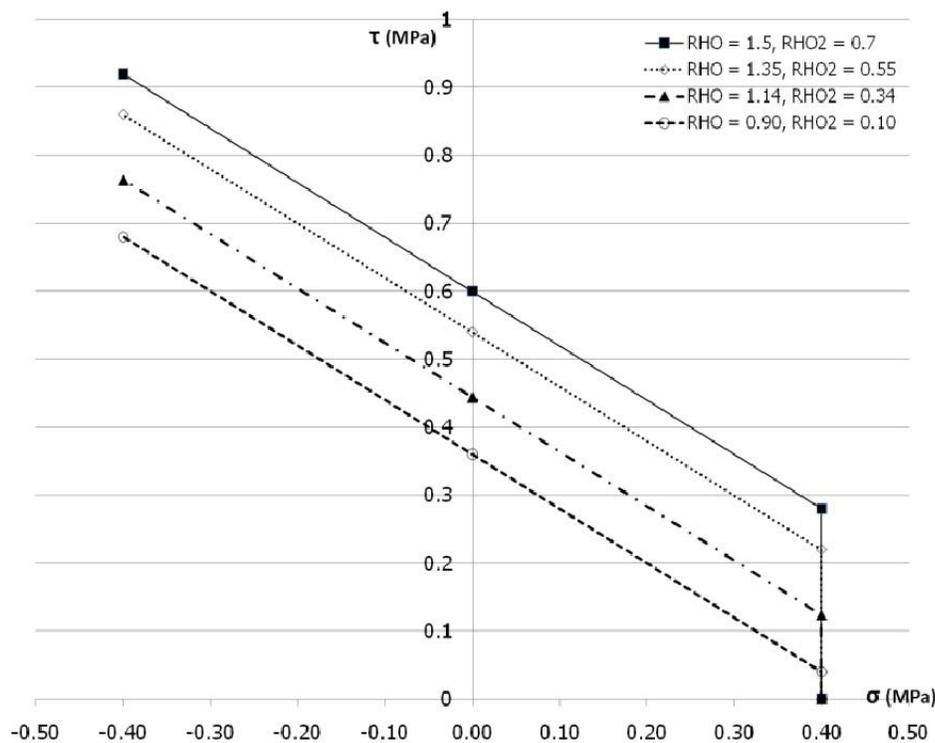
Figure S.7. Selected fracture criterion curves representing factorial of 21 cases investigating influence of τ_c and τ^* . Note that RHO (ρ) = τ_c/f_t and $RHO2$ (ρ_2) = τ^*/f_t .

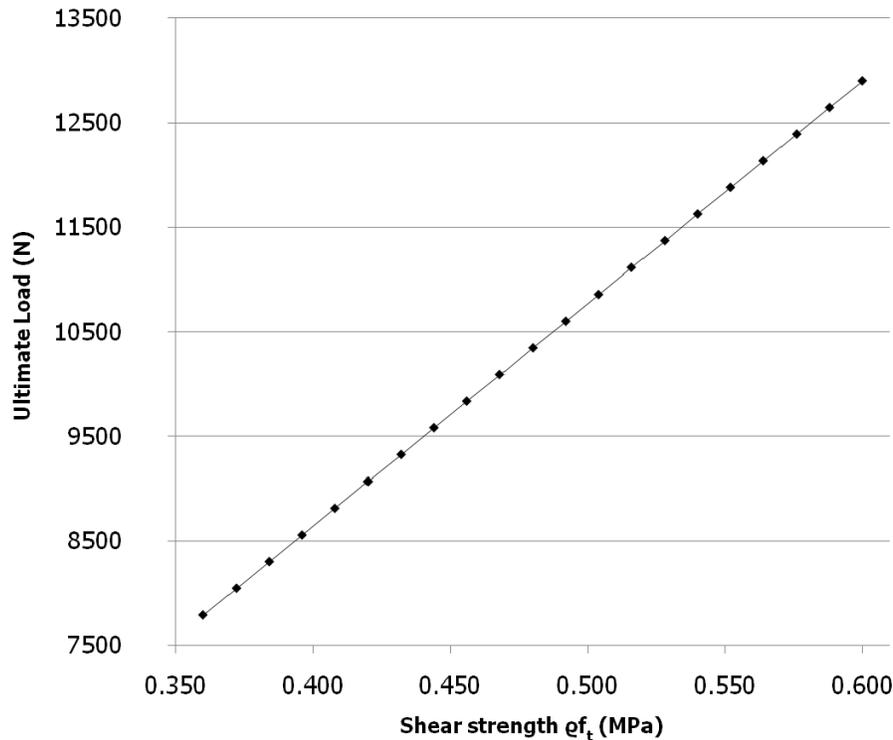
Figure S.8. Relationship between ultimate load and shear strength τ_c at interface for cases with interface nearest support ($l_6 = 25$ mm) and tensile strength $f_t = 0.4$ MPa.

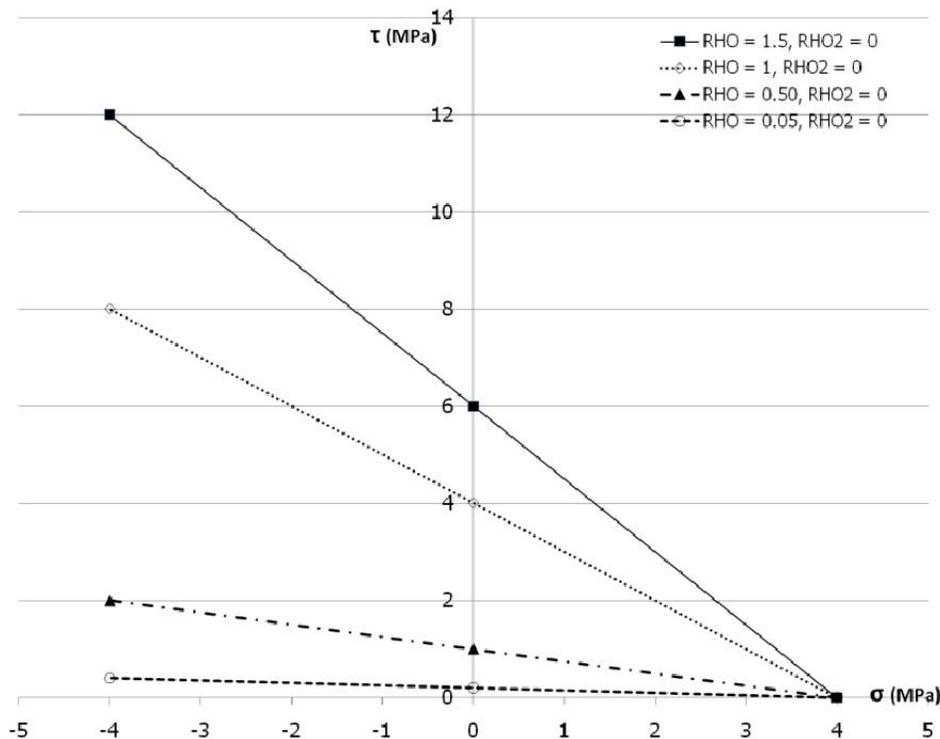
Figure S.9. Selected fracture criterion curves representing factorial of 40 cases investigating influence of τ_c when $\tau^* = 0$ and $f_t = 4.0$ MPa.

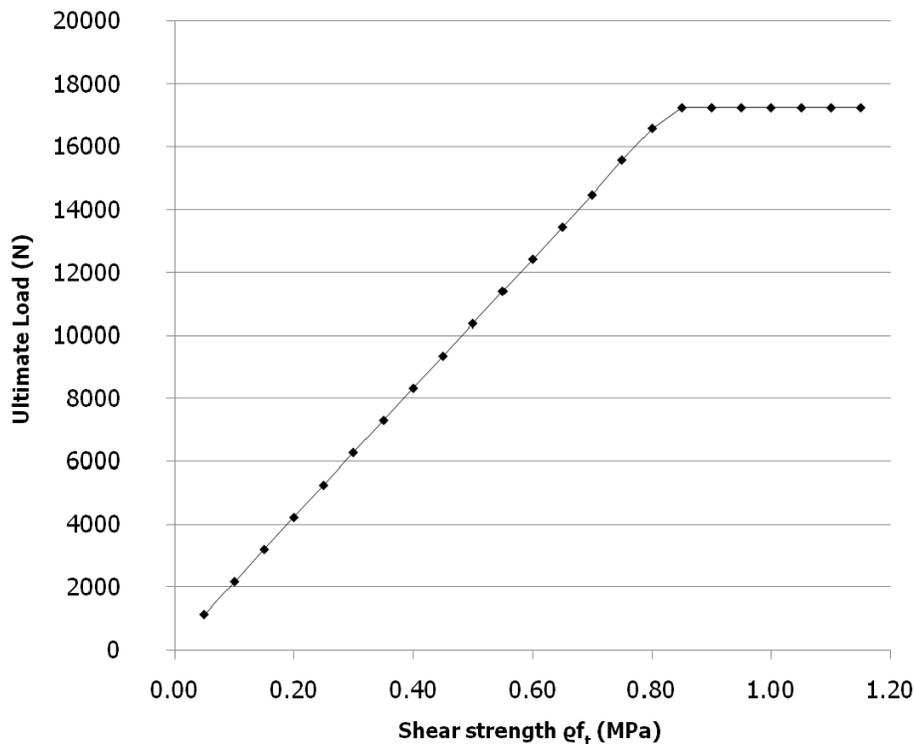
Figure S.10. Relationship between ultimate load and shear strength τ_c at interface for cases with interface nearest support ($l_6 = 25$ mm) and tensile strength $f_t = 4.0$ MPa.

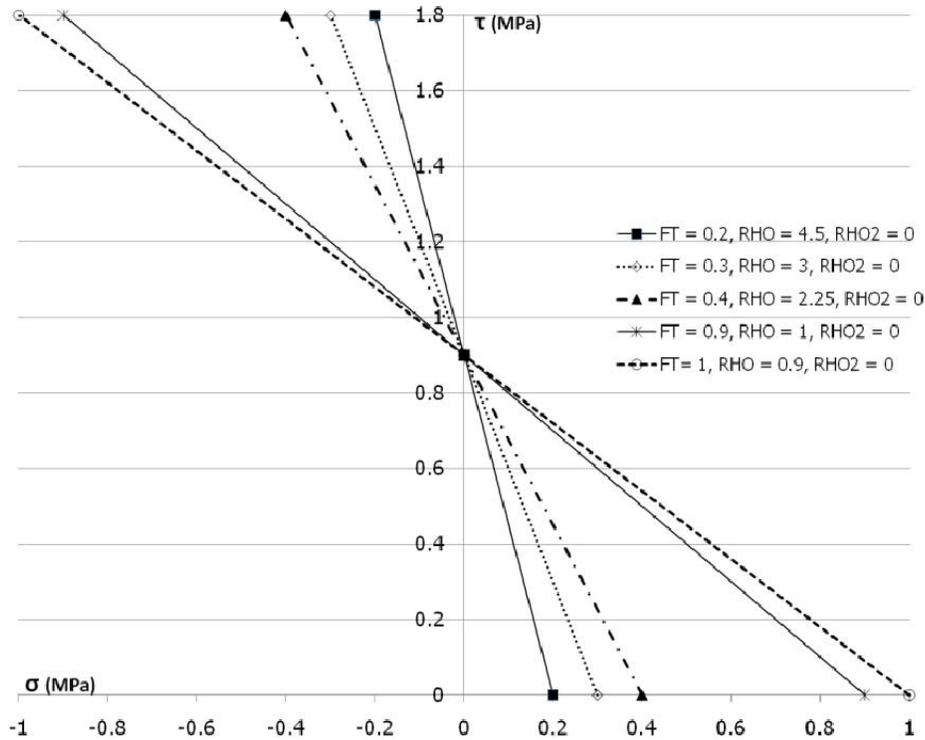
Figure S.11. Fracture criterion curves for $f_t < 1.0$ MPa with $\tau_c = 0.9$ MPa and $\tau^* = 0$.

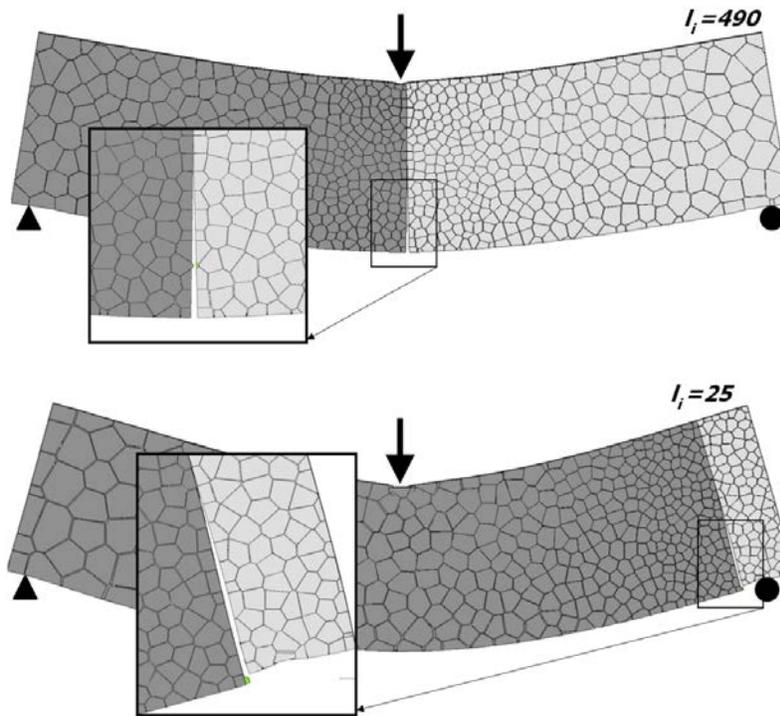
Figure S.12. Failure in composite beams with weakened interface near midspan and near support under loading.

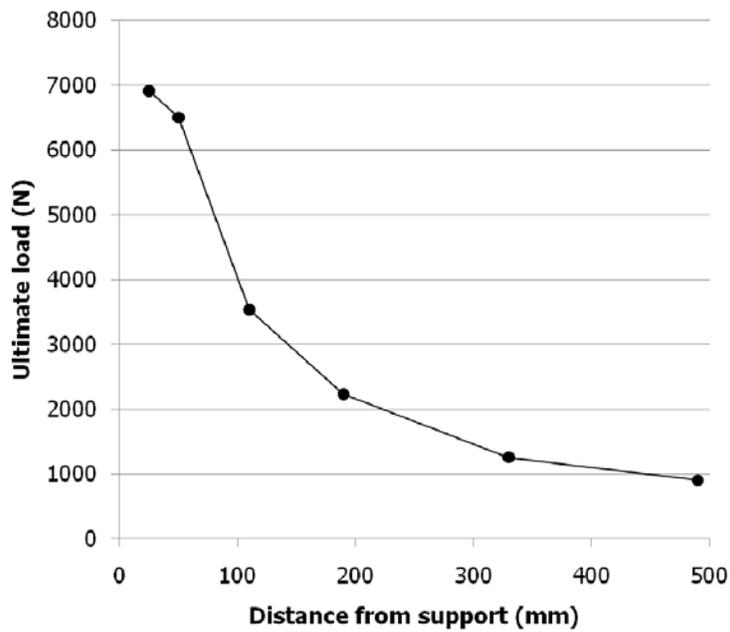
Figure S.13. Reduction of ultimate load as weak interface is moved toward midspan.

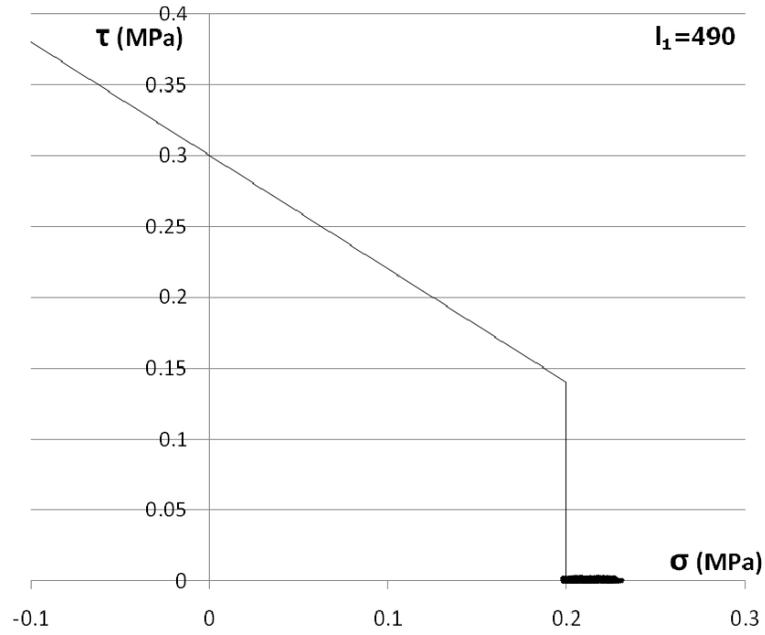
Figure S.14. Failure in tension predominates at a weakened interface near midspan ($l_1 = 490$ mm).

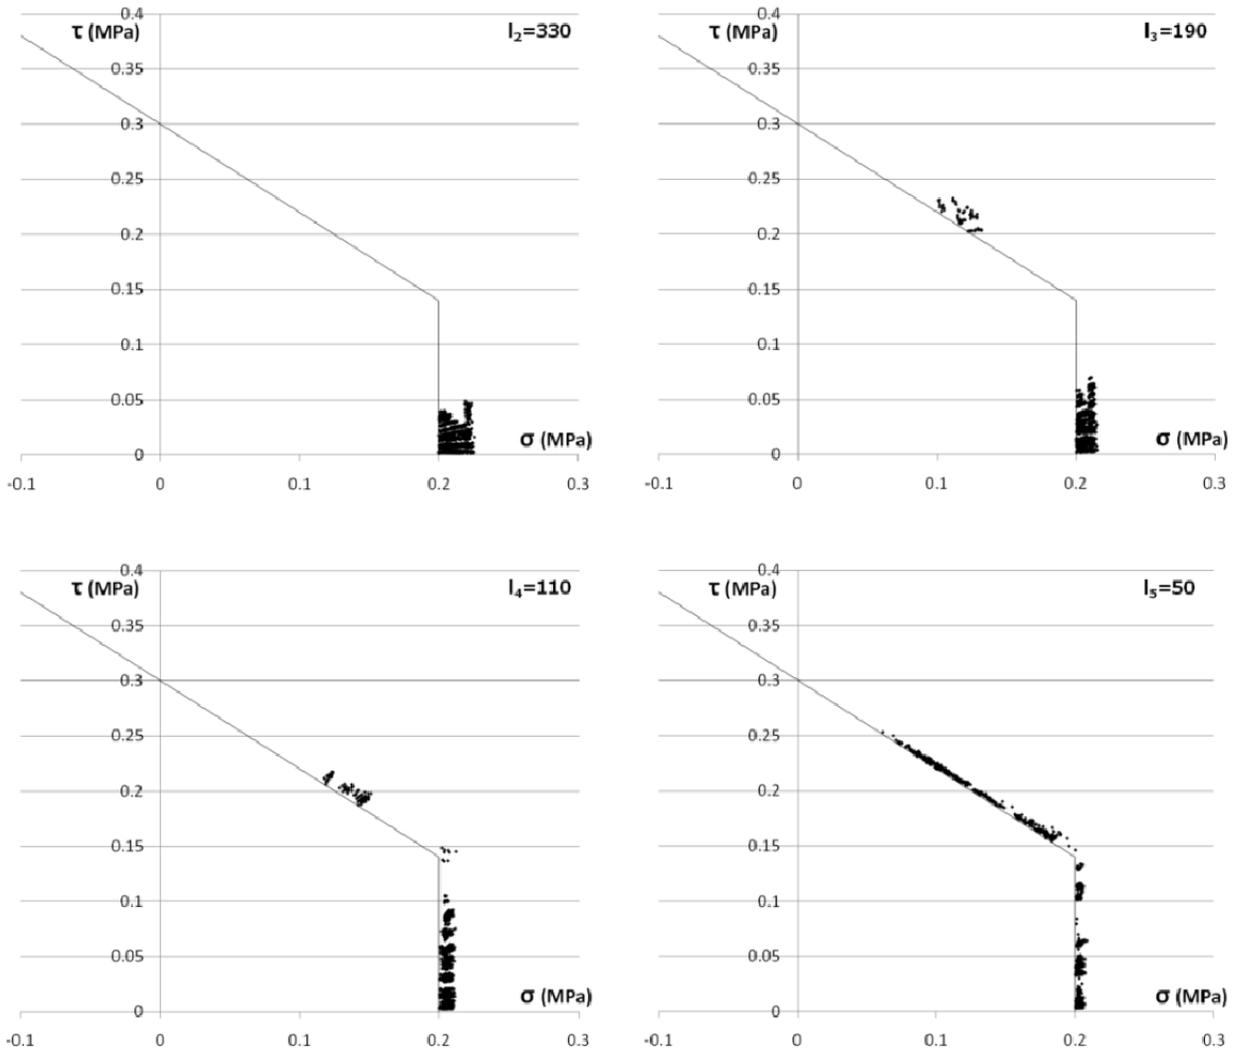
Figure S.15. Evolution of mixed-mode fracture as interface is moved from midspan toward support (beginning top left with $l_2 = 330$ mm, finishing bottom left at $l_5 = 50$ mm).
