REPORT S2-R21-RW-4

Composite Pavement Systems: Appendices

S H R P 2 R E N E W A L R E S E A R C H

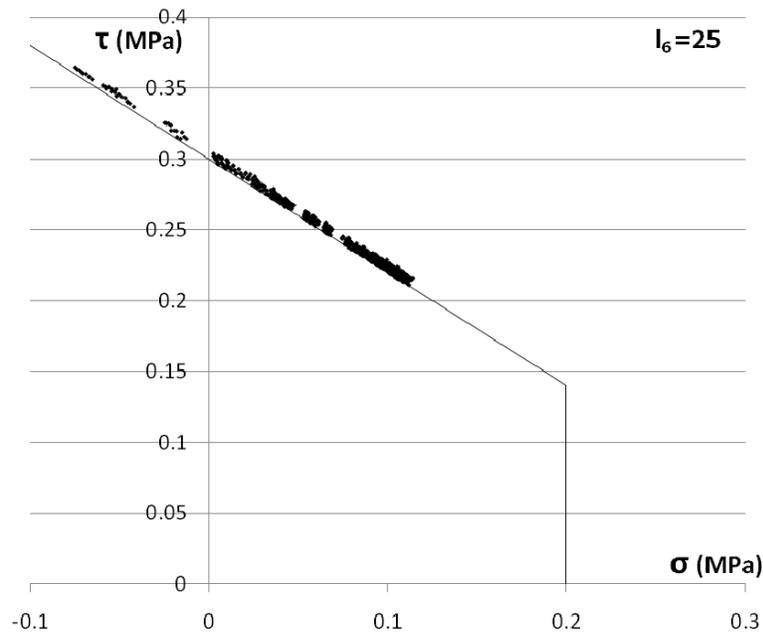
Figure S.16. Shear events characterize mixed-mode failure at a weakened interface near support ($l_6 = 25$ mm).

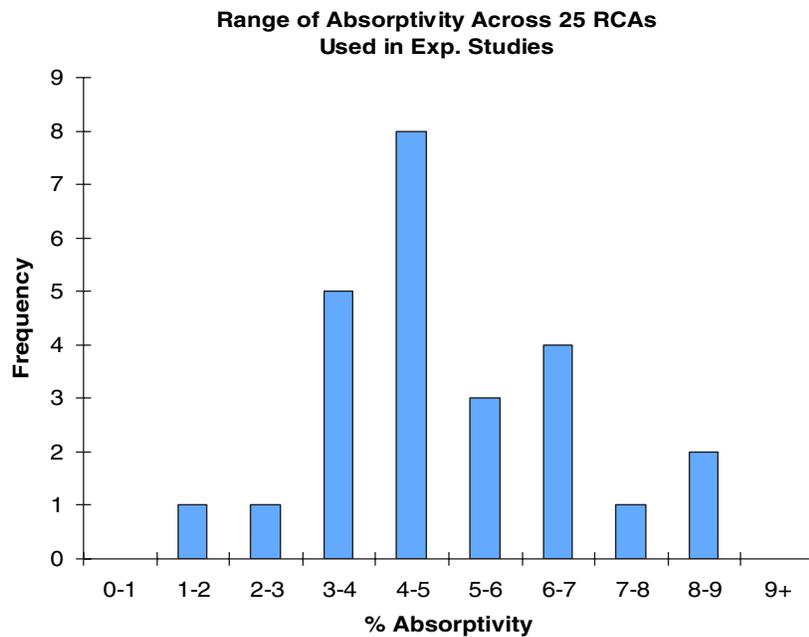
Figure T.1. Range of absorptive capacities of RCA encountered across 17 studies in the R21 Interim Report on RCA.

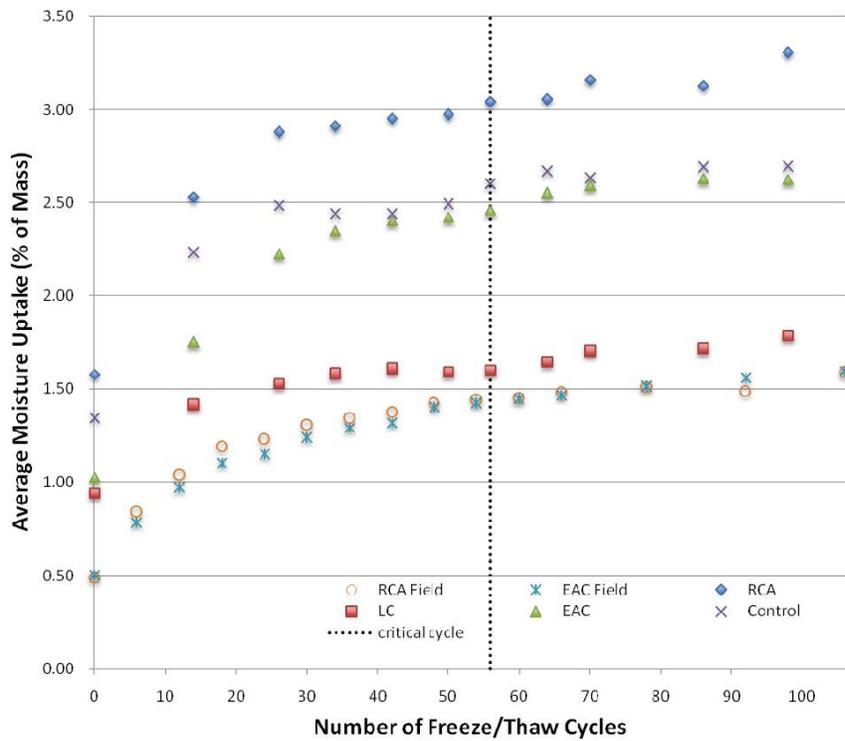
Figure U.2. Field and laboratory sample average moisture uptake as a percentage of sample mass during freeze-thaw cycles.

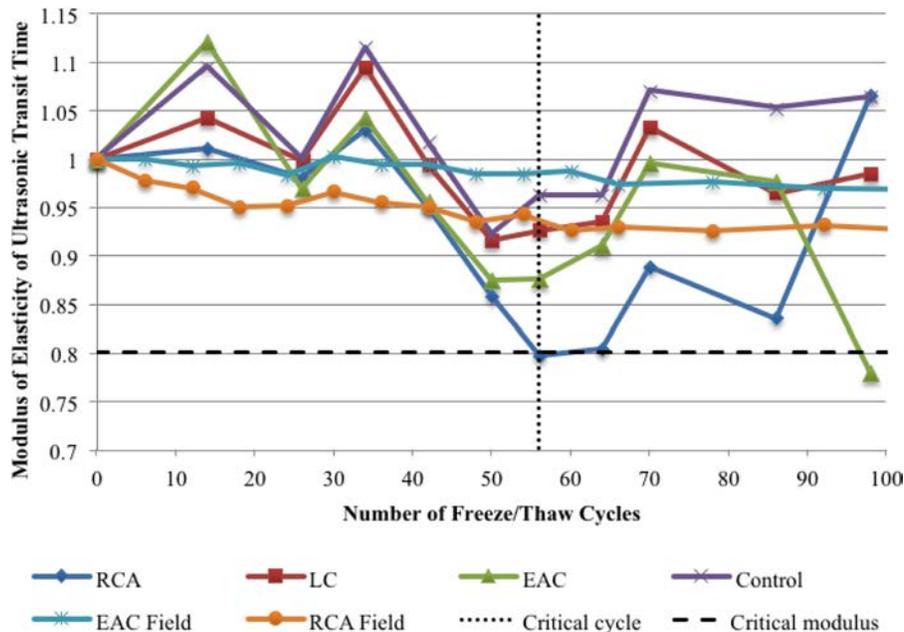
Figure U.5. Modulus of elasticity of ultrasonic pulse velocity.
