# REPORT ON PROJECT SUMMARIES AND CASE STUDIES

August 2013

Projects funded by Innovative Bridge Research and Construction Program (1998-2005) and Innovative Bridge Research and Deployment Program (2006-2009)

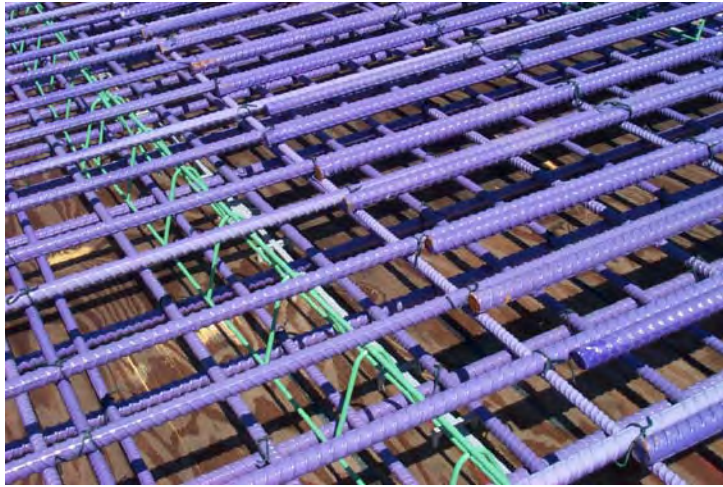
Photos of corroded rebar ends attached.

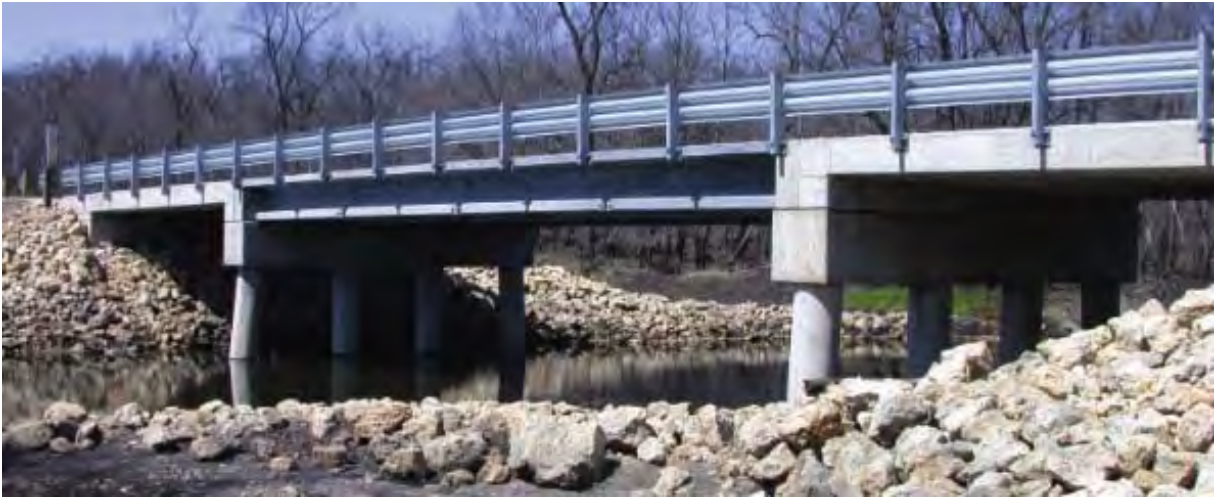
**Figure 1:** Completed Jakway Park Bridge, pi-girders used for middle span only

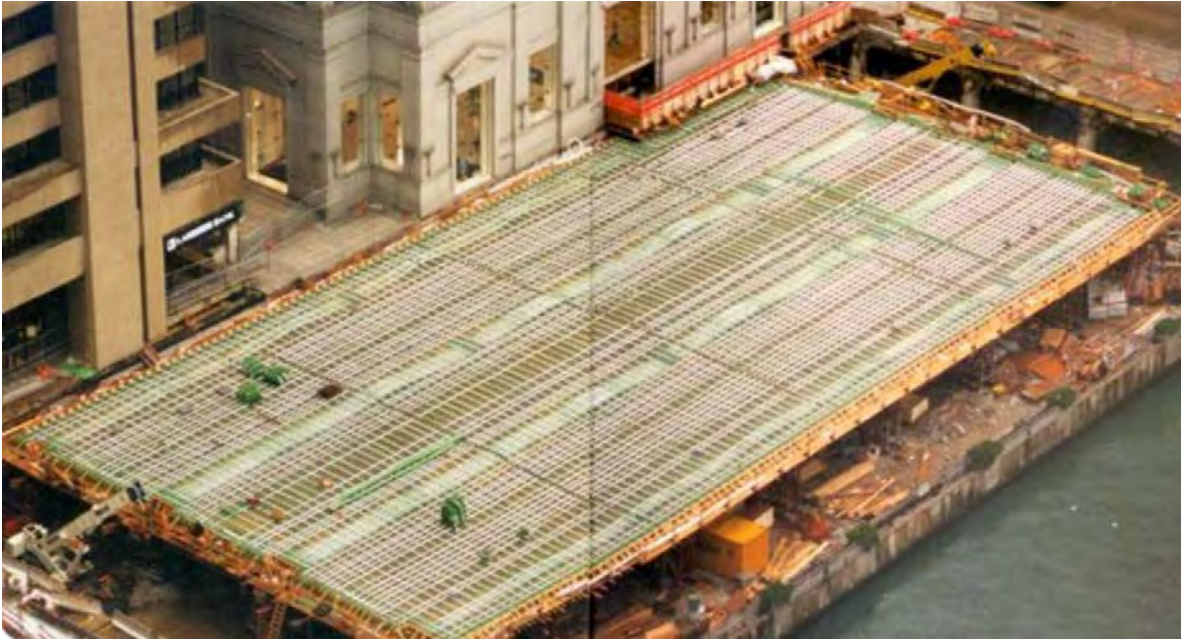
**Figure 4:** Aerial photo of deck construction during rebar placement

During construction the mix was pumped onto the deck and placed with a finishing machine. After hardening, the concrete was abrasively blasted. A 2.75 inch thick LMC layer was then placed on top of the concrete to act as the short-term sacrificial layer that soaks up winter road salts and chemicals. Approximately 25,000 cubic yards of concrete was used during the entire job, and was applied at a maximum rate of 220 cubic yards an hour. Pours reached up to 240 feet long and 110 feet wide.

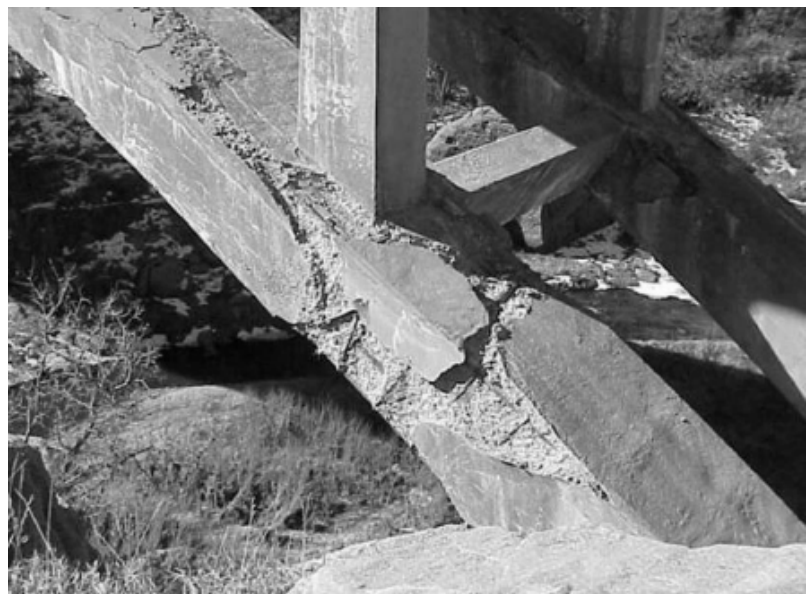
**Figure 2:** Spalling concrete and exposed steel before renovation

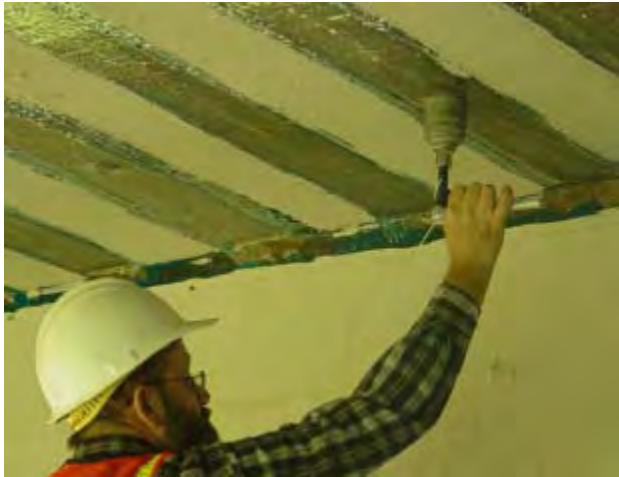
**Figure 14:** Pull-off test performed in field

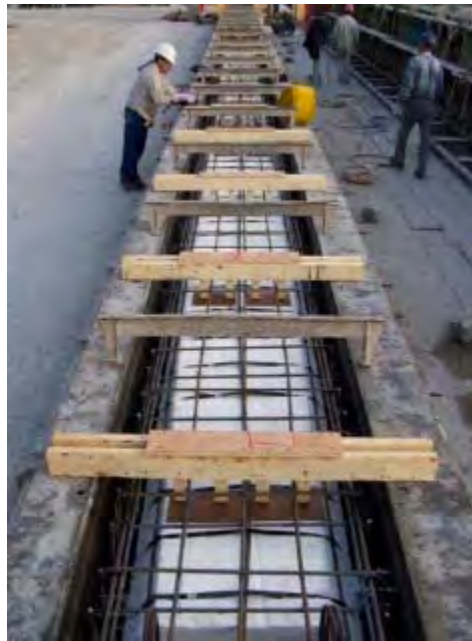
**Figure 9:** SCC beam with wooden void restraints installed and ready to be cast

casting the webs of the box section. The fourth and final stage of the process involved casting the webs and top flange. During the fourth stage, the concrete was poured directly on top of the Styrofoam block and manually distributed throughout the formwork. Sufficient vibration was used in the sidewalls to ensure that a cold joint did not develop between the bottom flange and the sidewalls.

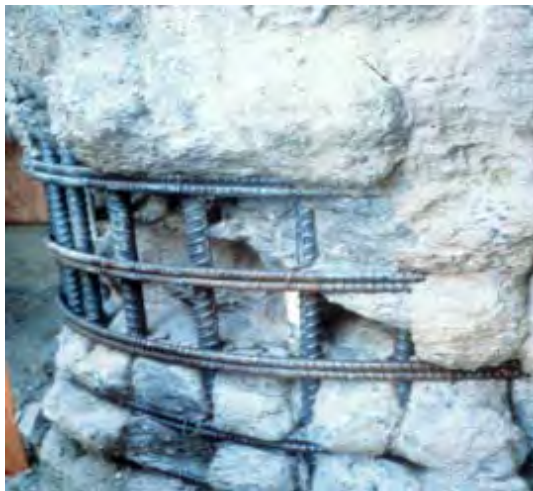
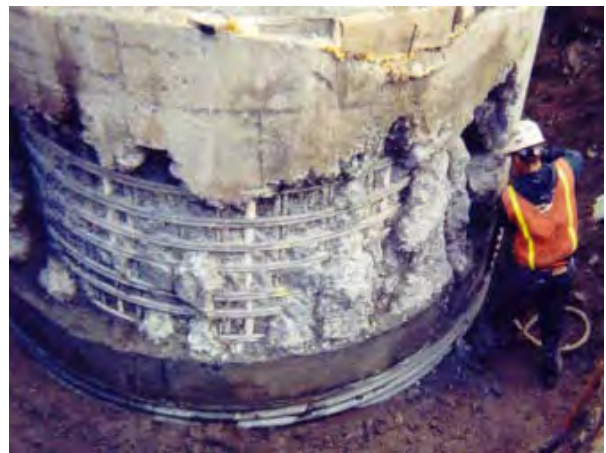
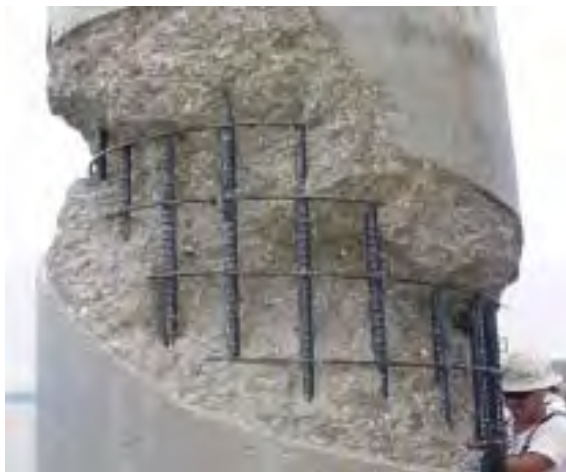
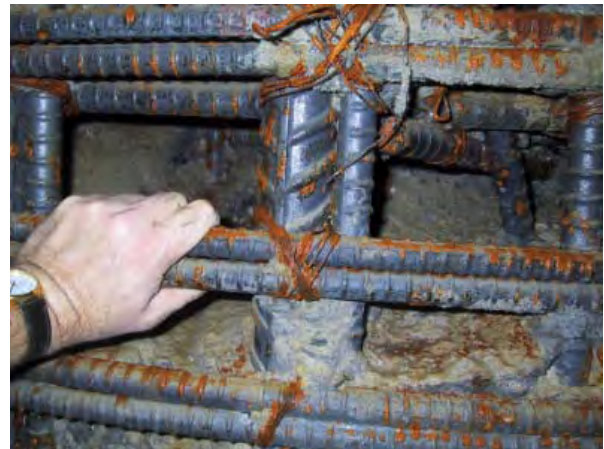
**Figure 1:** Various defects in drilled shafts, throughout the United States, due to loss of workability

Since drilled shafts typically have deep foundations, the tremie concrete method is used to place the concrete into the shaft. This is completed by pouring the concrete below the water line through a pipe; then, the lower end is kept immersed in fresh concrete so that the rising concrete from the bottom displaces the water.

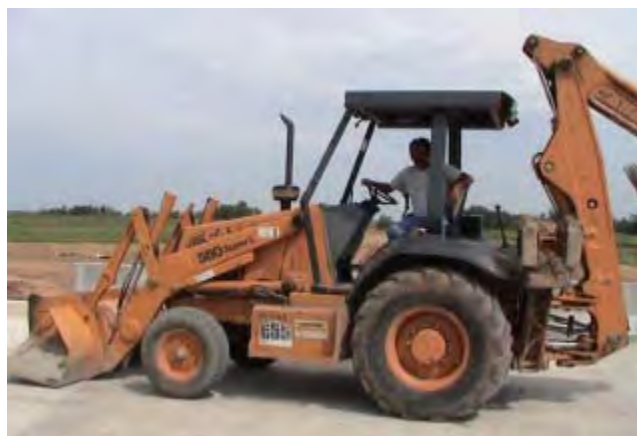
**Figure 6:** Backhoe used for serviceability acceleration testing

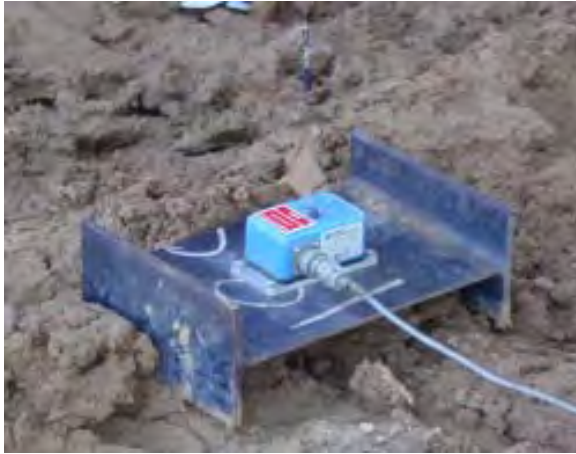
**Figure 7:** String pot

methods were used. The first used variable resistors in the form of string pots which were placed under the bridge. String pots measure deflection as a change in voltage as the string is pulled out of the device. The second method used laser deflection. The laser deflection device attaches directly to the girders and measures the natural frequencies of the structure which can be found through examination of the accelerations in the bridge after the load excitation and the bridge is in free vibration.

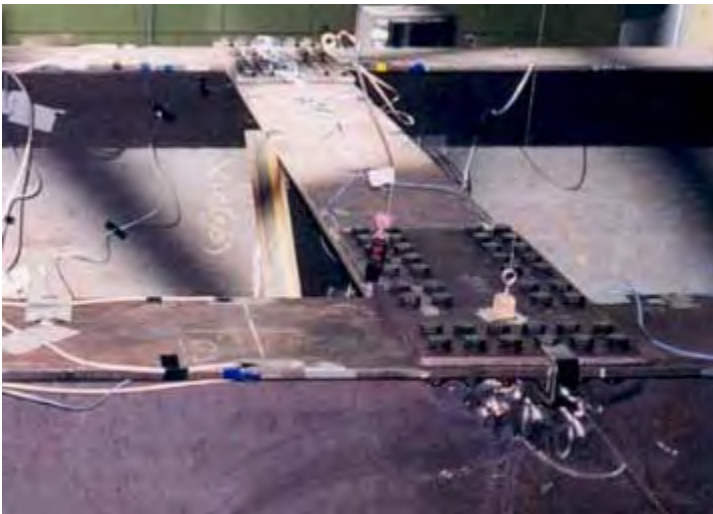
**Figure 7:** Set-up of flange rotational restraint testing

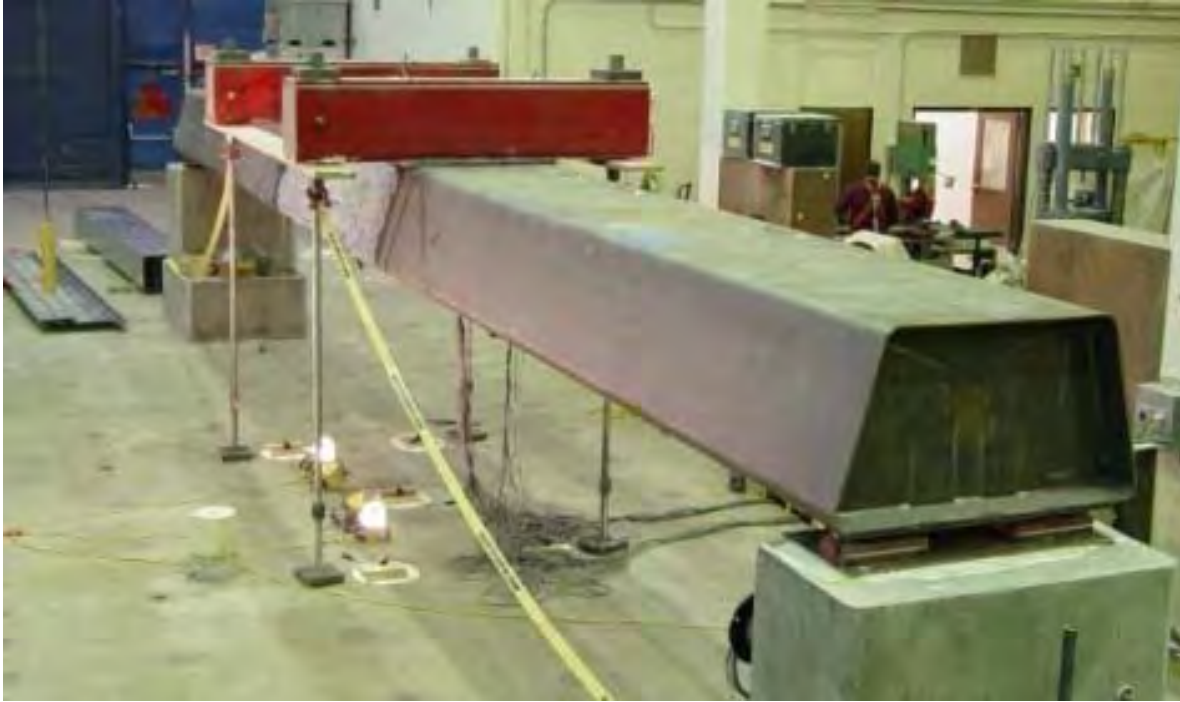
**Figure 1:** Folded plate girder during testing phase

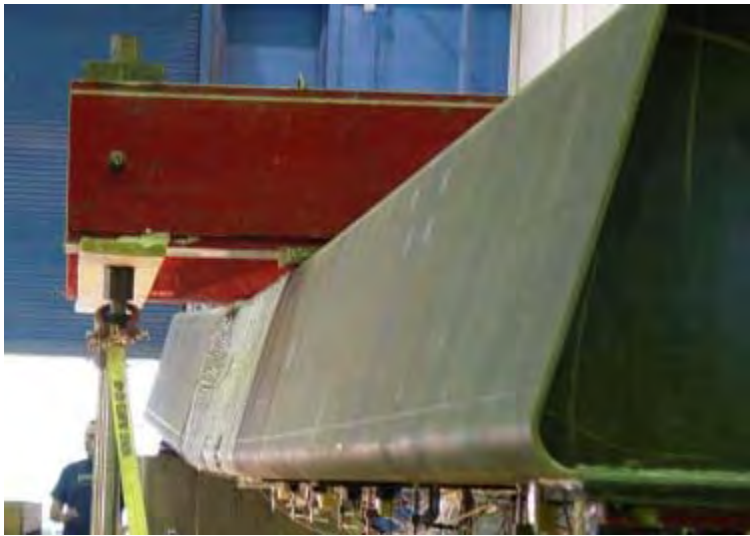
**Figure 4:** Loaded girder

During the first phase, the girder was loaded three times at low load ranges where girder behavior was both linear and elastic. First, the girder was loaded with all tie plates in place and then unloaded. Then, the middle three tie plates were removed for the second loading. After the girder was unloaded again, the tie plates were re-installed and it was loaded again.

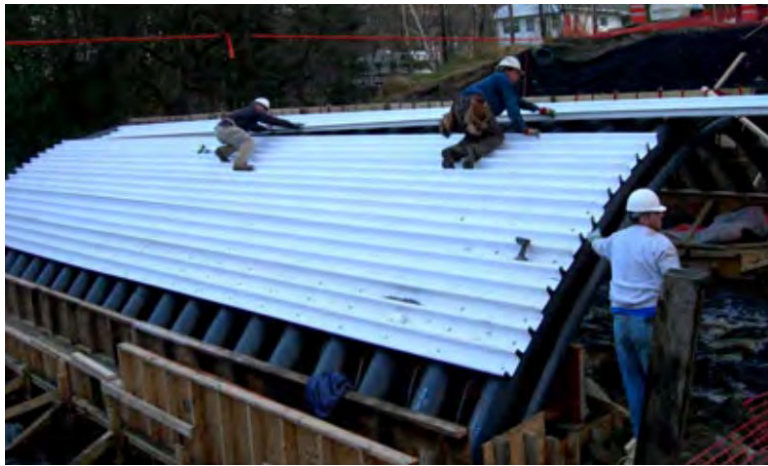
**Photo 7.** Final arch placement with corrosion resistant decking being installed

Next, workers encased the base of the arches with concrete by filling the footing forms. Once completely cured, the retaining walls were then completed and the area above the decking forms was filled in with compacted fill material as with typical arch bridge construction.

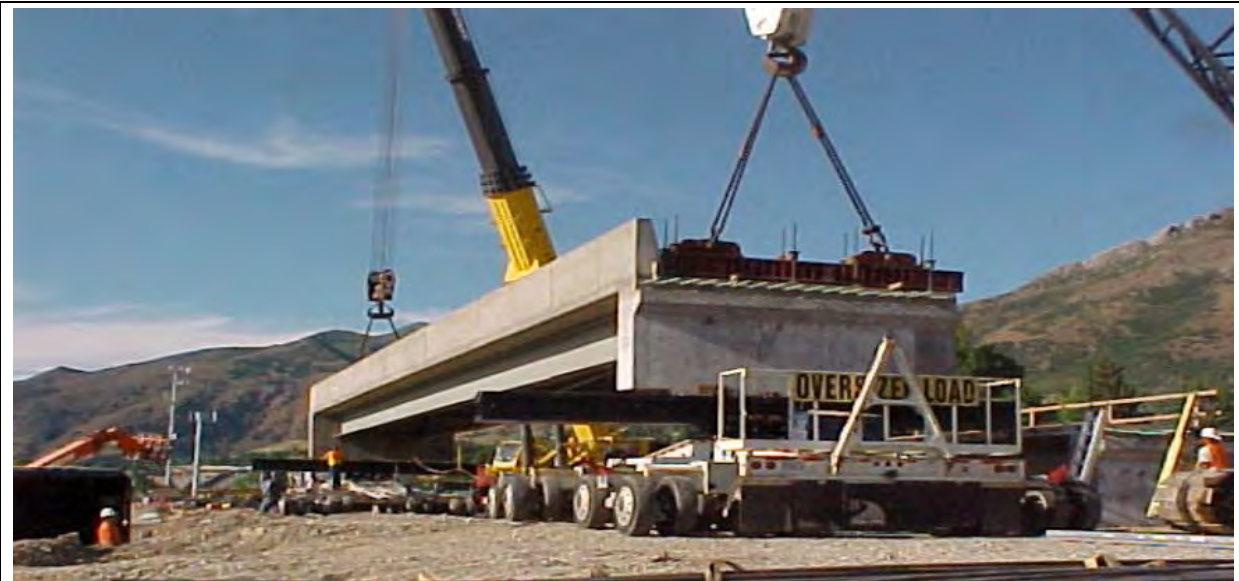
**Figure 1:** Bridge lowered onto SPMT for transport to bridge site

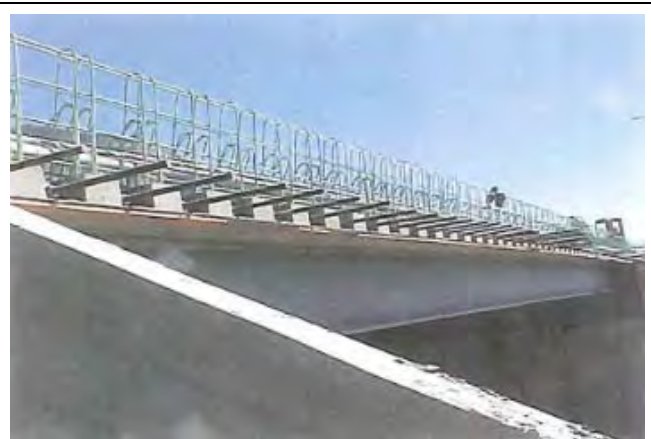
**Figure 7:** Post tensioning bars installed and ready for tensioning

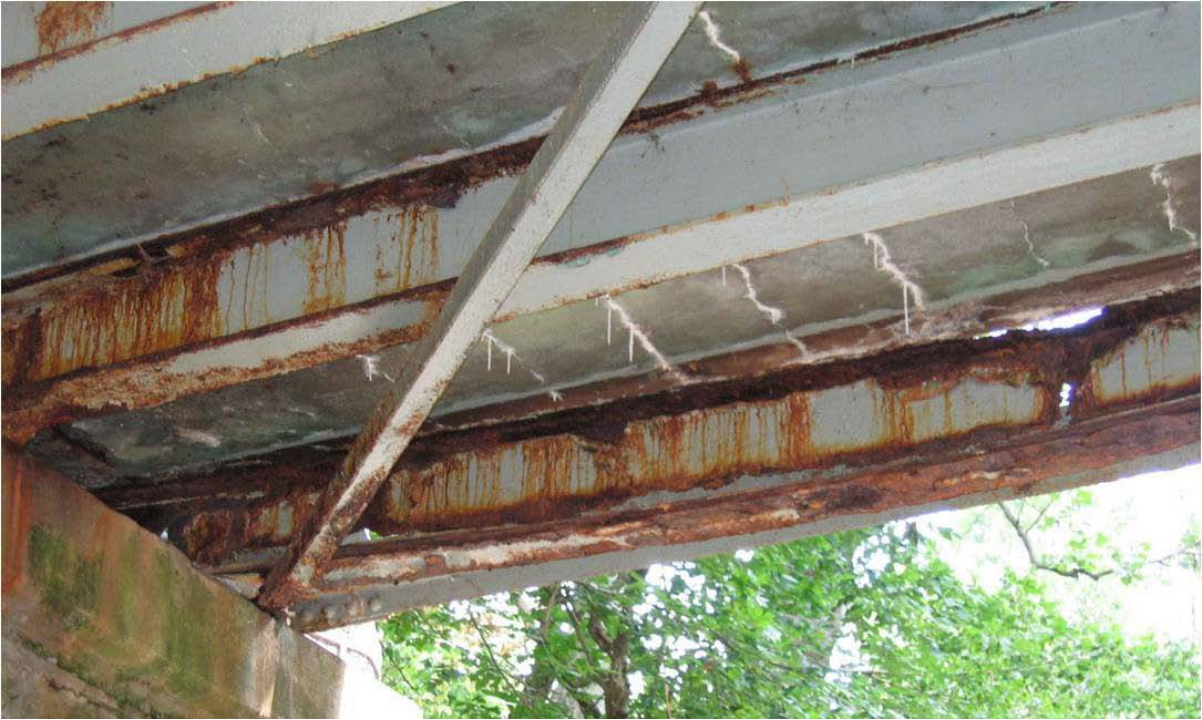
**Figure 2:** Original stringers, lateral bracing and concrete deck showing sin

The original bridge KY-974 was in need of rehabilitation due to severely corroded fascia stringers, and extensive corrosion on interior stringers, lateral bracing, and floorbeam elements of the bridge. The existing concrete deck also exhibited cracking and efflorescence. These deficiencies are shown in Figure 2. Due to this deterioration, a load posting of 17 tons was required. The load rating of the rehabilitated structure takes advantage of the light weight design that the aluminum deck panels offers.

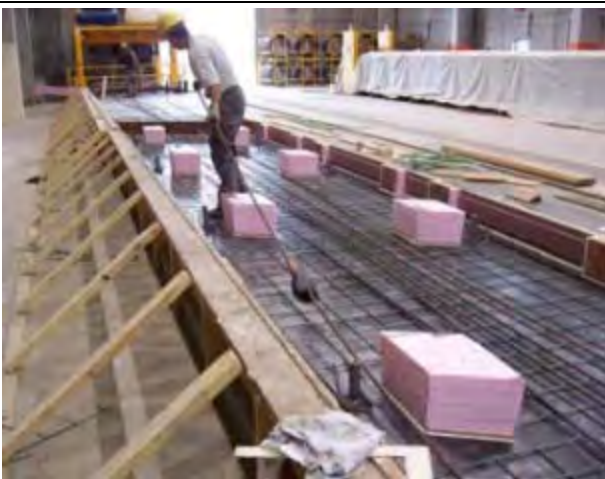
**Figure 4:** Prestressing strand being placed between foam blockouts and wire fabric prior to tensioning

Following conclusive testing results, Phase 2 could be started. The first step was the fabrication of the concrete deck panels. The panels required numerous foam blockouts prior to placing prestressing strands or concrete. The blockouts were used to form the pockets for the shear stud connectors that would later be used to develop the composite action with the steel girders. Next, welded wire fabric was placed at the top and bottom of the deck panel to control cracking during shipping and erection. After the wire fabric was in place, the prestressing strands were set into position, as shown in Figure 4. The stands for prestressing were stressed using a hydraulic jack. Once the strands were stressed the post-tensioning hardware was put into position. This included plastic ducts for the longitudinal and transverse directions along with anchorage hardware for the post-tensioning. The final step in reinforcing the panels was to place epoxy coated steel bars into a position to be used to connect the cast-in-place parapet wall to the bridge deck. For the panels, a Self-Consolidating Concrete (SCC) mixture was used. This concrete was poured between the panel formwork. After curing for 24 hours, the final step was releasing the stands to allow the prestress force to transfer to the deck panels. Figure 5 shows the completed precast concrete deck panel used for the Door Creek Bridge site.

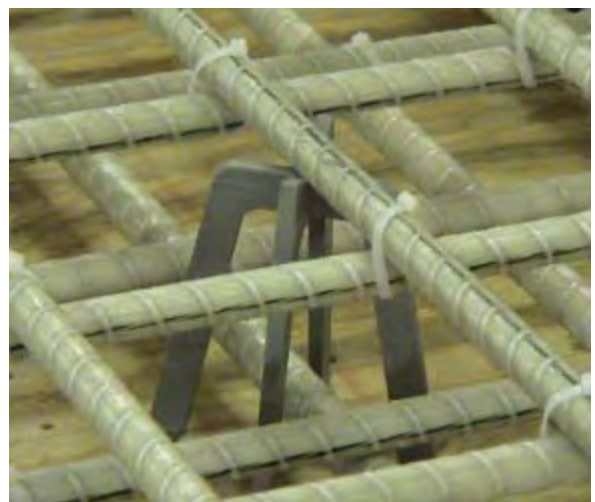
**Figure 2:** GFRP reinforcement

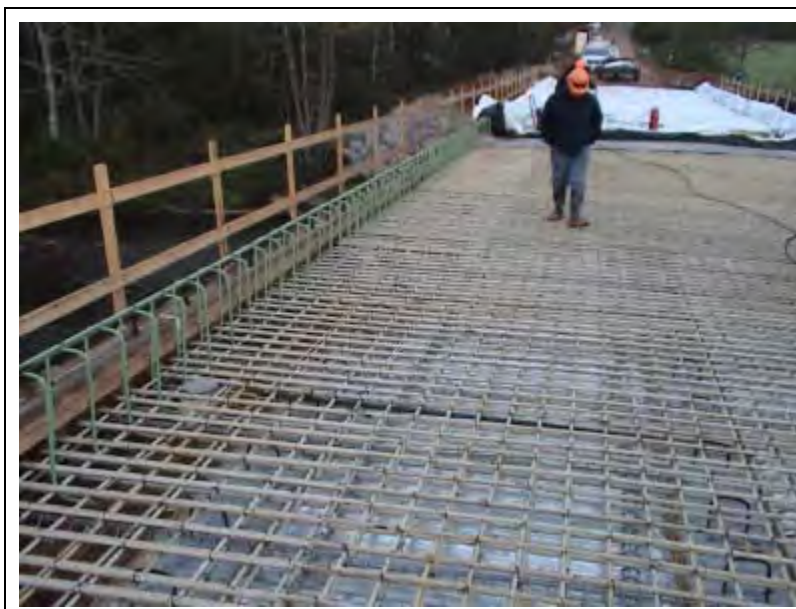
**Figure 5:** Completed deck reinforcement grid

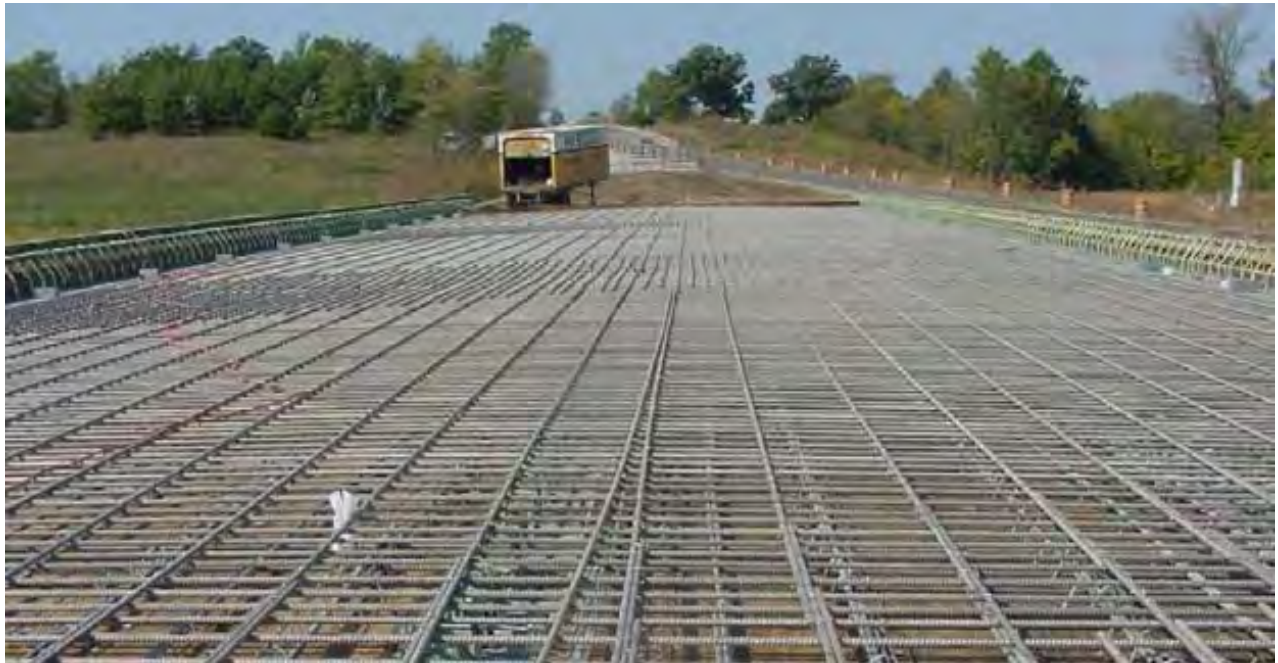
**Figure 1:** Stainless steel reinforcing at bridge A6059

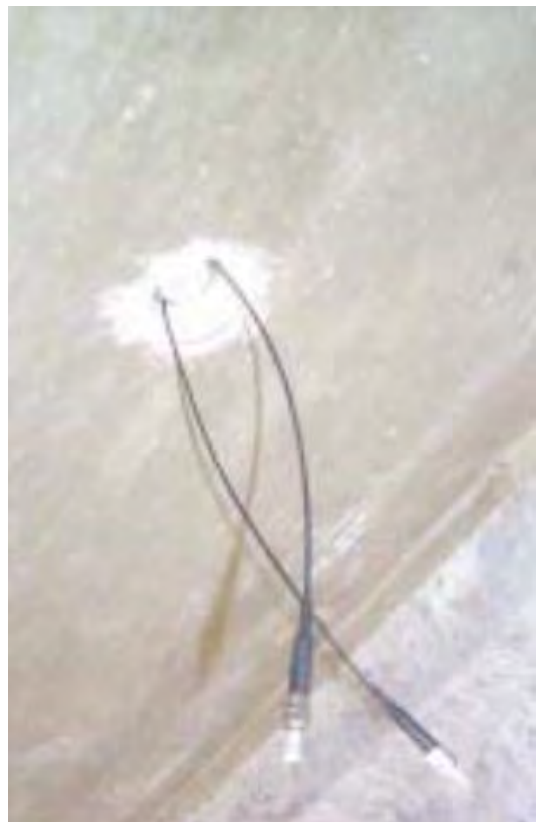
**Figure 4:** Fiber optic sensor fully installed

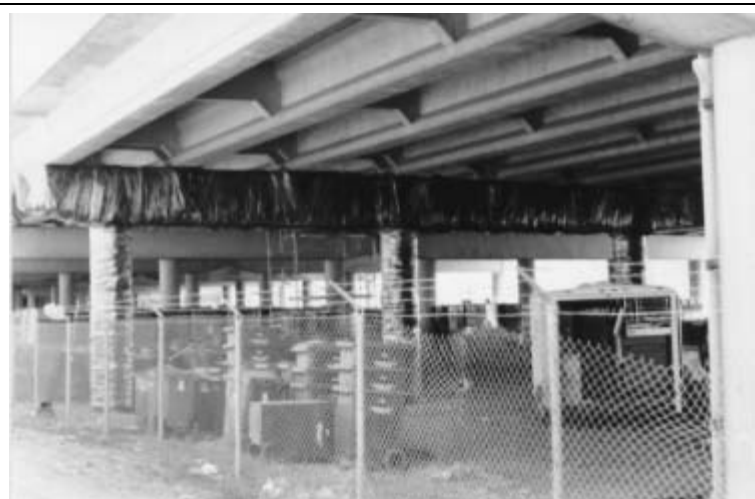
**Figure 5:** ECE system in place at Pier 37

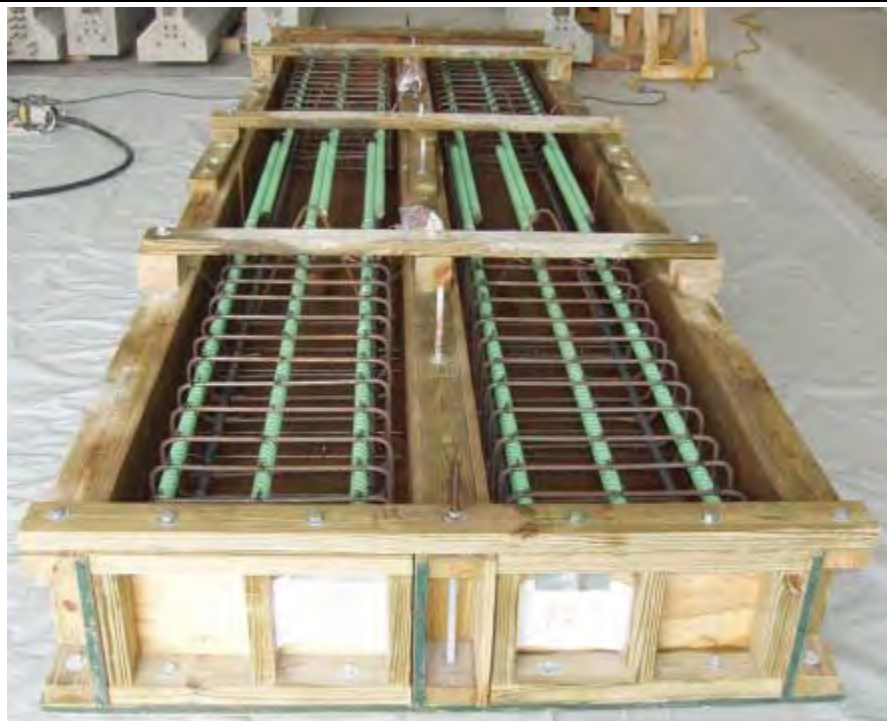
**Figure 1:** Epoxy coated rebar used during testing

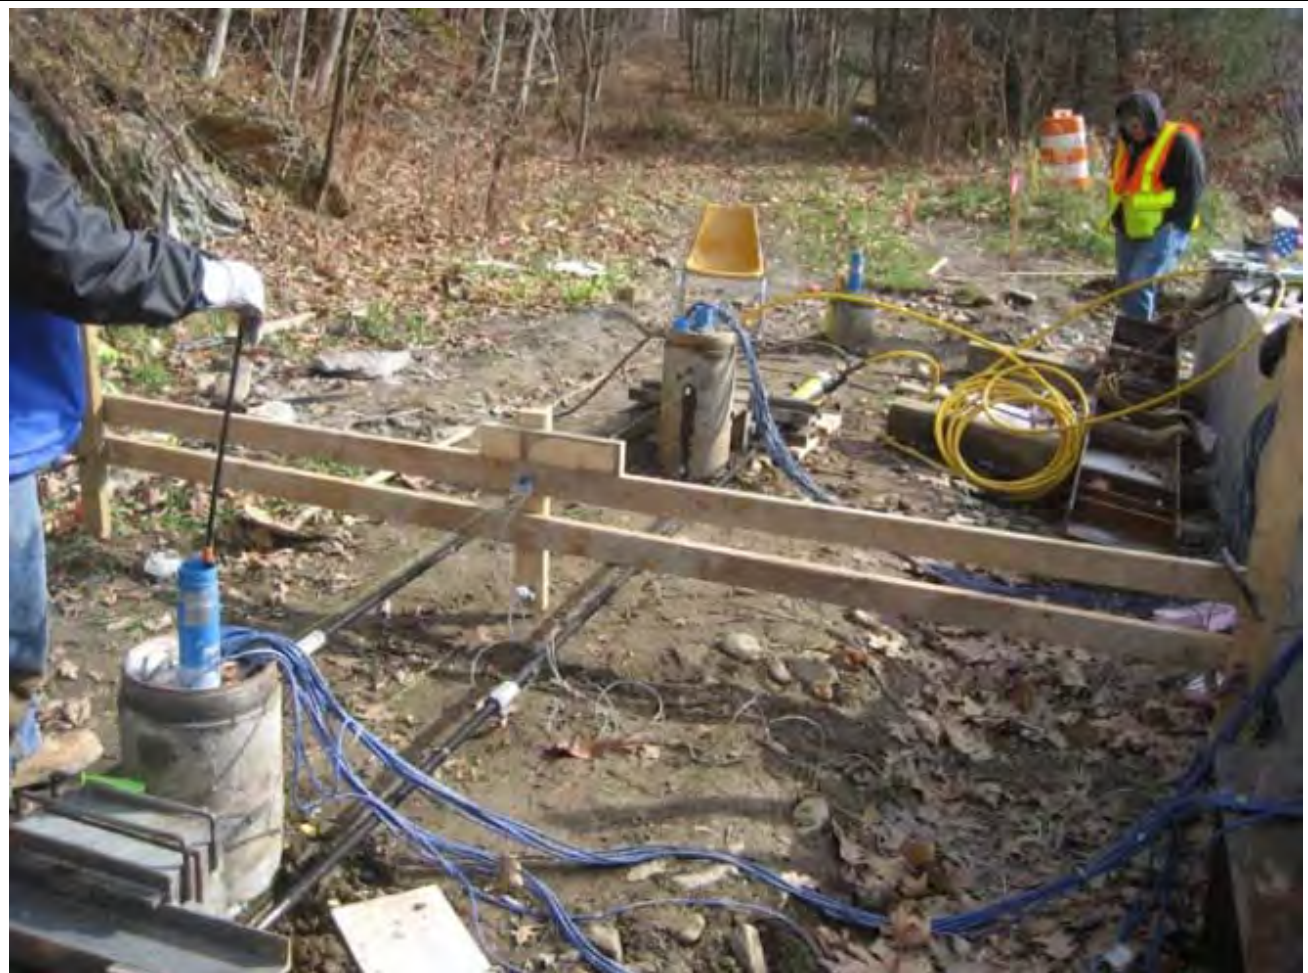
**Figure 1:** Load test showing load frame, reference beams, and actuators

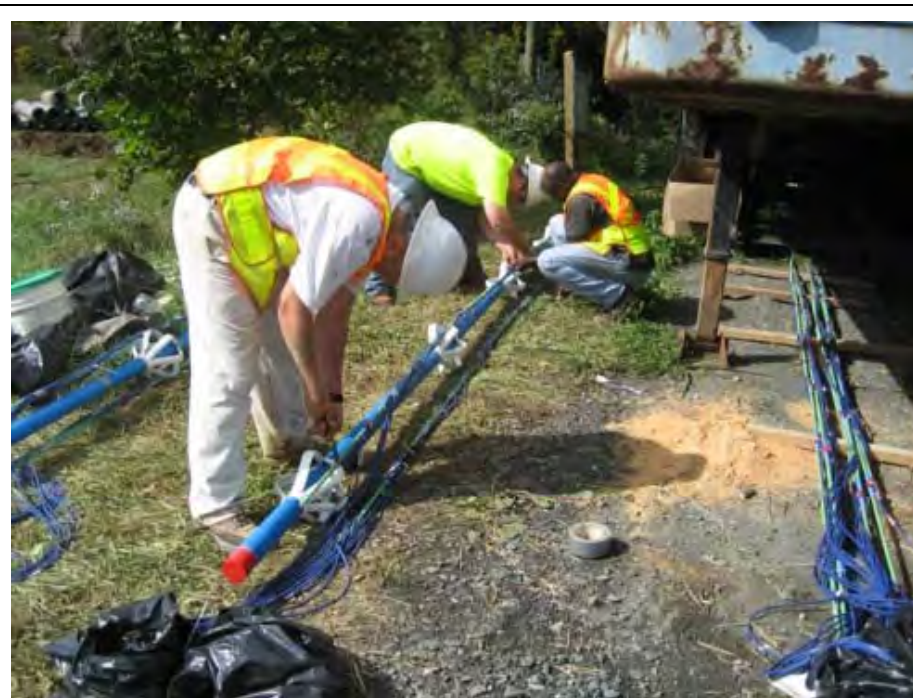
**Figure 3:** Assembly of the inclinometer and strain gages

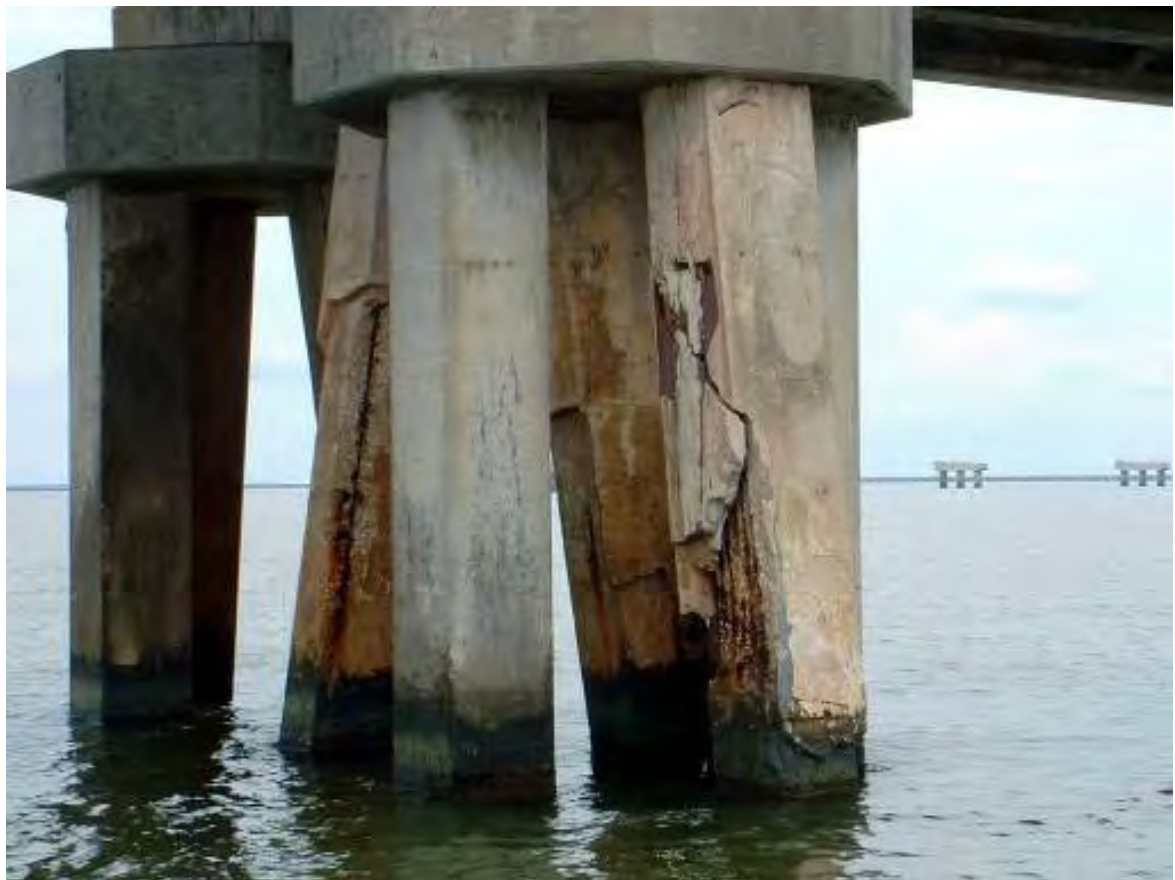
**Figure 1:** Condition of existing concrete piles at the Key Royale Bridge site before rehabilitation

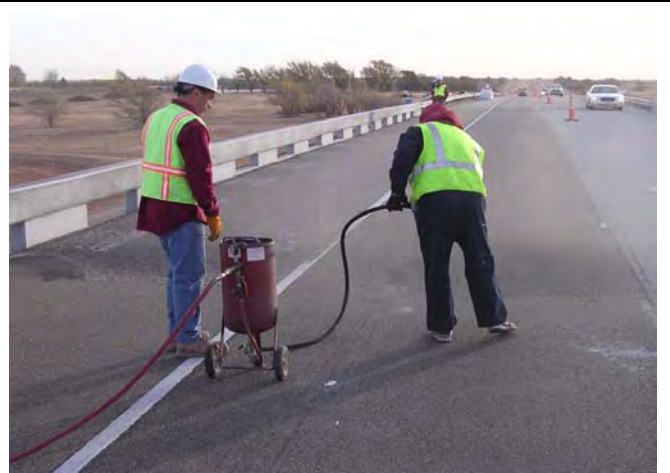
**Figure 3:** Sand blasting of existing surface to remove any dust, contaminants or other loose material

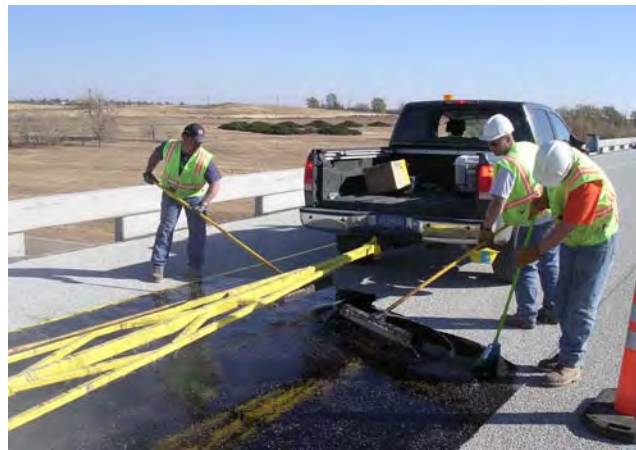
**Figure 4:** Epoxy mixed on site and applied using squeegees to the existing pavement surface

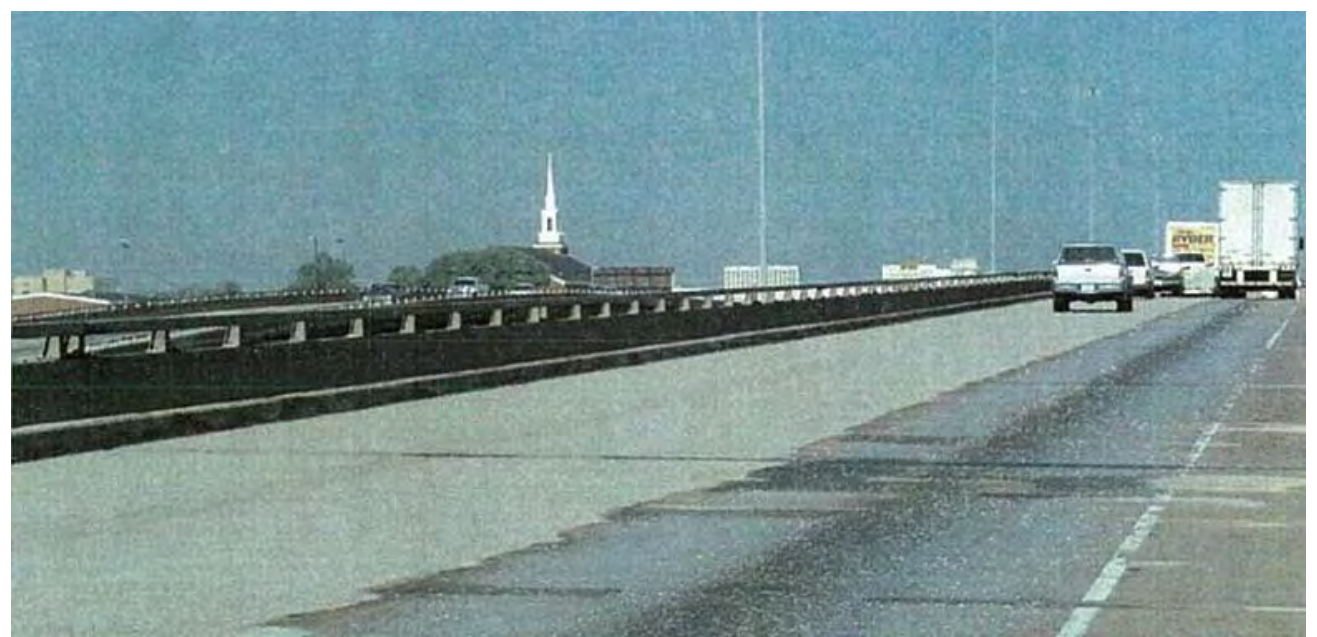
**Figure 1:** Westbound bridge with one lane treated with polymer overlay

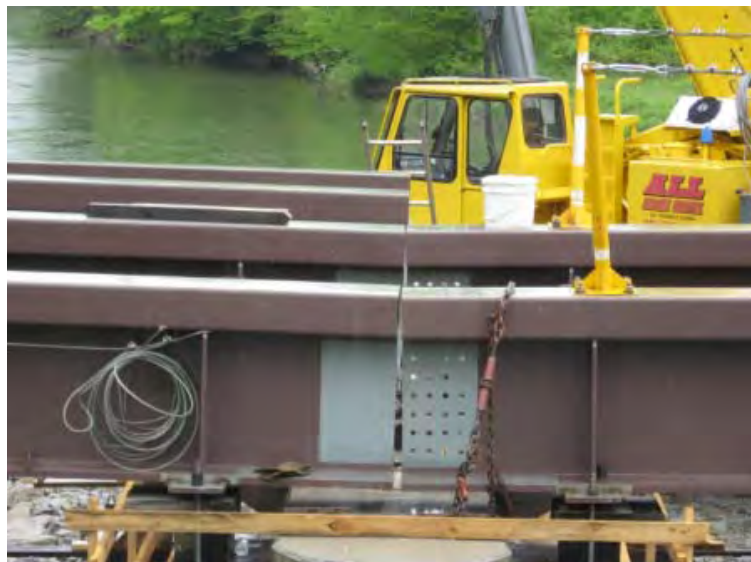
**Figure 3:** Field splice at pier

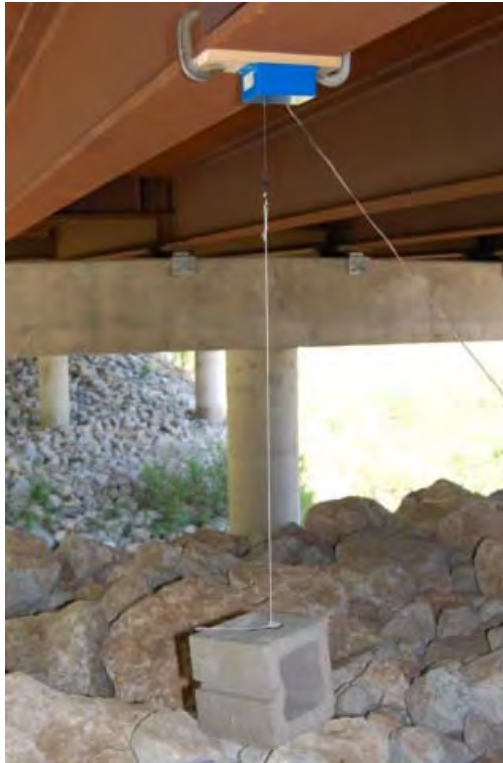
**Figure 5:** Potentiometers installed at midspan
