RUNCORN, UNITED KINGDOM

BRIEF: RUNCORN BUSWAY

Runcorn Busway

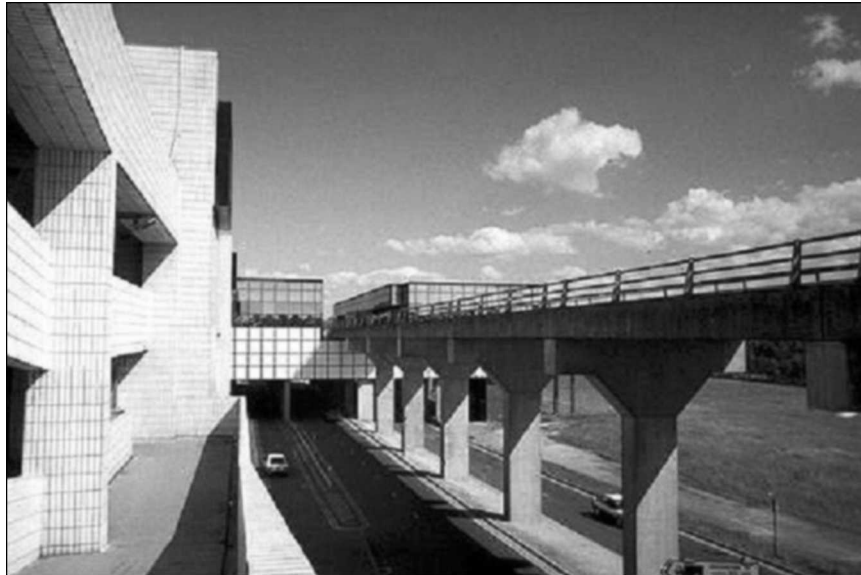
Figure 1: Elevated Section of Runcorn Busway (As it Enters the Shopping Complex)

- Stations are located at approximately 400-meter [0.25-mile] intervals. (See [Figure 4](#).)
 - There is only one elevated section of the busway, where it enters the town center shopping complex at a high level (see [Figure 5](#)). Other crossings with normal roads are at-grade; traffic management is effectively employed through signal-controlled junctions with bus actuation. Generally, buses do not have to stop at other road crossings.

- Total costs of developing the busway (including construction and land) were reported as \$15 million in 1973. Most of the costs were attributed to the elevated sections of the busway in the town center and grade separations at major intersections.

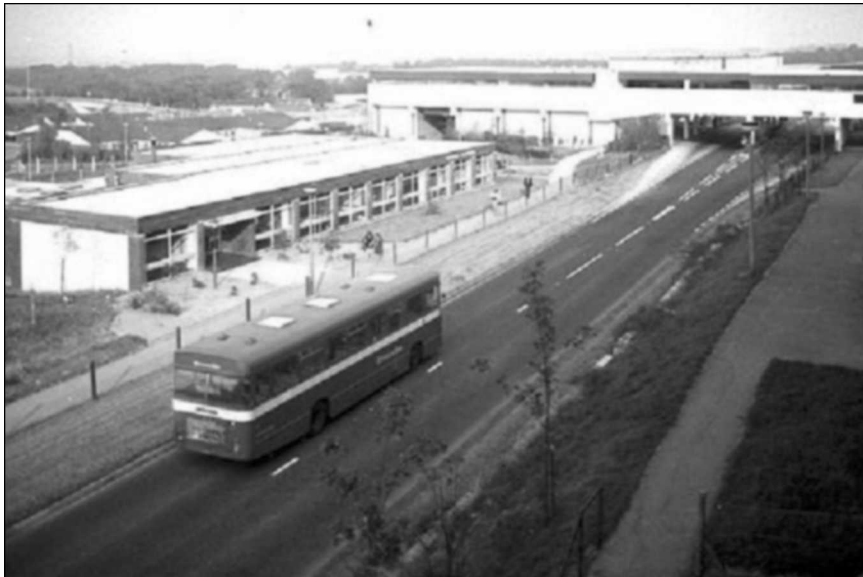
Figure 4: Bus Stops at a Local Center

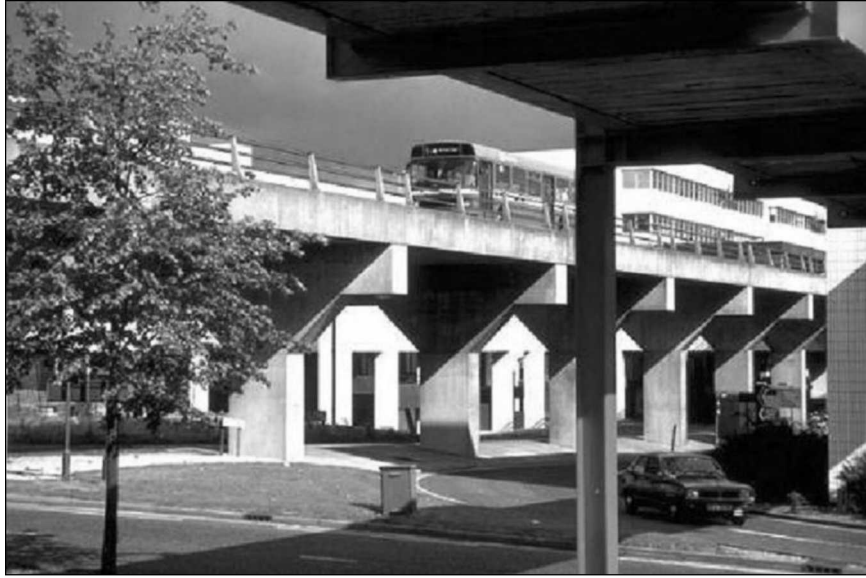
Figure 5: View of Elevated Business Town Center
