CHAPTER 2

SYSTEM SAFETY AND OPERATING EXPERIENCE

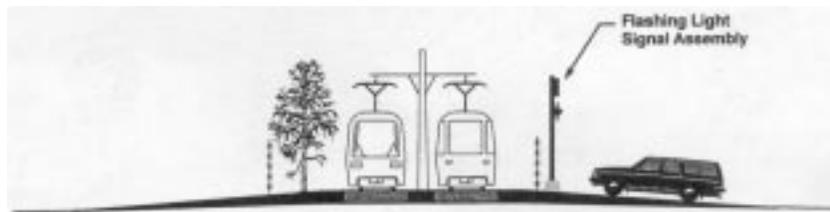
Figure 2-3. Semi-Exclusive, Type b.1.

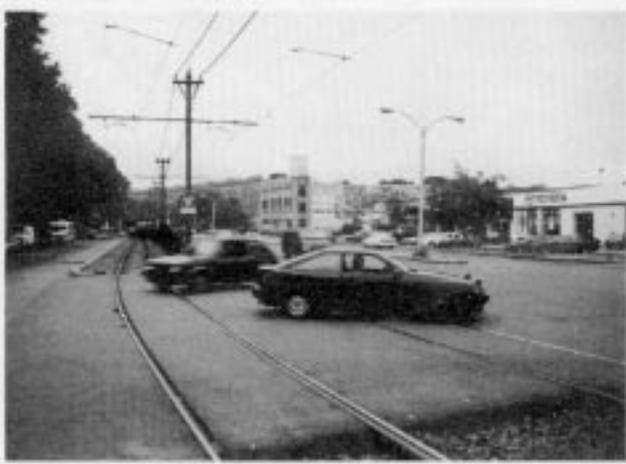
Figure 2-13. Boston LRT System Commonwealth Ave./Linden St. Intersection.

Field reconnaissance of the Green line indicated a complex, irregular street pattern. Intersections are often offset, multiply approached, or obliquely angled (see Figure 2-13). LRT trackage to and from the Reservoir Yard is used in conjunction with awkward intersection geometry along Chestnut Hill Avenue at Cleveland Circle and Commonwealth

Commonwealth Avenue–Linden Street. This unsignalized intersection has poor road geometry and numerous conflicting movements. The problem is a geometric one rather than one of traffic control devices. Proceeding from north to south, there is a two-lane westbound service road, the LRT tracks, a four-lane main road, and a two-lane eastbound service road. Eastbound vehicles turning left into Linden must do so from a shared lane. This requires finding a gap in the opposing traffic stream as well as a gap across the tracks (since storage is inadequate). In the southbound direction, automobiles must wait on tracks for gaps in traffic. Of the 14 accidents at this location, 8 involved vehicle collisions with the front end of LRVs; 3 involved collisions with the right side of LRVs, and 2 involved collisions with the left side of LRVs.

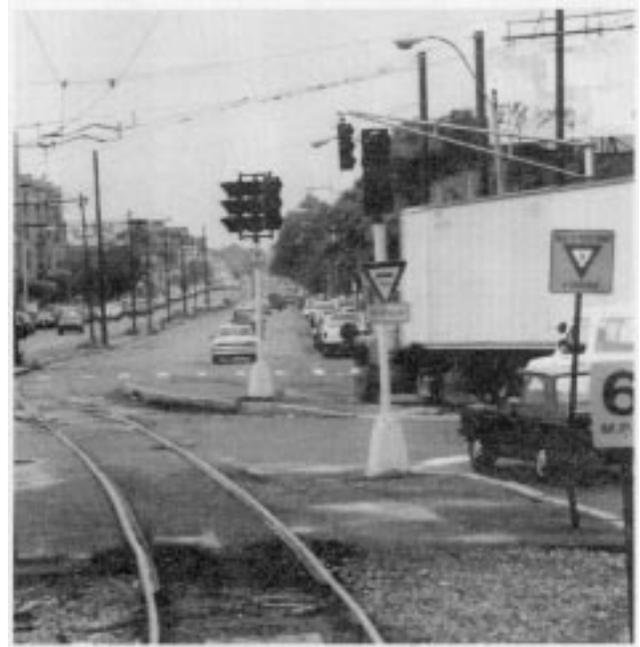
Figure 2-14. Boston LRT System Regulatory Turning Signs.

- The MBTA places advisory traffic signs at LRV station stops where passengers board or alight in the street, where LRVs turn, and where left turns are permitted across the LRT right-of-way. These signs are usually pole mounted, sometimes 15 feet above the roadway; most are too small and have too much copy to be legible and understood by someone in motion.
- Triangular signs reading YIELD TO TROLLEY on turns (Figure 2-14) are also too small to be effective.
- There are no advance warning signs at most vehicular crossings.
- Active signs to warn motorists of an approaching LRV at unsignalized vehicle and pedestrian crossings are not provided.
- The narrow passenger safety islands along Huntington and South Huntington Avenues are routinely traversed by motorists.
- The LRV dynamic envelope² is not delineated at crossings, around turns, or in mixed traffic.

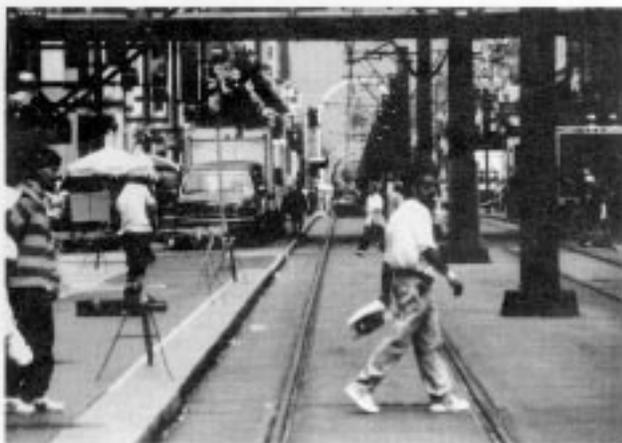
Figure 2-16. Buffalo LRT System Main St. LRT/Pedestrian Mall.

Perceived problems on the transit mall are typically attributed to negligent drivers and pedestrians (Figures 2-16 and 2-17). According to interviews with representatives from NFTA, most of the problems on their system are due to cross-street (right-angle) motorists disobeying traffic signals.

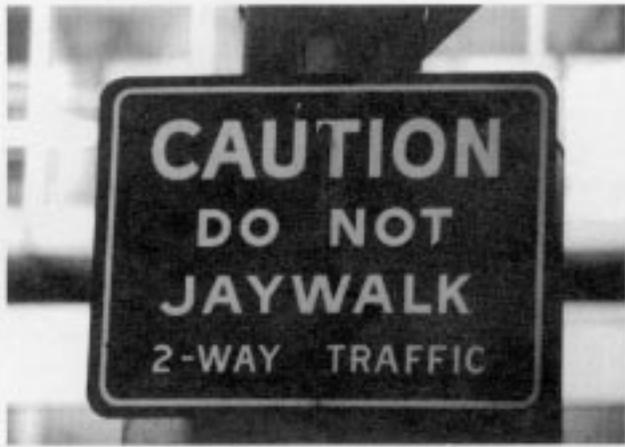
Figure 2-19. Calgary LRT System CAUTION DO NOT JAYWALK Sign.

WALK—2-WAY TRAFFIC signs were installed in 1987 at midblock locations (Figure 2-19).

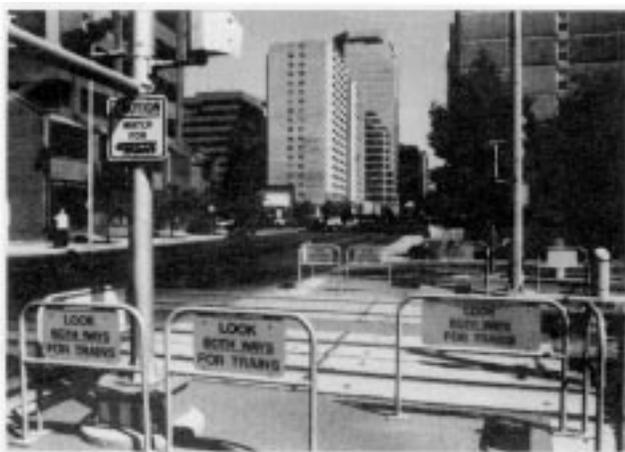
Figure 2-20. Calgary LRT System Bedstead Barriers.

- Bedstead barriers were installed in 1985 at pedestrian grade crossings at street intersections. Mounted on each barrier is a LOOK BOTH WAYS FOR TRAINS sign. These barriers are placed in an offset, mazelike manner so that the pedestrian must navigate around them (Figure 2-20); this forces the inattentive pedestrian to be alert while crossing the LRT tracks. Calgary Transit indicated that these barriers are effective and have low maintenance costs.

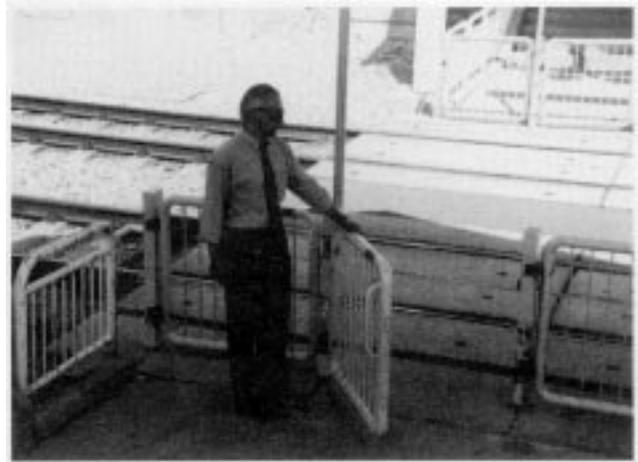
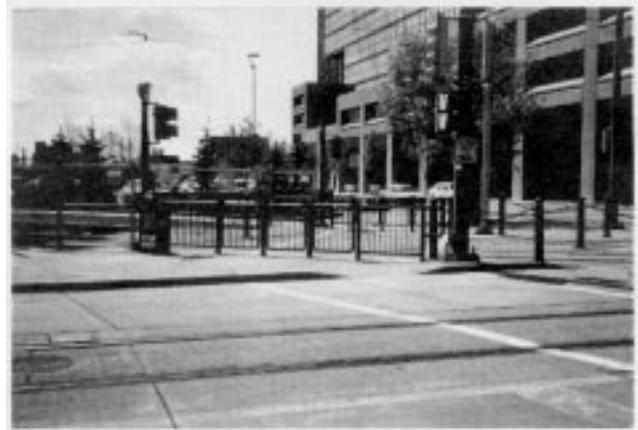
Figure 2-21. Calgary LRT System Swing Gates.

- Swing gates were installed in 1988 at some stations where pedestrians cross the LRT tracks to access the boarding area and at the intersection of Seventh Avenue S.E. and Third Street S.E. (Figure 2-21). With this gate device, the pedestrian must take a physical action (pulling the gate open) prior to entering the LRT track environment. Calgary Transit indicated that swing gates have proven effective although they are somewhat maintenance intensive. To remind pedestrians to look both ways prior to crossing LRT tracks, Calgary Transit installed large LOOK BOTH WAYS FOR TRAINS signs above the swing gates at stations.

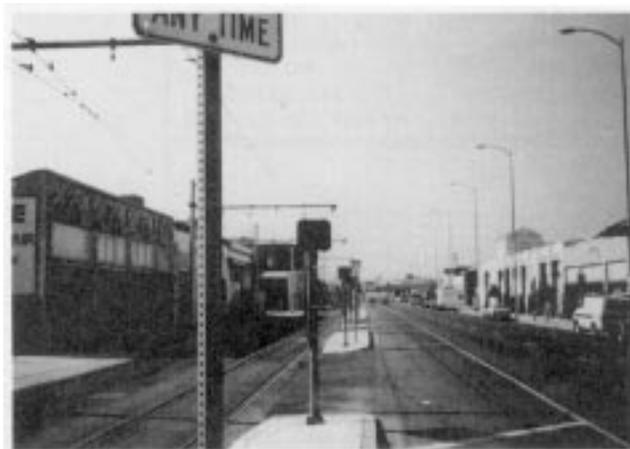
Figure 2-23. Los Angeles LRT System Flower Street.

- In downtown Los Angeles on Flower Street (Figure 2-23), motorists who exit driveways and pedestrians who cross the street at midblock are often confused about which way the LRV is approaching. Flower Street is a one-way street with LRT operating in both directions on a side alignment (type b.3).

The accident experience confirms observed problems along the Blue line, notably along Long Beach Boulevard (in Long Beach), Flower Street (in Los Angeles), and Washington Boulevard (also in Los Angeles). Both motorists and pedestrians are confused by the two-way, side-aligned LRT operations on Flower Street, where motor vehicle traffic travels one way southbound. Motorists exiting driveways and pedestrians crossing the street at midblock tend to look only for traffic moving southbound and sometimes cross in front of an LRV approaching from the northbound direction.

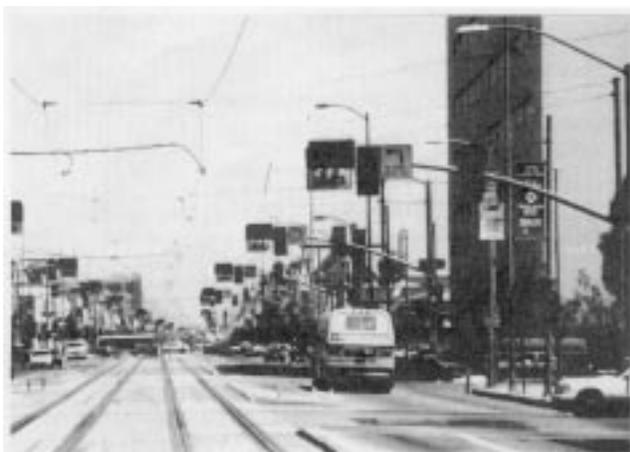
Figure 2-24. Los Angeles LRT System Washington Boulevard.

- At the end of the high-platform LRT stations, pedestrians often ignore an approaching or departing LRV as they attempt to catch another LRV or bus.
- At intersections on Long Beach Boulevard in Long Beach and on Washington Boulevard in Los Angeles, motorists violate the red left-turn arrows (1) at the end of the exclusive left-turn phase, unaware of an overtaking LRV on the median; (2) when an LRV disrupts the normal signal phasing, canceling the leading left-turn phase and immediately providing a green signal indication to the parallel through traffic; and (3) when a white "T" LRT signal indication occurs. Motorists have expressed confusion over the "T" LRT signals and the traffic signals at intersections along Long Beach and Washington Boulevards (Figure 2-24).

and the city of Long Beach have changed from a leading to a lagging left-turn phase. This prevents motorists from experiencing any changes in the phasing sequence when the LRVs approach the intersection, and left-turning motorists who may violate the start of the red arrow indication do so after the LRVs have cleared the intersection.

- To address the problem of motorists violating red leftturn arrows when the "T" LRT signal on the mast arm changes to a proceed indication, the "T" aspect LRT signals will be relocated from the mast arm to the far side above the traffic lights and the lenses will be replaced with a white bar aspect.

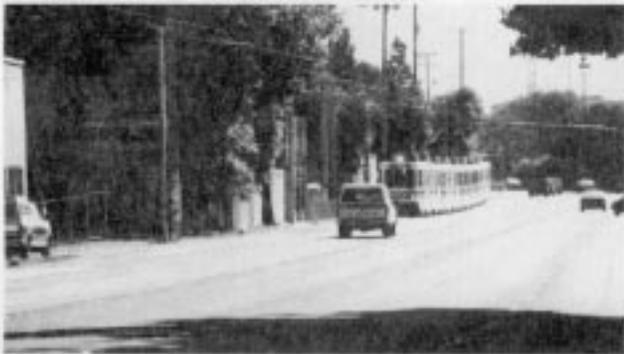
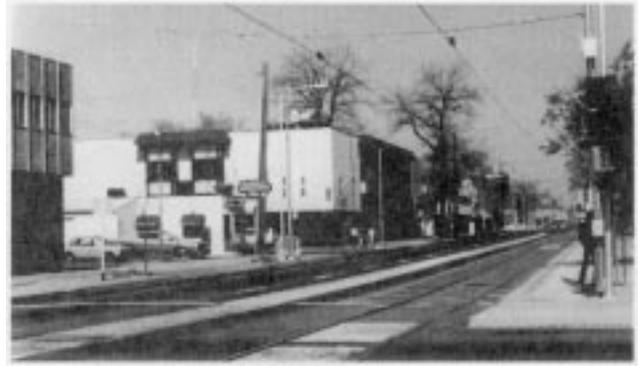
Figure 2-29. Sacramento LRT System 12th Street.

Figure 2-30. Sacramento LRT System 12th Street.

- Sacramento has had various problems with two-way side-aligned LRT operations on a one-way street (i.e., 12th Street). On 12th Street, LRVs traveling southbound in the same direction as traffic operate in a shared lane with motor vehicles (type c.1). Contra-flow LRVs operate in a striped exclusive LRV lane (type b.4) (see Figure 2-29). Most of the problems arise from motorists exiting or entering a driveway or minor street: motorists fail to look both ways at stop (R1-1) sign-controlled intersections and thus often fail to see an LRV approaching northbound, in the opposite direction from vehicular traffic. Also, at some intersections with 12th Street (e.g., at 12th and Ahern Streets) (Figure 2-30), stopping-sight distances are very limited and make it difficult for both the LRV operator and motorists to see one another safely.

- Also of concern are LRV-motor vehicle left-turn collisions at the intersection of 12th and F Streets that result from the unusual lane arrangement. Southbound LRVs continue straight through the intersection in mixed flow using a lane that is designated as an exclusive left-turn lane. The adjacent lane is a through motor vehicle lane. The LRVs proceed through the intersection with the

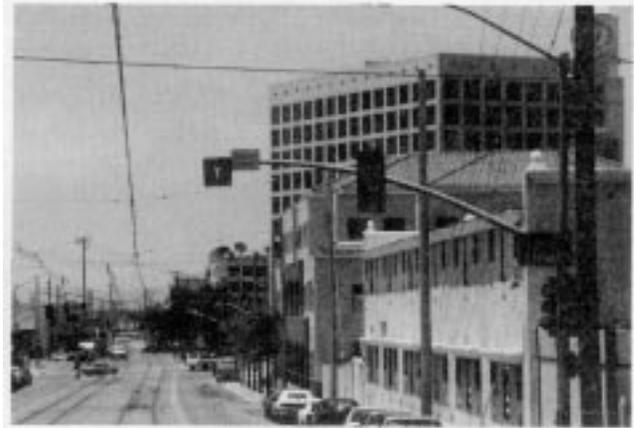
Figure 2-32. San Diego LRT System Commercial Street.

Street. A similar situation occurs on 12th Avenue and on Commercial Street: motorists cross, turn, and drive in a median LRV-only lane that is striped with solid double yellow lines (Figure 2-32). To solve the C Street problem, San Diego Trolley installed 12- by 18-inch NO VEHICLES ON TRACKS symbol signs on 36-inch-high flexible posts placed between the double set of LRT tracks at both ends of each block (Figure 2-33). San Diego Trolley indicated that the signs have been effective in keeping motor vehicles off the LRT tracks.

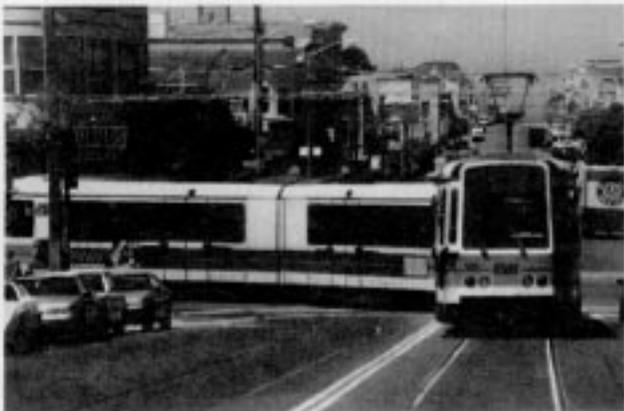
Figure 2-35. San Francisco LRT System 9th Avenue/ Irving Street Intersection.

rear-end collisions, 16 percent involved sideswipes, and 15 percent involved right-angle collisions. Two of the three locations, 9th Avenue/Irving Street (Figure 2-35) and 30th Street/Church Street, involve 90-degree LRV turns, whereas the third, 19th Avenue/Winston Drive (Figure 2-36), involves a complex left-turn lane geometry.

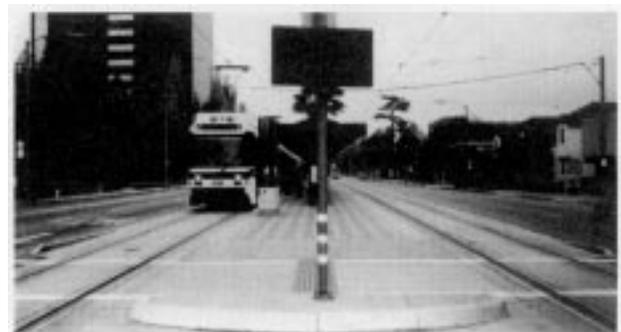
Figure 2-38. San Jose LRT System Active TROLLEY COMING Sign.

illuminated TROLLEY COMING signs at all left-turn pockets (Figure 2-38). These signs have effectively reduced the number of left-turn collisions between LRVs and motor vehicles. Additionally, SCCTA installed a separate LRT proceed phase to allow LRVs to enter the intersection ahead of potentially conflicting parallel movements.

SCCTA has a safety program to reduce collisions between LRVs and pedestrians and motor vehicles. For example, it has installed active, internally illuminated TROLLEY COMING signs to warn motorists of the increased risk associated with violating a red left-turn arrow indication (see Figure 2-38). This treatment has proven effective (documented in more detail in Chapter 4 of this report) in reducing left-turn collisions when the LRV preempts the normal, expected traffic signal cycle.

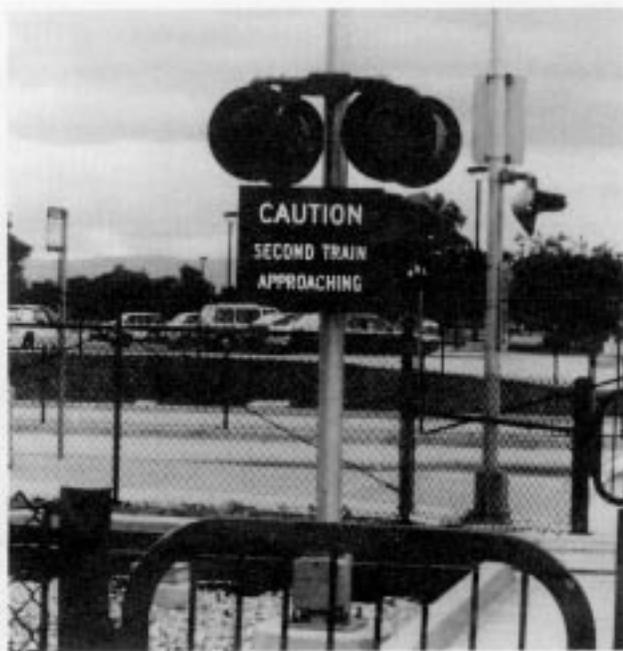
Figure 2-39. San Jose LRT System Pedestrian Crossing at Ohlone/Chynoweth.

- At the Ohlone-Chynoweth Station, SCCTA has installed pedestrian swing gates at a crossing of the LRT tracks. These gates force the pedestrian to take a physical action (pulling the gate open) before entering the LRT track environment. These gates, in combination with an active SECOND TRAIN APPROACHING sign, have proven effective in reducing the number of collisions between pedestrians and LRVs at this location (Figure 2-39).

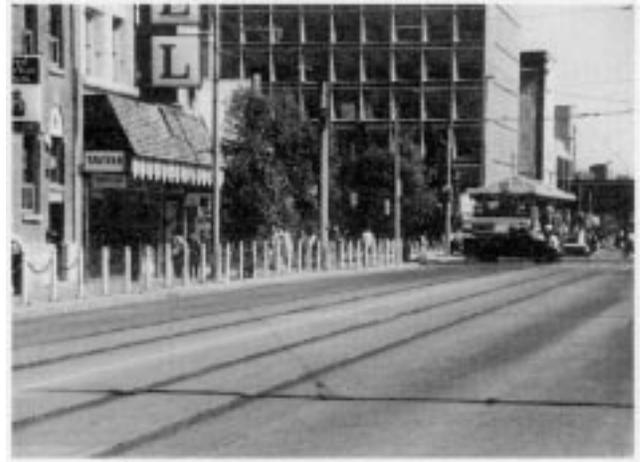
Figure 2-42. Calgary Curbside Pedestrian Barriers.

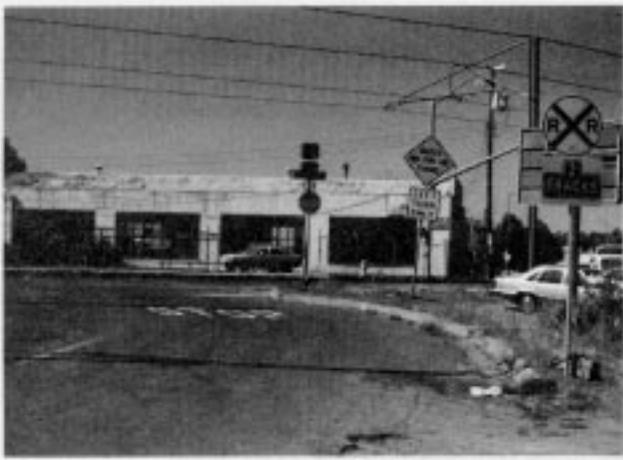
Figure 2-44. Sacramento Potential Closure of a Minor Street.

The side alignment along 12th Street is a major concern. Accordingly, the Sacramento Regional Transit District and the city of Sacramento are continuing to take a role in closing driveways and minor streets (e.g., Ahern Street) on the east side, where the LRT operates (see Figure 2-44).

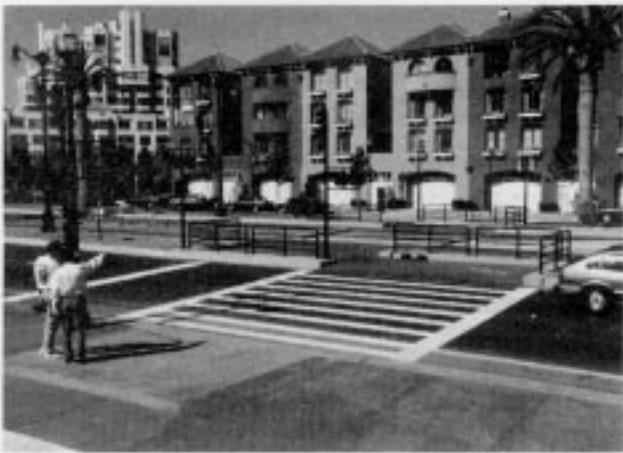
Figure 2-45. San Francisco Pedestrian Z-Crossing.

Where space permits, MUNI is installing median boarding station platforms where LRVs operate in the street (type c.1) to better protect pedestrians/passengers from parallel motor vehicle traffic. Further, as shown in Figure 2-45, MUNI has installed pedestrian Z-crossings along the South Embarcadero MUNI Metro Extension (type b.3) and plans to install them on the Mid- and North-Embarcadero F line (type b.3) as well. Using contrasting pavement texture and coloring at these crossings, MUNI has clearly marked the LRV dynamic envelope and pedestrian queuing safety areas.

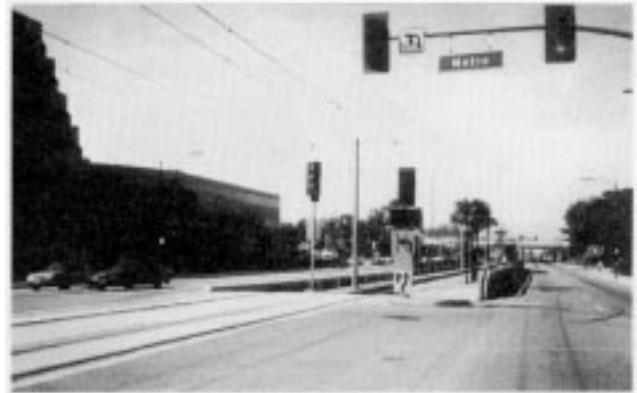
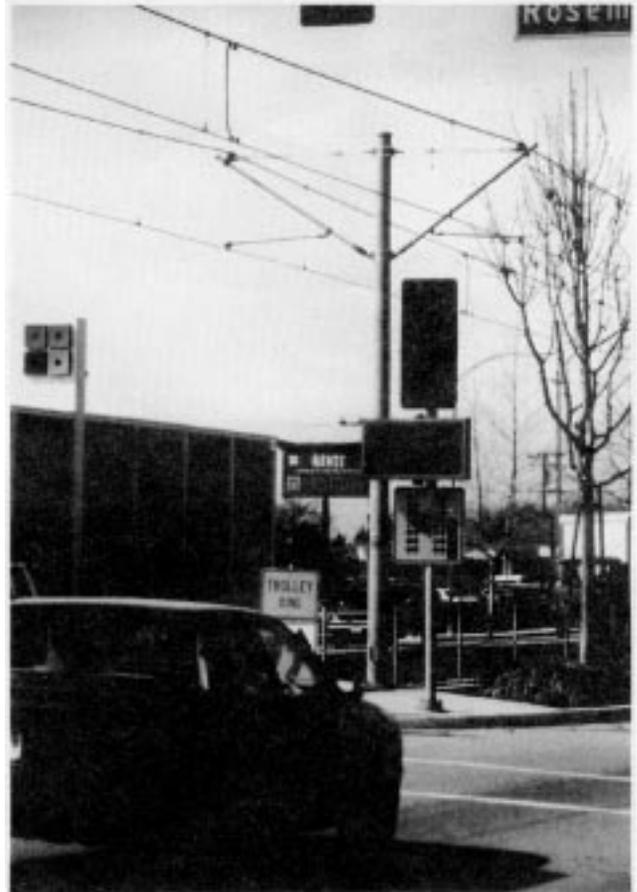
Figure 2-46. San Jose Left Turn Over LRT Tracks.

Further, based on their experience with the current system, SCCTA is not planning to install the square warning signs that depict LEFT TURN OVER LRT TRACKS in the planned LRT extensions. Instead, they plan to install only the active, internally illuminated TROLLEY COMING sign. Removal of the remaining LEFT TURN OVER LRT TRACKS signs is planned (see Figure 2-46).

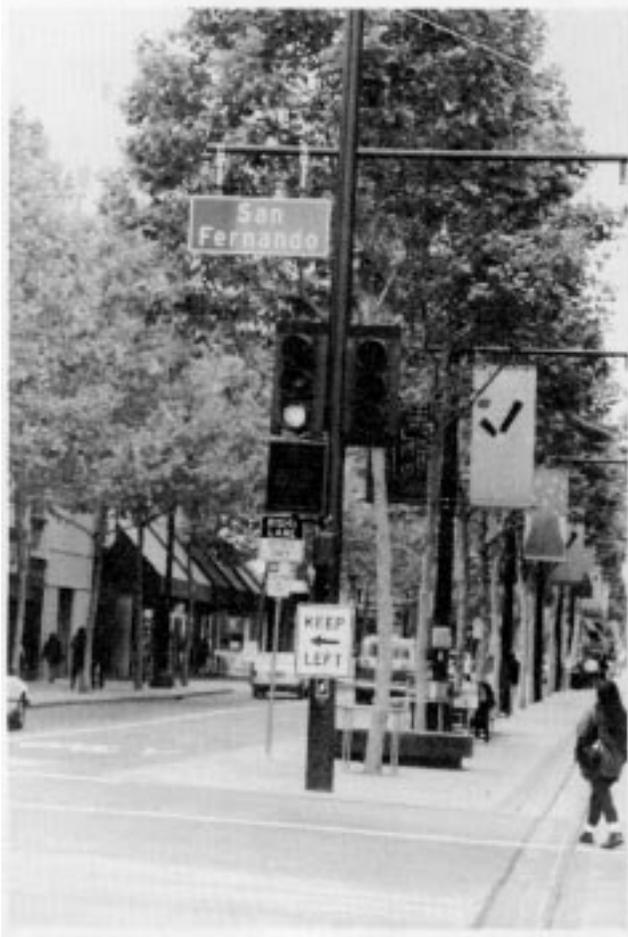
Figure 2-47. San Jose LRT Signal Louvers.

Changing the original far-side colored "T" LRT signal indications to a single white "T" with louvers has decreased confusion for motorists at signalized crossings (see Figure 2-47). Therefore, SCCTA plans to install farside, single-lens, white bar LRT signals in the planned extensions of the system. On the near side of the intersection, SCCTA will install louvered, three-head, colored "T" indication signals.
